**PRELIMINARY ASSESSMENT  
FOR  
CAU 485:  
CACTUS SPRING RANCH Pu AND DU SITE  
CAS NO. TA-39-001-TAGR:  
SOIL CONTAMINATION**

**TONOPAH TEST RANGE, NEVADA**

**Revision No. 1**

**JULY 1998**

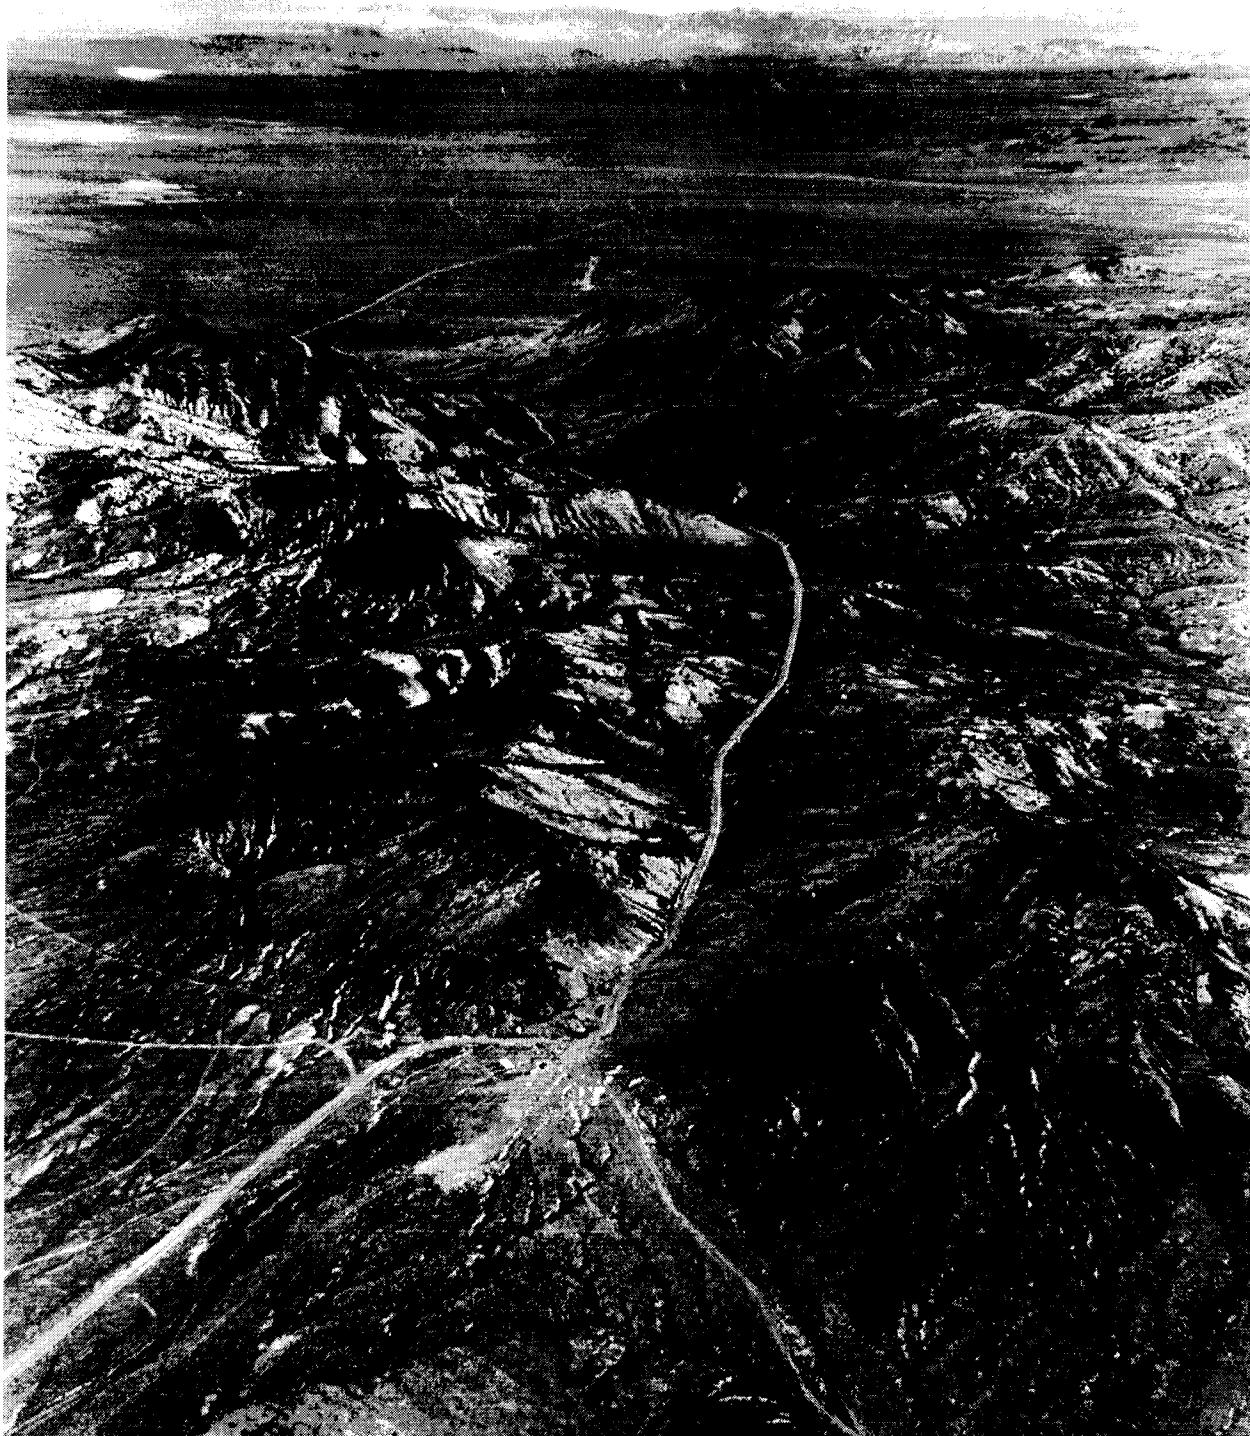
**Aerial view of Cactus Spring:** This view looking west shows Cactus Spring in foreground, Sleeping Column Canyon in midground, and Double Track Fallout Array on Range 71 (Nellis Air Force Base) in background (Photo # OH-3517). This photo was taken during or after 1963.

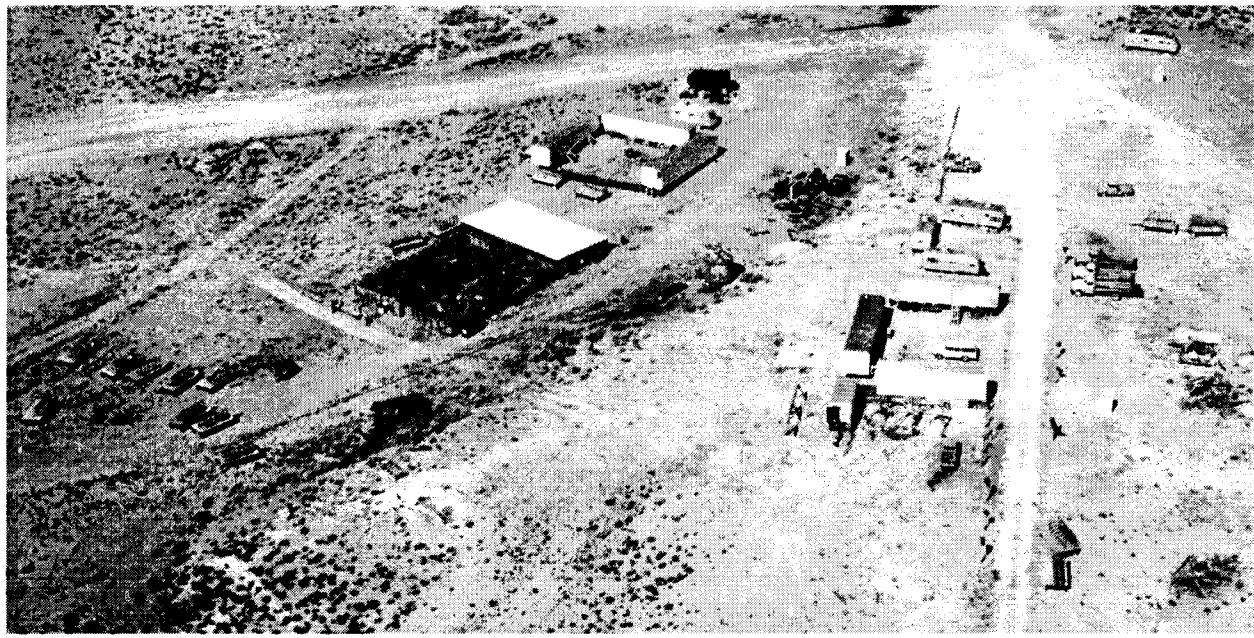
Aerial view of Cactus Spring Animal Farm from 400 feet above ground (Photo # OH-3491).  
Photo taken May 2, 1963.

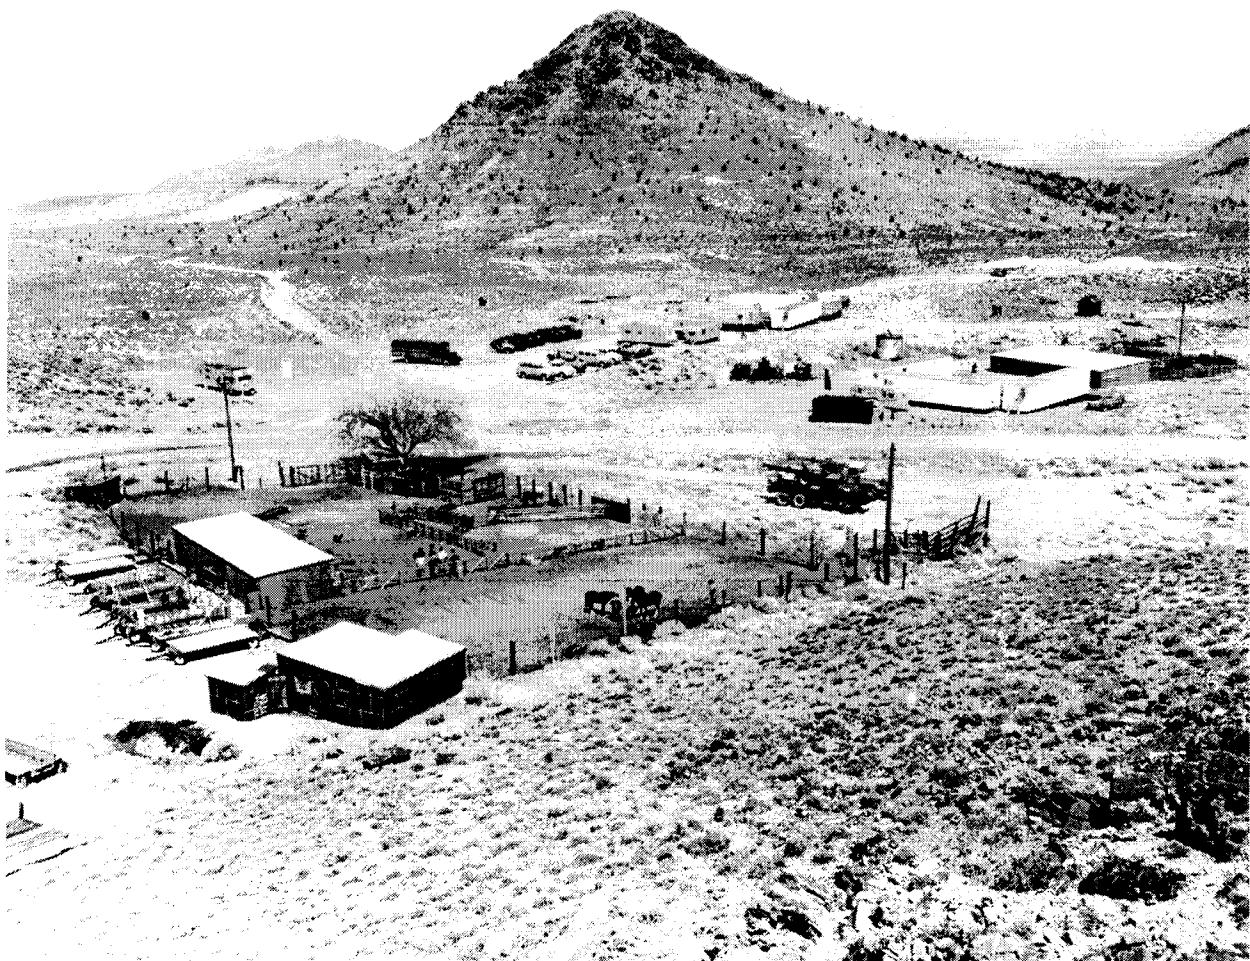
View of Cactus Spring Ranch, Tonopah Test Range, Nevada (Photo # OH-3490). Photo taken May 1, 1963.

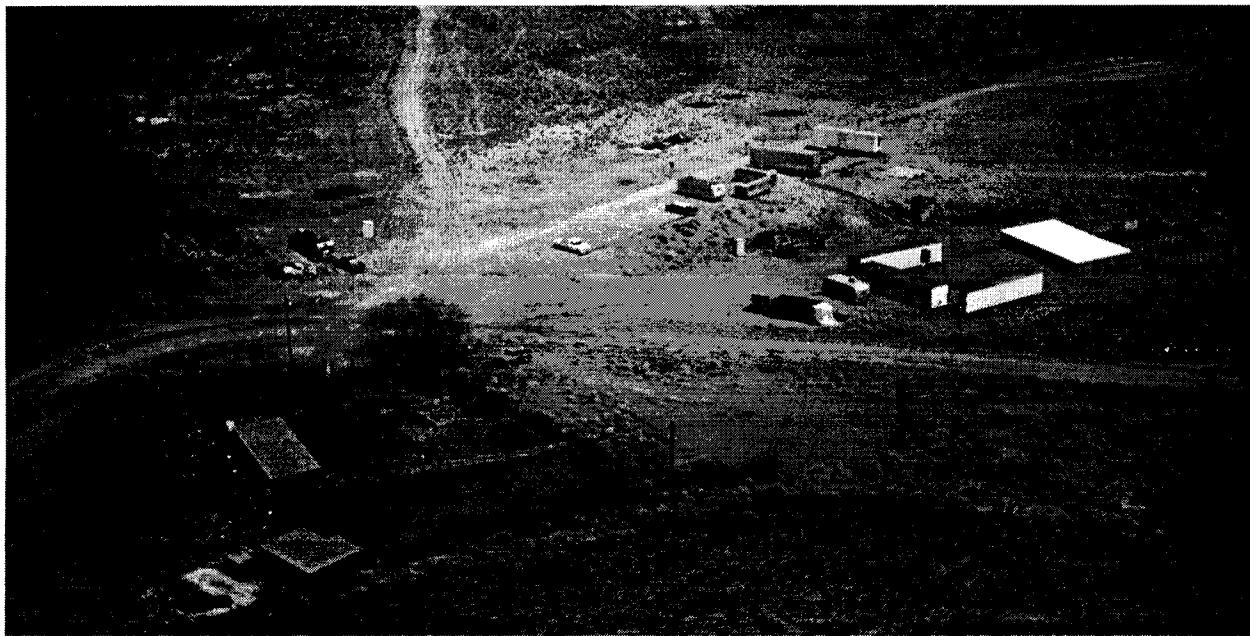
Cactus Spring Ranch/animal holding areas looking northeast (Photo # OH-3507). Photo taken in 1963.

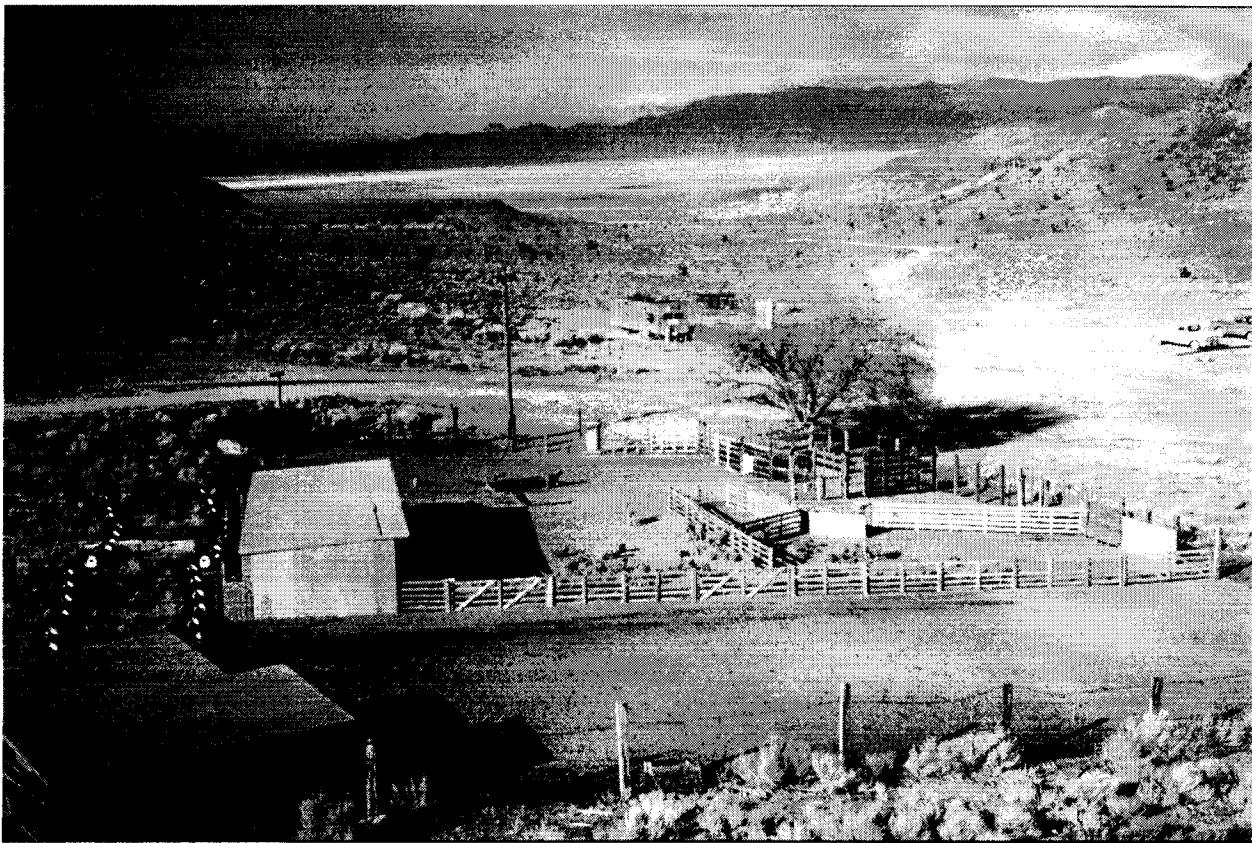
Cactus Spring Ranch/animal holding area looking northeast (Photo # OH-3513). Photo taken in 1963.

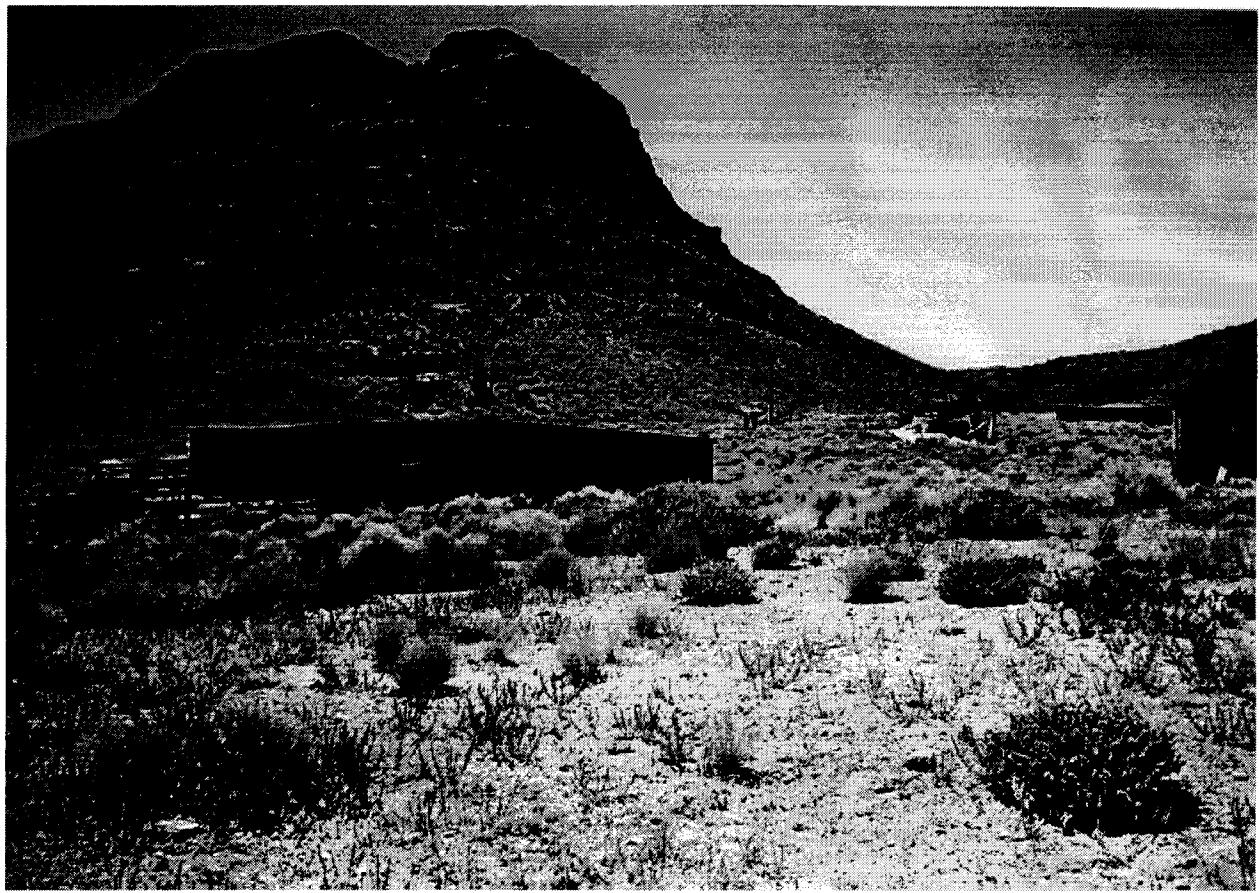
Remains of east burro shed at Cactus Spring Ranch in August 1993 (photo taken from IT monument # 50) (Photo # A-TTR-02-28).

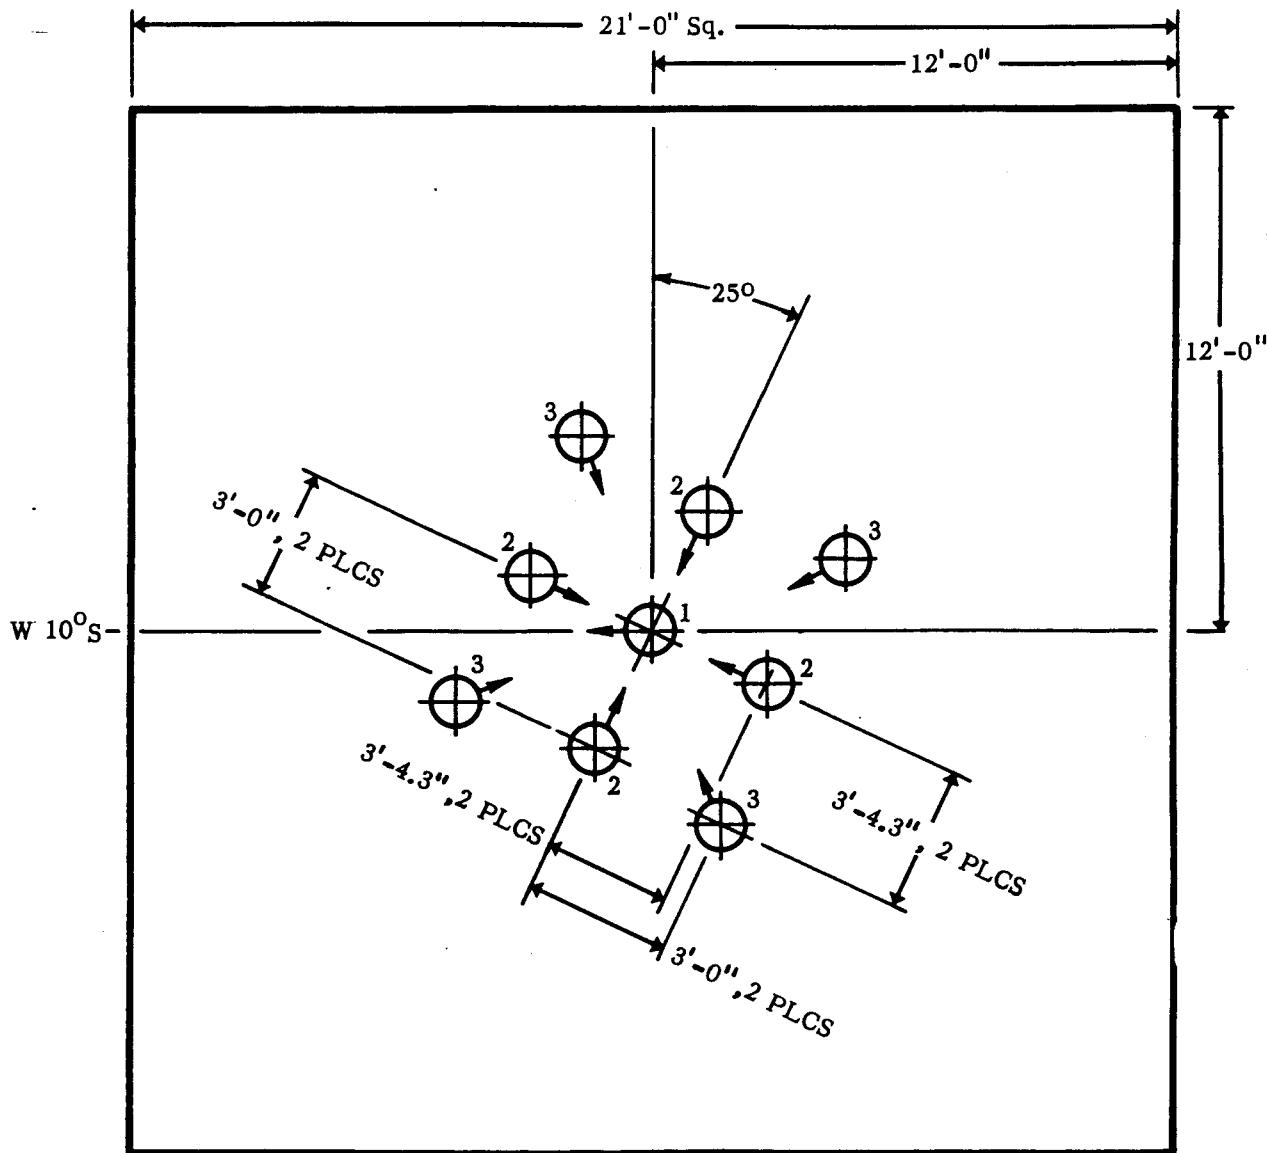
**Figure 2 – Clean Slate No. 1 Device Array**

Clean Slate 1 used a total of nine devices. One of the devices contained plutonium and had the same modifications as the one used for Double Tracks. The other eight devices did not contain plutonium; all orralloy, tuballoy, and plutonium were replaced with a similar mass of depletalloy.

ARROW INDICATES DETONATOR ORIENTATION

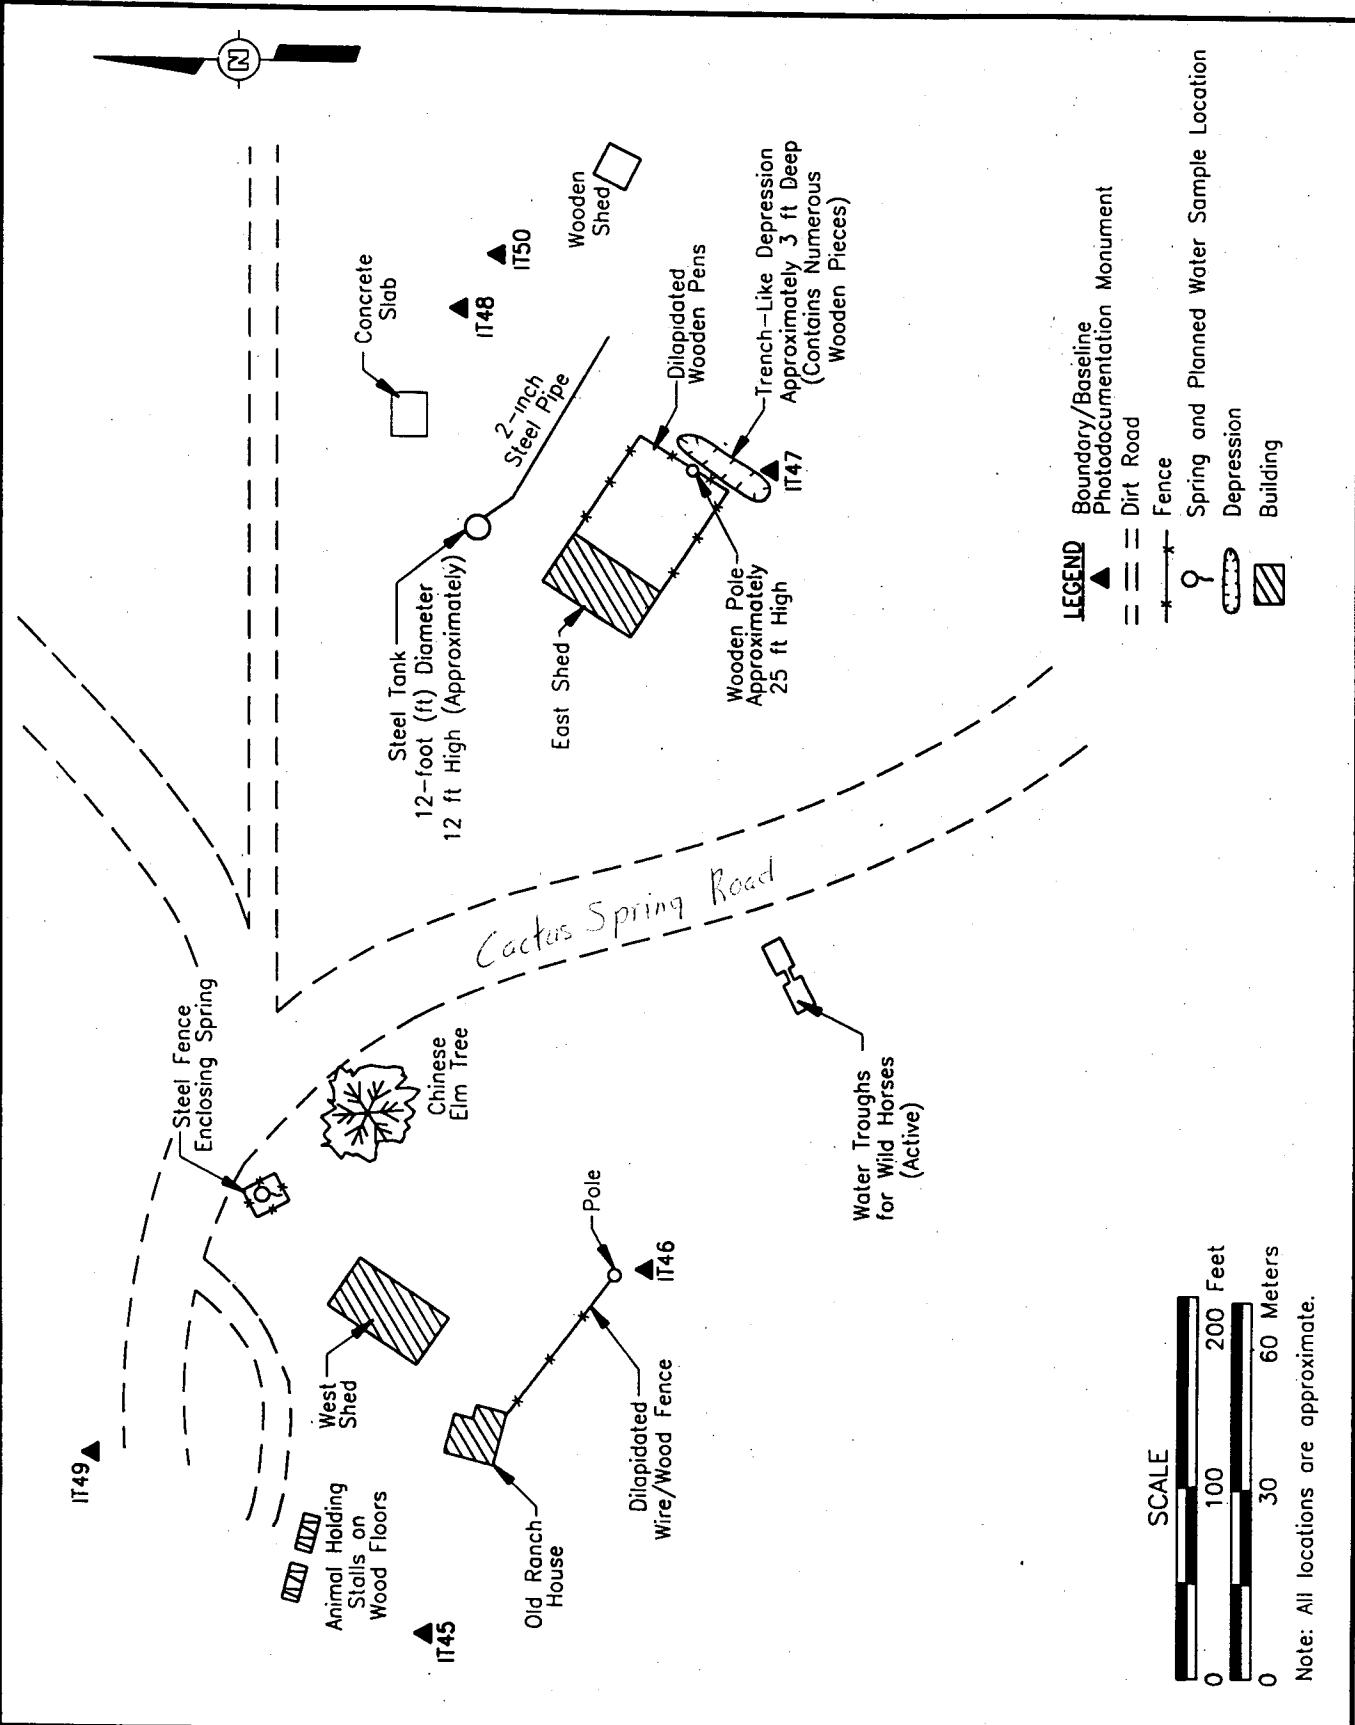
**Figure B-5**  
**Site Location Map, Cactus Spring Ranch,**  
**Tonopah Test Range, Nye County, Nevada**

The Cactus Spring Ranch CAS is the former Operation Roller Coaster animal holding facility and is located on the east flank of the Cactus Range. The facility is situated on a broad, moderately protected saddle at the east mouth of the Sleeping Column Canyon. The remains of several structures are located at this site and include dilapidated structures that pre-date

Operation Roller Coaster and two animal holding corrals that were constructed to support Operation Roller Coaster (Wilson, 1995a). The site terrain is comprised of uneven ground that slopes gently to the east. A natural spring discharges near the Cactus Spring road and flows a short distance to the southeast before infiltrating into the subsurface. The historical and archeological importance of the site have not been evaluated at this time.

- The Cactus Spring Site is located within a canyon on the east flank of the Cactus Range. The remains of several structures are located at this site and include dilapidated structures that pre-date Operation Roller Coaster and two animal holding pens. The site terrain is comprised of uneven ground that slopes to the east. A natural spring discharges near the Cactus Spring Road and flows a short distance before infiltrating into the subsurface (DOE/NV, 1996). This natural spring could transport radionuclides, and this possibility should be considered.
- Coordinate information is available for IT monuments 45 through 50 (Rodriguez, 1997).
- See Figure B-5 for locations of IT monuments 45 through 50 (DOE/NV, 1996).

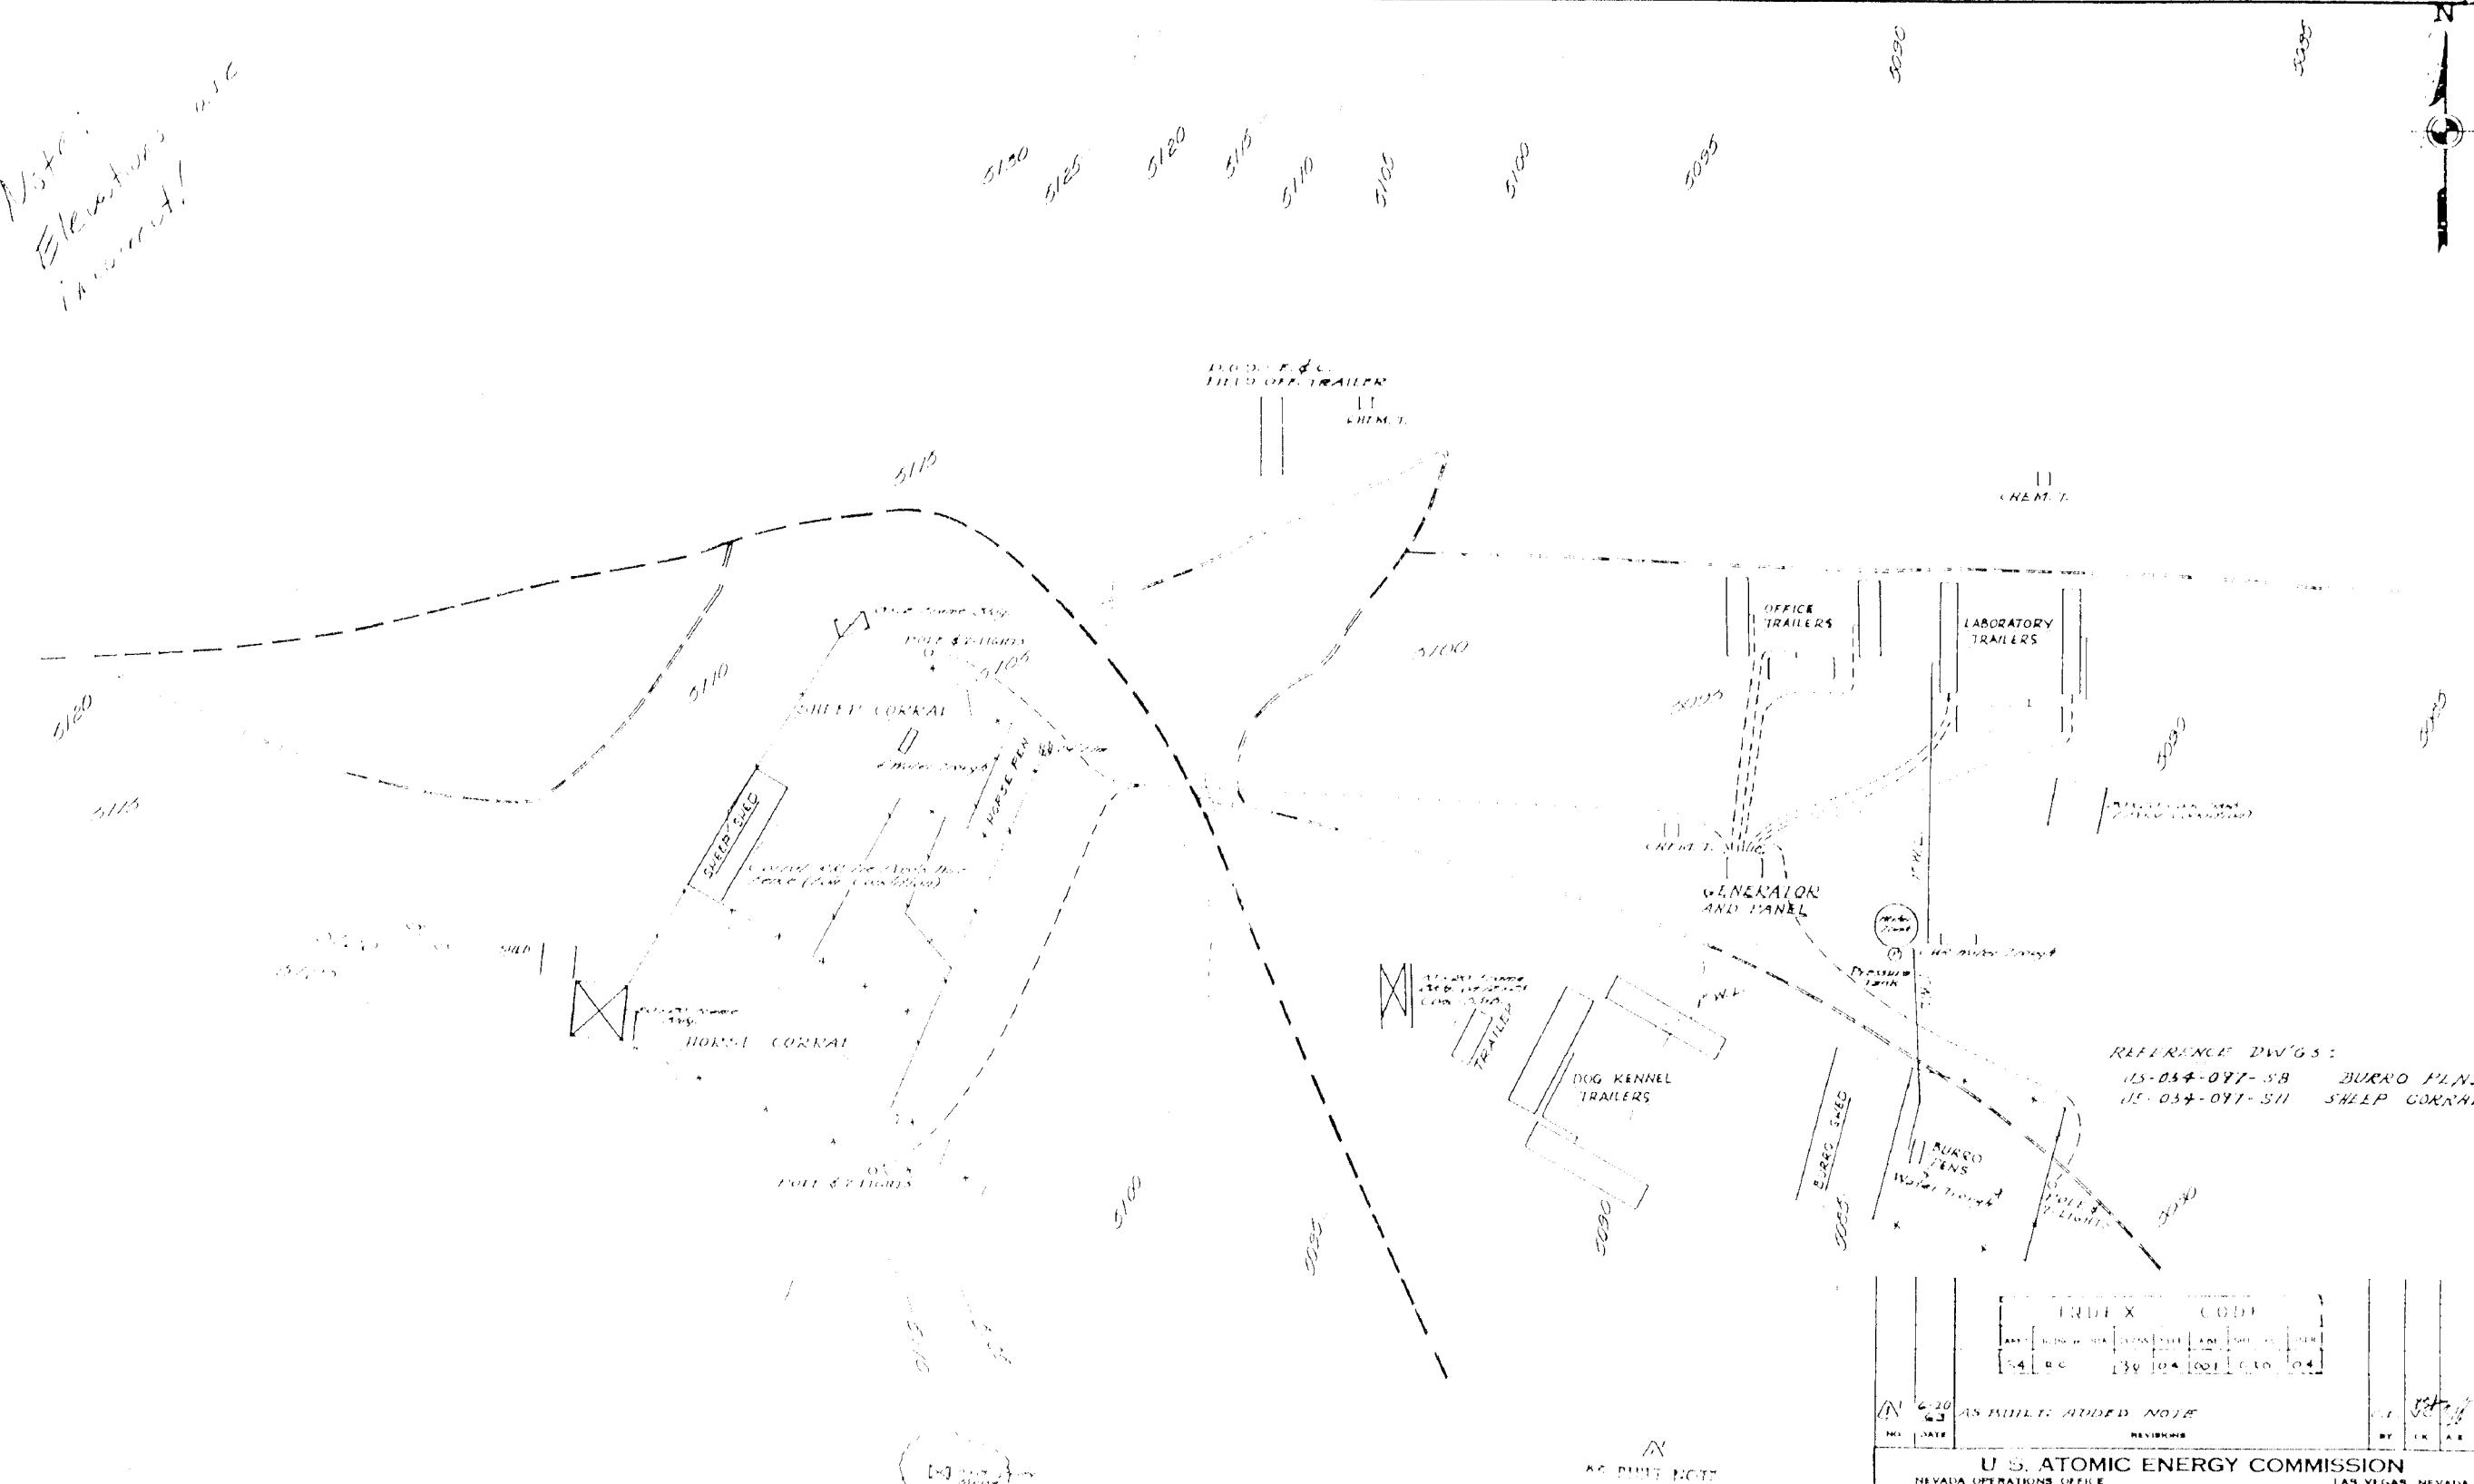
**Drawing of Cactus Spring Animal Holding Area**

AS BUILT  
HOBSON & HARVEY, INC.  
Engineers - Constructors  
Date 6/27/63 By C.L. TORDA  
Approved: *C.L. Torda*

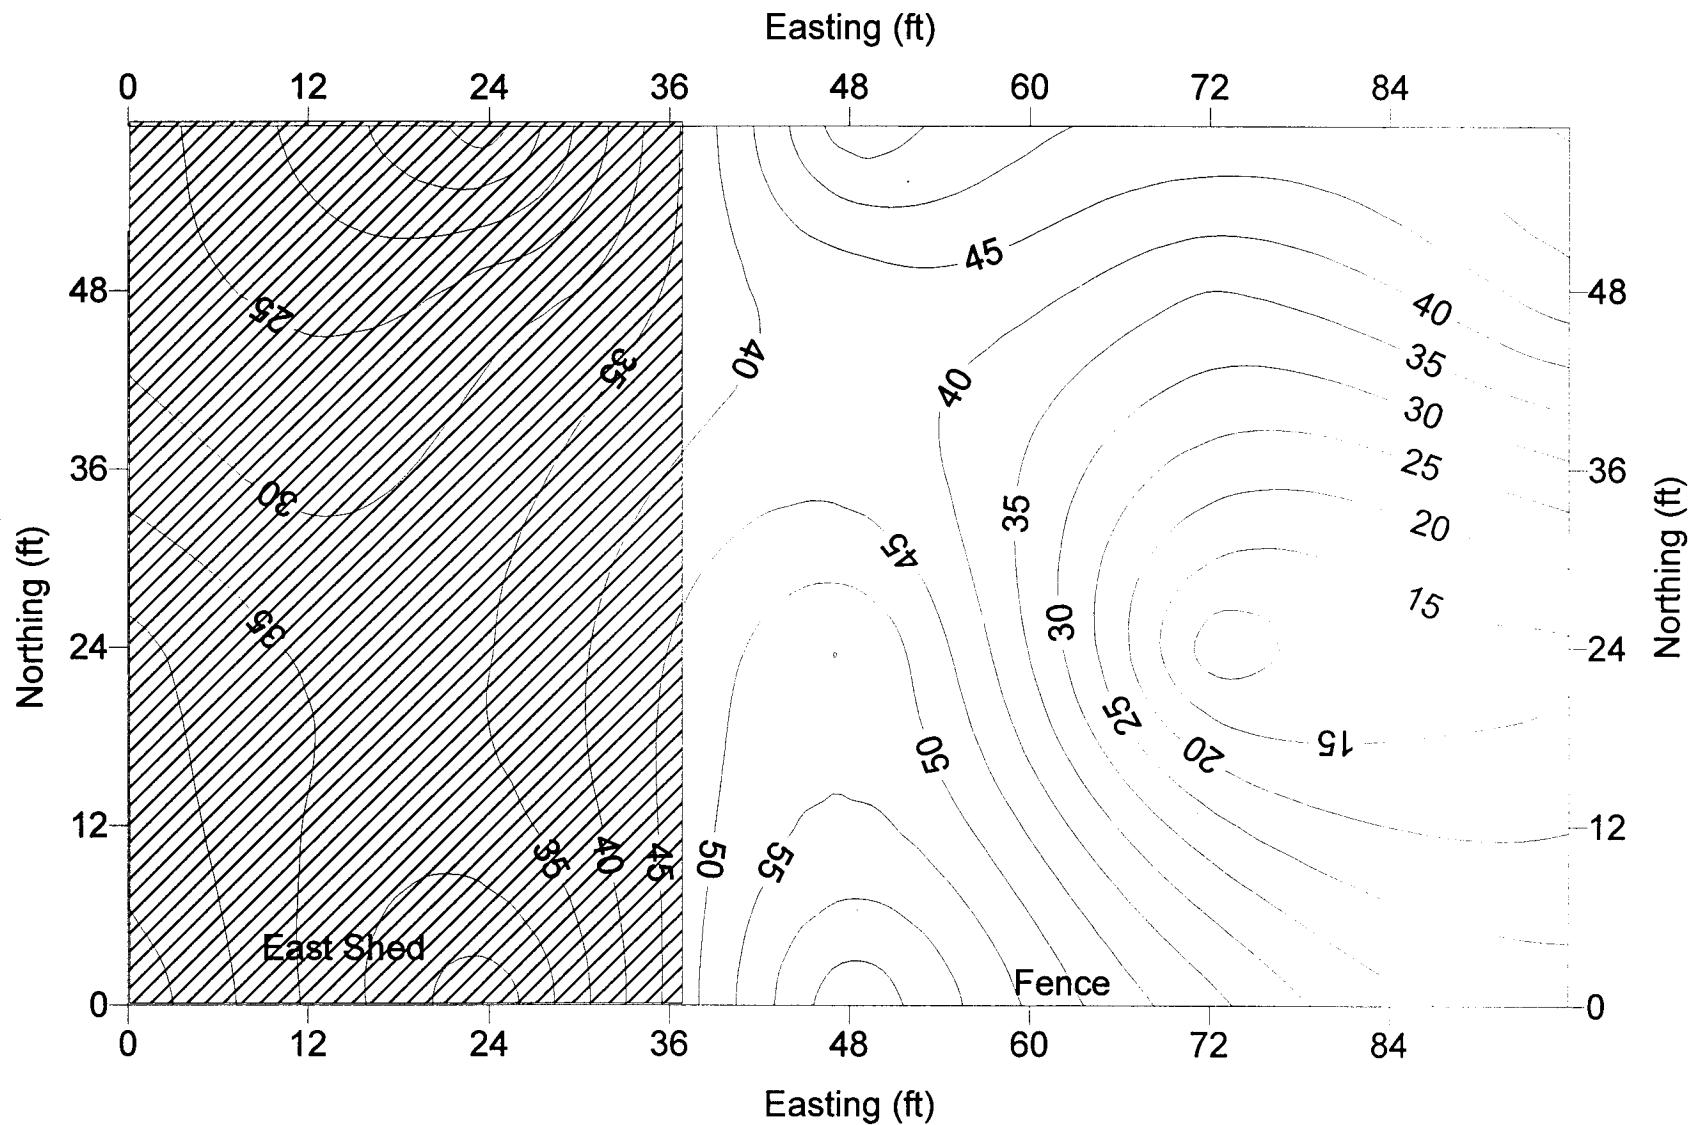
The results of the surveys are shown in Figures 2 through 7. Figures 2 through 4 show isoactivity lines for the alpha, beta, and gamma surveys performed at the east shed and holding pen. Figure 2 is the alpha activity survey for the east shed and holding pen. The survey results do not demonstrate the presence of elevated surface alpha activity above that found at background locations. The alpha areal activity concentration varies from 10 to 65 disintegration per minute per square decimeter ( $dpm/dm^2$ ). The alpha activity changes slowly from one location to another without any abrupt increases. This would be expected for two reasons. First, the activity of the animals would tend to distribute the surface soil uniformly around the pen and shed area. Secondly, the potential Pu activity from the burros' excretions is minimal in comparison to the alpha activity emitted from the natural alpha emitters present in the soil. The Pu expected to be present on the soil surface, less than 1 picocuries per gram ( $pCi/g$ ), is only a small fraction of the alpha activity emitted from natural uranium and thorium isotopes and their alpha-emitting decay products, which range from 12 to 25  $pCi/g$  of total alpha emissions (McArthur and Miller, 1989; Atlan-Tech, 1992). There is elevated alpha activity in the vicinity of coordinates easting 48-feet (ft) to 49-ft and northing 0 to 3-ft. The area defined by the easting 48-ft and northing 3-ft coordinates represents the highest alpha activity measured in the east shed and holding pen area. The alpha activity concentration represents the normal variation in concentration of background alpha emitters.

# Cactus Spring Soil Contamination East Shed and Holding Pen

## Beta Measurements (DPM/100 sq. cm)

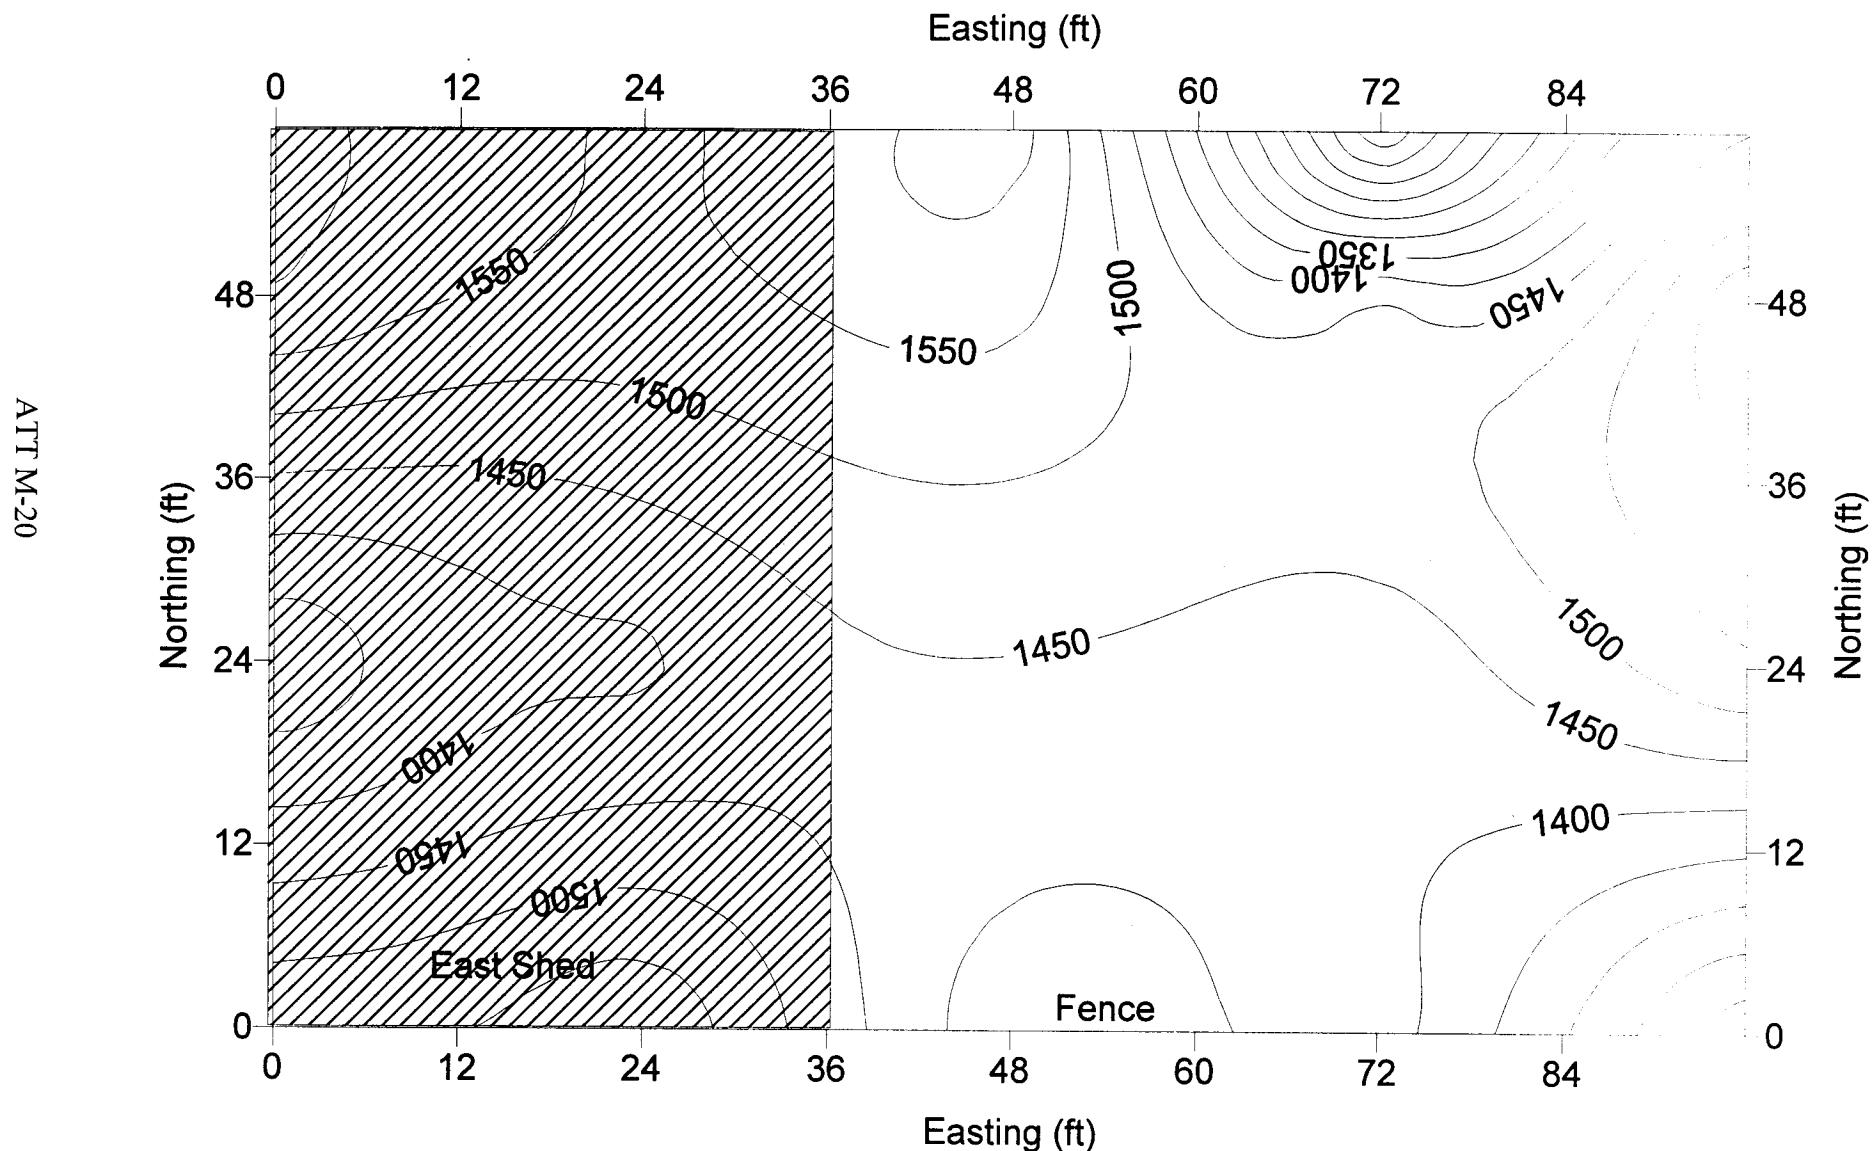
Figure 3

The beta contamination survey results for the east shed and holding pen are shown in Figure 3. Like the alpha survey results discussed previously, no elevated concentrations were detected above background. The beta activity varies from 1,400 to 1,550 dpm/dm<sup>2</sup>. The only Pu isotope that is a beta emitter is <sup>241</sup>Pu and it contributes about thirty percent of the total Pu activity source material (DOE, 1996). No other beta emitting Pu decay product will have grown-in sufficiently during the last thirty-five years to contribute significantly to the beta activity. The natural, total beta activity in surface soils ranges from 50 to 80 pCi/g (McArthur and Miller, 1989; Atlan-Tech, 1992). The highest beta survey results are in the vicinity of coordinates easting 52-ft and northing 3-ft. The beta survey results are not inconsistent with the variations in natural background.

# Cactus Spring Soil Contamination East Shed and Holding Pen

## Gamma Count Rate Measurements (CPM)

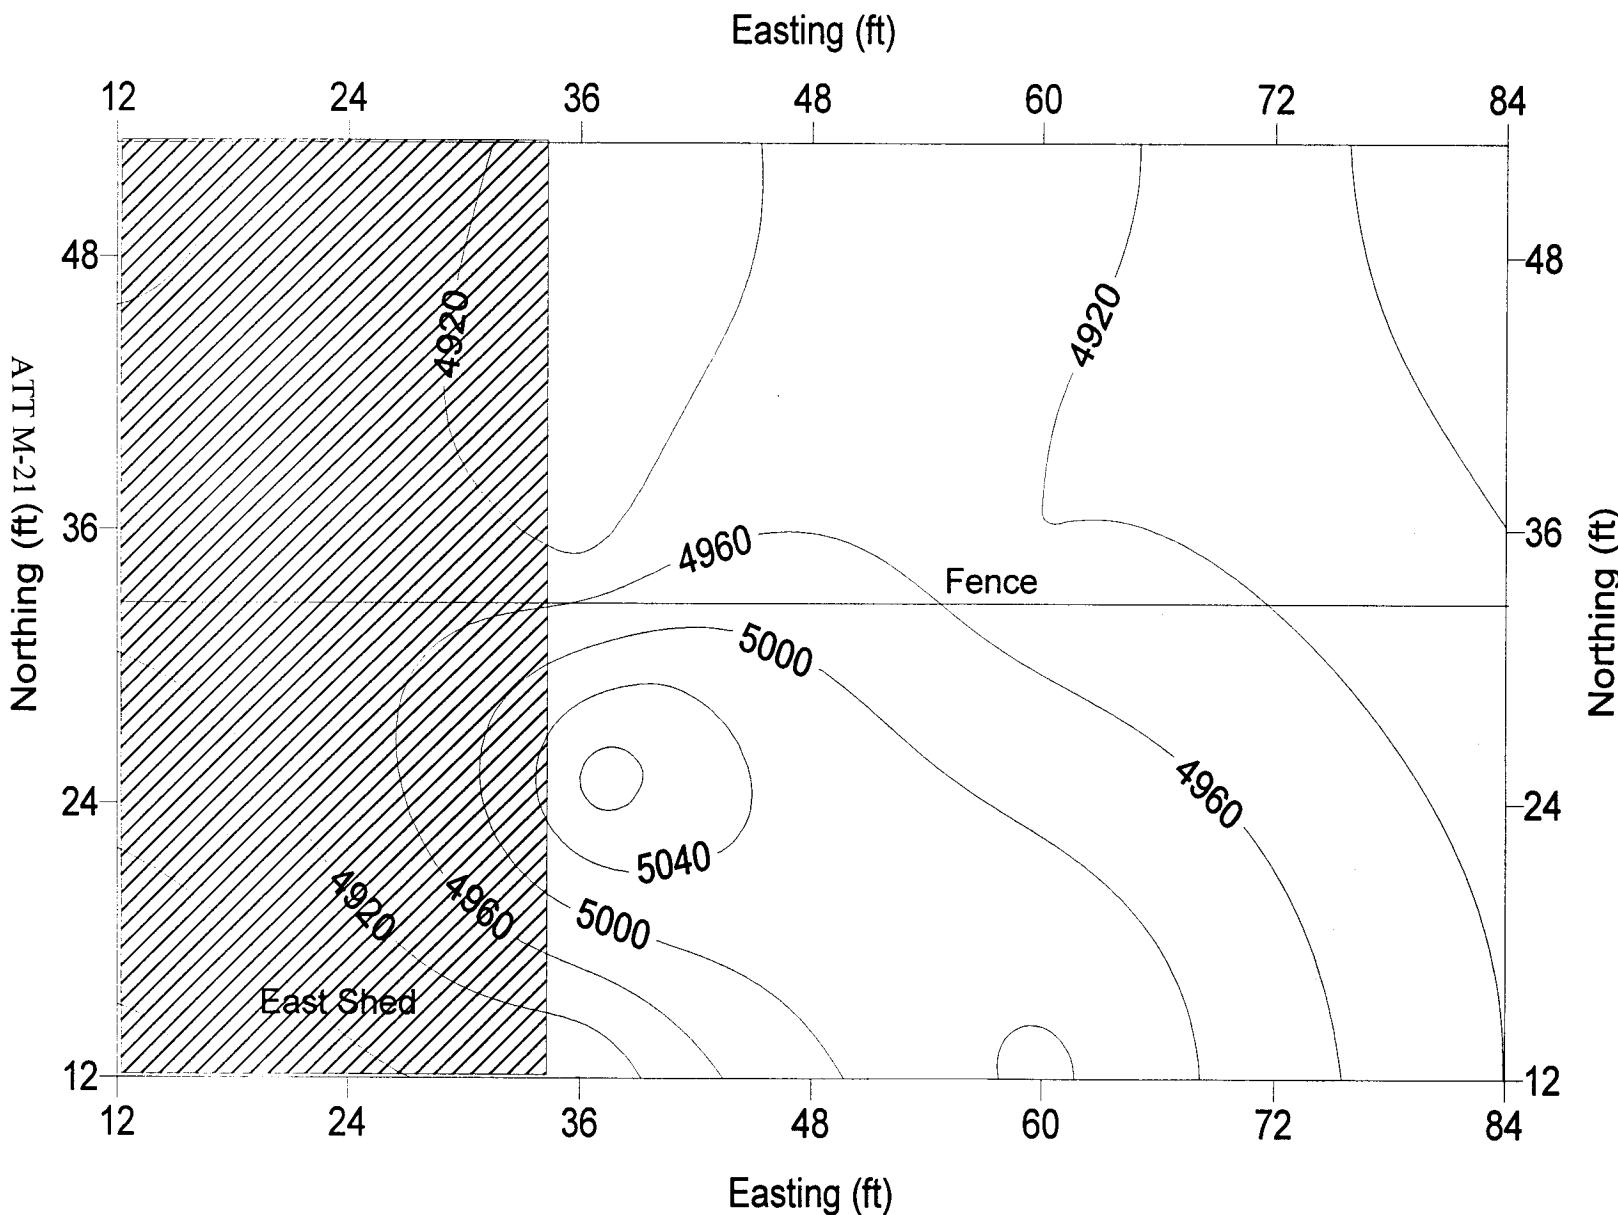
Figure 4

The gamma count rate measurements for the east shed and holding pen are shown in Figure 4. The source material used in the Roller Coaster tests emits gamma photons, most of them coming from the americium-241 (<sup>241</sup>Am) growing in from the decay of the <sup>241</sup>Pu. The <sup>241</sup>Am emits a 59.6 kiloelectron volt (keV) photon during 35.7 percent of its emissions (Shleien, 1992). Like the previous two surveys, this survey did not detect count rates exceeded that found in background locations. The gamma count rate varies from 4,920 to 5,080 count per minute (cpm). These values are not different from the background count rates taken from the vicinity of the east shed and holding pen area (Speer, 1998). There is a trend of elevated gamma contamination in the vicinity of coordinates easting 36 to 38-ft and northing 23 to 25-ft. These values are more due to the variation in the natural background, but based upon the data shown in Figure 4, they represent the highest gamma count rate.

# Cactus Spring Soil Contamination West Shed and Holding Pen

## Alpha Measurements (DPM/100 sq. cm)
