**PRELIMINARY ASSESSMENT  
FOR  
CAU 485:  
CACTUS SPRING RANCH Pu AND DU SITE  
CAS NO. TA-39-001-TAGR:  
SOIL CONTAMINATION**

**TONOPAH TEST RANGE, NEVADA**

**Revision No. 1**

**JULY 1998**

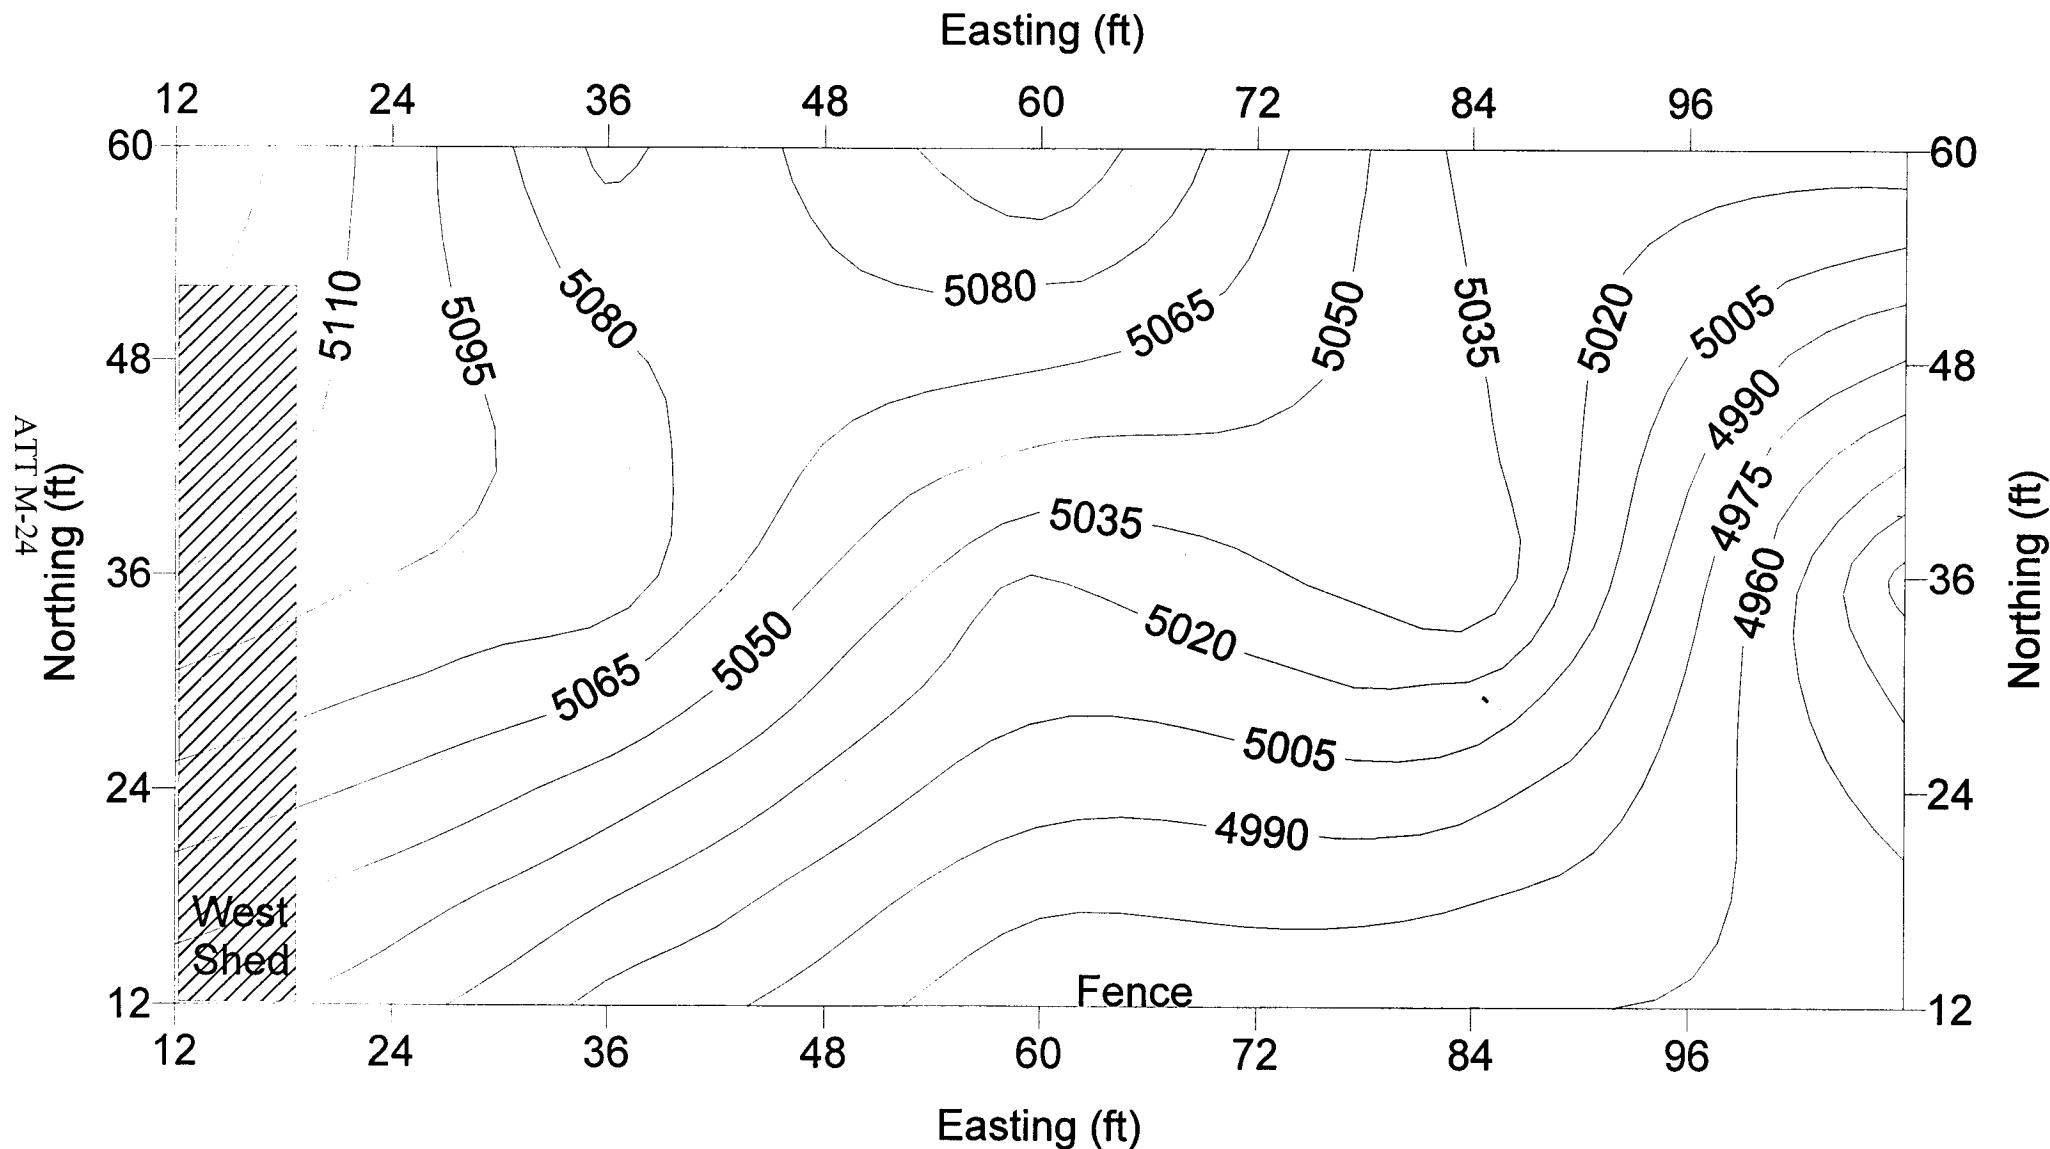
Figure 7

The gamma count rate measurements for the west shed and holding pen are shown in Figure 7. Like the previous gamma surveys, this survey did not detect any elevated gamma activity exceeding that found in background locations. The gamma count rate varies from 4,915 to 5,125 cpm. These results are not different from the gamma count rates taken from the east shed and

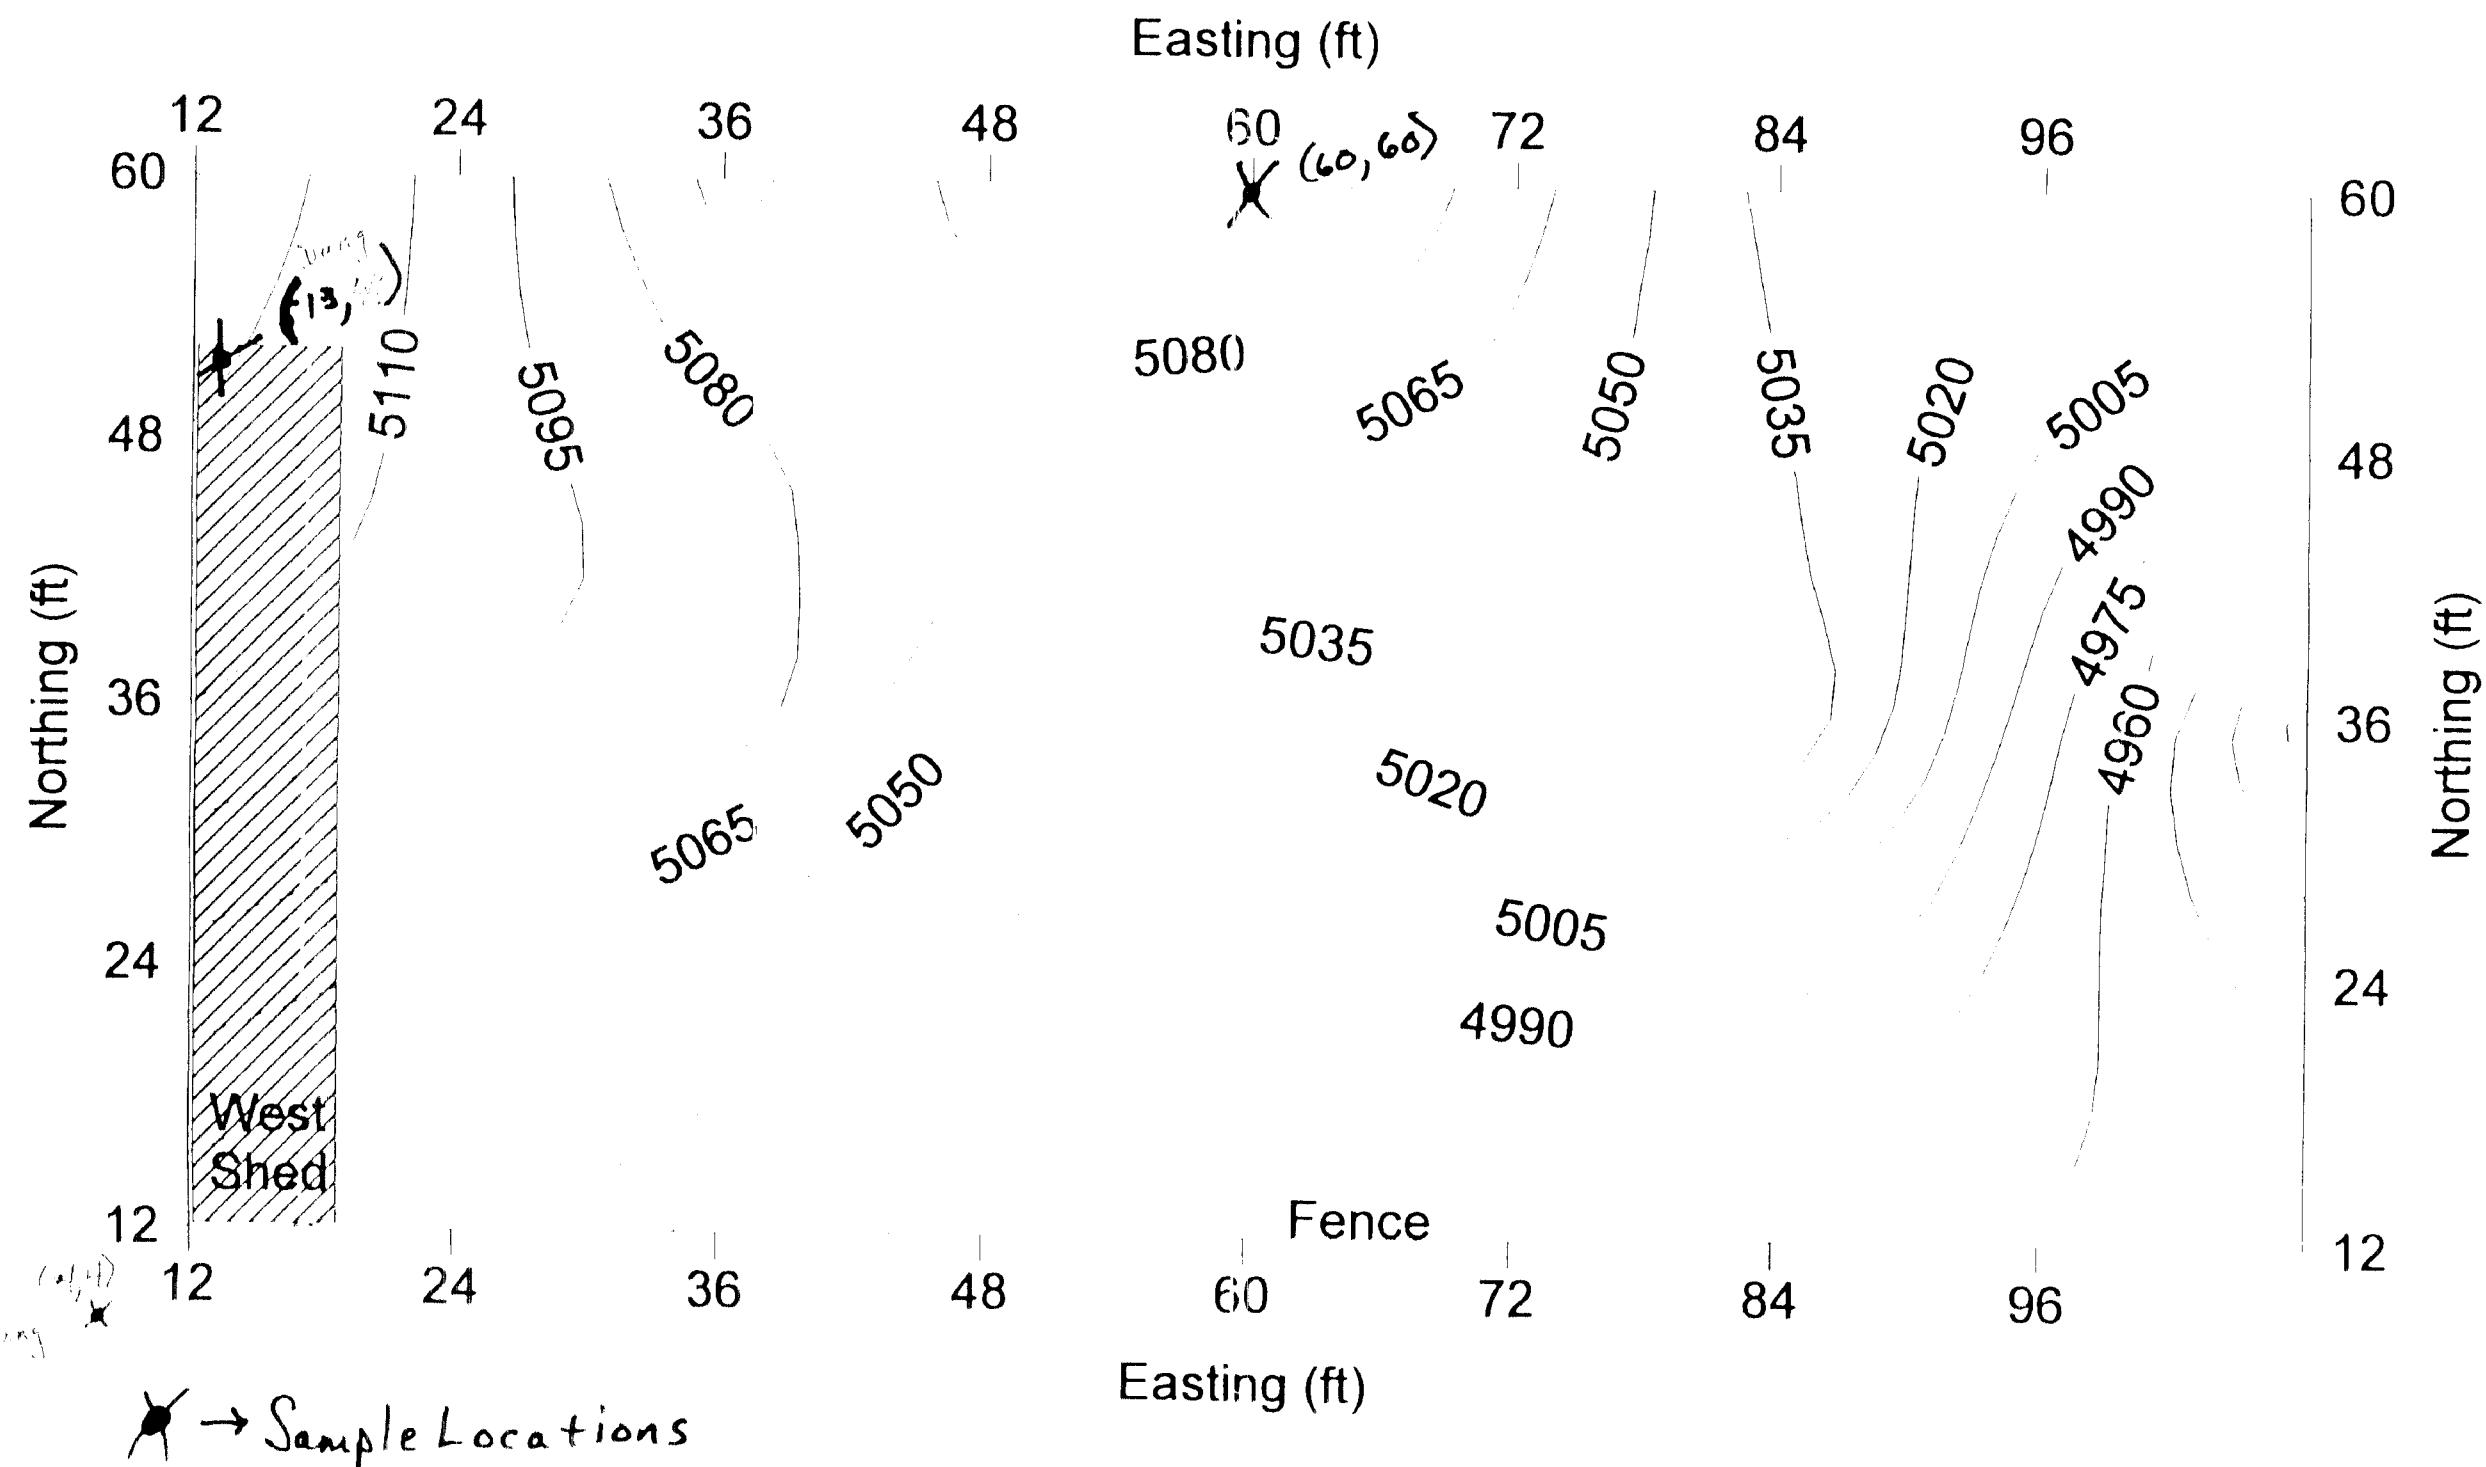
# Cactus Spring Soil Contamination West Shed and Holding Pen Gamma Count Rate Measurements (CPM)
