SAND99-0099  
Unlimited Release  
Printed January 1999

# **Subsidence at the Weeks Island SPR Facility**

## Subsidence at the Weeks Island SPR Facility

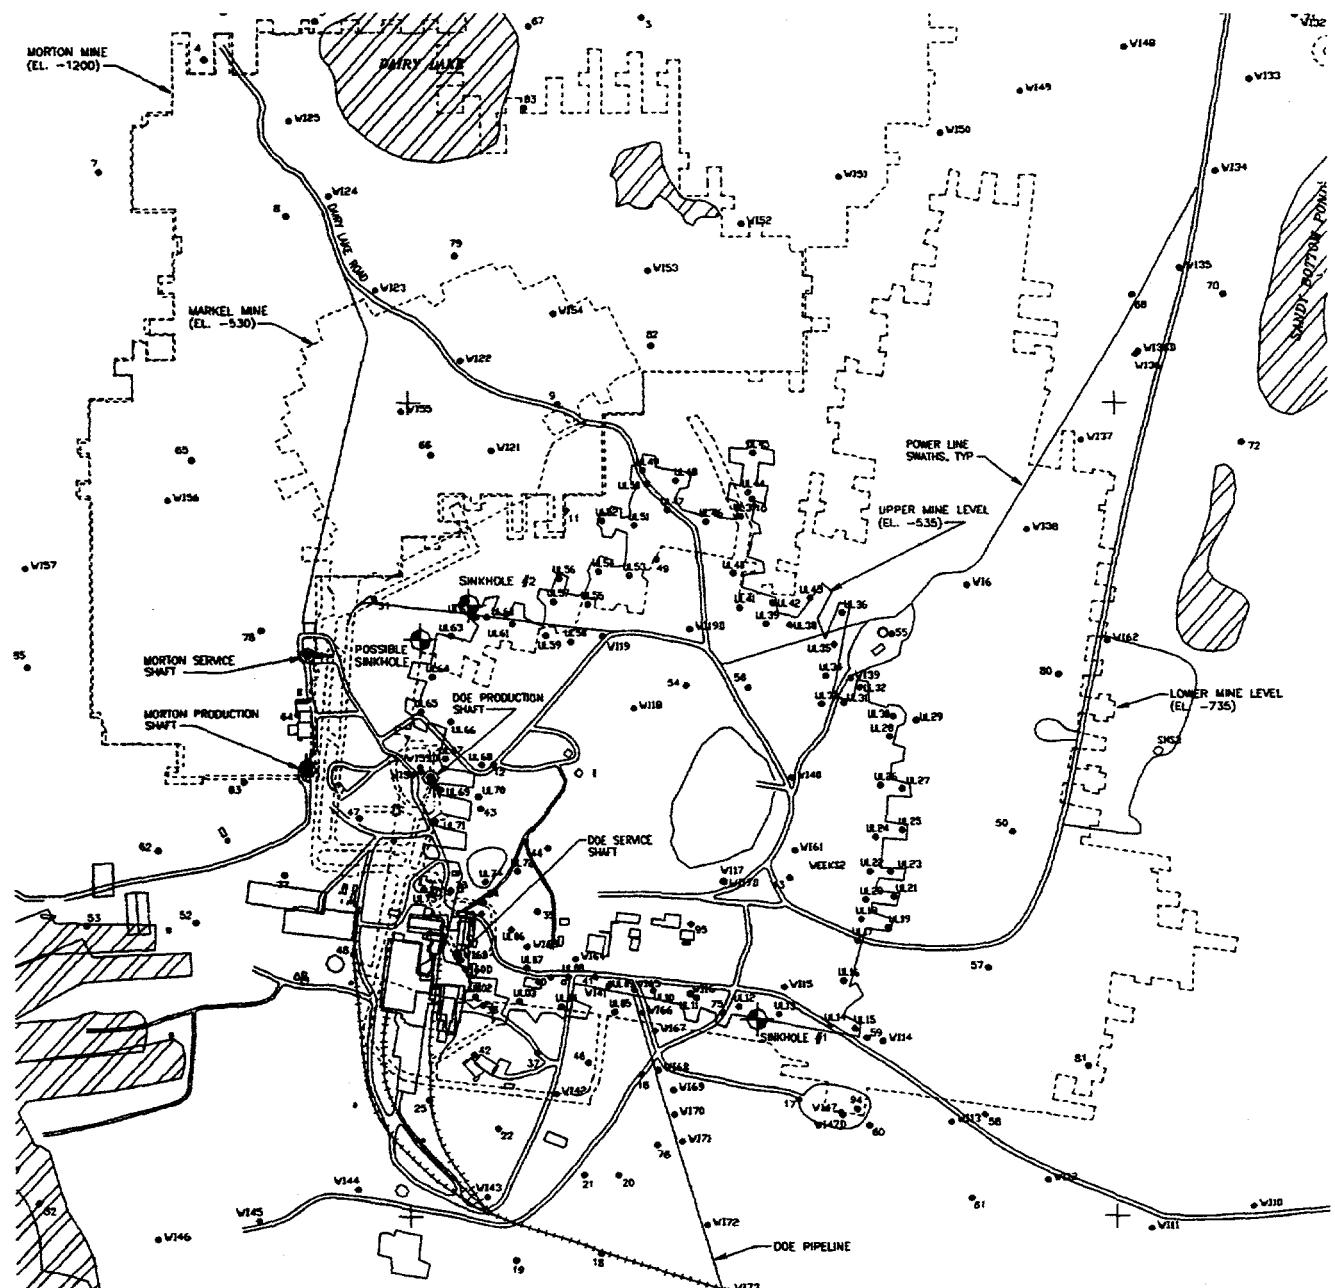
Figure 1. Site location map showing mine footprints and locations of newer subsidence monuments.

The Weeks Island Strategic Petroleum Reserve (SPR) facility is a former conventional two level room and pillar mine (Figure 1) purchased by the Department of Energy (DOE) from Morton Salt for the purpose of storing SPR oil. The mine was originally opened in 1902 and salt was extracted commercially until 1977, at which time Morton Salt developed a new mine immediately adjacent to the northwest while the older workings were converted for oil storage. The mine contained approximately 73 million barrels of crude oil from 1981 to 1996, at which time the removal of oil began.

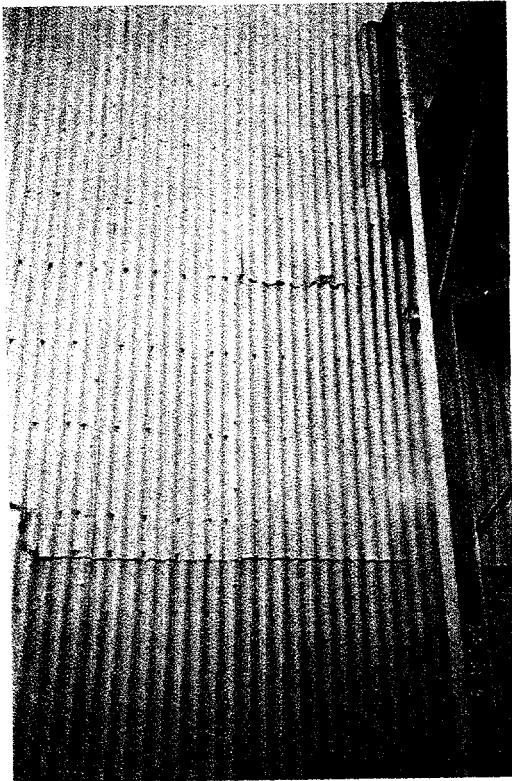
In mid September inspections of the Production Shaft building at Weeks Island were made in conjunction with other site related work. Observations of the exterior of the building show striking compressional features on the northeast side of the building (displaced nail holes and folded and faulted fiberglass sheeting) as shown in Figure 2. The deformation is accommodated on the southwest side of the building with extensile features as indicated by stretched nail holes in the fiberglass sheeting, horizontal cracks in the basal blocks of the building, and vertical cracks in the airlock room as shown in Figure 3. In addition, this room may be separating from the rest of the structure.

Figure 2a. Distant view of bent and sheared fiberglass panels on northeast side of hoist building.

From the above observations, it appears that the Production Shaft building is leaning from the southwest to the northeast towards the center of subsidence over the mine. Evidence of the origin of this leaning can be seen inside the building. The floor may be described as an inner collar that comes right up to the shaft edge, and an outer collar area. In places there is a horizontal separation between the two collar segments as evidenced by Figure 4. Little to no relative vertical displacement was observed at this parted interface. The joint appeared to have been sealed at some time in the past with a bead of silicon joint compound. The joint now has more than half an inch of horizontal offset in places. Both the inner collar and outer collar are cracked, however, the outer collar appears to be much more heavily cracked.

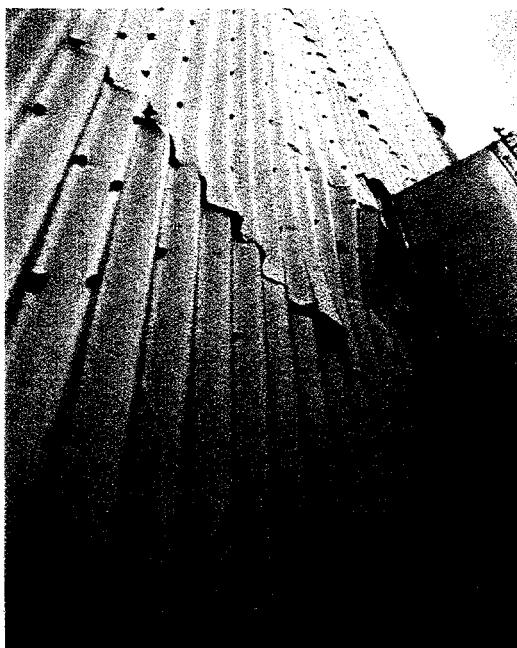
Figure 2c. Oblique view of bent and sheared fiberglass panels on northeast side of hoist building.

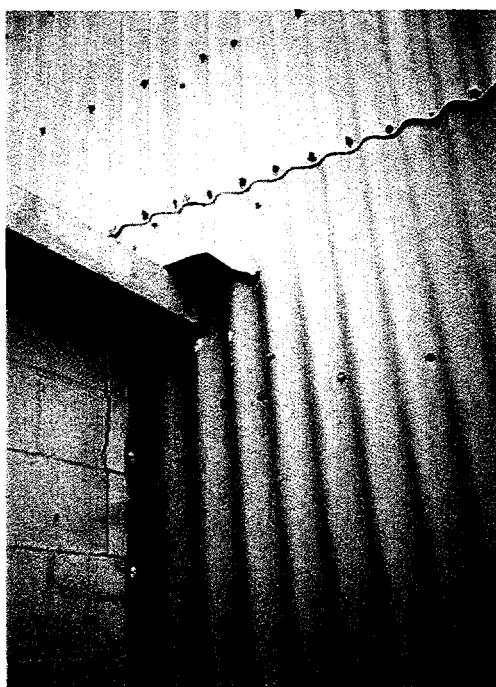
Figure 3a. Vertical crack in wall joining airlock room and hoist building (southwest side of hoist building).

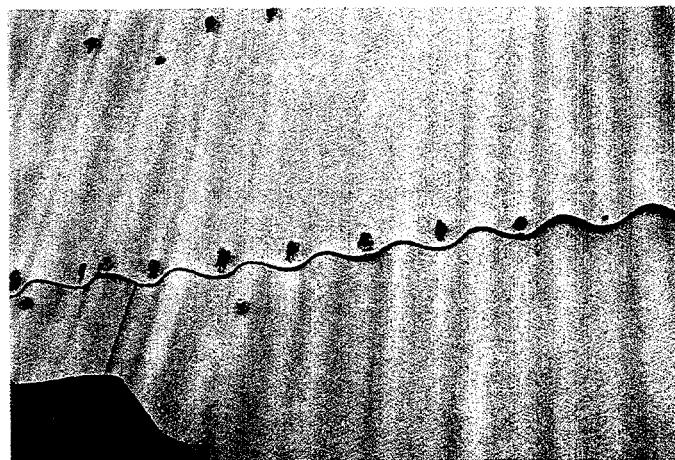
Figure 3d. Stretched (extended) nail holes on southwest side of hoist building.

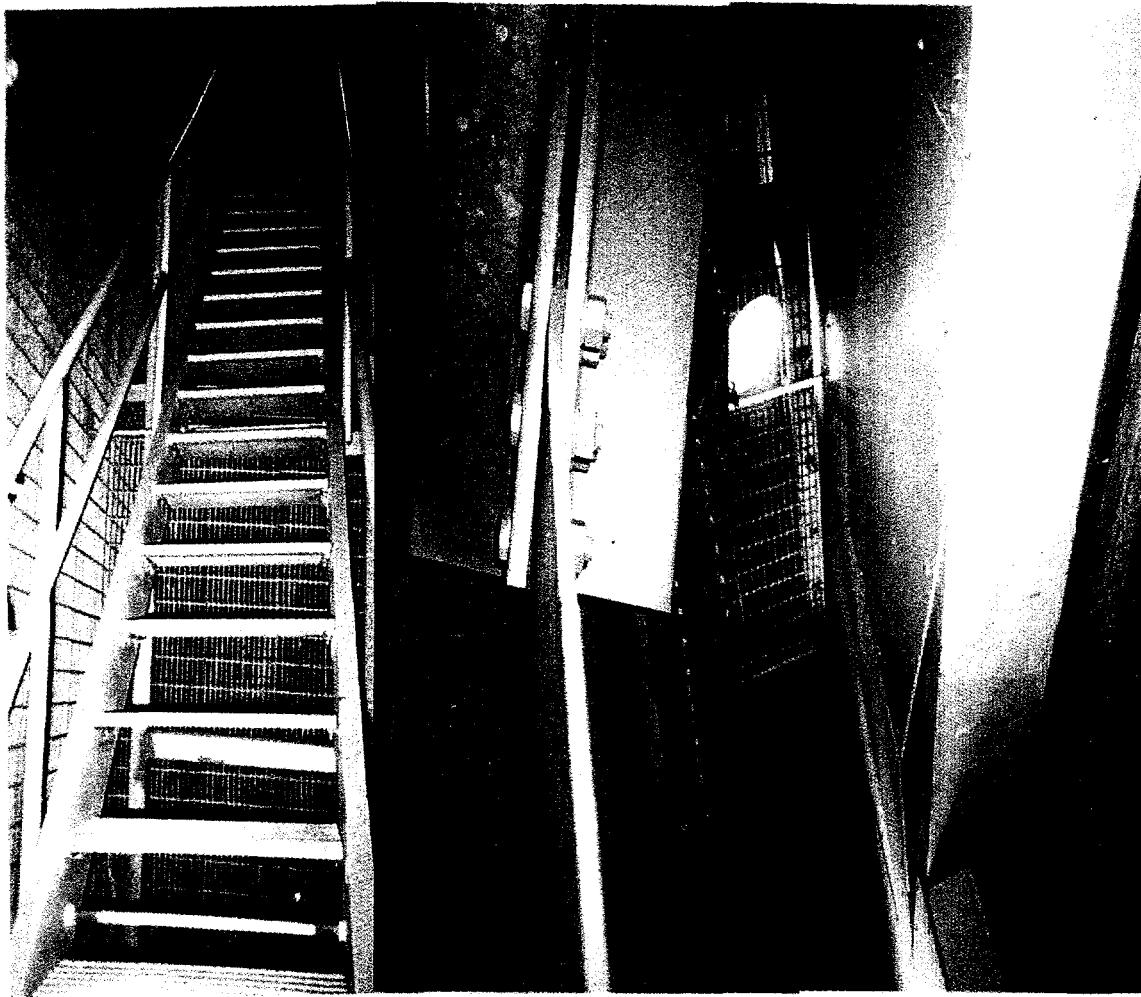
The cracked concrete pad shows some vertical displacement immediately above the shaft liner where the inner collar appears to be lifted about an inch. This amount of displacement is consistent with the amount of cracking in the 3 to 4 foot thick concrete pad. The fiberglass panels inside the building are buckled in places, a stair rail is bent

and a steel joint is cracked adjacent to a bent steel member (Figure 5). The function of all of these elements has been maintained. These observations are not unexpected given the pad cracking. Some leaning of the building frame has likely occurred, and certain non-structural elements have deformed in response.

Figure 5. Bent stair rail, bent steel member and cracked steel joint, and buckled fiberglass panels inside hoist building.

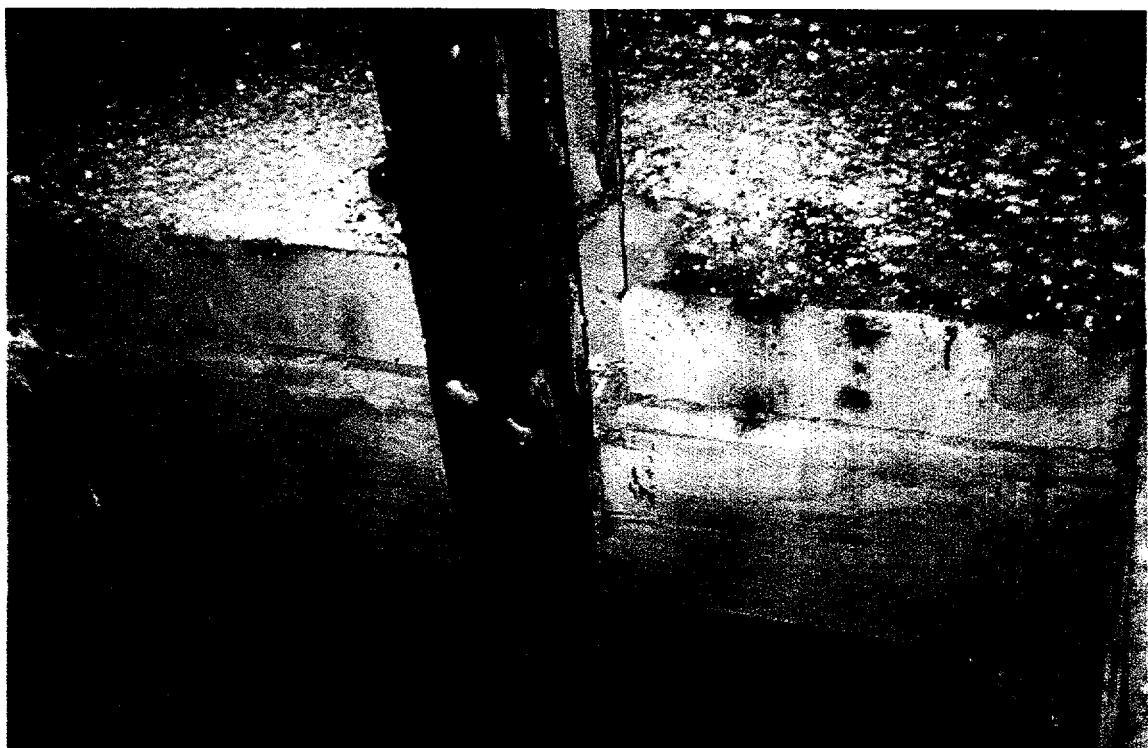
Deformation immediately around the shaft itself was also observed (Figure 6). The lift guides are tied to massive horizontal timbers through an intervening steel plate. Immediately below where the guides are tied to the massive horizontal timber members there is a horizontal crack in each of the horizontal timber members. The crack in each opposing member appears widest (about 0.5") at the center of the beam; the crack on both timbers dies out at the ends. It appears that the timbers are being pulled upward from where they are fastened to the vertical guides. It is adjacent to the cracked horizontal timbers that the inner collar appears to be lifted off the timbers about an inch. One corner of the inner collar had localized deformation in the form of cracking and shear displacement. No cracks were observed in either of the cross timbers, which run perpendicular to those connected to the lift guides. Also, it is important to note that no cracks were observed in the vertical lift guide timbers. The function of the system is again retained.

Figure 6a. Vertical lift guide connected to massive horizontal (cracked) timber. Note vertical separation between inner collar and the top of the timber (about an inch). Also note lack of deformation in timber perpendicular to the cracked one.

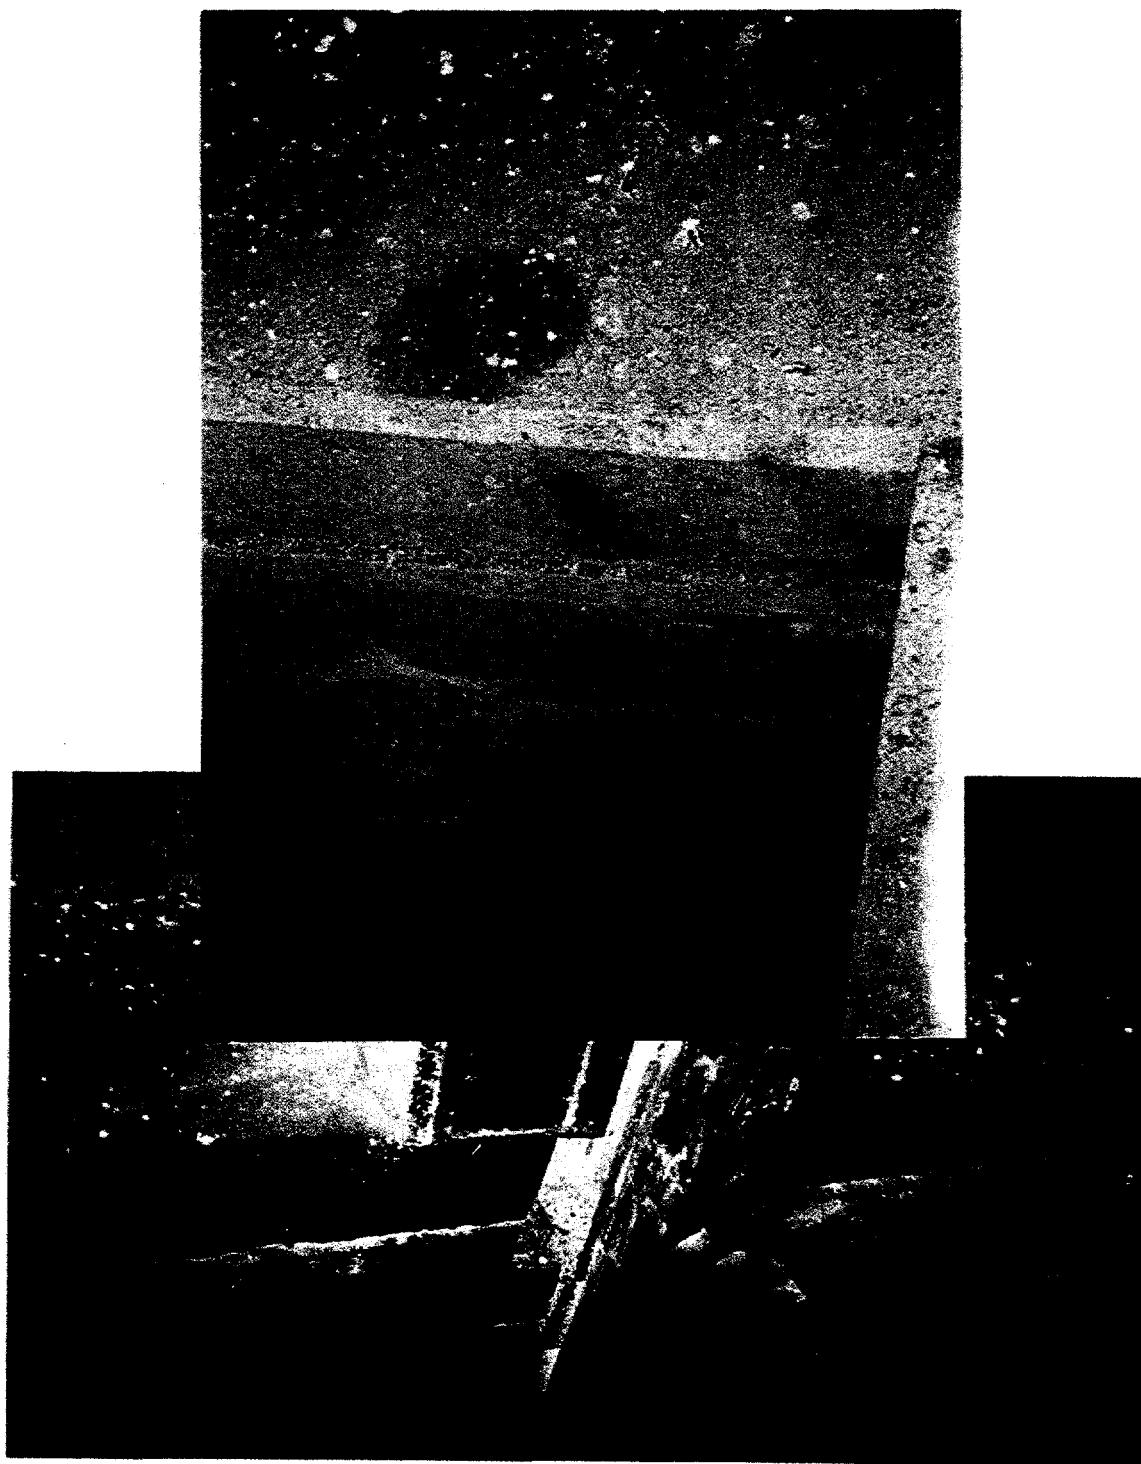
Figure 6b. Vertical lift guide connected to massive horizontal (cracked) timber on opposing side to Figure 6a. Note similar vertical separation between inner collar and the top of the timber (about an inch). Also note localized deformation in corner of concrete collar.

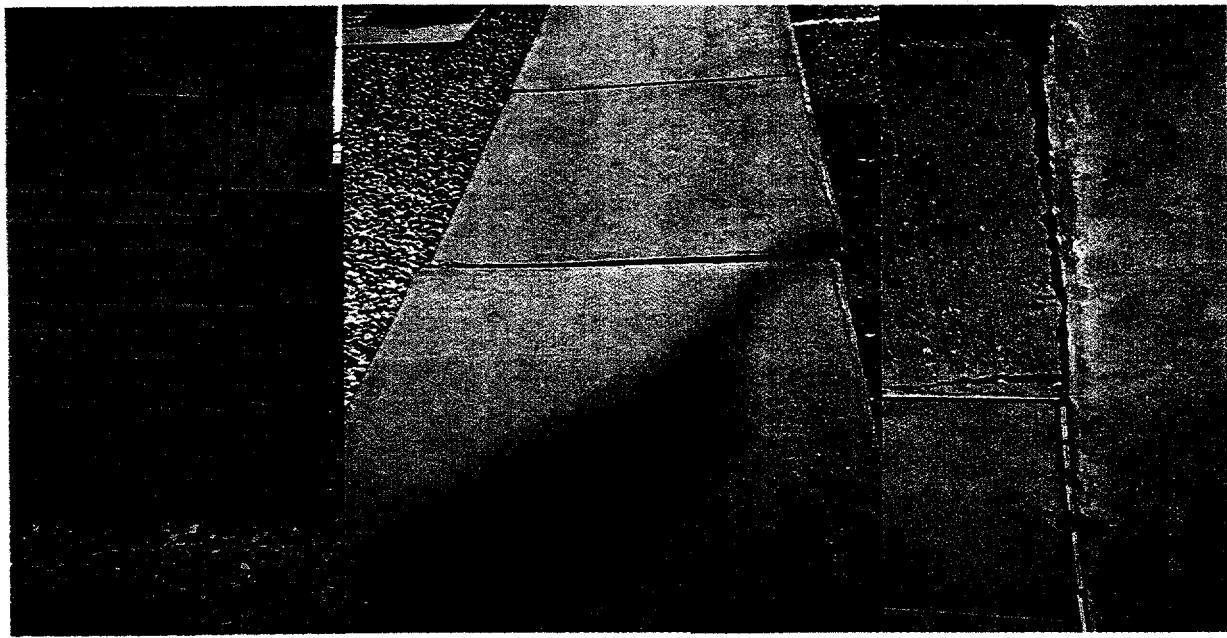
Some observations were made inside the DOE main area, that are indicative of damage to surface facilities, which are also likely the result of surface subsidence. The brick fascia on the corners of the administration building has vertical cracks and attendant displacement. The concrete walkway on the south of the administration building and the one to the west of the old guard house has been cracked and displaced (Figure 7). A pipe support is sinking away from the pipe it is supposed to be supporting and a concrete abutment is rotating (Figure 8). There are cracks in the block work inside and outside of the door to the restroom next to the shop and shear cracks can be found in the tile work in the wall of the restroom (Figure 9). These observations should be expected in facilities which overlie ground across which considerable differential subsidence has been documented. The function of these facilities has not been effected by the deformations present. Further, the observations have led to an increased awareness of subsidence and its effects on surface facilities, an increase in the frequency of subsidence measurements, and a more aggressive attitude towards brine refill of the mine.

Figure 7. Administration building area: (a) cracking and horizontal displacement of brick fascia and (b) displacement of concrete walkway and (c) cracking and displacement of concrete walkway.

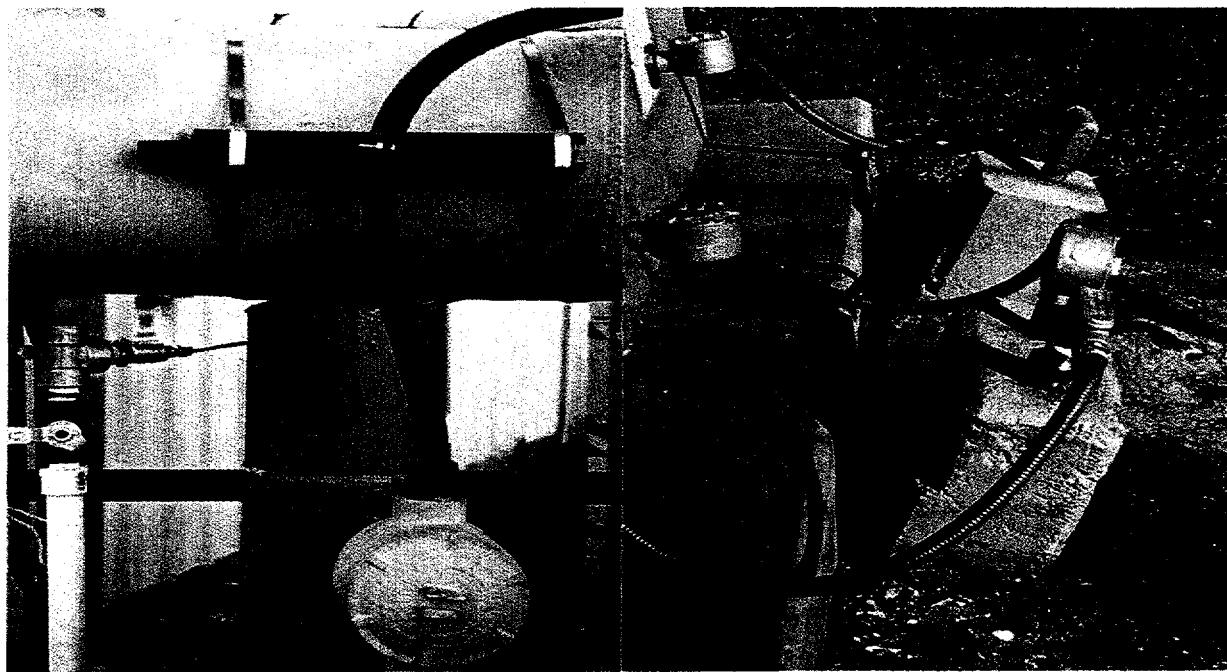
Figure 8. (a) pipe support separated from pipe it had been supporting, (b) concrete abutment that has undergone rotation.

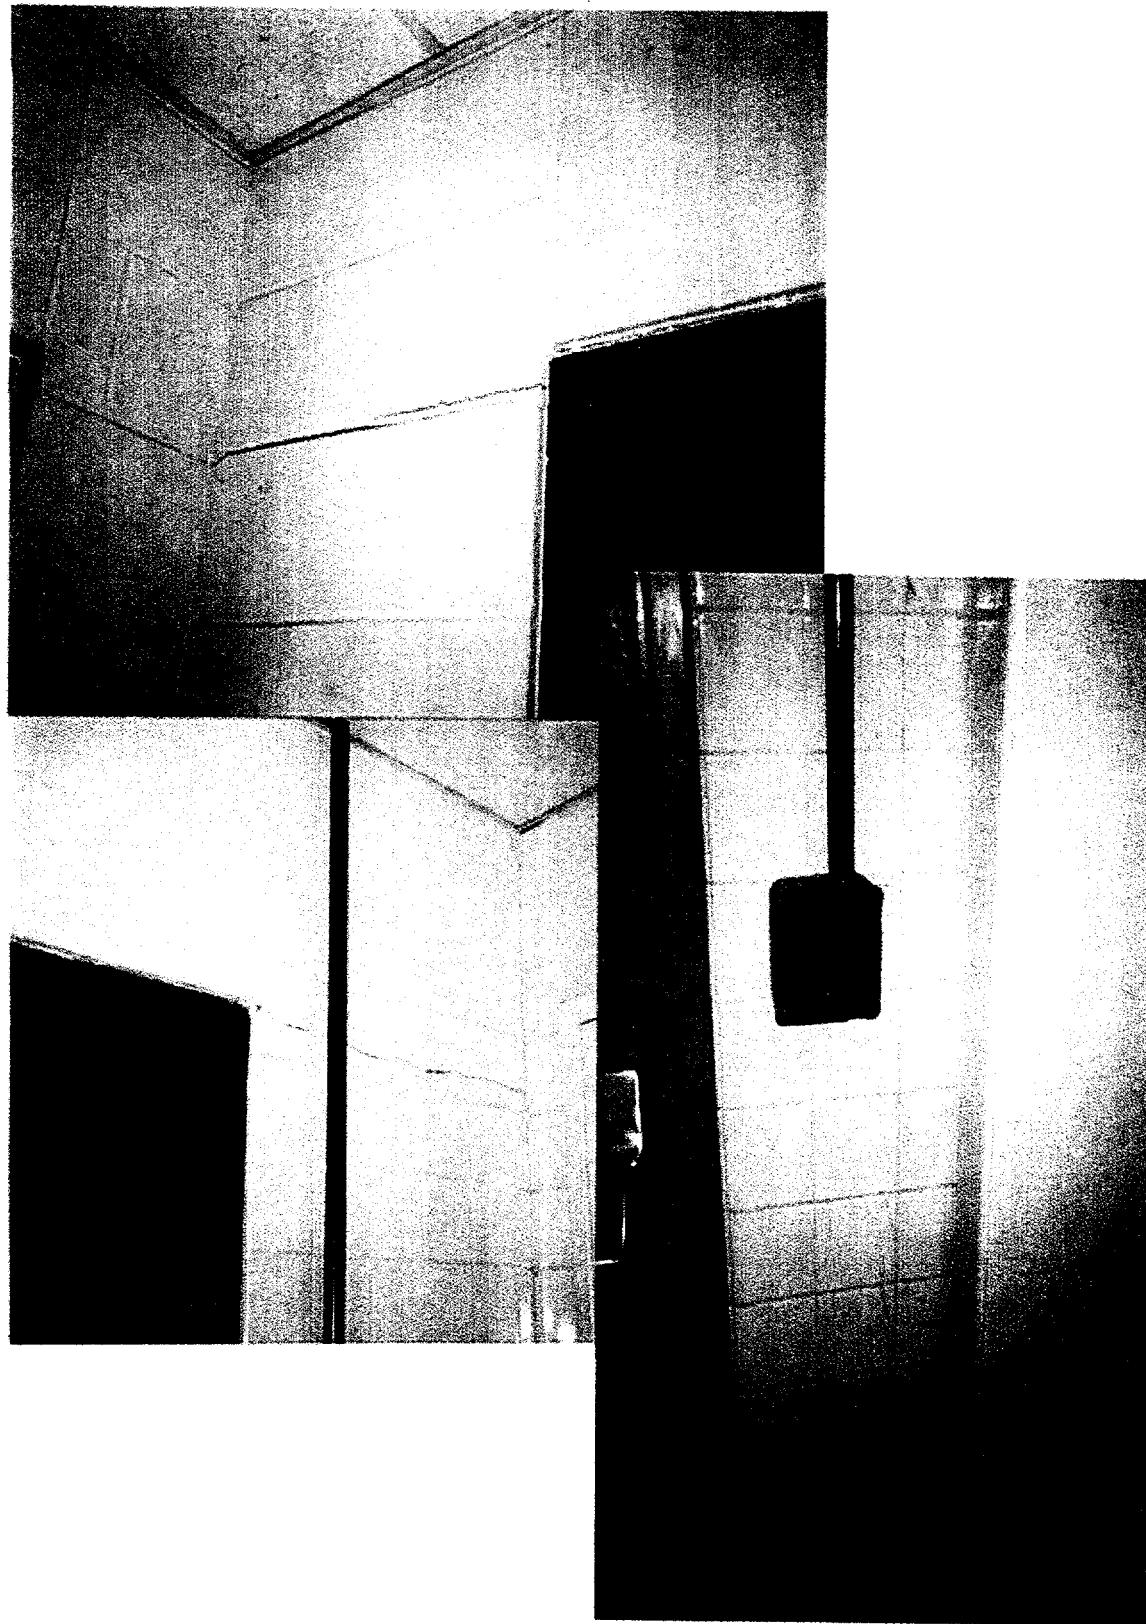
During a recent quarterly surface inspection, evidence of possible effects of subsidence upon other DOE structures was observed (Bauer, 1998). Again these observed cracks in buildings and displacements in concrete walkways are likely the result of differential subsidence at the site.

Figure 9. Restroom near shop: cracks in block work near door, shear cracks in tile work.

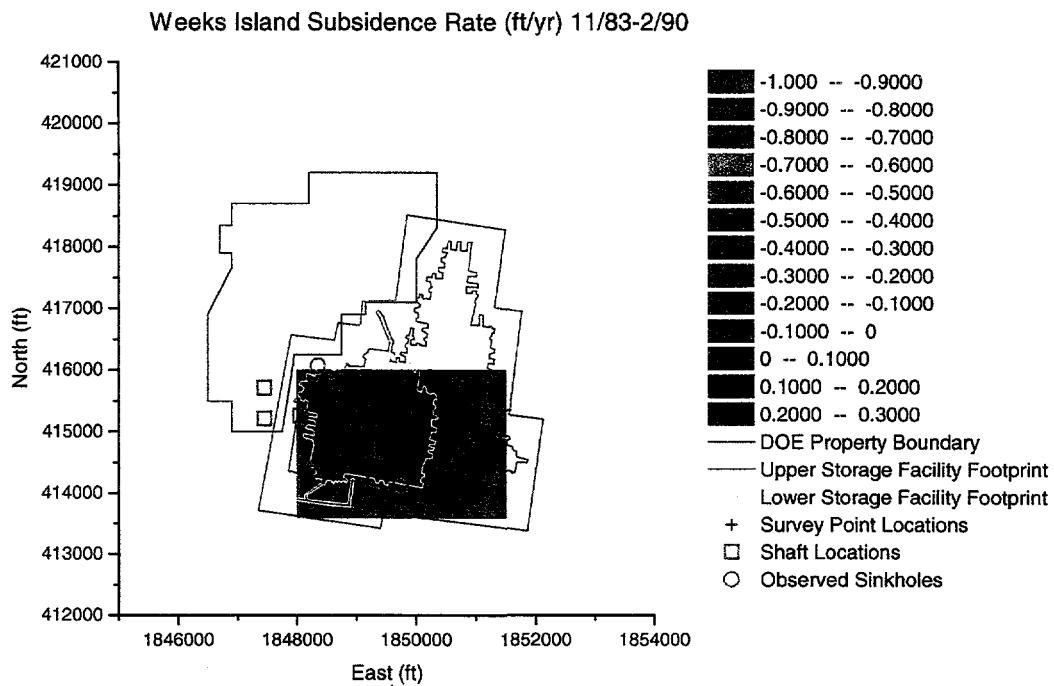
From 1983-1990 the area surveyed was relatively small (about a quarter of a square mile) compared to the DOE property boundary, and contained only about twenty measurement stations (Figure 10). The subsidence rate averaged between 0 and 0.1 ft/yr during this time period, but only one station was located over the center of the mine.

Figure 10. Weeks Island subsidence rates (ft/yr) 11/83-2/90.

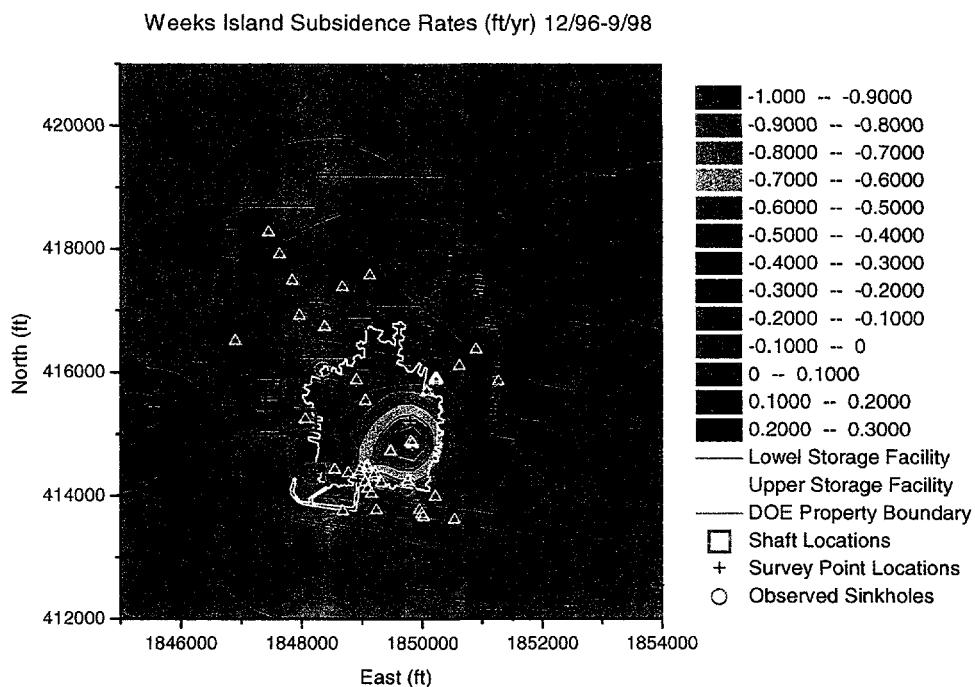
Between 12/96 and 9/98 the subsidence rates over the DOE facility increased markedly (Figure 14). Maximum subsidence rates are near 1 ft/year (near subsidence monuments Weeks 2 and WI-61- see red contour area on Figure 14). Subsidence rate increases were observed for most of the DOE facility area, in the 0.3 to 0.5 ft/yr range. In summary, local rates increased by a factor of up to four to five, whereas overall rates increased by a factor of two to three. Subsidence rate increases of two to three are also observed to the northwest, over the Morton facility. The white triangles in Figure 14 represent stations that experienced a factor of three or greater increase in subsidence rate. In looking at the figure one must be careful to understand the relative amount of the increase in context with the absolute amount of increase. The high rate increases found over much of the

Figure 14. Weeks Island subsidence rates (ft/yr) 12/96-9/98.

DOE and Morton facilities are potentially due to emptying the mine and may in part be the result of the continued mining or an increase in extraction in the Morton mine.

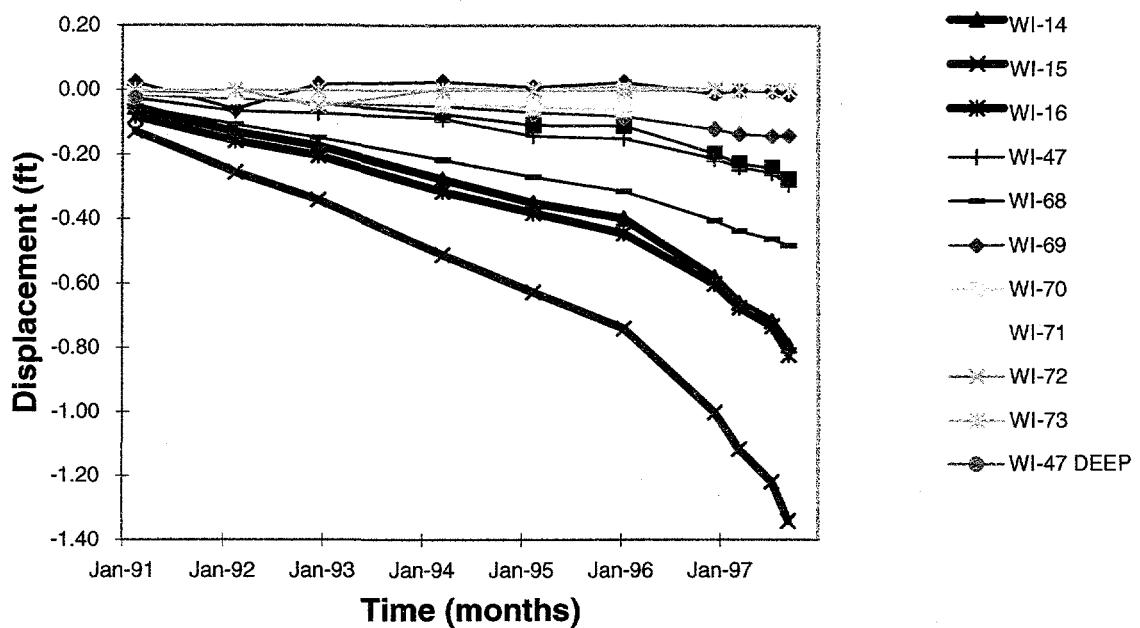
The vertical displacement for each station relative to WI-73 versus time is plotted in Figure 2 beginning in 2/90. All data presented in Figure 2 are derived by subtracting the elevation change for Monument WI-73 from that observed at a given station. The last 3 measurements plotted constitute the recent data collected for this report (3/97, 7/97, and 9/97). Data plotted begins in 2/91 and runs until 9/97. The data trend indicates a slight increase in the downward displacement rate since 1/96. While it appears that the subsidence rates have

Figure 2. Weeks Island cumulative displacement (ft) relative to monument WI-73.

In Figure 2 the subsidence rate for WI-15 is consistently greater than the others measured beginning in 2/91. Although WI-15 is closest to the sinkhole, its movement may be due primarily to its position relative to the mine center.

There is a slight increase in subsidence rate after the 1/96 measurement. This is consistent with the timing for oil withdrawal.

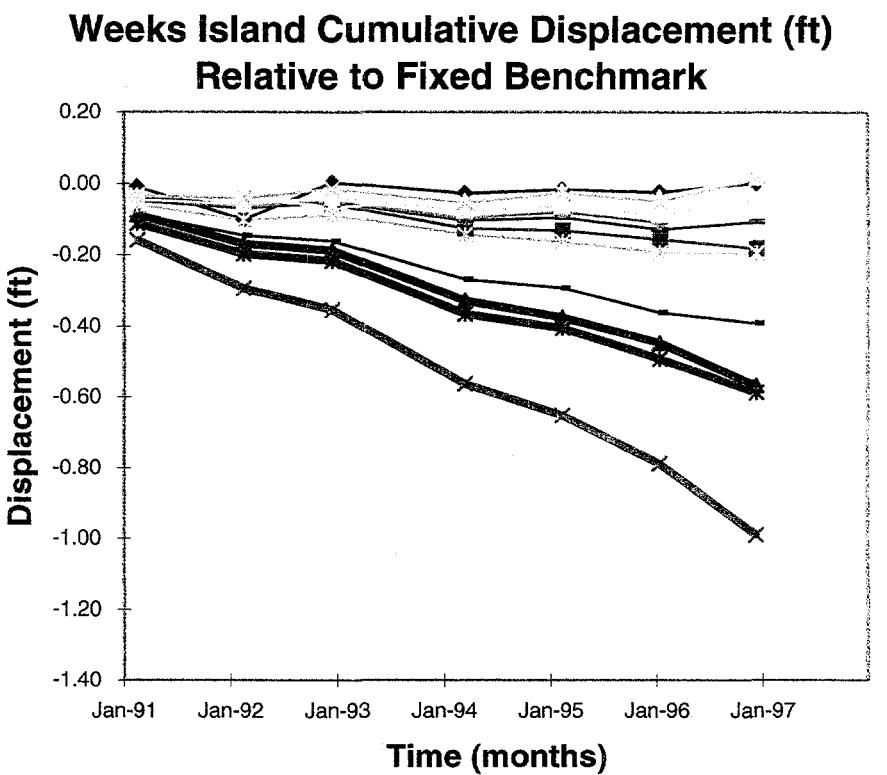
Figure 3 presents subsidence displacements considered relative to the benchmark off the site through 12/96. This presentation is made to provide a comparison with the WI-73 method. The differences observed are small, except that the downward trend in the data after 1/96 is less for the "fixed" benchmark data set. This implies that using the WI-73 method has some validity, however it is unclear if the magnitudes in downward displacement are really as great as indicated in Figure 2; this could be an artifact of the analysis method. The recent measurements will be reassessed with the next fixed benchmark study scheduled for this spring.

Figure 3. Weeks Island cumulative displacement (ft) relative to fixed benchmark for all monuments included in this study.

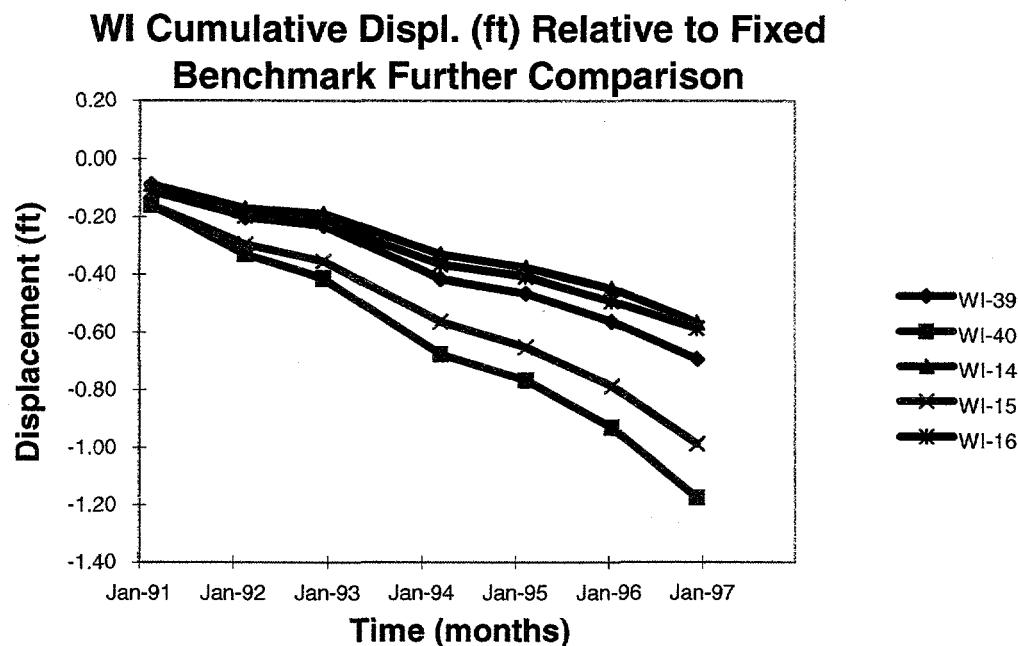
In Figure 4, WI-14, 15, 16 (already discussed) are presented as well as WI-39 and WI-40. The comparison is made to demonstrate that WI-14, 15, and 16 data are consistent in magnitude with historical data elsewhere over the mine.

Figure 4. Weeks Island cumulative displacement (ft) relative to fixed benchmark for selected monuments included in this study as well as other monuments for comparison.
