Christina M. Lynch
Paul F. Moniz
Mary Ann H. Reimus
Los Alamos National Laboratory
PO Box 1663, MS: E502
Los Alamos, NM 87545

EVALUATION AND CHARACTERIZATION OF GENERAL PURPOSE HEAT SOURCE GIRTH WELDS FOR THE CASSINI MISSION

ABSTRACT: General Purpose Heat Sources (GPHSs) are components of Radioisotopic Thermoelectric Generators (RTGs) which provide electric power for deep space missions. Each GPHS consists of a ^{238}Pu oxide ceramic pellet encapsulated in a welded iridium alloy shell which forms a protective barrier against the release of plutonia in the unlikely event of a launch-pad failure or reentry incident. GPHS fueled clad girth weld flaw detection was paramount to ensuring this safety function, and was accomplished using both destructive and non-destructive evaluation techniques. The first girth weld produced from each welding campaign was metallographically examined for flaws such as incomplete weld penetration, cracks, or porosity which would render a GPHS unacceptable for flight applications. After an acceptable example weld was produced, the subsequently welded heat sources were evaluated non-destructively for flaws using ultrasonic immersion testing. Selected heat s

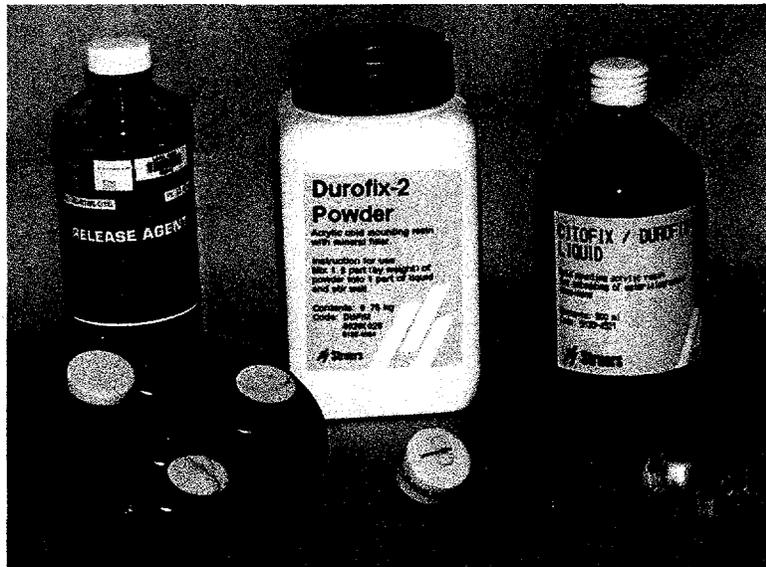
FIGURE 9
MOUNTING PRODUCTS

Each metallographic section was cold-mounted by positioning it with a *Uniclip*TM inside a mold and pouring *Durofix*TM mounting media over it. This product produces a iridium mount hard enough for good edge retention, while not requiring an excessive amount of grinding time. This material also has the advantage of curing rapidly, allowing grinding and polishing operations to begin within a few hours of mounting (Figure 9).

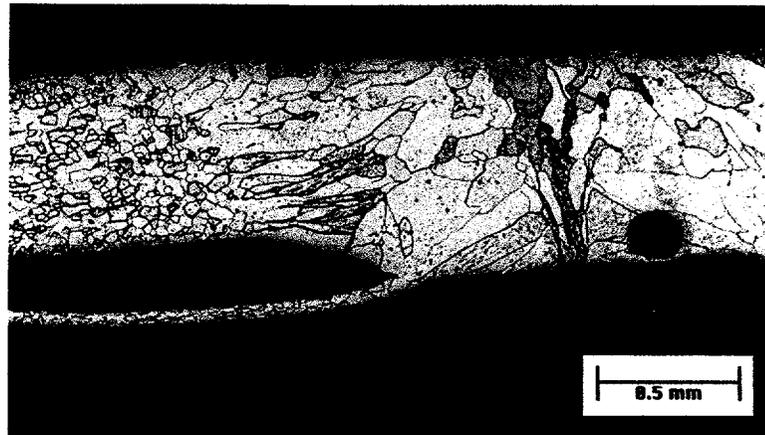
Metallography was performed on selected heat sources which failed UT inspection and on heat sources subjected to impact studies. This enabled a positive determination to be made as to what condition caused the UT failure. It was important to determine if a particular UT failure was caused by weld shield fusion (Figures 14-16) or a cup mismatch (Figure 17), as opposed to a

FIGURE 14
MICROGRAPH OF REJECTED IRIDIUM WELD
WITH WELD SHIELD FUSION AND POROSITY

FIGURE 15
MICROGRAPH OF REJECTED IRIDIUM WELD
WITH WELD SHIELD FUSION AND POROSITY

FIGURE 16
MICROGRAPH OF REJECTED IRIDIUM WELD
WITH WELD SHIELD FUSION AND POROSITY

defect such as a crack. A GPHS with weld shield fusion or a cup mismatch might still be suitable for flight applications. A GPHS with a condition adversely affecting its strength or integrity, such as a crack in the weld, would not. Figure 18 is a micrograph of a normal fully penetrating weld without anomalies. In collaboration with Westinghouse Savannah River Company, the metallography was correlated with the UT data to build a database for flaw classification. This was used in conjunction with artificial intelligence software. Although this was nascent technology during Cassini production, it could prove to be very valuable for verifying future heat source acceptability. Since each GPHS costs approximately \$300,000.00 to produce, saving previously rejected heat sources could result in significant cost benefits to future missions.
