KAPL-P-000205
(K97159)

**THE CORROSION EFFECT OF OZONATED SEAWATER SOLUTION ON TITANIUM IN
POLYMER GENERATED CREVICE ENVIRONMENTS**

A Thesis submitted to the Graduate
Faculty of Rensselaer Polytechnic Institute
in Partial Fulfillment of the Requirements for the Degree of

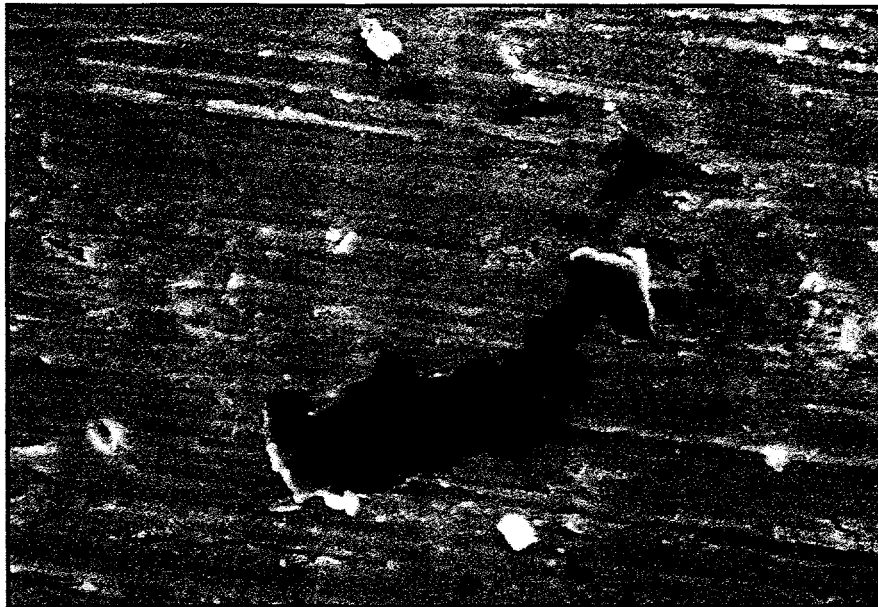
Figure 4.8 SEM Micrograph of Aerated PVC Sample #2-4 (Front). 1210X

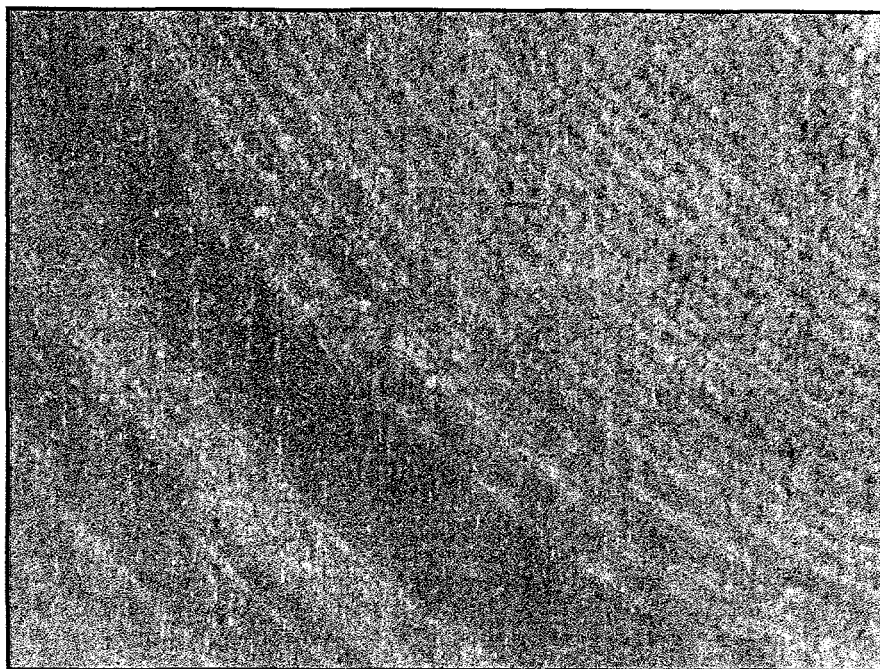
Figure 4.10 Ozonated PEHD Sample #3-3 (Back). Higher Magnification Photo of Highlighted Area in Figure 4.9.

Figures 4.9 and 4.10, photographs of sample #3-3 (back), show strong corrosion rings on the ozonated PEHD sample, typical of this test group. The colors of the corrosion products were green/purple shades, similar to the corrosion colors of the PTFE crevice samples and much more pronounced than the brown coloring of the PVC crevice samples. EDS of the surface found spotty areas of relatively high levels of fluorine on one of the coupons and chlorine present on another. Figure 4.11 is an SEM photograph of the green/purple ring on the sample which showed fluorine. Location #1 on the photograph, the darkened area, contained fluorine, while location #2, the lighter area, showed no sign of fluorine. Figure 4.12 shows the surface of PEHD aerated sample #3-6 (front). The ring of corrosion product can be attributed to crevice corrosion involving the chloride ion.

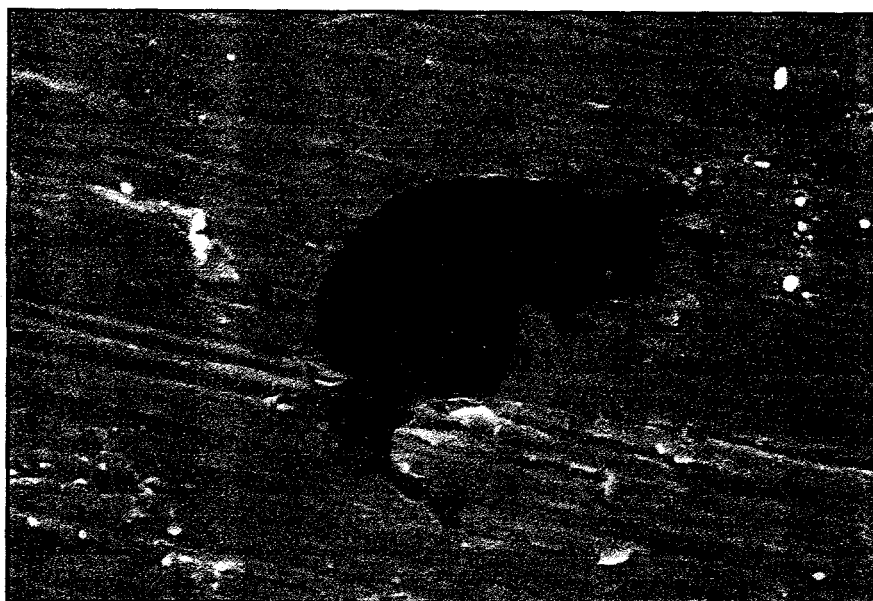
Figure 4.12 SEM Micrograph of Aerated PEHD Sample #3-6 (Front). 1120X

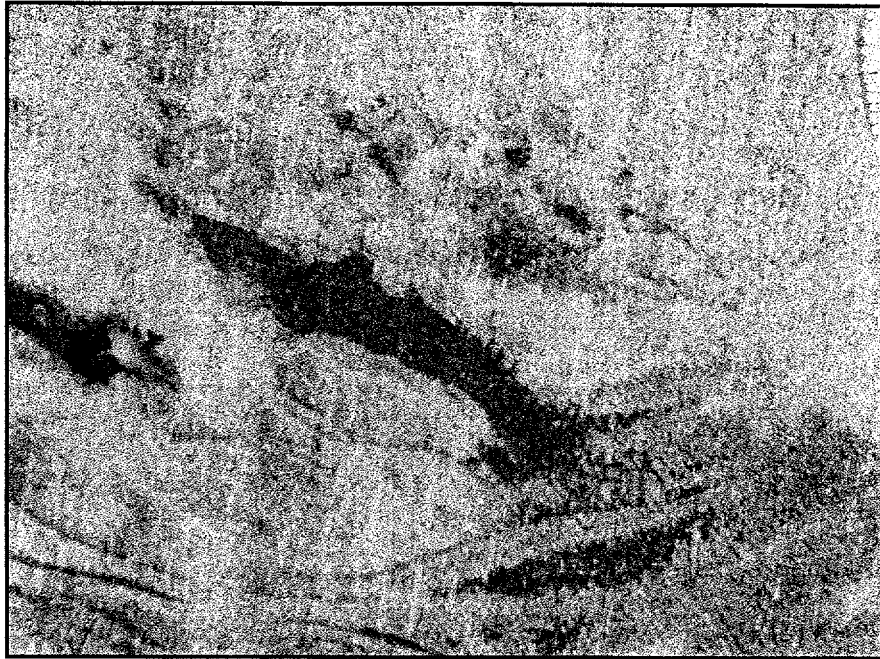
Figure 4.14 Ozonated Saran Sample #4-1 (Back). Higher Magnification Photo of Highlighted Area in Figure 4.13.

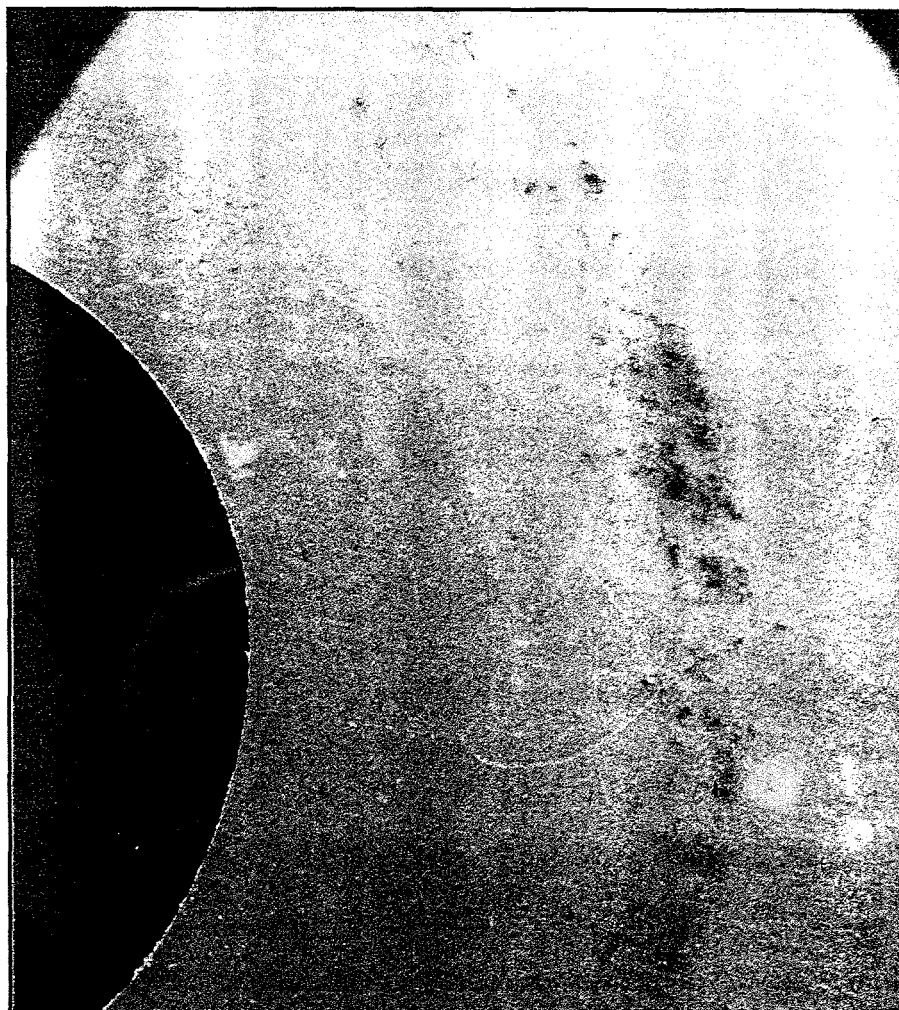
Figure 4.25 SEM Micrograph of Aerated PTFE Sample #5-1. 14.4X

The results in the aerated tank with the PTFE washers had no macroscopic corrosion, but under low and high magnification SEM analysis, Figures 4.25 and 4.26, a corrosion product was evident. In addition, EDS revealed strong indications of fluorine in the darkened areas along the outer edge of the PTFE flat washer of sample #5-1. Sample #5-2, a crenelated washer, showed similar microscopic effects and exhibited the presence of both fluorine and chlorine in the effected areas.
