X-ray K-edge Analysis of Drain Lines in Wilhelm Hall, Ames Laboratory

Terry Jensen and Craig Whitmore

Ames Laboratory and Center for NDE
Iowa State University
Ames, IA 50011

January 5, 1999

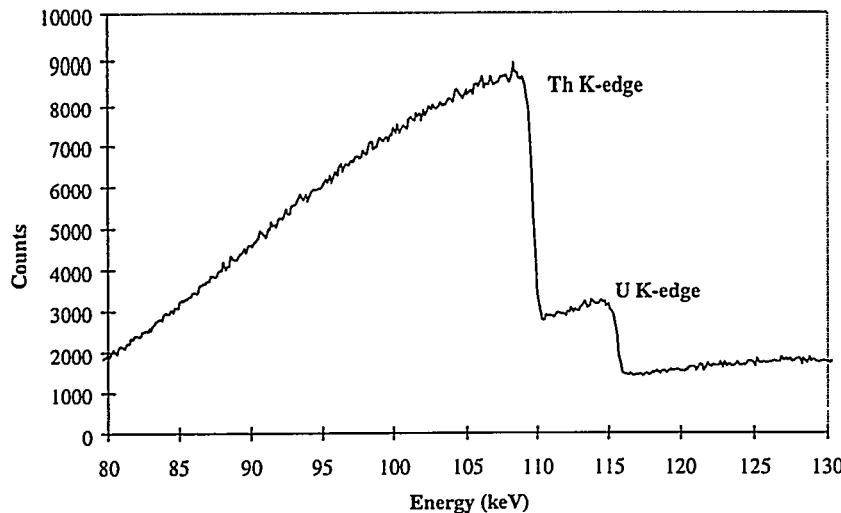
Figure 1. Example spectrum from K-edge inspection of thorium and uranium calibration foils through 1/8 inch of steel.

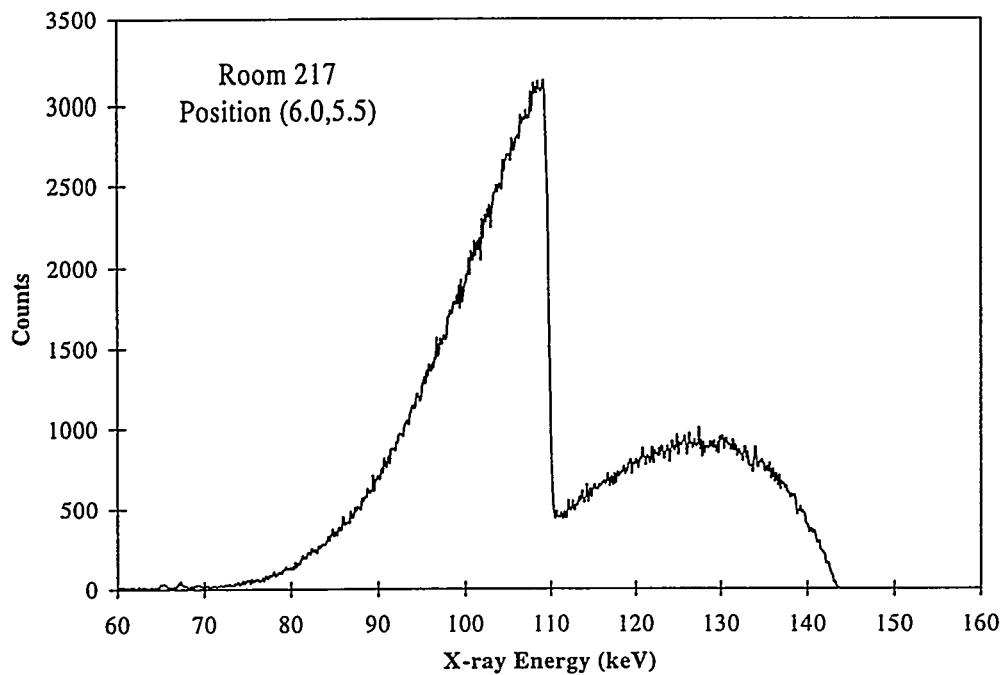
Figure 3. Spectrum showing the highest concentration of thorium found ($\sim 0.5 \text{ g/cm}^2$) in the drain trap in room 217.

K-edge measurements indicate substantial thorium deposits in this drain trap (as high as 0.5 g/cm^2), and moderate thorium contamination in the joint region downstream of the trap. The joints also contained substantial amounts of lead (likely from soldering) which made it quite difficult to obtain adequate statistics in these regions. It was not possible to position the K-edge system on the straight section of the pipe.

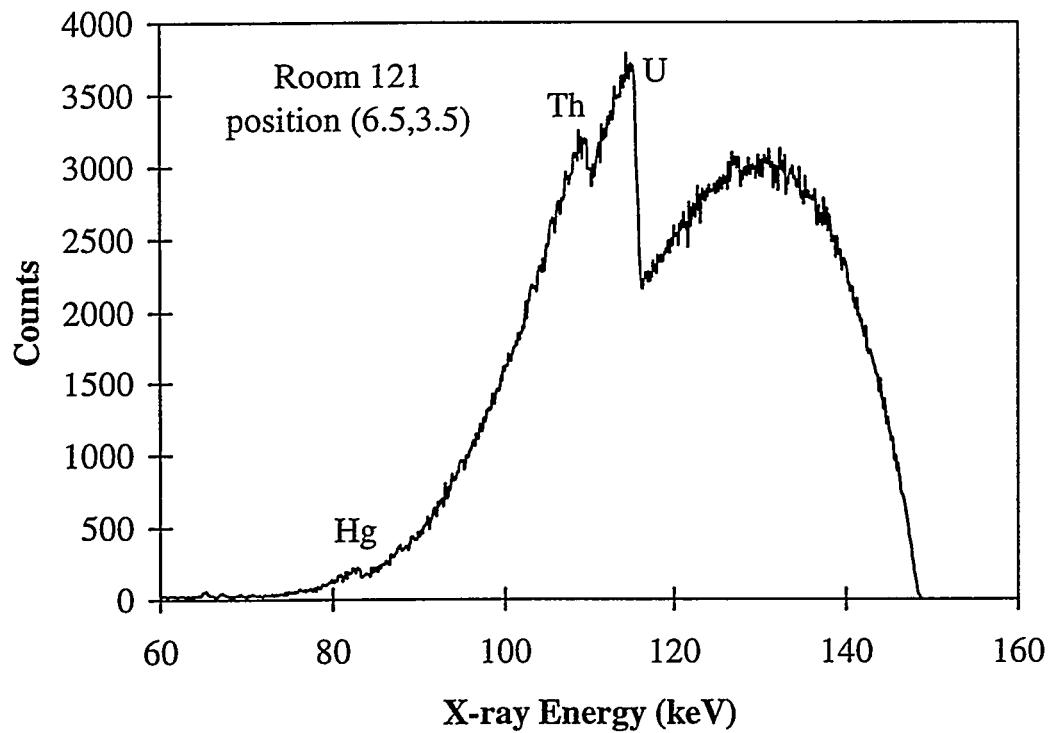
Figure 4. Spectrum from a region of the drain trap in room 121 showing signals for uranium, thorium and mercury.

K-edge measurements indicate significant deposits of mercury, thorium and uranium in this trap. Mercury and uranium are found throughout the trap, whereas thorium appears to be concentrated in a small region. Several measurements were also made on the straight section of pipe just downstream from this trap. No significant contamination was found in this region, with limits of $<11 \text{ mg/cm}^2$ Hg, $<4 \text{ mg/cm}^2$ Th, and $<7 \text{ mg/cm}^2$ U.

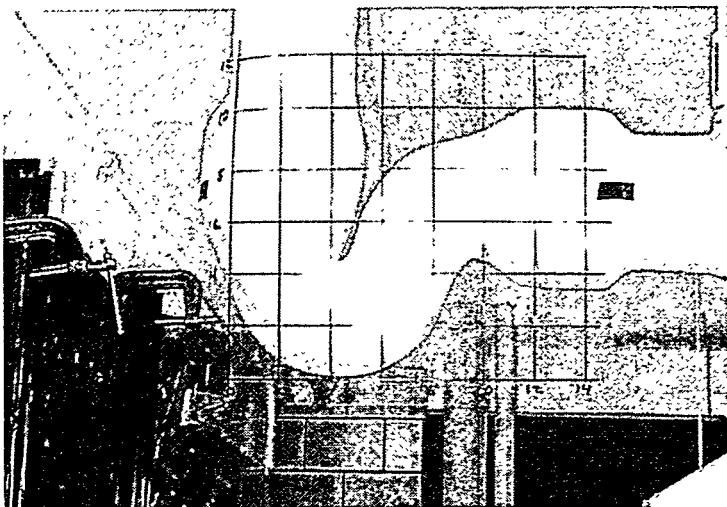
Drain Trap, Room 129

There is an easily accessible drain trap in the Southwest corner of the room. A radiograph shows scale buildup towards the downstream side of the trap with density variations throughout the region. Hand-held survey meter readings indicate 5-10 $\mu\text{R}/\text{hr}$ above background in the trap and in the straight section of pipe downstream.

K-edge measurements indicate significant deposits of mercury in the trap, but show no evidence for thorium or uranium. There was also a strong signal for lead, which, along with the mercury, could explain the observed strong absorption of X-rays. This resulted in greater uncertainty in the thorium and uranium measurements. The observed limits for these elements are consistent with the 5-10 $\mu\text{R}/\text{hr}$ survey meter readings. A measurement on the straight section of pipe near the joint indicated $<20 \text{ mg}/\text{cm}^2$ Hg, $<4 \text{ mg}/\text{cm}^2$ Th, and $<10 \text{ mg}/\text{cm}^2$ U.

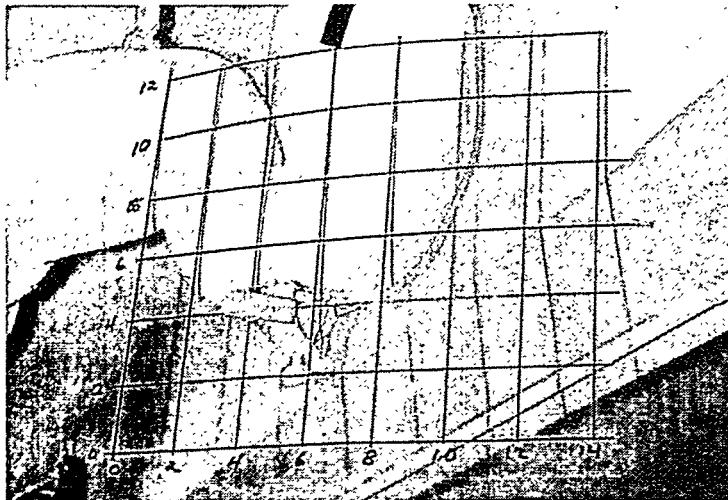
Drain Trap, Room 209

The drain trap is near a support beam that limits access. The drain line extends to the South side of the room where it connects into another pipe. A radiograph showed some scale buildup but no strong features. Hand-held survey meter measurements showed nothing above background. K-edge measurements are consistent with this, showing no

significant contamination. A measurement on the straight section of the pipe just downstream of the trap indicated $<9 \text{ mg/cm}^2$ Hg, $<6 \text{ mg/cm}^2$ Th, and $<8 \text{ mg/cm}^2$ U.

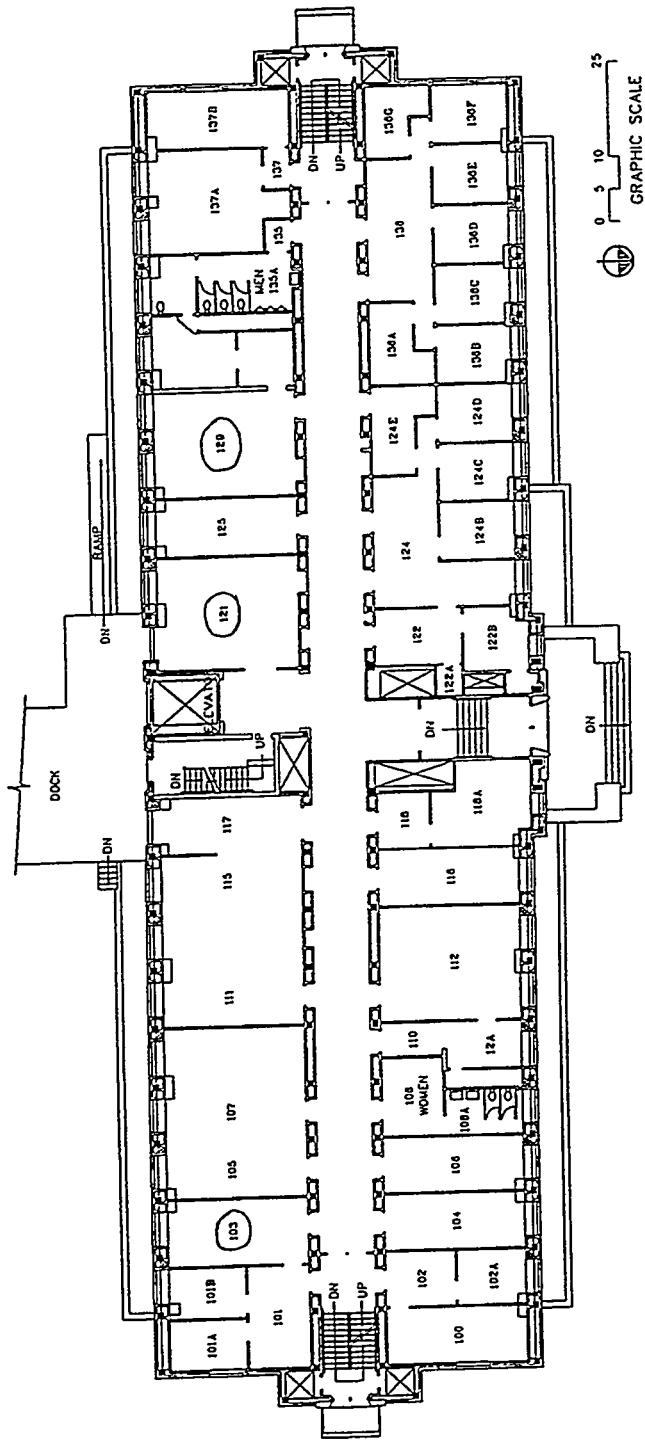
WILHELM HALL
FIRST FLOOR PLAN

Wilhelm Hall First Floor layout with rooms targeted for K-edge inspection circled.

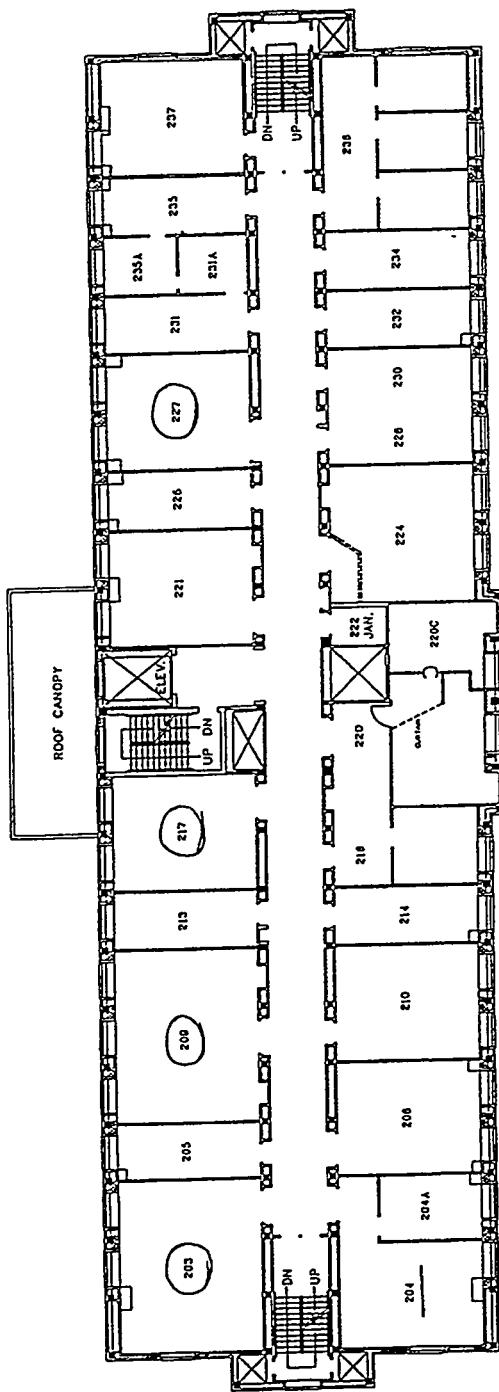
WILHELM HALL
SECOND FLOOR PLAN

Wilhelm Hall Second Floor layout with rooms targeted for K-edge inspection circled.
