## ENGINEERING DATA TRANSMITTAL

| 8. Originator Remarks:<br>Authorization Basis upgrade plan for miscellaneous TWRS<br>Facilities, Tanks and Components. | | | | 9. Equip./Component No.:<br>N/A | |

| 15. DATA TRANSMITTED | | | | | (F) | (G) | (H) | (I) |
|---|---|---|---|---|---|---|---|---|
| 1 | HNF-2503 | N/A | 0 | Authorization Basis<br>Status Report<br>(Miscellaneous TWRS<br>Facilities, Tanks and<br>Components) | ES | 2 | 1 | 1 |

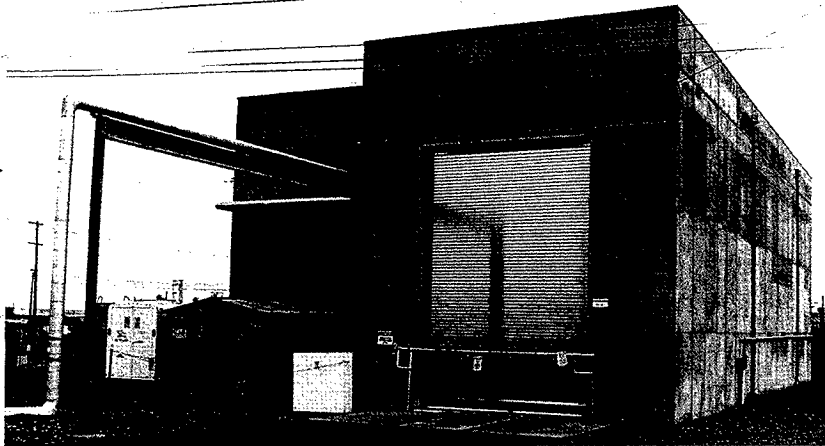
H98030126.3

The 204-AR Waste Unloading Facility is located south of the 244-AR Vault and west of the 241-AX Tank Farm. The facility was designed to receive liquid waste from rail tank cars or tank trailers and pump these wastes to a designated 200-E Area tank farm. Included in the facility design is a chemical adjustment capability utilizing four chemical make-up tanks and a sluicing system to remove sludge from the tank cars. A photo and diagram of the facility is shown in Figure 3-2. The 204-AR Waste Unloading Facility was constructed in 1981 and is a reinforced concrete structure approximately 19.5 m (64 ft) long by 12.2 m (40 ft) wide by 7.8 m (25.5 ft) high. The facility is still active except for two chemical tanks that are no longer used.

Figure 3-2. 204-AR Waste Unloading Facility

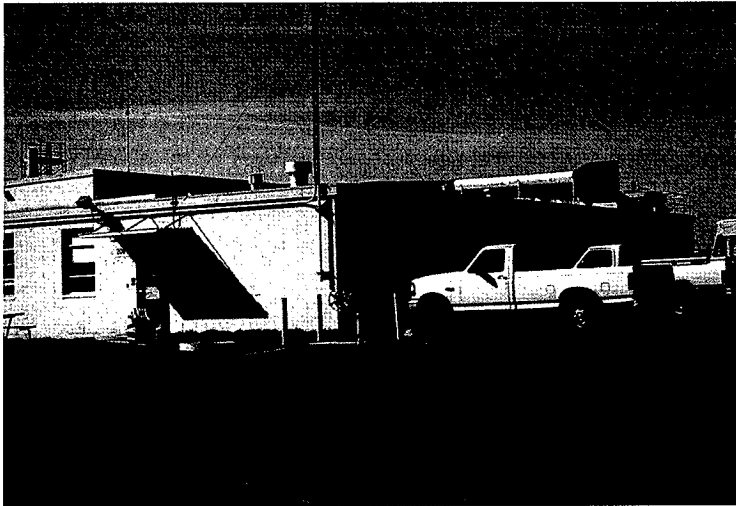
Criticality experiments were conducted in the CAR, which contains two reactor hoods where the critical assemblies were held. Each hood has its own high-efficiency particulate air (HEPA) filter and instrumentation that was monitored from the control room. Contaminated equipment located in the CAR includes four hood assemblies, a water tank and eleven process tanks ranging from 38 L (10 gal) to 400 L (106 gal). They are:

Figure 3-3. 209-E Critical Mass Laboratory

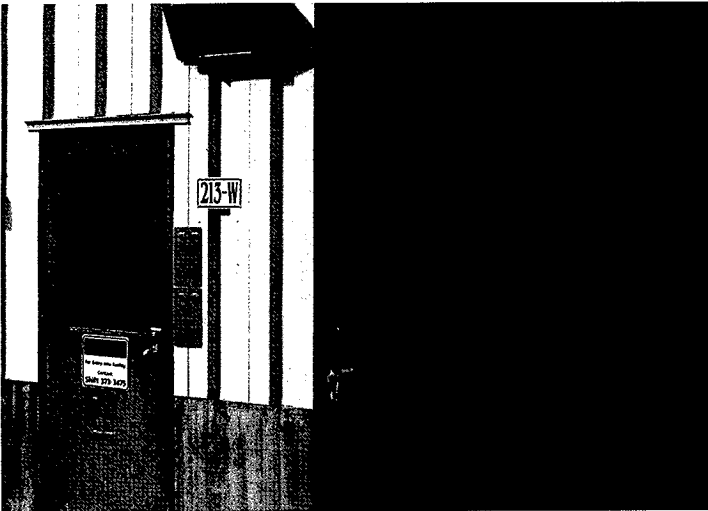
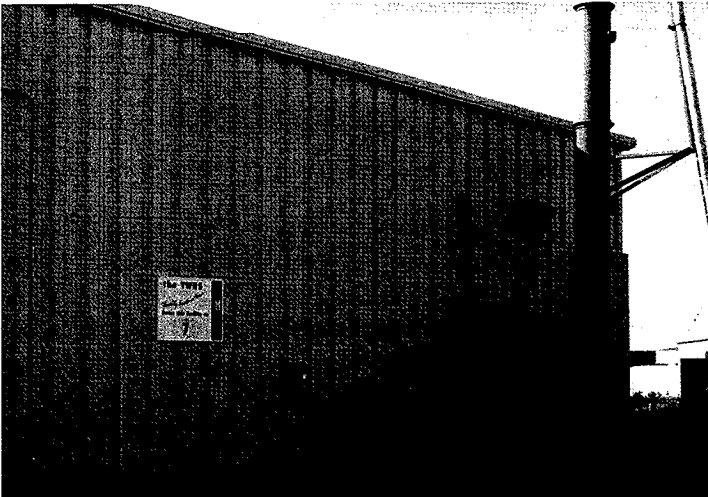
The 213-W Dry Waste Compactor Facility is no longer used to compact low level solid waste. The compactor is empty and is only slightly contaminated. Radiation surveys are performed weekly in this facility and recent results indicate no alpha contamination, less than 1,000 dpm/100 cm<sup>2</sup> (beta) smearable contamination, and less than 5,000 dpm/100 cm<sup>2</sup> (total beta) contamination. Dose rates throughout the facility are less than 0.5 mR/hr at 30 cm. The Compactor Room in the facility is still occasionally used for equipment maintenance and repair activities. Waste materials or chemicals in other than household quantities are not stored there. The catch tank adjacent to the facility formerly contained floor drainage from the compactor room and the ventilation system. The contents of this catch tank have been sampled and have been determined to be below the level of radiological concern.

Figure 3-4. 213-W Dry Waste Compactor

The 213-W Building is located in the 200-W Area, adjacent to and north of the 272-WA building and south of the Central Waste Complex. This facility was used to compact low-level solid wastes and is referred to as the Dry Waste Compactor Facility. The facility was constructed in the mid 1980s and was used only sporadically starting in 1985 to compact low activity solid waste for disposal in the 200-W Area Low Level Waste (LLW) Burial Grounds. Compaction activities have ceased and will not be resumed. Activities such as contaminated instrument repair take advantage of the controlled environment in the 213-W Building, which is unoccupied except during such activities. Photos of the facility are shown in Figure 3-4.

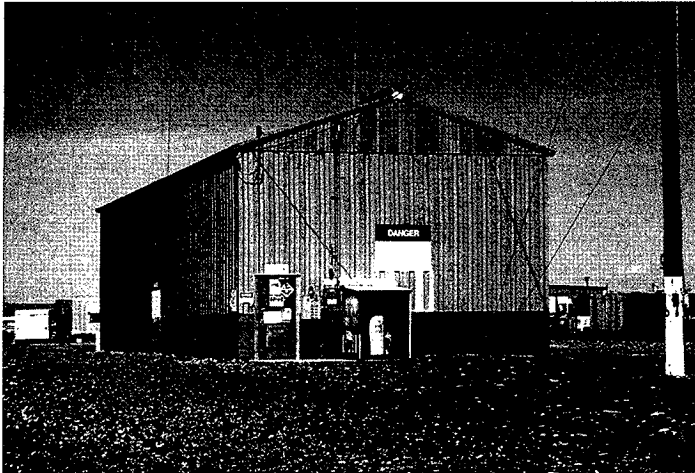
The headspace of each sodium storage tank contains pressurized nitrogen gas 14 Kpa to 69 Kpa (2 to 10 psig) to preclude oxidation of the sodium. A nitrogen gas pressure monitoring system is connected to each tank through an externally mounted, common weatherproof control panel. The common control panel includes an audible horn, indicator lights, and a strobe light. The 8.5 m by 26 m (28 ft by 84 ft) building encloses one large room with a floor space of approximately 214 m<sup>2</sup> (2,300 ft<sup>2</sup>). Features of the building include:

- Four passive roof ventilators are located on the ridge line of the roof approximately 6.7 m (22 ft) above grade. Personnel doors on each end of the building are louvered for ventilation.
- The metal building is electrically grounded by interconnected, 2.4 m (8 ft) grounding rods in six locations to form a grounding grid. Each internal sodium tank is grounded to the building grounding grid. The tank pressure control panel and the externally mounted master fire alarm cabinet outside the facility are also connected to the grounding grid.
- No water or steam service is provided and external signs visible from all angles clearly indicate water should not be used to fight fires. No weeds or other combustibles are allowed near the building.

Figure 3-14. 2727-W Sodium Storage Facility

External resistance heaters wrapped around the tanks to melt the sodium are disconnected (i.e., the sodium is solid). An insulating layer of refractory brick held in place by a wire mesh covered with an aluminum sheath surrounds the heaters and tanks. A second sodium storage facility (2727-WA) is located East of 2727-W that was used for drum storage. There are no tanks within the facility. This facility is currently empty, and there are no plans for its future use.
