Report DOE/PC/90545-3

Addendum to  
OST Long-Term Testing Report

## FULL-SCALE DEMONSTRATION OF LOW-NO<sub>x</sub> CELL<sup>TM</sup> BURNER RETROFIT

September 1994 Outage:  
Examination of Corrosion Test Panel  
and UT Survey in DP&L Unit #4

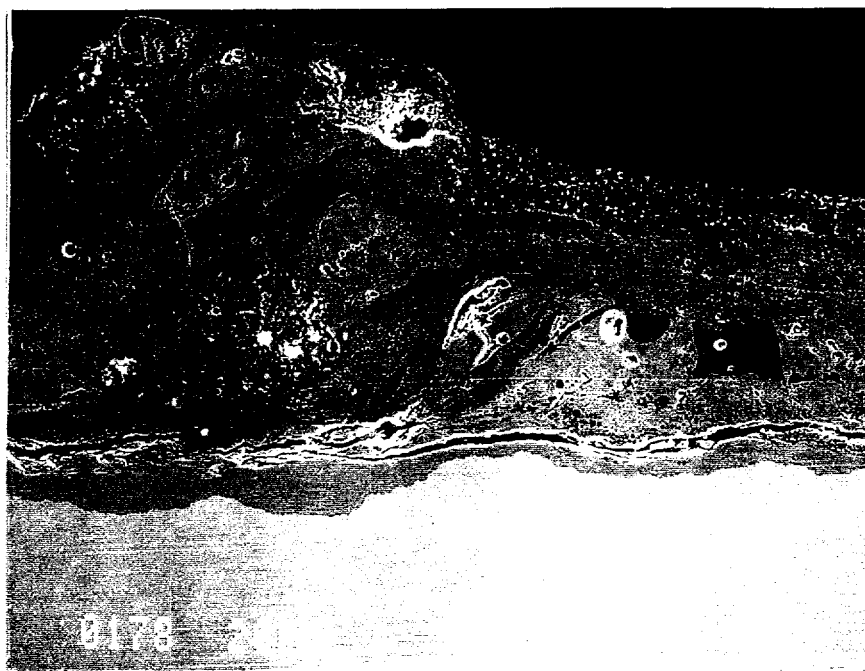
Figures 9 and 10 are the cross-sectional SEM micrographs of 309 and 308 weld-overlay coatings on T2 tubes, respectively. The surface composition of 309 weld overlay is equivalent to that of 309SS (Fe-22Cr-12Ni), and the surface chemistry of 308 weld overlay is comparable to that of 304SS (Fe-18Cr-8Ni). After the 31-month field exposure, both coatings demonstrated excellent corrosion resistance to the sulfidation attack in JMSS4. The surfaces of these weld overlays have formed a thin corrosion scale underneath the coal ash layer. EDS analyses revealed that the scale was rich in Cr and O, and also contained some Fe, Ni, and S. These compositions suggest that the scales consist of primarily Cr-rich spinel oxide and a small amount of spinel sulfide. As mentioned previously, the formation of an oxide-base scale on metal can provide much better corrosion protection than the corresponding metal sulfide. Consequently, the good performance of these weld overlaid T2 in JMSS4 was attributed to the ability of oxide formation on these coated surfaces upon exposure to the reducing combustion gases. These findings are again in agreement with the previous field study during the April 1993 outage after the corrosion test panel had been exposed for 15 months.

Figure 9 - Cross-sectional SEM micrograph of 309 weld-overlaid T2 at the bottom elevation of the corrosion test panel.
