TASK REPORT

FULL-SCALE DEMONSTRATION OF LOW-NO_x CELL™ BURNER RETROFIT

Long-Term Testing

Report DOE/PC/90545-1
(Babcock & Wilcox Report RDD:94:40090-030-036:01)

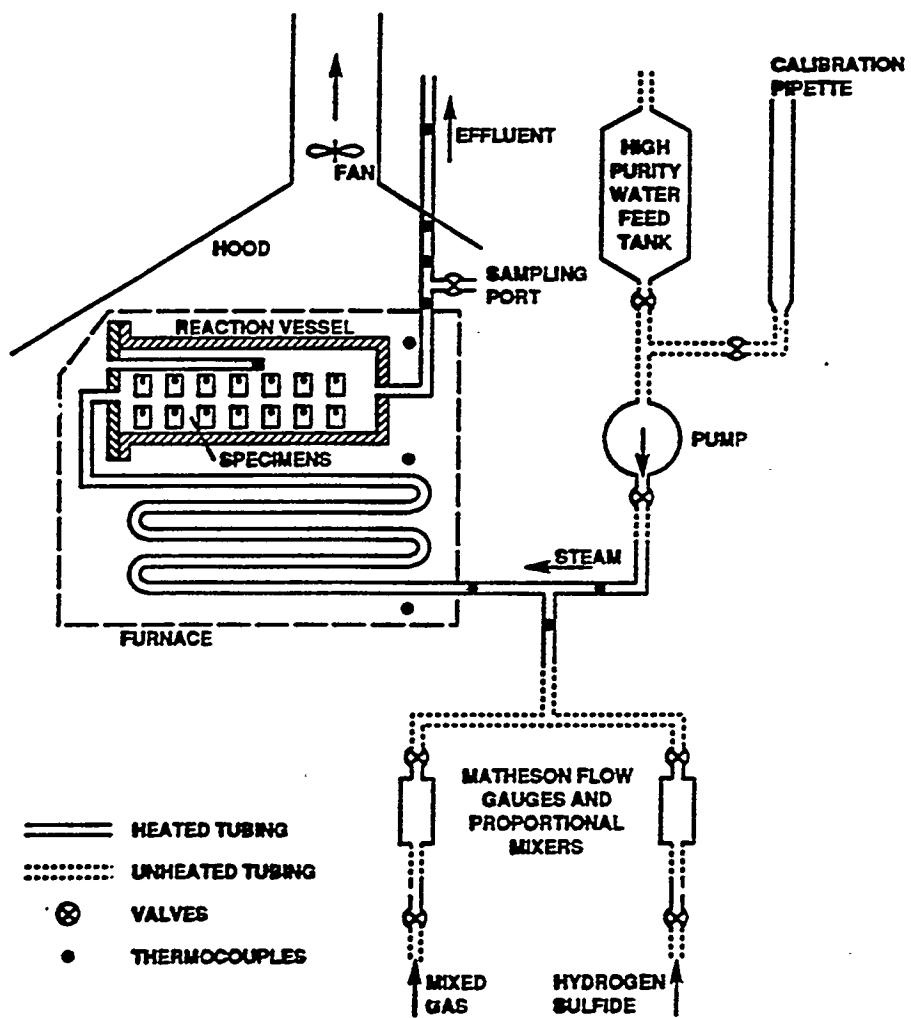
Figure 2-1 Schematic illustration of the laboratory test system employed for the retort study

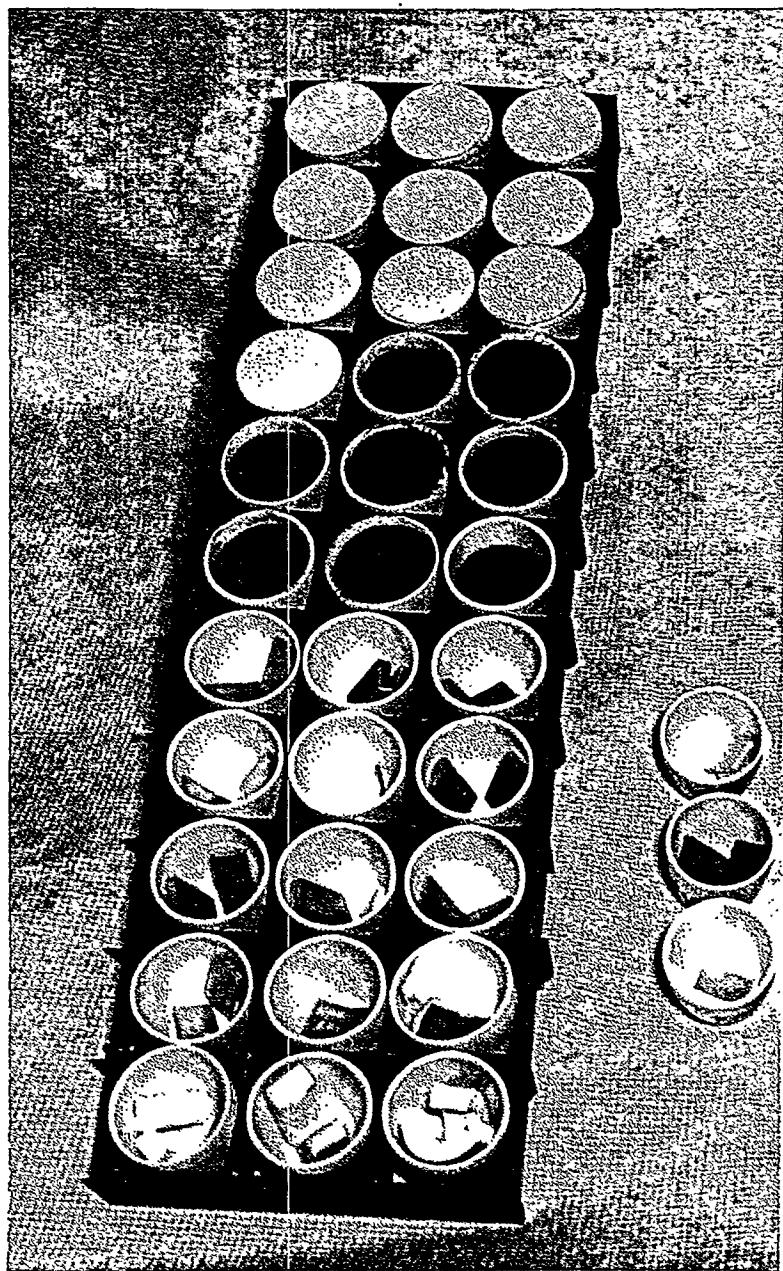
Figure 2-2 Photograph of an assembled steel rack containing alumina crucibles prior to the retort exposure

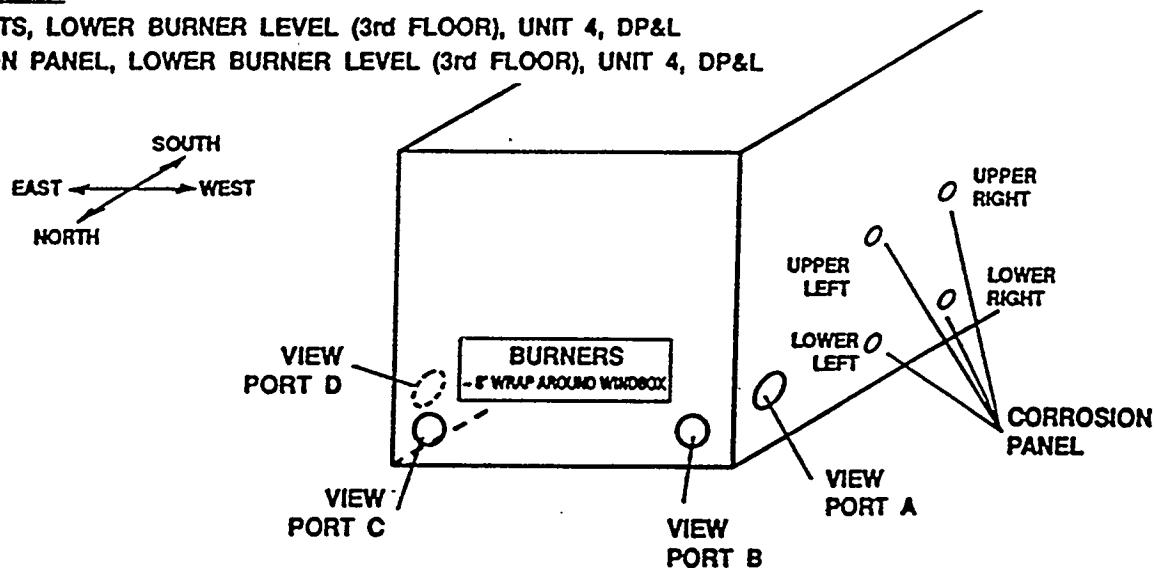
Figure 2-3 Sampling positions for on-line H_2S monitoring

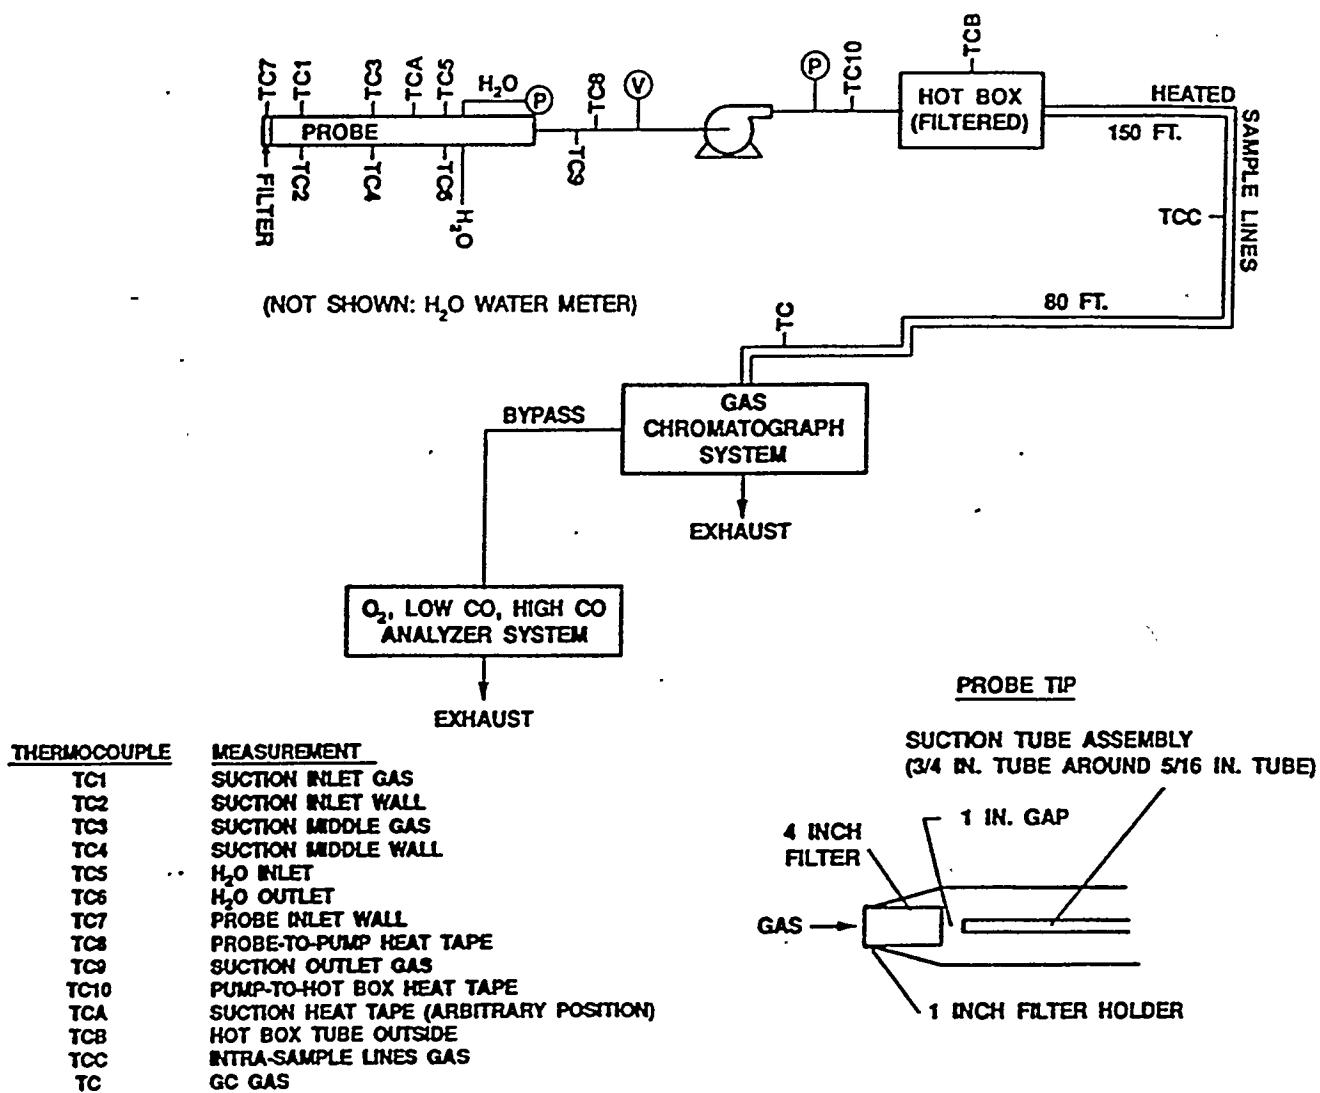
Figure 2-4a Sampling train for on-line H₂S monitoring — view ports

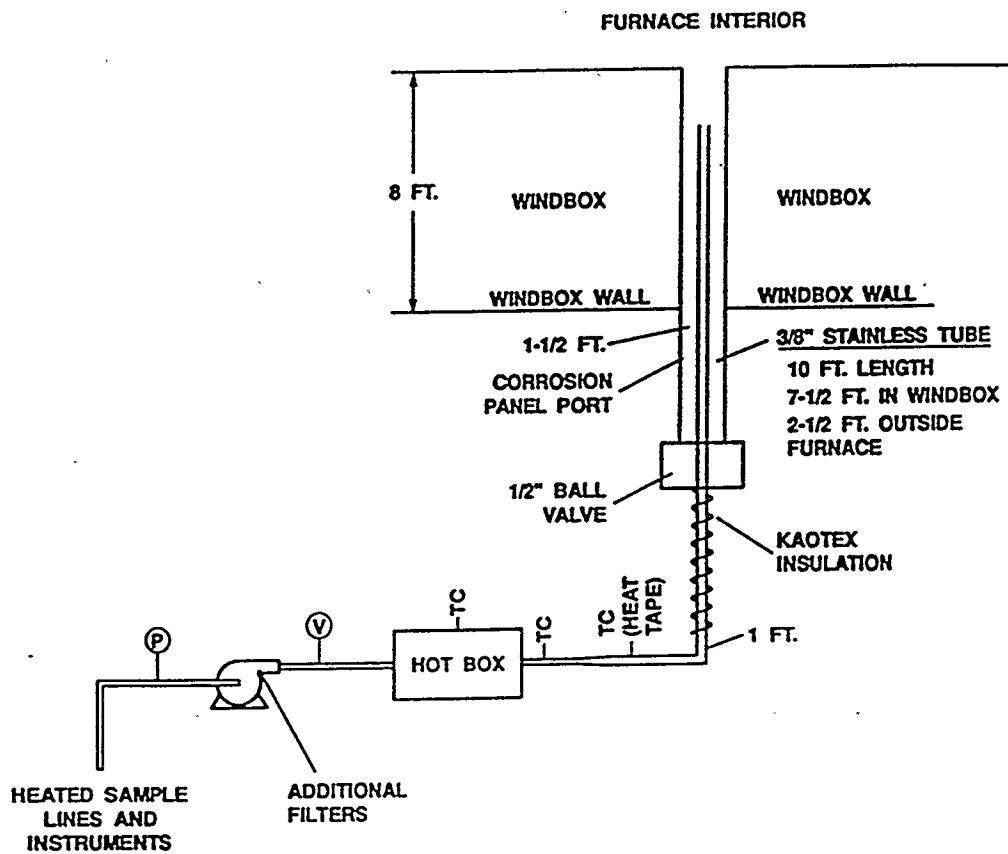
Figure 2-4b Sampling train for on-line H₂S monitoring — corrosion panel

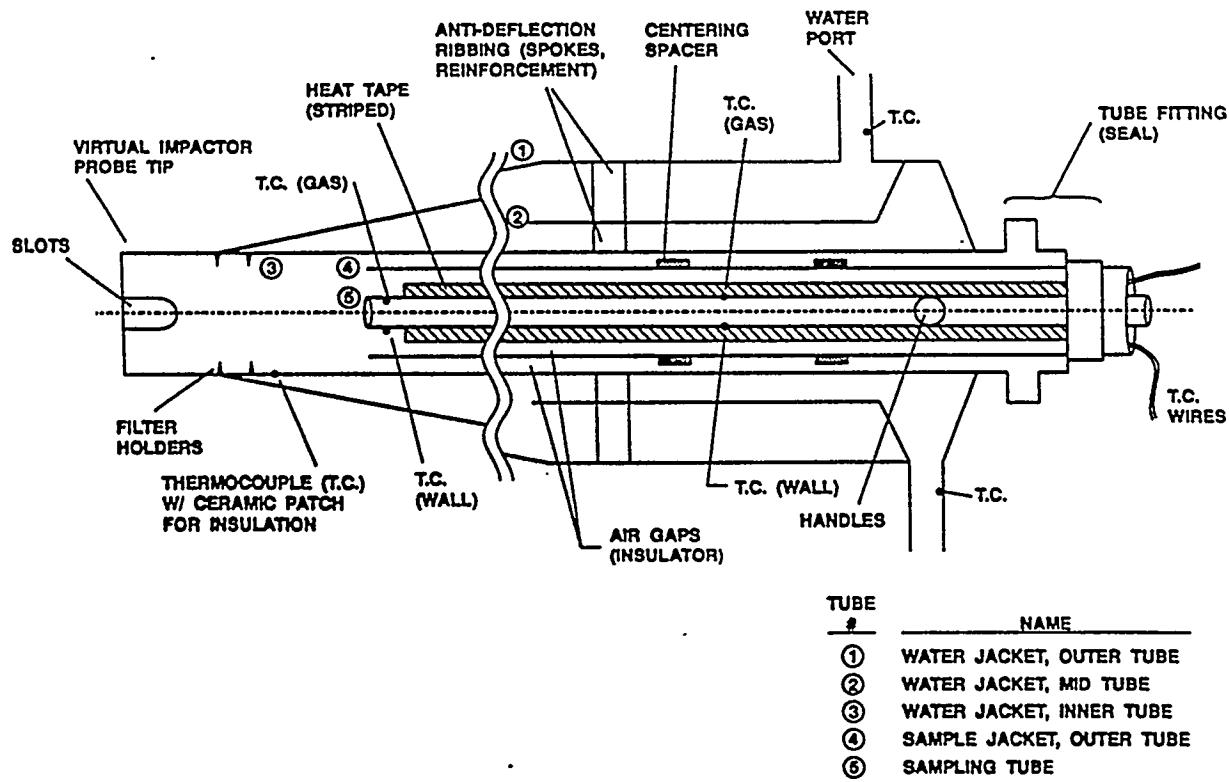
The SSFP consisted of an assembly of five concentric tubes, fitted with a filter tip. The innermost tube was a heat-taped sampling tube. This tube was welded inside another tube to form a heated sample jacket. The heated sample jacket fitted retractably inside a double-tubed cooling water jacket. The water jacket was lined with a ribbing.

Figure 2-5 Schematic of the sustained-sampling furnace probe (SSFP)

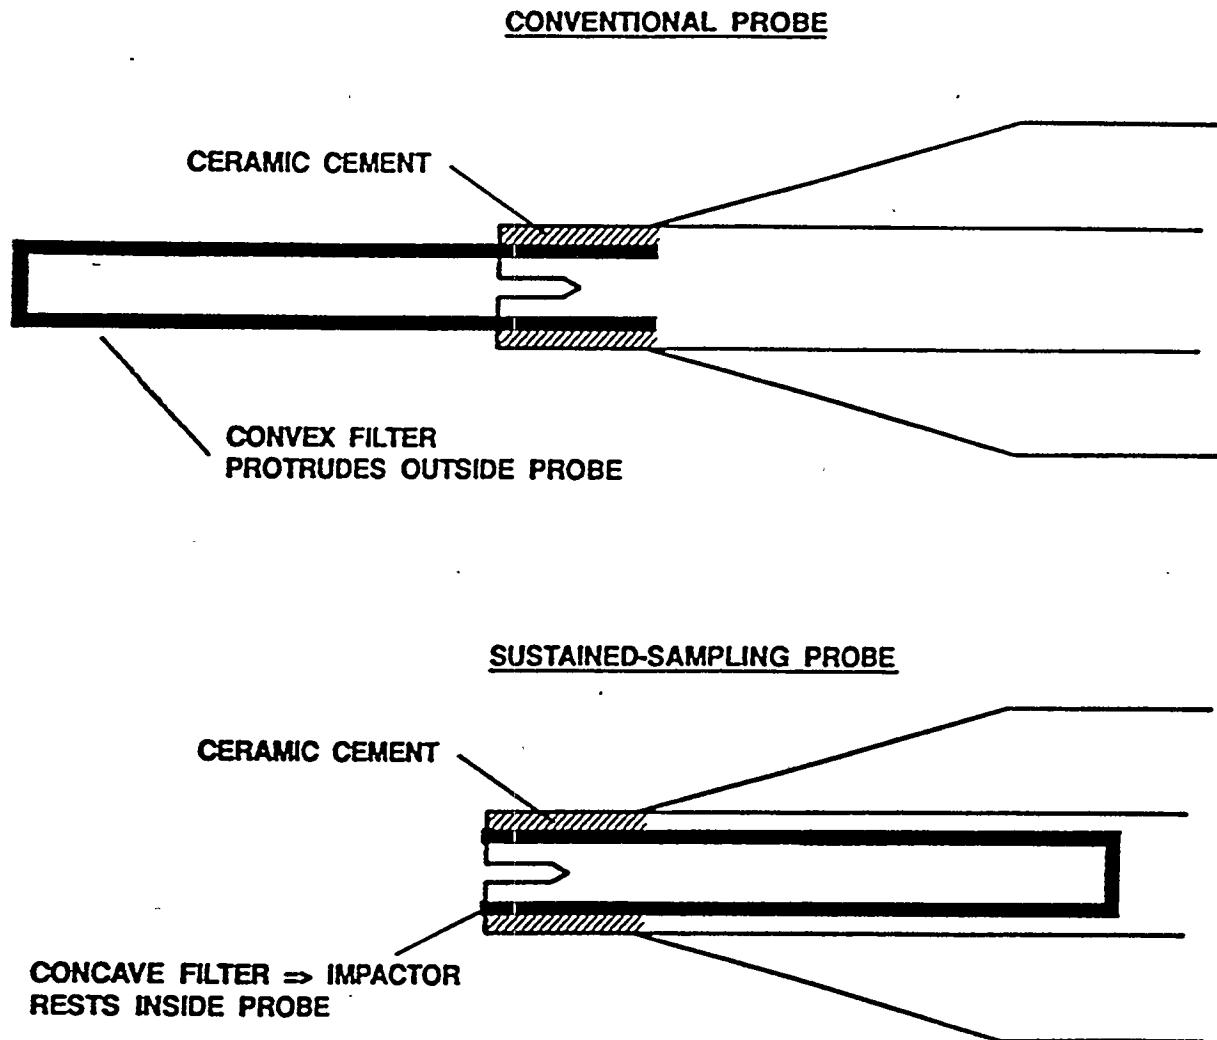
Meanwhile, the filter remained cool because it rested inside the water-cooled probe. A thermocouple mounted inside the stainless steel tube wall at the probe's tip indicated a wall temperature that ranged from 200° to 300° F. The low tip temperature increased the filter's life, as the filter was still functioning even after over 2.5 hours of continuous usage. The coolness of the probe's tip also aided sample gas quenching. The sample gas was able to quench to approximately 300°F, at a position less than 1 inch downstream of the filter.

Figure 2-6 The impactor filter tip

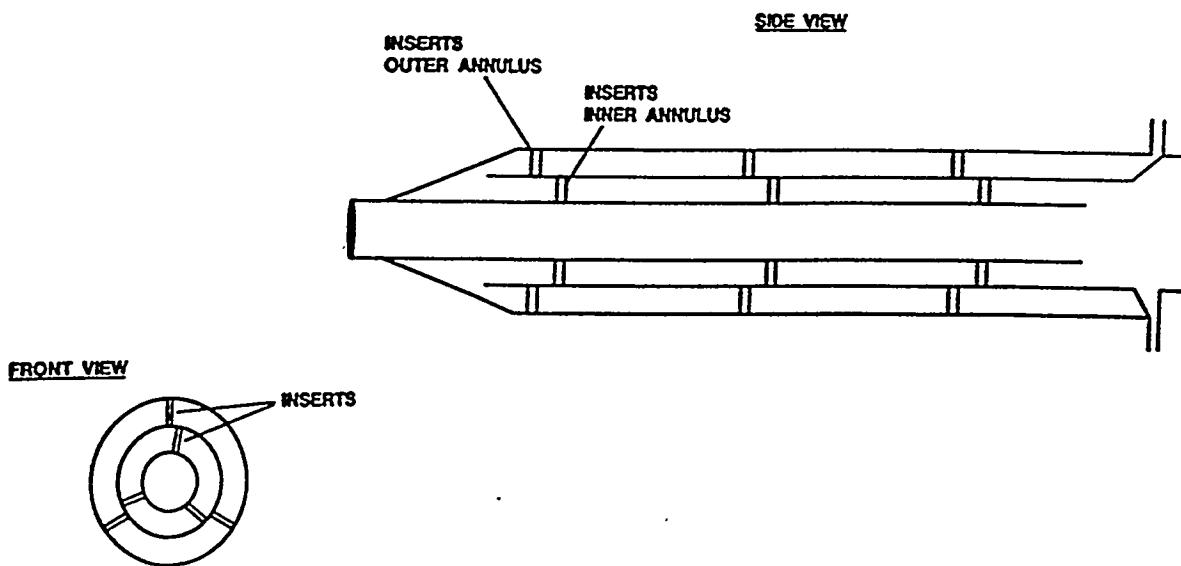
The probe anti-deflection ribbing reinforced the sampling probe and reduced its deflection substantially. No bending of the probe was evident even after several hours of use. In fact, the SSFP was still easily retractable from the furnace after almost 7 hours of use.

Figure 2-7 The probe anti-deflection ribbing

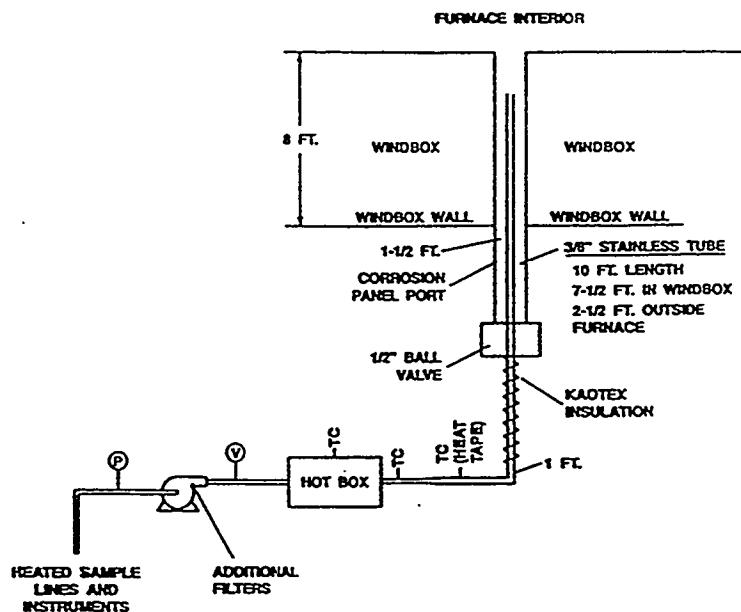
- 1) Able to be designed and constructed in the field within a few hours
- 2) Easily inserted and retracted through the 3/4-inch opening of the corrosion panel's ports
- 3) Maintenance of a wall temperature of below 1000°F for the sampling tube, to prevent H₂S reactions with hot stainless steel
- 4) Maintenance of sample gas temperatures of approximately 300°F through the entire length of the sample probe
- 5) Safety

Figure 2-8 Schematic of the corrosion panel's sampling probe

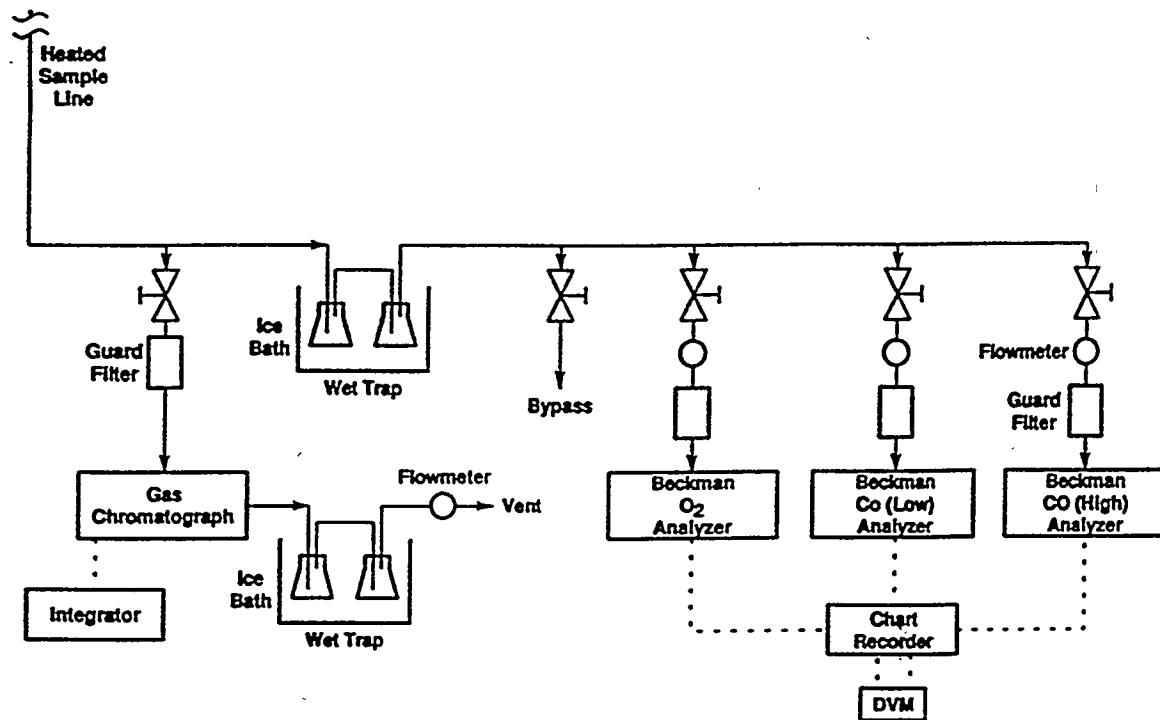
- **Gas Chromatograph (GC).** The GC used to quantify H₂S levels was a Varian Model 3400 equipped with a flame photometric detector maintained at 230°C (446°F). Nitrogen carrier gas at 30 ml/min flowed through a 30 inch x 1/8 inch OD Teflon (FEP) column packed with Porapak QS 80/100 mesh maintained at 60°C (140°F). This column provided greater sensitivity to H₂S than the column utilized during the pre-retrofit tests.

Figure 2-9 Schematic of the gas analyzer system

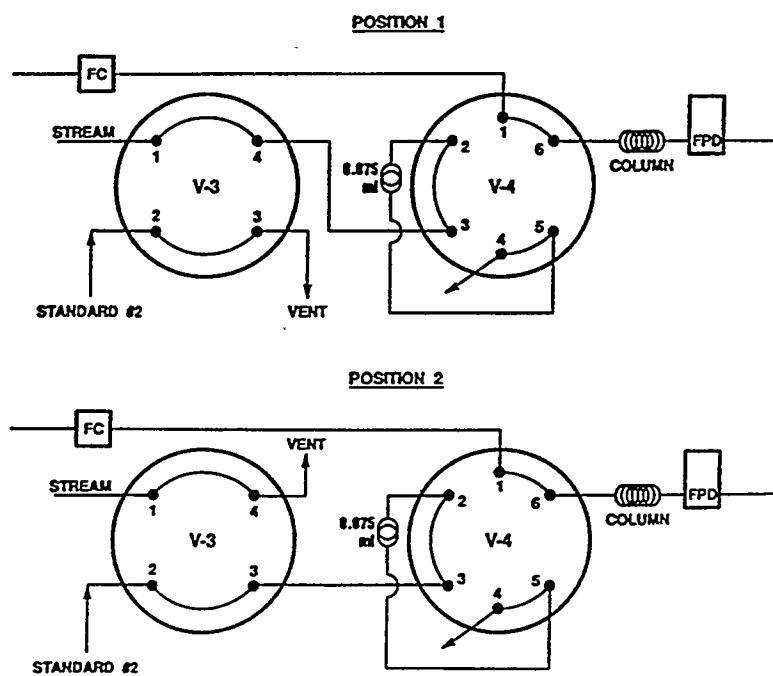
- **Sample Stream Analysis.** Although H₂S was the sulfur compound of analytical interest and its retention time was only 0.9 minute, the analysis time between chromatographic runs was 5 minutes. This extra length of time was necessary in order to allow COS and SO₂, if present, to elute from the column before injecting another gas sample. Figure 2-12 shows the chromatogram obtained when H₂S, COS, and SO₂ were present.

Figure 2-10 Schematic of the gas chromatograph's stream-select valves for H₂S analysis

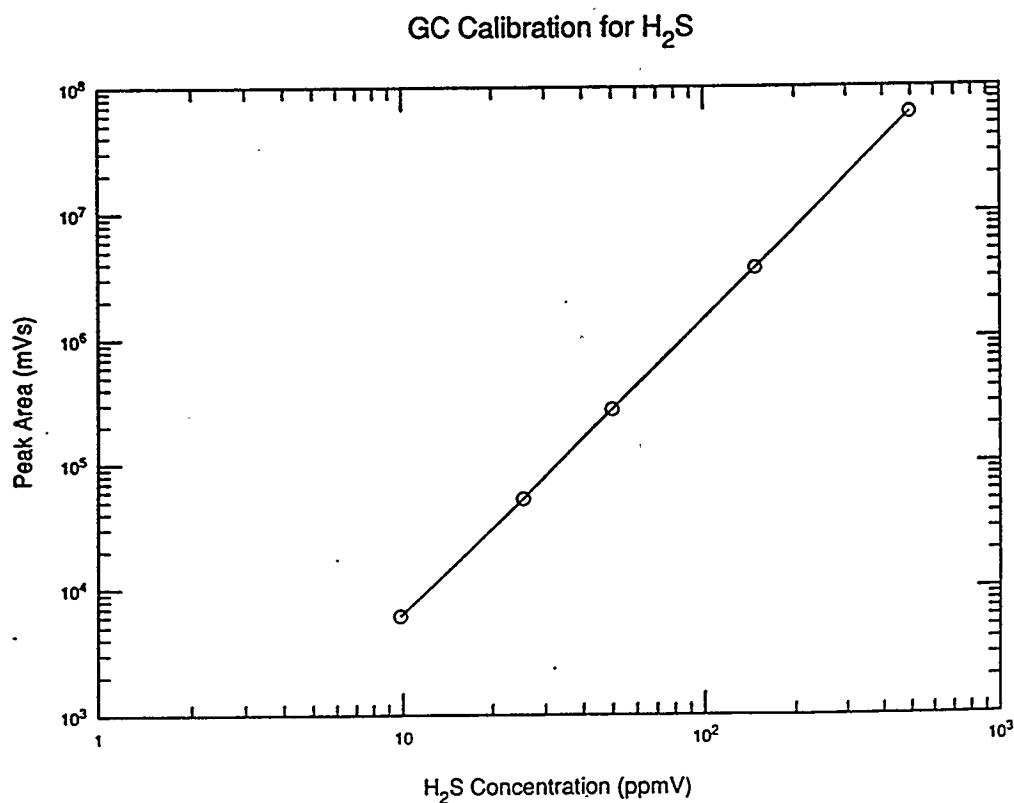
Figure 2-11 Typical gas chromatograph calibration curve for H₂S measurement

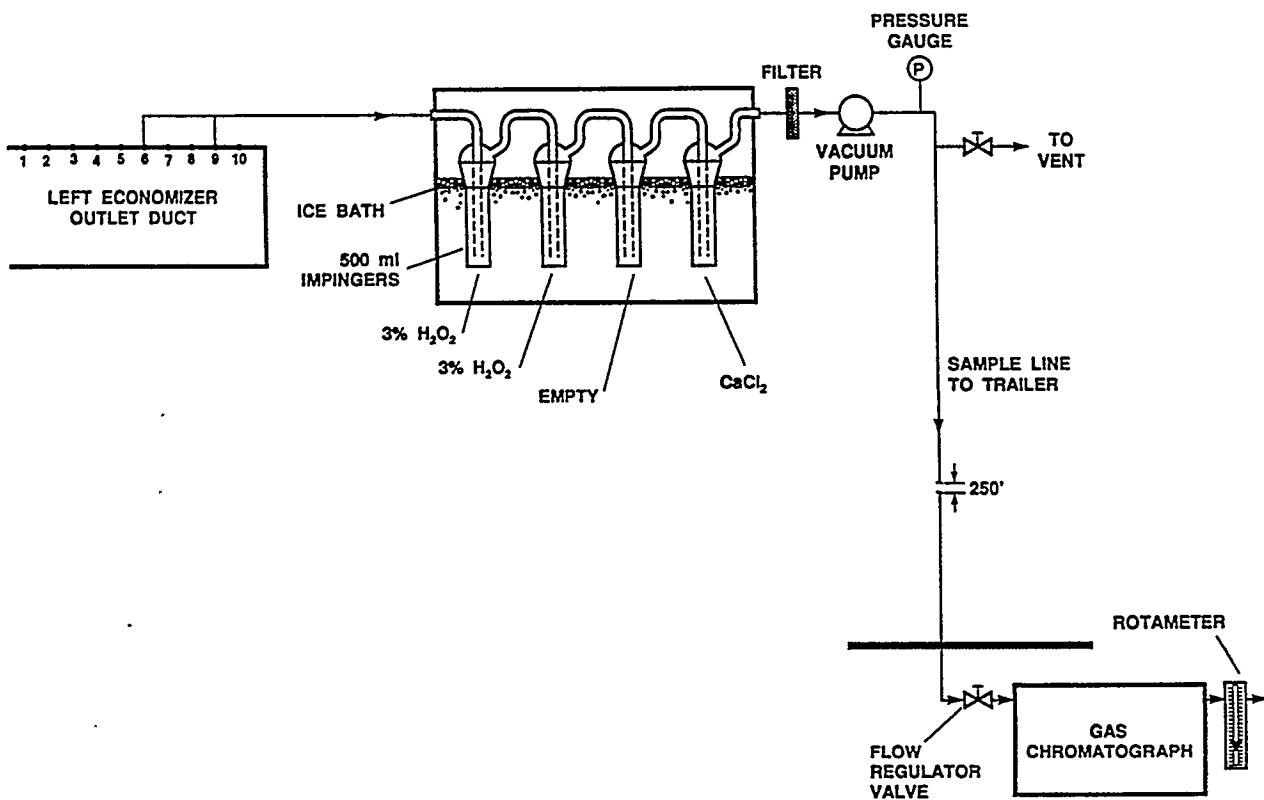
- The N₂O gas sampling valves were located in the column oven and kept at 40°C, whereas the H₂S gas sampling valves were housed in the injection block of the GC and maintained at 140°C.
- The selector switch handle for N₂O analyses was located on the right side of the GC, instead of on top of the instrument as for H₂S.
- For N₂O analyses, a 1 ml gas sample loop was employed in the six-port gas sampling valve as compared to a 0.075 ml sample loop used for H₂S.

Figure 2-13 Gas sampling system for N_2O determination

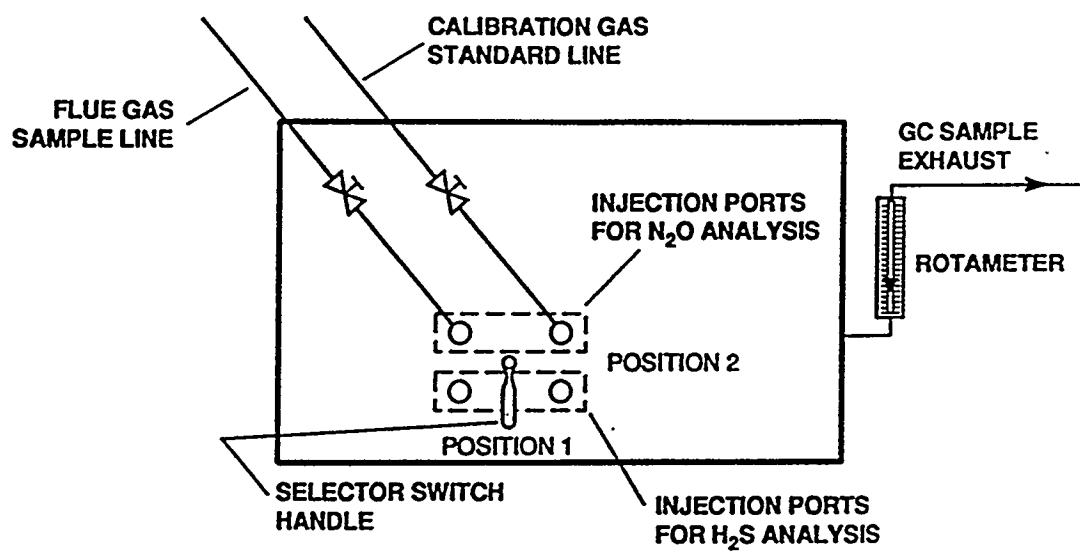
Figure 2-14 Top view of the gas chromatograph showing the location of injector ports for gas standard calibration and flue gas sampling — N_2O analyses

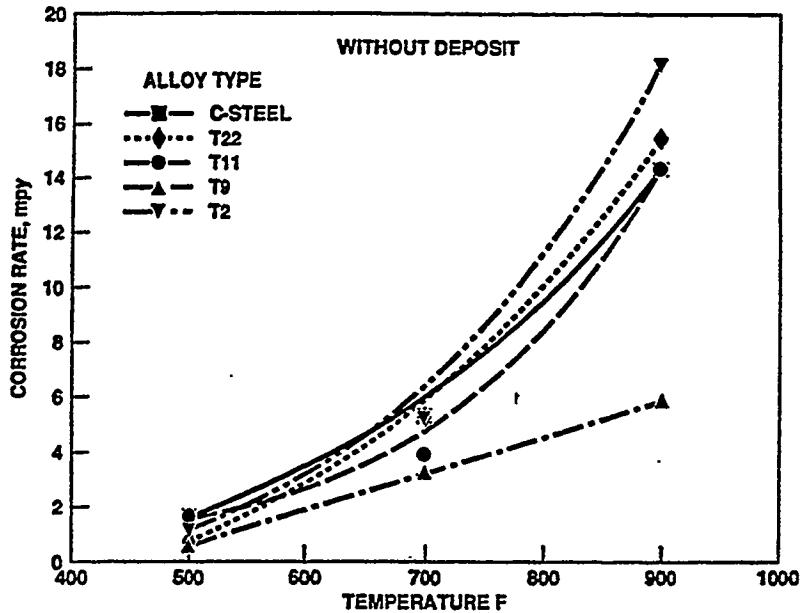
Figure 3-1 Variation of the corrosion rates with temperature for Group-I alloys without the coverage of simulated ash deposit

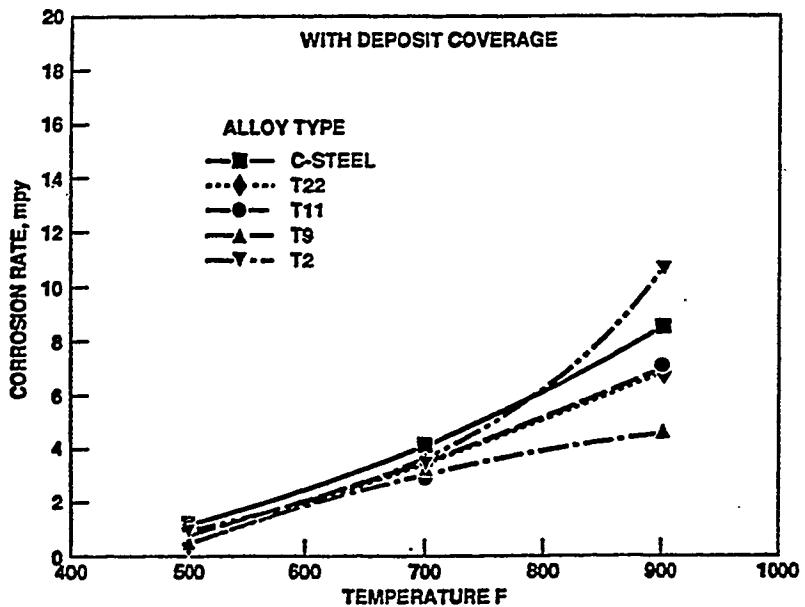
Figure 3-2 Variation of the corrosion rates with temperature for Group-I alloys with the coverage of simulated ash deposit

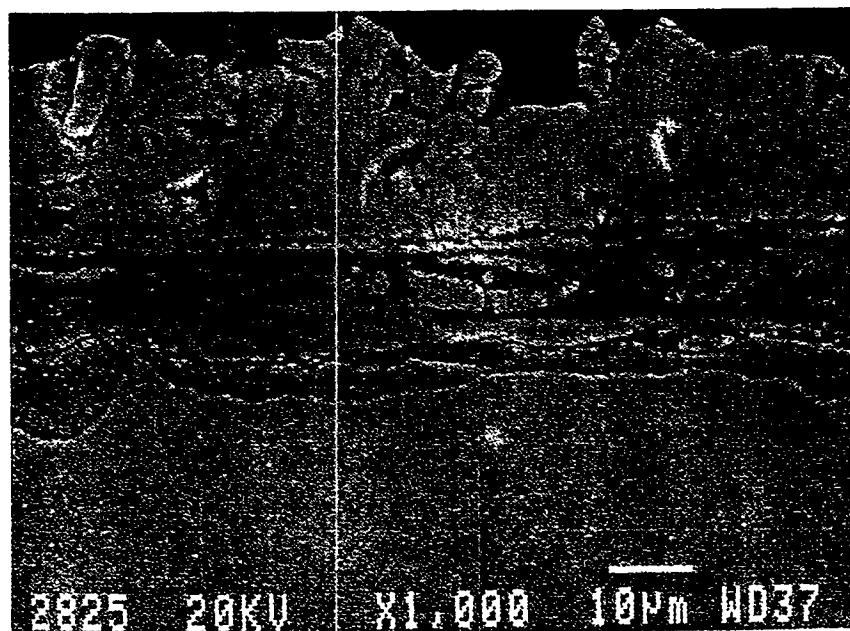
Cross-sectional metallographic examinations using SEM/EDX revealed that sulfidation was the predominant corrosion mode operating on the surfaces of all Group-I alloys. Figures 3-3 and 3-4 are the SEM micrographs of SA213-T11 and SA213-T9 after being exposed to the mixed gas in Test #2 (0.05% H₂S at 700°F for 1000 hours). The morphologies of these two cross sections are essentially identical in nature, i.e., both show multi-layered corrosion products formed on the alloy surfaces. The thick outermost layer is comprised of a faceted structure with a composition of nearly pure iron sulfide. Underneath the sulfide layer, a relatively porous mixed scale is present. EDX analyses suggested that the mixed scale contained some iron oxide and primarily iron sulfide (presumably Fe₃O₄ and FeS).

Figure 3-3 Cross-sectional SEM micrograph of SA213-T11 after exposure to the Test #2 condition

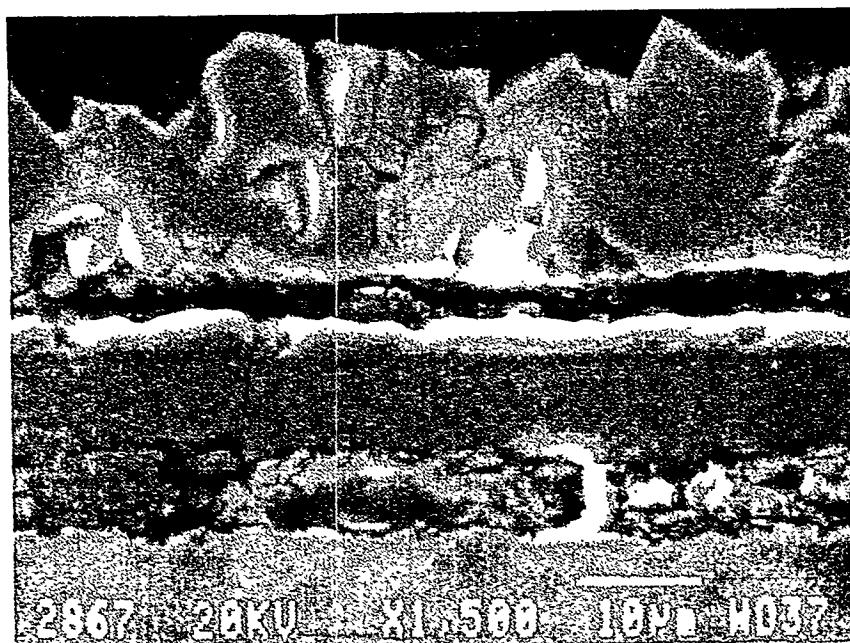
Figure 3-4 Cross-sectional SEM micrograph of SA213-T9 after exposure to the Test #2 condition

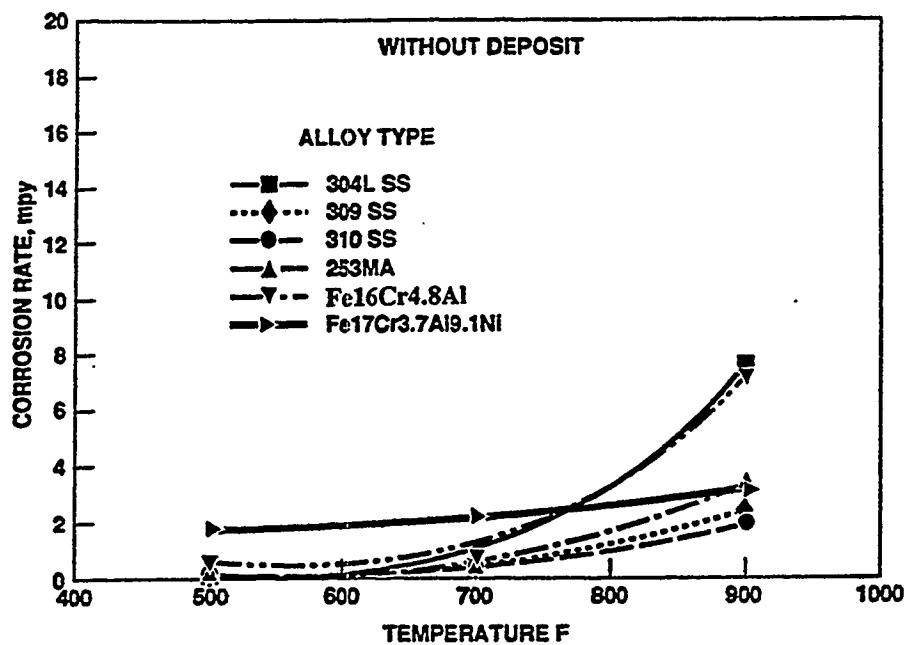
Figure 3-5 Variation of the corrosion rates with temperature for Group-II alloys without the coverage of simulated ash deposit

However, the corrosion rates of these free-standing coating materials in Figures 3-5 and 3-6 are relatively high compared to those of the other Group-II alloys. To understand the cause of this behavior, the exposed coating materials were carefully examined under SEM/EDX. Figure 3-9 shows a cross-sectional SEM micrograph of an FeCrNiAl sample after exposure in Test #2. In general, the corrosion products on the outer surface were very thin, despite the detection of some iron sulfide by EDX. The thin corrosion products formed on the surfaces indicate that the inherent compositions of these coating materials are quite resistant to the simulated reducing combustion gases.

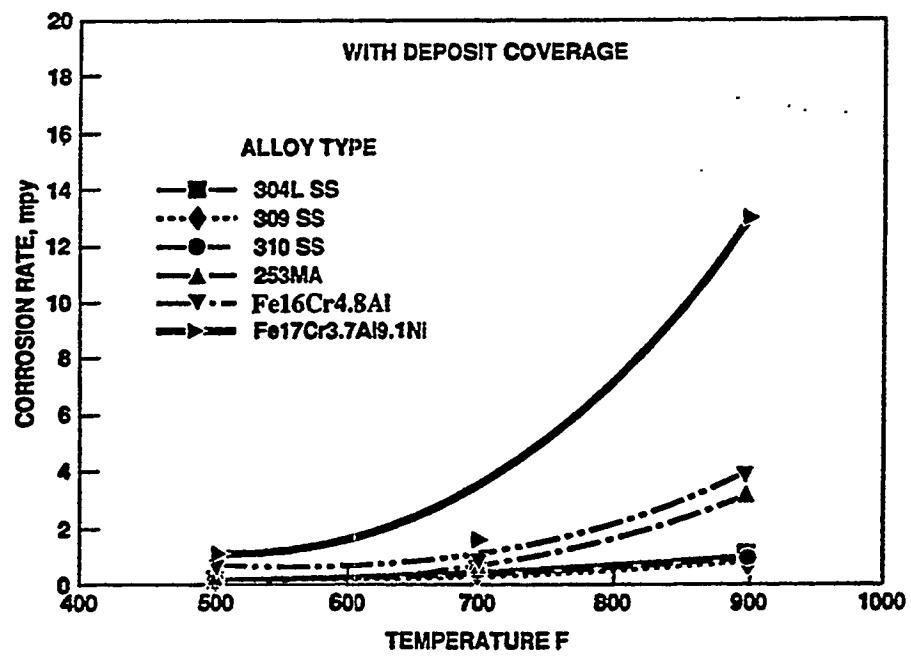
Figure 3-6 Variation of the corrosion rates with temperature for Group-II alloys with the coverage of simulated ash deposit

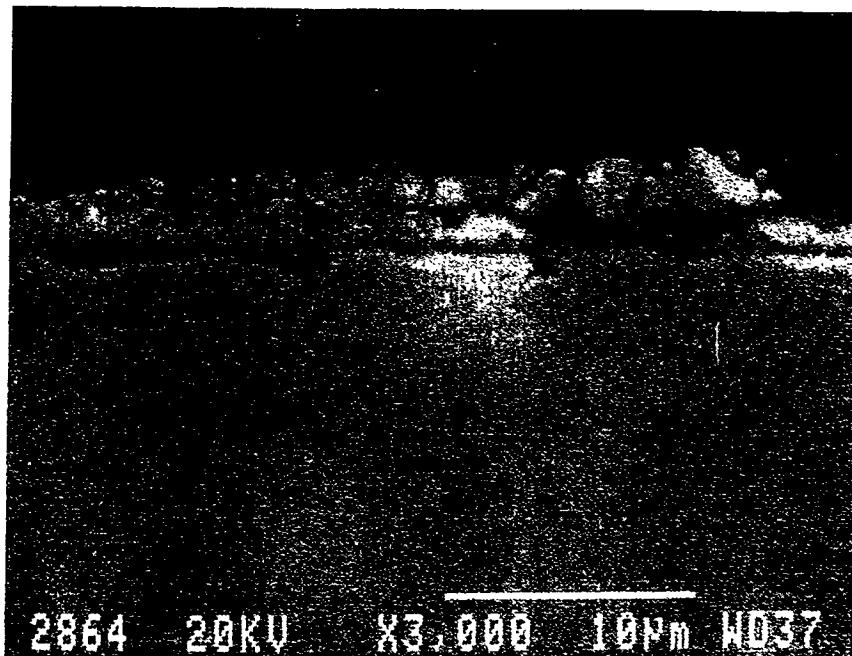
Figure 3-7 Cross-sectional SEM micrograph of SA213-310 after exposure to the Test #2 condition

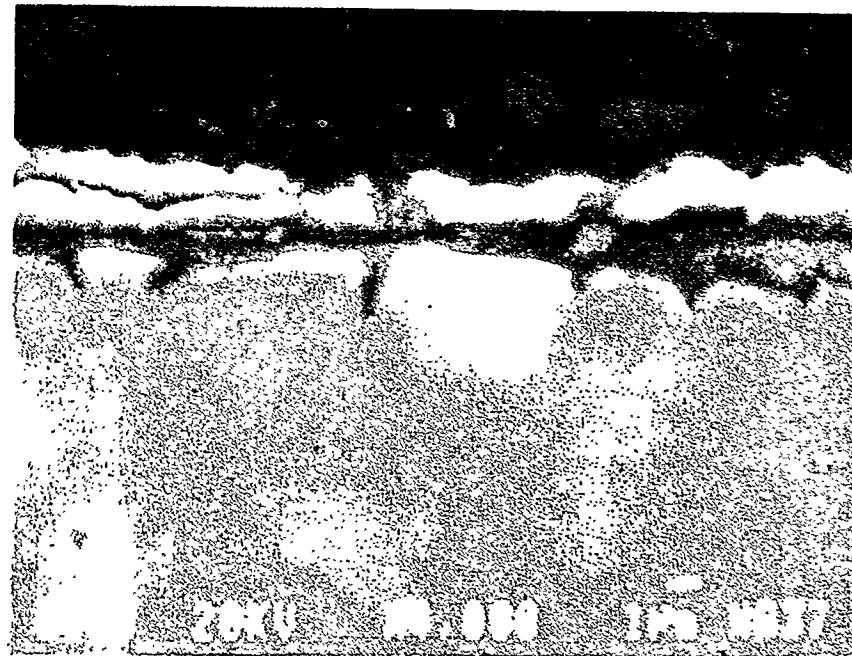
Figure 3-8 Cross-sectional SEM micrograph of Alloy 253MA after exposure to the Test #2 condition

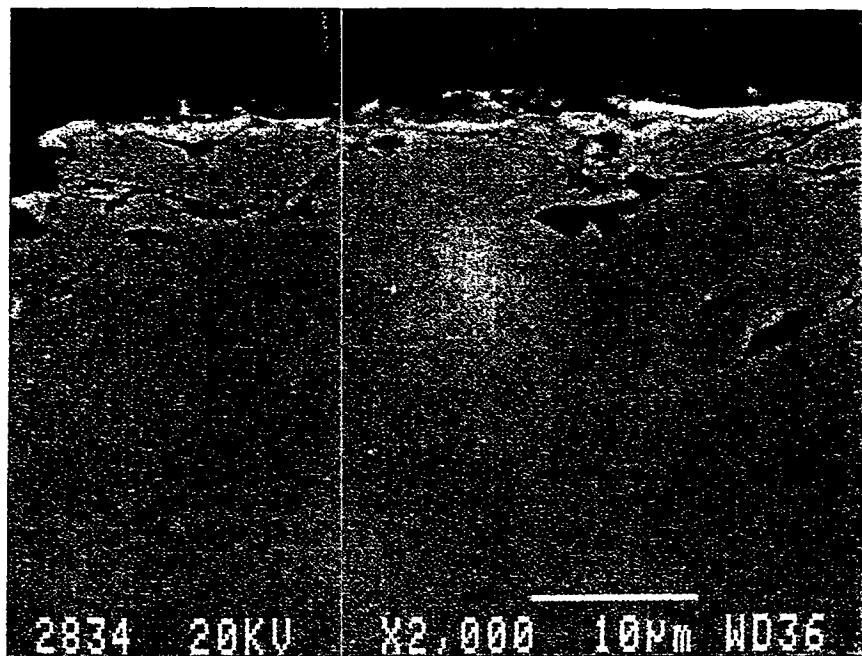
Figure 3-9 Cross-sectional SEM micrograph of an FeCrNiAl alloy after exposure to the Test #2 condition

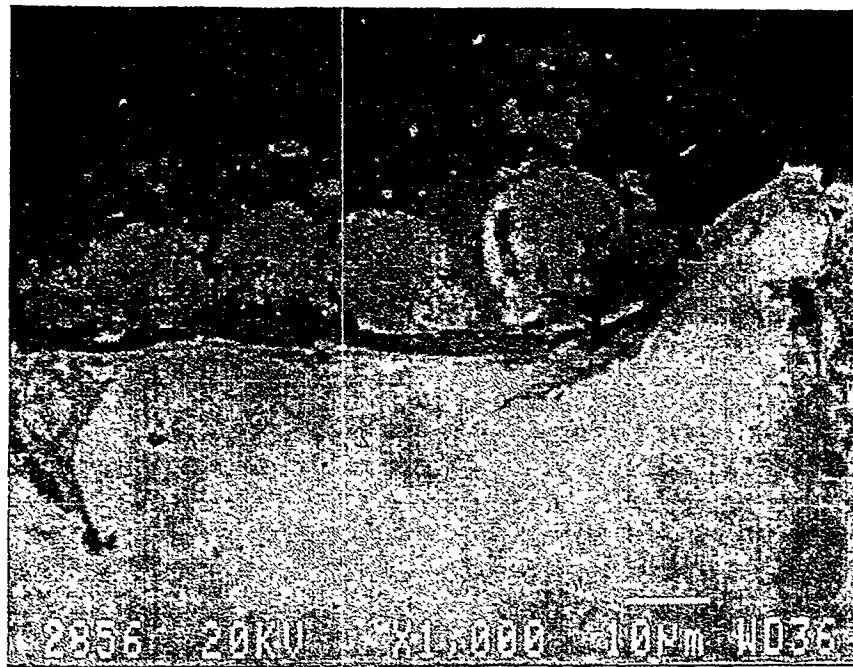
Figure 3-11 Cross-sectional SEM micrograph of an Al/T2 sample at the coating/substrate interface after exposure to the Test #2 condition

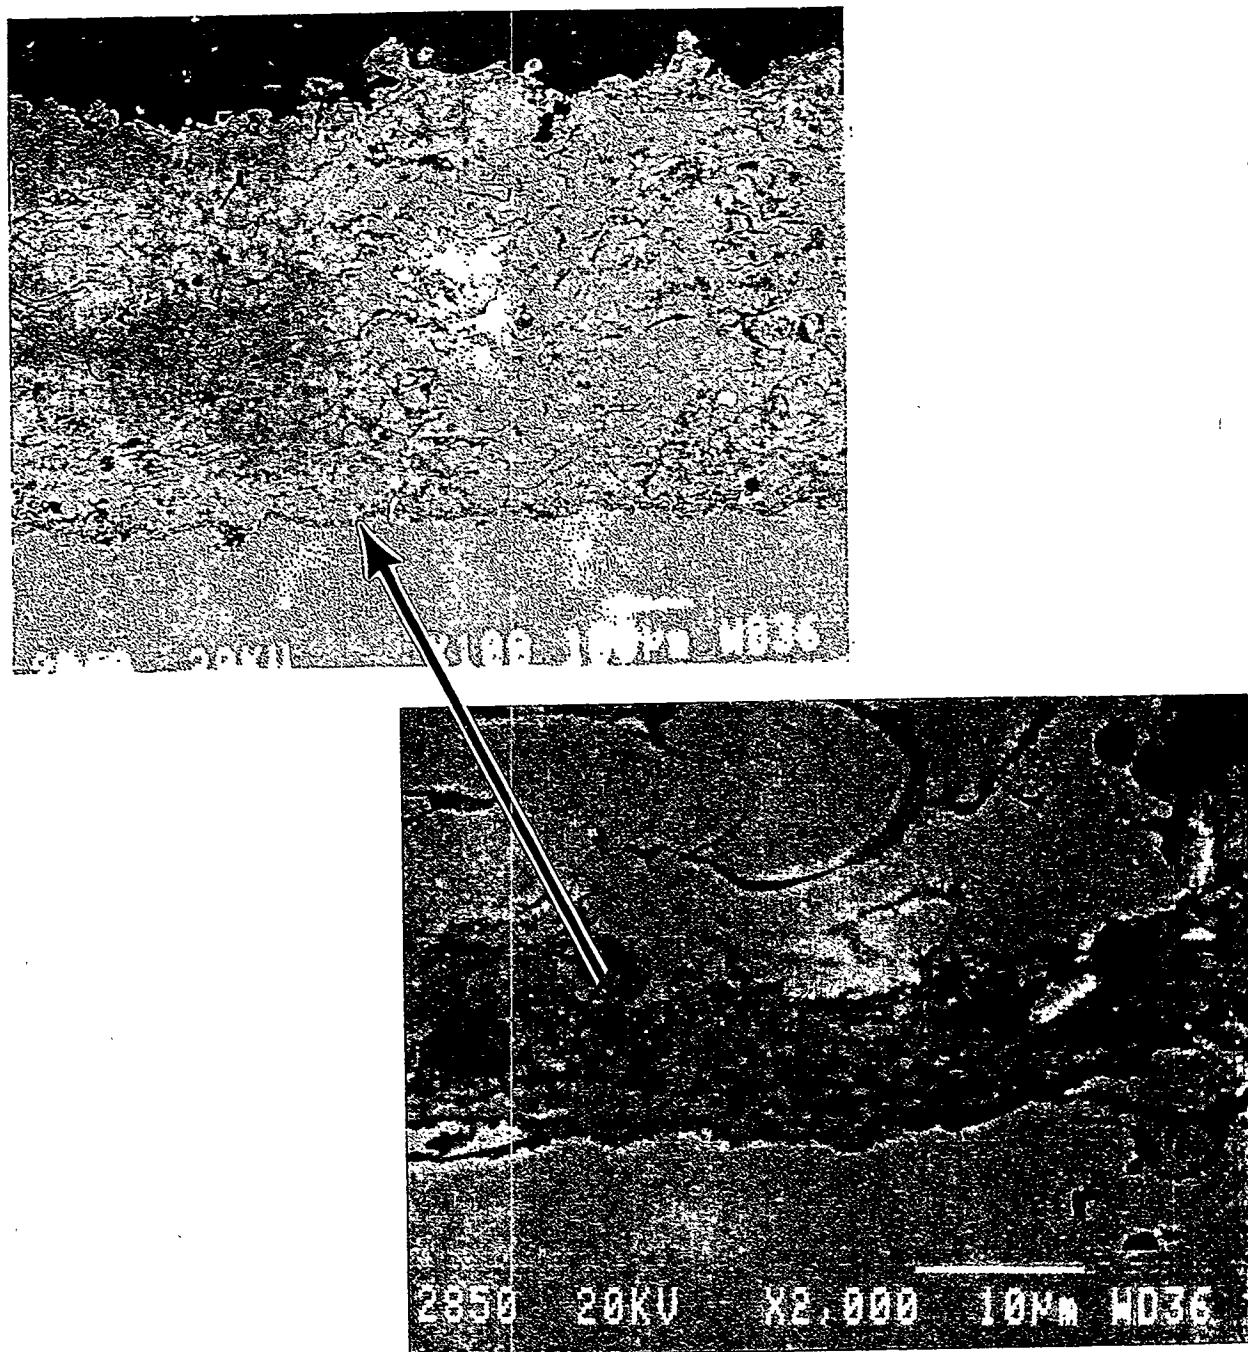
Figure 3-12 Cross-sectional SEM micrograph of an FeCrNiAl/T2 sample at the coating/substrate interface after exposure to the Test #2 condition

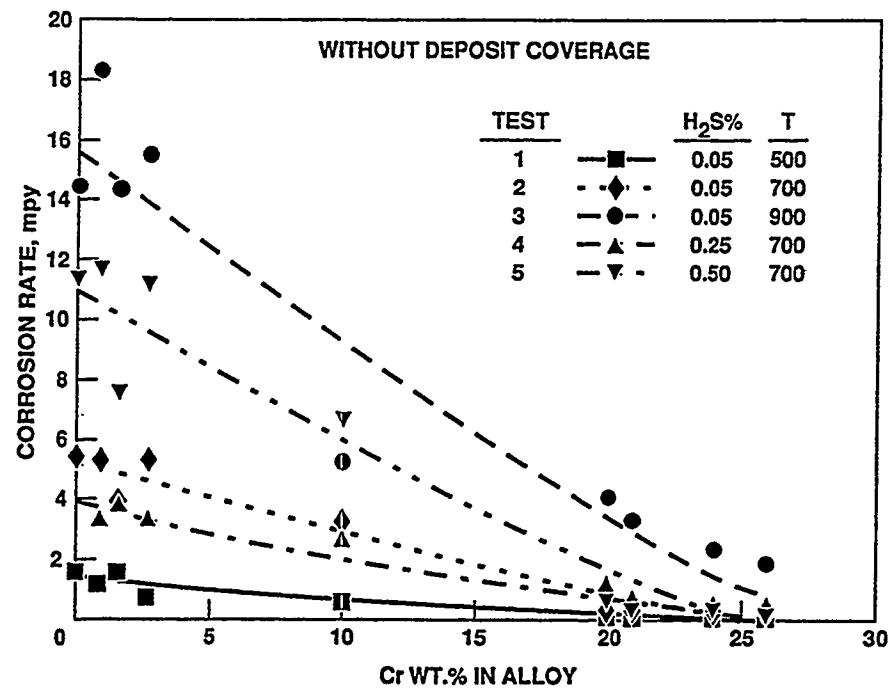
Figure 3-14 Variation of the corrosion rates with Cr concentration in alloys without the coverage of simulated ash deposit

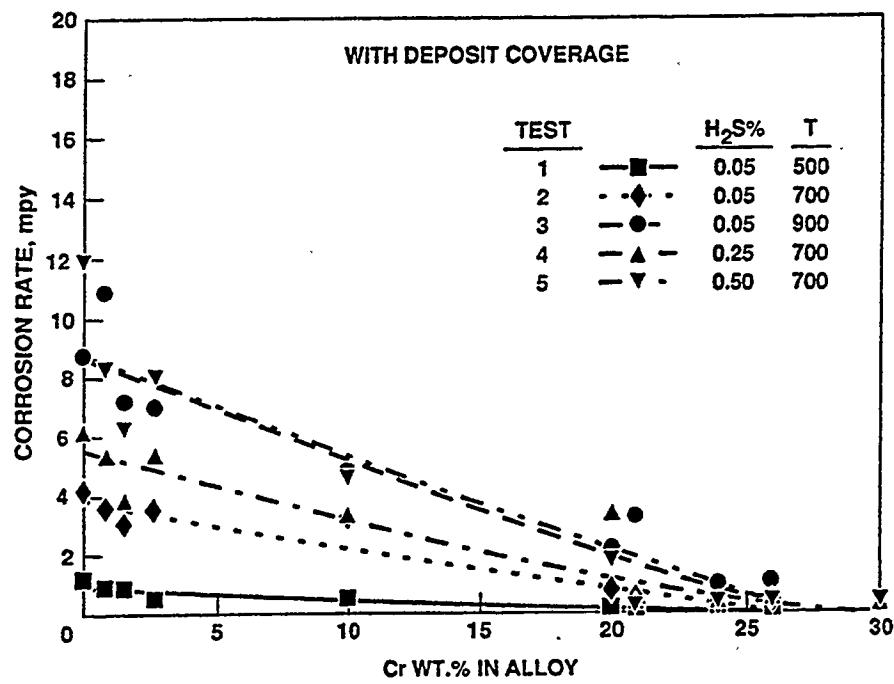
Figure 3-15 Variation of the corrosion rates with Cr concentration in alloys with the coverage of simulated ash deposit

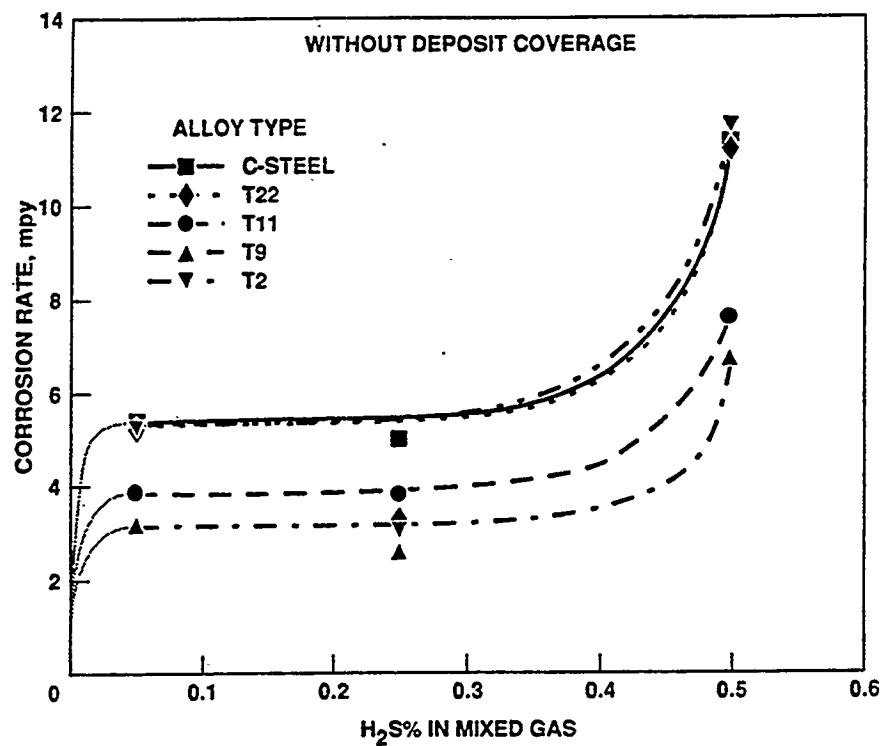
Figure 3-16 Variation of the corrosion rates with H_2S concentration in the mixed gas for the Group-I alloys at 700°F without the coverage of simulated ash deposit
