TASK REPORT

FULL-SCALE DEMONSTRATION OF LOW-NO_x CELL™ BURNER RETROFIT

Long-Term Testing

Report DOE/PC/90545-1
(Babcock & Wilcox Report RDD:94:40090-030-036:01)

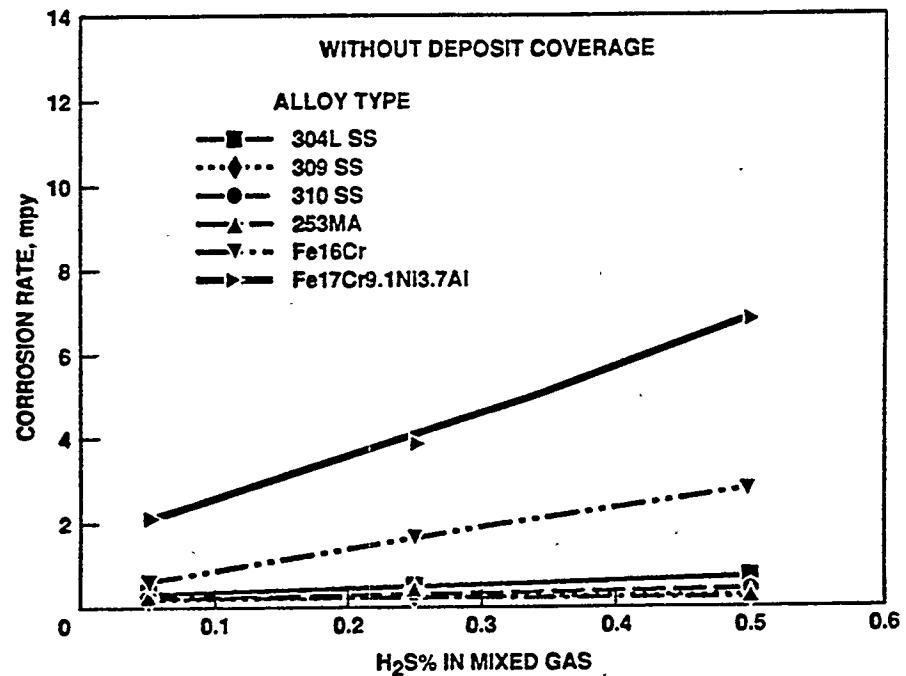
Figure 3-17 Variation of the corrosion rates with H_2S concentration in the mixed gas for the Group-II alloys at 700°F without the coverage of simulated ash deposit

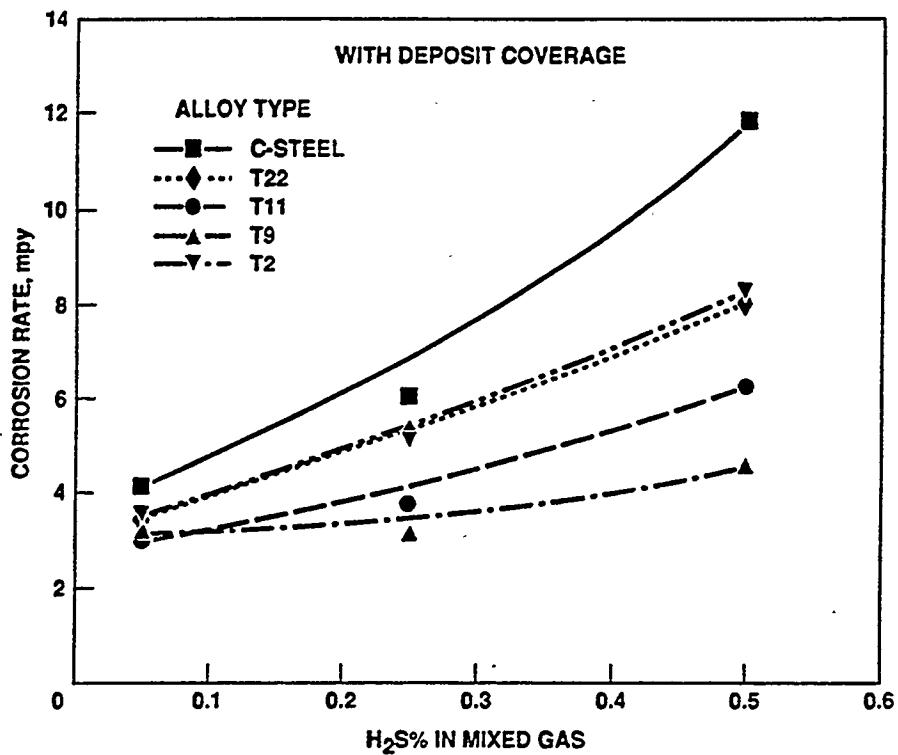
Figure 3-18 Variation of the corrosion rates with H_2S concentration in the mixed gas for the Group-I alloys at 700°F with the coverage of simulated ash deposit

Figures 3-18 and 3-19 show the corrosion rates of Group-I and Group-II alloys, respectively, as a function of the flue-gas H₂S concentration *with* the coverage of deposit at 700°F. Perhaps with the exception of the carbon steel (SA178-A), the dependency of corrosion rate upon the H₂S concentration within 0 - 0.5% H₂S is relatively small. It appears that, when covered with the ash deposit, the corrosion rates of the low-alloy steels can be noticeable only at an H₂S concentration above 0.5%, outside the concern of many low-NO_x technologies.

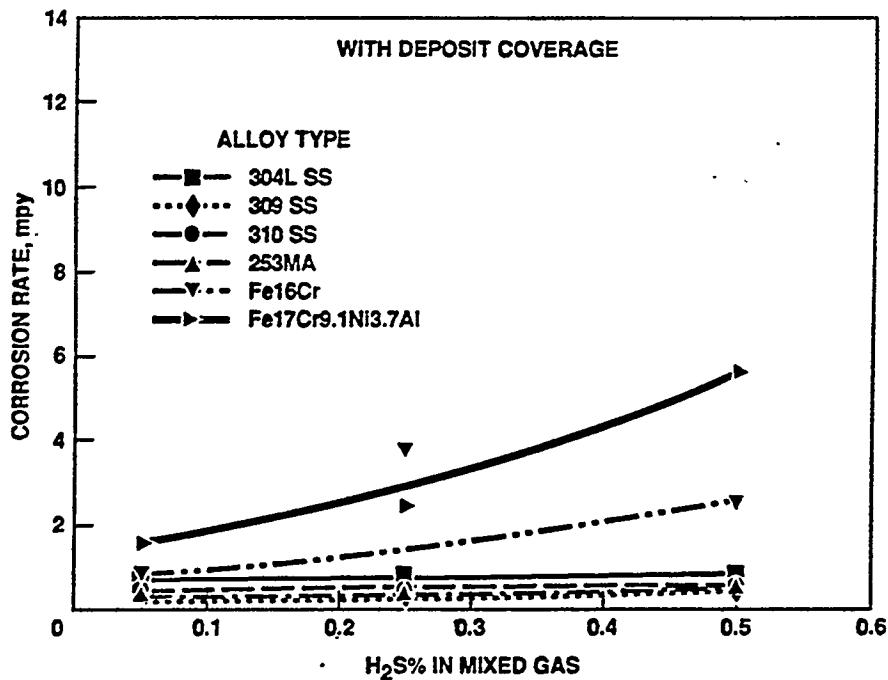
Figure 3-19 Variation of the corrosion rates with H_2S concentration in the mixed gas for the Group-II alloys at 700°F with the coverage of simulated ash deposit

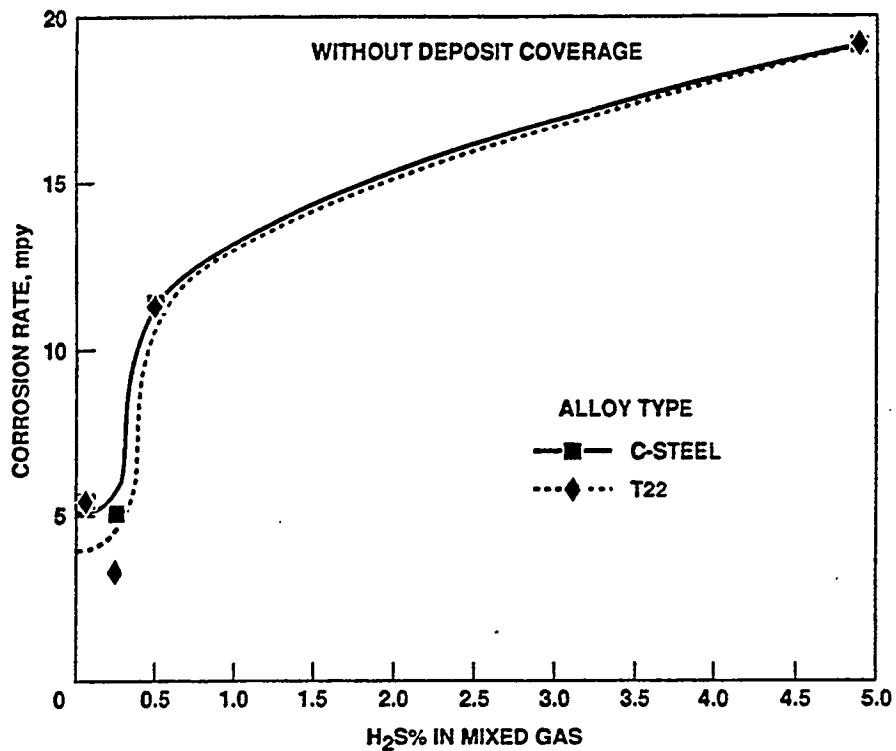
Figure 3-20 Variation of the corrosion rates with H₂S concentration in the mixed gas for SA213-T22 at 700°F without the coverage of simulated ash deposit

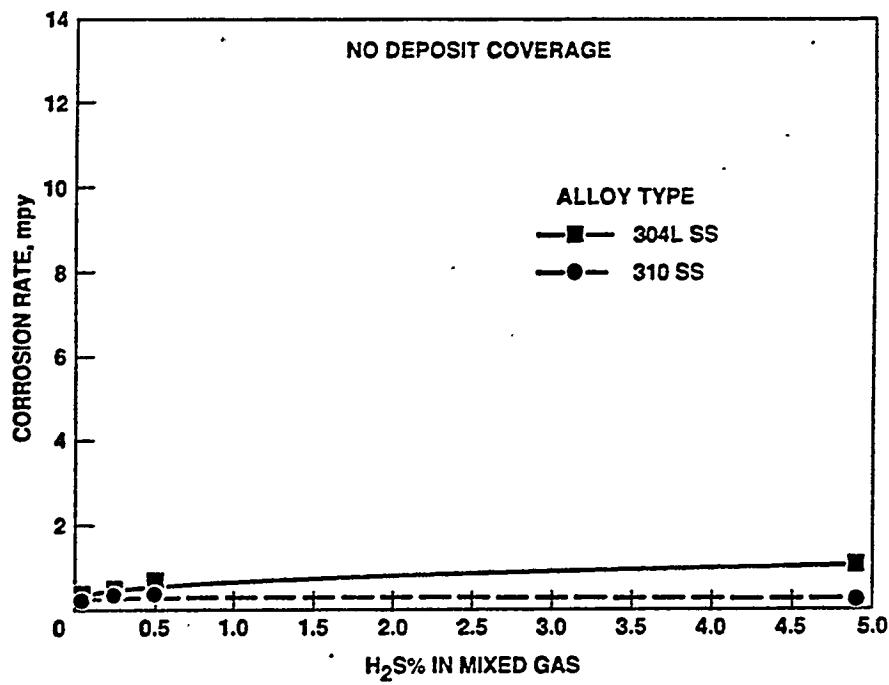
Figure 3-21 Variation of the corrosion rates with H₂S concentration in the mixed gas for SA213-304 and SA213-310 at 700°F without the coverage of simulated ash deposit

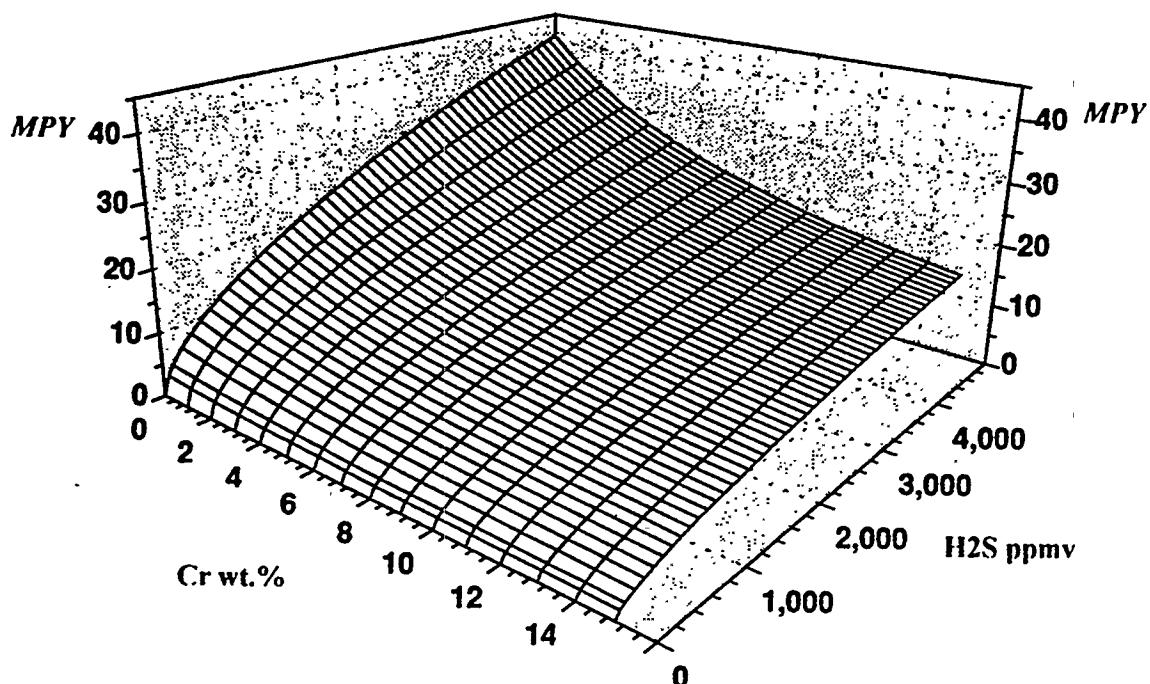
Figure 3-22 Variation of the predicted corrosion rate of alloys containing <15 wt.% Cr with H_2S concentration in the mixed gas and Cr concentration in the alloys at 850°F

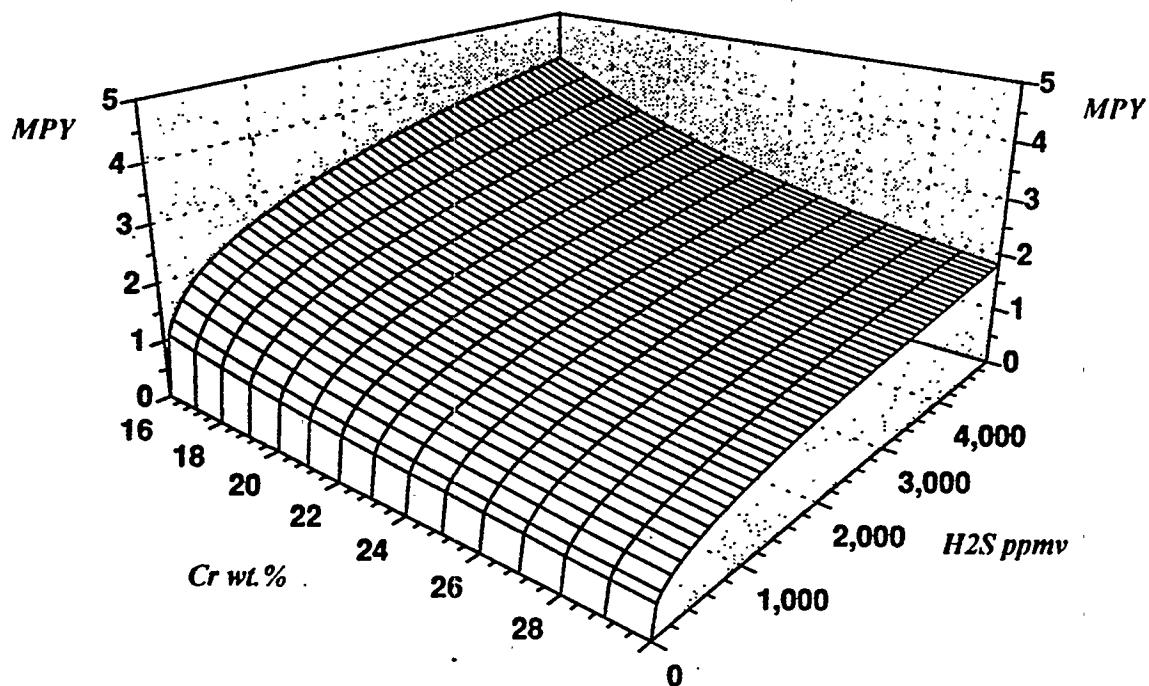
Figure 3-23 Variation of the predicted corrosion rate of alloys containing >16 wt.% Cr with H_2S concentration in the mixed gas and Cr concentration in the alloys at 850°F

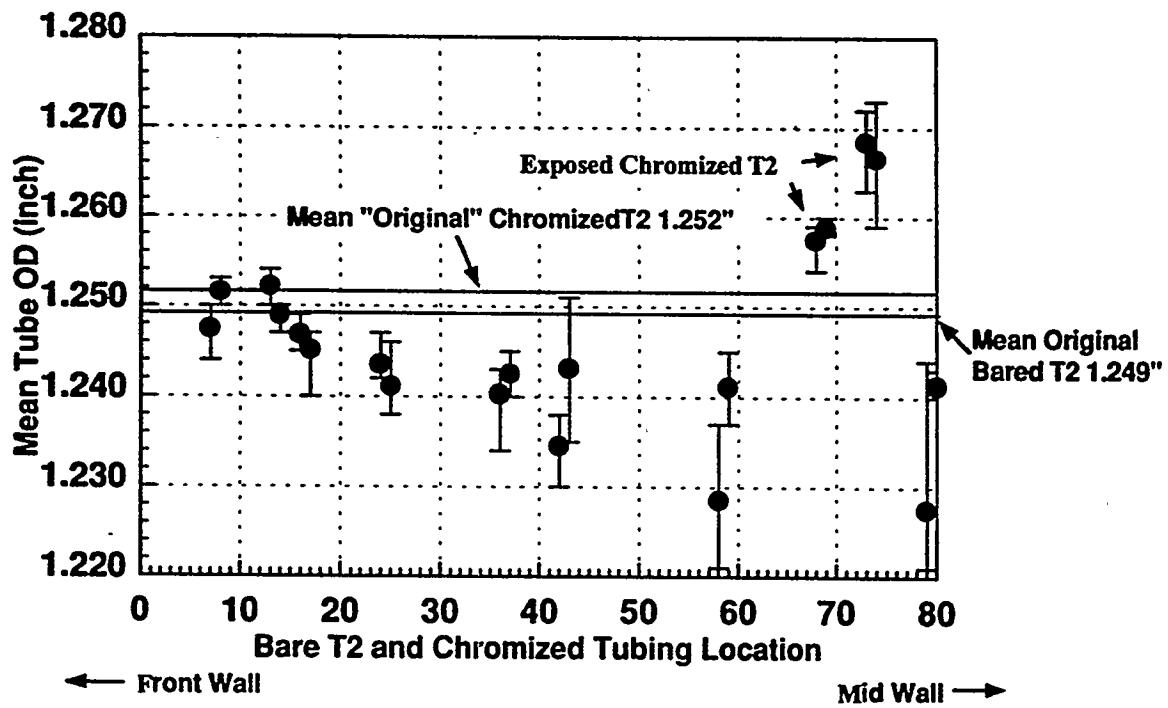
Figure 3-24 Statistical OD values of bare T2 and chromized T2 tube samples from the top segment of the test panel

Figures 3-24 and 3-25 show the measured ODs of bare T2 tubing and chromized T2 tubing from the top and bottom locations of the test panel across the test panel. At least seven OD measurements from each tube sample were obtained for each data point. The ranges of variations are indicated by the range bars and their mean values are given by the filled circles.

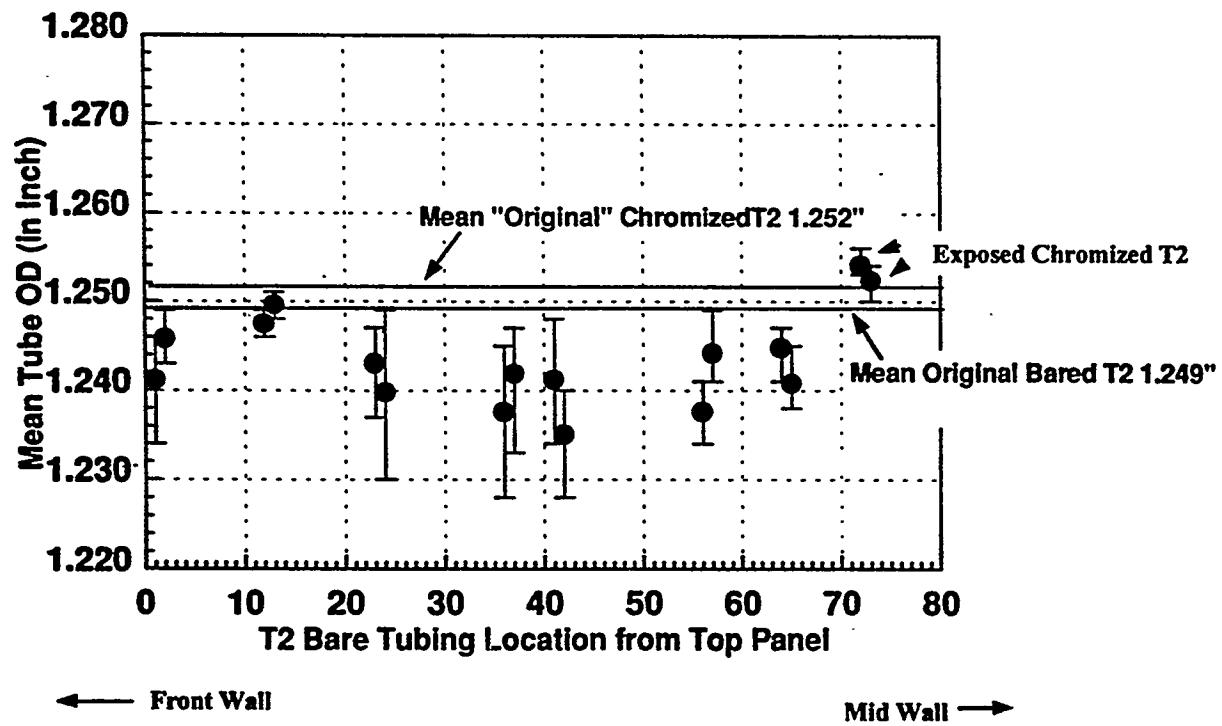
Figure 3-25 Statistical OD values of bare T2 and chromized T2 tube samples from the bottom segment of the test panel

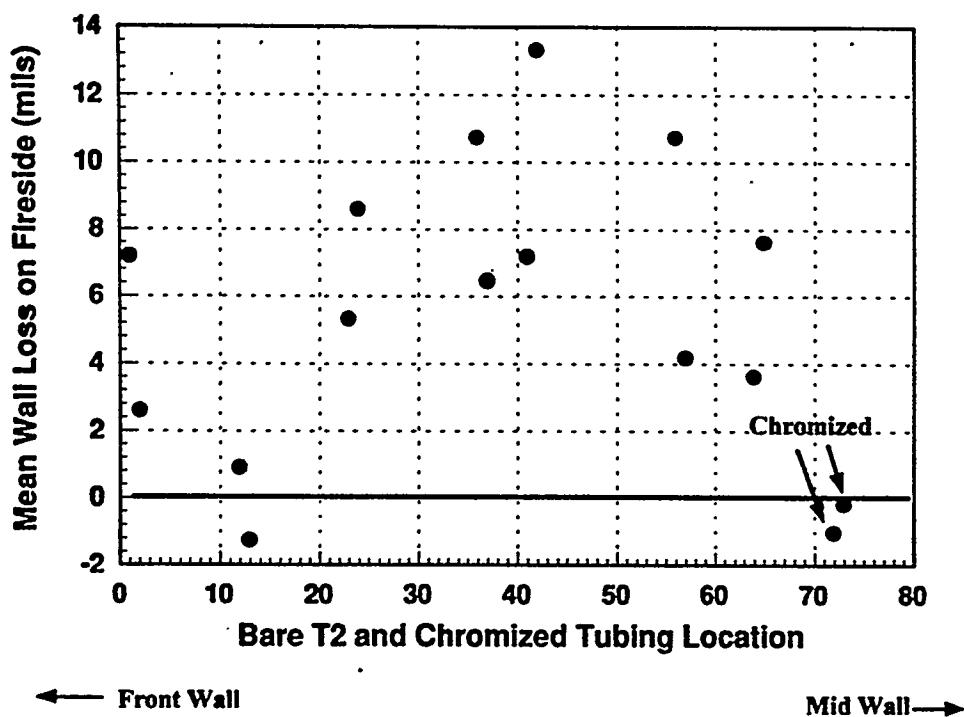
Figure 3-26 Thickness loss of bare T2 tubing along the top segment of the corrosion test panel

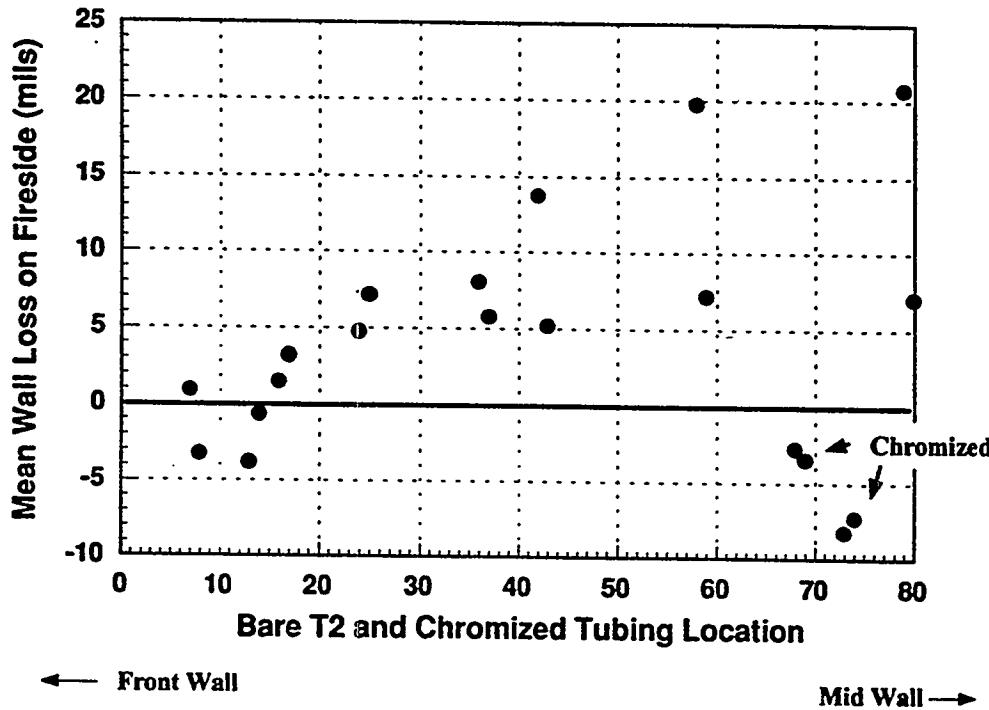
Figure 3-27 Thickness loss of bare T2 tubing along the bottom segment of the corrosion test panel

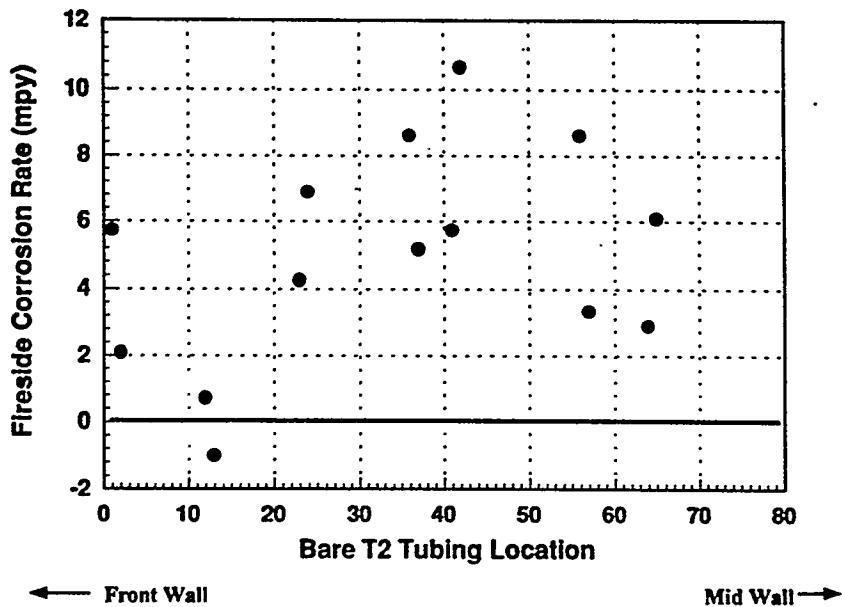
Figure 3-33 Corrosion rate of bare T2 tubing across the top segment of the test panel using the measured metal wastage and exposure time

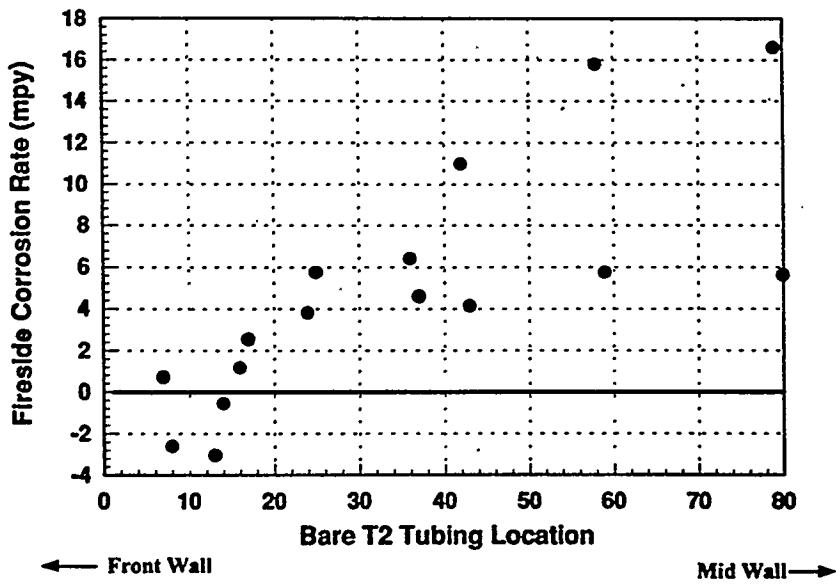
Figure 3-34 Corrosion rate of bare T2 tubing across the bottom segment of the test panel using the measured metal wastage and exposure time

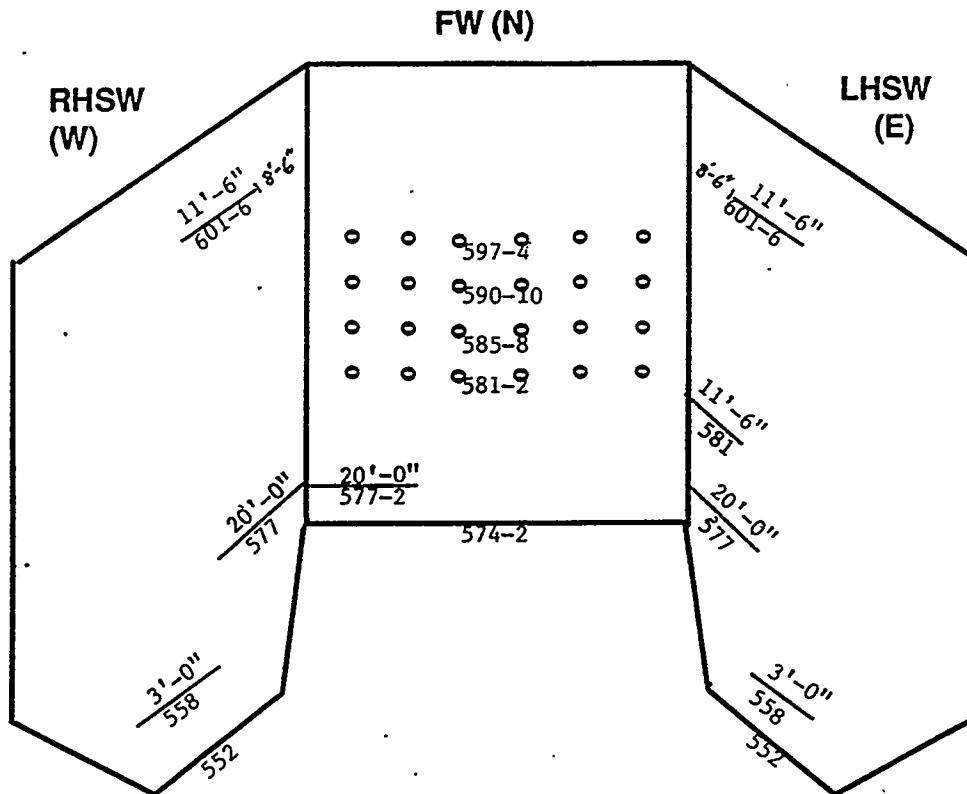
Figure 3-35 Elevations and locations of UT survey performed during the November 1991 and April 1993 outages

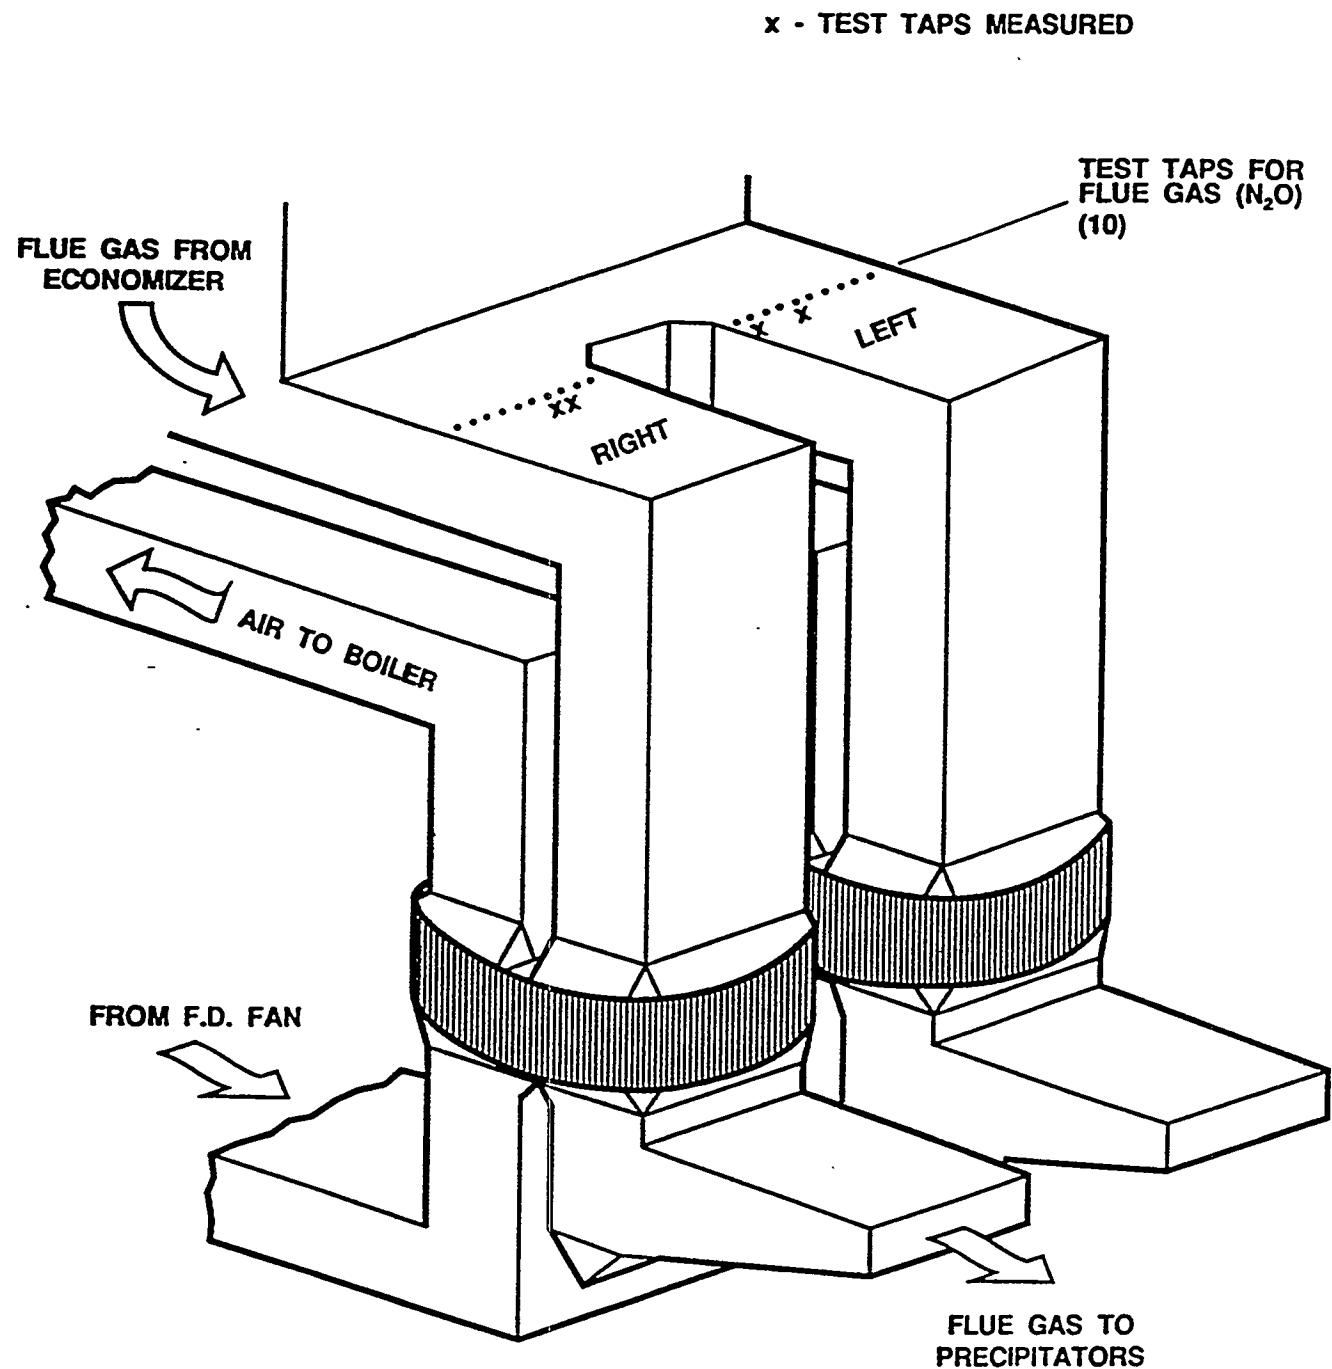
Figure 3-36 Nitrous oxide test port locations on JMSS 4

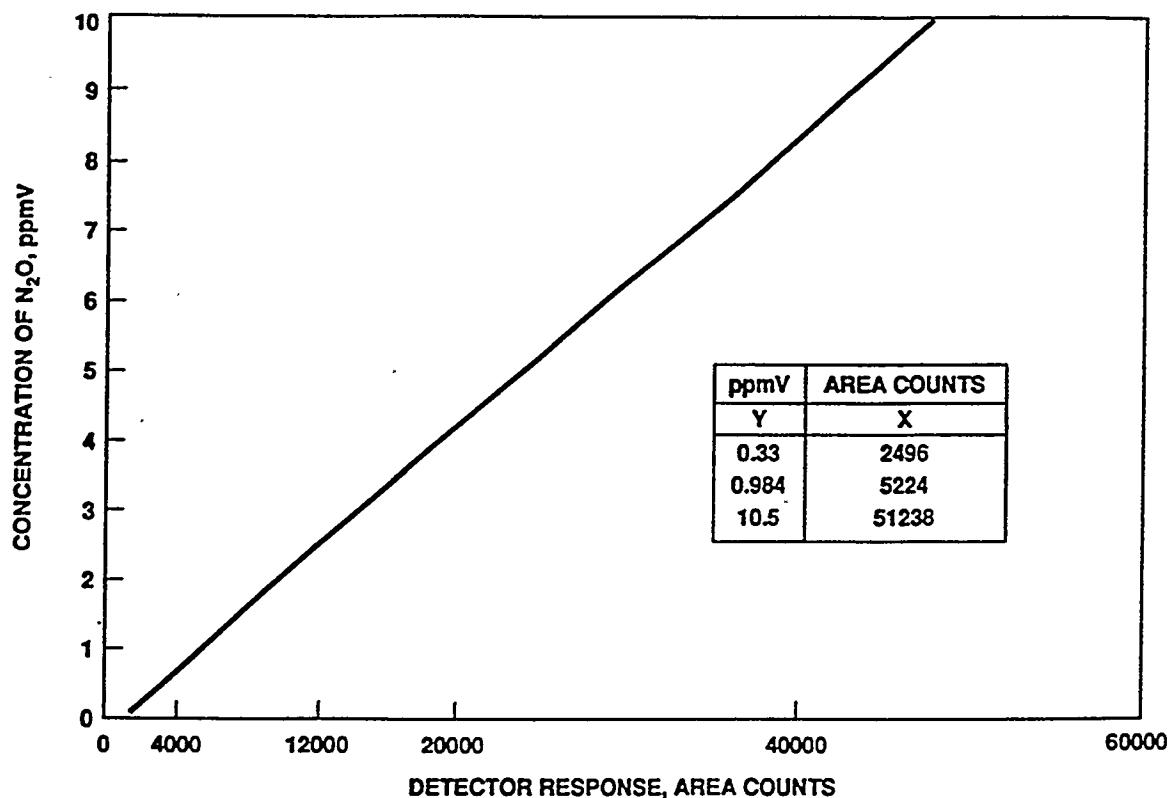
Figure 3-37 Graph of concentration of nitrous oxide against peak area (Data points = 3, correlation coefficient = 0.999; Intercept = -0.1465; and slope = 0.0002)

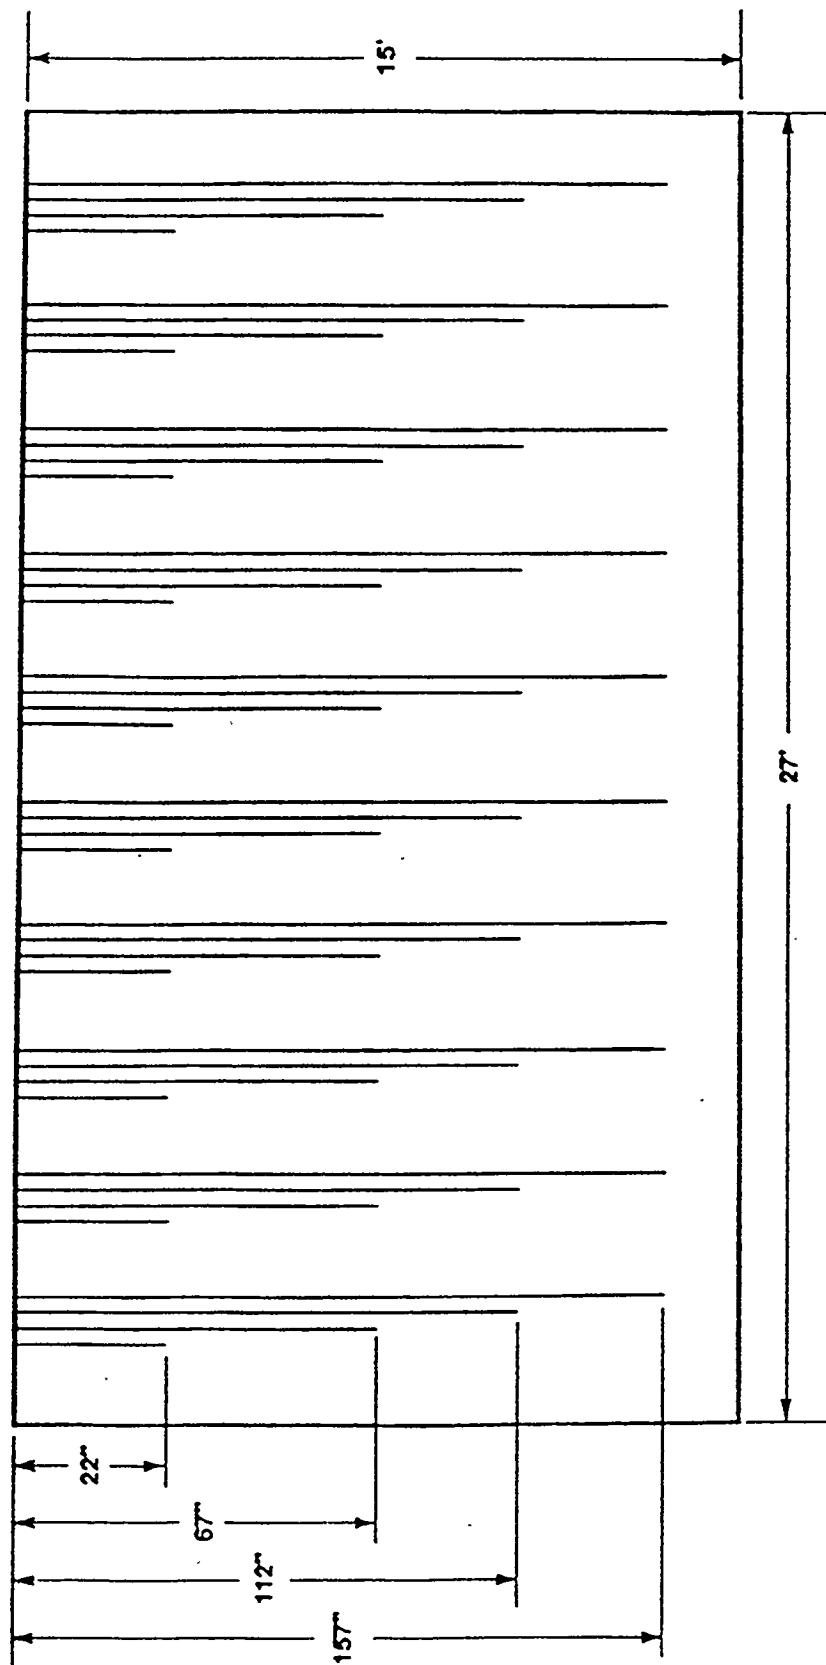
Figure 3-38 Economizer outlet gas sampling grid (1 of 2) 5/16-inch tubing connections to the sample lines

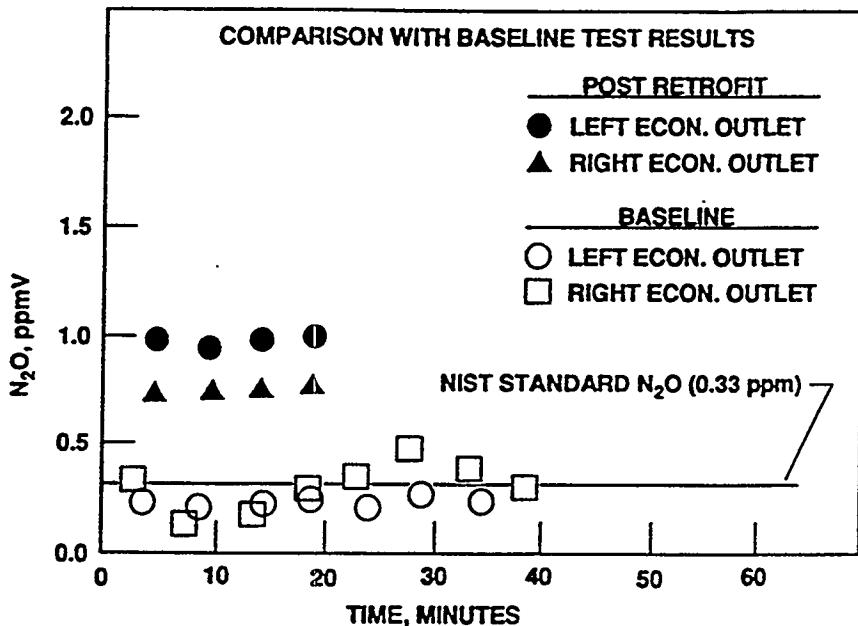
Figure 3-39 N₂O at economizer outlet

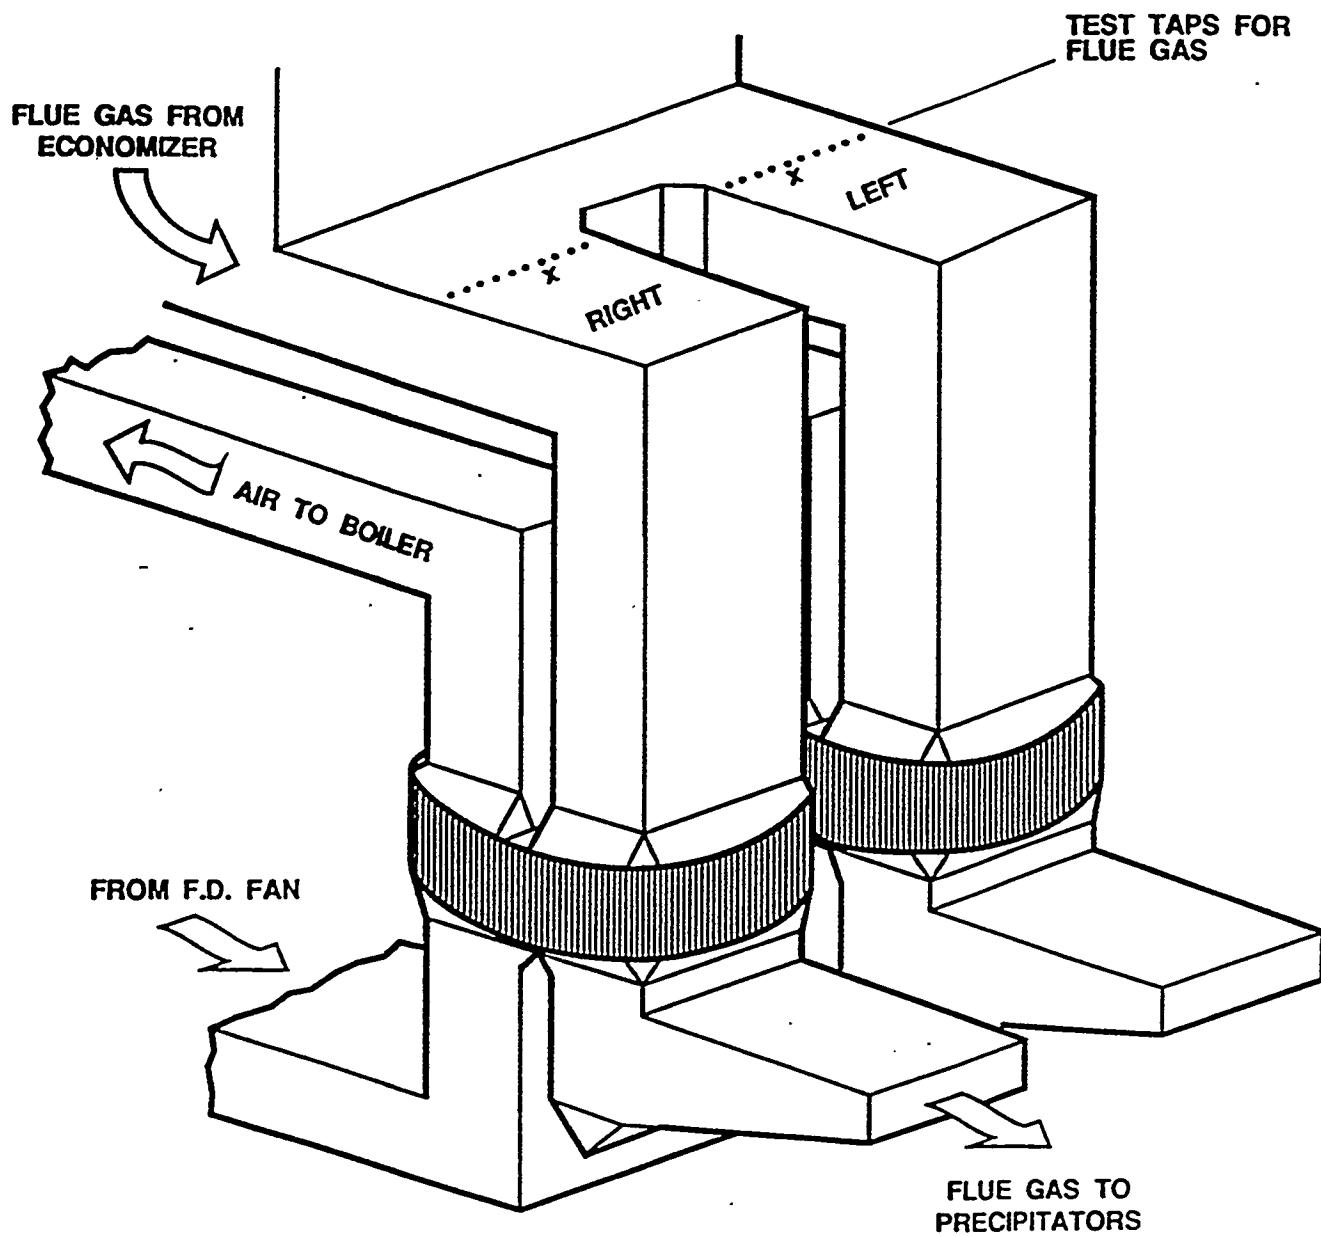
Figure 3-40 Emissions test port locations for Acurex long-term monitoring

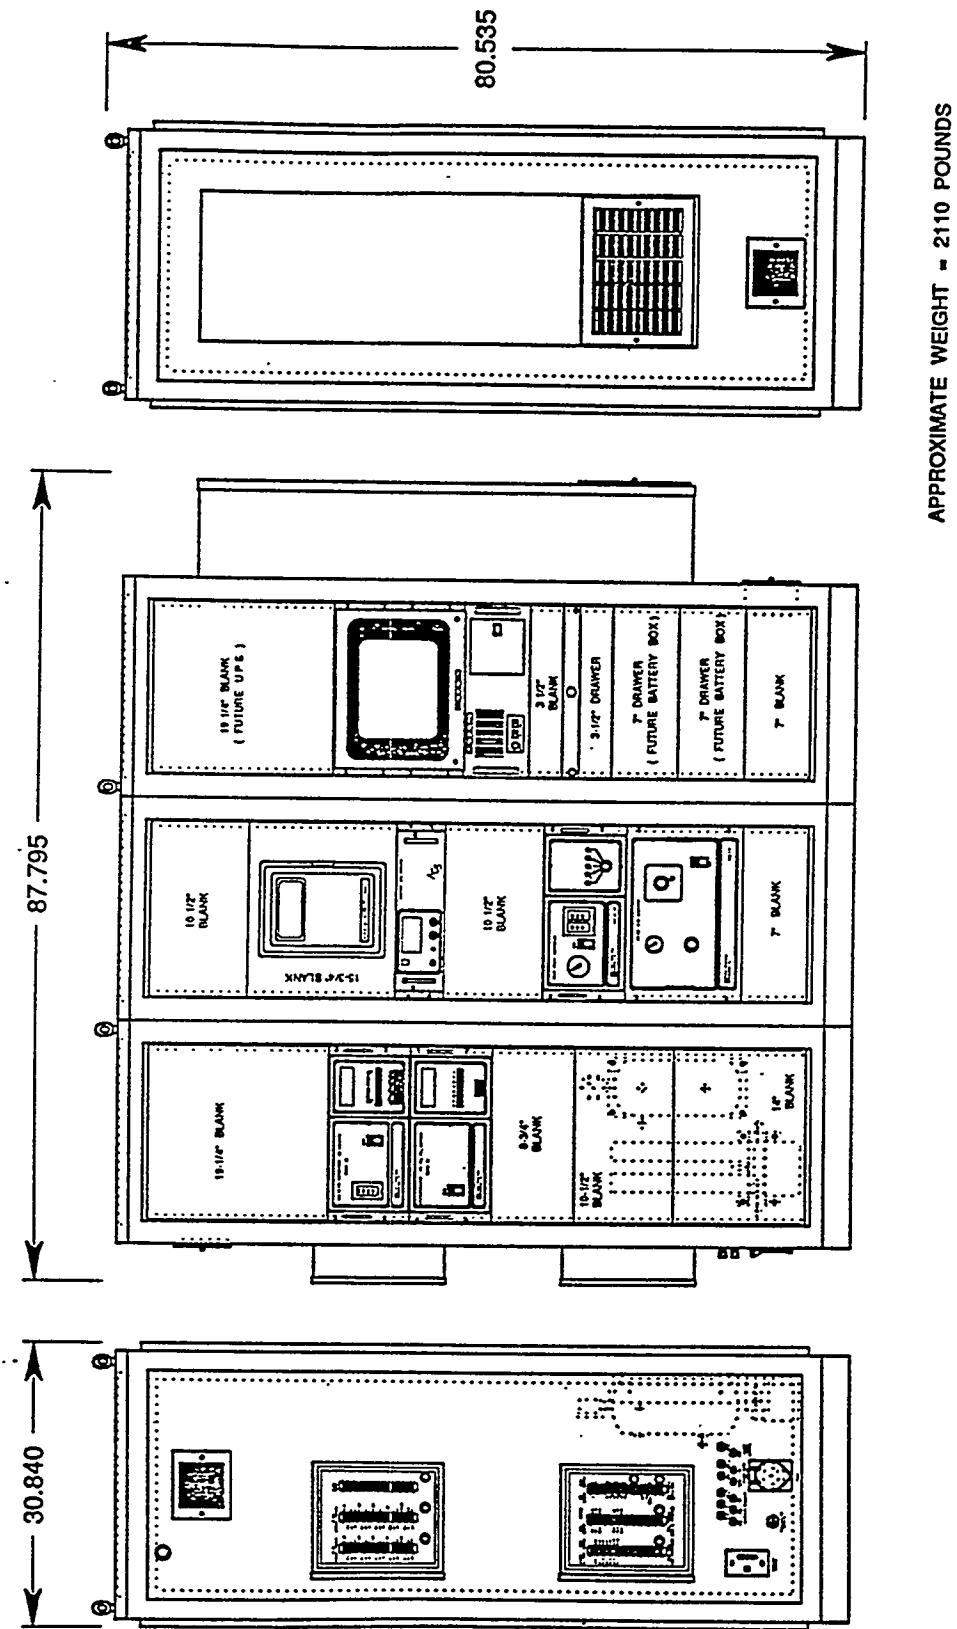
Figure 3-41 Continuous emission monitoring (CEM) system — Unit No. 4

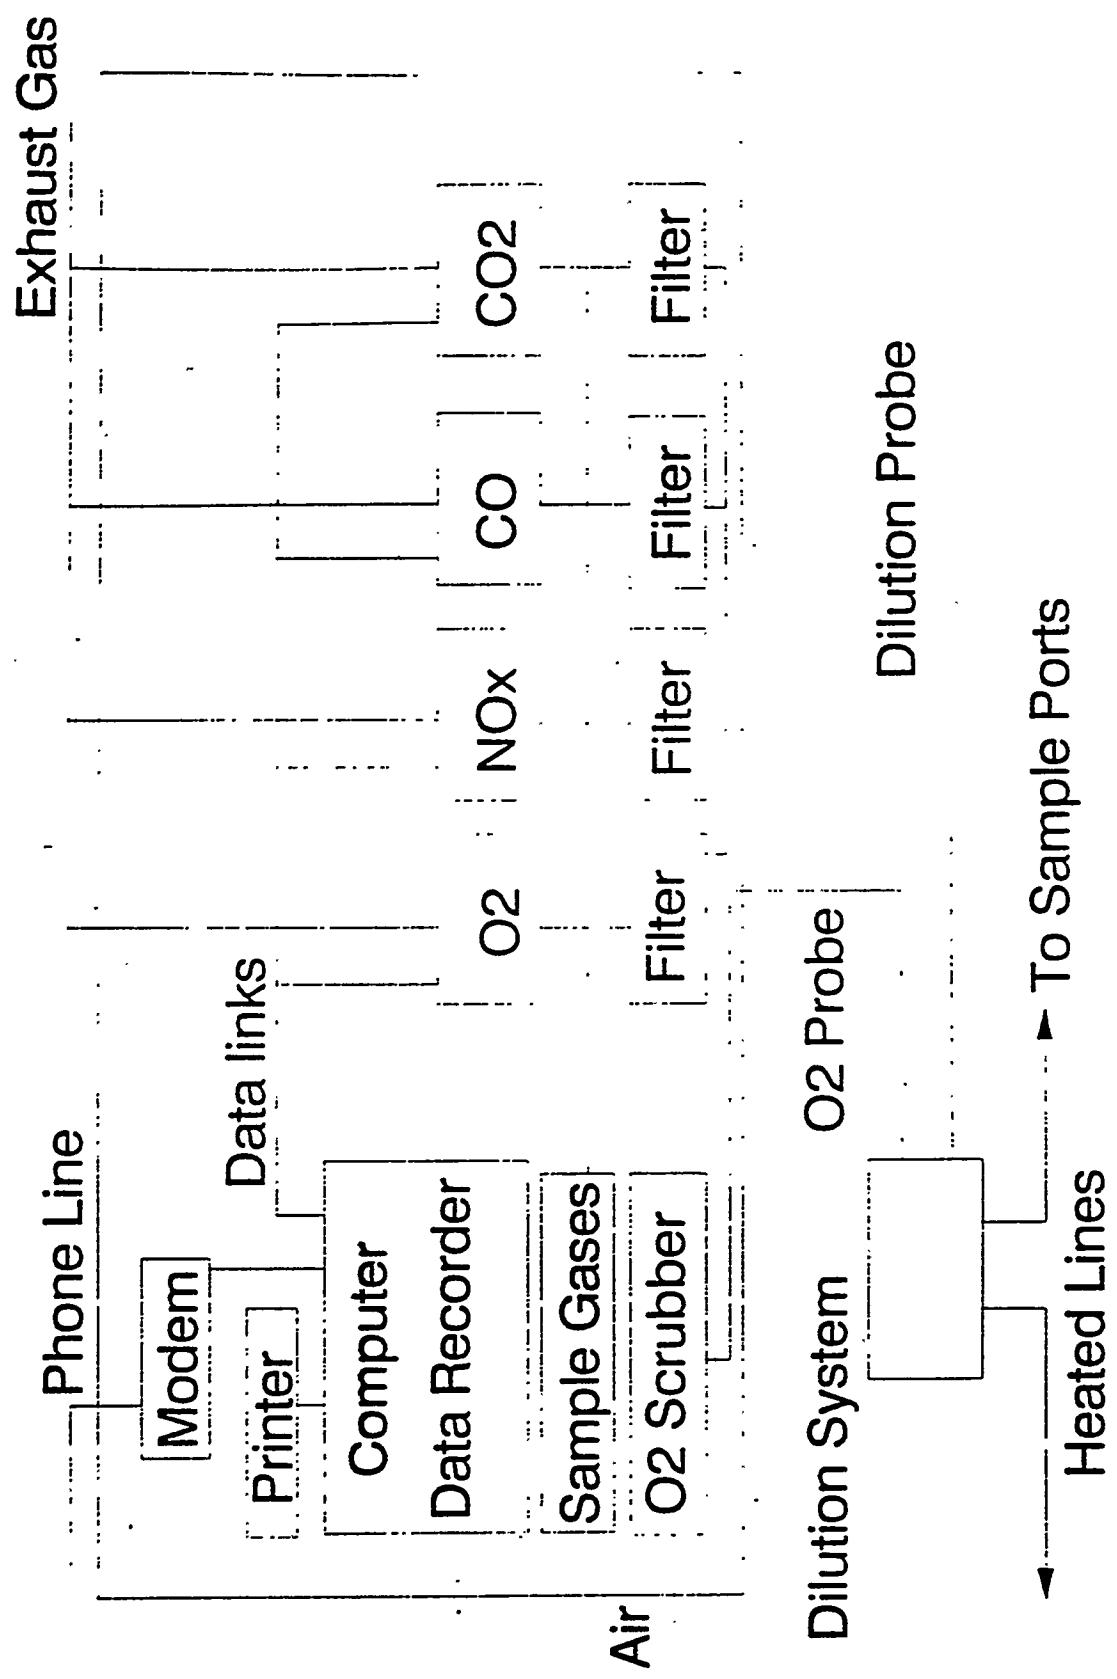
Figure 3-42 Schematic of Dilu-CEM 500

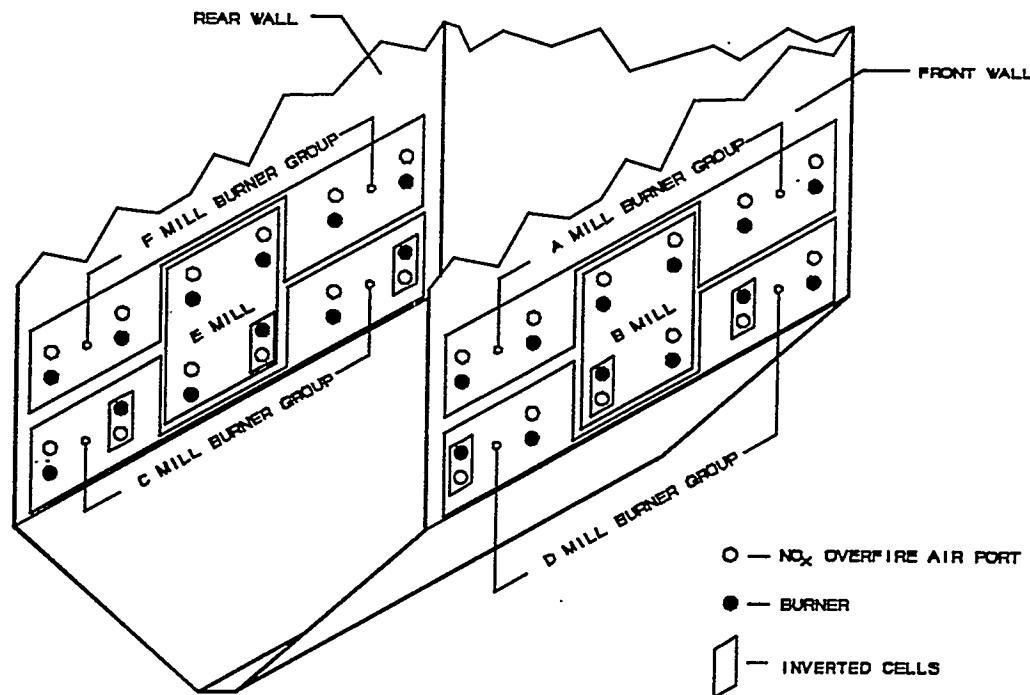
Figure 3-43 Burner, overfire air ports, and mill group layout

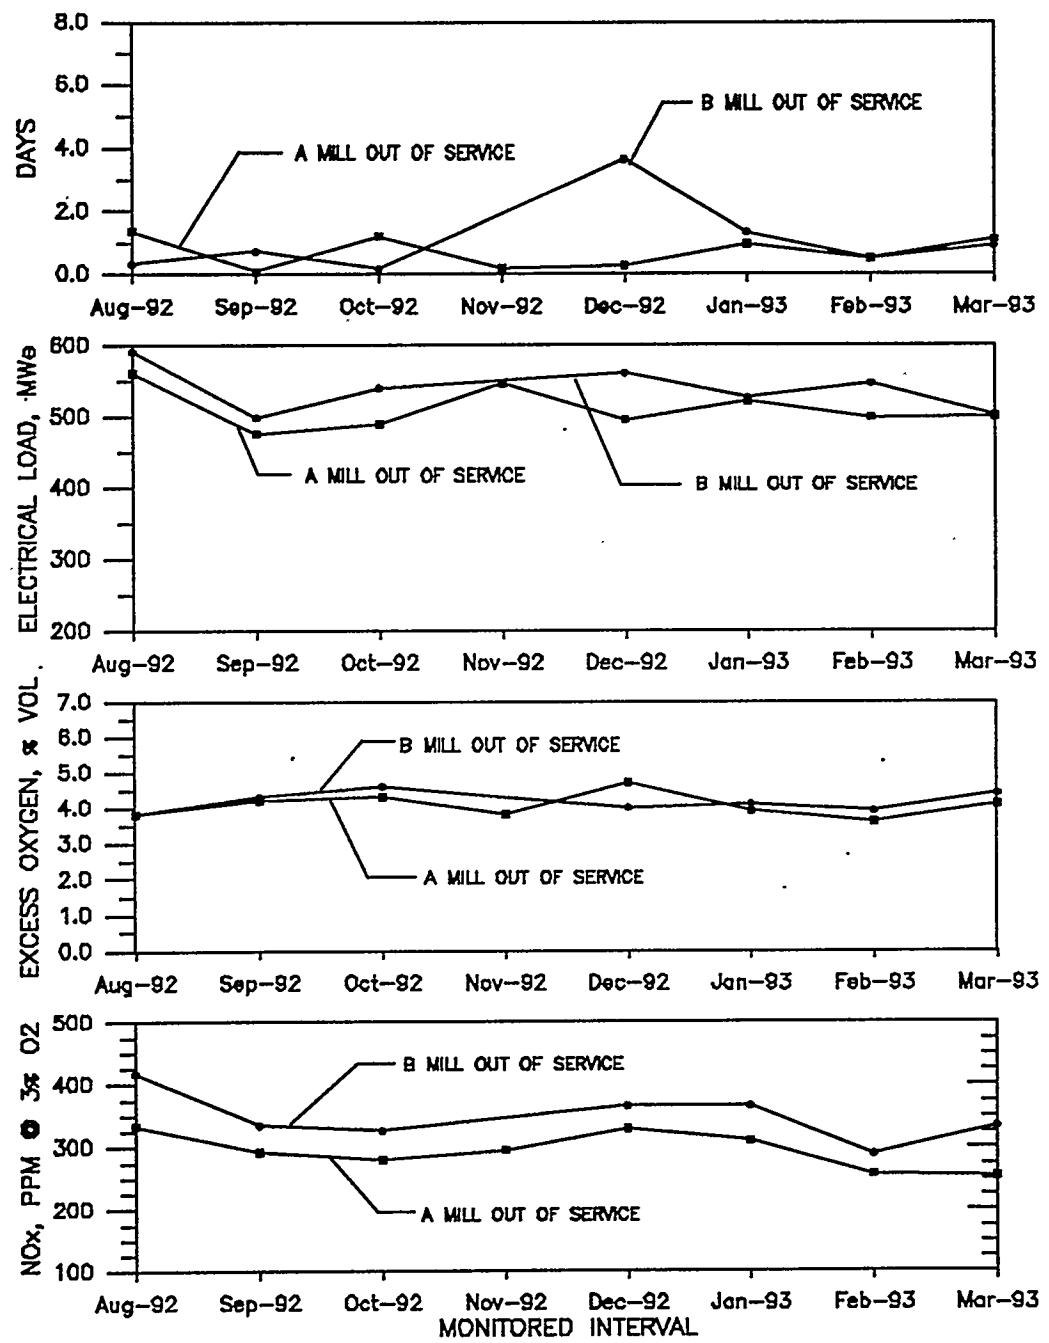
Figure 3-44 NO_x for A-mill out-of-service versus B-mill out-of-service
