TASK REPORT

FULL-SCALE DEMONSTRATION OF LOW-NO_x CELL™ BURNER RETROFIT

Long-Term Testing

Report DOE/PC/90545-1
(Babcock & Wilcox Report RDD:94:40090-030-036:01)

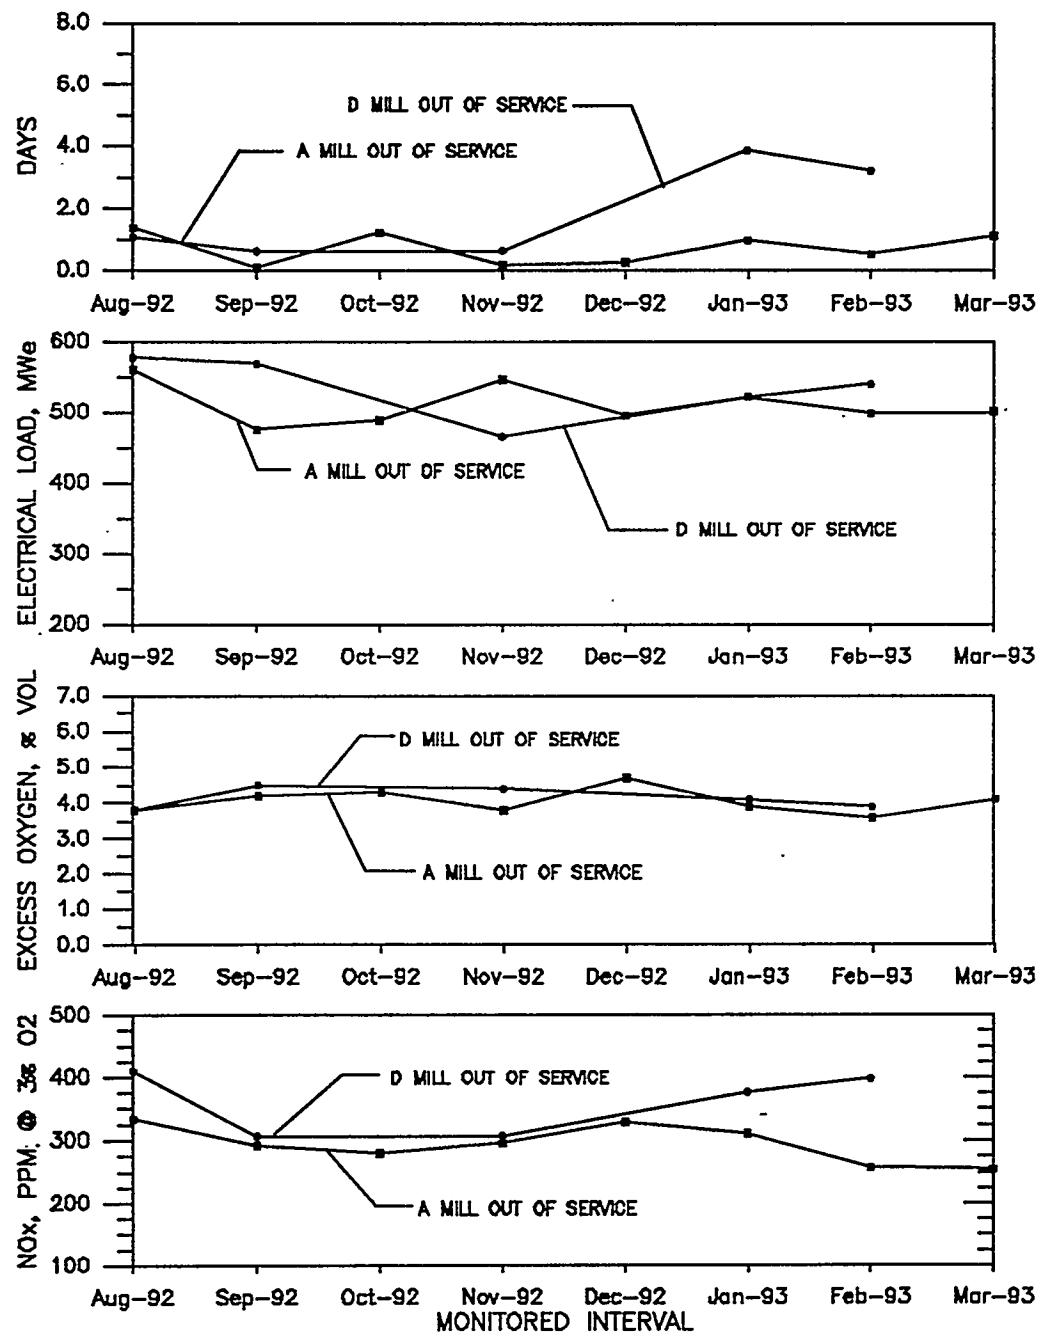
Figure 3-45 NO_x for A-mill out-of-service versus D-mill out-of-service

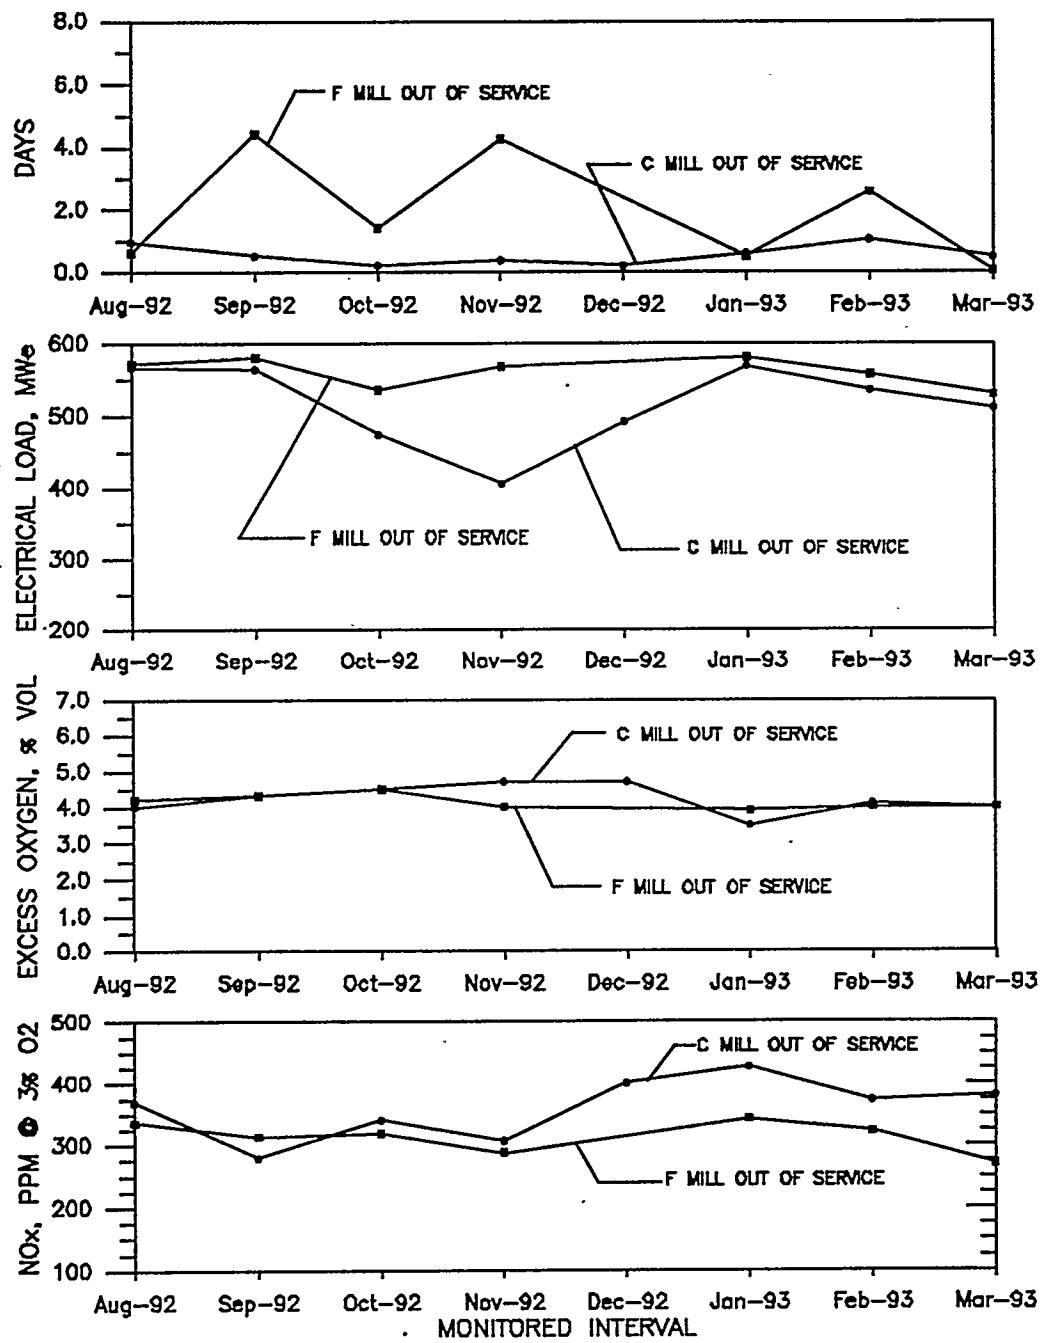
Figure 3-46 NO_x for F-mill out-of-service versus C-mill out-of-service

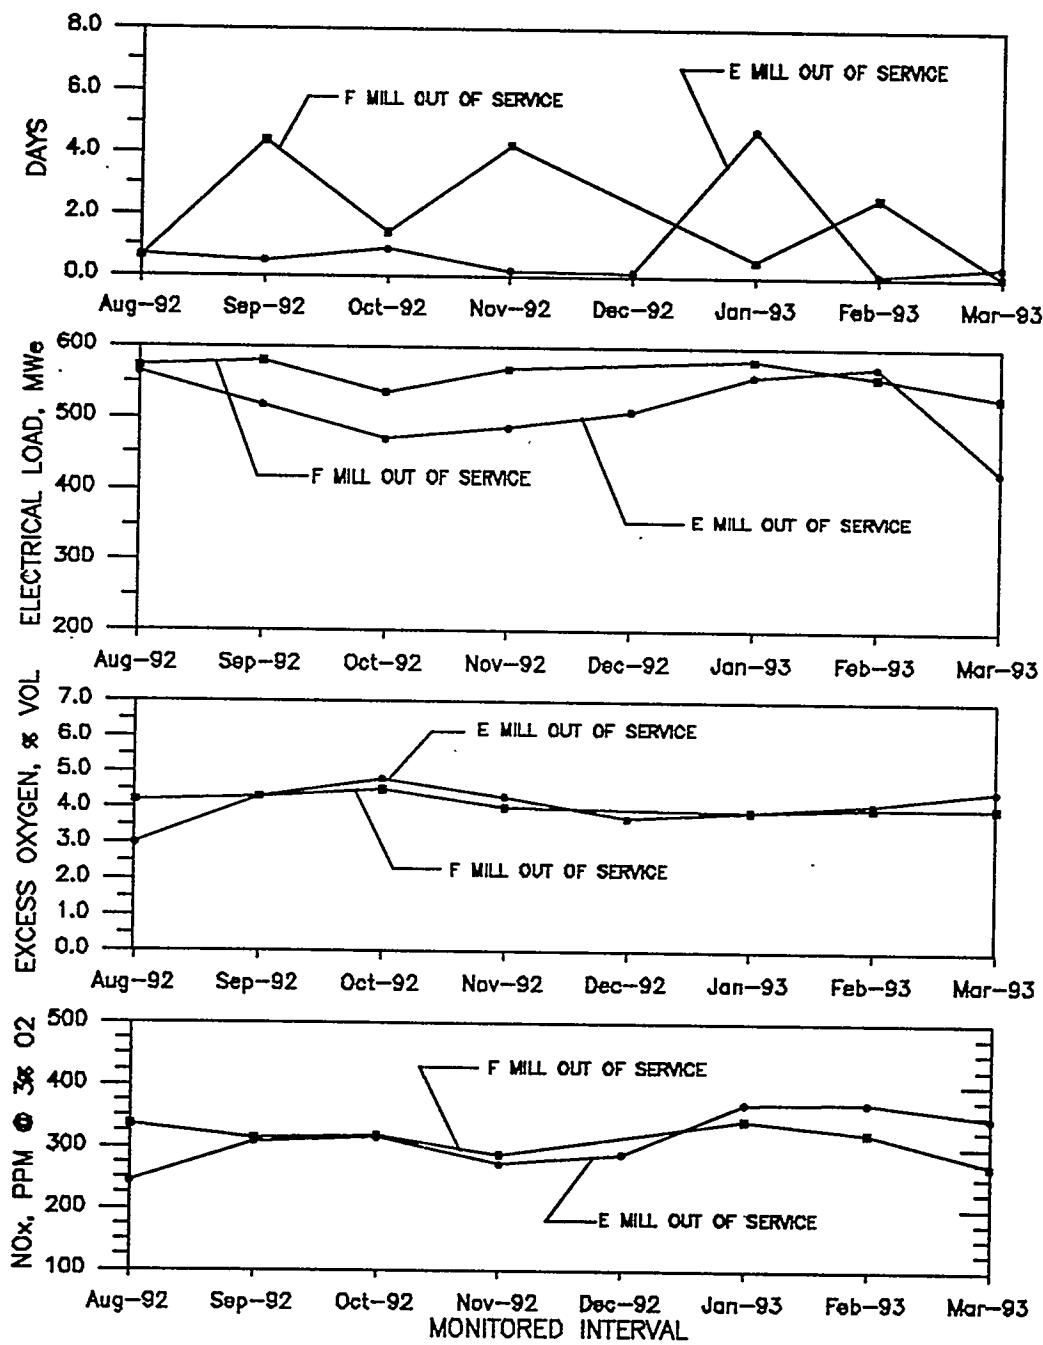
Figure 3-47 NO_x for F-mill out-of-service versus E-mill out-of-service

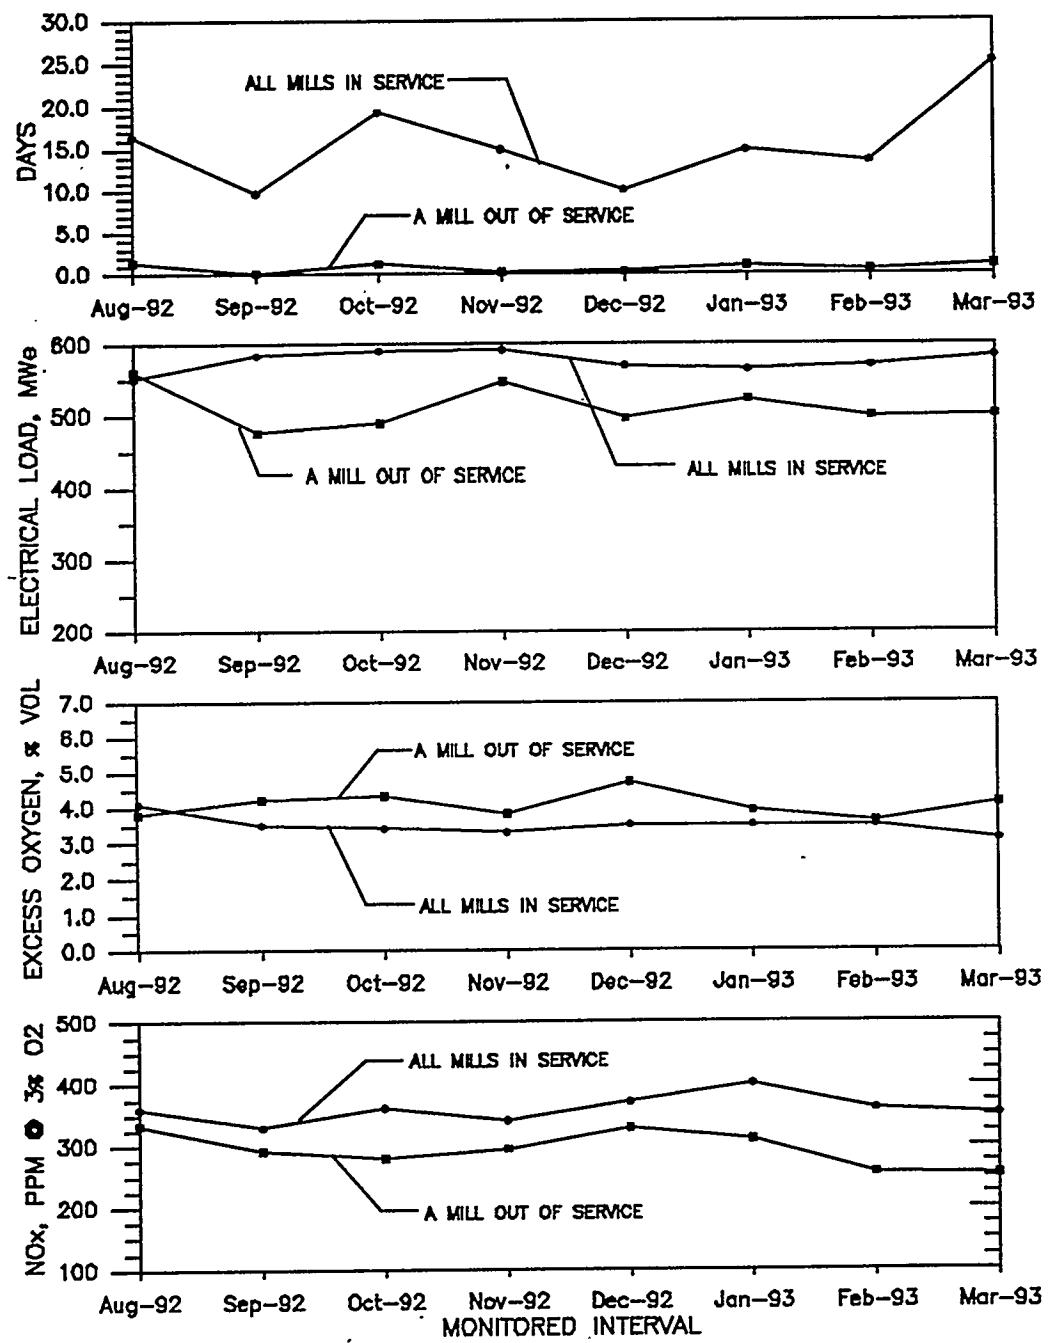
Figure 3-48 NO_x for A-mill out-of-service versus all mills in-service

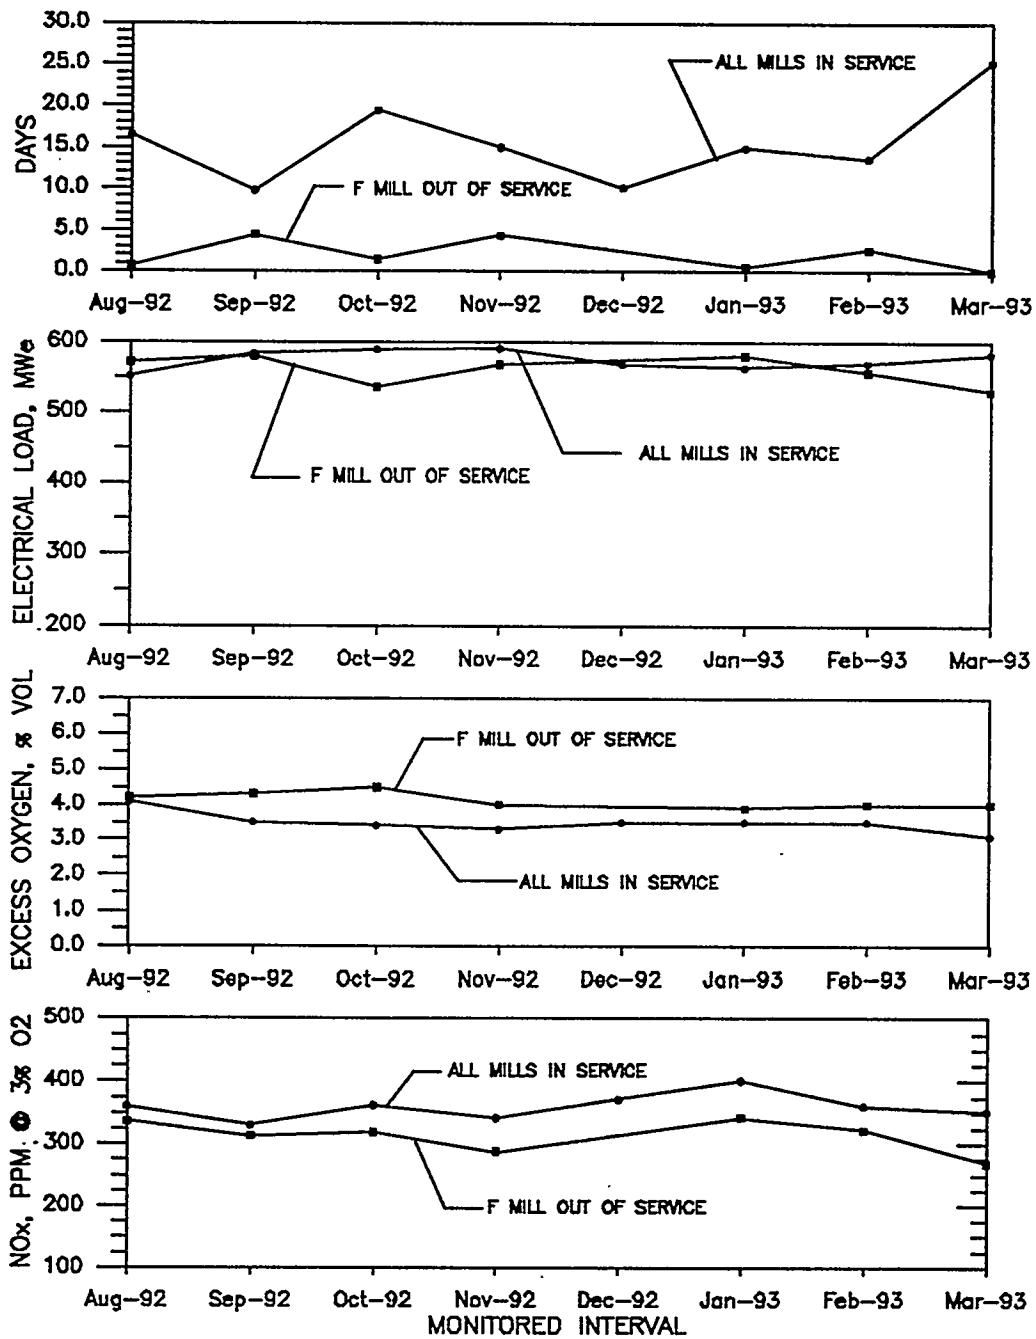
Figure 3-49 NO_x for F-mill out-of-service versus all mills in-service

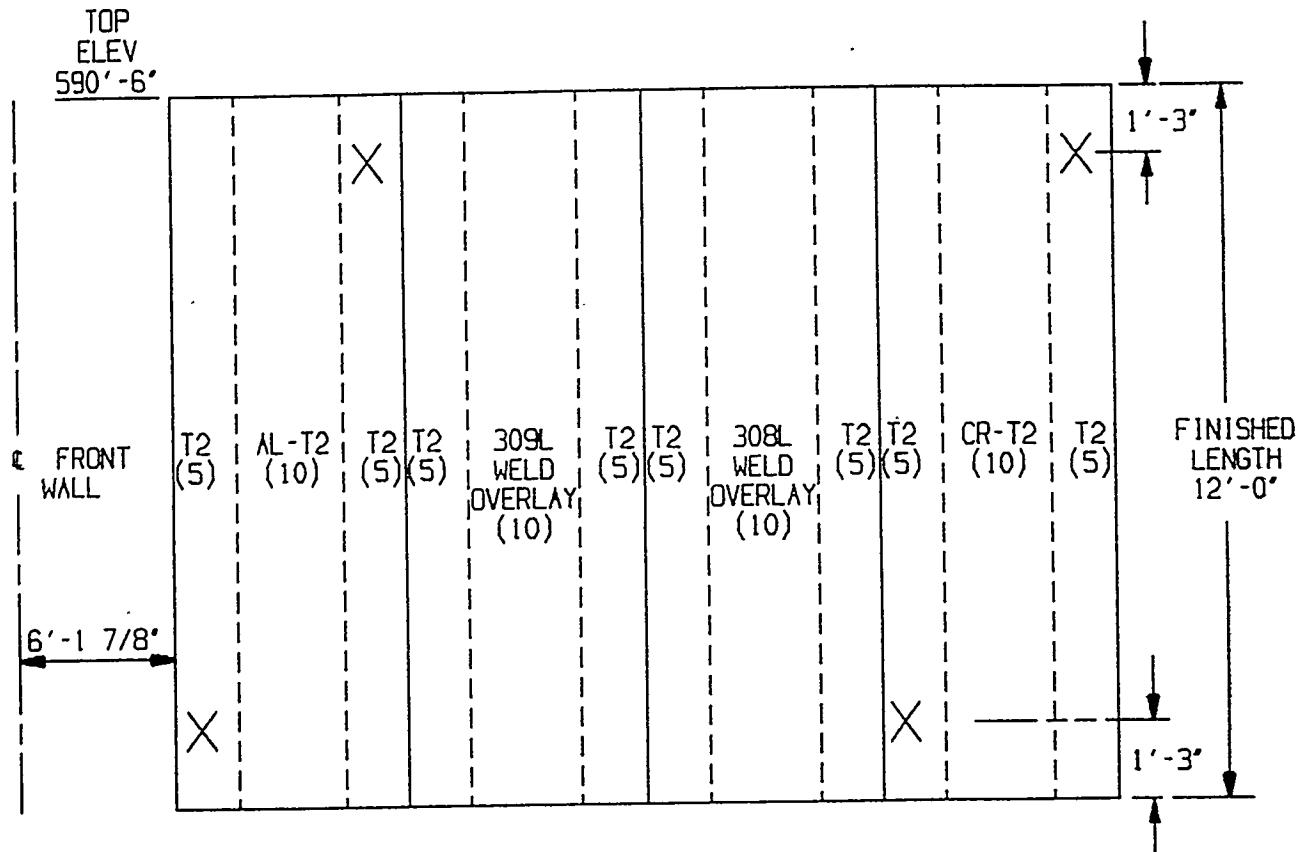
Appendix A
LAYOUT OF THE TEST PANEL INSTALLED IN JMSS 4

X INDICATES H₂S PORT LOCATION. CHORDAL THERMOCOUPLES ARE ADJACENT TO PORT LOCATIONS
