ASSESSMENT OF CIRCUIT BOARD SURFACE FINISHES FOR ELECTRONIC ASSEMBLY
WITH LEAD-FREE SOLDERS

U. Ray, I. Artaki, D. W. Finley and G. M. Wenger
Lucent Technologies, Bell Laboratories, Princeton, NJ

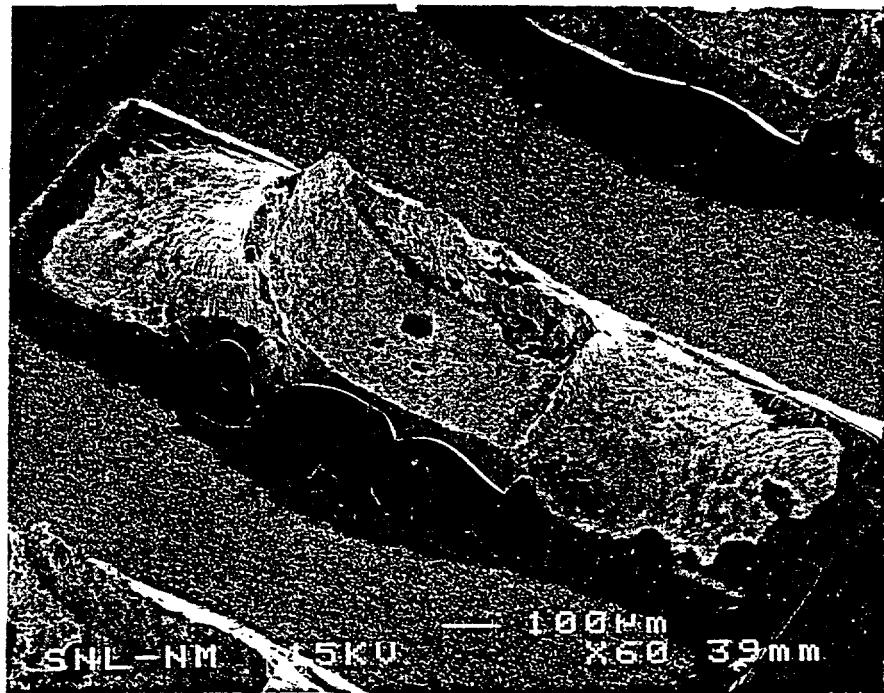
Figure 1. Scanning electron micrograph of the solder joint pull test failure (circuit board pad) for Castin solder, imidazole PCB finish and SnPb lead finish.

The fracture morphologies of the CASTIN™ solder joints were sensitive to the coating composition. Shown in Fig. 1 is a scanning electron micrograph of the failure morphology of the circuit board pad from an as-fabricated test vehicle having the imidazole coating; the lead had a Sn-Pb coating. The contour of the failure path followed that of the lead. A similar morphology was observed when the lead finish was changed to pure Sn. However,

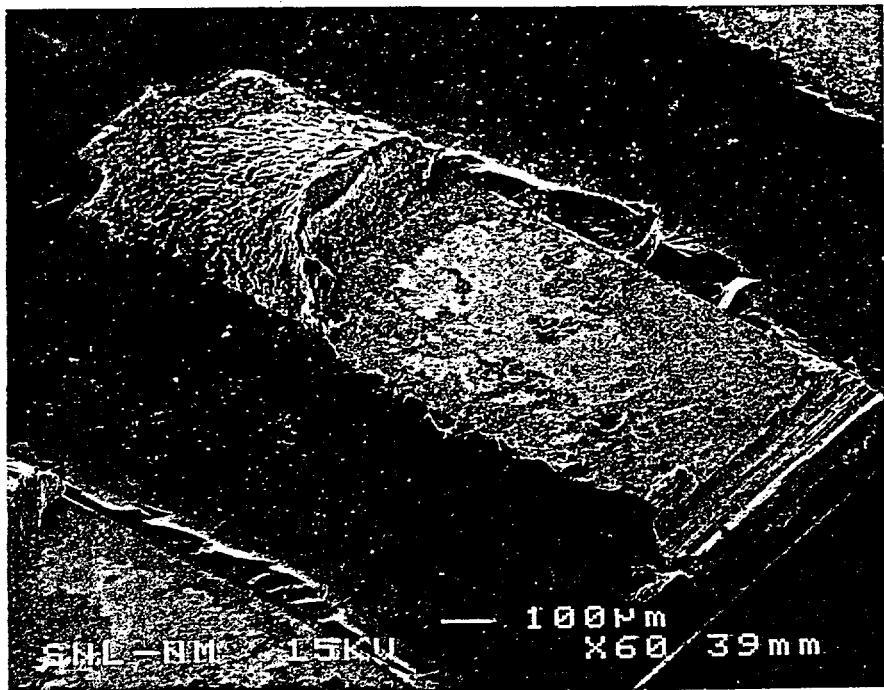
Figure 2. Scanning electron micrograph of the solder joint pull test failure (circuit board pad) for Castin solder, SnPb (HASL) PCB finish and SnPb lead finish.

the fracture path of the joints made with Sn-Pb on both the lead *and* the circuit board pad progressed along the solder/copper pad interface (Fig. 2). This result suggests that the HASL coating caused failure to preferentially occur there. Irrespective of the difference in the failure mode, the pull strength of the CASTINTM/HASL/Sn-Pb joints was not significantly different from that of the other joint materials combinations.

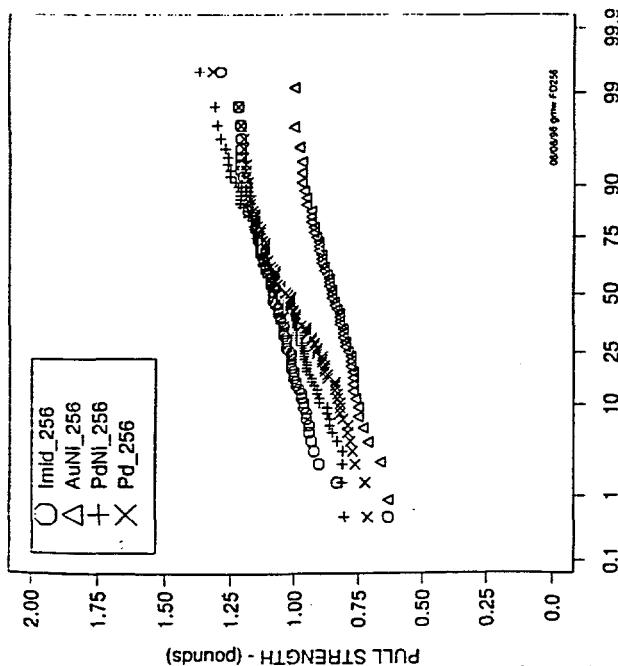
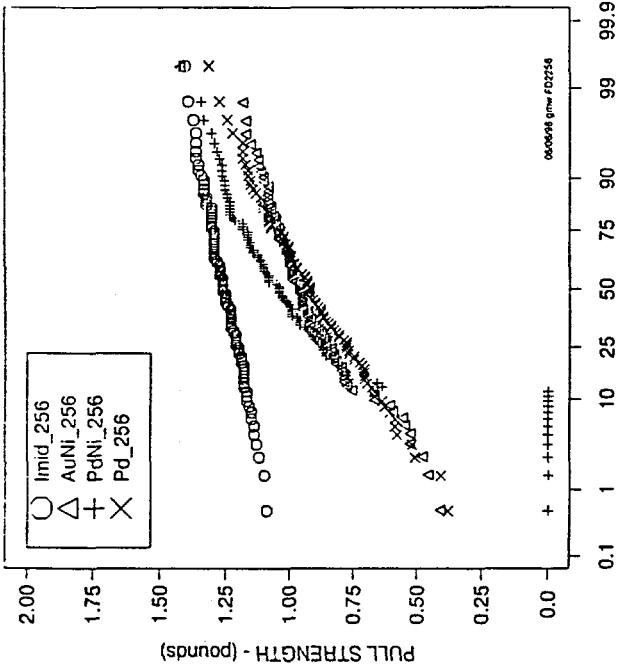
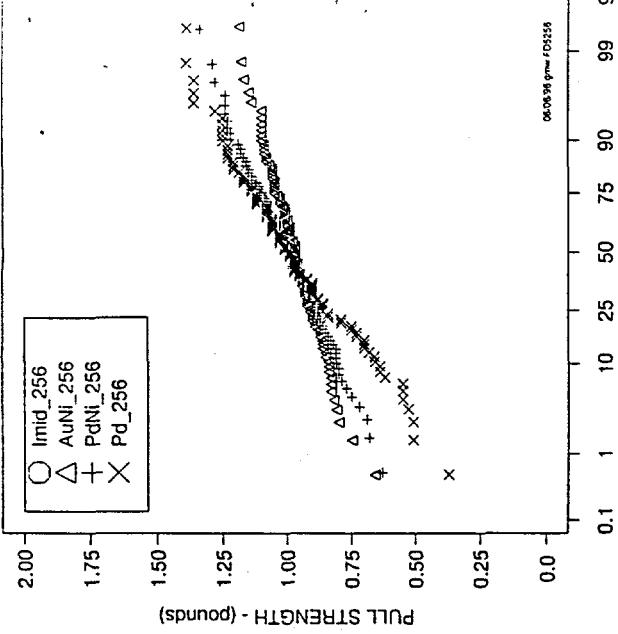
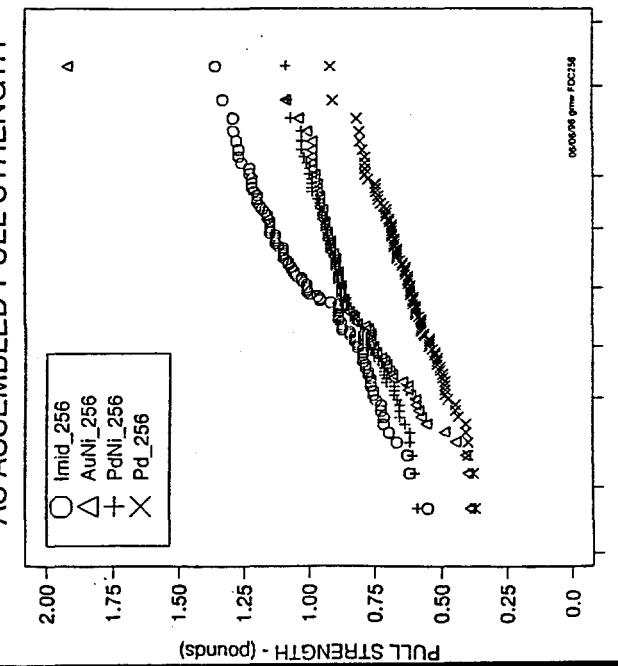
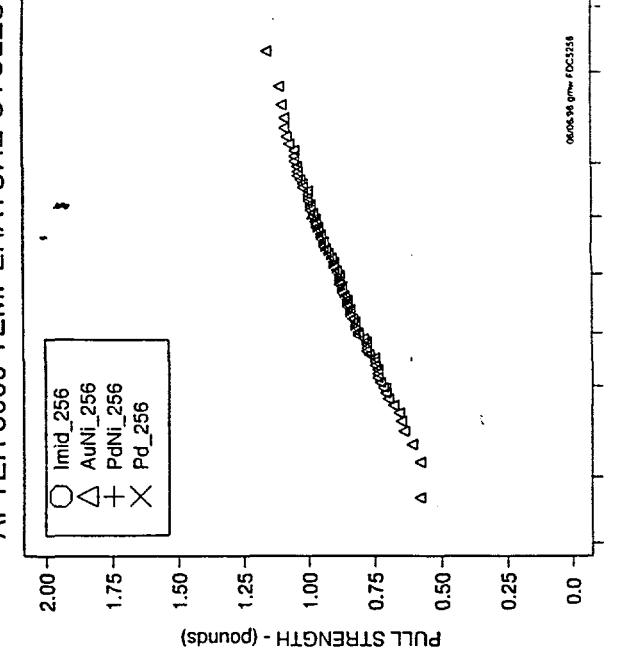
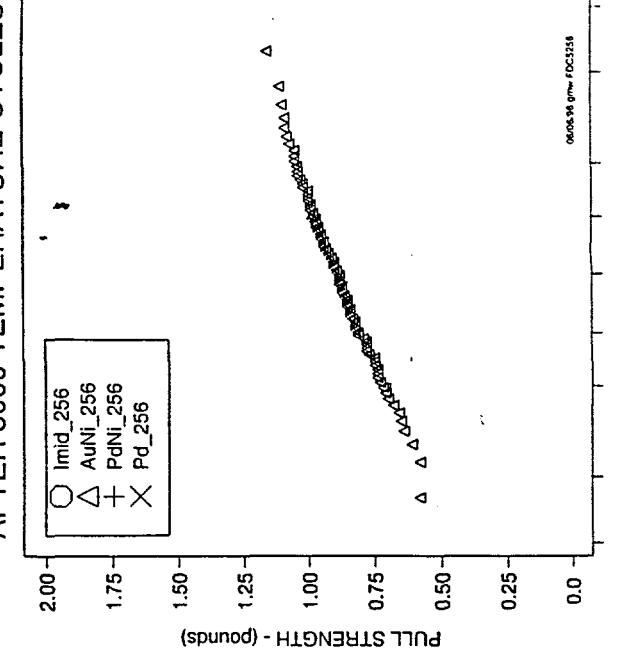
Figure 3: Mechanical pull test data for 256 I/O, 0.4 mm pitch PQFPs before and after thermal cycling

Prior to thermal cycling, the average pull strength for 0.4mm pitch PQFP leads was about 1 pound while the average for the bigger 50 mil pitch PLCC leads was over 3 pounds (data not shown). A fracture in the solder fillet near the peripheral lead was the typical mode of failure when the leads were pulled vertically. The solder fillet usually remained on the STV surface mount land. Although the craters formed when the leads separate from the solder fillets appear to indicate a lead/solder interface separation, examination of the leads and fillets show the separation to be a cohesive failure in the bulk solder. This was the case for the majority of the pull tests. For the case of Pd, there is preliminary indications of a “seeding” problem (i.e., adhesion of Pd to Cu).

A comparison of the PQFP pull strength frequency distribution before and after temperature cycling clearly indicates a non-ideal behavior of the Pd-based finishes. This trend is stronger with the CASTIN™ solder, where there is a significant decrease in the pull strengths after 2500 cycles. Current work in progress shows that this decrease continues after 5000 cycles (data not shown in this paper).

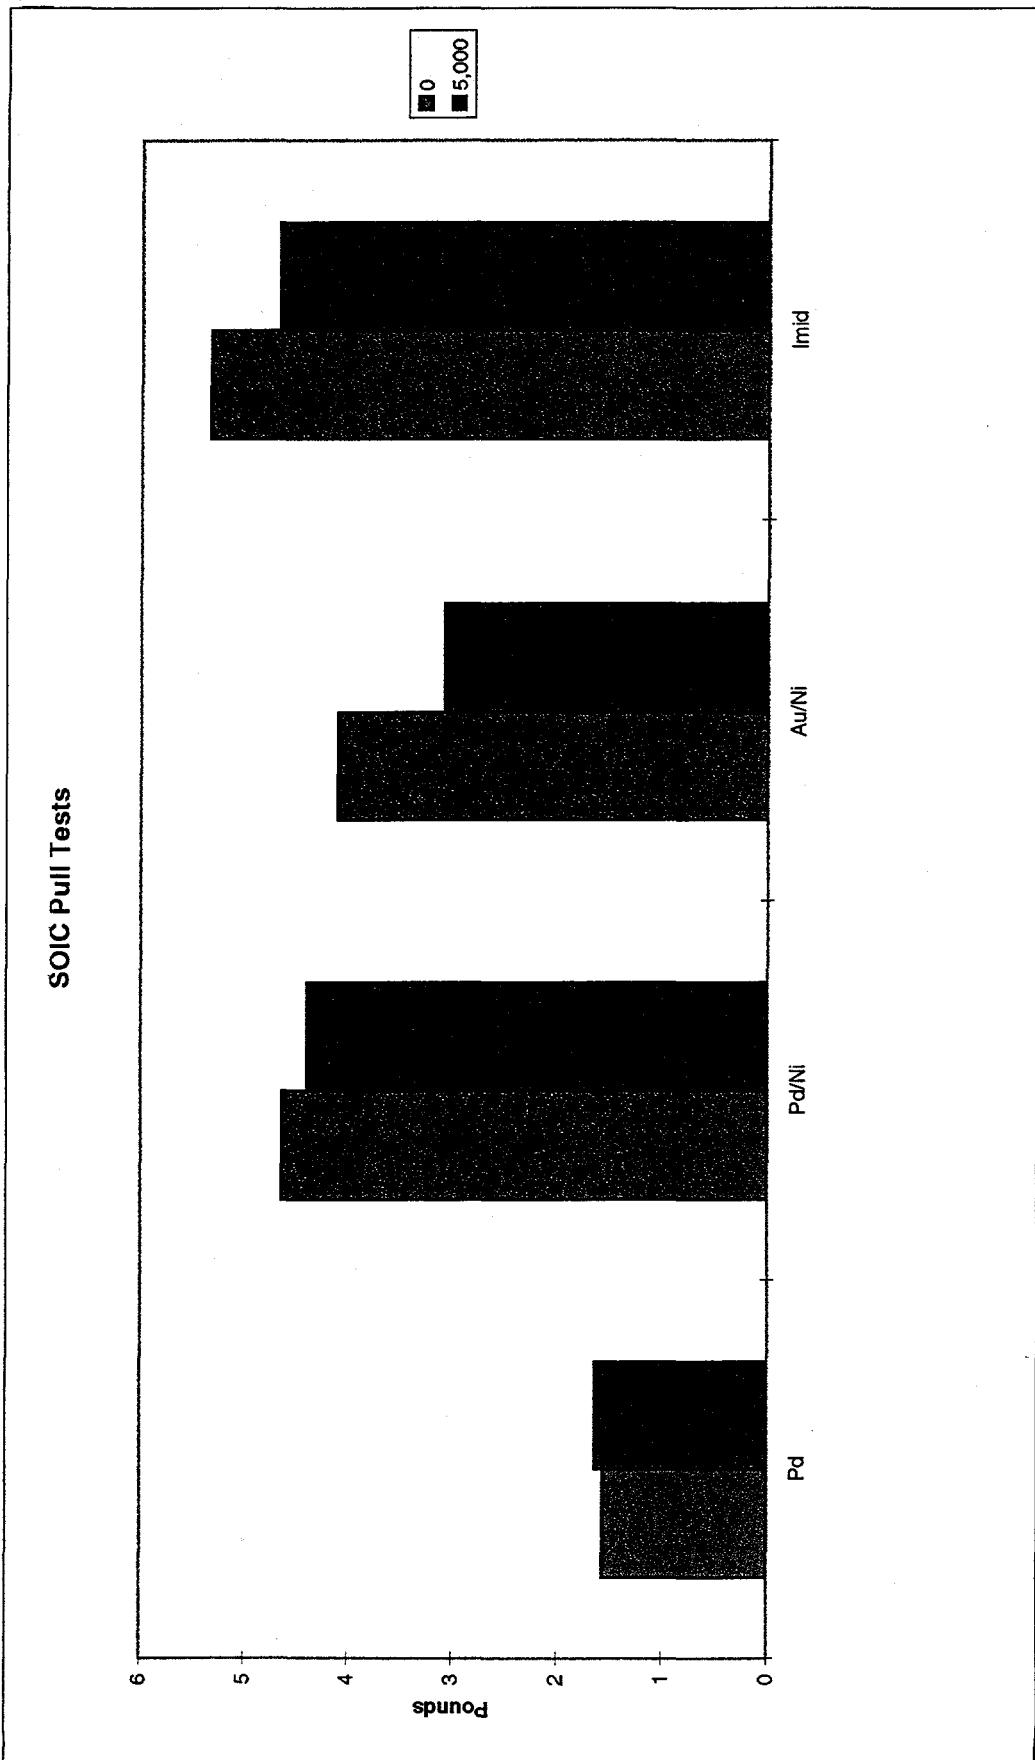
Figure 4: Mechanical pull test for 50 mil pitch SOICs before and after thermal cycling

Figure 4 shows the mechanical pull test data from the 50 mil pitch SOICs, which clearly shows a lower pull strength for the electroless Pd finishes both before and after temperature cycling as compared to the other finishes. The differences in pull strength for the other surface finishes before and after thermal cycling is not statistically significant.

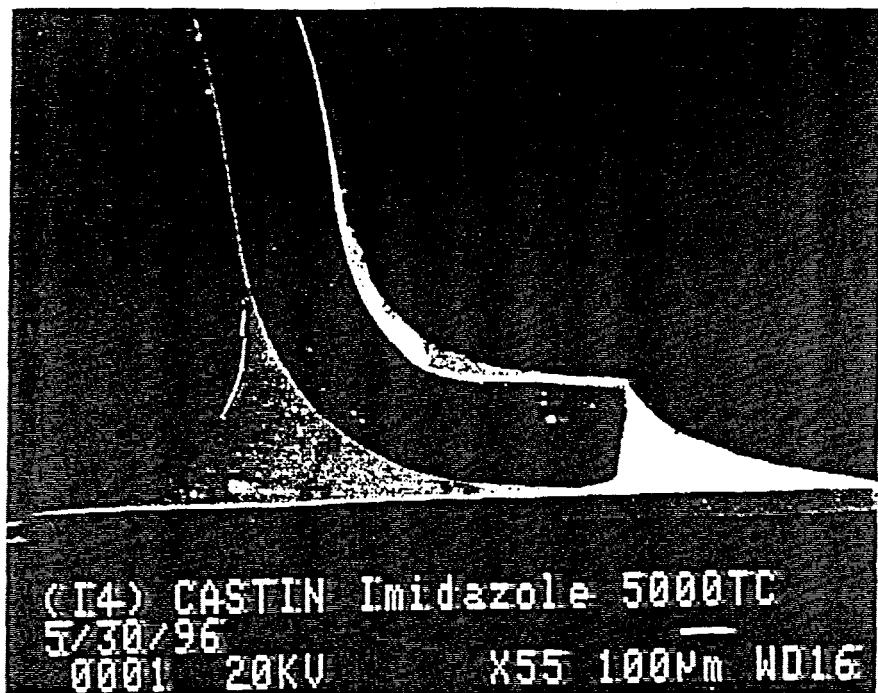
Figure 5. Scanning electron micrograph of the cross-section of a SOIC lead on a imidazole-finished PWB after 5000 thermal cycles.

The joints on all 4 surface finishes exhibited good solder wetting, and the imidazole finished joint after 500 cycles shown in Figure 5, is a typical example. Both toe and the heel of the leads were adequately formed, and the solder spread to completely cover the copper pad on the substrate. The wetting angles of the joint on the copper pad were between 20 to 25°. And the wetting angle along the lead is typically less than 10°.

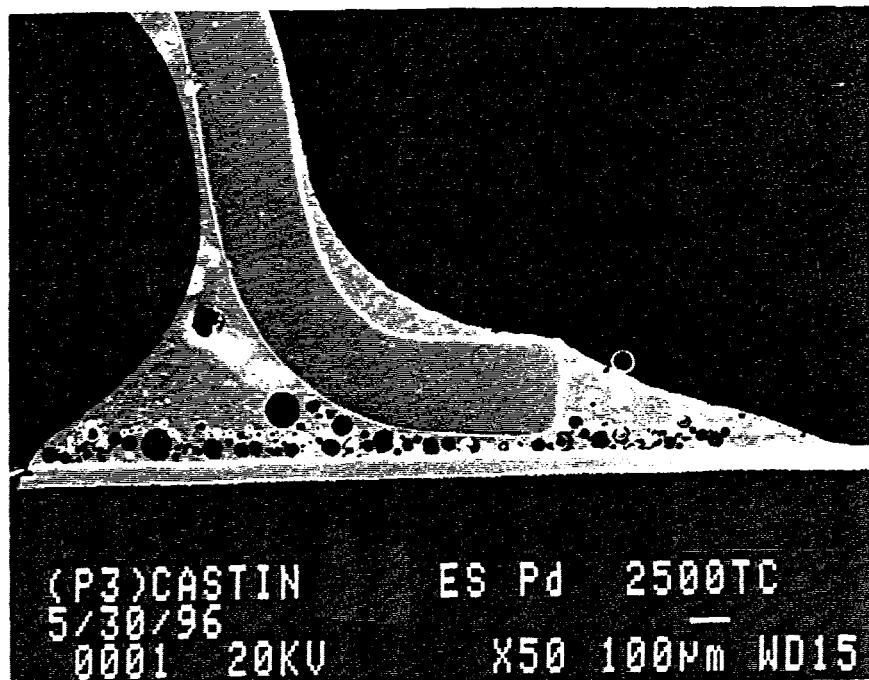
Figure 6. Scanning electron micrograph of the cross-section of a SOIC lead on a Pd-finished PWB after 2500 thermal cycles.

The joints with the electroless Pd finish had many voids along the interface of the copper pad, as evidenced by the micrograph (after 2500 cycles) in Figure 6. The size of the voids range from several μm to 100 μm in diameter. The large amount of the voids correlates with a low pull strength measured from joints made with this surface finish.

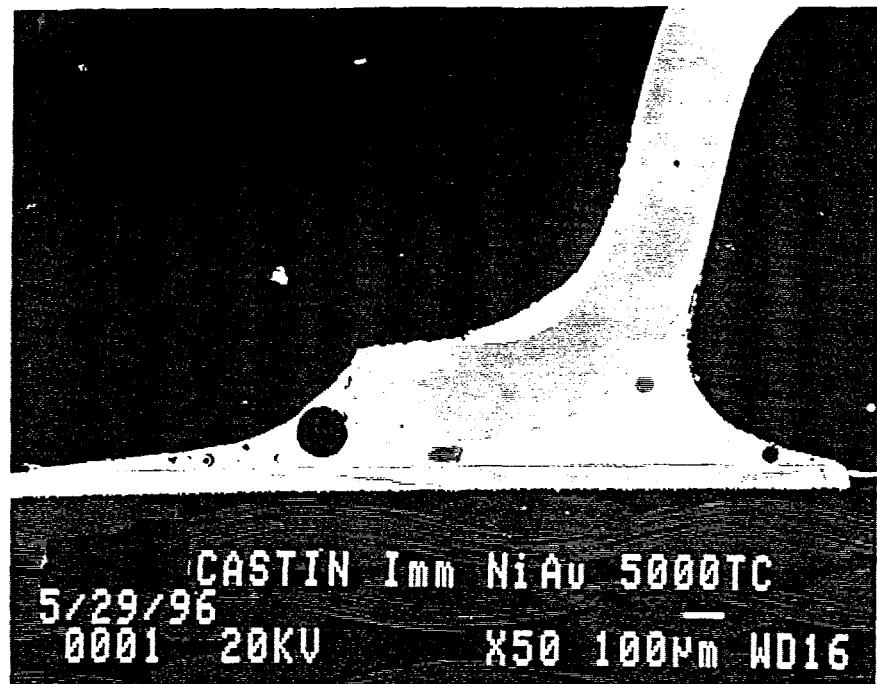
Figure 7. Scanning electron micrograph of the cross-section of a SOIC lead on a immersion Ni/Au-finished PWB after 5000 thermal cycles.

Some voids were also found in the joints with an immersion Ni/Au finish, as can be seen in Figure 7, but not nearly as many as in those with the Pd finish. The pull strength of the Ni/Au finish is slightly less than the imidazole and Ni/Pd joints ; the differences might not be statistically significant.

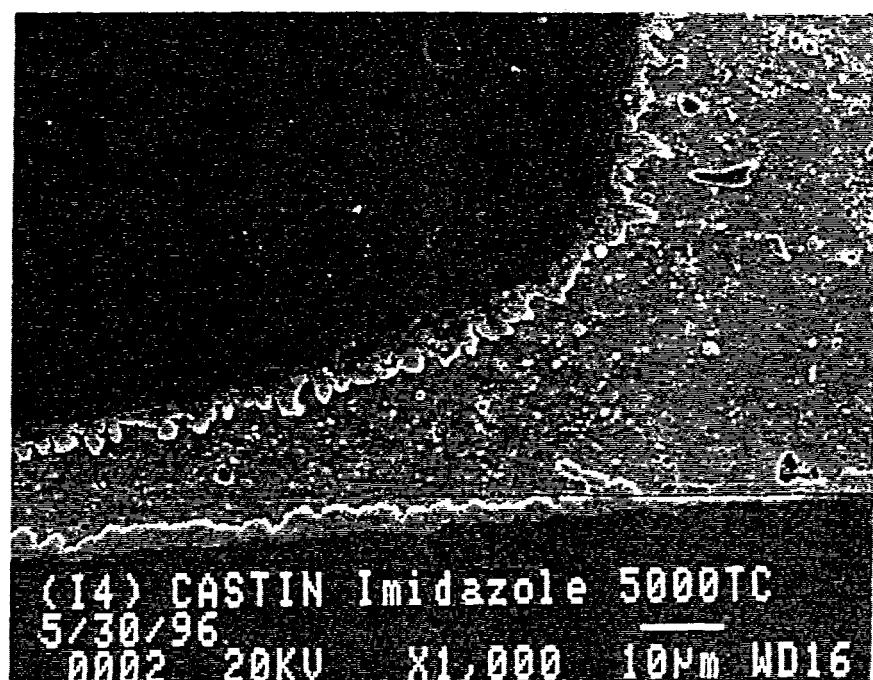
Figure 8. Secondary-electron micrograph of the cross-section of a solder joint between the SOIC lead and PWB on a imidazole-finished PWB after 5000 thermal cycles, magnified from Figure 5.

The metallurgy at the solder-substrate interface and in the solder joints is dependent, to a large measure, on the surface finishes. The joint made with an imidazole surface finish have the typical nodular-shaped Cu_6Sn_5 intermetallic compound at the interface between the solder and the copper substrate, as shown in Figure 8. The compound is about 3 to 4 μm thick. There are also some Cu_6Sn_5 compound floating in the solder, which may be the precipitate from the copper content in the solder, or from Cu dissolved in the solder from both the copper substrate on PWB and/or the copper lead of the SOIC. Silver in the solder appears as a Ag_3Sn precipitate, typically 1 μm or less in size. Antimony (Sb) remained largely in solid solution in the Sn-rich phase.

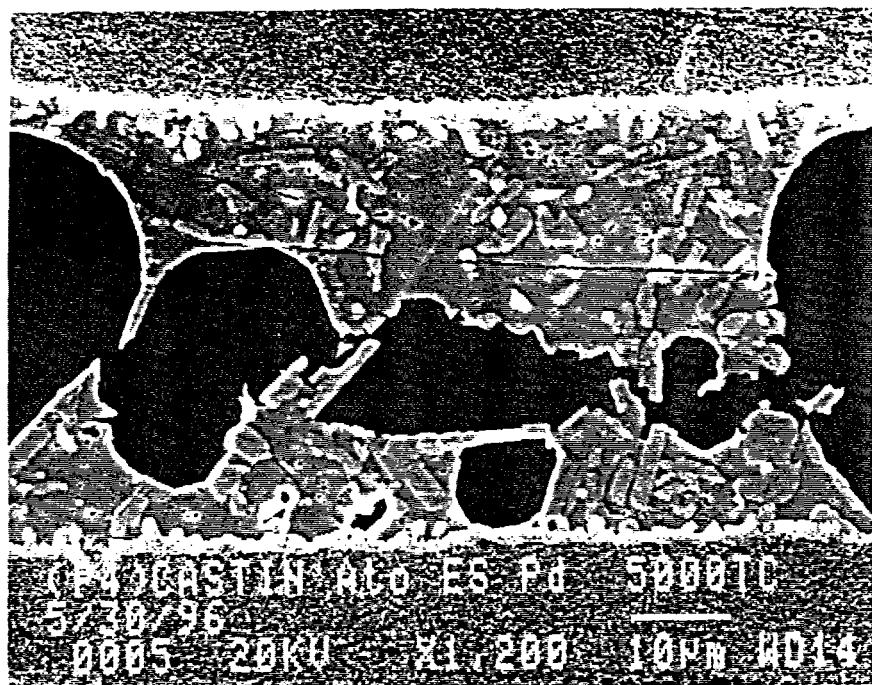
Figure 9. Secondary electron micrograph of the cross-section of a solder-joint between the SOIC lead and PWB on a Pd finished PWB after 2500 thermal cycles, magnified from figure 6.

The joint made with the Pd finish have many PdSn_4 precipitates in the joint. Figure 9 is a magnified micrograph of the solder between the lead and the substrate in Figure 2. The voids in the joints are clearly visible. The voids are connected, possibly due to cracks generated during the thermal-cycle testing. The rectangular light-gray precipitate in the solder is PdSn_4 intermetallic compound, with Pd coming from the dissolution of the Pd surface finish. The intermetallic compound at the interface of solder and substrate appears to be Cu_6Sn_5 , which is formed when the Pd dissolves and the solder contacts the Cu on the PWB directly.

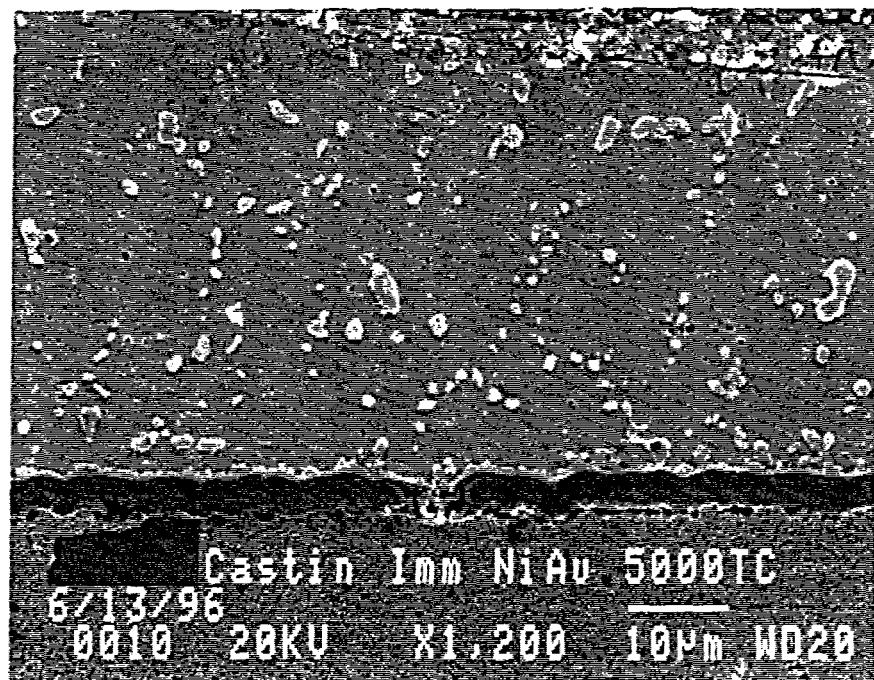
Figure 10. Secondary electron micrograph of the cross-section of a solder joint between the SOIC lead and PWB on an immersion NiAu-finished PWB after 5000 thermal cycles.

A micrograph of the Ni/Au finished joint seen in Figure 10 shows a 5 μm -thick Ni layer, with a $(\text{Cu},\text{Ni})\text{-Sn}$ compound on it. The $(\text{Cu},\text{Ni})\text{-Sn}$ compound is a continuous sub-micron layer, but the morphology is different from the same compound above Pd/Ni finish joints which have large particles extending into the solder. There was no Au in evidence from viewing the micrograph. The Ag_3Sn precipitate in the solder are generally larger than those in the other surface finished joints. Pin-holes were often seen in the Ni layer, a typical example can be seen in the center of Figure 10. The hole is filled with Cu_6Sn_5 compound since there is a direct contact between the solder and the Cu substrate.
