NUREG/CP-0151
ORNL/TM-13187

IAEA Specialists' Meeting on Cracking in LWR RPV Head Penetrations

Held at
ASTM Headquarters
Philadelphia, Pennsylvania
May 2-3, 1995

Proceedings prepared by
Oak Ridge National Laboratory

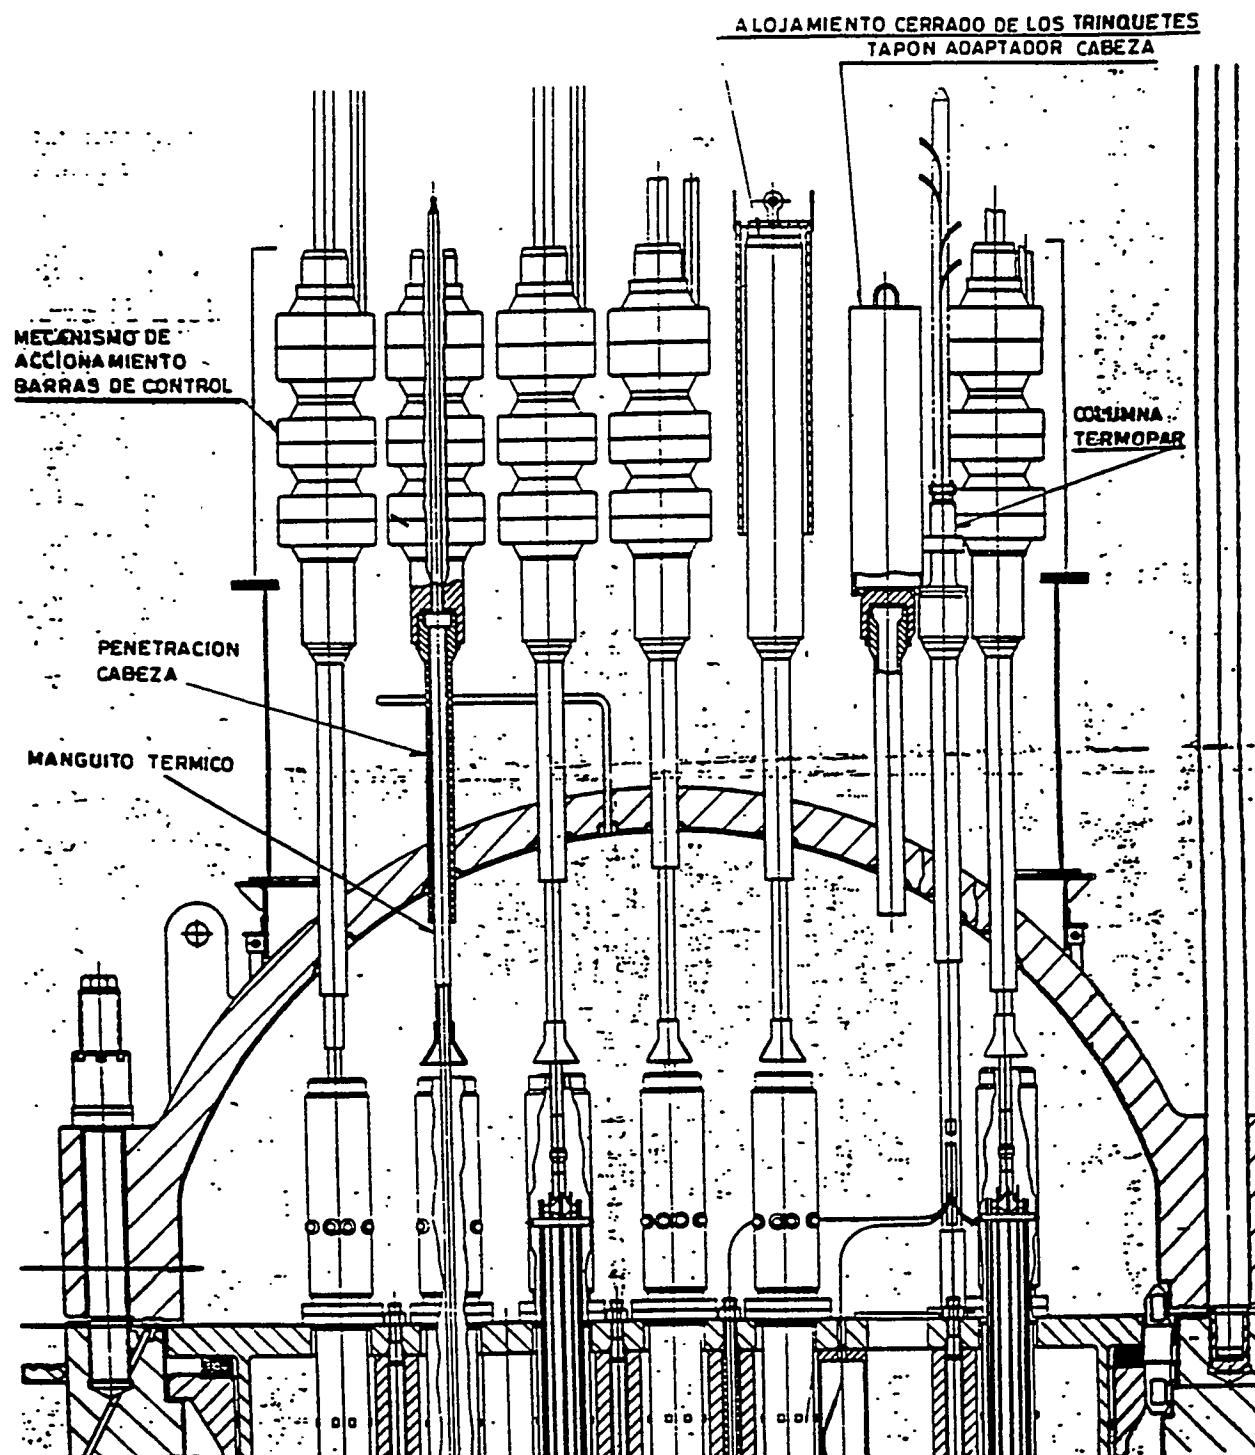
Fig. 1

FIGURE 1: ASCO & ALMARAZ RV HEAD PENETRATIONS

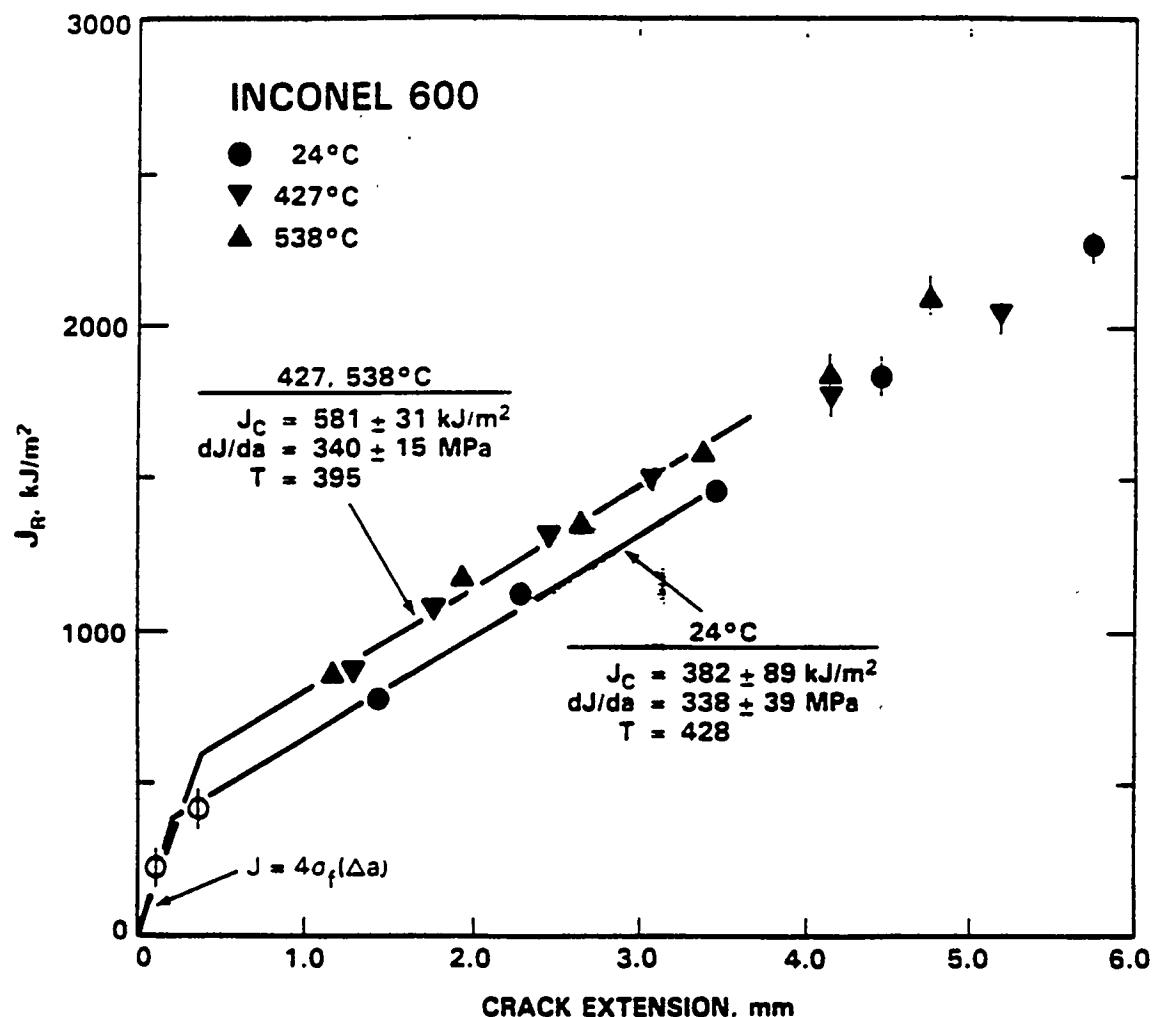
**FRACTURE TOUGHNESS OF ALLOY 600
AT SEVERAL TEMPERATURES**

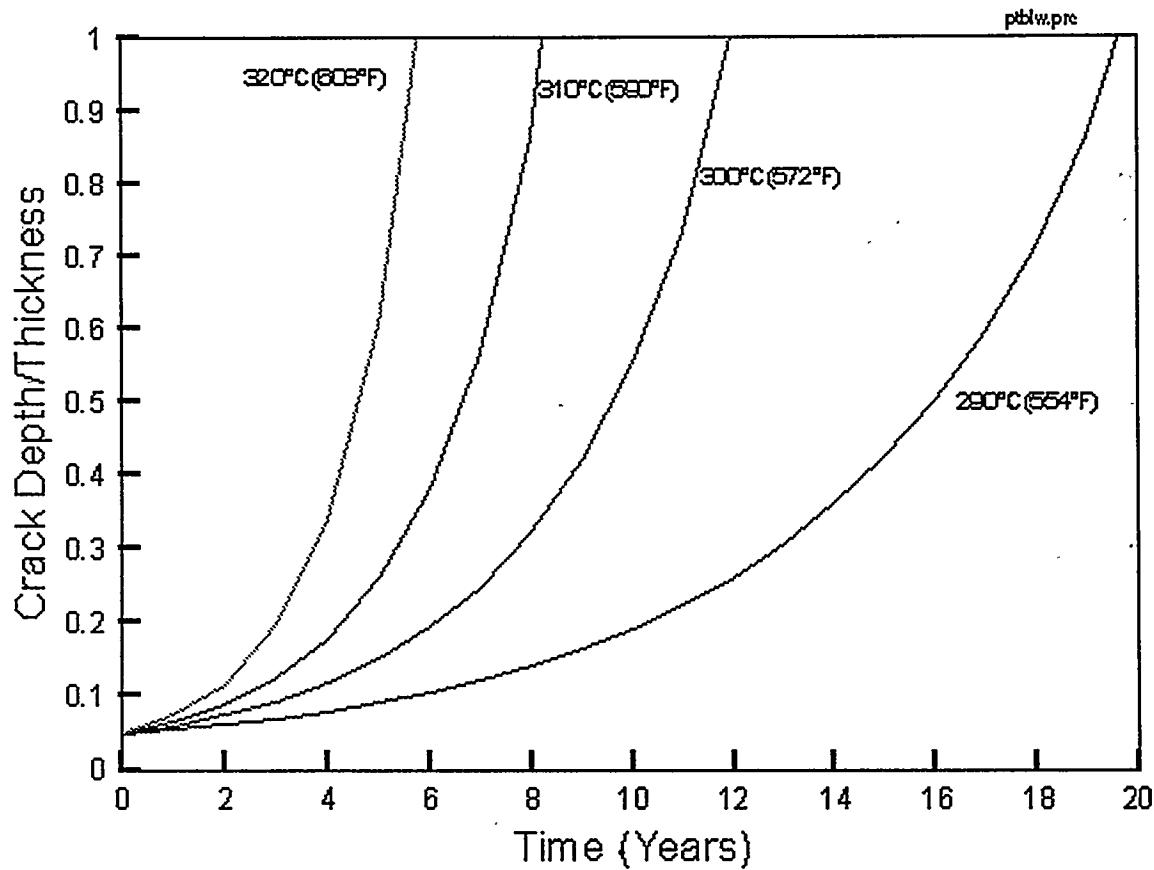
Example of Crack Growth Calculations For Postulated Axial Flaws In A Head Penetration

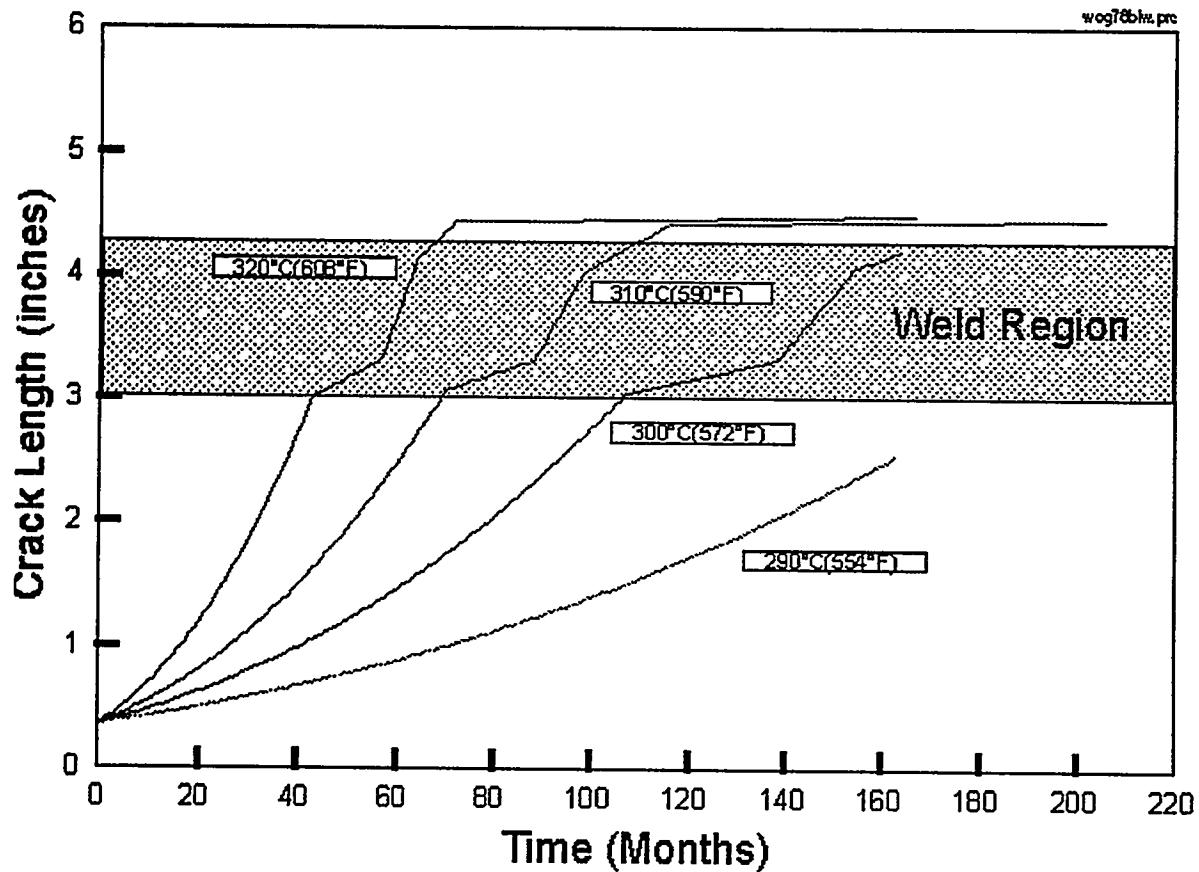
**Example of Crack Growth Calculations For Postulated
Axial Surface Flaws In A Head Penetration**

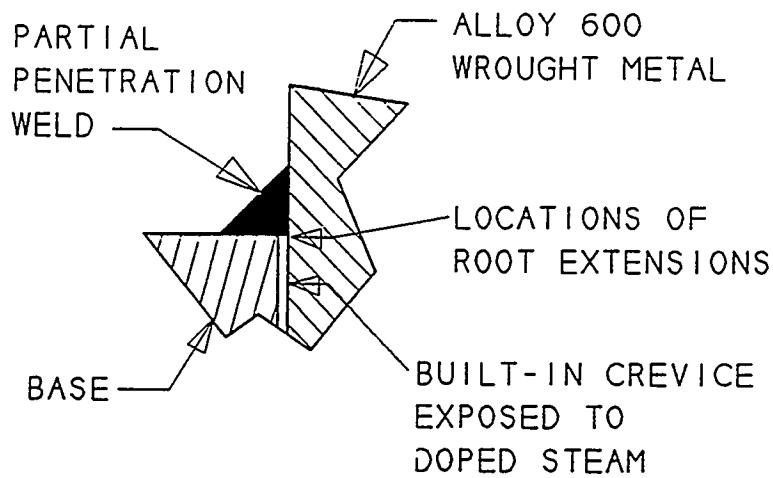
FIGURE 1. PARTIAL PENETRATION WELD GEOMETRY

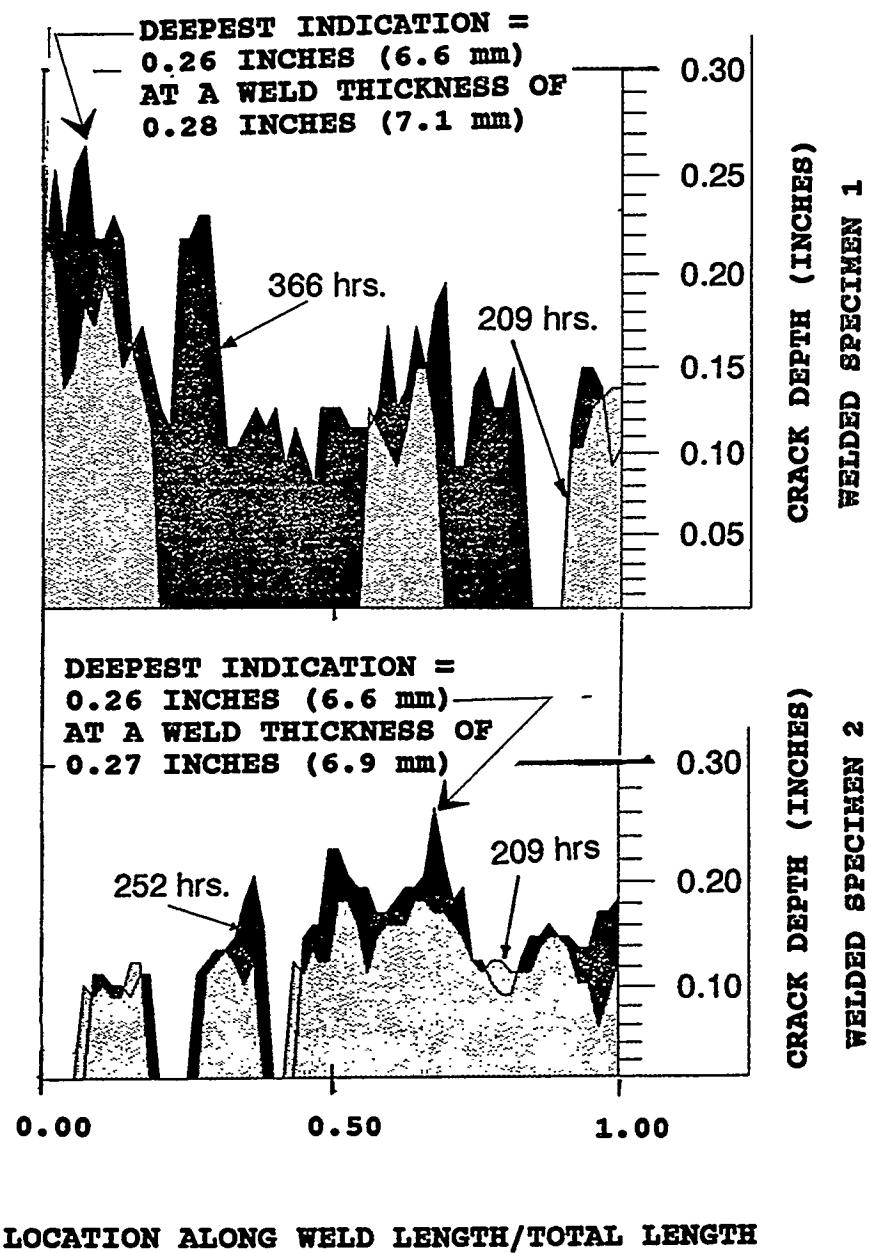
**FIGURE 3. UT INDICATION OF CRACK SIZES IN WELD METAL
OF WELDED SPECIMENS 1 AND 2 (1 INCH = 25.4 mm)**

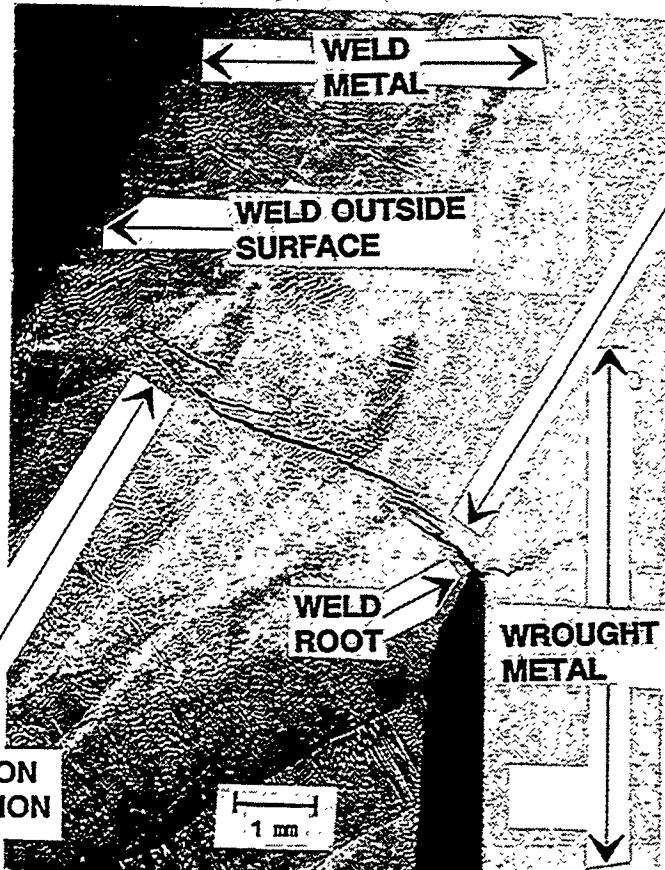
FIGURE 4a. CRACK OVERVIEW

FIGURE 4. PHOTOMICROGRAPHS OF WELDED SPECIMEN 2
AFTER 252 HOURS OF EXPOSURE TO
DOPED STEAM (PHOSPHORIC ETCH)

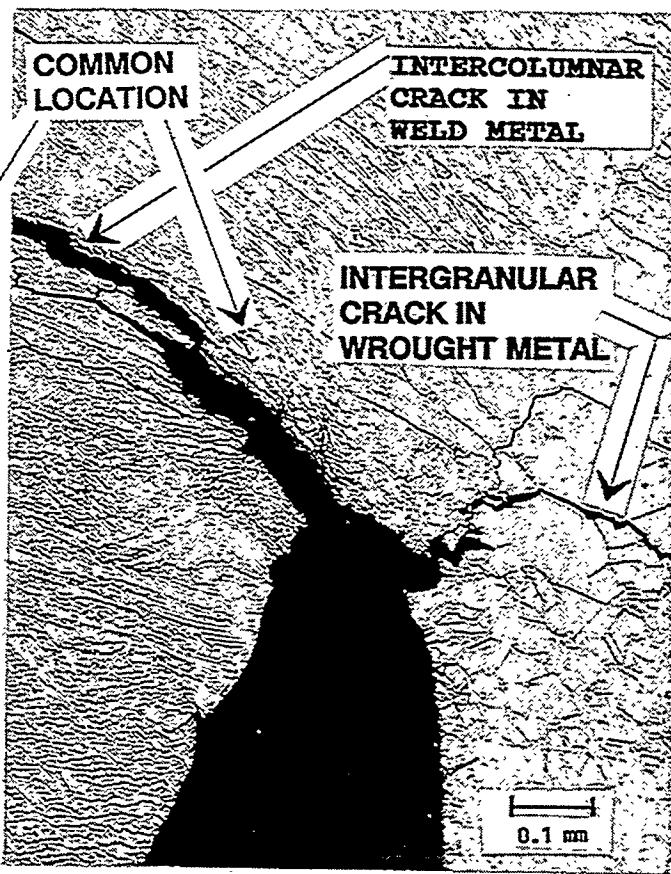
FIGURE 4b. WELD ROOT

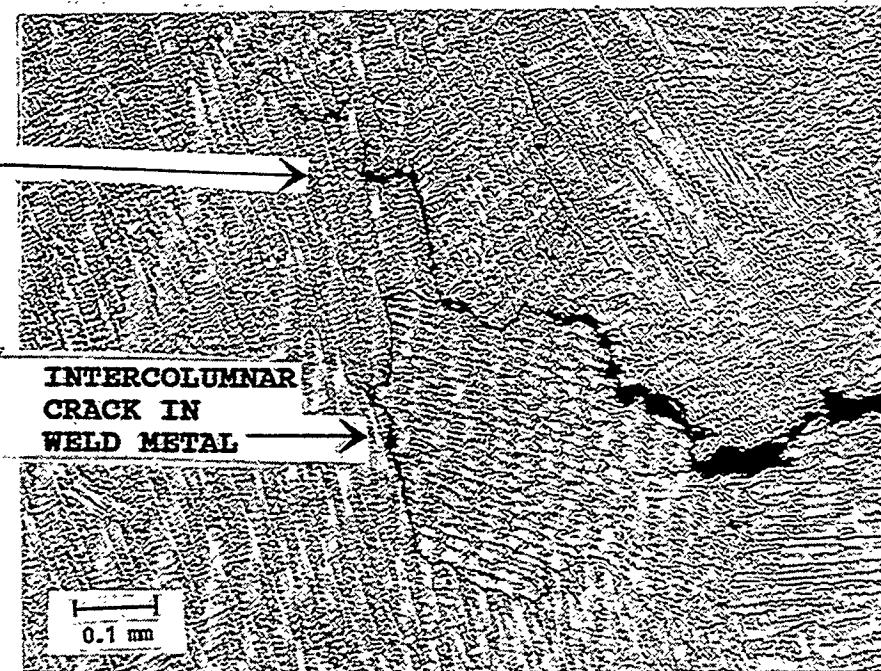
FIGURE 4c. CRACK TIP IN WELD METAL

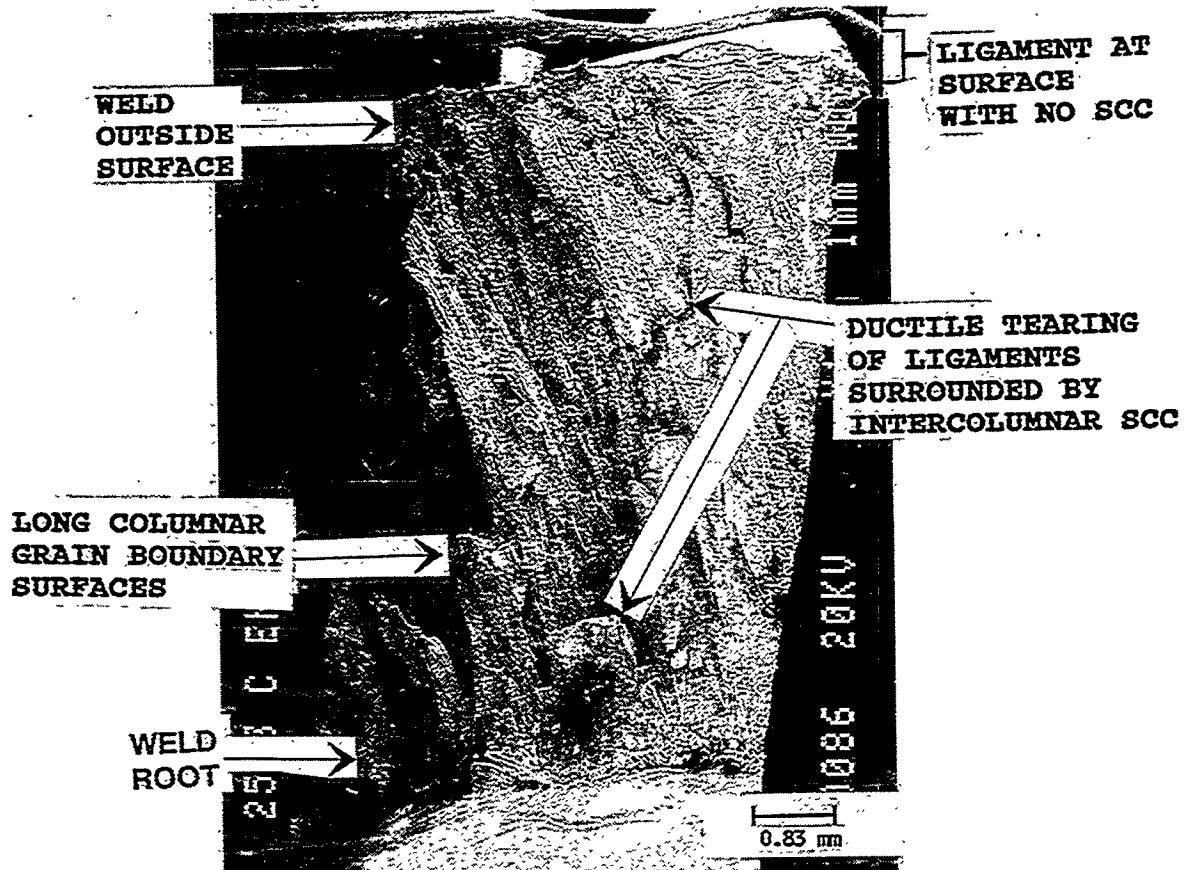
FIGURE 6. FRACTOGRAPH OF WELDED SPECIMEN 2

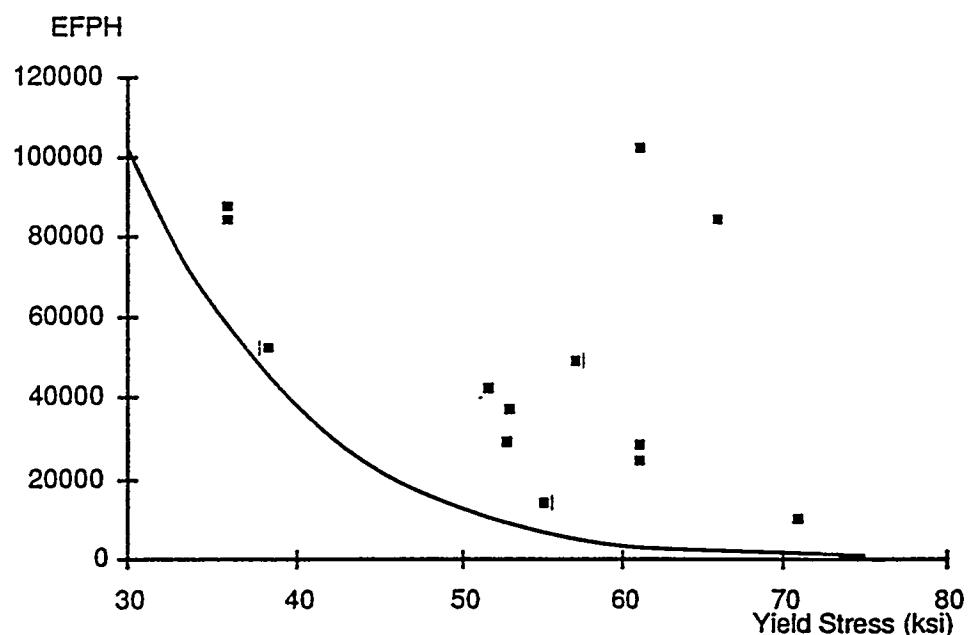
Fig. 1 Acceptance criteria for time-to-failure to a crack depth of 3/8 inch for In-600 forged nozzles at 653°F.

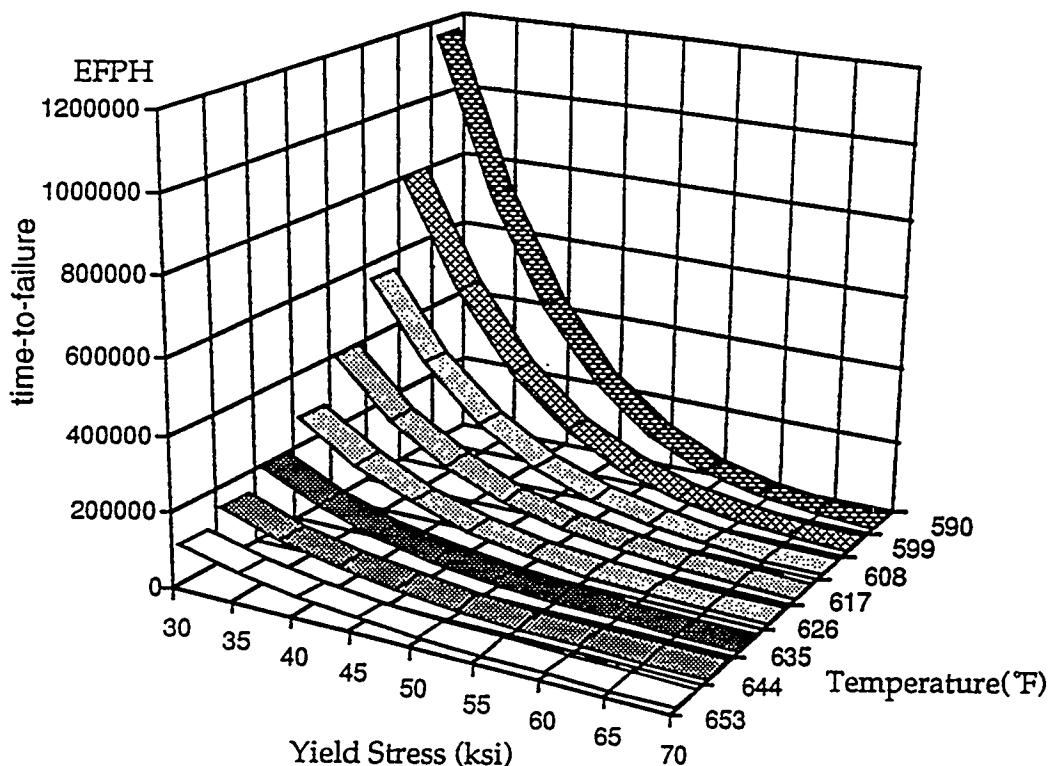
Fig. 2 Acceptance criteria for time to failure for In-600 forged nozzles.

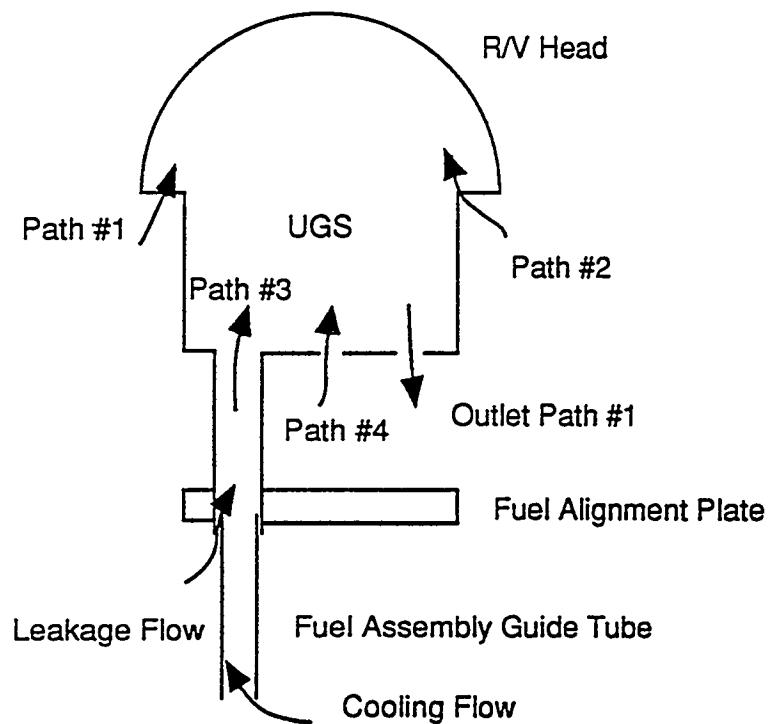
Fig. 3 Schematic View of Flow Paths to Reactor Head

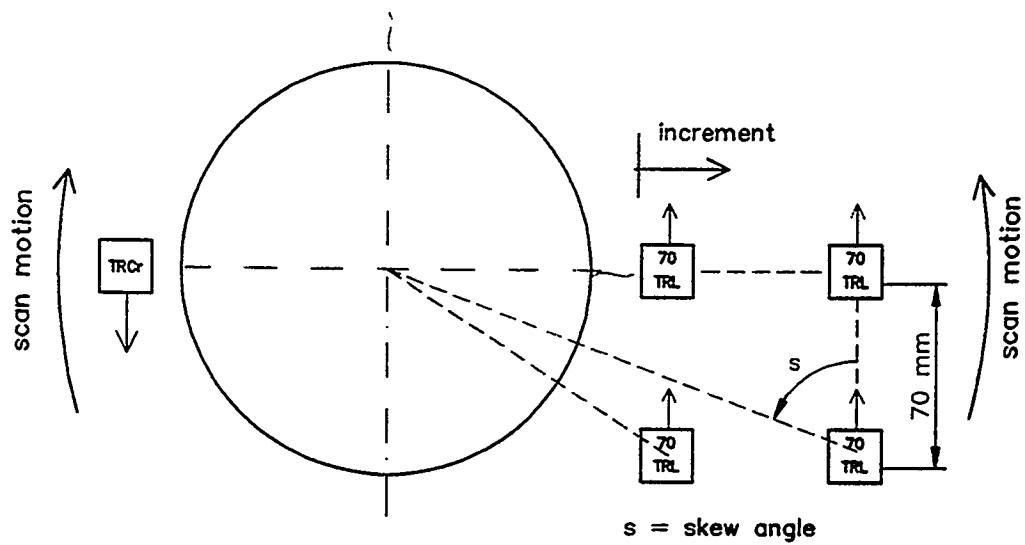
RADIAL SCANNING
(CIRCUMFERENTIAL DEFECTS DETECTION)

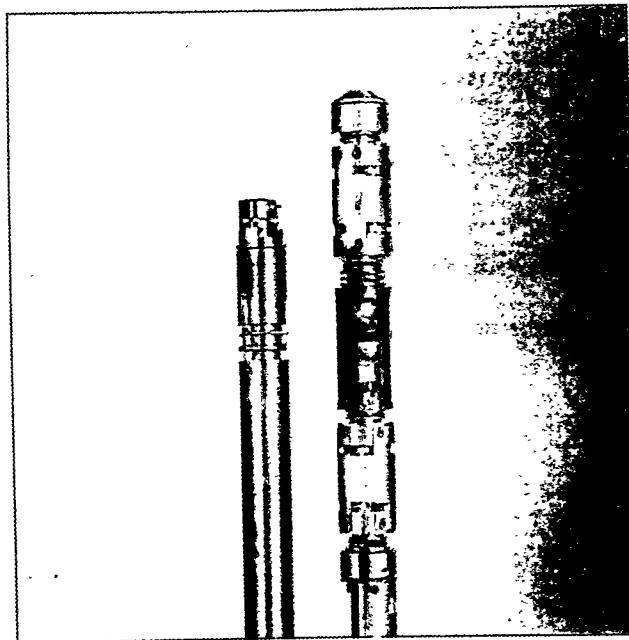
Figure 3

Thermal Sleeve Cutting

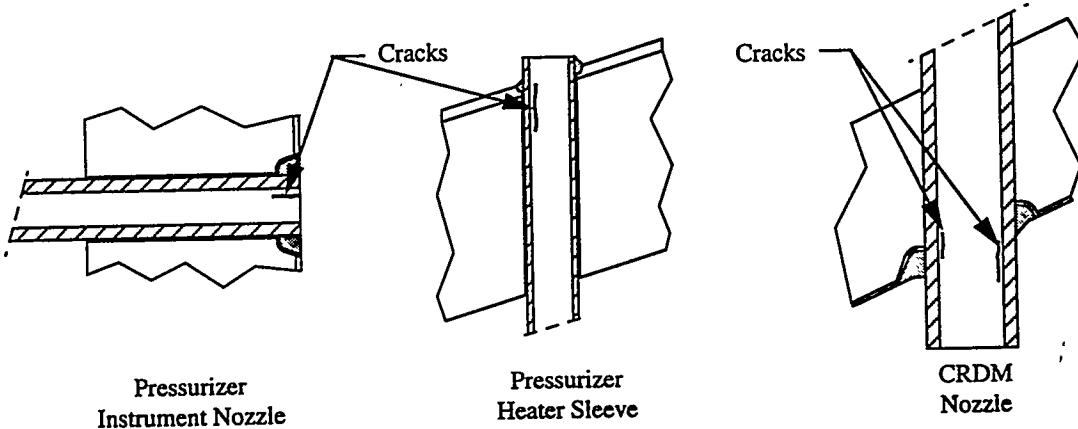
Figure 1—Typical Alloy 600 Penetrations and Crack Locations

Primary water stress corrosion cracking (PWSQC) of Alloy 600 primary loop penetrations in PWR plants was first reported in 1982 in a pressurizer heater sleeve at Arkansas Nuclear One Unit 2. PWSQC has subsequently been reported in several other types of primary loop penetrations in PWR plants including pressurizer instrument nozzles, steam generator drains, and reactor vessel head CRDM nozzles (1). Figure 1 shows typical penetration arrangements and crack locations. It is noted that the cracks in all of the penetrations are located near the J-groove welds which attach the penetrations to the vessel shells.

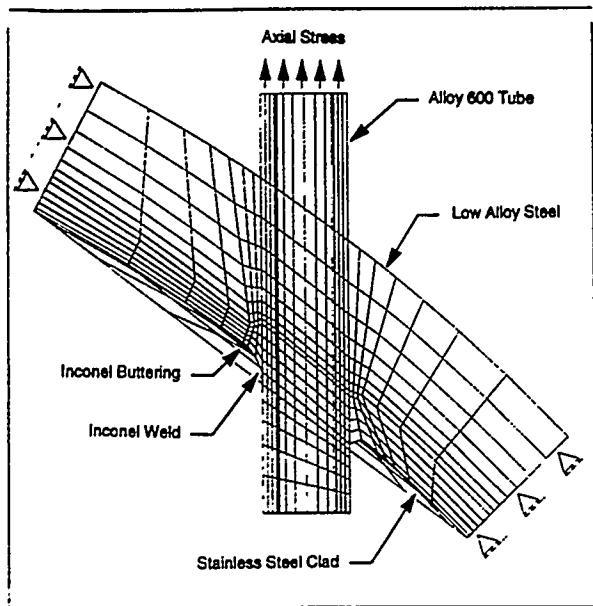
Figure 2 – Finite Element Model of Typical CRDM Nozzle

Welding – All of the nozzles evaluated are joined to the vessel shells by J-groove welds. The J-groove welds are simulated as rings of weld metal in which one ring is applied at a time. Non-axisymmetric effects of progressively deposited welds are neglected. Parametric analyses showed that two weld passes provide a good approximation of the stress distributions on the inside surface of the nozzles predicted using larger numbers of passes. The welding process is simulated by combined thermal and structural analyses. Thermal analyses are used to generate temperature distributions throughout the joint at several points in time during the welding process. These temperature distributions are then used as input conditions to the structural analyses. The sequence of thermal analyses followed by structural analyses was duplicated for each of the two simulated welding passes. Figure 5 shows the temperature distribution during the first pass of a typical CRDM nozzle weld.

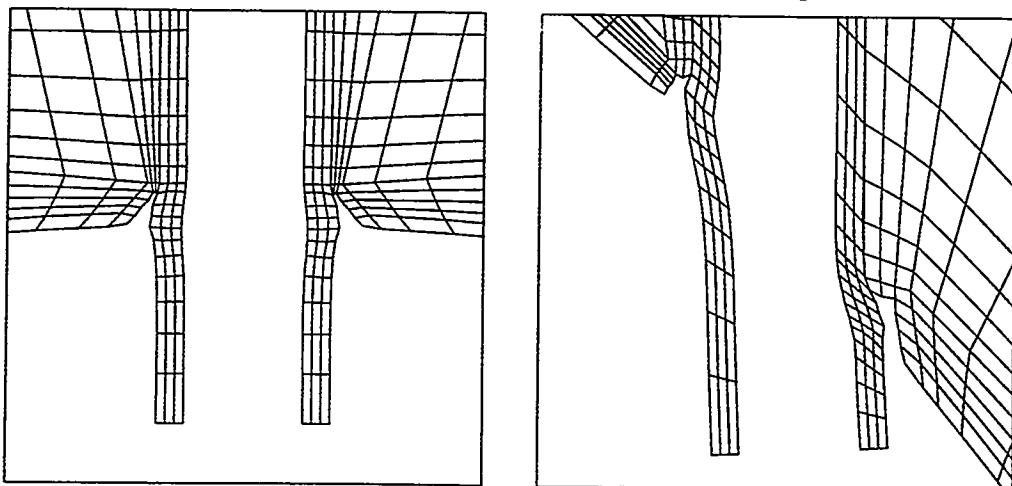
Figure 6 – Deflections After Welding in Typical Central and Outer Row CRDM Nozzles

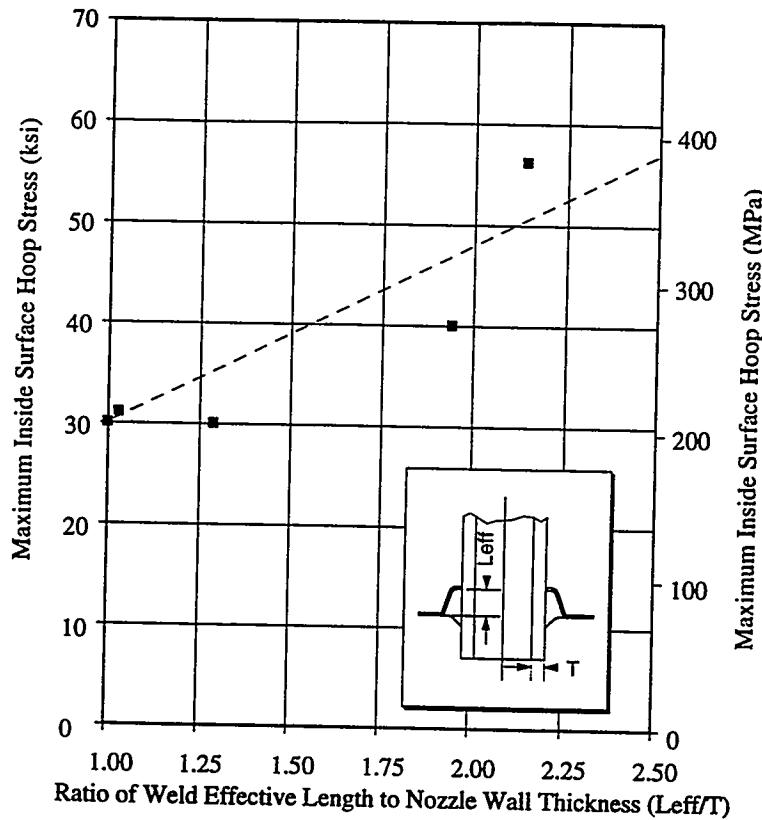
Figure 11 – Effect of Weld Size on Maximum Hoop Stress in Central CRDM Nozzles

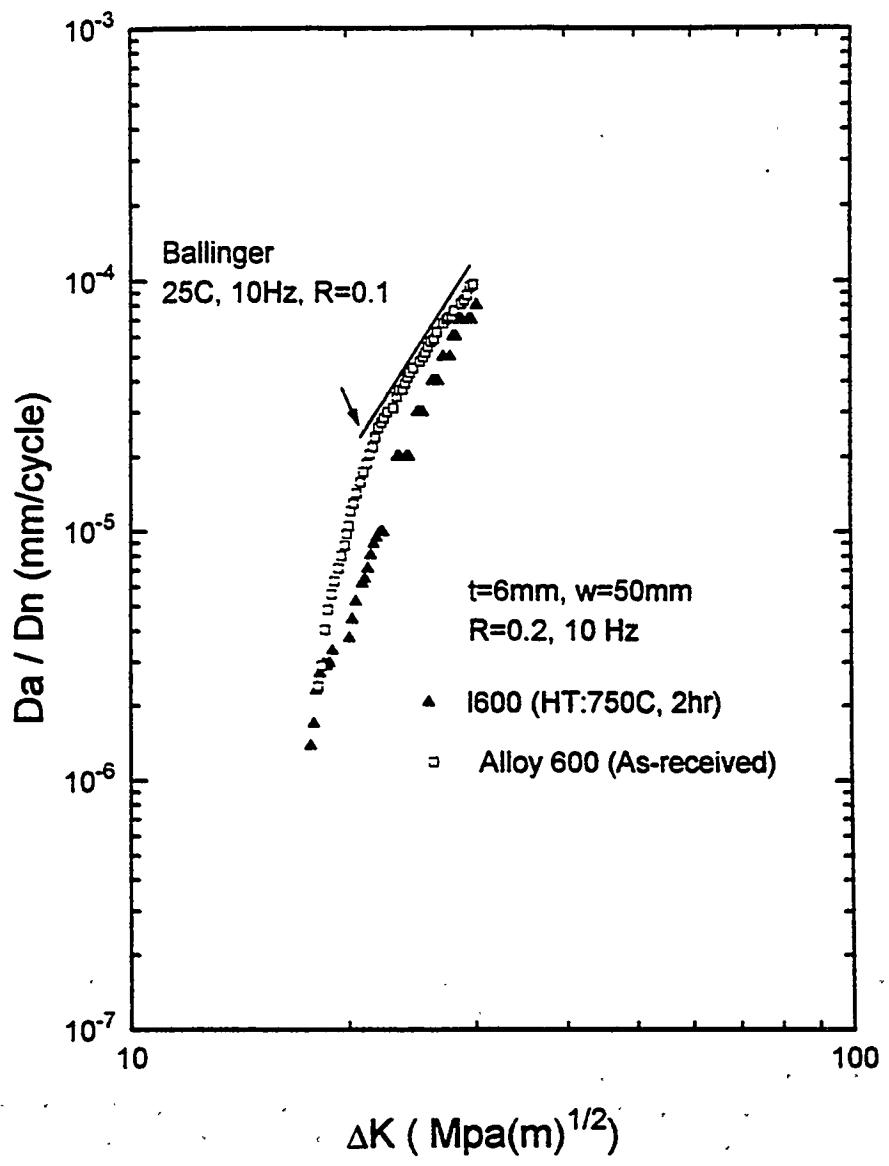
Fig.2 Fatigue Cracking Properties of Inconel 600 Alloys

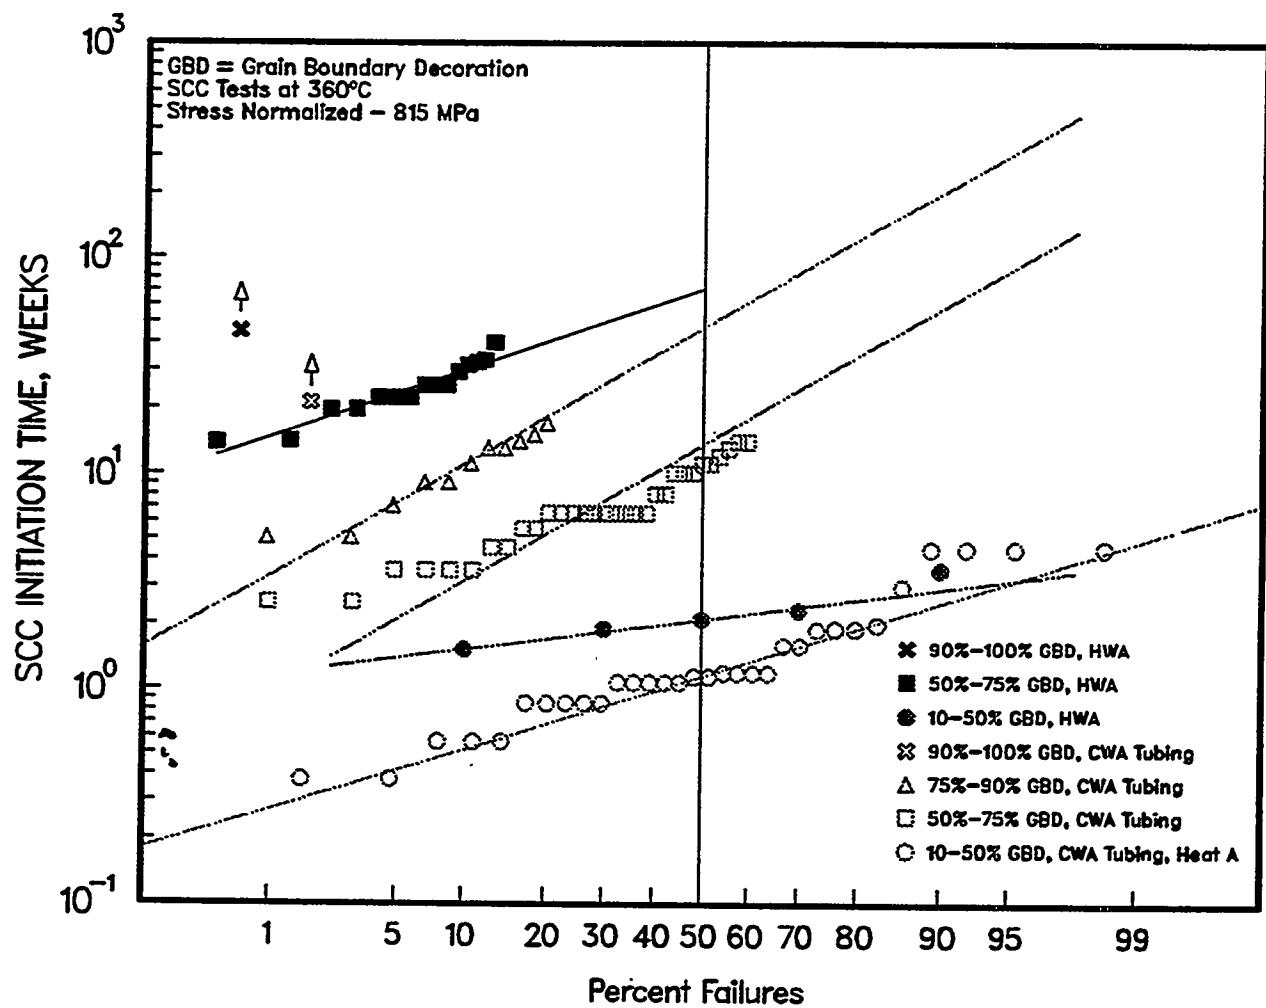
Figure 1: Cumulative Distribution Function failure plot of Alloy 600 SCC data, corrected for stress

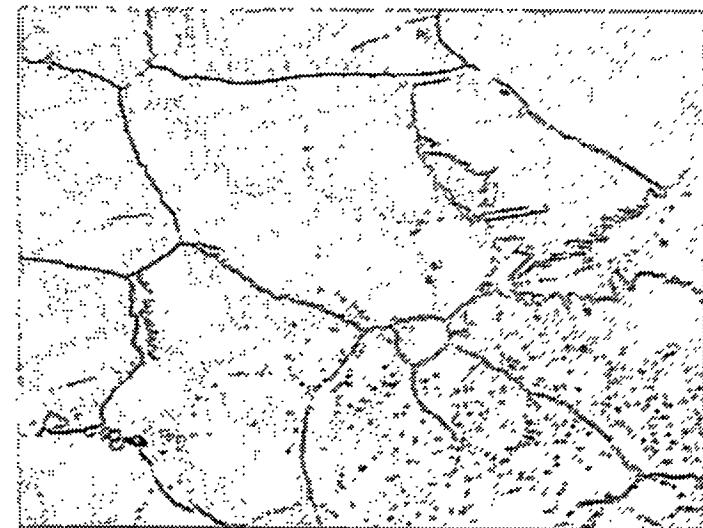
(a) Heat B in high temperature processed condition.

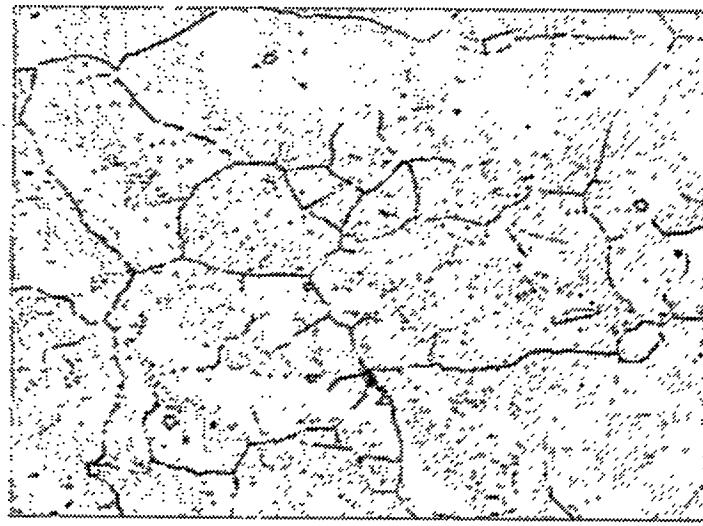
(b) Heat B in conventional processed condition.

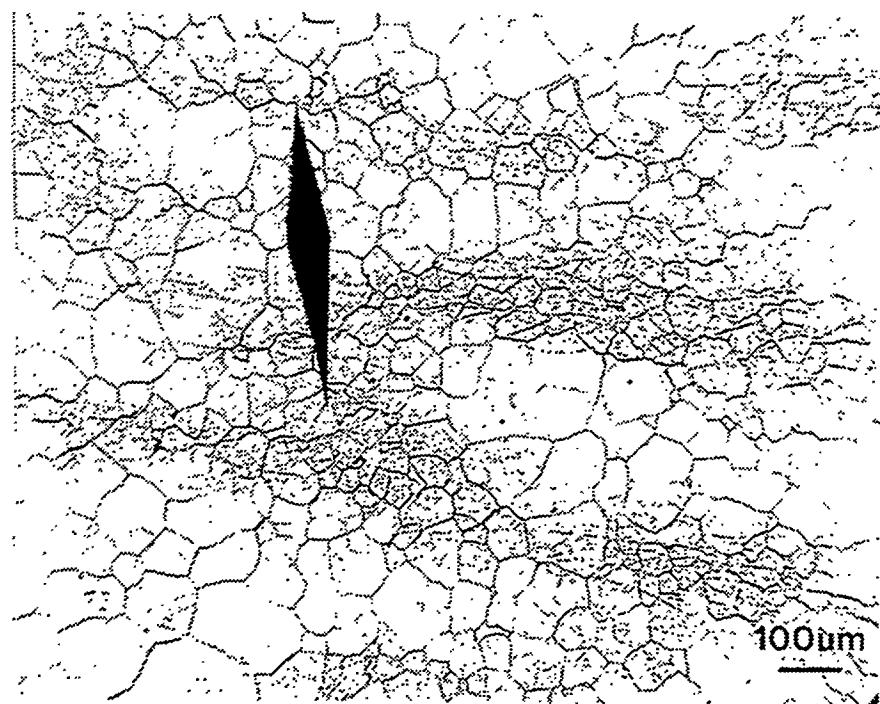
Figure 4:

Example of banding in a ring rolled forging.

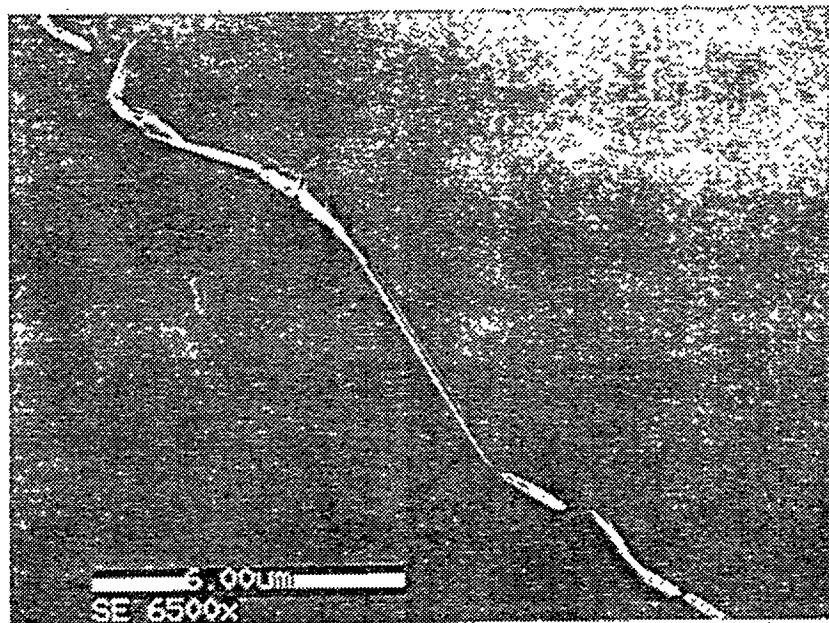
Secondary electron images of the high-temperature processed forging material (final anneal at 1060°C) showing (a) the "semi-continuous" morphology in the material final-annealed at 1060°C for 2 h.

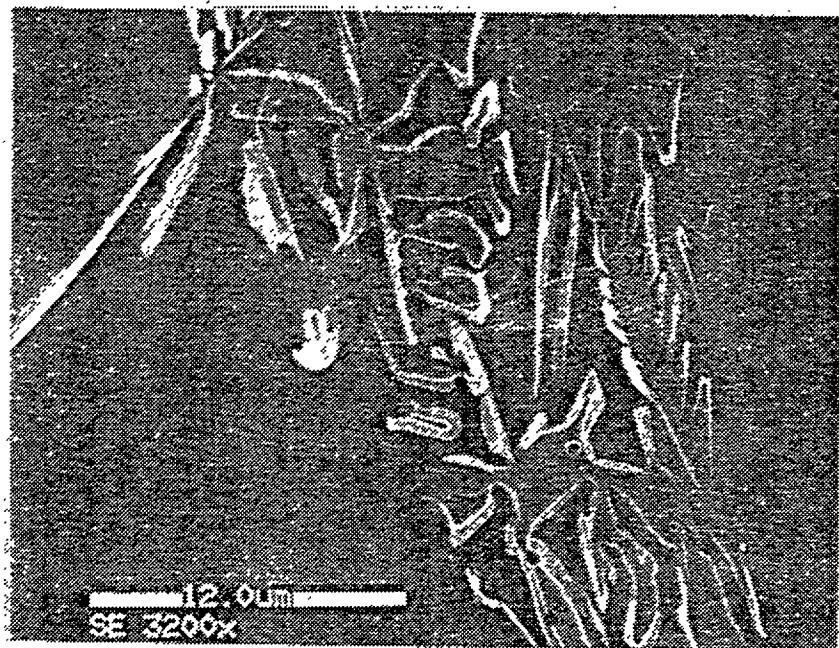
Figure 7

Inclined angle secondary electron images of the high-temperature processed forging material (final anneal at 1060°C) showing (b) the dendritic-type morphology of the M_7C_3 carbides observed in the material final-annealed at 1060°C for 2 h.

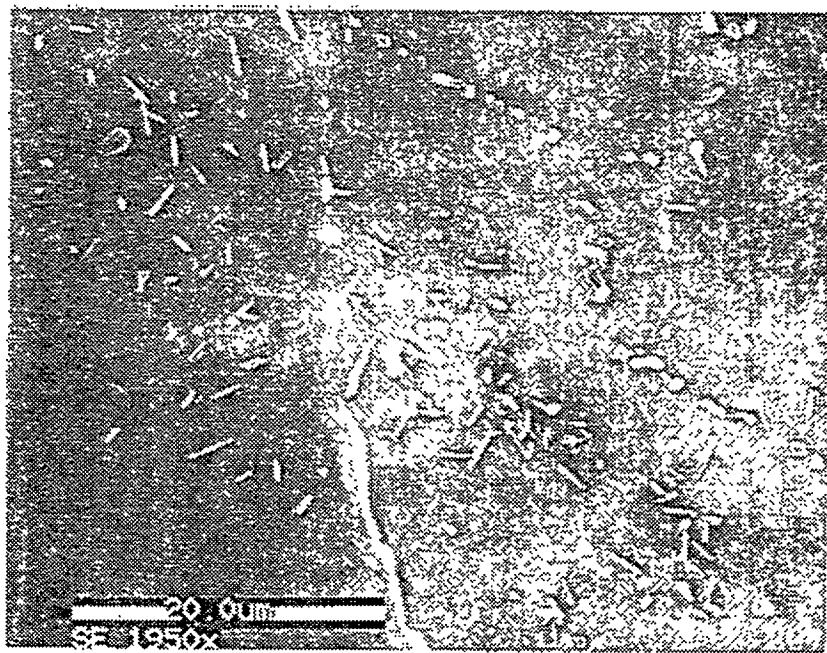
Figure 8

Secondary electron image showing one of the few regions containing both intergranular and intragranular carbides associated with residual carbide banding in material final-annealed at 1060°C for 2 h.

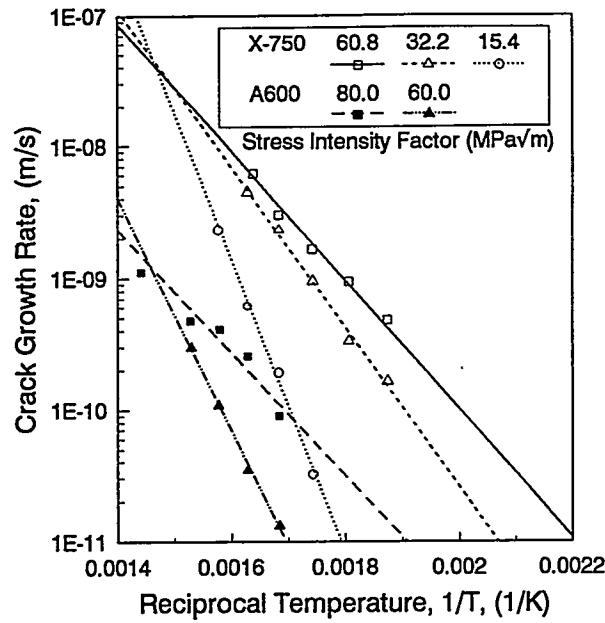
Figure 2. Effect of Temperature and Stress Intensity Factor on Crack Growth Rate. Data From Ref. 12.

There are few primary water IGSCC crack growth rate data, obtained on NiCrFe alloys, that are suitable for benchmarking the IGSCC-CGR model given by Eq.(10) above. The best available data are from the work by Shen and Shewmon¹² and Speidel and Magdowski¹³. However, there are limitations to each of these data sets. Both sets of data were obtained on displacement controlled specimens, which results in a decreasing stress intensity factor as crack growth occurs. Crack growth rates were determined by Shen and Shewmon using in-situ measurements of crack length but their tests were conducted in steam, instead of water. Speidel and Magdowski obtained crack growth rates from measurements of average crack extension divided by the total exposure time. Their rates do not, therefore, account for the time to the onset of IGSCC crack growth. The Shen-Shewmon data obtained on Alloy X-750 and Alloy 600 are shown in Fig. 2 and Fig. 4. The Speidel-Magdowski data obtained on Alloy 600 are shown in Fig. 3, Fig. 5 and Fig. 6. Note that the best fit Arrehnius curves for each data set in Fig. 2 and Fig. 3 were adjusted slightly to intersect at a common athermal temperature, T_o . The Shen-Shewmon data are best fit using an athermal temperature of 682 K while the Speidel-Magdowski data could be fitted reasonably well using

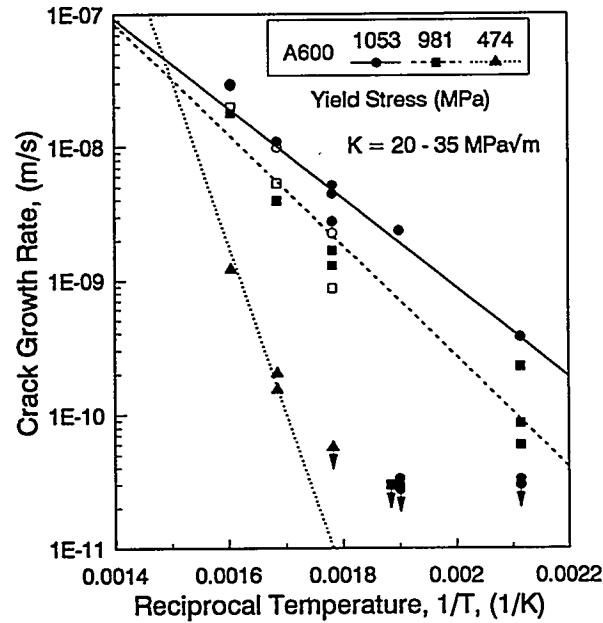
Figure 3. Effect of Temperature and Yield Stress on Crack Growth Rate. The solid symbols represent data taken from Ref. 13. The open symbols represent values obtained by cross-plotting the data correlations shown in Figure 5 for $K = 30 \text{ MPa}\sqrt{\text{m}}$.

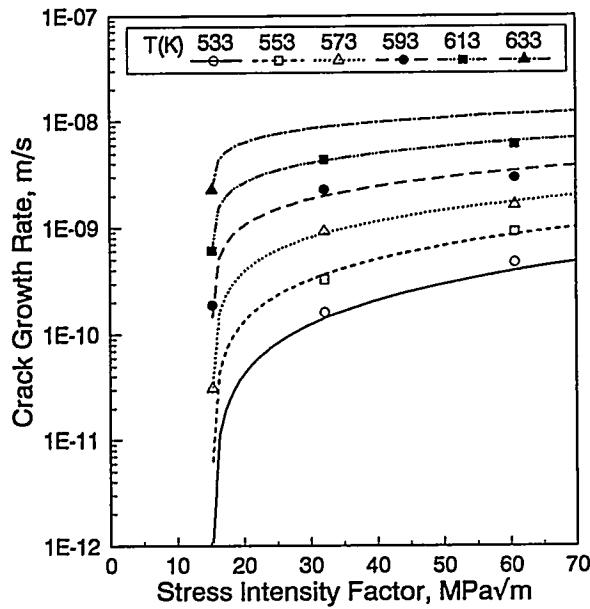
Figure 4. Alloy X-750 Crack Growth Rate as Function of the Stress Intensity Factor. Data From Ref. 12.

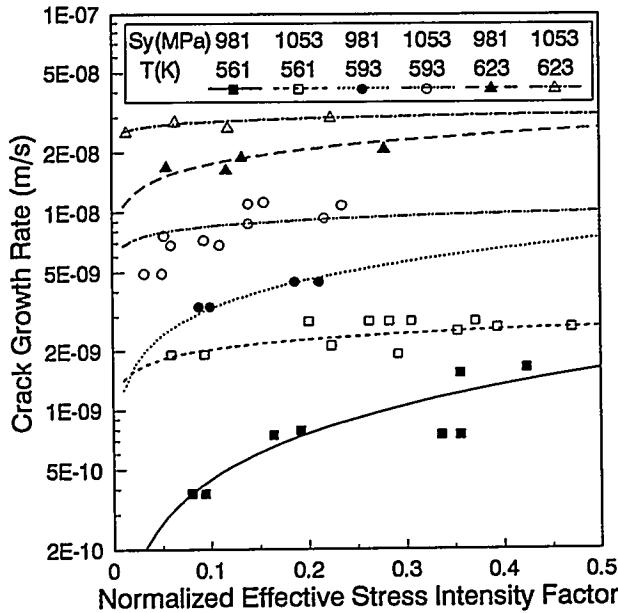
Figure 5. Alloy 600 Crack Growth Rate as Function of the Normalized Effective Stress Intensity Factor. Data From Ref. 13.

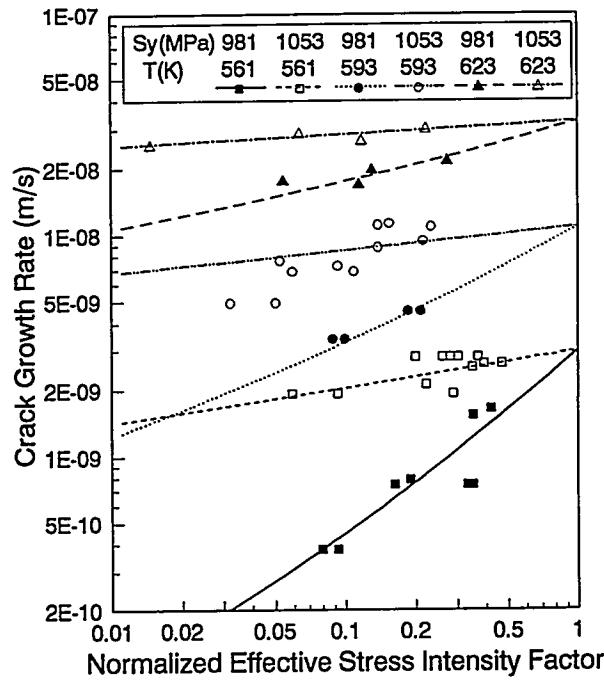
Figure 6. Alloy 600 Crack Growth Rate as Function of the Normalized Effective Stress Intensity Factor. Data From Ref. 13.
