NUREG/CP-0151
ORNL/TM-13187

IAEA Specialists' Meeting on Cracking in LWR RPV Head Penetrations

Held at
ASTM Headquarters
Philadelphia, Pennsylvania
May 2-3, 1995

Proceedings prepared by
Oak Ridge National Laboratory

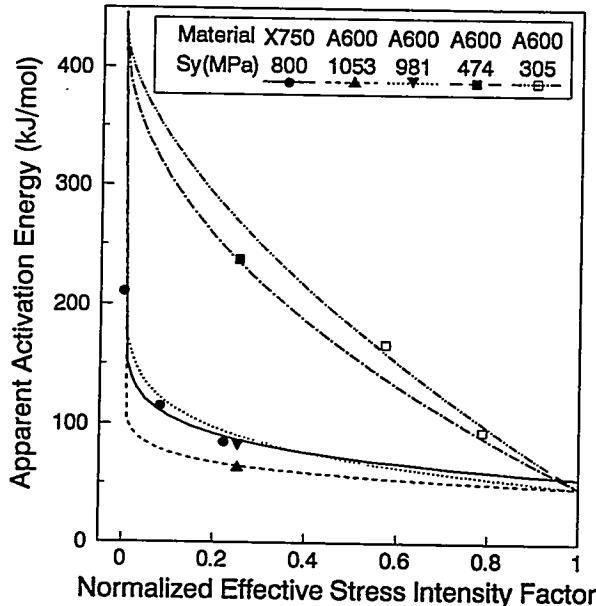
Figure 7. Apparent Activation Energy as Function of the Normalized Effective Stress Intensity Factor Showing the Effect of Yield Stress. The A600 curves are derived from the A600 data from Ref. 13 and the open symbols represent the Q values derived from the A600 data from Ref. 12.

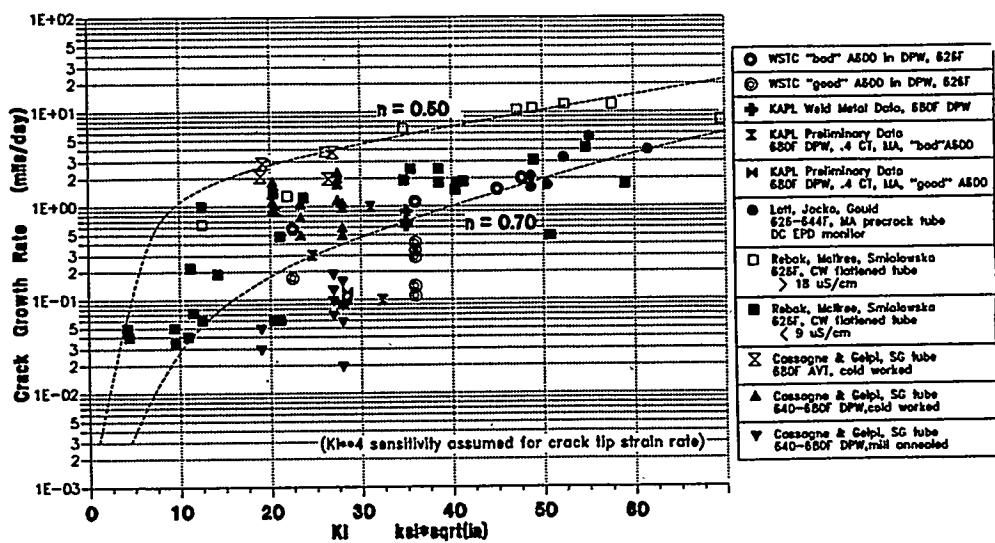
Figure 1. Compilation of Alloy 600 crack growth rate data in high temperature deaerated pure water and Ford/Andresen model correlation for crack growth rate vs. K_I for 'n' values of 0.5 and 0.7.

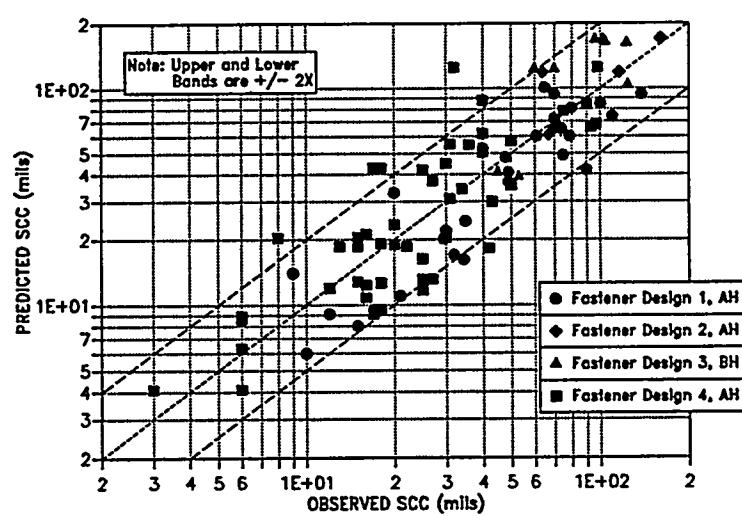
Figure 7. Predicted crack length based on CT specimen data versus observed crack length for wide range of fastener geometries, applied stress, and temperature.

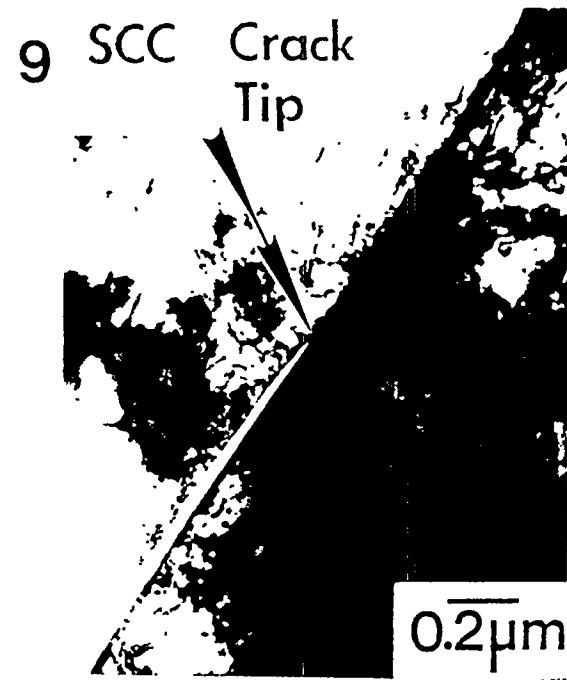
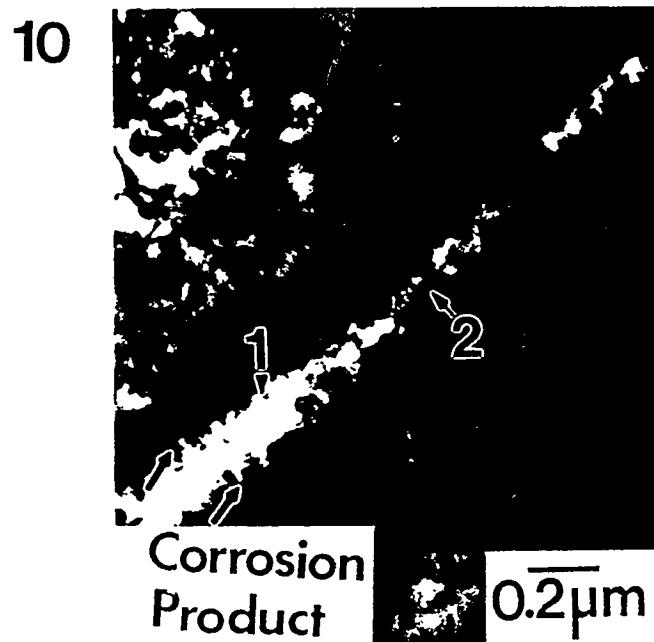
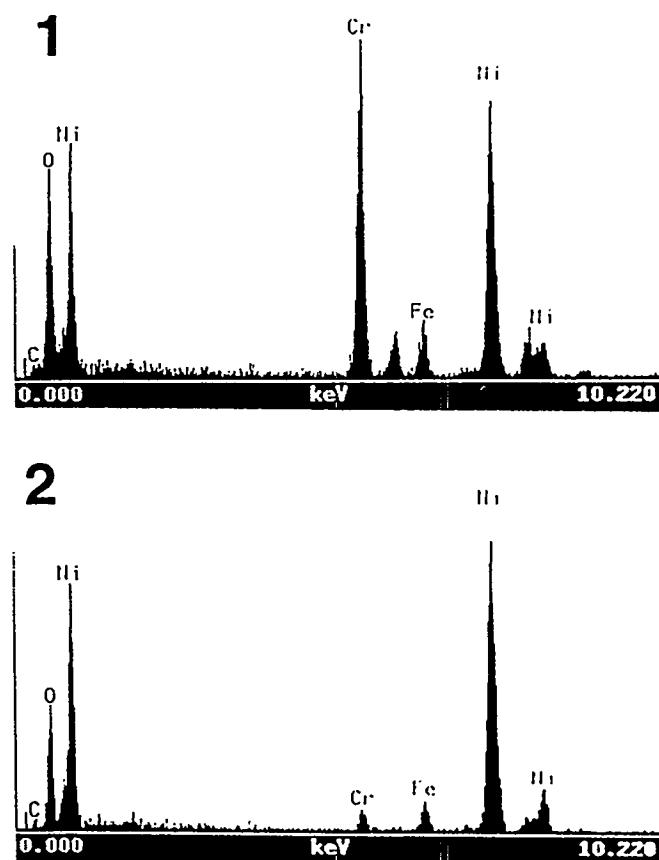
FIGURE 8. AEM CROSS-SECTIONAL IMAGE SHOWING SCC CRACK PROPAGATING AROUND COMPLEX GRAIN BOUNDARY CONTAINING Cr_7C_3 CARBIDES. NOTE AS CRACK CHANGES DIRECTION DISLOCATION STRUCTURE REMAINS THE SAME.

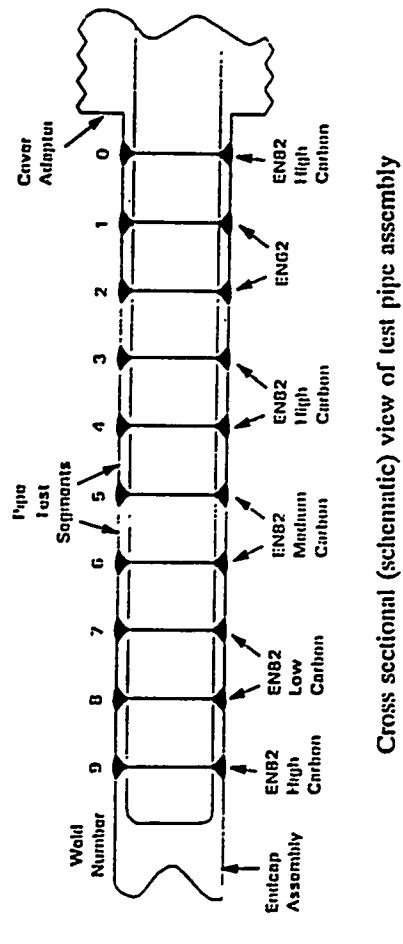
Cross sectional (schematic) view of test pipe assembly

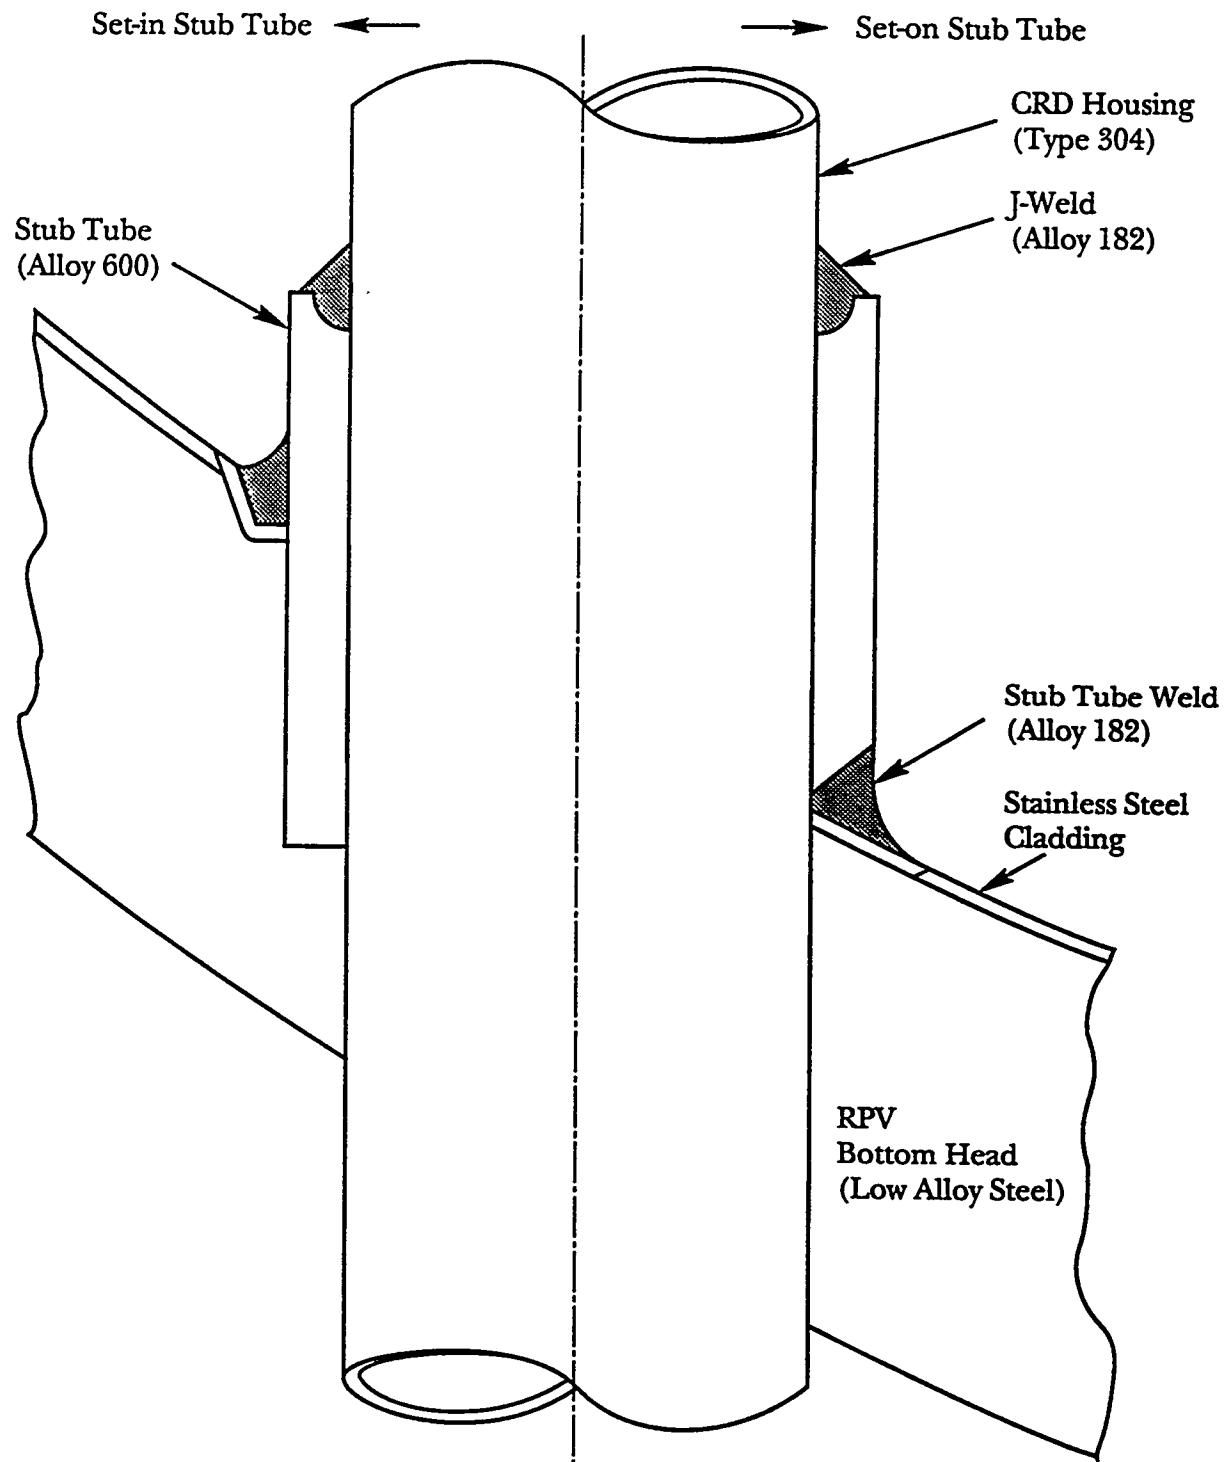
Figure 1. BWR CRD Penetration
