ORNL-2832  
UC-25 - Metals, Ceramics, and Materials

CORROSION ASSOCIATED WITH FLUORINATION  
IN THE OAK RIDGE NATIONAL LABORATORY  
FLUORIDE VOLATILITY PROCESS

A. P. Litman and A. E. Goldman

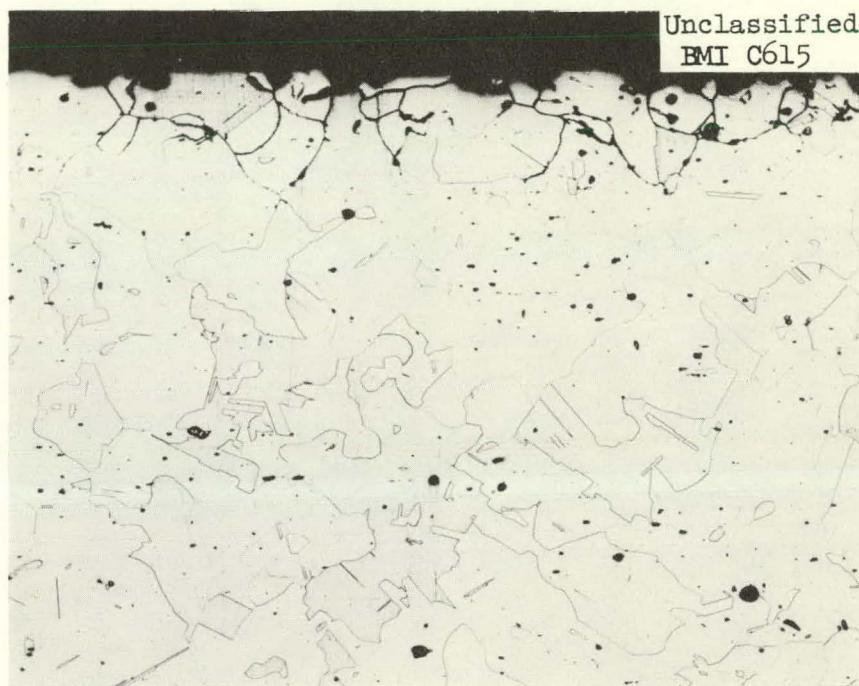
Fig. 20. Microstructure of Sample from Interior Surface of Mark II VPP Fluorinator 19 in. Below Slip-on Flange (Vapor Phase, Area A). Etchant: Nitric-acetic acid. 100X.

Typical photomicrographs of sections from the Mark II fluorinator can be seen in Figs. 19 through 23. Intergranular attack was prevalent in all

sections in all regions but penetration was deepest in the samples from the interface and salt regions. Maximum grain-boundary attack was found to be 33 mils in the salt-phase sample A-3b which was in the vicinity of the shell to head girth weld.

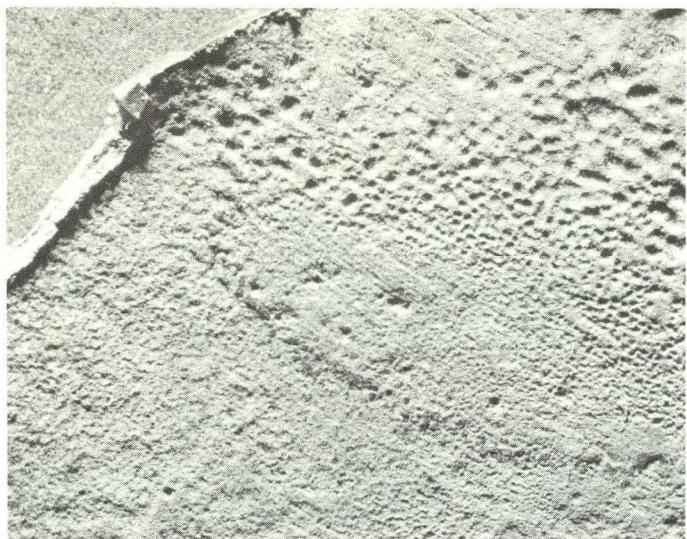
A pitting attack was found on the interior wall near Area C in the vapor region, about 3 in. down from the bottom of the slip-on flange. Figure 24 shows the appearance of the surface at 3X, and Fig. 25 shows a metallographic section through this pitted area. The latter indicates a level of intergranular penetration similar to that found in other upper-vapor regions. The depth of intergranular attack did not appear to vary from top to bottom of the pits.

Fig. 24. Photograph of Sample from Interior Surface of Mark II VPP Fluorinator 3 in. Below Slip-on Flange (Vapor Phase, Area C) Showing Pitting-Type Attack. 3X.

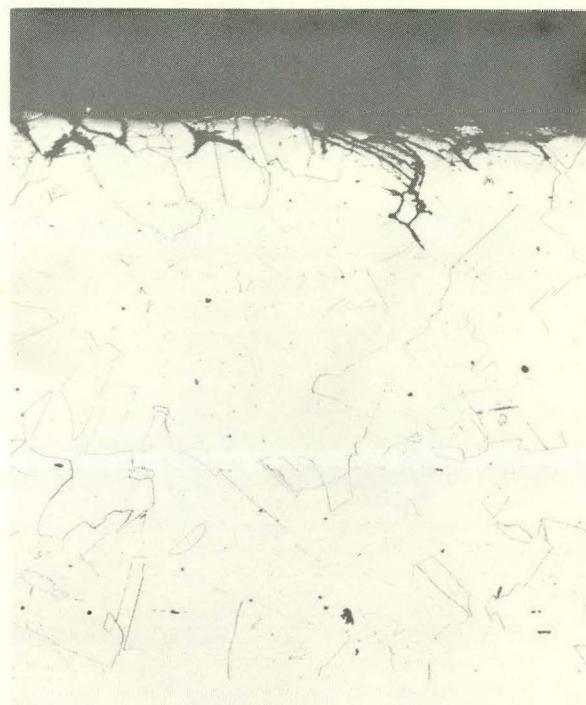
The exterior of the vessel displayed a corrosive attack which appeared to be intergranular in nature. Penetration varied from 1-6 mils, the maximum occurring at or below the vapor-salt interface (Fig. 28, Sample A-3b). However, there was one exception to this pattern. A grain-boundary penetration of approx 12 mils in depth was found on the exterior surface opposite the pitted region in the vapor near Area C.

Fig. 28. Microstructure of Sample from Exterior Surface of Mark II VPP Fluorinator Approx 47 in. Below Slip-on Flange (Salt Phase, Area A) Showing Result of Air Oxidation. Etchant: Nitric-acetic acid. 100X.

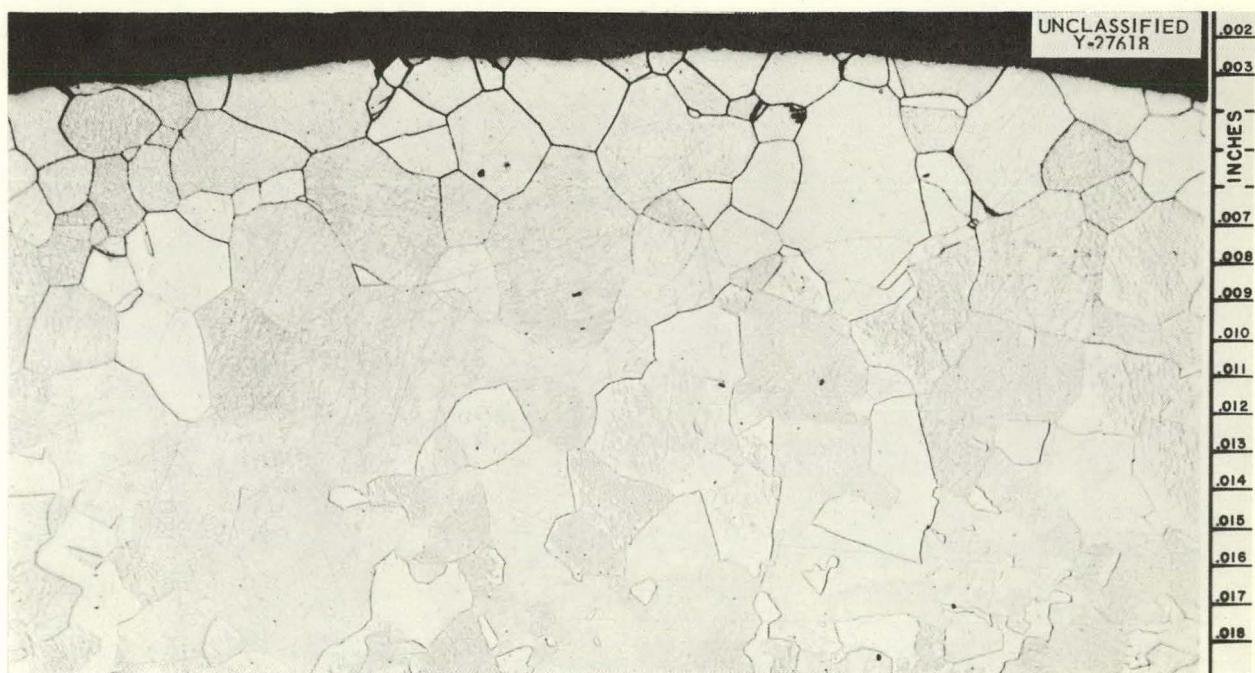
Fig. 59B. Portion of Fig. 59A. Typical Surface and Microstructure. Note intergranular attack. Etchant:  $KCN-(NH_4)_2S_2O_8$ . 200X.

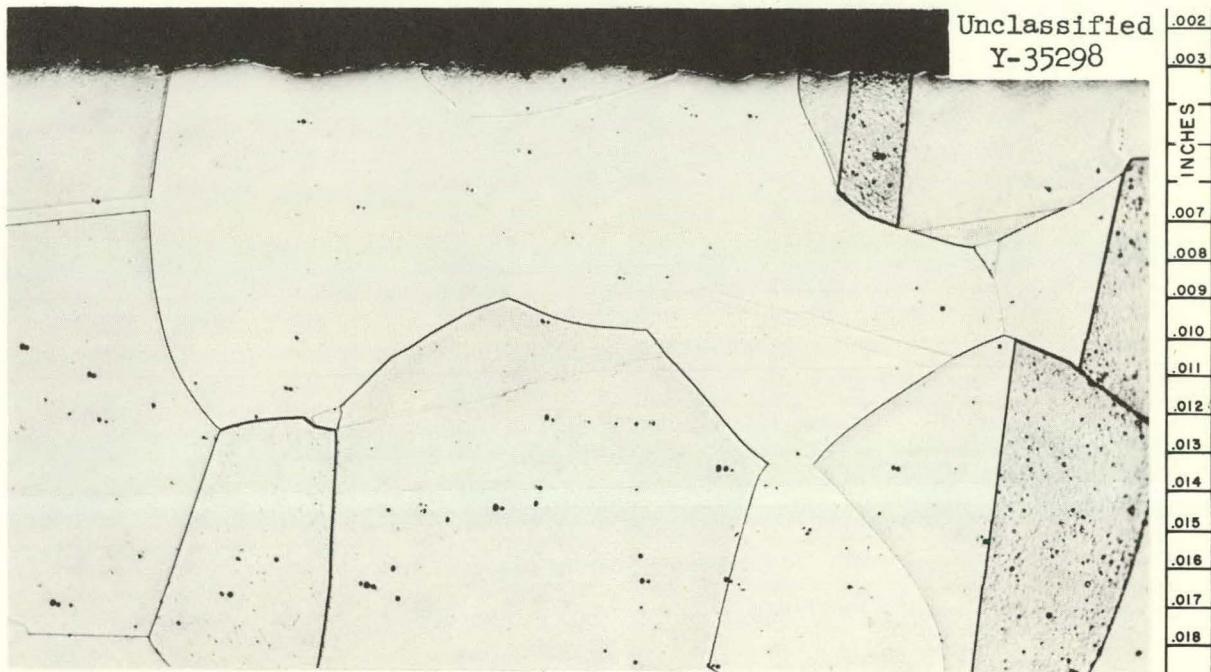
Fig. 65. Section of Vapor Region Sample from Monel Corrosion Specimen (Runs E-3-E-6:3) Showing Typical Surface and Microstructure.  
Etchant:  $\text{HC}_2\text{H}_3\text{O}_2:\text{HNO}_3:\text{HCl}$ . 200X.

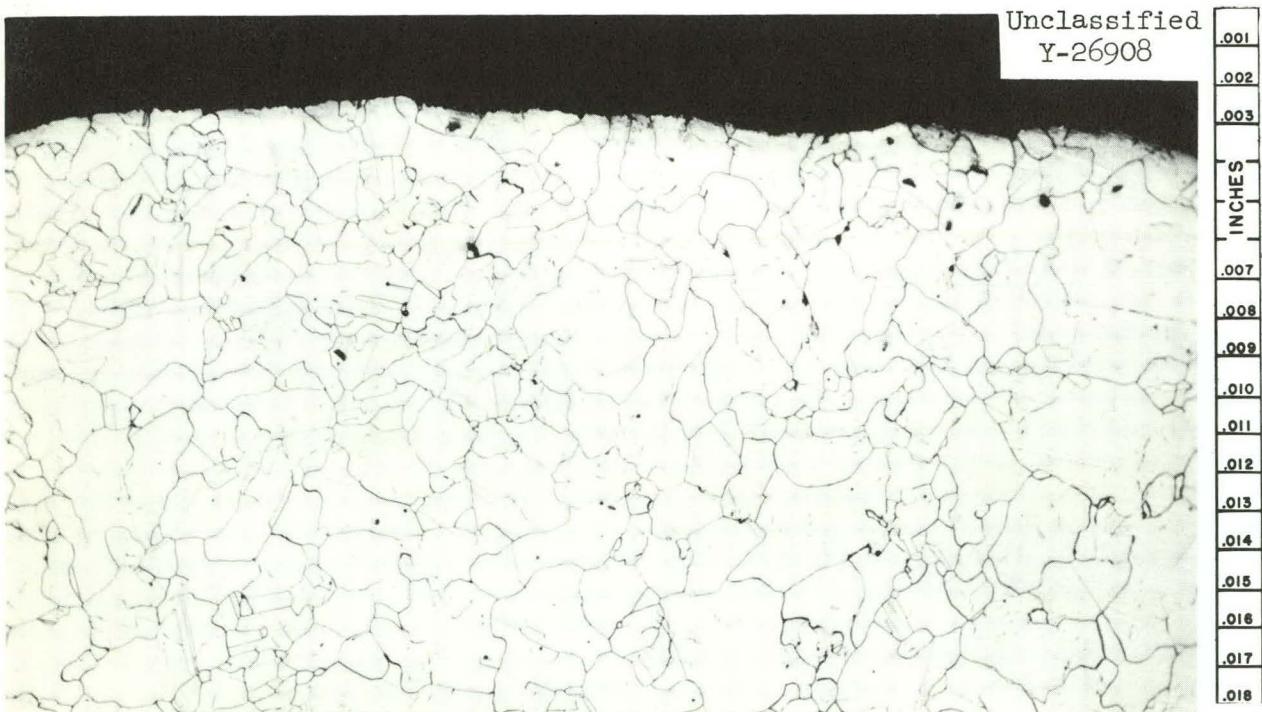
Fig. 68B. Portion of Fig. 68A. Typical Surface and Microstructure. Etchant: Dilute  $\text{HNO}_3$ . 200X.

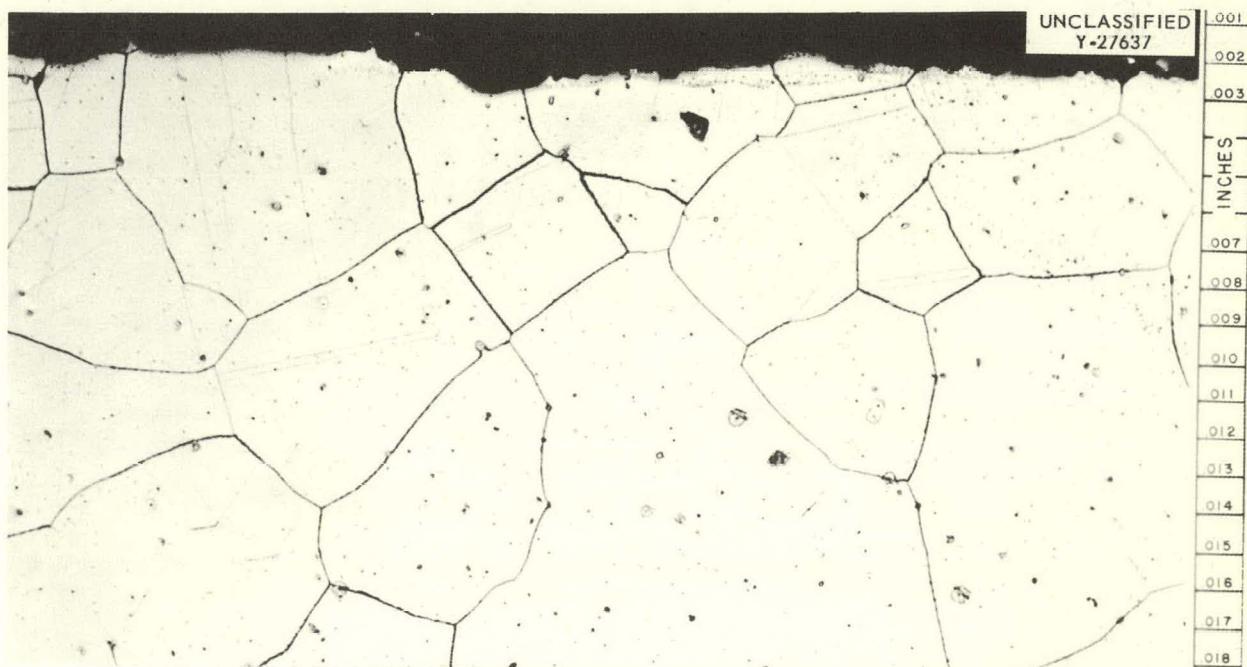
Fig. 77B. Portion of Fig. 77A. Typical Surface and Microstructure. Etchant: Aqua regia. 200X.

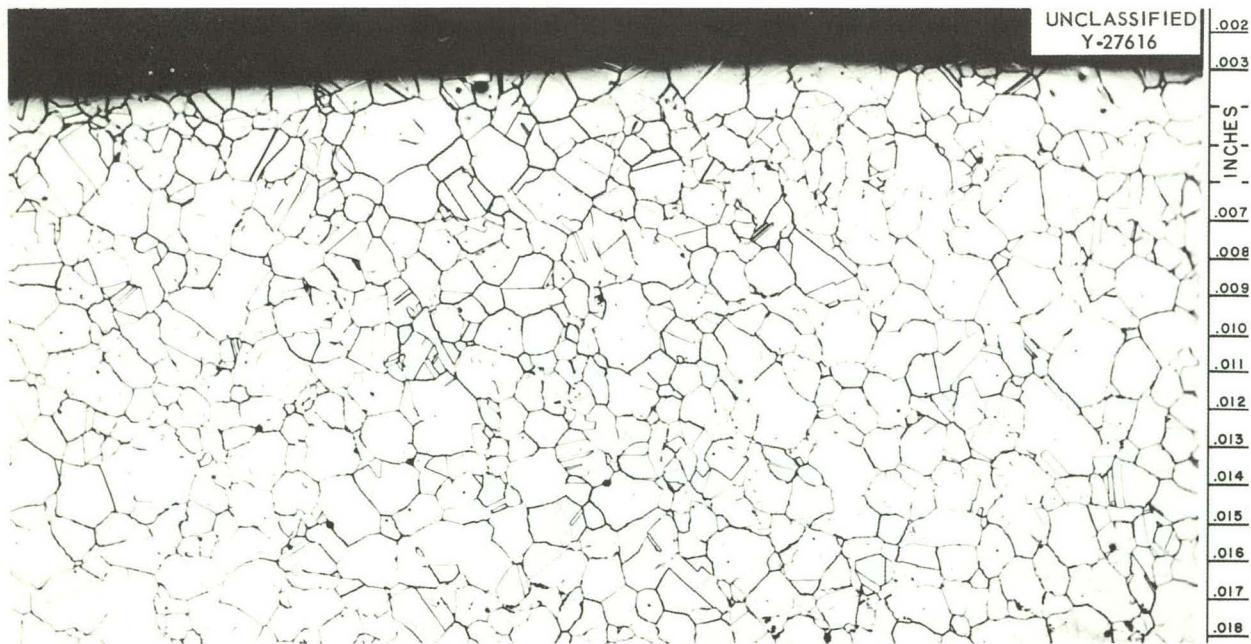
Fig. 78B. Portion of Fig. 78A. Typical Surface and Microstructure. Etchant: Aqua regia. 200X.
