ANL-6785
Metals, Ceramics, and
Materials
(TID-4500, 27th Ed.)
AEC Research and
Development Report

CORROSION EXPERIENCE WITH ALUMINUM
POWDER PRODUCTS

J. E. Draley, W. E. Ruther,
and S. Greenberg

November 1963

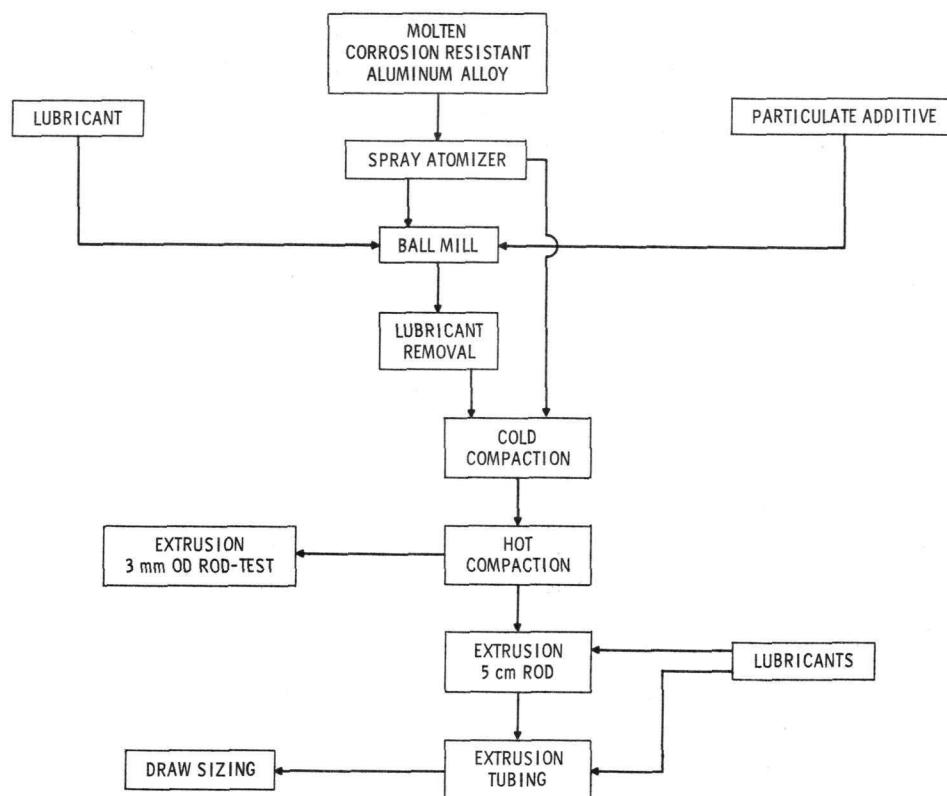
Figure 1. Flow Diagram for the Production of Powder-product Tubing

The flow diagram of Figure 1 illustrates the steps in the production of tubing by ARF. For the pilot run of tubing described in this report, no particulate additive was used. Although no details were available, it was assumed that a similar production scheme was also used by the other powder-product suppliers.

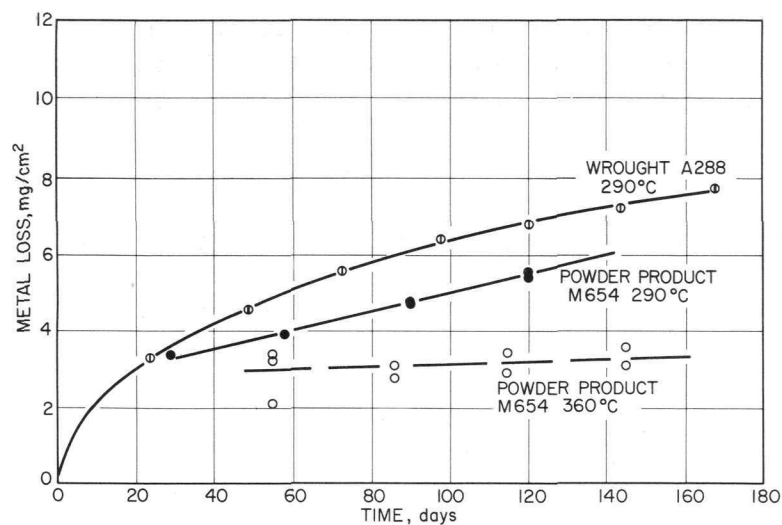
Figure 2. Corrosion of Aluminum

M654 specimens initially showed corrosion behavior equivalent to that of the wrought alloy of the same composition (A288). There were small mounds or blisters in the dark coating, but the corrosion rates were quite satisfactory up to about 120 days (see Figure 2) of exposure at 290°C. Increased corrosion of the cut ends of the tubing was noted at this time. Corrosion penetration and swelling of the sample edge perpendicular to the extrusion direction has previously been noted with powder products. Specimens tested at 360°C suffered less general attack (see Figure 2) and no swelling of the cut ends. A test temperature of 290°C appears to be the most severe for powder products produced from low-silicon alloy powders. This is not surprising, since this is also the temperature of maximum corrosion for the wrought alloy.

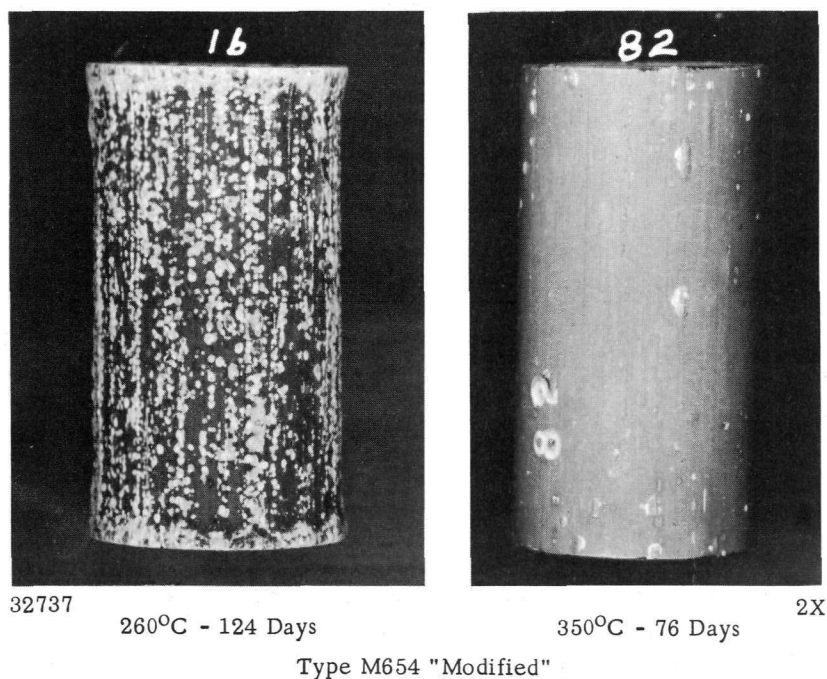
Figure 3. Appearance of Corroded ALCOA Tube Specimens

The corrosion resistance of the modified M654 tubing was inferior to that of M654 when tested at temperatures of 350°C and 260°C. Figure 3 illustrates the accelerated corrosion of the cut ends of the tubing at 260°C and the better corrosion resistance obtained at 350°C.

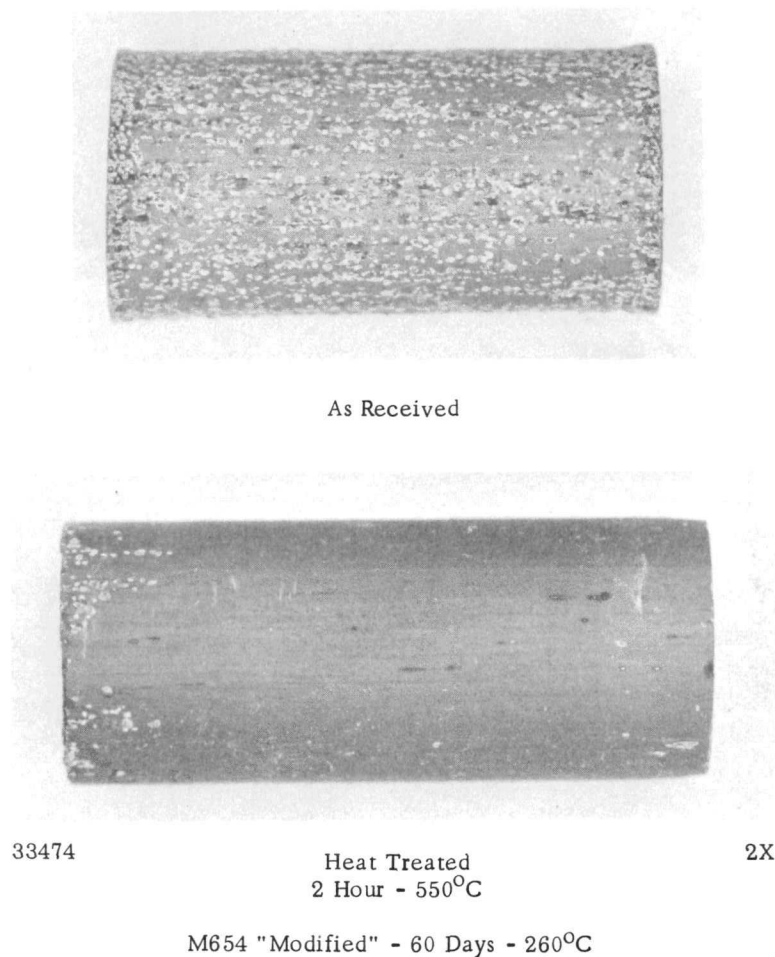
Figure 4. Beneficial Effect of Pre-corrosion Heat Treatment

It was assumed that the corrosion penetration at the ends was along unbonded longitudinal areas resulting from oxide stringers, hydrogen-filled voids, and extrusion nonbonds. To ameliorate this condition, a few specimens of the modified M654 were vacuum heat treated for 2 hr at 550°C before corrosion testing at 260°C, and compared with "as received" controls in the same autoclave. That this provided a beneficial effect is evident in Figure 4. At the end of 60 days at 260°C, the heat-treated specimen showed only a very slight tendency for swelling on one end, while the end "belling" is quite apparent on the "as received" control. A large fraction of the surface blistering was also eliminated by this treatment.

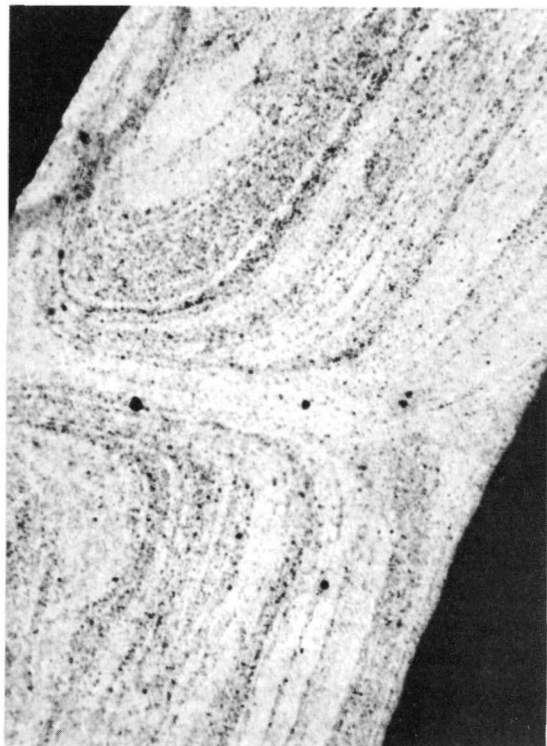
34841

Tubing for corrosion testing in water at 290°C was prepared from four types of powder. Metallographic examination of the as-received tubing indicated widespread porosity and numerous chunky inclusions. Metal flow lines were visible in the material from 72-hr and 48-hr ball-milled powder in the as-polished condition and became very pronounced on etching (see Figure 5). The as-atomized tubing mostly showed porosity and evidence of short-range longitudinal stringering.

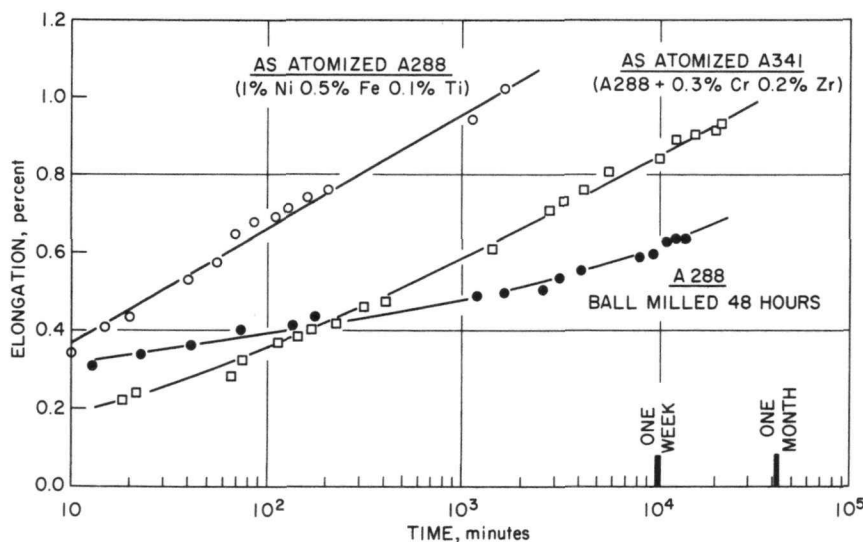
Figure 6. Creep of Aluminum Powder-product Tubing at 2.8 kg/mm^2 and 290°C

time (see Figure 6). Extrapolating the plots to 1% creep gave times of 1 day for as-atomized A288 tubing, 30 days for as-atomized A341 tubing, and about 10,000 days for a tube manufactured from powder that was ball milled 48 hr. The time of the creep test (~2 weeks) was too short to have any confidence in the last value, but the numbers serve to illustrate the improvement. A piece of wrought alloy (A288 type) was observed to creep 5% in less than one hour under these conditions.

Relatively short creep tests have been performed on three powder tubes at 290°C and 2.8 kg/mm². These conditions of temperature and stress were chosen as representative for a tube in an EBWR-type reactor. The creep curves appear roughly linear when the strain is plotted against log

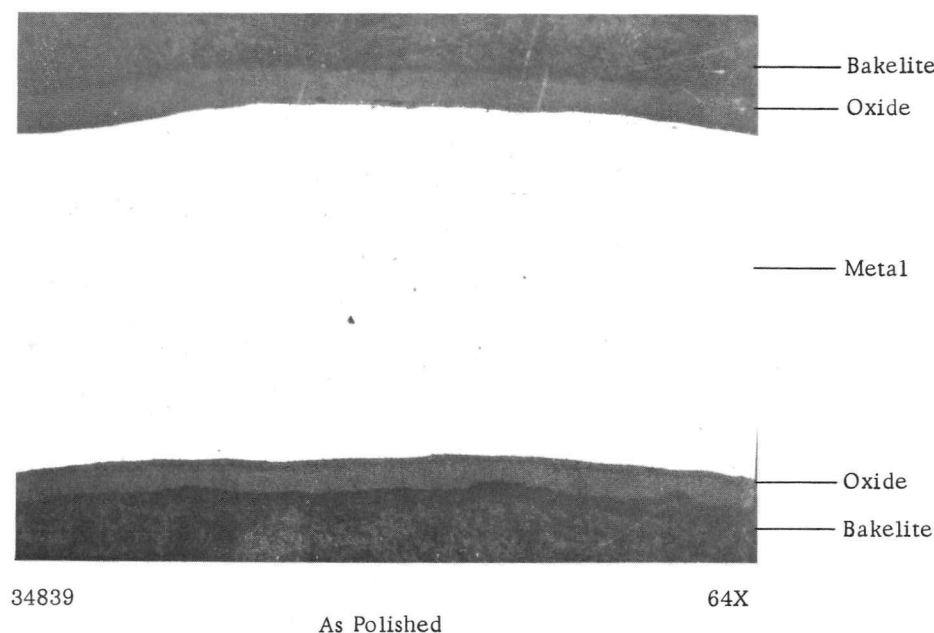
Figure 7. General Corrosion of 48-hr Ball-milled Powder-product Tube after 8 Mo in Water at 290°C

Some samples had still appeared to be free from accelerated corrosion attack, but sectioning of some of these "good" specimens showed internal defects in each. For example, most of the cross section of the 48-hr ball-milled sample was uniformly corroded, as in Figure 7, but at several spots corrosion penetration of the entire thickness was noted, as in Figure 8. By means of the metal flow lines these spots were identified on etching as the bond area between the joined metal streams emerging from the bridge die. All of the tubing types made by ARF exhibited these flaws, although typically only one or two of the bond areas would be attacked out of four possible zones.

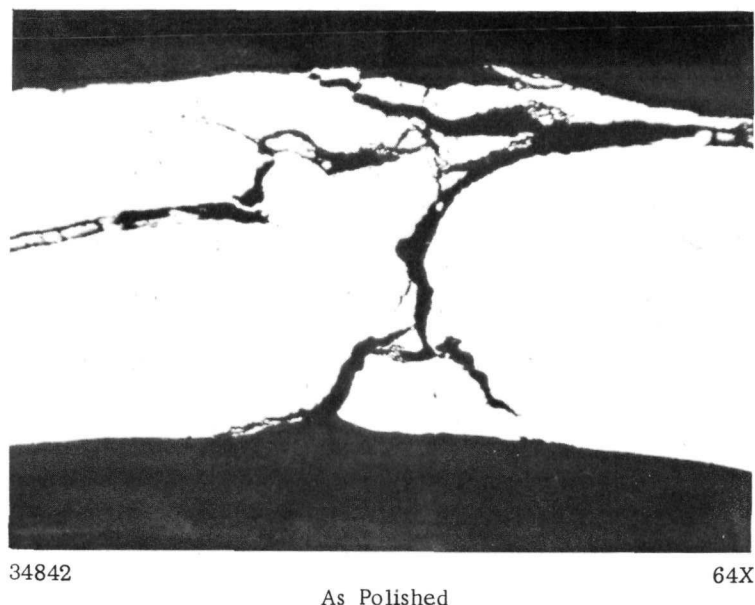
Figure 8. Localized Corrosion of 48-hr Ball-milled Powder-product Tube after 8 Mo in Water at 290°C

With this in mind, the few 10-mo survivors were gently compressed laterally with pliers. As expected, all cracked in a brittle fashion in at least one longitudinal area where the metal had been completely penetrated. The attack was quite insidious, since there was practically no external evidence of the severe oxidation.

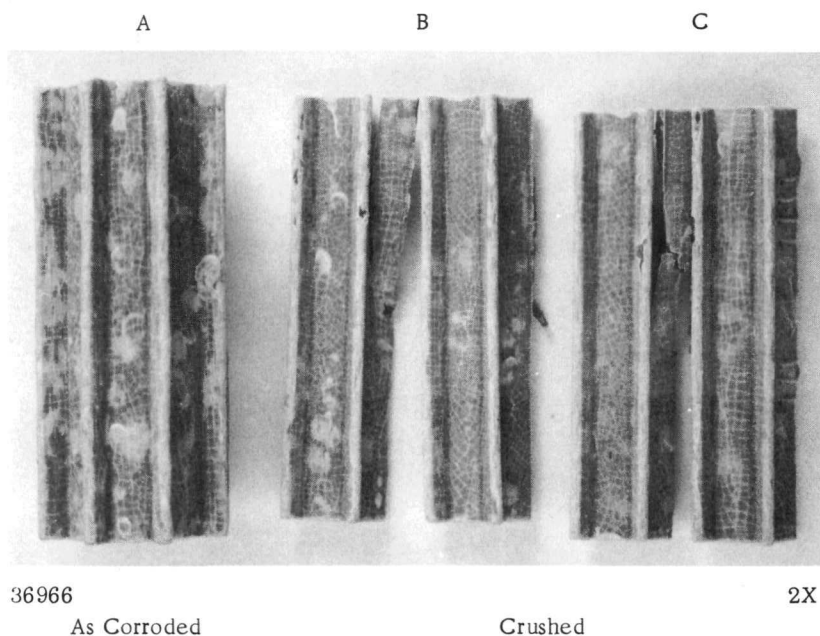
Figure 9. Appearance of Tubing, Extruded by Torrance Brass,
after 515 Days in 290°C Water

Torrance Brass Company: Some additional A288 as-atomized, finned tubing was directly extruded over a mandrel from billets supplied by ARF. This material was of about the same corrosion resistance as the as-atomized A288 tubing extruded through the bridge die by ARF and showed the same improvement with vacuum heat treatment. This suggests that a significant portion of the corrosion resistance of the final product is determined in the steps prior to final extrusion. Figure 9A illustrates the appearance of a vacuum heat-treated specimen after 515 days in water at 290°C. Figures 9B and C show the brittle fracture of a similar tube when compressed laterally with ordinary pliers. Essentially all of the metal had been converted to oxide.

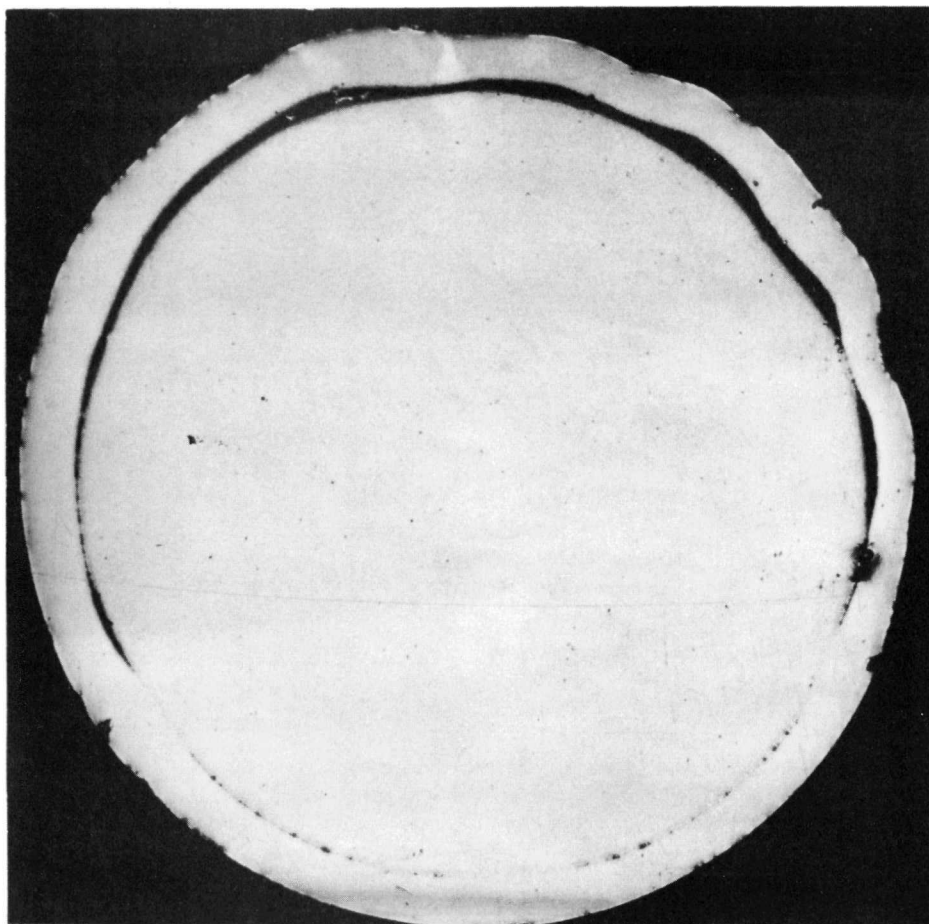
Figure 10. Section through a Failed End Closure

Exposed 7 Days to 290°C Water

A short (7 days) corrosion test of several of these sealed tubes in 290°C water quickly showed that this bond, although initially helium leak free, had an unsatisfactory resistance to corrosion penetration (see Figure 10). The bulges in the circumference of the sample shown in Figure 10 were larger hollow blisters before the sample was subjected to Bakelite mounting pressures. Although not shown in this figure, some joint areas did exhibit good corrosion resistance. Metallographic examination indicated that these spots had a relatively better bond between the tube and plug than the other areas with poorer corrosion resistance (see Figures 11 and 12).

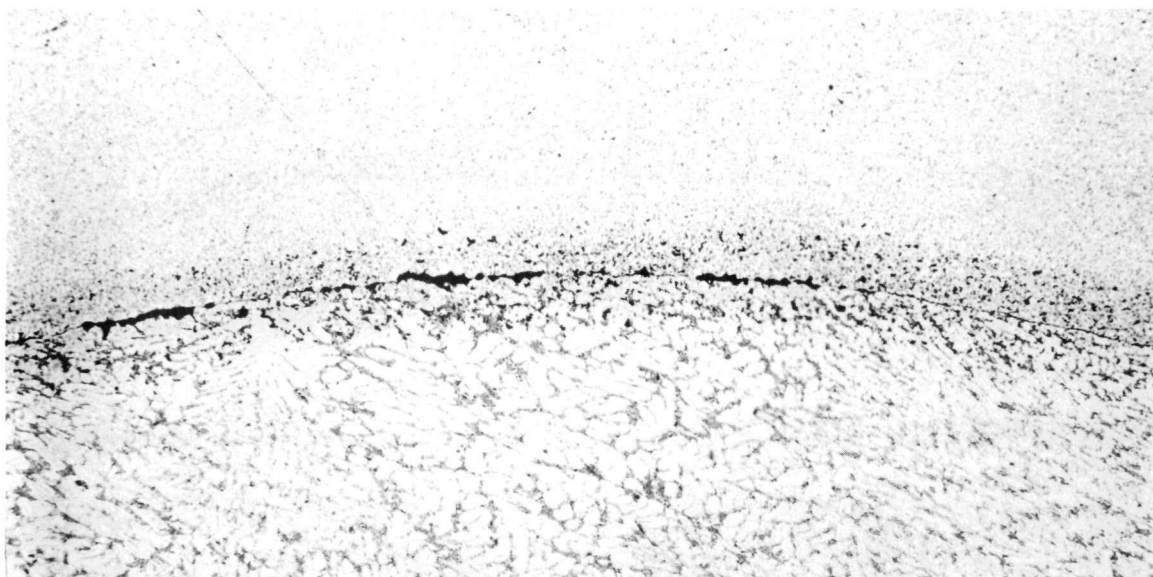
Figure 11. Bond Area of Failed Closure

Etched
290°C - 7 Days

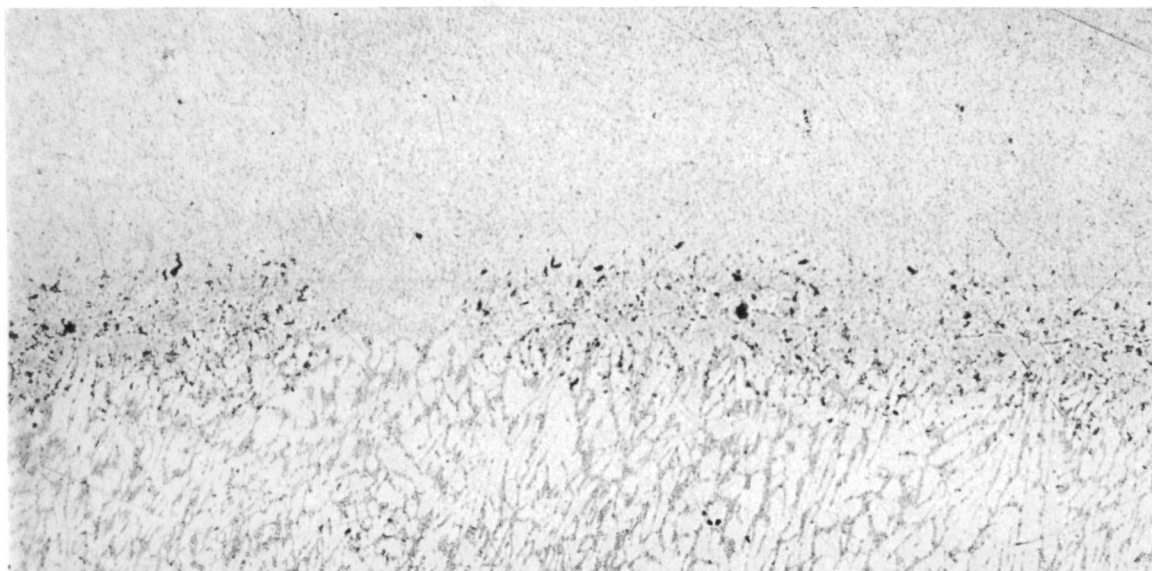
Figure 12. Bond Area of "Good" Closure

Etched
290°C - 7 Days

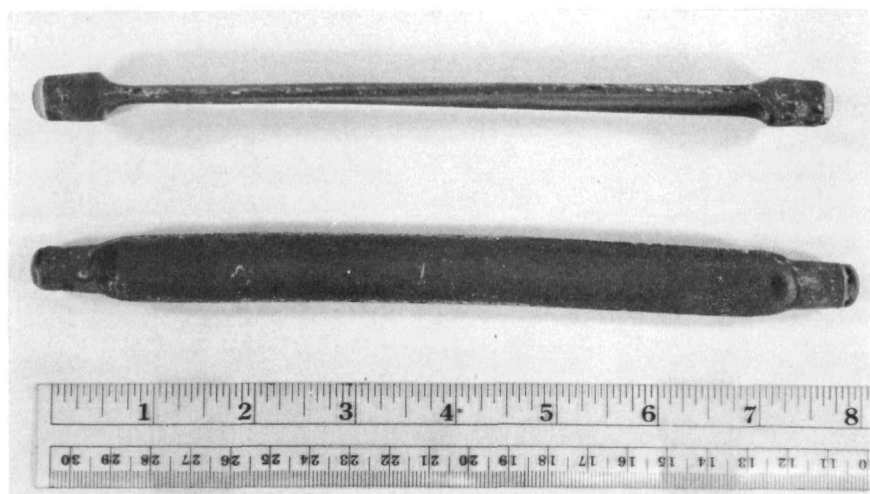
37069

F. McCuaig of the ANL Coatings and Jacketing Group then used a "motor arc" electric welder to fusion weld the entire end of some of the tubes bonded by AI. The additional welding process greatly increased the resistance to corrosion penetration. For example, five tubes treated in this fashion were tested for a total of 292 days in 290°C water and showed none of the usual visual indications of bond failure (see Figure 13). Transverse sections of several bonded tube ends also indicated no corrosion penetration. Some of the heavy corrosion product flaked off the outside of the tube ends after long exposure, but these relatively bare spots were not attacked on subsequent exposure.

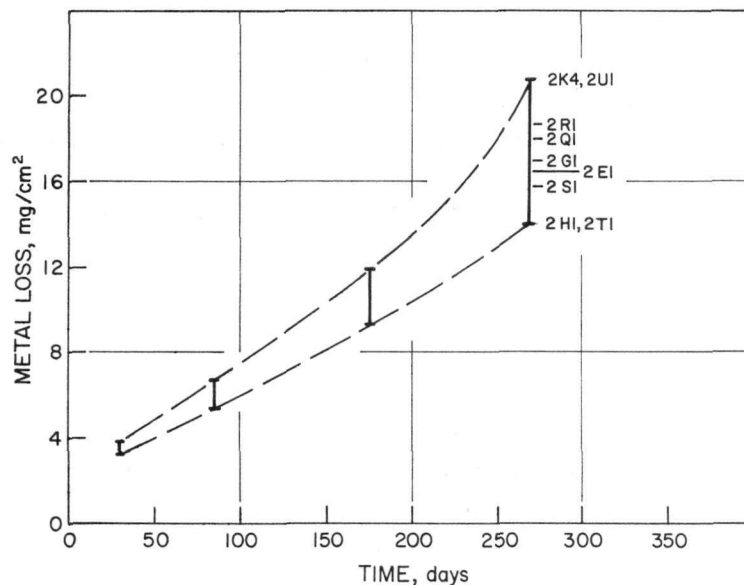
Figure 14. Corrosion of Experimental Rod Extrusions (ARF) in 290°C Water

Armour Research Foundation: During the course of the ARF contract many small (0.32-cm-OD) rods were extruded for evaluation of mechanical properties. A smaller number of the promising extrusions were also corrosion tested in 290°C water for extended periods. The pertinent fabrication and mechanical properties data as reported by ARF are shown in Table IV with a generalized corrosion evaluation added in the last column. A graphical representation of the actual corrosion data is given in Figure 14. The spread in values of metal loss of the various extrusions increased as the test progressed. Even for the better extrusions the corrosion rate appeared to increase slightly with prolonged exposure.

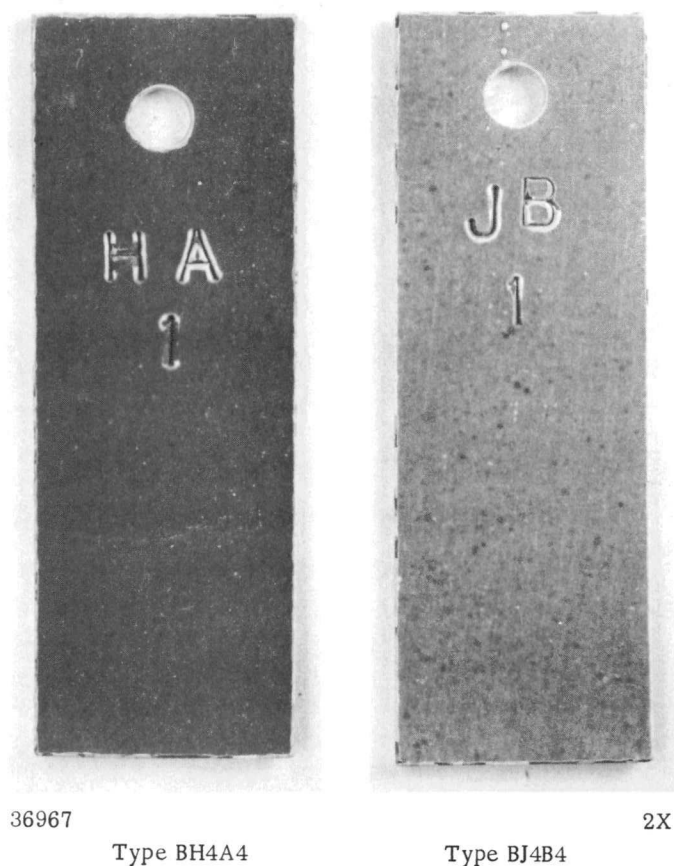
Figure 15. Trefimetaux Corrosion Specimens after 293-day Exposure to 290°C Water (Static)

The products were exposed to static 290°C water for 293 days. Both extrusions and thin-sheet samples hot rolled from them were tested. The sheets were used to approximate the sample surface-to-volume ratio of tubing specimens. All demonstrated very satisfactory corrosion resistance, although minor defects, such as small oxide-filled protuberances, were observed (see Figure 15). The M and H series of as-extruded rod specimens developed a saw-tooth attack on one edge of the rectangular cross-section extrusion when first exposed. This did not continue to develop with increasing time and may have been related to poor lubrication of the extrusion die at that point, with resultant defects.

Small blisters and minor surface eruptions were noted on the thin-sheet specimens. Dark specks in the eruptions, with a brown-red stain around the spot, suggested that these were the results of iron inclusions in the aluminum. No edge swelling due to corrosion was noted, but on the G and M series a number of slightly raised ridges of oxide ran from one edge of the specimen to the other, parallel to the rolling direction. Attempts to identify the source of the ridges were inconclusive, and they all but disappeared with continued corrosion exposure.

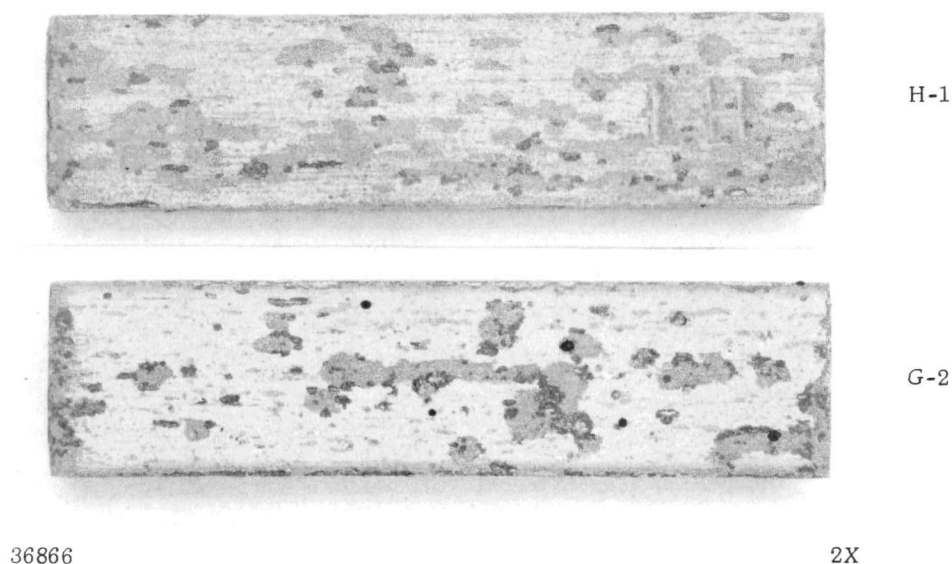
Figure 16. Trefimetaux Corrosion Specimens after 89 Days
in 315°C Water Flowing at 5.5 m/second

After 89 days of exposure portions of the outer layers of oxide tended to flake off as the sample dried, giving the appearance shown in Figure 16. The black cones previously described are particularly noticeable on the lower sample (G2).

Unfortunately, the dynamic corrosion behavior at 315°C (with water flowing at 5.5 m/sec) was not as satisfactory. Cones of a hard, very dark corrosion product (up to 1 mm in diameter and height) were formed on the surface of some of the specimens in as little as 30 days. The number and size of these cones increased in the order: H extrusion samples (lowest); M (intermediate); and G (most and largest). Disproportionately small pits were located under some cones; under others there were none. X-ray analysis of the cones was confused by the large number of lines obtained even after those for boehmite, the normal aluminum corrosion product, were deleted.

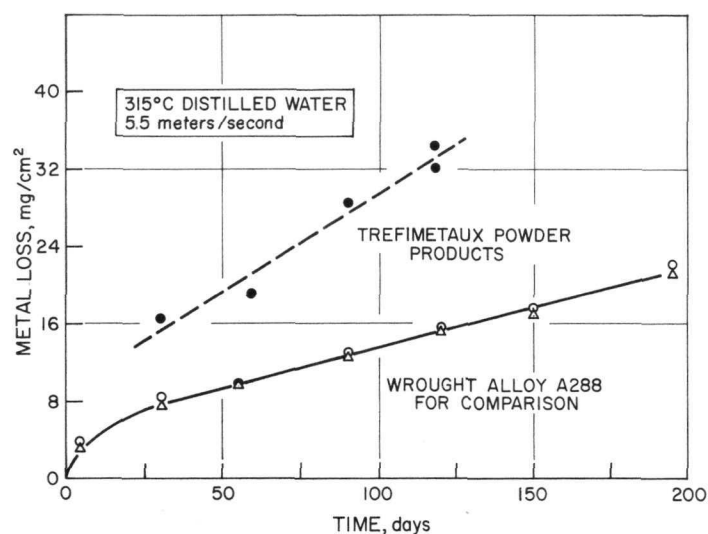
Figure 17. Corrosion of Trefimetaux Specimens
in Flowing Water

The metal-loss data were limited by the small number of specimens available. The corrosion of these specimens is compared with that of one of the better wrought alloys (measured in the same equipment) in Figure 17. These powder products appear to suffer considerably more corrosive attack in this environment than does the wrought alloy.
