CHARACTERIZATION OF IRRADIATED FUEL RODS
USING PULSED EDDY CURRENT TECHNIQUES*

M. R. Martin and W. C. Francis

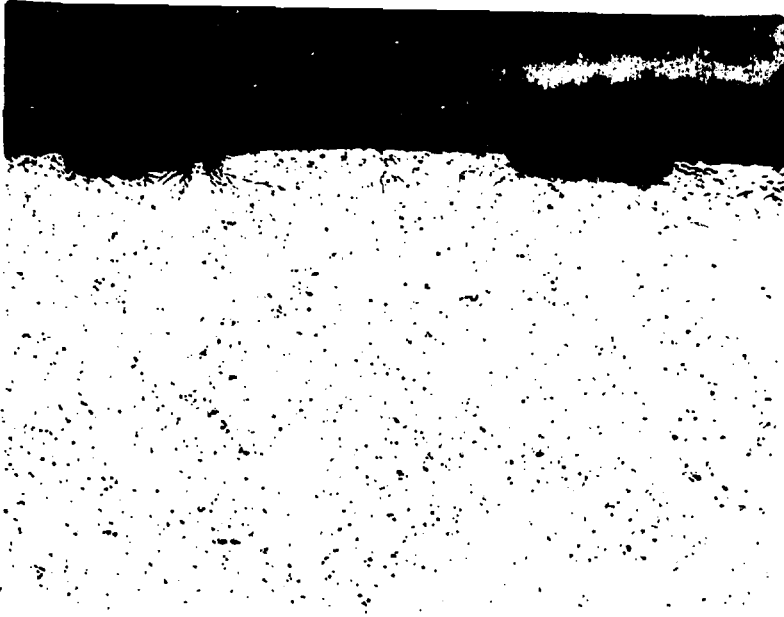
Neg. No. 75B-13

Examination of the metallography specimens revealed only the former phenomena; no cracking was found in any of the areas examined. The wear marks caused by the spacer grids were comparatively easily located, both on the pseudo-maps and in the metallography specimens. A double set of wear marks is shown in Figure 8. This set and similar observations on other rods are shallow (0.00050 to 0.00075 in. deep), fairly broad (0.005 to 0.006 in.), and flat bottomed. The comparatively

Figure 8 - Double-set of spacer grid wear
marks found on water tube Std. 50
at 200° in metallography mount M-3.
As-polished 200X

large indications on the PEC scans are thought to be the result of the width of the "defect", rather than the depth as with a crack or scratch.

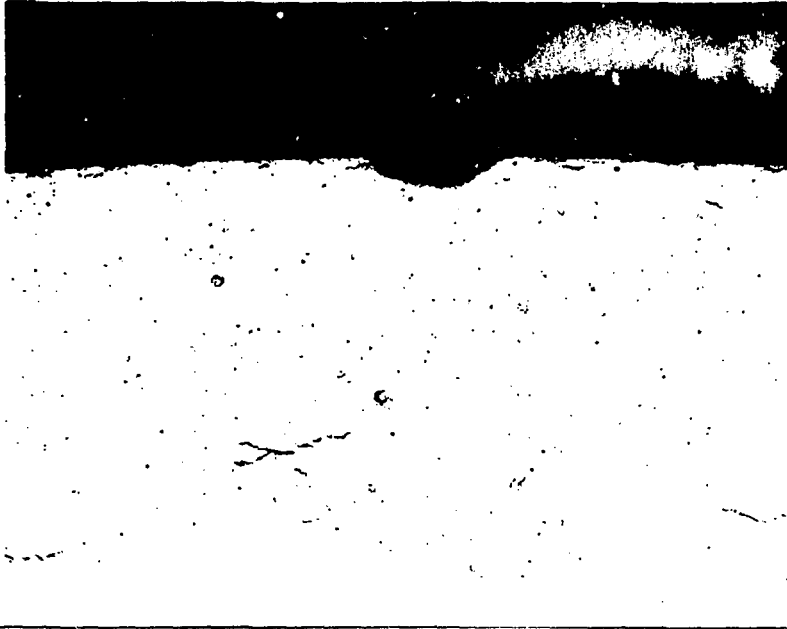
Neg. No. 75B-30

Other "defects" which were located metallographically are shown in Figures 9-11. Figure 9 shows a section through a longitudinally oriented groove on the rod OD, approximately 0.004 in. wide by 0.001 in. deep. Figures 10 and 11 illustrate two conditions not normally identified as defects, but which caused a "defect" indication in the PEC system. Neither condition was common, and the majority of the defects examined were of the types shown in Figures 8 and 9, or surface "scuffing" which resulted in very broad but very shallow deformation. Figure 10 shows very minor surface irregularities (too small to be detectable) overlaid with a 0.0035 in. layer of hydride concentration. Figure 11 shows a 0.0025 in. thick layer of adherent corrosion products which caused a momentary lift-off of the PEC sensing coils and resulted in a "defect" signal on the output recorder. Isolated buildups like this one were rare because the rods and tubes had been "decruded" prior to the PEC examination. The type of "defect" indication produced by these buildups is generally identifiable and distinguishable from the type of indication produced by cracks, scratches, etc. "Defect" signals are produced on both the OD and ID channels, with that of the OD channel being somewhat larger, and the indications show limited axial length as opposed to individual spikes for more conventional defects.

Figure 9 - Longitudinally-oriented groove found
on the OD surface of fuel rod 837.
As-polished 200X
