UCRL-51919

THE EFFECT OF STRESS ON THE MICROSTRUCTURE OF A GRAYWACKE SANDSTONE FROM THE SITE OF THE RIO BLANCO GAS-STIMULATION EXPERIMENT

L. A. Dengler

September 30, 1975

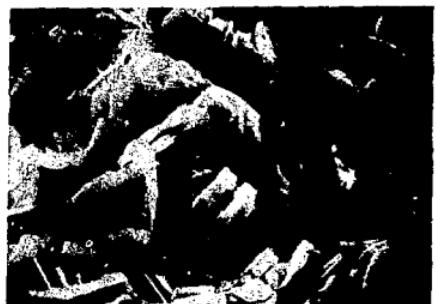
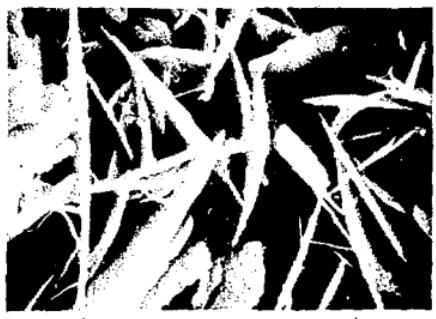
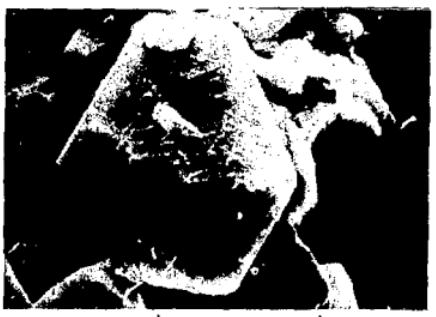
Fig. 6. High-magnification photomicrographs showing some of the crystal forms seen in the matrix of unstressed rock (ultrasonically cleaned specimen).

is caused by a "hairy" coat of clay and cement (Fig. 4). In some cases, as shown in Fig. 5, the clay minerals appear to be emerging out of the grain surface. At high magnification, the intricacies of matrix and pore structure can be observed with the SEM. Figure 6 shows some of the crystal forms making up the matrix,

crystals in this figure). The delicate structure of these crystals indicates that specimen preparation has left this area undisturbed. The porosity can be seen in the void spaces around and between the cement structure. The "average" pore is angular in shape and less than 10 μm in width (Fig. 8). The measured low gas permeability⁹ of the sandstone is probably caused by the small average pore size and the sinuosity of the pore network.

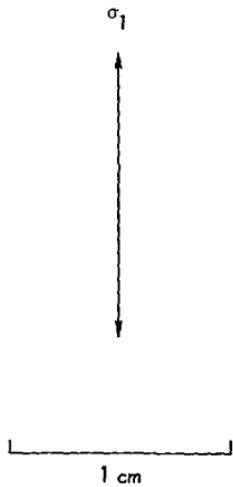
Fig. 14. Axial sections from three uniaxially stressed samples (photographed with doubly polarized light). Each photomicrograph is of a longitudinal plane, parallel to the axis of maximum principal stress (σ_1). (a) RB 7, 0.1 MPa confining pressure. Brittle behavior: note the well-defined fault zone; failure occurred mainly at grain boundaries, with the bulk of the sample appearing undisturbed. Compare with unstressed rock in Fig. 14d. (b) RB 8, 100 MPa confining pressure. Transitional behavior: note the shear zone and barreling of the sample; transgranular failure is predominant on the shear zone and is seen occasionally throughout the sample.

Fig. 14 (continued). (c) RB 12, 600 MPa confining pressure. Ductile behavior: note the poorly defined shear zone, barreling of the sample, and frequent occurrence of transgranular fracture throughout the sample. (d) Unstressed rock.

show failure occurring predominantly at grain boundaries (Fig. 14a). The few transgranular fractures that were seen were restricted to the immediate zone of failure. Away from this zone the sample appears indistinguishable from the unstressed rock (Fig. 14d).

The transitional samples were barreled (this can be seen in the slight curvature of the cylinder outline in Fig. 14b, differing from the straight cylinder profile of Fig. 14a). As in the brittle regime, the cylinders were separated into two pieces by throughgoing shear fractures. The mode of failure differed from the brittle mode by a predominant occurrence of transgranular fracture

The only sample studied that failed in the ductile regime (RB 12, tested at 600 MPa confining pressure) was macroscopically barreled and wholly intact (no well-defined shear zone truncating the sample). The optical section (Fig. 14c) shows
