ORNL-2685  
C-84 - Reactors-Special  
Features of Aircraft Reactors

ANP MATERIALS MEETING

NOVEMBER 16-18, 1954

METALLURGY DIVISION

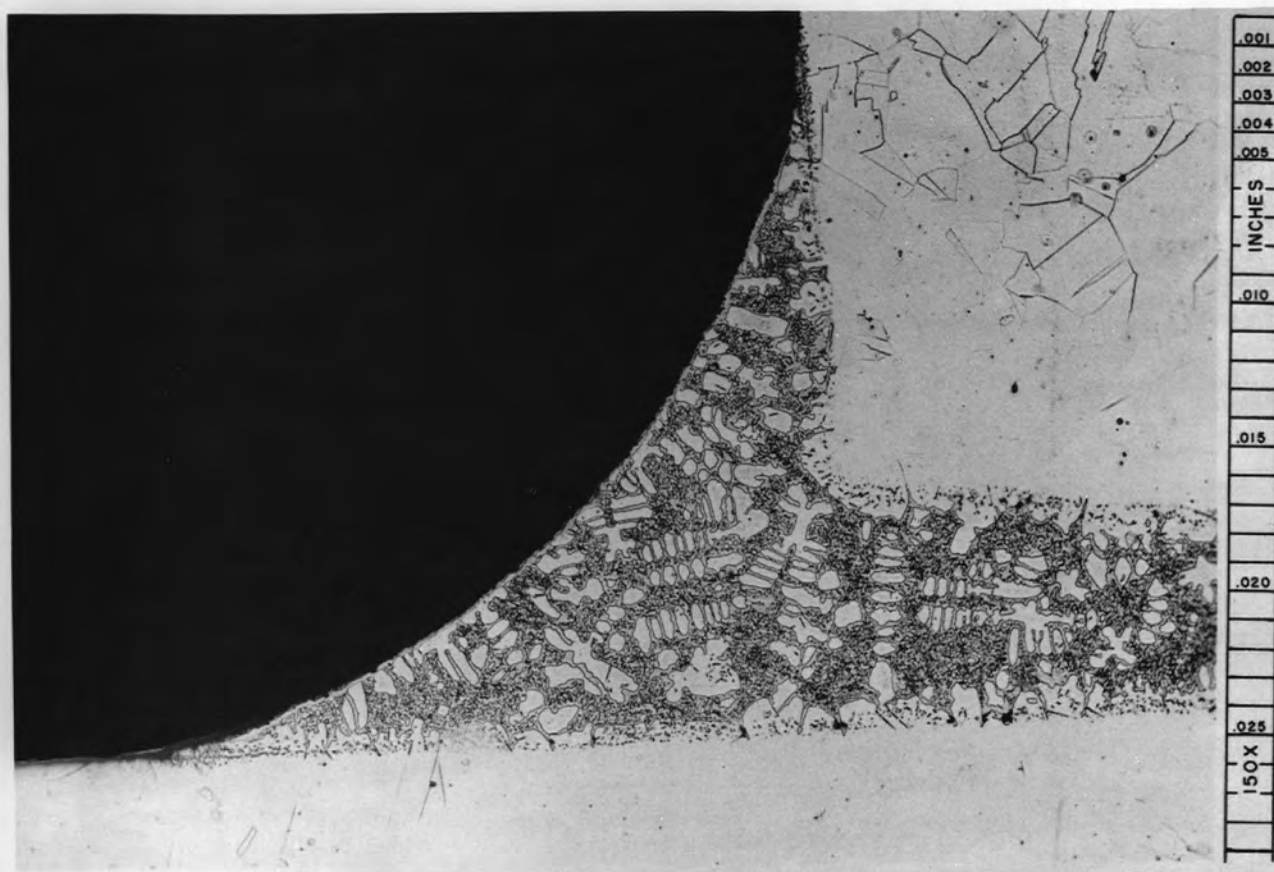
Fig. 24 (Y-13066) Inconel "T" Specimen Assembled with General Electric 62 Braze Alloy and Exposed to Static Na for 100 Hr. 150X. Unclassified.

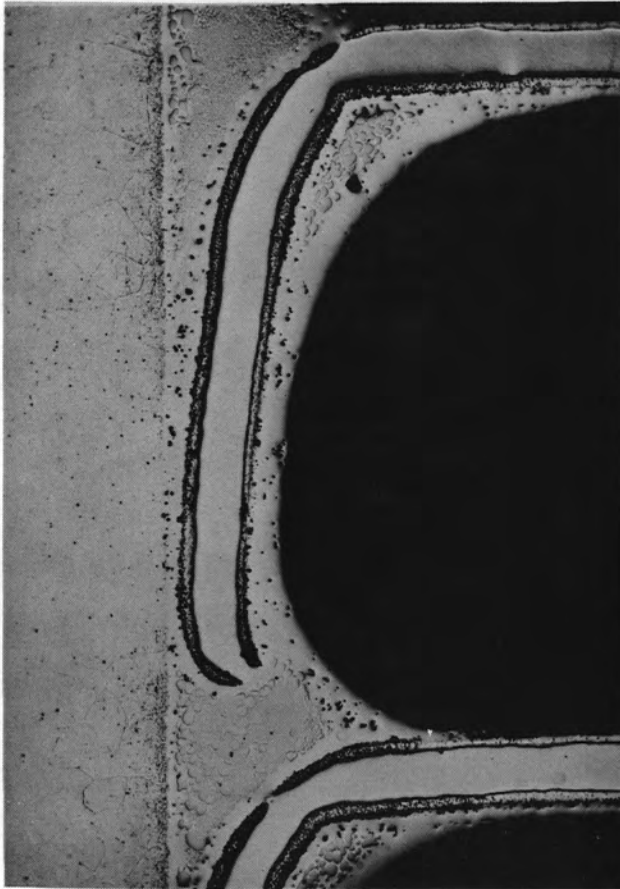
**Fig. 29** (Y-12605) Type 430 Stainless Steel-Clad Copper Brazed with Coats Metals 52 and Exposed to Static Air at 1500°F for 400 Hr. 50X.  
Unclassified.

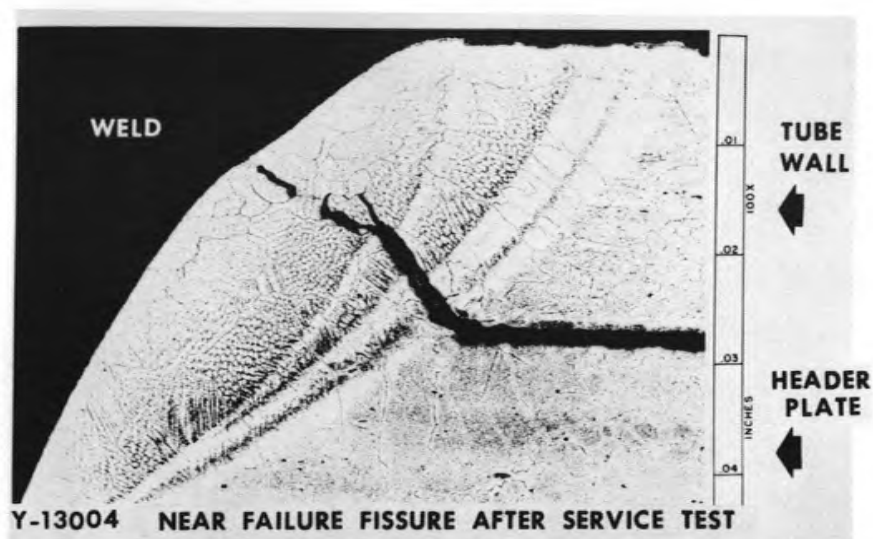
Fig. 34 (Y-13230) Propagation of Fissures in Tube-to-Header Welds of the Heat Exchanger of Fig. 31.

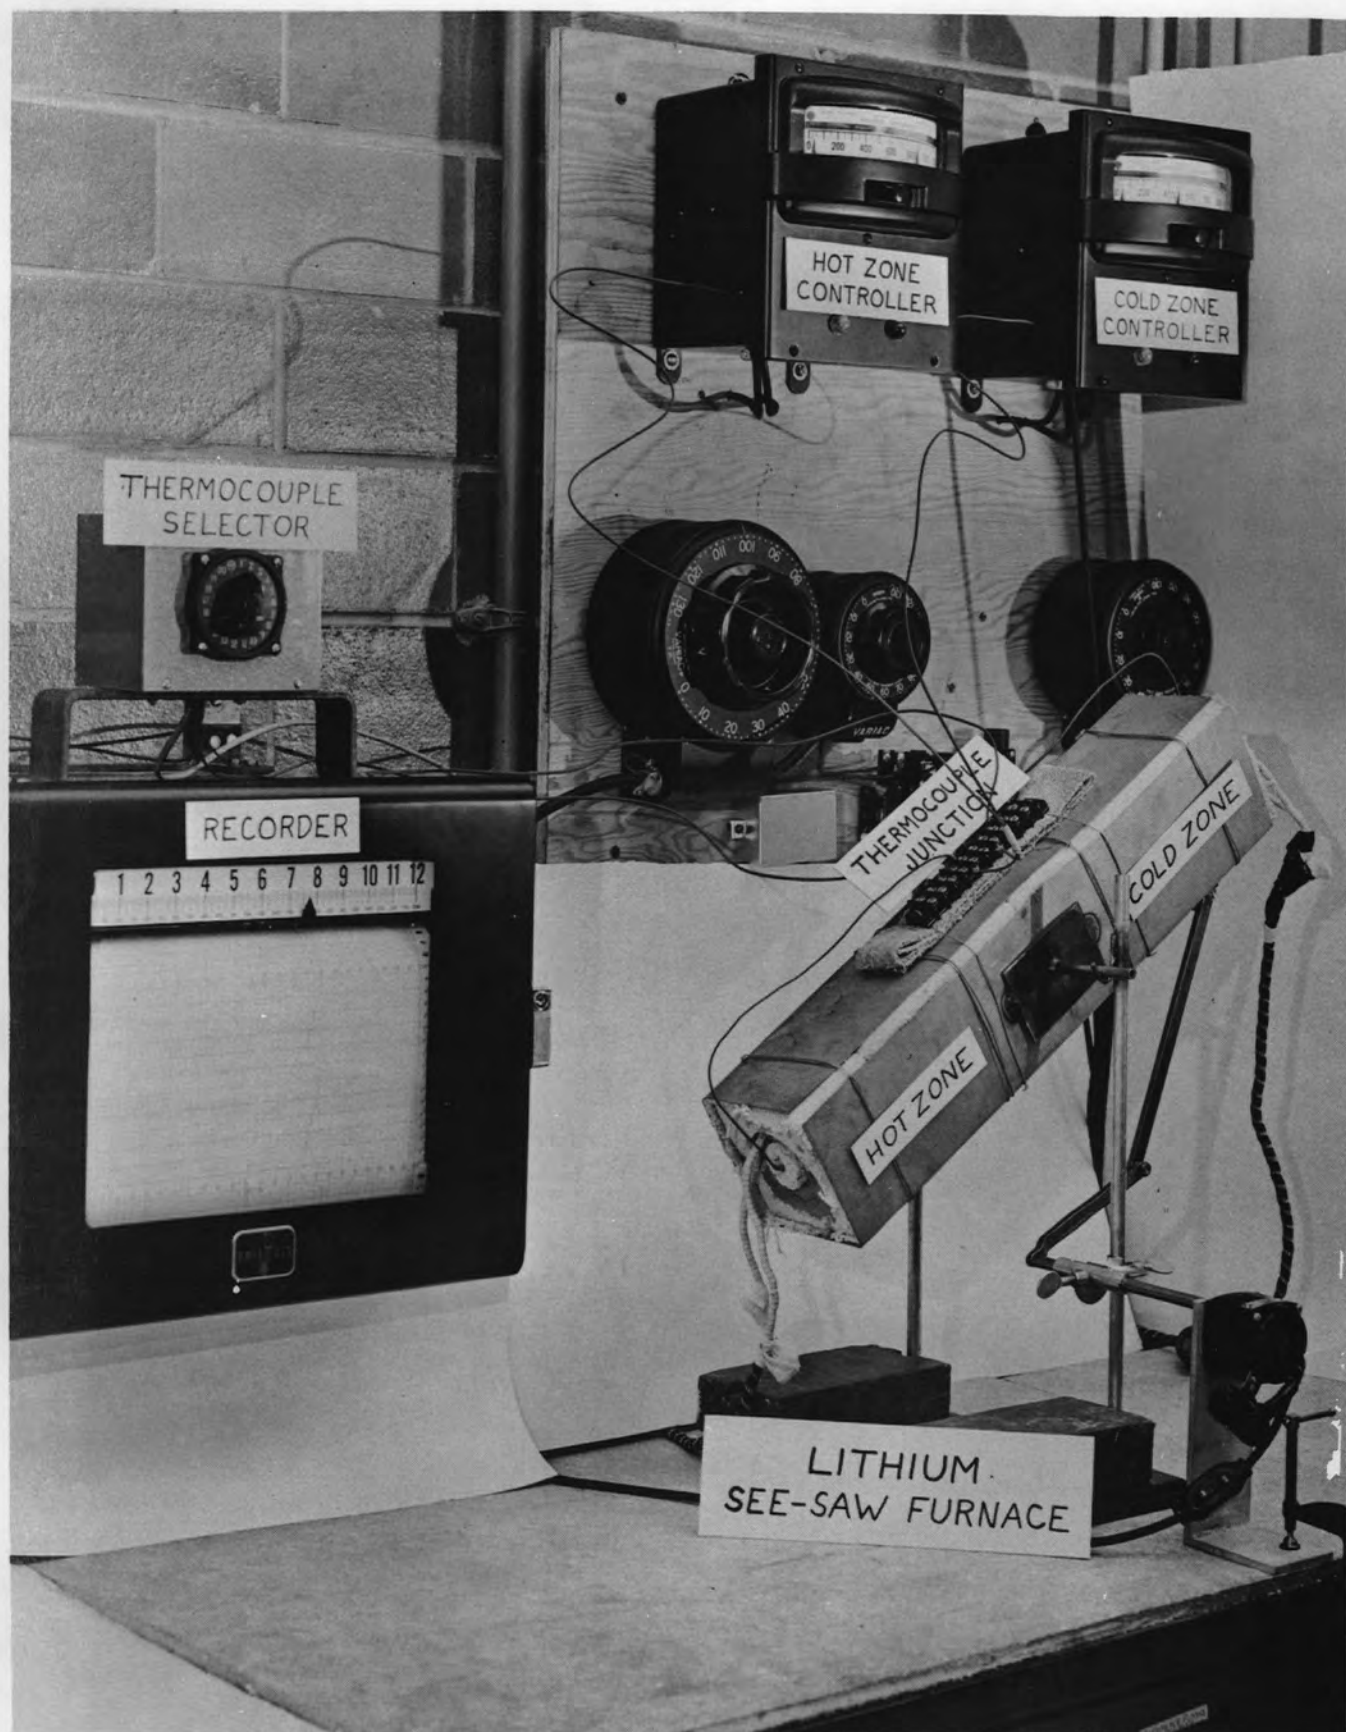
Fig. 46 (Y-9782) Lithium See-Saw Furnace. Unclassified.

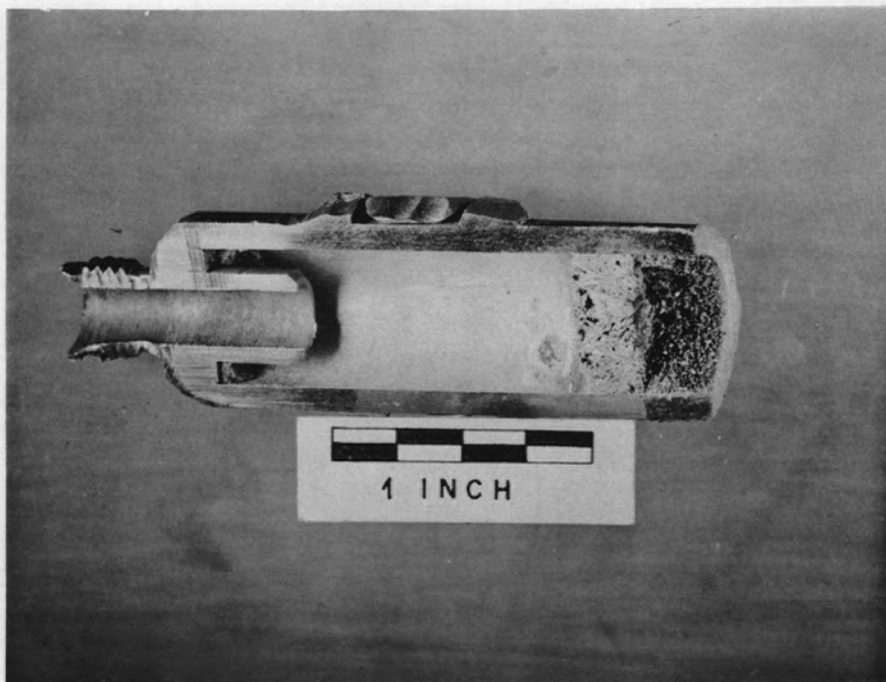
**Fig. 86** (T-5211) Layer of Chromium Crystals Found in the Trap of an Inconel Loop after Circulating Fused Fluorides for 5000 Hr at 1500°F. Unclassified - ~~Secret~~ with caption.

Even with the expected increased attack in the pump loops, the item of most concern is not the depth of attack in the hot leg but what happens to the deposited metal in the cold leg. In the proposed reactors, the heat exchangers will consist of a large number of small-diameter tubes which will be very easy to plug. A layer of chromium-metal crystals from a 5000-hr loop is shown in Fig. 86. This layer was found in the trap at the bottom of the cold leg just above a liquid-solid interface. While exact material balances are almost impossible to make, the amount of chromium found in the layer plus the increase in concentration of the fluorides do not appear to be enough to balance that lost in the hot leg. It is thought that some of the chromium attaches itself to the cold-leg surface and diffuses into the metal.
