REMOVAL OF
THE MATERIALS TEST REACTOR
OVERHEAD WORKING RESERVOIR

Aerojet Nuclear Company

IDAHO NATIONAL ENGINEERING LABORATORY

DATE PUBLISHED—OCTOBER 1975

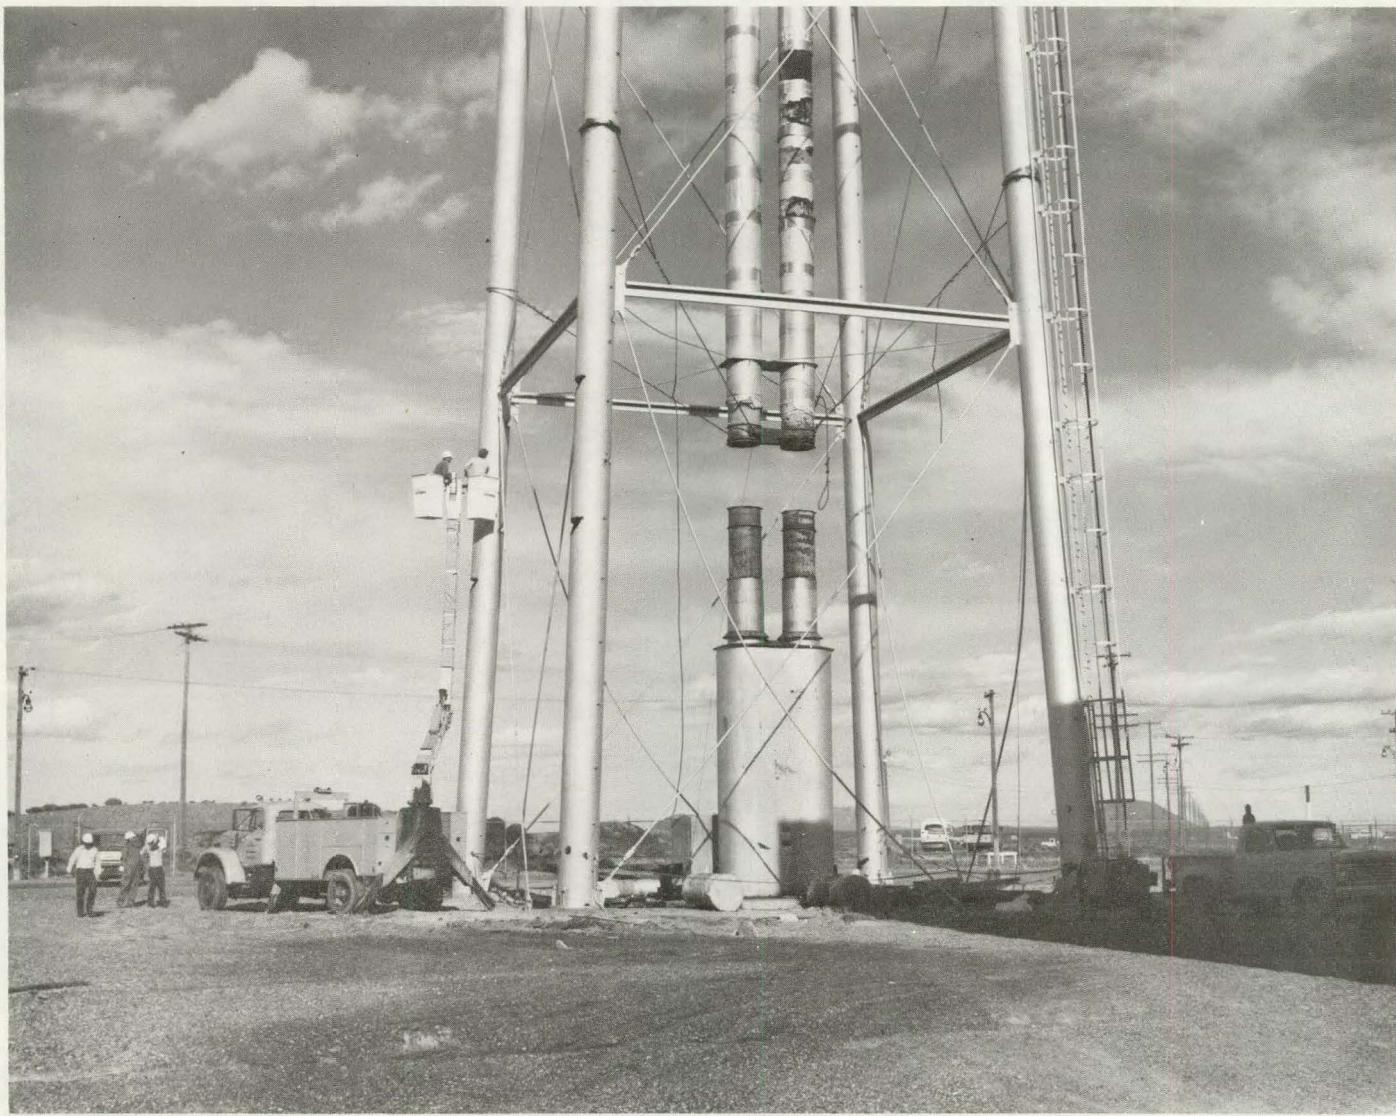
Sections of the inlet, outlet, and overflow pipes and certain structural members were removed to assure proper directional felling of the OWR (see Figure 4). Cuts into the contaminated piping were made with mechanical cutters (Wheiler-Fein milling saw) through urethane foam which was injected between two balloons within the pipe. Torch-cut notches were made in the support legs (see Figure 4) to facilitate utilization of sections of flexible lineal shaped charge (FLSC) explosives (see Figure 5). Redundant charges were provided to assure proper removal of leg sections to control the direction of fall. A total of 47,200 grains of RDX-type explosive was used. The firing of different charges (the highest single

Fig. 4 View of the OWR showing removed sections of the inlet and outlet piping.

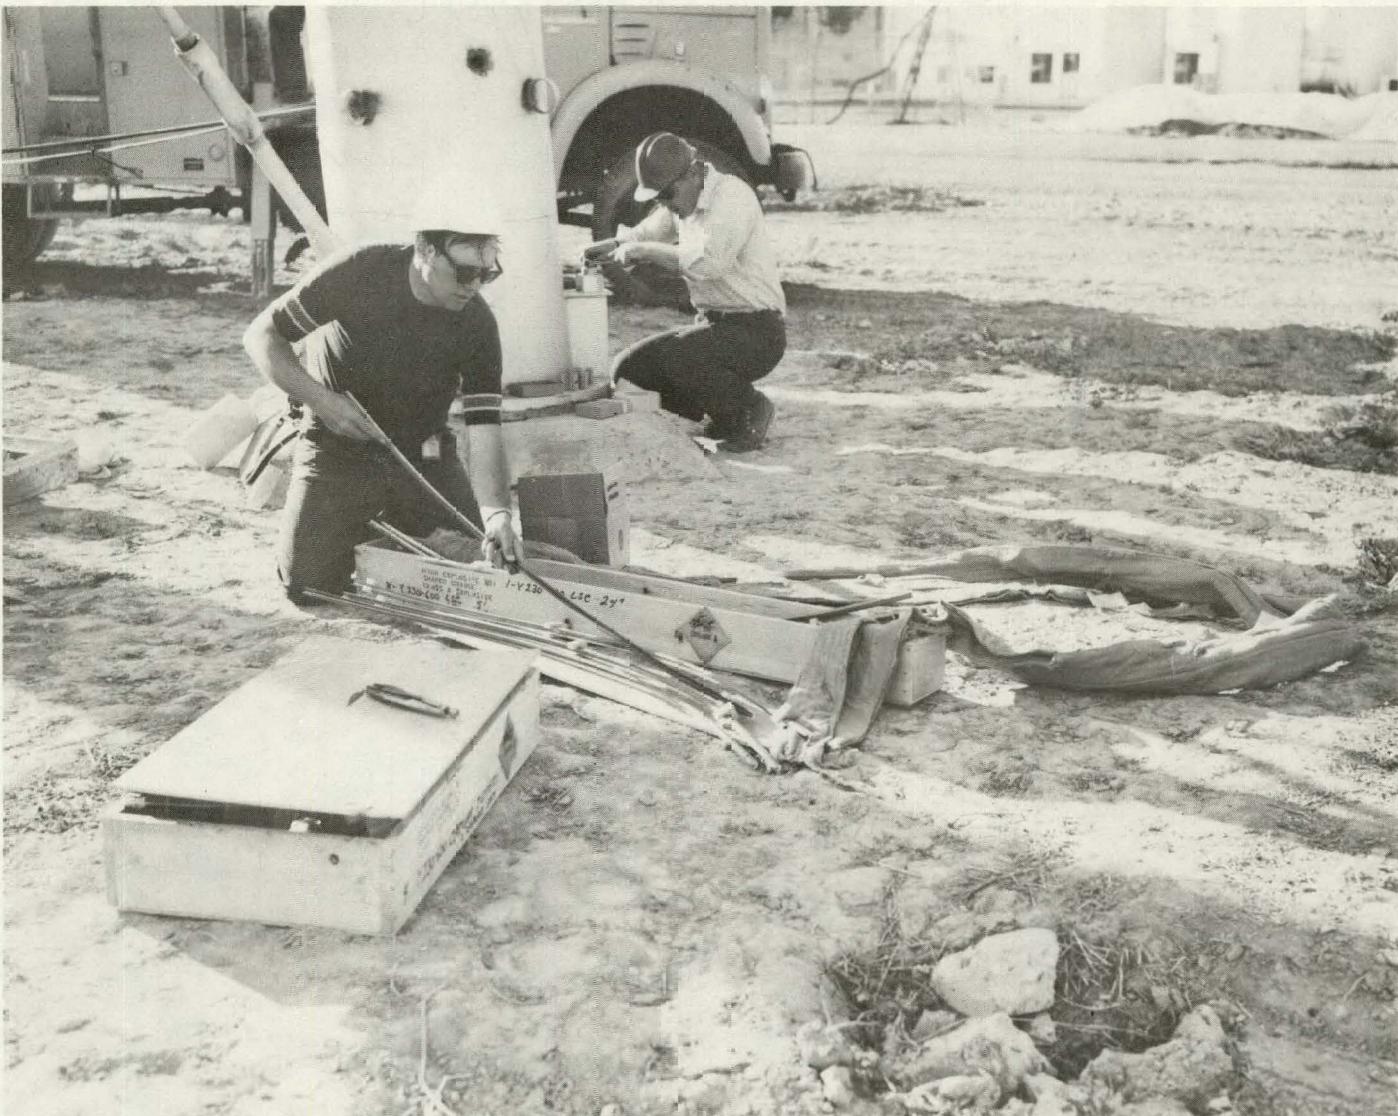
Fig. 5 View of a portion of the flexible lineal shaped charges (FLSC).

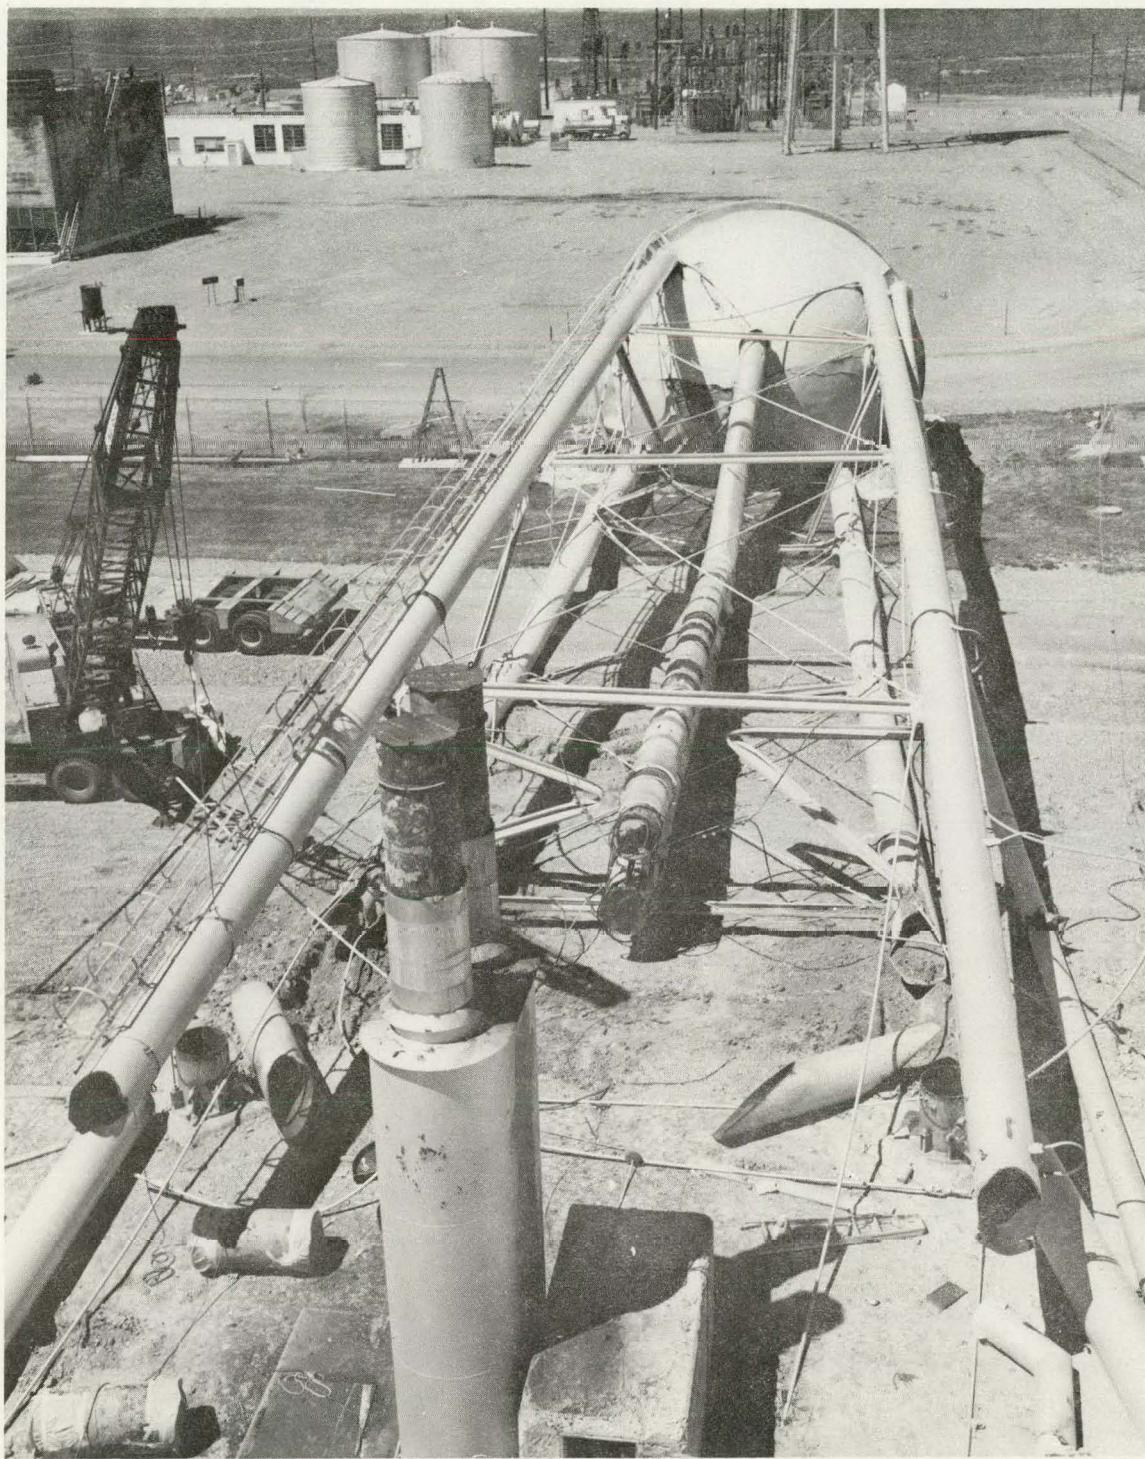
Fig. 7 Overhead view of the OWR on the ground.

charge did not exceed 24,000 grains) were time delayed to reduce air blast effects. The charges were activated at 12:40 a.m. on June 5 (see Figure 6, special effects photograph). The prerelease preparations were successful since the tank impacted the ground at the predetermined location and did not rupture (Figures 7 and 8 provide views of the OWR on the ground prior to dismantling). Monitoring of the area indicated contamination releases were insignificant. Figure 9 shows a view of an FLSC cut in one of the 30-inch-diameter legs. (Note the coarseness of the preparatory notching flame cut as compared to the smoothness of the FLSC cut.)

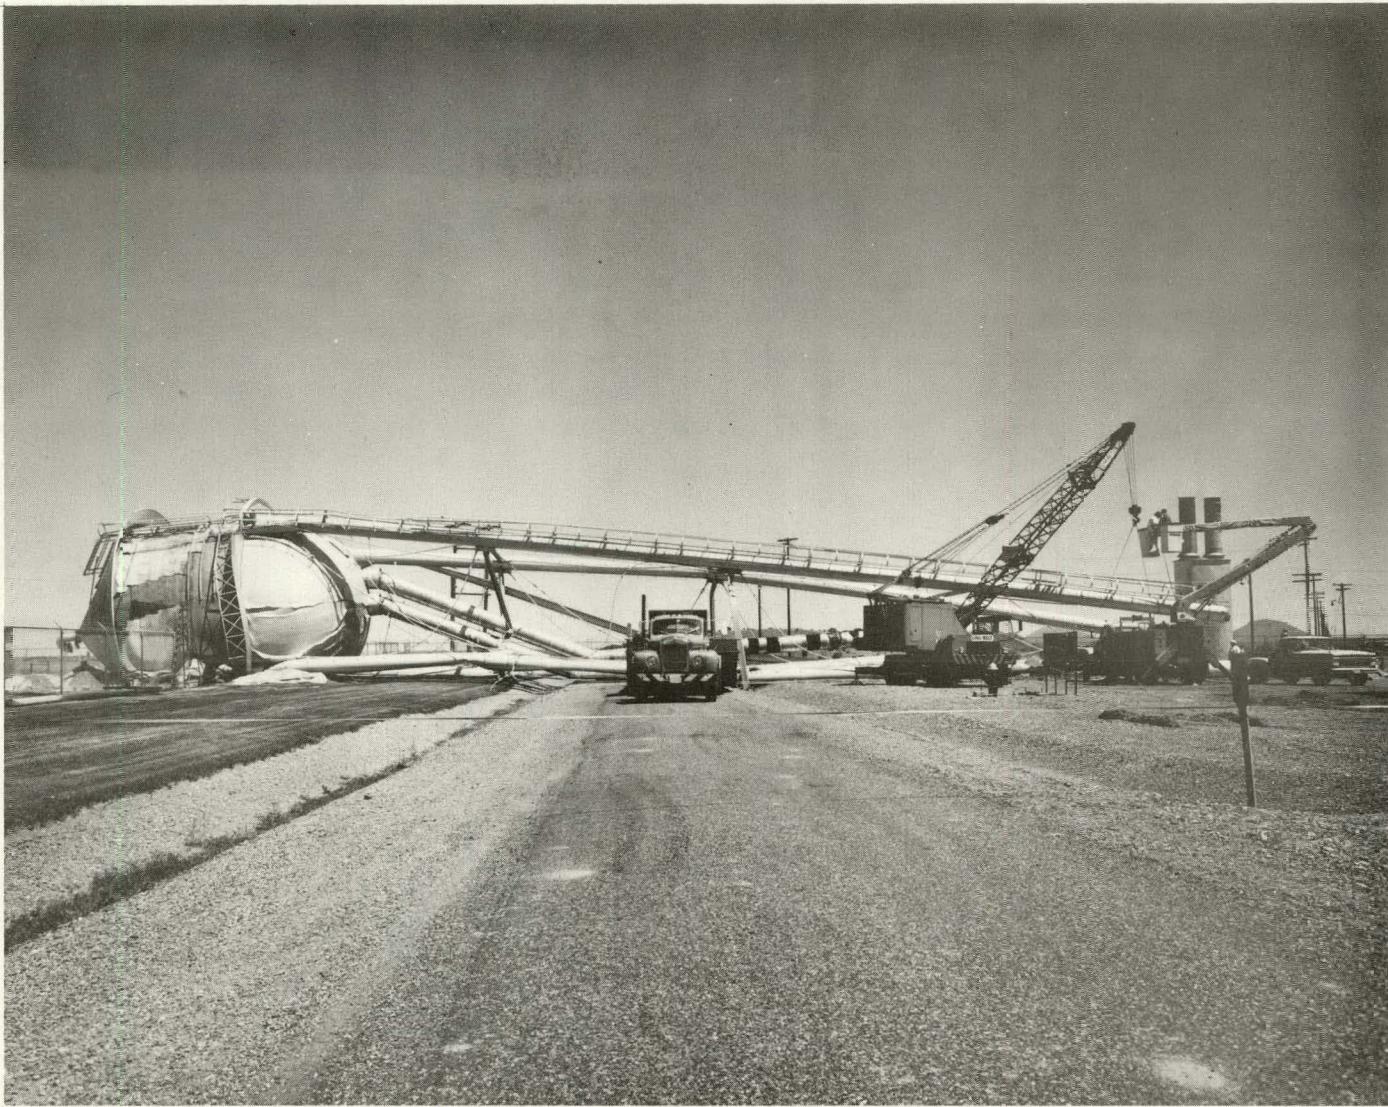
Fig. 8 View of the OWR on the ground.

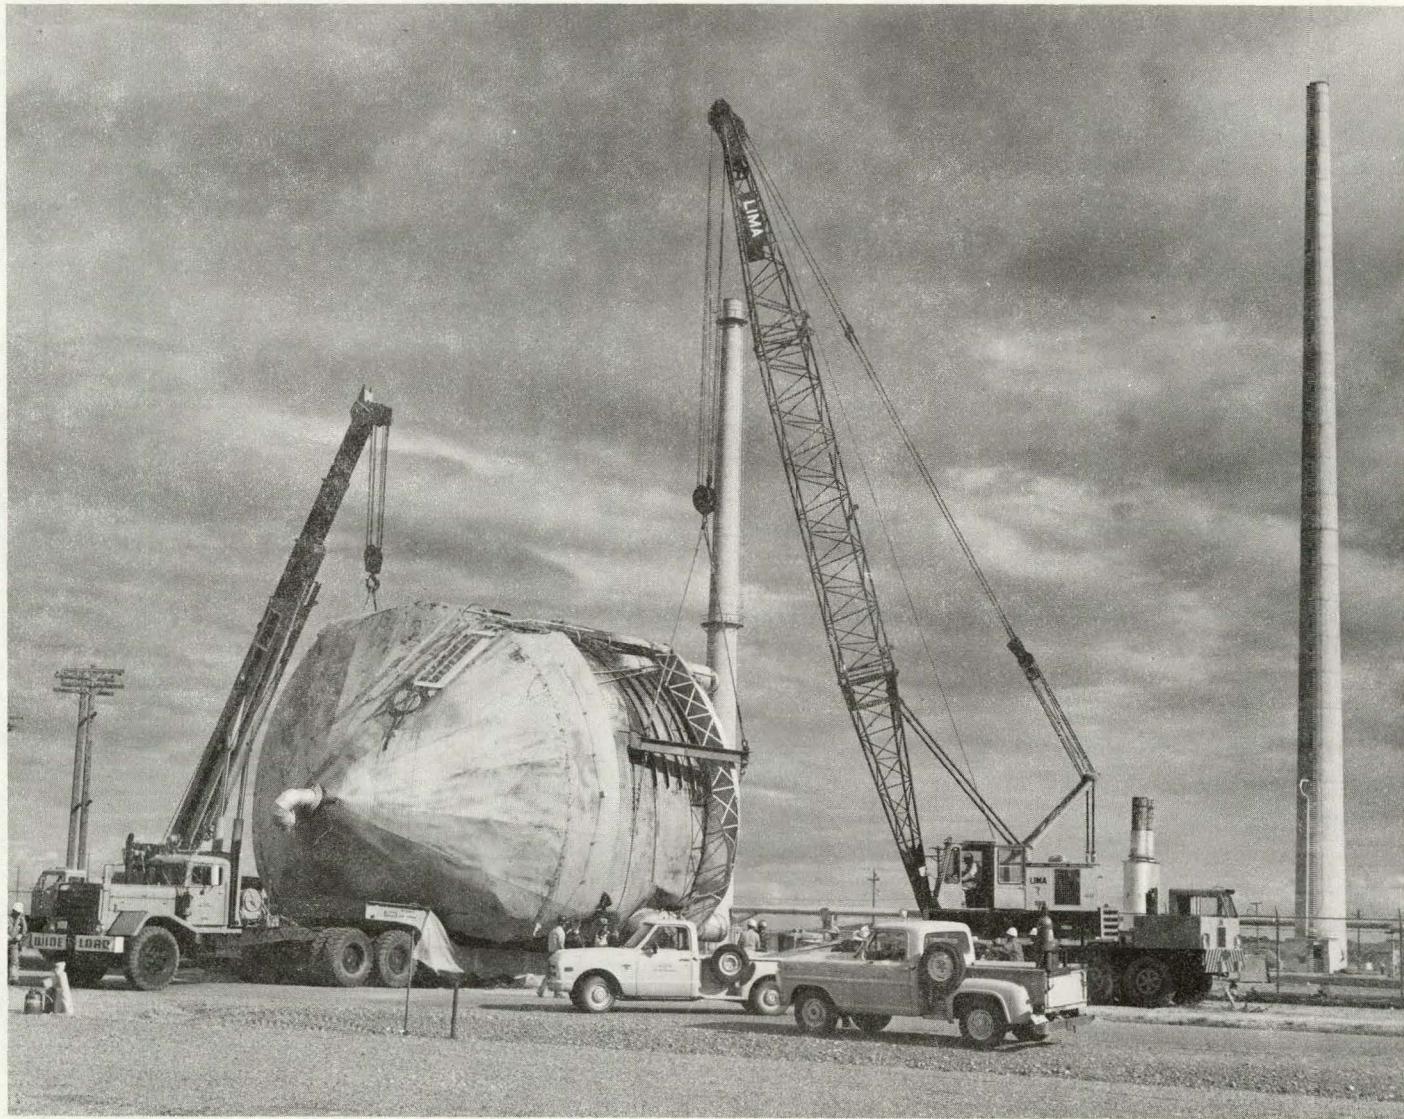
Fig. 10 View of the OWR being loaded for transportation.

Following the successful explosive release of the OWR, the piping and support members were cut into sections up to 30 feet long for ease of hauling. Openings in contaminated items were sealed with plastic, and the items were transported to the RWMC for disposal. Reusable noncontaminated material was disposed of as surplus material. Contamination-free scrap was taken to the Central Facilities Area waste disposal site. Openings into the tank were sealed with plastic, and TURCO 5580G was sprayed over external areas of the tank body suspected of being contaminated. Two cranes were used to lift the approximate 45-ton tank onto a 100-ton lowboy trailer (see Figure 10). Soil bearing contamination was removed from the OWR site and disposed of at the RWMC. The area was cleaned up and restored as required with the project work being essentially completed as scheduled on June 30, 1975.
