Report No. BMI-1446

EXPERIMENTS TO DETERMINE THE RADIATION
STABILITY OF UN DISPERSIONS IN
STAINLESS STEEL

June 14, 1960

BATTELLE MEMORIAL INSTITUTE
505 King Avenue
Columbus 1, Ohio

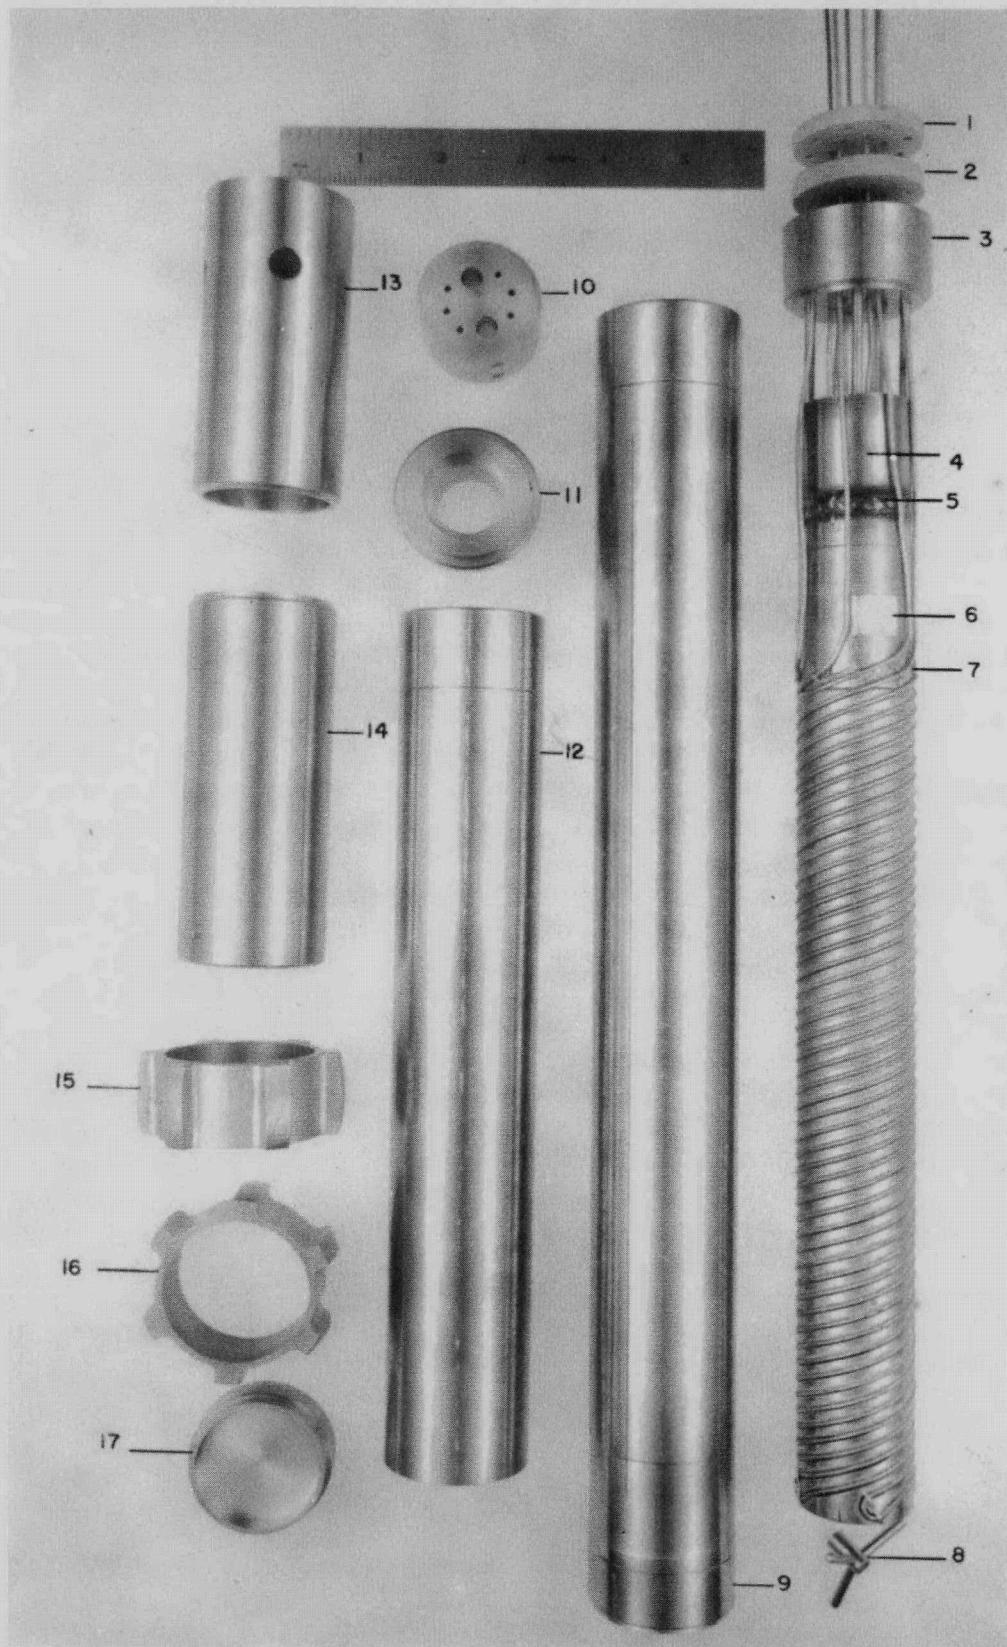
FIGURE 1. COMPOSITE PARTS OF CAPSULE BMI-28-1

- 1. Lavite disk
- 2. Lavite disk
- 3. Second thermocouple seal
- 4. First seal
- 5. Weld
- 6. Fission boss
- 7. Heaters
- 8. Centering pin
- 9. Outer shell
- 10. Saddle clamp
- 11. Lead tube junction
- 12. Long extension
- 13. Top spacer
- 14. Short extension
- 15. Centering ring
- 16. Centering ring
- 17. Bottom plug

In order to obtain good comparison between the radiation stability of UN and UO₂ dispersions, a capsule was designed which would permit both the measurement and control of specimen temperatures. To accomplish these requirements, electric-resistance heaters and six thermocouples were incorporated in the design. The capsule itself was of a double-walled, NaK-filled, high-temperature type, designed to maintain specimen surface temperatures of 1650 F \pm 50, in a specified neutron flux (see Figure 1).

The outer capsule shell, or water-contacting wall, was made of stainless steel and was approximately 0.1 in. thick with an outside diameter of 1.750 in. The outer capsule was separated from the inner capsule by an 0.068-in.-wide helium annulus when at operating temperature. The gas annulus was uniform over the capsule length and served as the primary heat-transfer barrier. Four nickel-cobalt dosimeters, placed 90 deg apart, were affixed in grooves along the outside of the outer shell. Two nickel-cobalt dosimeters were extended the length of the specimens in the inner capsule.

The inner capsule was machined from a solid block of Type 304 stainless steel to eliminate the need of a bottom weld. The outside diameter of the inner body was 0.699 in. at the operating temperature and was supported and centered in the outer shell by four short axial rods at the top and a spider at the bottom. This arrangement maintained concentricity without imposing axial restraint on the inner capsule, thus permitting relative motion resulting from differential thermal expansion between the inner and outer shells as a result of heating. Two 1-kw heaters sheathed with 1/16-in. of stainless steel and packed with MgO were brazed into spiral grooves machined into the outside diameter of the inner capsule. To achieve good heat transfer, approximately one-half of the

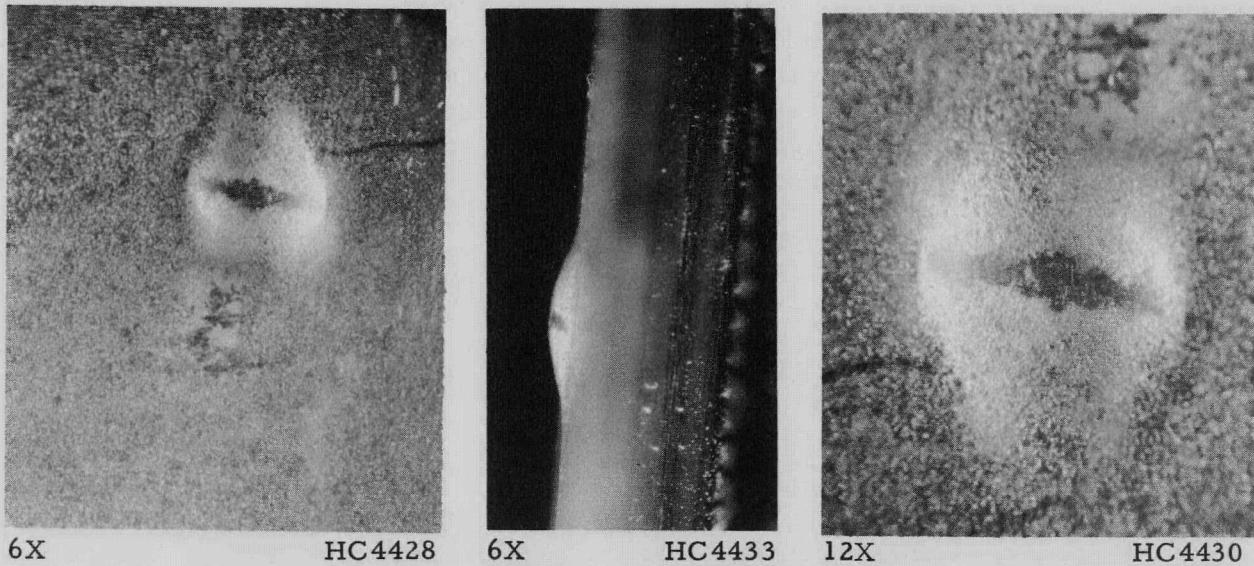
FIGURE 7. CONDITION OF BLISTERED AREA ON SPECIMEN 51 (UO_2)

The specimen was irradiated at 1500 to 1880 F to a burnup of 3.6 a/o uranium-235.

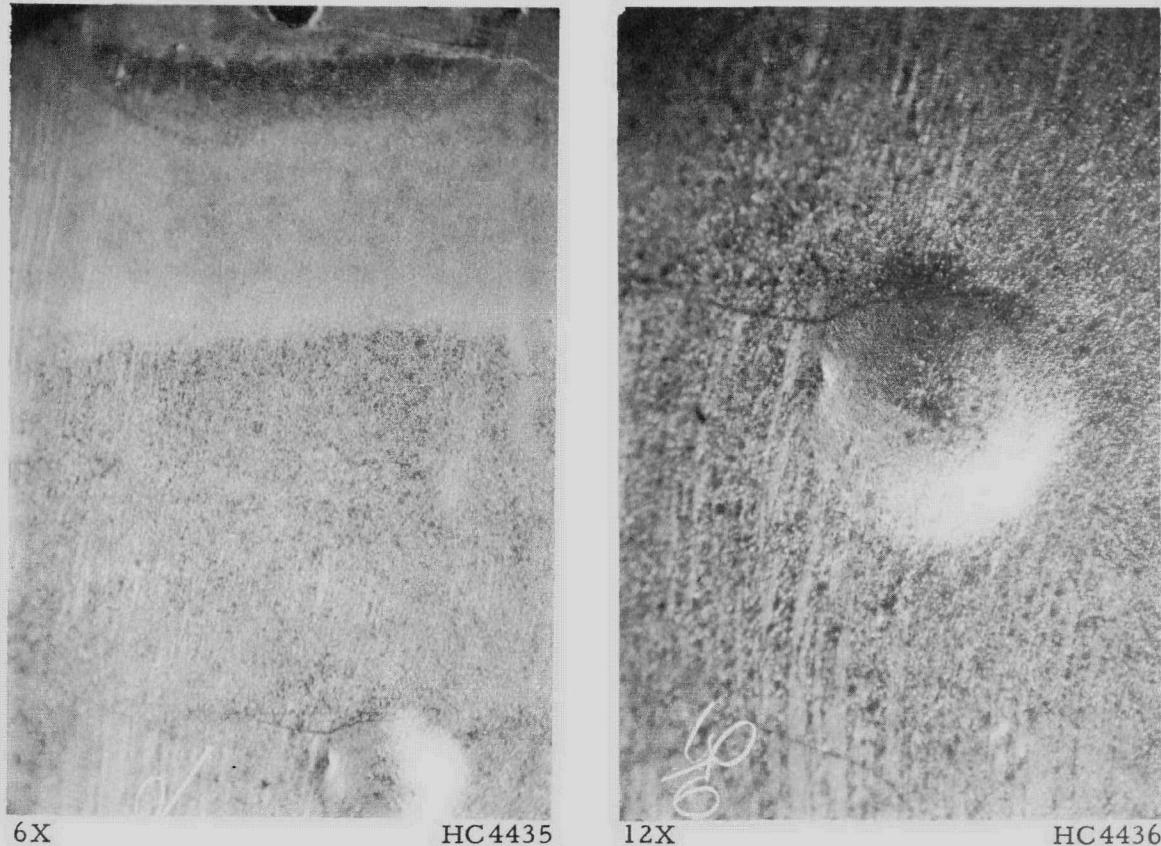
FIGURE 8. CONDITION OF BLISTERED AREA ON SPECIMEN 55 (UN)

The specimen was irradiated at 1575 to >1800 F to a burnup of 4.8 a/o uranium-235. Note the rough surface of the cladding over the fueled area and the apparent crack near the blister. Thorough examination of the blistered area failed to establish definitely whether the mark near the blister was a scratch or crack.

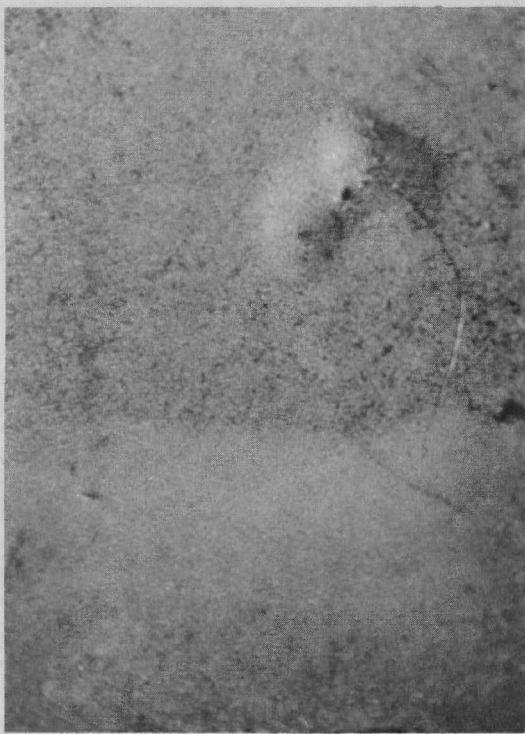
FIGURE 9. CONDITION OF BLISTERED AREA ON SPECIMEN 56 (UN)

The specimen was irradiated at 1590 to >1850 F to a burnup of 5.0 a/o uranium-235. The blister occurred near the top end of the specimen. The mark near the blister is believed to be a surface scratch.

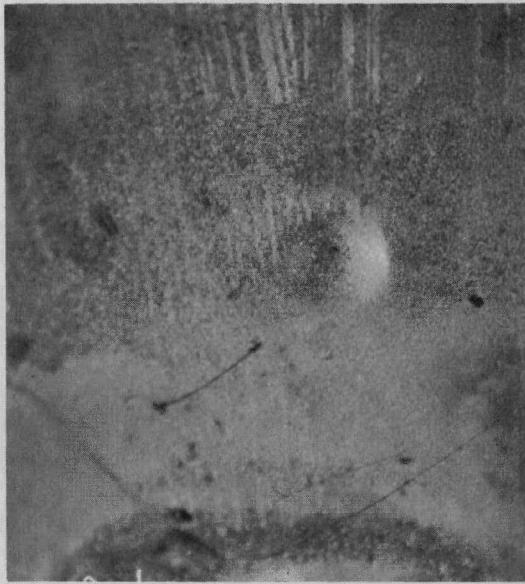
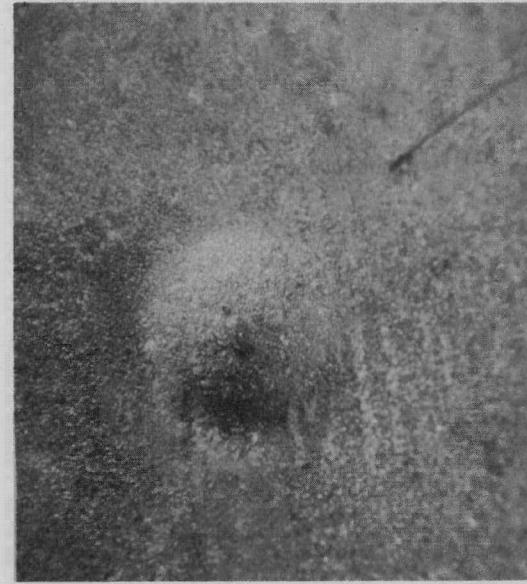
FIGURE 10. CONDITION OF BLISTERED AREA OF SPECIMEN 57 (UN)

The specimen was irradiated at 1460 to >1750 F to a burnup of 4.3 a/o uranium-235. This blister occurred near the edge of the fueled core. The cause of the light parallel marks on the specimen surface is unknown.

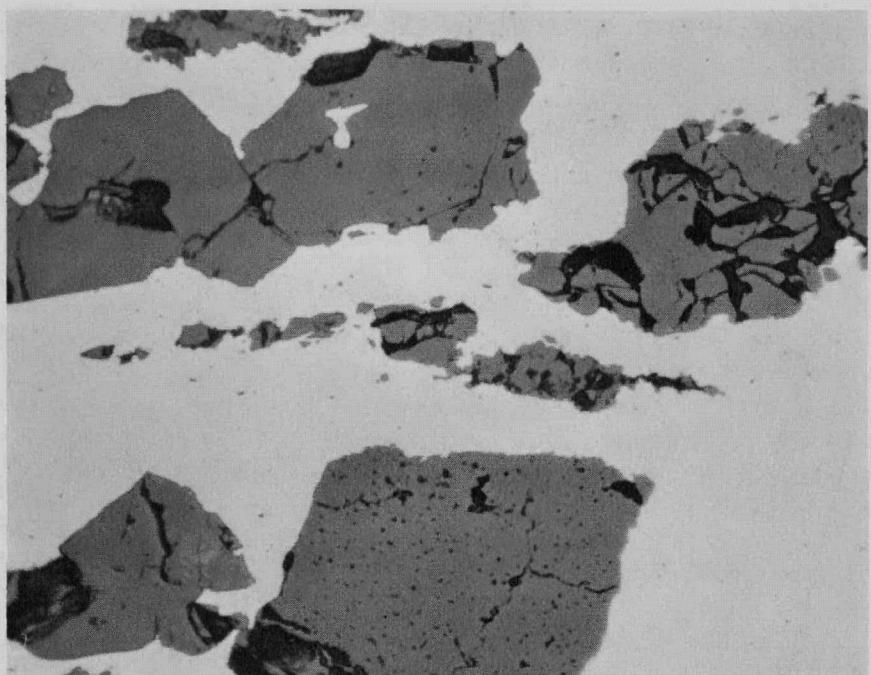
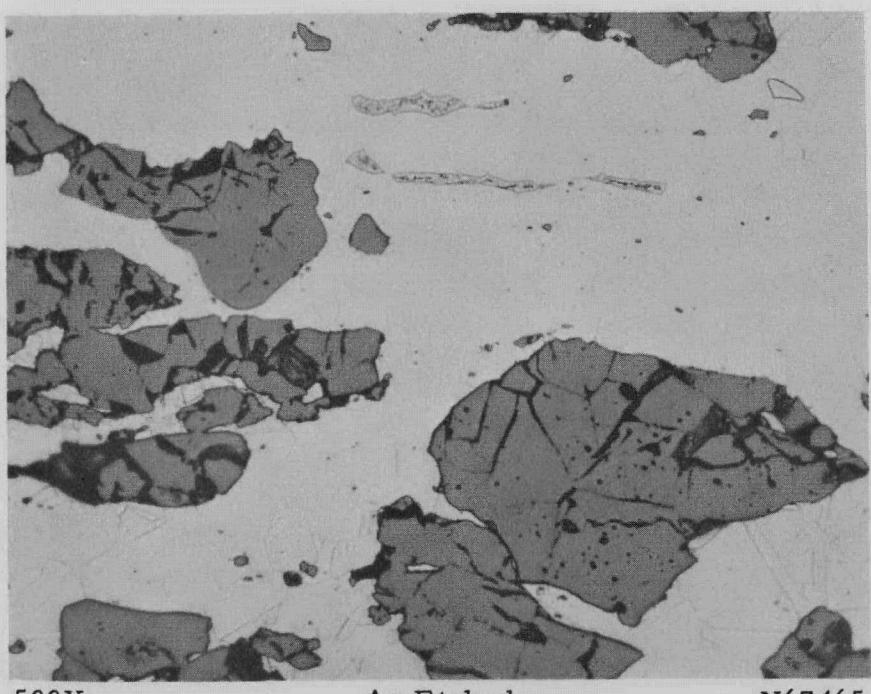
FIGURE 12. TYPICAL MICROSTRUCTURE OF UNIRRADIATED SPECIMEN OF 30 w/o UO₂ DISPERSED IN TYPE 318 STAINLESS STEEL

Swab etched with 20 cm^3 glycerine, 20 cm^3 HCl, and 5 cm^3 of HNO_3 solution.

A structure representative of the 30 w/o UO_2 dispersion is shown in Figure 12 prior to irradiation. The structure of the material after irradiation is shown in Figure 13. In general, no structural changes were detected by light microscopy in the UO_2 and stainless steel that could have resulted from the effects of irradiation or reaction between the UO_2 and stainless steel. However, a study of the contact areas between the UO_2 particles and matrix by electron microscopy indicated that a phase or zone surrounding the unirradiated UO_2 particles had disappeared during irradiation, Figure 14. This was apparently a zone of reaction between excess oxygen in the UO_2 and constituents of the stainless steel matrix and appeared to follow grain boundaries leading away from the UO_2 particles into the matrix. The zone was apparently formed during fabrication and its disappearance during irradiation could be due to diffusion and fission-fragment bombardment effects.

Examination of the microstructure of the UO₂ dispersions by light microscopy indicated that the UO₂ particles were slightly fragmented prior to irradiation. The distribution of the fuel particles within the matrix appeared to be uniform without noticeable stringering or other defects. The matrix appeared sound and no reaction between the UO₂ particles and the Type 318 stainless steel matrix was observed. There was only a very slight porosity visible in the UO₂ particles. After irradiation, neither the fuel particles or the matrix appeared changed, except for the blisters discussed earlier.

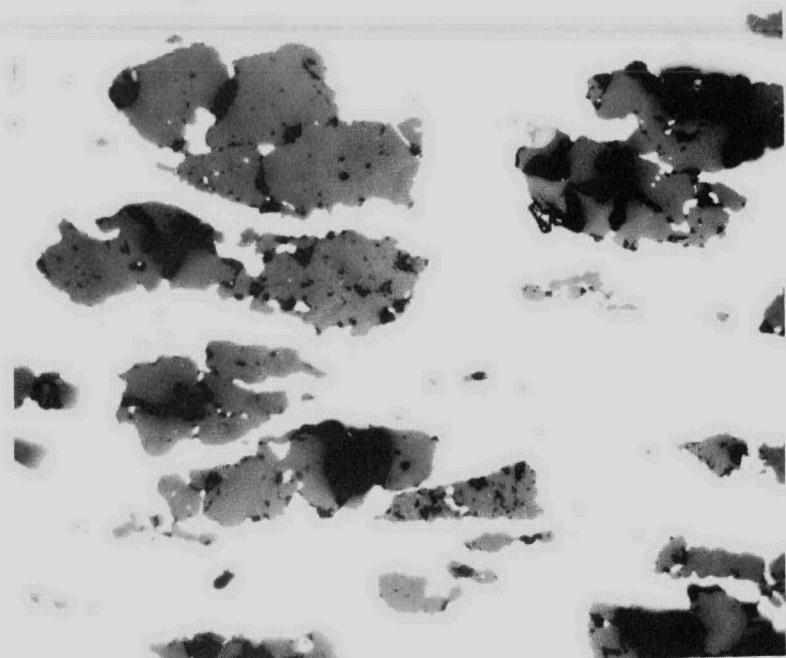
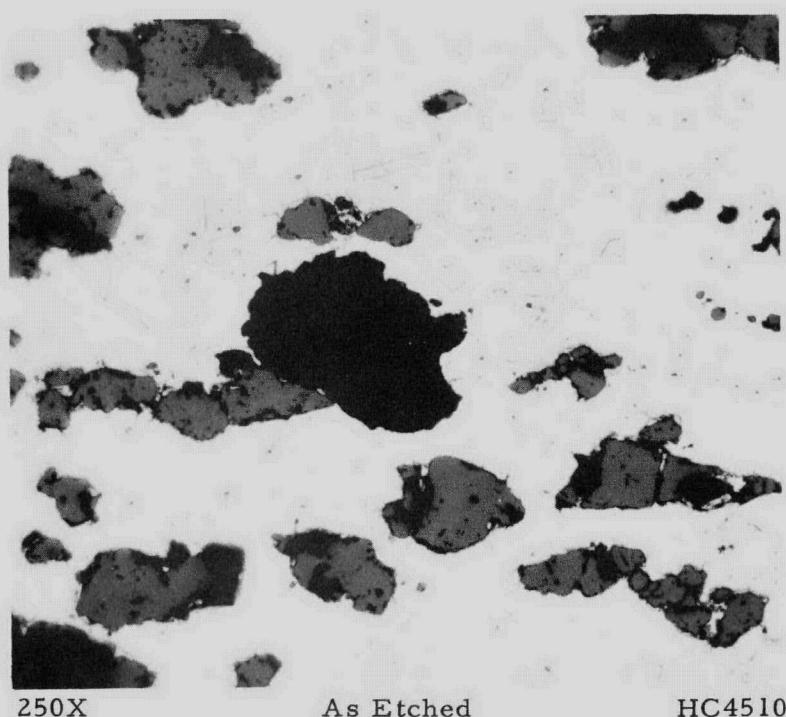
FIGURE 13. TYPICAL MICROSTRUCTURE OF 30 w/o UO_2 DISPERSION IN TYPE 318 STAINLESS STEEL AFTER IRRADIATION, SPECIMEN 51

Burnup was 3.6 w/o of uranium-235.

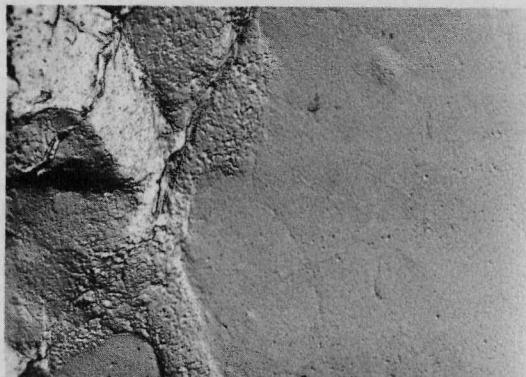
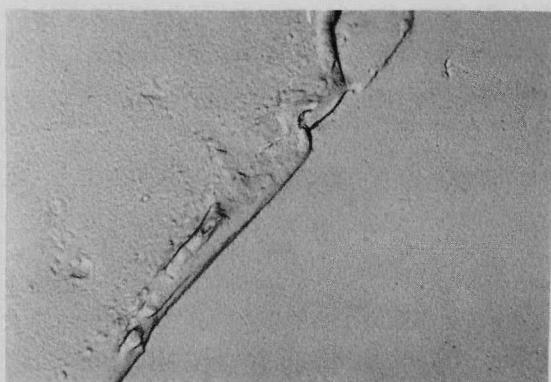
FIGURE 14. STRUCTURE OF CONTACT ZONE BETWEEN A UO_2 PARTICLE AND THE STAINLESS STEEL MATRIX IS SHOWN BEFORE AND AFTER IRRADIATION

Note that the phase surrounding the UO_2 particle in the unirradiated condition does not appear in the irradiated specimen. This phase is believed to be a reaction zone formed during fabrication between the matrix and the excess oxygen in the UO_2 particles.

Examination of the UO₂ dispersions by electron microscopy before irradiation indicated the existence of a very small separate and distinct zone around the larger fuel particles and continuing outward into the matrix along grain boundaries. This zone was apparently the result of reactions between the constituents of the stainless steel matrix and excess oxygen in the UO₂. Similar examinations of these specimens after irradiation indicated that this zone had apparently disappeared, possibly as a result of the heavy bombardment of this area by fission fragments and diffusion.

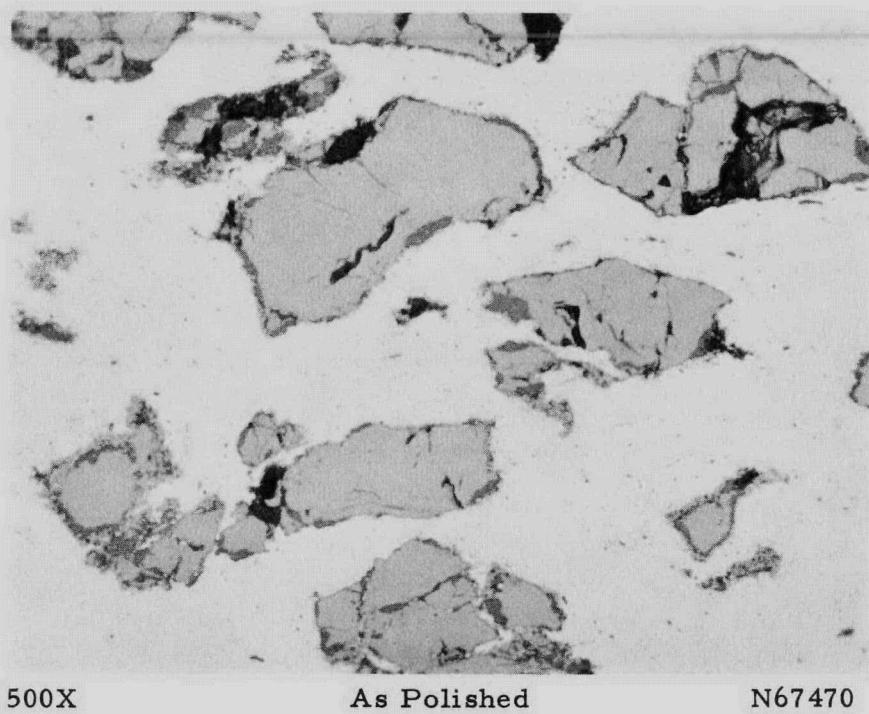
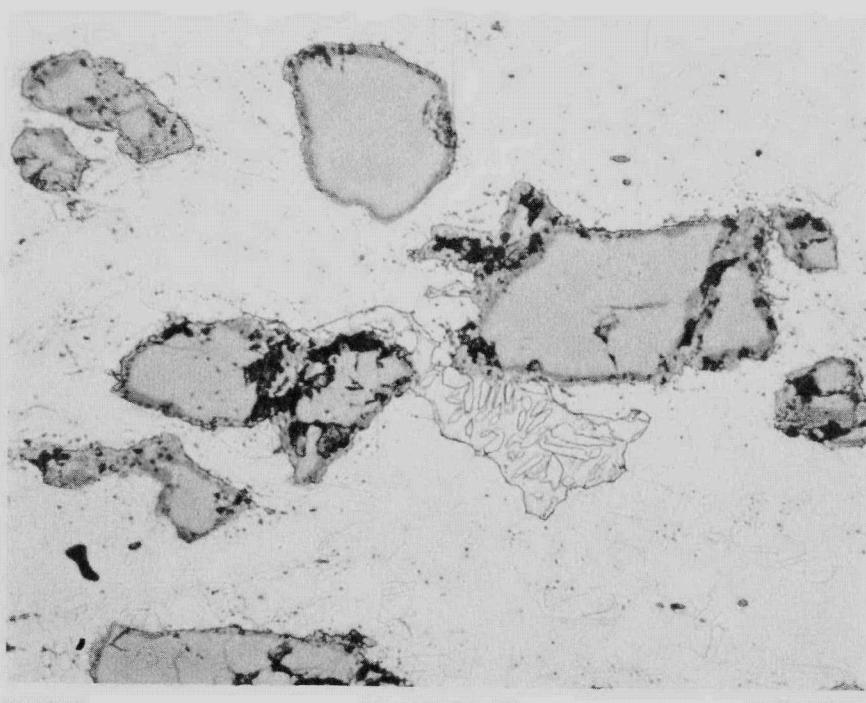
FIGURE 15. TYPICAL MICROSTRUCTURE OF UNIRRADIATED 28 w/o UN DISPERSIONS IN TYPE 318 STAINLESS STEEL

Note the appearance of the dark gray reaction zone at the surface of the particles.

The typical appearance of the microstructure of UN dispersions in Type 318 stainless steel before irradiation is shown in Figure 15. A dark gray-colored reaction zone was observed on the surface of the UN particles, which was apparently formed during fabrication. The UN particles did not appear porous. The gray reaction zone still appeared around the UN particles after irradiation and porosity was observed, Figures 16 and 17. A small zone in the matrix around each fuel particle was rapidly attacked by the etchant after irradiation. This compares with the results reported by others⁽³⁾ in the case of irradiated UO_2 dispersions.

A study of the microstructure of unirradiated UN dispersions by light microscopy indicated that the fuel particles were evenly distributed without any evidence of stringering. Only very occasional fractures were observed in the fuel particles. There was no indication of any porosity in the fuel particles and the Type 318 stainless steel matrix appeared sound. A gray area was observed on the surface of the UN particles which may have resulted from gettering of oxygen from the matrix by the UN. After irradiation, the gray area was still visible. A slight porosity was also observed in the irradiated fuel particles which could have resulted from expansion of fission gases. The matrix appeared to be in good condition, except for the blisters as discussed earlier. Chemical etching of the irradiated specimens produced a pitted and eroded area in the matrix surrounding the fuel particles. The rapid attack of this area by the etchant was probably caused by a reaction between the stainless steel constituents and free nitrogen produced from the fission of UN and the damage caused by fission fragments attenuated in the small volume of matrix surrounding each fuel particle.

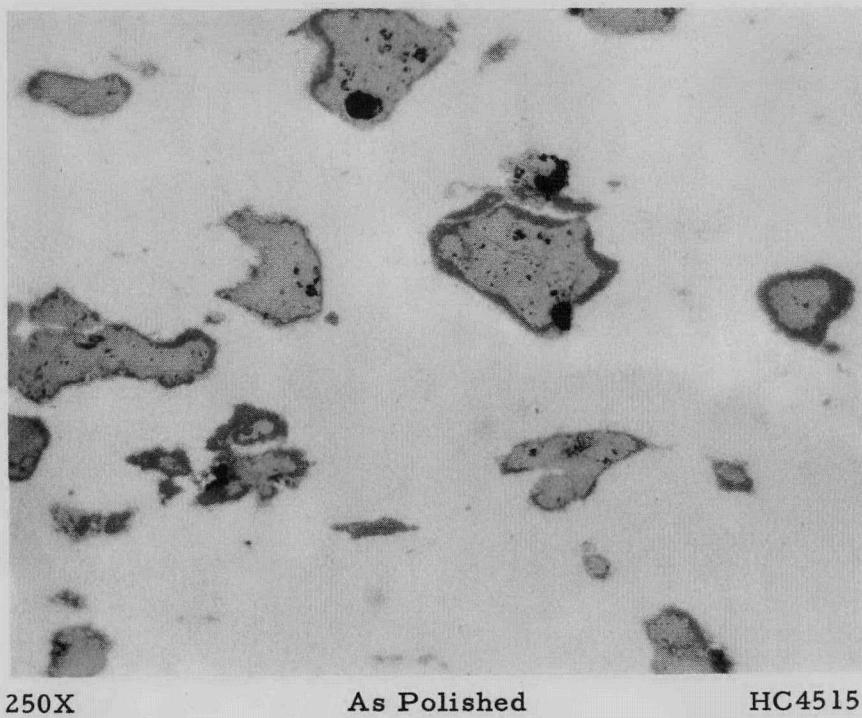
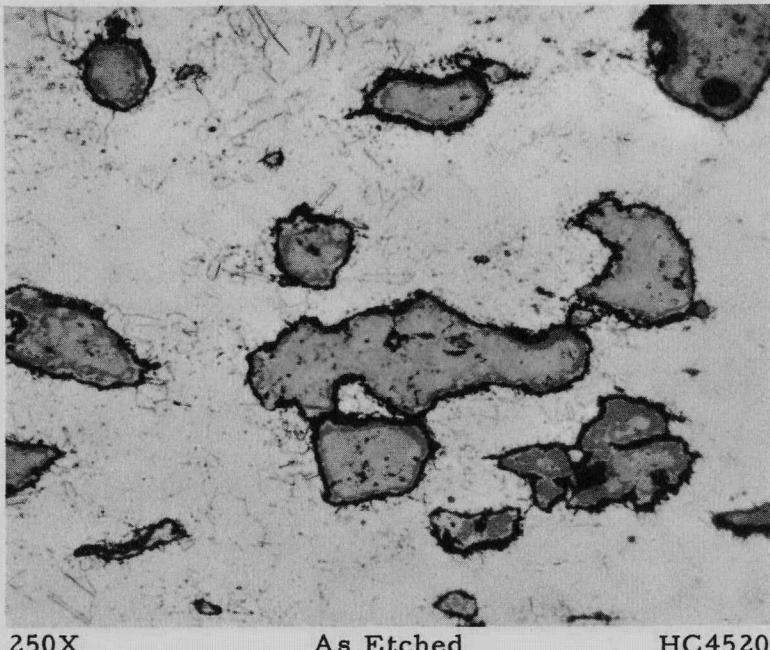
FIGURE 16. TYPICAL MICROSTRUCTURE OF IRRADIATED 28 w/o UN DISPERSED IN TYPE 318 STAINLESS STEEL, SPECIMEN 55

Note the porosity formed in the UN and the continued presence of the gray zone around the UN particles. During etching, it was found that a thin zone of the matrix surrounding the fuel particles was rapidly attacked and removed by the etchant. Burnup was 4.8 a/o of uranium-235.

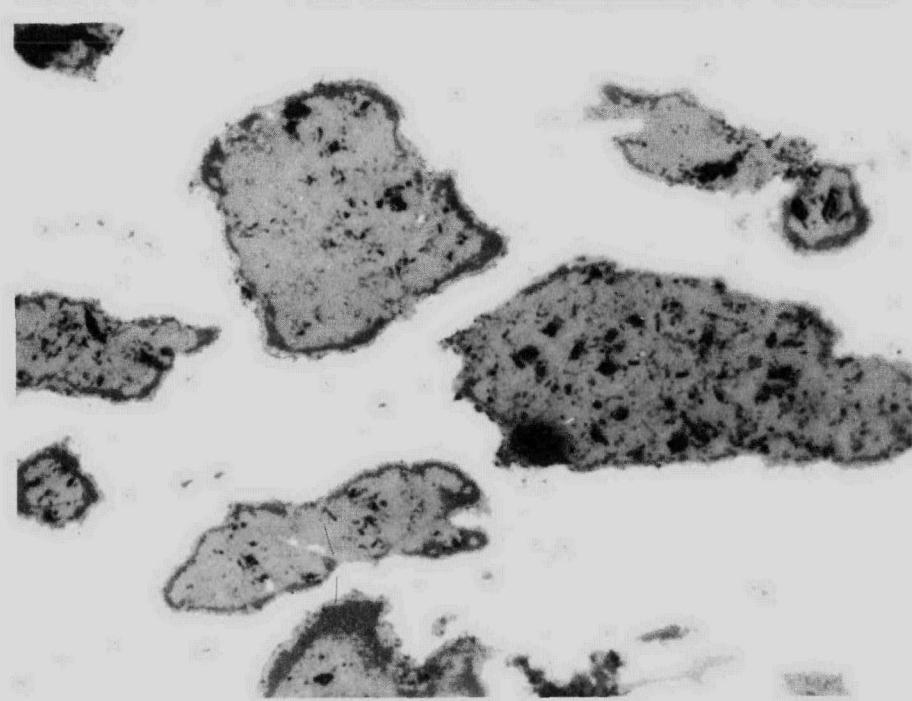
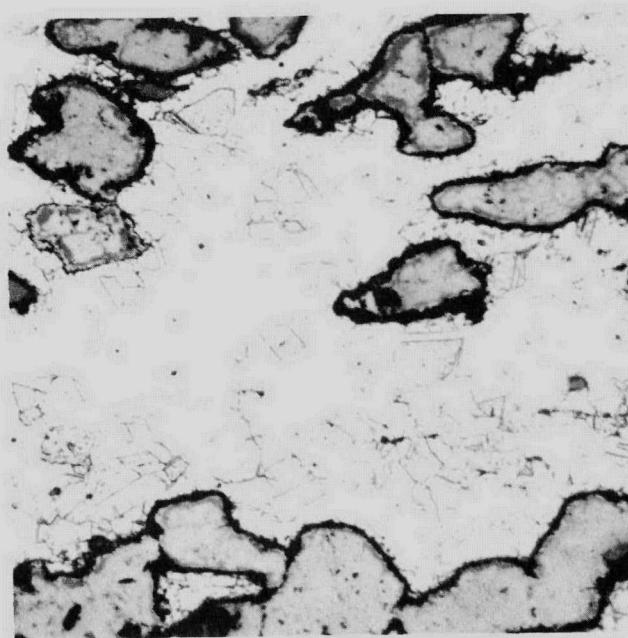
FIGURE 17. TYPICAL MICROSTRUCTURE OF IRRADIATED 28 w/o UN DISPERSED IN TYPE 318 STAINLESS STEEL, SPECIMEN 56

Note the porosity in the UN particles and the continued presence of the gray zone around each particle in the as-polished condition. Etching the specimen resulted in the removal of a thin layer of the matrix surrounding the fuel particles. Burnup was 5.0 a/o uranium-235.

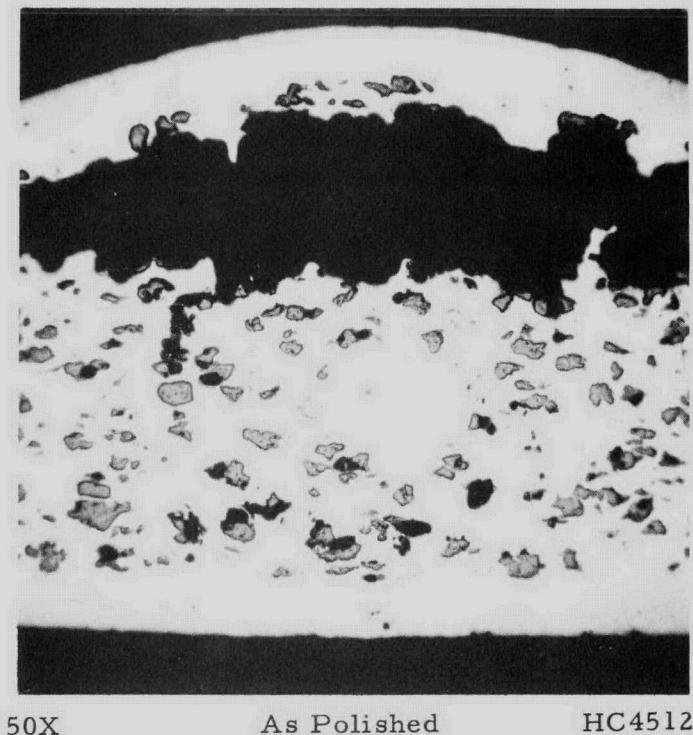
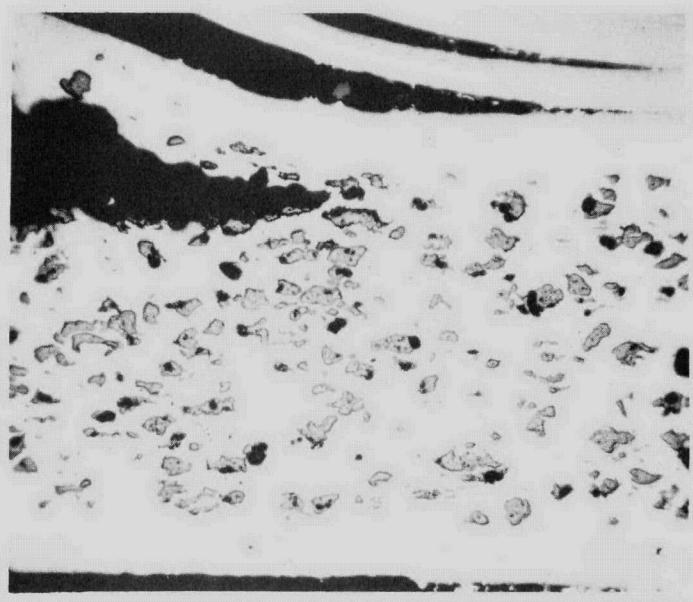
FIGURE 19. AREA UNDER BLISTER ON SPECIMEN 55

Note that the separation occurred in the core.

The typical microstructure of an area directly beneath a blister is shown in Figure 19. The separation obviously occurred in the fuel matrix rather than at the core-cladding bond. The crack also appears to follow along the edges of fuel particles. This type of blistering has been observed in other irradiations of dispersion and alloy fuel materials.
