Title:
Development and Testing of PRD-66 Hot Gas Filters

Conference:
Advanced Coal-Fired Power Systems '96 Review Meeting

Development and Testing of PRD-66 Hot Gas Filters

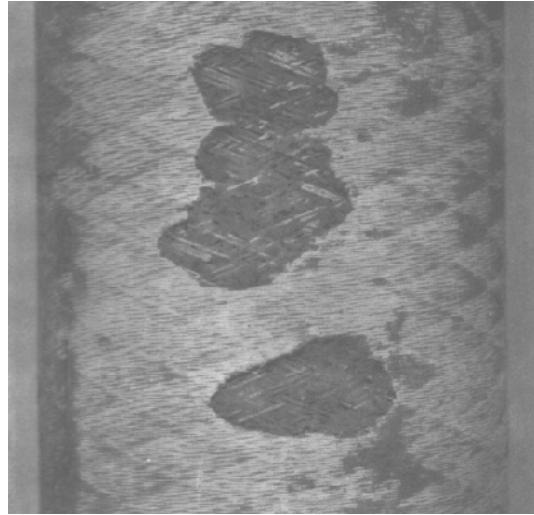
Figure 1. Divots in a PRD-66 filter segment.

Divots are pieces of the candle filter membrane and body, avulsed from the filter. Such divots were found aligned along the filter body on roughly opposite sides. A divot was also found under the sock and holder, which eliminates mechanical impact as a cause of the damage. There was no visible evidence of corrosion. The filter body walls were filled with ash, as they had been in Test Segment 4. The body of the filter was covered with a thin layer of loose ash, roughly 2mm thick in most regions. There were also denser ash deposits, aligned with the divots described above. All divots were packed with dense ash, though some ash-packed divots were covered with loose ash. Finally, in Test Segment 5, all filters of all types in the top array were somehow 'glued' in place, i.e., they were strongly adhered to their holders. This was not observed in the middle or bottom arrays. Filter segments tested by Westinghouse showed no decrease in mechanical properties after exposure. Finally, micrographs taken at EERC by Tina Watne showed inclusions of a white material, identified by EDX as containing magnesium, calcium, sulfur, and oxygen, well inside the filter body. (See Figure 2) This white deposit was of a physical size far too large to have penetrated the undamaged
