SAND74-8503
Unlimited Release
Printed December 1974

CORROSION BEHAVIOR, MECHANICAL PROPERTIES, AND LONG-TERM AGING OF NICKEL-PLATED URANIUM

Sandia Laboratories, Livermore

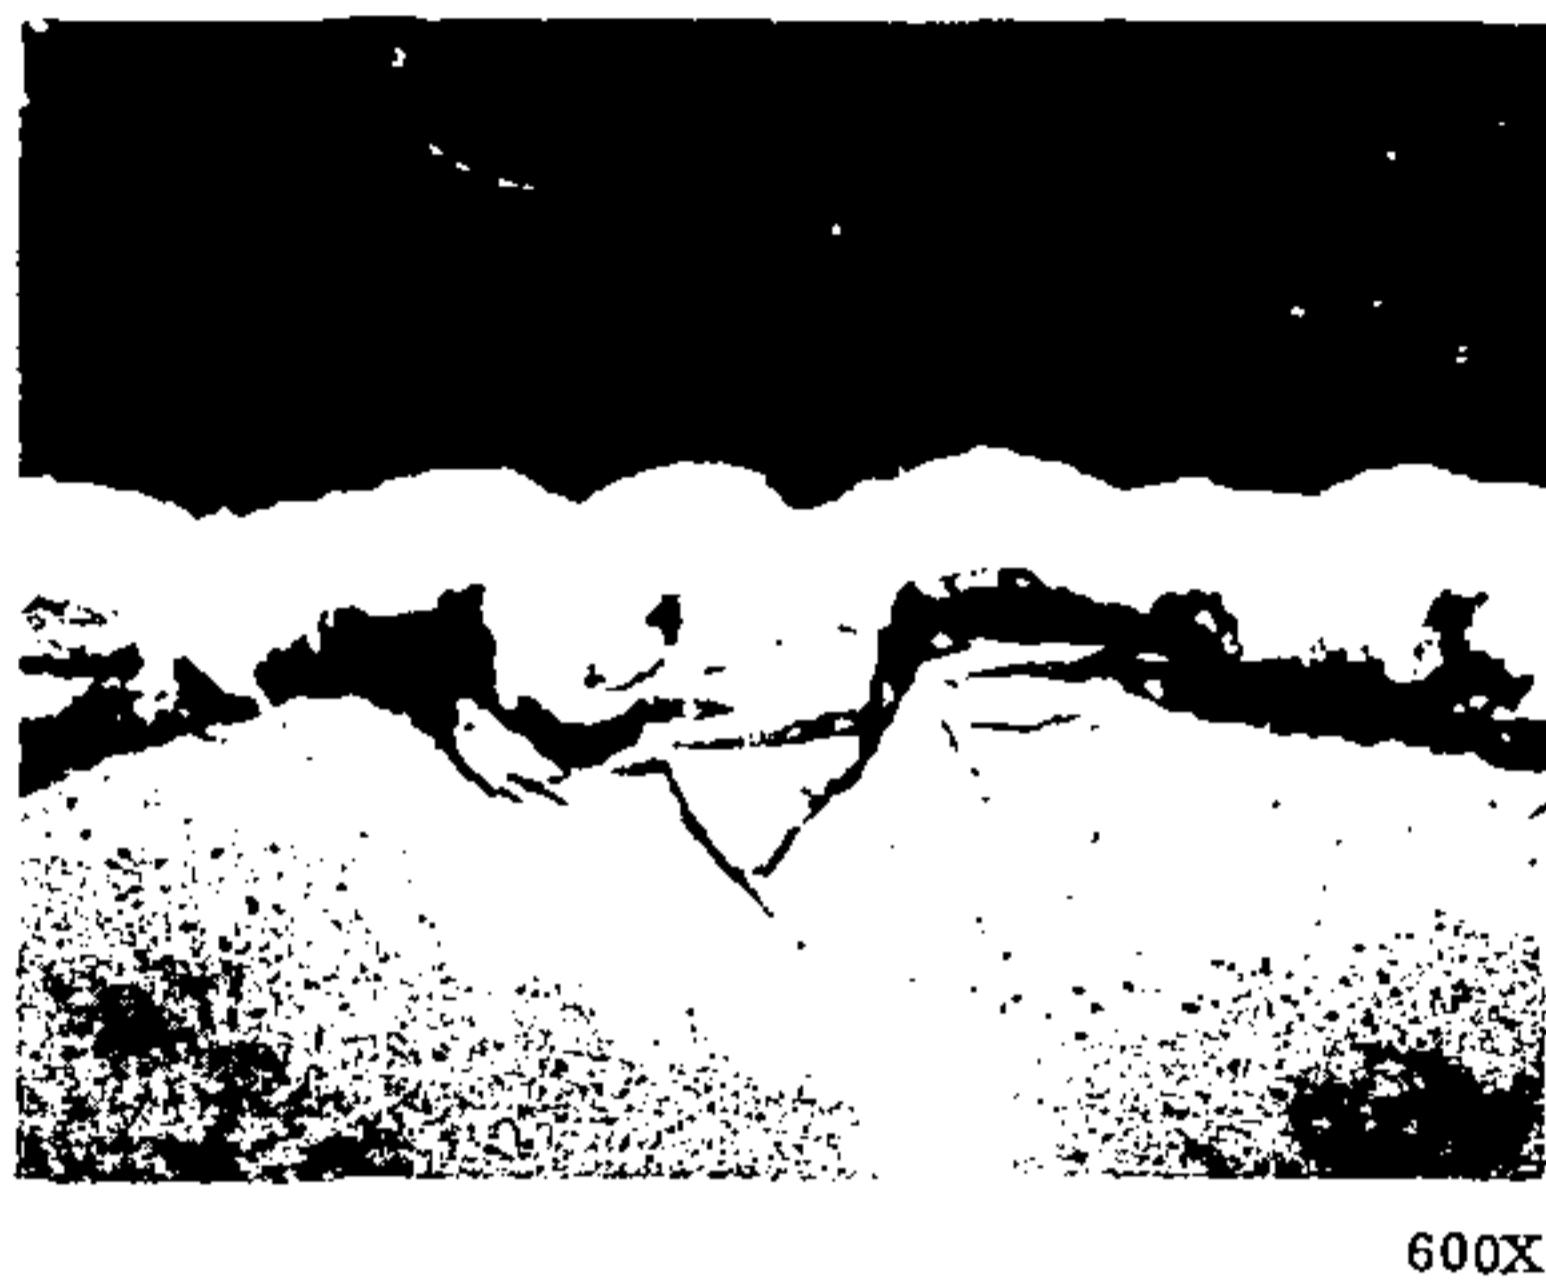
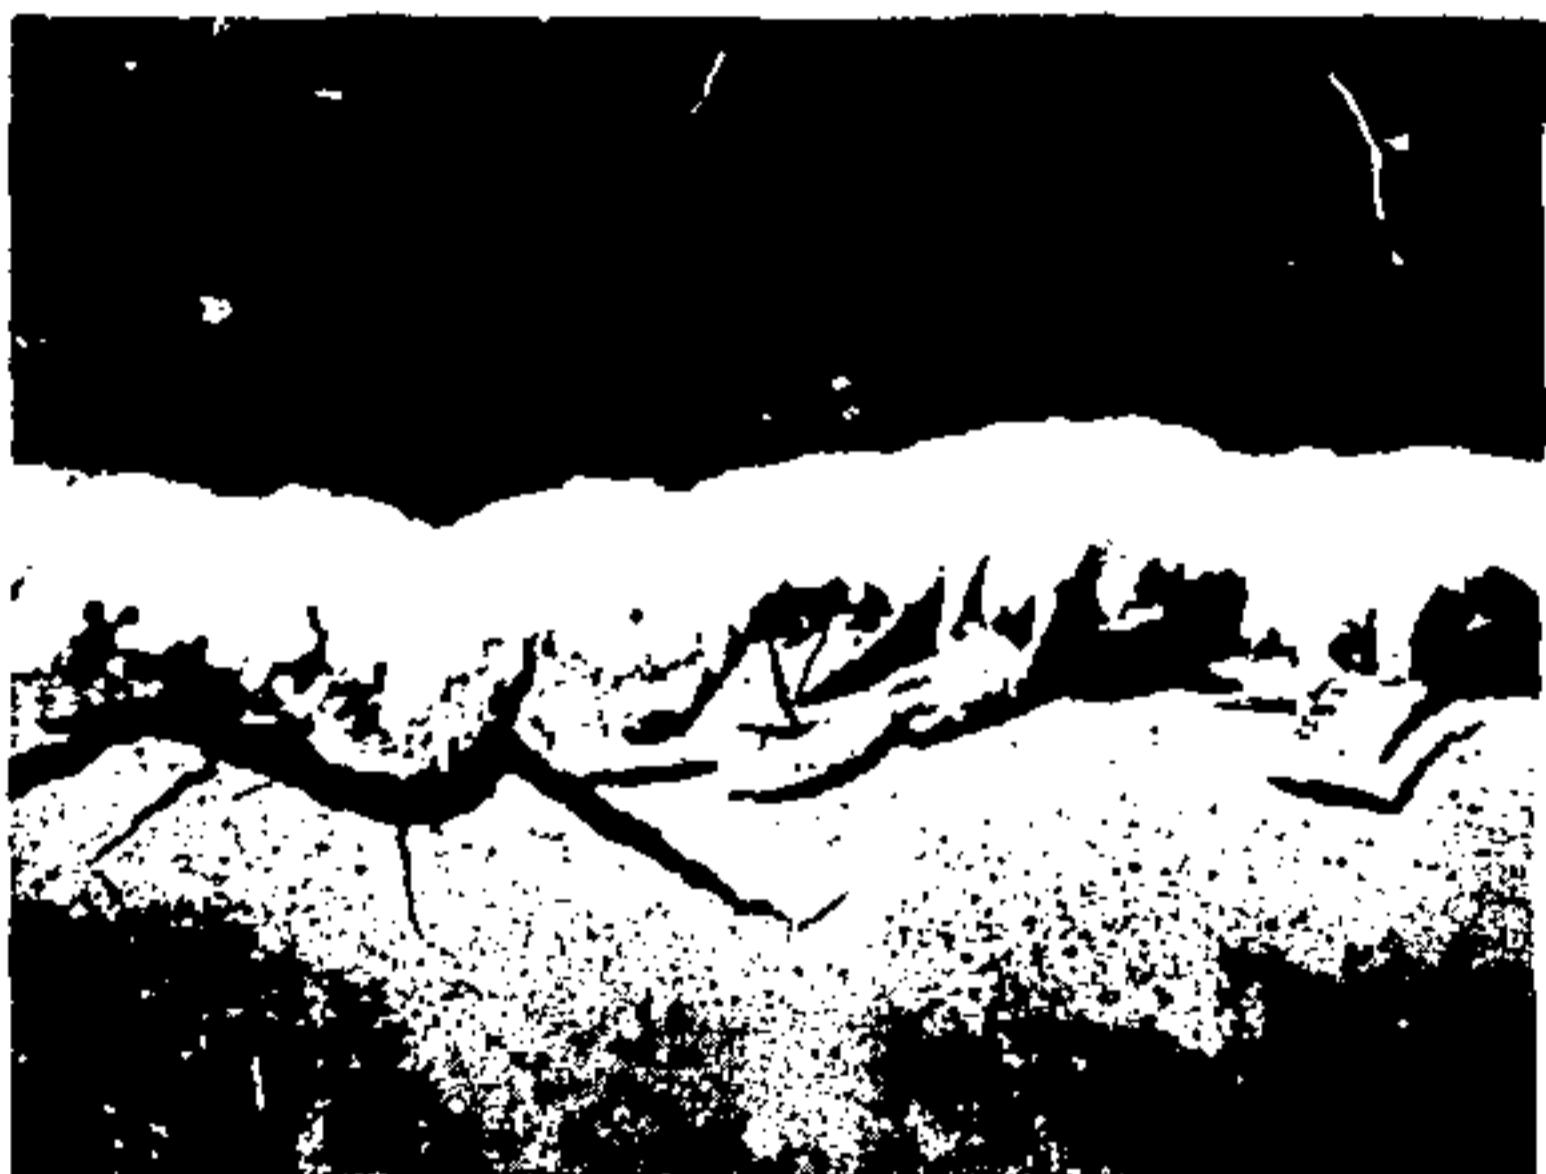
Figure 4. Uranium Hydride Platelets Observed in Specimens Exposed to Moist Nitrogen (electrolytically etched in oxalic acid)

Use of an electrolytic oxalic acid etch, per Jackson⁵, revealed uranium hydride platelets beneath the 0.013-mm and 0.025-mm coatings, as shown in Figure 4. These platelets are quite similar to those seen by Brevers and Newman⁶ and by Adamson et al⁷ with thermally or cathodically charged uranium.

With regard to the former, Orman et al.² observed that uranium hydride could form at the nickel-uranium surface, and that this could account for the apparent cessation of hydrogen evolution. They postulated that the hydride can be formed as a result of hydrogen diffusion through the nickel film and/or along the interface between the uranium and nickel, resulting in interface bond rupture at sites remote from the original pores.
