Report No. BMI-1348
UC-10 Chemistry - Separation
Processes for Plutonium and
Uranium (TID-4500, 14th Ed.)

CONSTRUCTION MATERIALS FOR THE HYDROFLUORINATOR
OF THE FLUORIDE-VOLATILITY PROCESS

June 3, 1959

BATTELLE MEMORIAL INSTITUTE
505 King Avenue
Columbus 1, Ohio

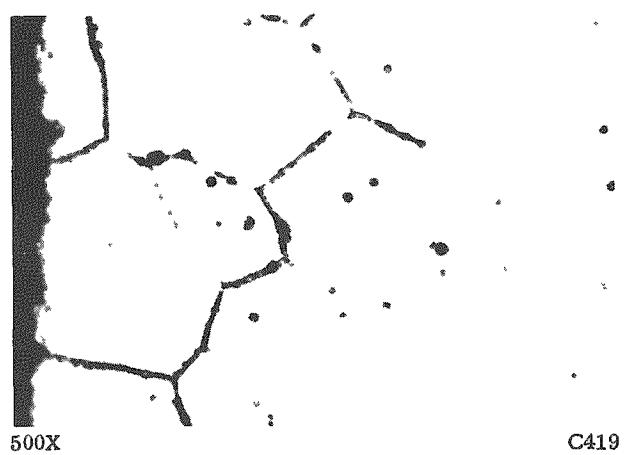
Nickel Thermocouple Tube Showing Intergranular
Attack After 1000 Hr

FIGURE 10. PHOTOMICROGRAPHS SHOWING INTERGRANULAR ATTACK OF NICKEL
EXPOSED TO EQUIMOLAR NaF-ZrF_4 AT 650 C

Specimens of "A" Nickel (Run 7) showed a corrosion rate of almost 10 mils per month. The attack was intergranular. Figure 10 shows photomicrographs illustrating the attack which occurred at 192 and 1000 hr.

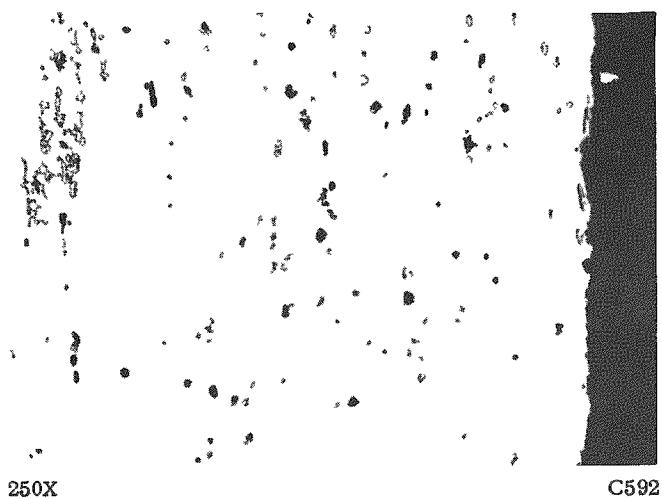
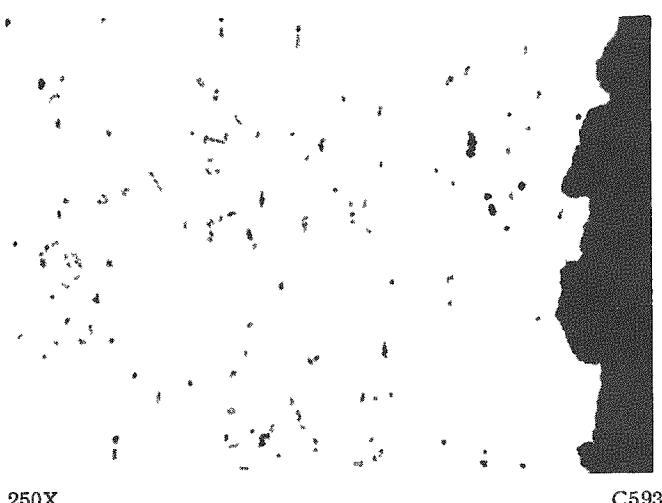
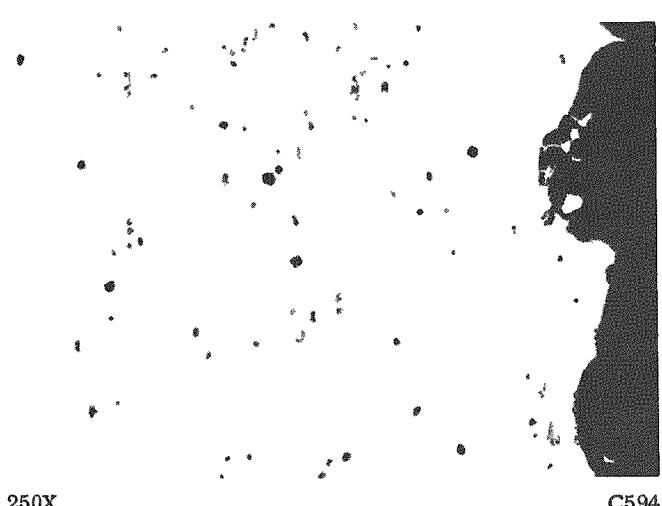
a. After 200 Hr at 600 C (Run 23)

b. After 200 Hr at 650 C (Run 23A)

c. After 160 Hr at 700 C (Run 23B)

FIGURE 16. PHOTOMICROGRAPHS SHOWING THE ATTACK ON INOR-8 AT VARIOUS TEMPERATURES IN NaF-LiF SALTS

The corrosive attack on INOR-8 material was sometimes general in nature and sometimes intergranular. Figure 16 shows photomicrographs illustrating the progressive roughening and surface attack on specimens exposed in the liquid phase caused by increased salt temperatures.

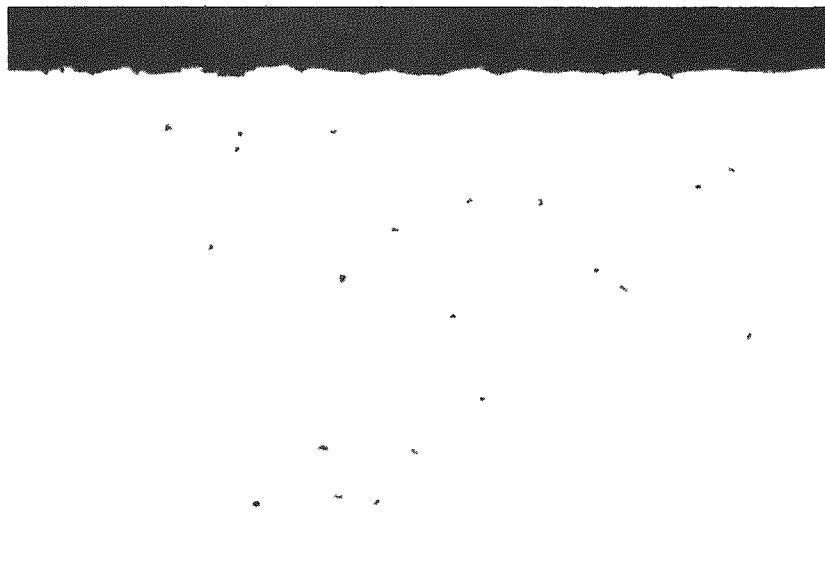
b. Liquid Portion, 2 In. From Bottom of the Well

FIGURE 20. ATTACK ON INOR-8 THERMOCOUPLE WELL IN RUN 25 WITH DISSOLVING
ZIRCALOY-2 PRESENT IN THE SALT

100X

Figure 20a shows the microstructure of the INOR-8 thermocouple well at the interface area where maximum attack occurred. It can be seen that considerable roughening of the metal took place and that the wall thickness was decreased. A very slight amount of intergranular attack was noted. Figure 20b shows the lesser amount of roughening which occurred on the metal immersed in the liquid.
