**CYCLIC PRESSURE TESTS OF  
LARGE SIZE PRESSURE VESSELS**

Contract No. AT(30-1)-2140  
Project No. 773-2  
Progress Report Number 6

15 April 1959

**SOUTHWEST RESEARCH INSTITUTE  
SAN ANTONIO, TEXAS**

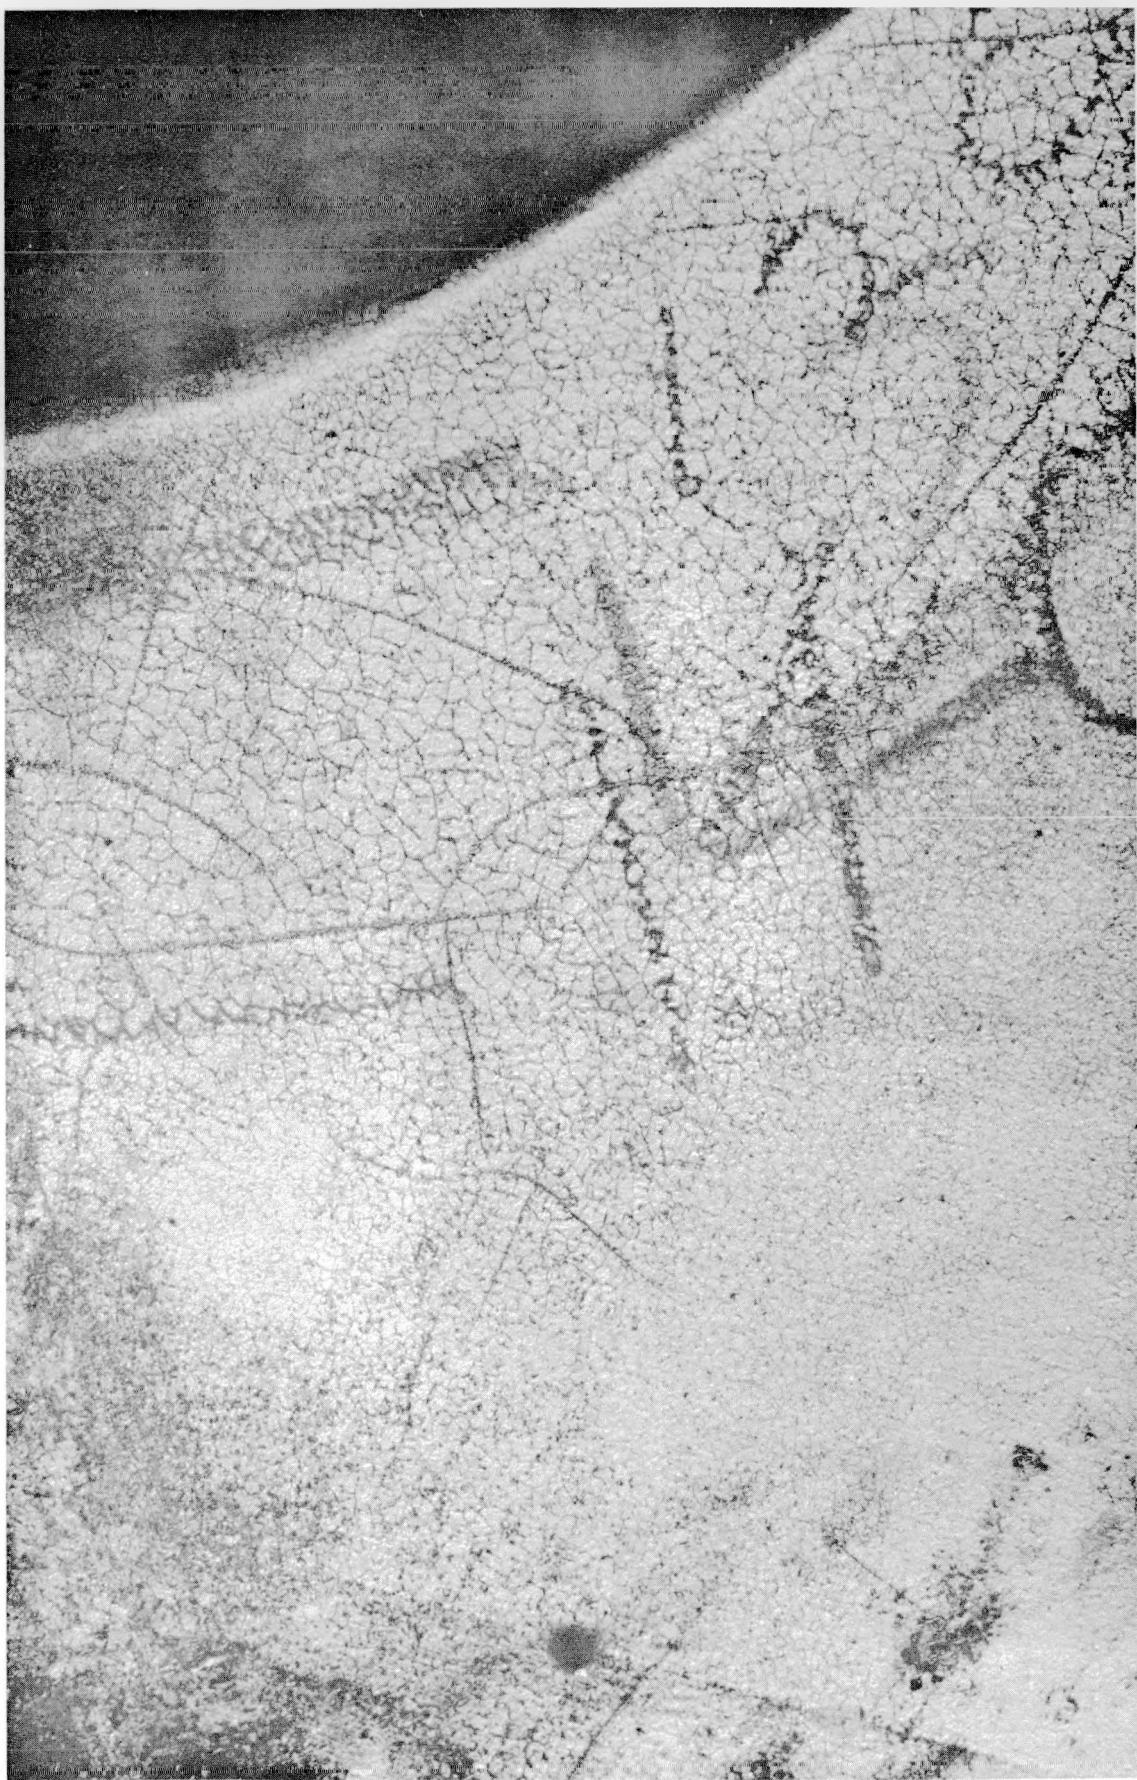
FIGURE 11. INTERIOR SURFACE STRESSCOAT PATTERNS AT RADIAL NOZZLE

Figures 11 and 12 are photographs of two of the most highly stressed areas of the interior surface of the vessel. Figure 11 was taken at the junction between the radial nozzle and hemispherical head at approximately 45 degrees to the line between the two nozzles on the head. The black grease pencil line nearest the nozzle marks the extent of the cracks in the brittle coating at 1200 psig (about 1 inch from junction of internal surfaces). These lines were radial from the nozzle. The outmost grease pencil line marks the average extent of the cracks in the brittle coating at 1440 psig, at which pressure the "mud cracking" appeared on the highly stressed area while areas farther away from the discontinuity were free of cracks. This "mud cracking" appears to be the result of nearly equal principal tensile strains in the biaxial field.

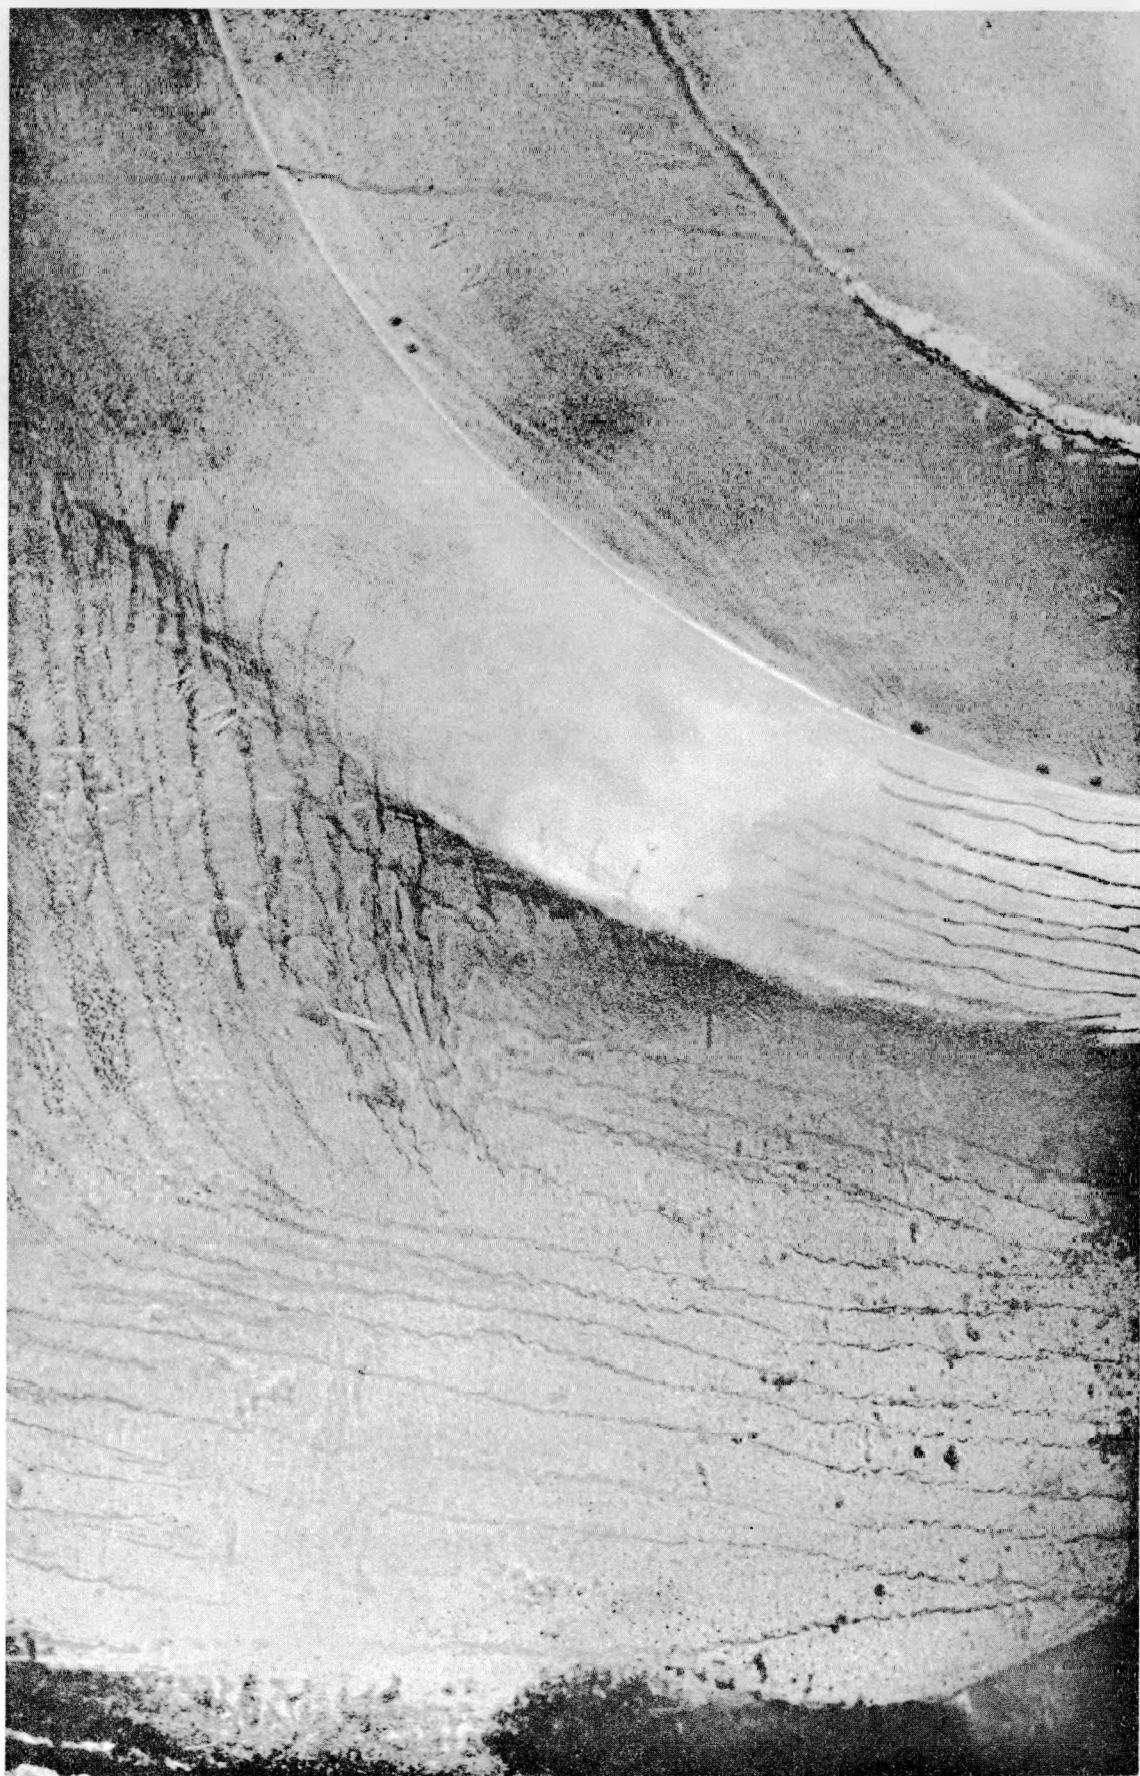
FIGURE 13. EXTERIOR SURFACE STRESSCOAT PATTERNS AT NOZZLE NO. 1

Figure 13 is a photograph showing the cracks in the brittle coating around the pad of Nozzle No. 1. "Mud cracking" developed in this area also, and the major crack lines are outlined with grease pencil. The Stresscoat on the nozzle and pad showed but a few widely spaced cracks in the brittle coating with no "mud cracking."

No visible cracks developed in the brittle coating at maximum Stresscoat pressure (2000 psig) and so the dye etchant sensitization technique was used. The cracks developed by this technique indicated that the greatest strains on the exterior surface occurred on the hillside nozzle Number 4, the pipe nozzle Number N-11, on the shell adjacent to nozzle Number 1, and on the nozzle-shell fillets.
