ANL-5893
Metallurgy and Ceramics
(TID-4500, 14th Ed.)
AEC Research and
Development Report

NONDESTRUCTIVE TESTING OF EBR-I MARK III
FUEL ELEMENTS AND COMPONENTS

May, 1959

ABSTRACT

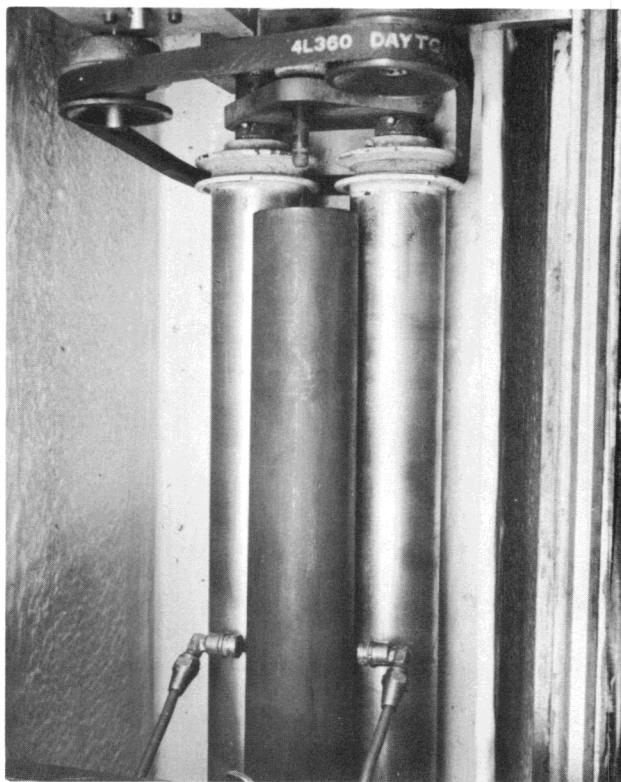
Figure 1

EBR-I Mark III Casting Mounted on Roller Assembly. The two inspecting transducers can be seen in left section of photo.

The inspection of the castings was performed in a $4\frac{1}{2}$ -foot tank scanner. A heavy-duty roller assembly was placed in the tank for supporting and rotating the uranium castings, as shown in Figure 1. The rollers were powered by a "V" belt drive coupled to a motor, the speed of which could be varied. The two inspecting ultrasonic transducers were mounted to a yoke assembly which was attached to the scanner carriage. This carriage provided the translatory motion for the transducers. The transducers were aligned so that the pulsed one-megacycle energy was transmitted through the center of the casting, to insure that the entire cross section of the casting was inspected.

With the combined rotational motion of the casting and the horizontal travel of the transducers, the composite motion produced a helical scan, the effective pitch of which could be varied. For this test, the rotational speed was preset at one revolution per second. The translational speed of the carriage was adjusted so that, with transducers of 1/4-inch diameter, an overlap of 1/16 inch could be obtained.

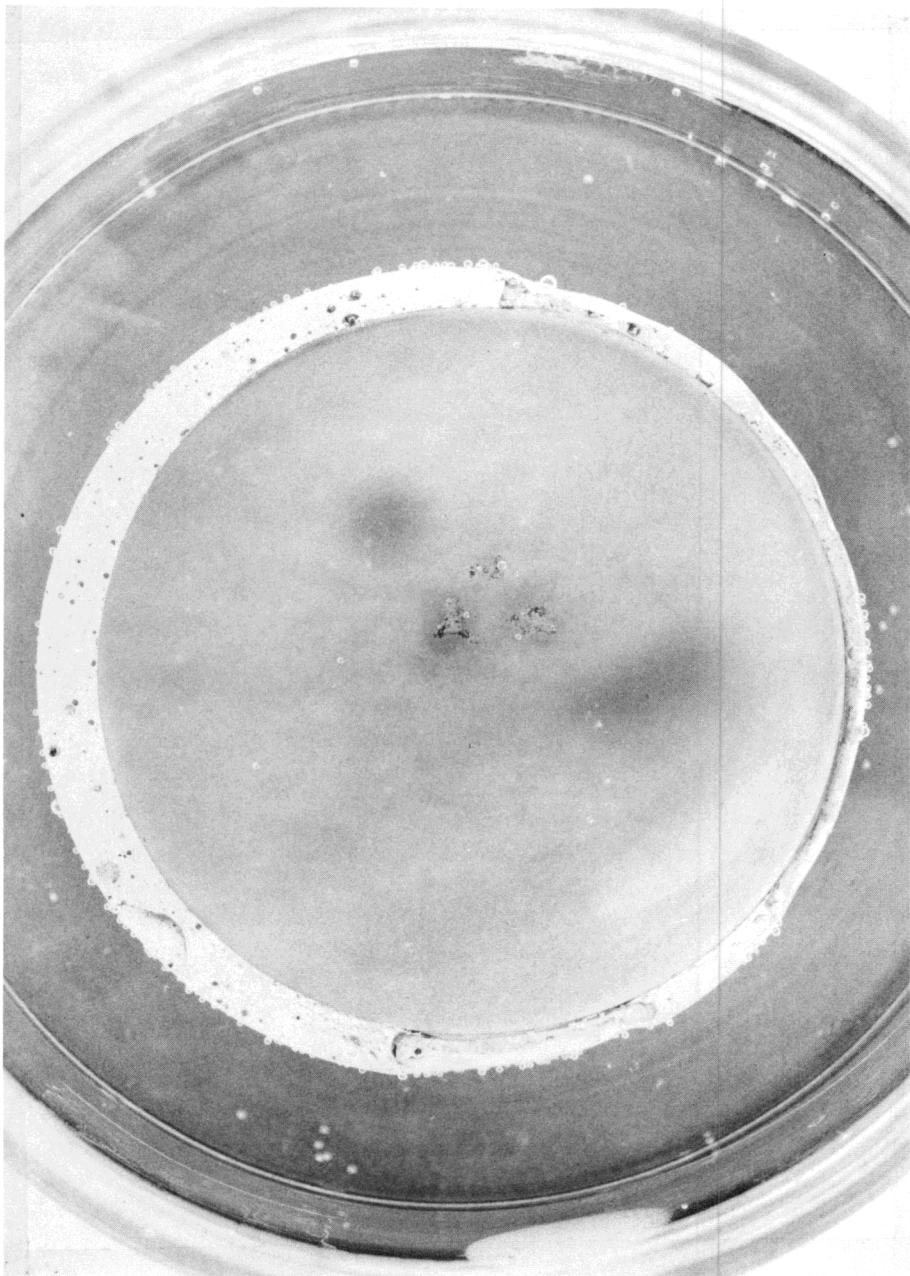
Figure 2
Cut-away Section of Casting Showing
Shrink Area in Center of Casting.

In order to correlate the recorded information with the defects in the material, a casting was selected at random and several recordings were made at various levels of sensitivity. This casting was then sectioned, polished and inspected. The type of defect which was considered detrimental can be seen in Figure 2. The transverse cut from the top of the castings revealed an area of shrink which extended into the casting for a distance of approximately 1.3 to 2 inches. The gate level of the ultrasonic equipment was then preset so that this defect would be recorded. A photograph of two recorded traces can be seen in Figure 3. The trace on the left indicates by the white spots and lines the presence of shrink areas. The trace on the right shows a casting free from shrink area. From the trace it was also possible to determine the approximate depth of the defect. By virtue of the fact that the inspecting crystals were positioned so that the transmitted ultrasonic energy passed through the middle of the casting, any defect centrally located would attenuate the energy during the complete revolution of the casting. An example of this can be seen as white bands in trace H483-8 of Figure 3. If the flaw was not centrally located, the attenuation would occur only during the time the revolving flaw passed before the inspecting crystals. This image would be repeated on the trace, since the flaw was viewed twice for every revolution of the casting.

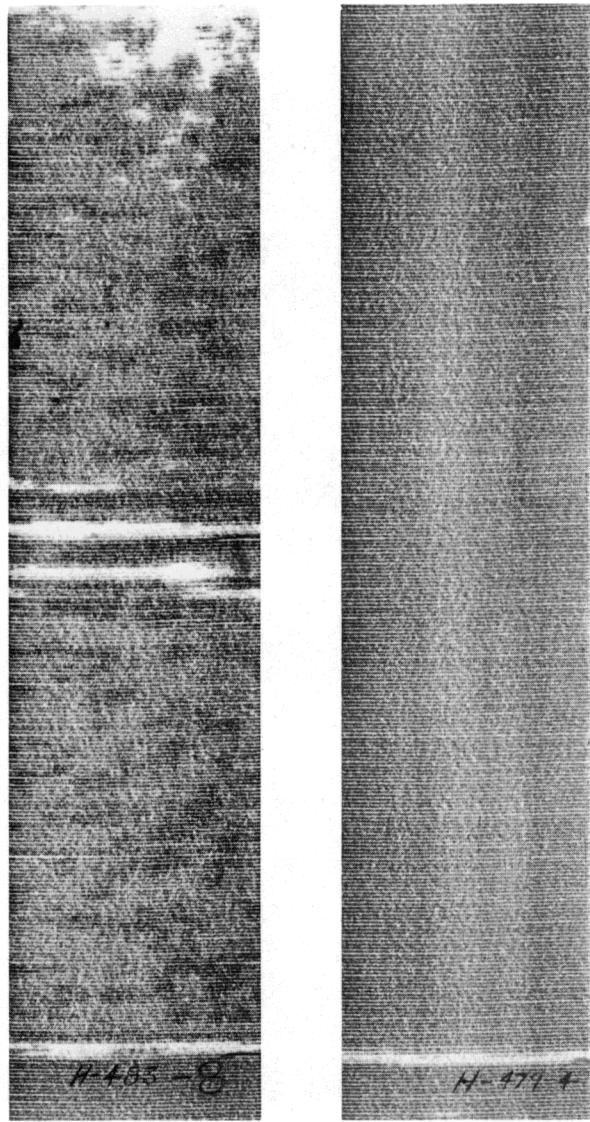
Figure 3

Recorded Traces of Two Castings. Trace at left indicates by white spots and lines the presence of shrink areas. Trace at right indicates sound casting. The white band near the bottom of the trace indicates the end of the billet.

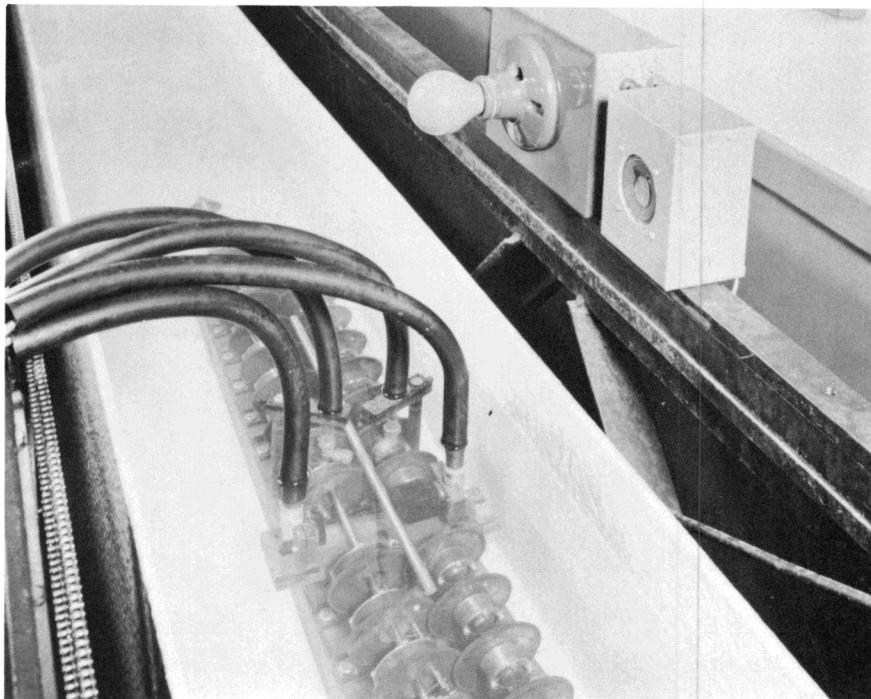
Figure 4

Test Apparatus Showing Roller Assembly Inspecting
Transducers and Alarm Systems

To test the fuel and blanket rods a double roller feed assembly was designed and fabricated as shown in Figure 4. The roller assembly measured 3 feet in length, 8 inches in width and 6 inches in height. The rollers were 3-inch, rubber-tired aluminum wheels, arranged in two rows. Each pair of diametrically opposed rollers were mounted on one common swivel bracket. All the brackets were ganged to one longitudinal shaft so that the relative angle of the rollers with respect to the center line of the assembly could be changed, thus providing a means whereby the effective translational pitch of a specimen mounted on the rollers could be varied. One row of rollers was powered by a common torsion shaft. The other row acted as idlers. Each roller could be independently adjusted to compensate for misalignment. This adjustment feature also made it possible to vary the overall spacing of the rollers so that cylindrical specimens of various diameters could be tested. In operation, the roller assembly was positioned in the tank of the $10\frac{1}{2}$ -foot ultrasonic scanner.(5) A belt joined the pulley on the roller assembly to the variable speed output shaft on the scanner. By varying the angle of the rollers and speed of the drive shaft, the translational speed and pitch of the fuel and blanket rod could be preset.

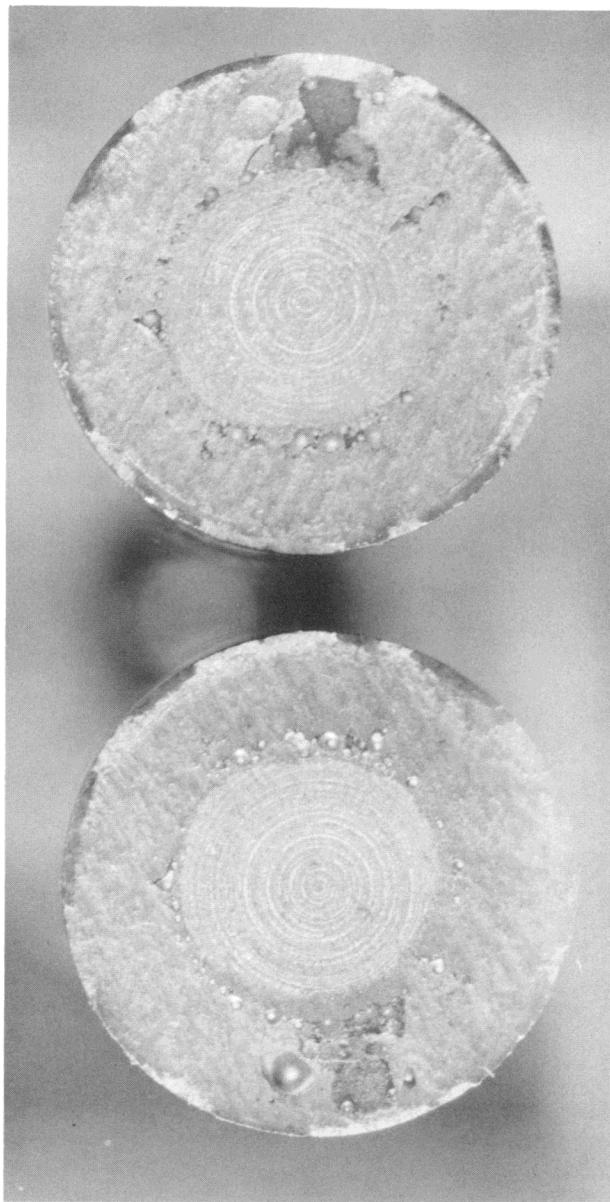
Section Bond Fracture Revealing a Bonded Interface of Less than 60% Total Area.

As a means of establishing a correlation between the nonbond area and the received ultrasonic energy, several samples of fuel elements, which had purposely been subjected to various melting temperatures by induction heating, were prepared. After the section bonding had been tested and recorded, the junction was fractured and the nonbond area was measured. Figure 5 is a photograph of a section bond interface where less than 60% of the area had fused. The ring effect visible in the middle of the rod is due to a machining operation prior to assembly and welding. In Figure 6 the fused area was greater than 70% and in Figure 7 the area is estimated greater than 80%.

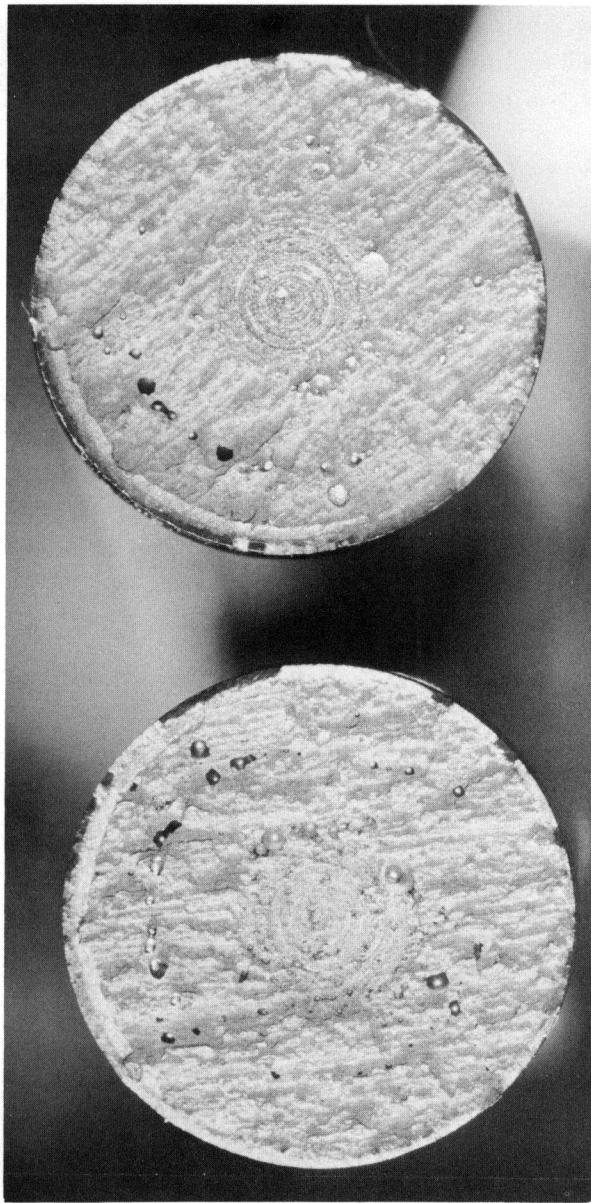
Figure 6

Section Bond Fracture Revealing
Approximately 70% of Area Bonded.

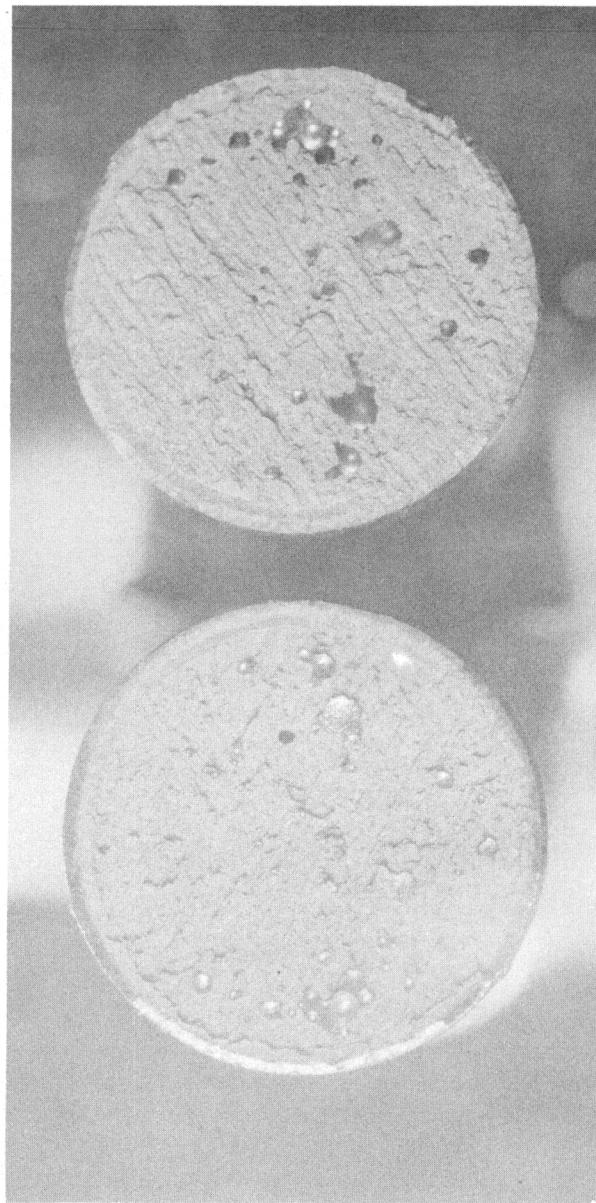
Figure 7

Section Bond Fracture Showing Inter-
face Bonding in Excess of 80% Total
Area.

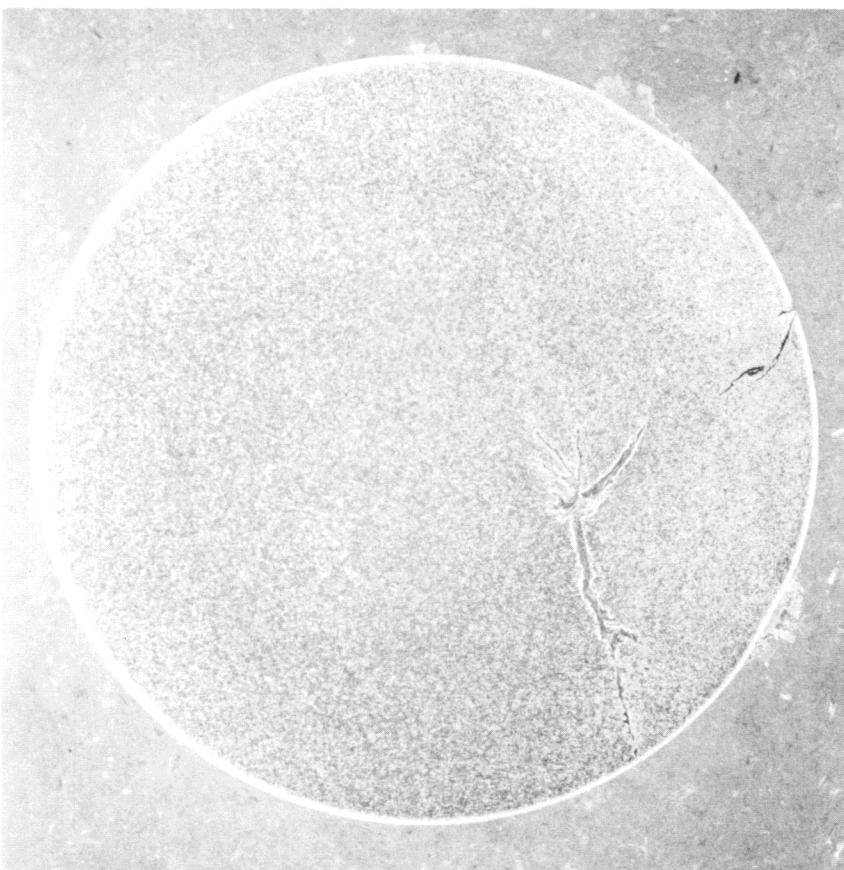
Cut-away Section
of Zircaloy Rod
Showing Cracks
and Breaks

The $1\frac{1}{2}$ -inch end caps which were welded to fuel-bearing rods were fabricated from extruded Zircaloy rods, 0.403 inch in diameter. In the process of induction welding the caps to the fuel assembly, it was noted that certain caps showed the presence of the star cracks. As a means of detecting this type of defect, the Zircaloy rod was subjected to an ultrasonic inspection. The existing scanning equipment was adapted to the test. The core-to-clad nonbond test crystals were used to detect longitudinal cracks. The section bond test crystals served to detect peripheral cracks. The alarm systems of the two ultrasonic detection units were preset to trip on a sub-surface crack 10 mils in depth. Approximately 100 feet of Zircaloy rod were inspected in this manner. In this test, the roller conveyor was manually operated so as to permit the operator to mark the areas indicating the presence of cracks. Defective areas were cut out of the rods and the remainder used in the manufacture of the fuel elements. Figure 8 shows an enlarged view of cracks in the Zircaloy rod which were detected by this test technique.

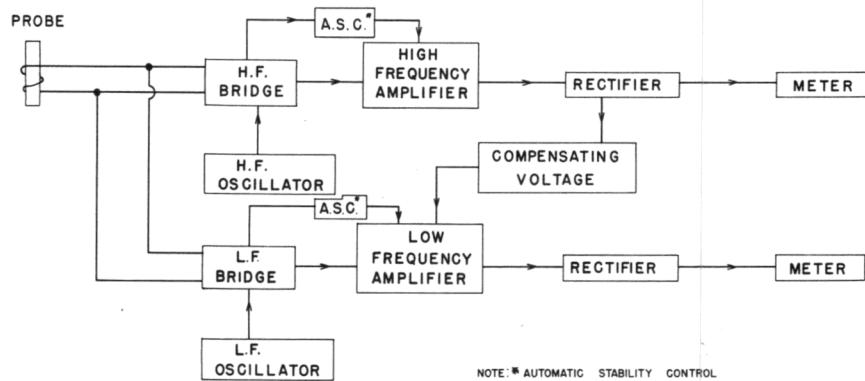
Figure 9
Block Diagram of System

It is simpler to consider each channel of the system separately. In the block diagram Figure 9, the elements of each channel are shown according to their function and not necessarily according to position in the circuit diagram. In the high-frequency channel, a sinusoidal voltage of 262 kc is generated and applied across the probe winding. The probe forms part of a bridge circuit which is balanced when the probe is far away from any metal. Any change in the field about the probe causes an

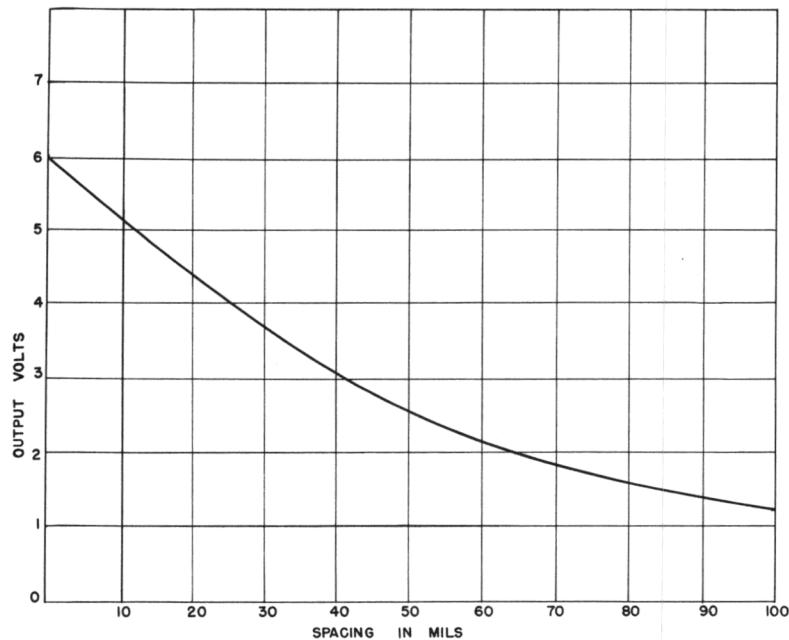
Figure 10
The High-Frequency Channel Output Voltage Plotted as a Function of Probe-to-Metal Spacing

The high-frequency channel output is practically independent of the cladding thickness, since a frequency of 262 kc is too high to be effective for the measurement of the cladding thickness.

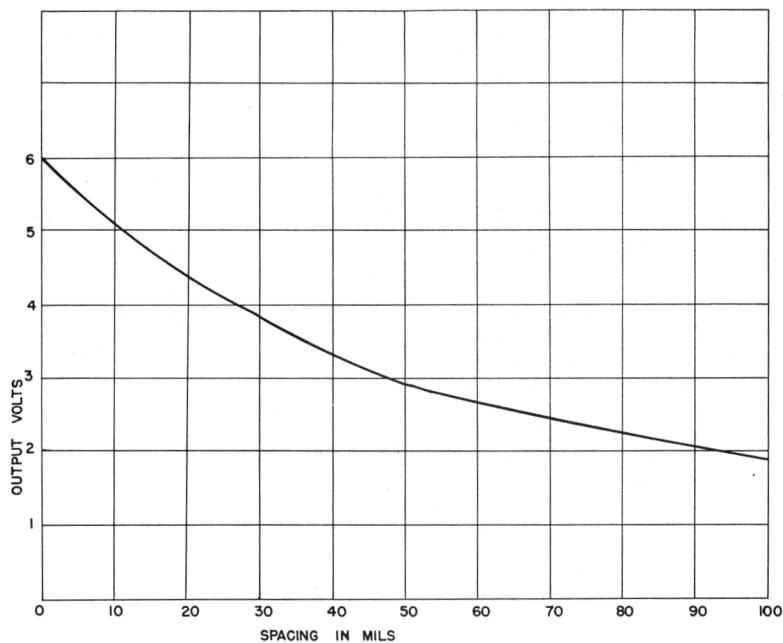
Figure 11

Amplified Low-Frequency Bridge Output Voltage Plotted as a Function of Probe-to-Metal Spacing

The other is the dependence upon probe-to-metal spacing of the low-frequency channel sensitivity to a given change in cladding. Figures 13 and 14 show how Figures 11 and 12 look after probe-to-metal compensation has been added. Details of the compensation process are given in Appendix IV of ANL-5861.

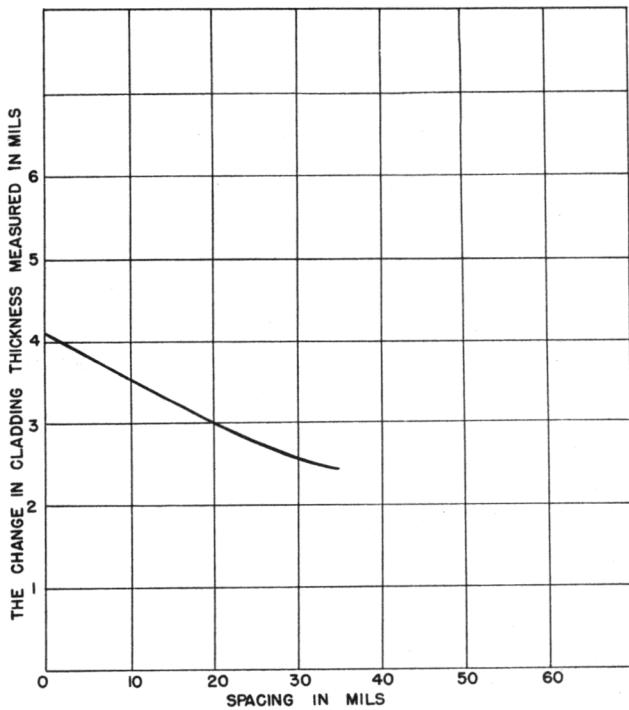
Figure 12

Low-Frequency Channel Sensitivity
Plotted as a Function of the
Probe-to-Metal Spacing

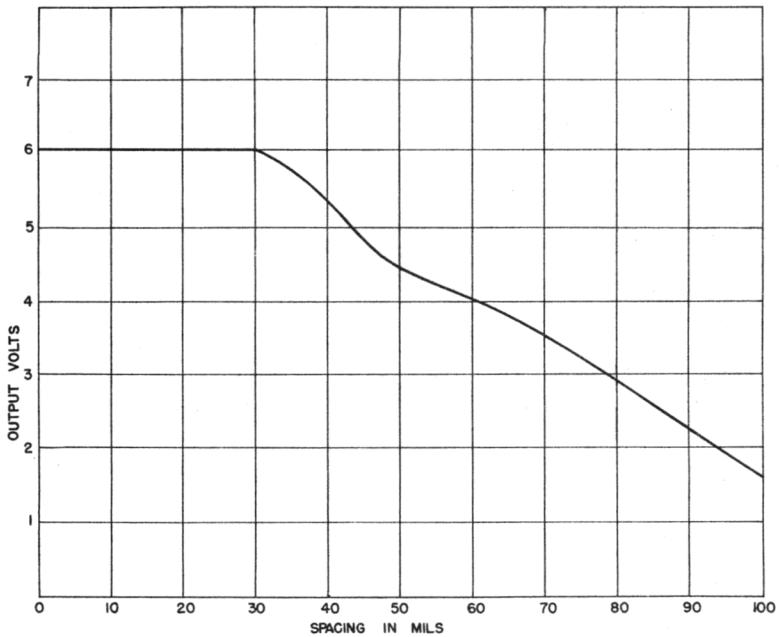
Figure 13

Low-Frequency Channel Output Voltage
Plotted as a Function of the
Probe-to-Metal Spacing. Compensation Used.

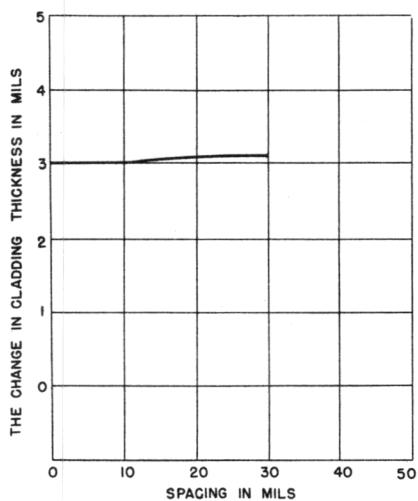
Figure 14

Low-Frequency Channel
Sensitivity Plotted as
a Function of the
Probe-to-Metal Spacing.
Compensation Used.

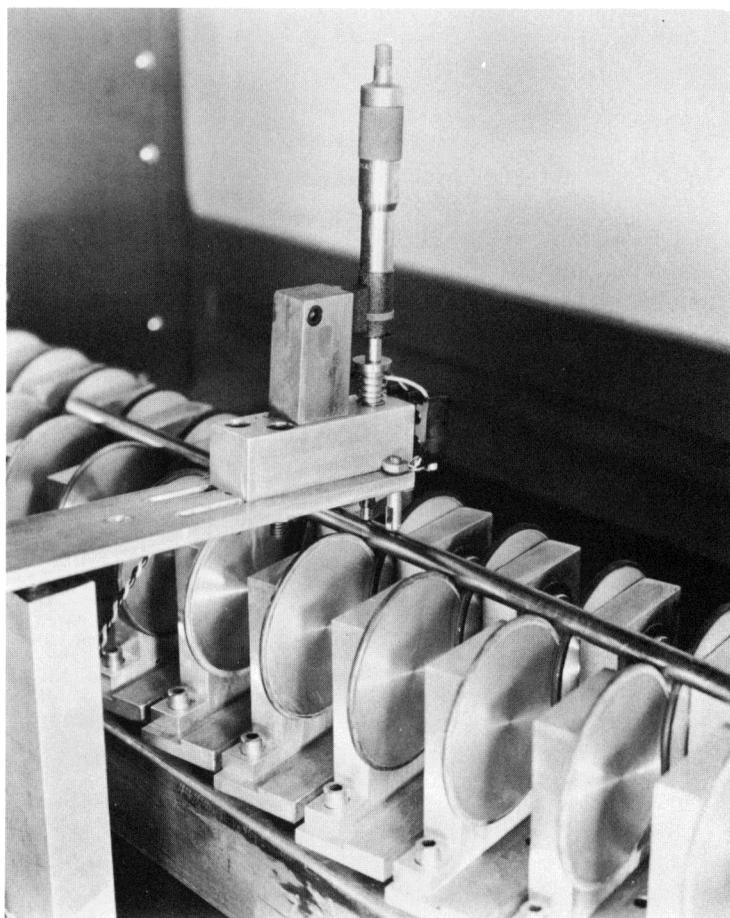
A Typical Probe Shown in Position over a Fuel Rod

The probes used in this application were wound on 1/4-inch or 3/16-inch cylindrical ferrite forms. The winding consisted of a single layer of #40 enameled wire. Single-layer windings usually possess smaller temperature coefficients of inductance than do multilayer windings. A typical probe is shown in Figure 15 in position over a segment of fuel rod. Probe inductance is not critical; a number of probes of widely different inductances have been used in this particular test problem with no important adjustments necessary, except balance of the bridges and the readjustment of the high and low-frequency channel gains.

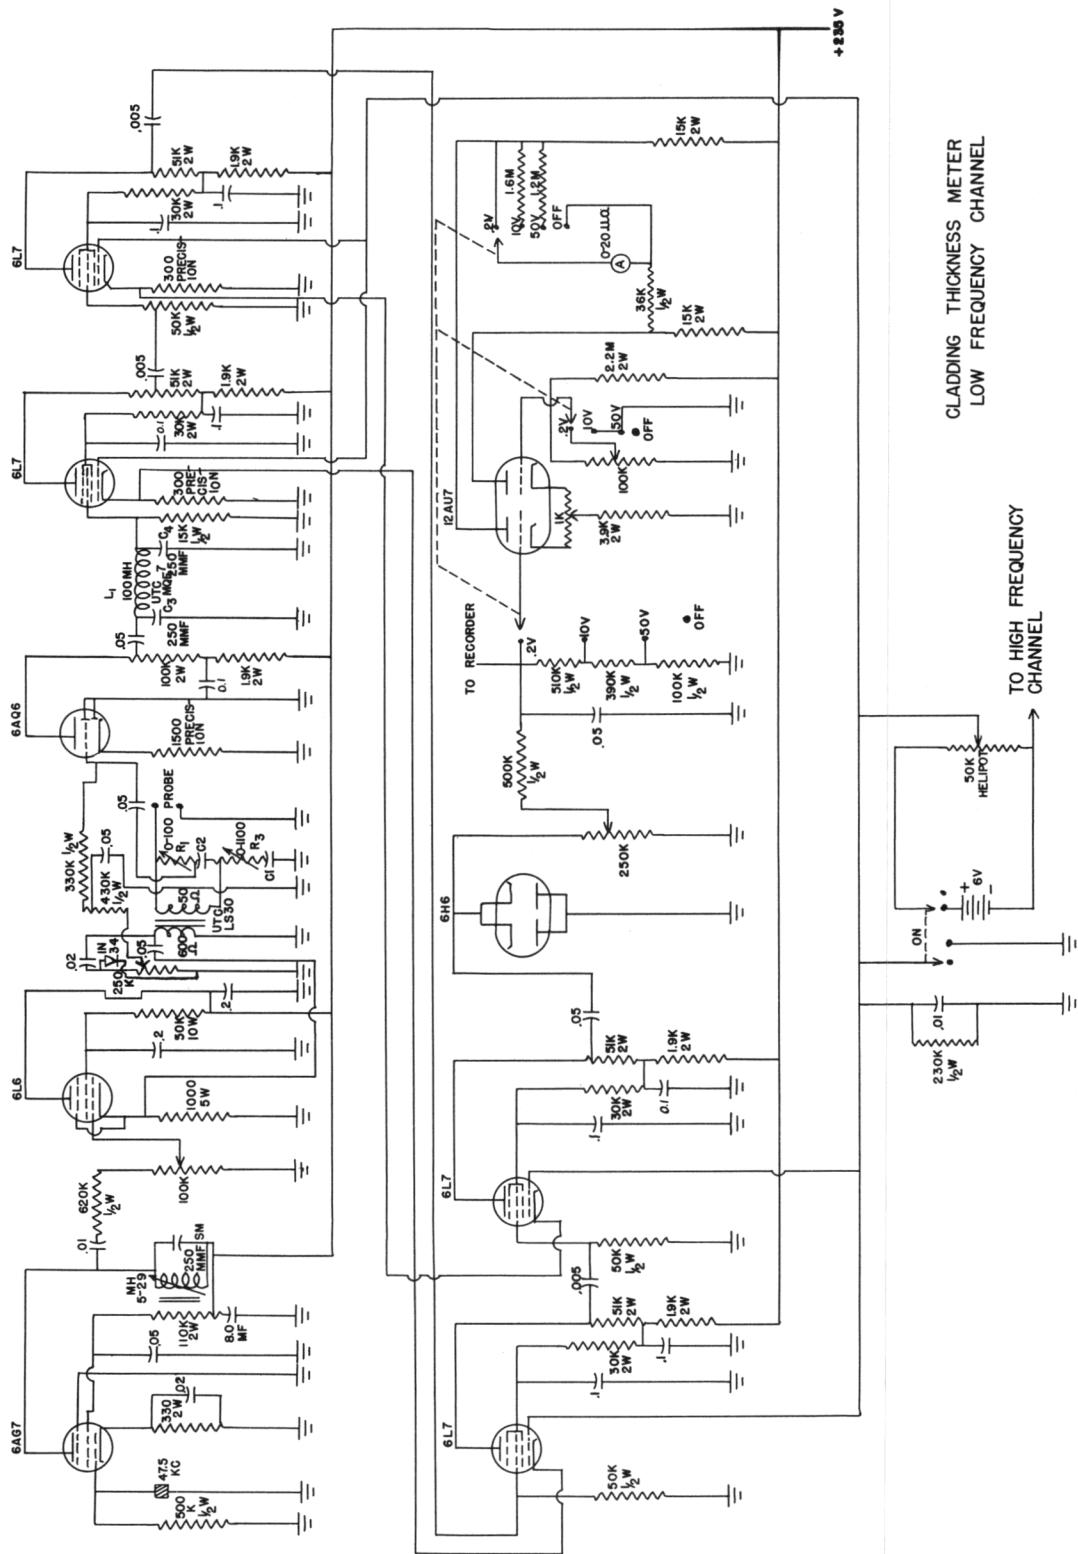
Figure 10
Circuit Diagram of the Low-Frequency Channel

The circuit diagram of the low-frequency channel is shown in Figure 16, and that of the high-frequency channel in Figure 17. Since the probe is a common element of each bridge, low-frequency voltage is present

in the output of the high-frequency bridge and vice versa. These undesired frequencies must be filtered out. This is done early in the amplifiers since the bridges are not balanced with respect to these frequencies and their relatively high amplitude would overload later stages of the amplifiers. The low-frequency bridge is always balanced first, since it affects the balance of the high-frequency bridge to a large degree, while the reverse effect is only slight. The bridges are balanced by means of the variable resistors R_1 and R_3 in each bridge. The crystal oscillators furnish the sine wave voltages needed to drive the probe. No particular frequency stability is needed; crystals are used in this instrument because the amplifiers in earlier models were sharply tuned. The crystal oscillators have been carried over from the earlier models. RC oscillators have been used successfully. The oscillators should provide voltage of less than 5% distortion. Changes in oscillator output amplitude are compensated by the IN34 diodes in each channel and their associated circuitry. Part of the oscillator output is rectified and fed to the 6AQ6 stage in each channel. Any change in oscillator output changes the gain of this stage so as to maintain the output of the 6AQ6 stage independent of routine variations in oscillator output. The 262-kc voltage is filtered out of the low-frequency channel amplifier by the low pass filter $L_1C_3C_4$. The doubly tuned transformer T_1 performs an analogous function for the high-frequency channel. The output of each channel is fed to separate difference voltmeters with several ranges. Two of the ranges on each voltmeter are useful when balancing the bridges. The most sensitive scale on the low-frequency channel difference voltmeter is calibrated directly in mils of cladding, while the most sensitive scale of the high-frequency channel difference voltmeter is used to keep check on the probe-to-metal spacing. An output from the low-frequency channel can be connected to a recording voltmeter.

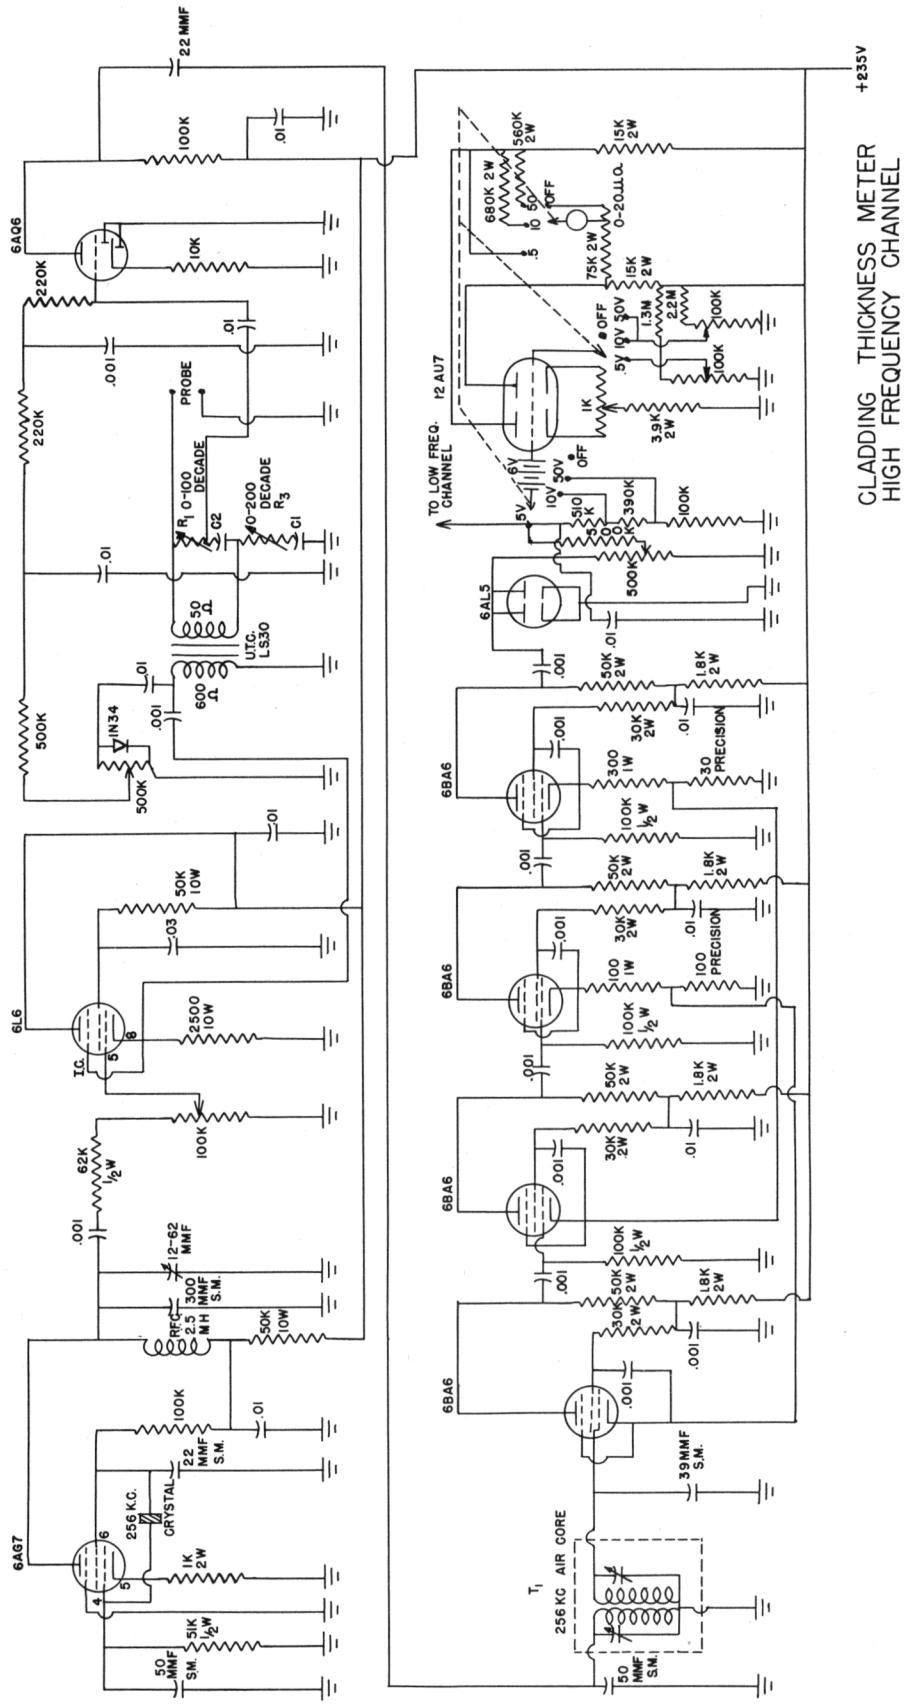
Figure 17 Circuit Diagram of the High-Frequency Channel

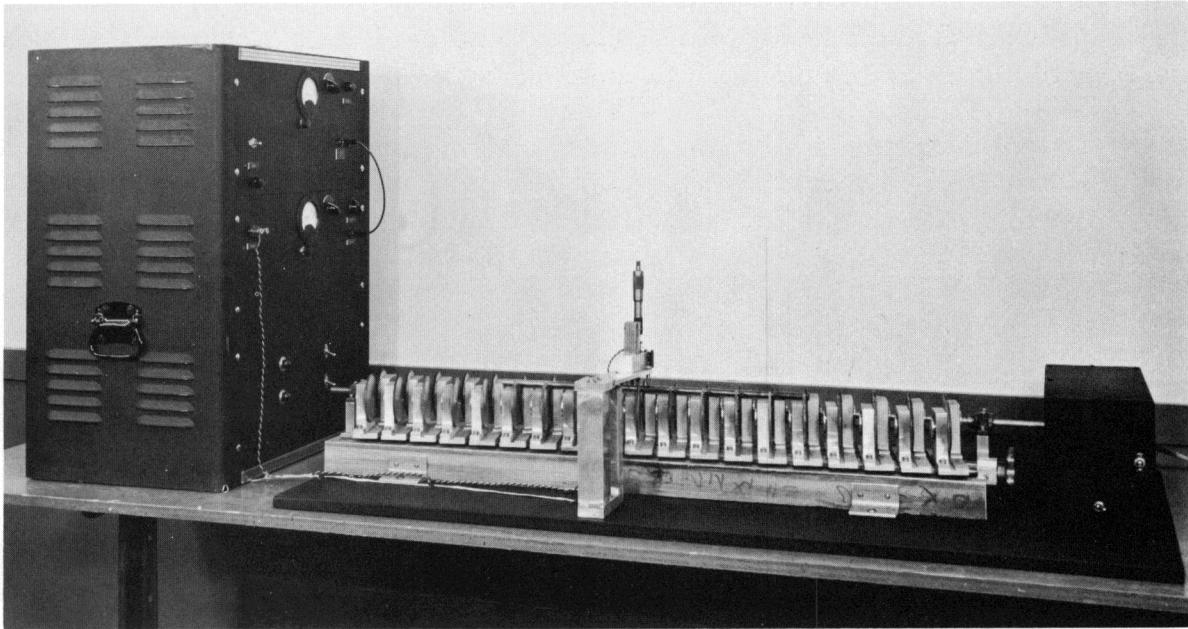
Figure 18
The Complete System

The instrument and conveyor to move the fuel elements past the probe are shown in Figure 18. Skewed wheels, equipped with rubber tires, rotate the rod and at the same time provide it with motion along its longitudinal axis. The pitch of the wheels is set so that every portion of the rod is inspected with some overlap included. No trouble was experienced in maintaining the fuel elements in the proper position for testing as they passed under the probe. Probe-to-metal spacing was easily held within the range over which nearly perfect compensation could be achieved. The probe inspected an area roughly equal to its cross-sectional area, since changes of cladding thickness which lie beyond the projection of the probe on the fuel rod influenced the measurements, while the probe was relatively insensitive to the thickness of the clad which lay immediately beneath its center. Inspection of a fuel element 19.8 inches long required about 30 seconds.

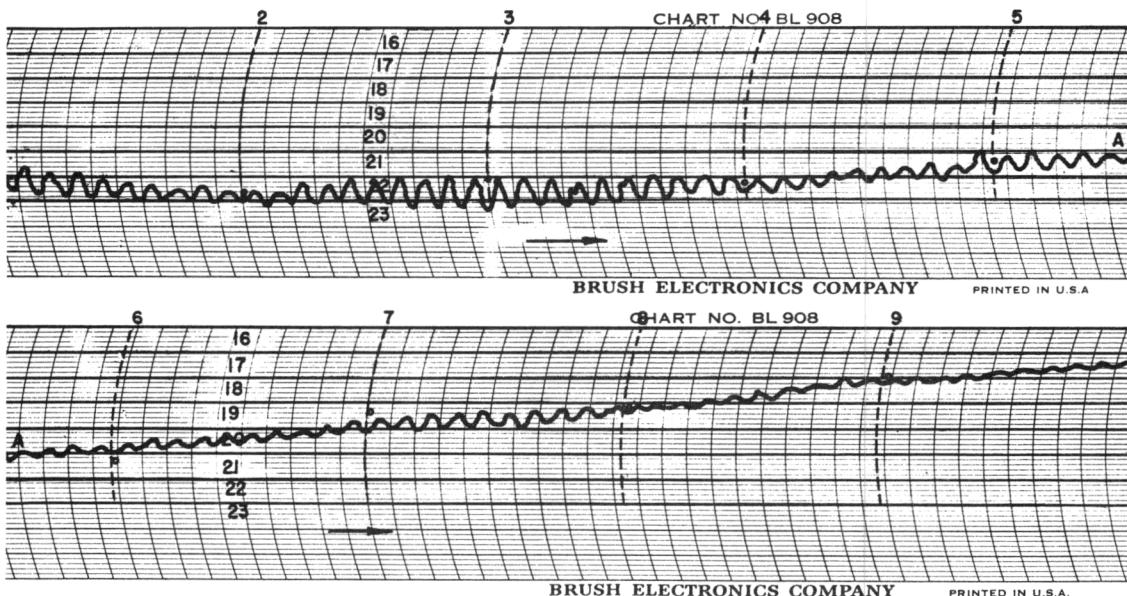
A Pen Recording of the Cladding Thickness of a Rod

Figure 19 shows an actual recording of the cladding thickness of a fuel element near the end of the extrusion. The heavy taper of the cladding made this region particularly suitable for sectioning. Exact comparison between nondestructive measurements and destructive measurements is impossible since the probe measures the average cladding thickness over a certain area while measurements made by the measuring microscope are obtained point-by-point. The oscillations of the trace in Figure 19 were caused by a slight eccentricity of the cladding. The dots shown in the trace indicate the average cladding thickness obtained when measurements were made on the cross section of the rod which lay immediately underneath the centerline of the probe at that time. The average cladding thickness was based on four measurements around the circumference. The probable difference between nondestructive and destructive measurements based on this tape is 0.25 mil.

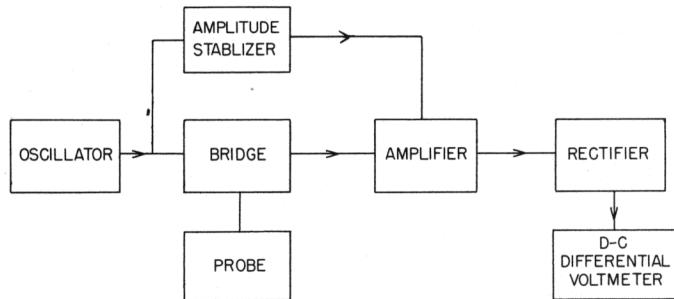
Figure 20
Block Diagram

The design of the EBR-I Mark III reactor included zirconium wire spacers for the fuel elements. An eddy current technique was used to check the quality of the zirconium wire for cracks and voids. The instrument used was a modification of the instrument discussed in Chapter III of ANL-5861, except that only the amplitude variations of the bridge output were used. A block diagram of the eddy current instrument is shown in Figure 20.

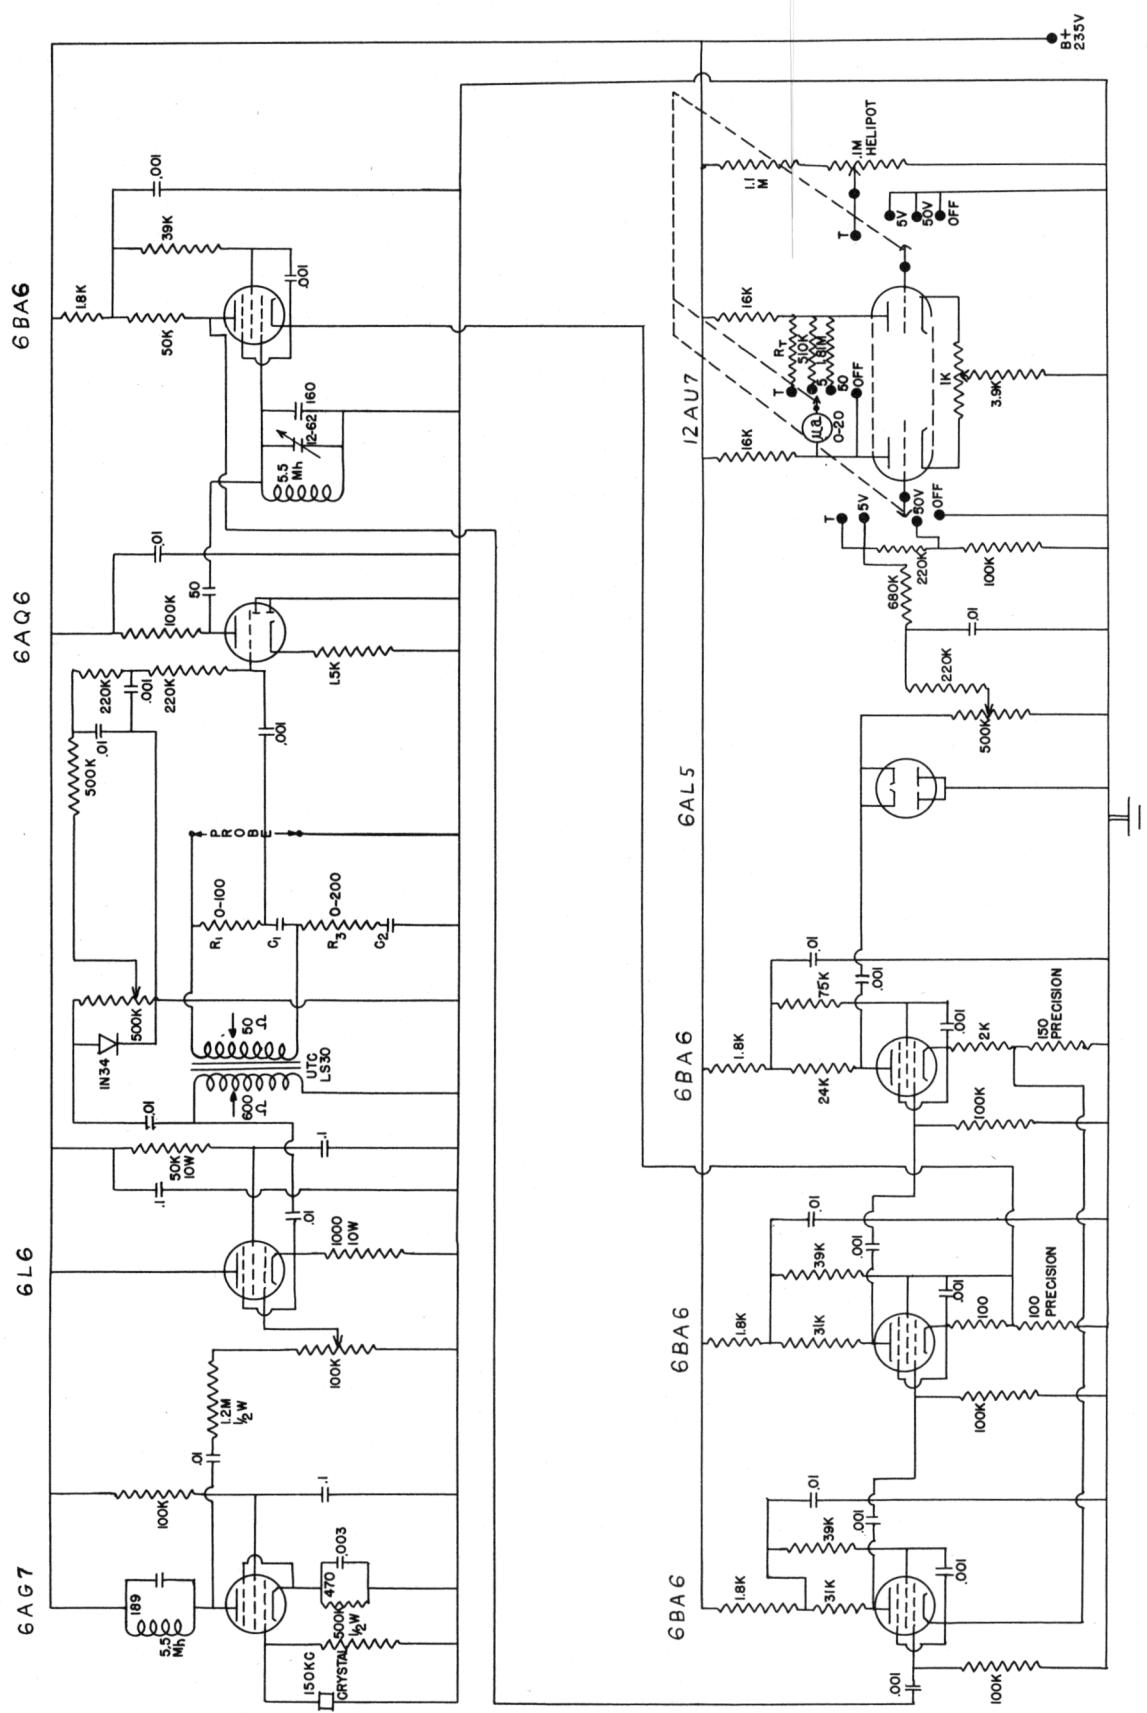
Figure 21
Circuit Diagram

The change in the impedance of the test coil was measured by the modified Owens bridge circuit shown diagrammatically in Figure 21. The circuit was composed of the test coil, two variable resistances, and two fixed capacitances. The two variable resistances were used for the final balancing of the bridge. Determination of the capacitance values will be discussed later.

The unbalanced voltage from the bridge circuit was amplified with the five-stage amplifier shown in Figure 21. A tuned circuit from the grid of the second stage to the ground was employed to eliminate the

varying the ratio of C_1 to C_2 . The capacitances C_1 and C_2 were determined experimentally for each coil. The correct values for the coil in this application are shown in Figure 21. Since the magnitude of the impedance change of the coil depended upon the electrical properties of the wire, the output voltage of the instrument also depended upon these properties. The electrical properties of the zirconium were fairly constant and no complications were introduced.

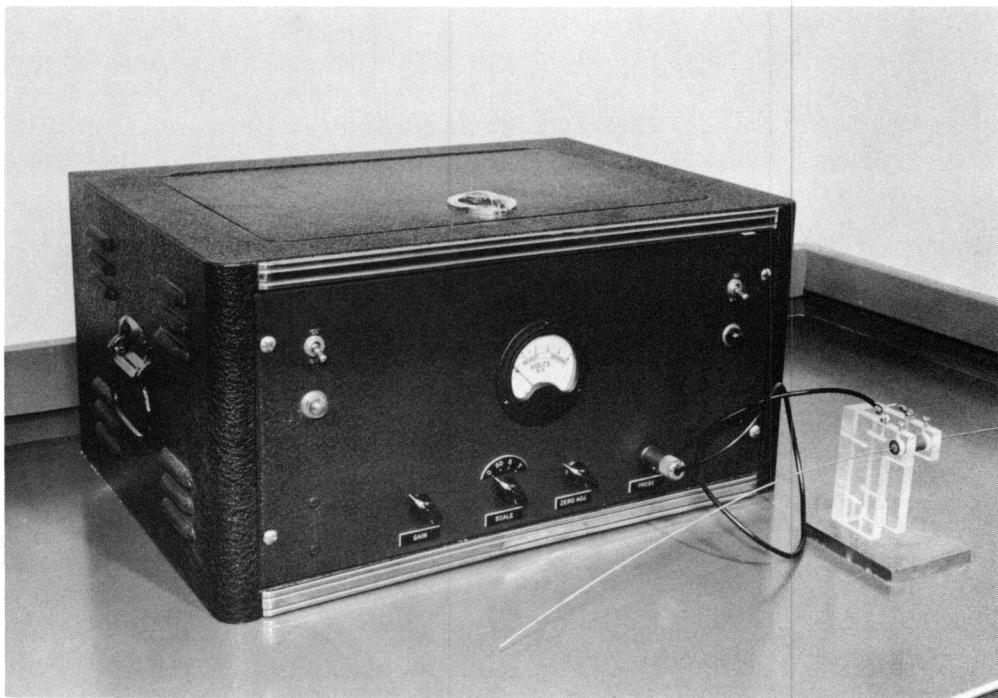
Figure 22
Photograph of the Completed Instrument

undesirable harmonics. The last four stages were coupled, by several degenerative feedback loops, to improve the stability. The amplifier output voltage was rectified and the DC output voltage was adjustable with the 500-kilohm variable resistance. The differential DC voltmeter in Figure 21 indicated the output voltage. The 50 and 5-volt scales were used for balancing the bridge and adjusting the output voltage for a given condition of unbalance. The test (T) scale was used for indicating the wire quality. When the meter was on the test scale, the variable resistance in the grid circuit of the 12AU7 balanced out a portion of the DC voltage. This allowed the remaining DC voltage to cover the entire meter range; thus the meter deflection was greatly increased for a given defect in the wire. A photograph of the complete instrument is shown in Figure 22.

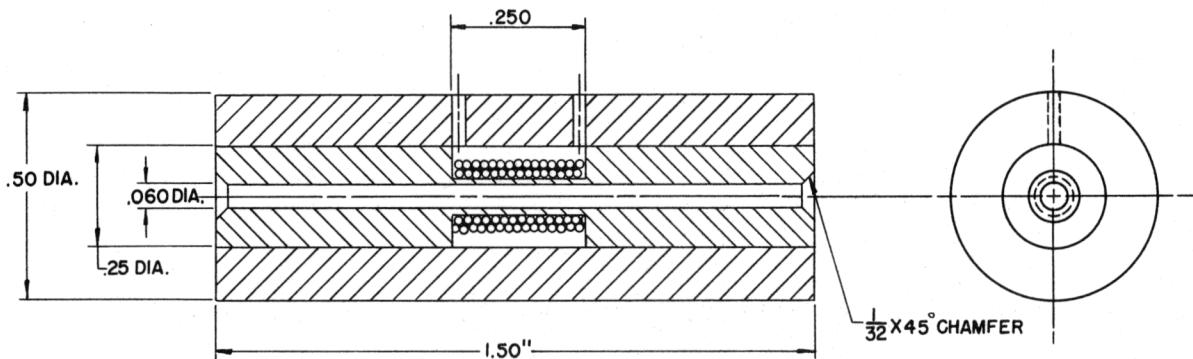
Figure 23
Test Coil Cross Section

The diameter of the coil that was used was about 0.015 inch greater than the wire diameter. The coil was close to the wire, and this greatly improved the sensitivity. The length of the coil was 0.188 inch. Since the length affected both the sensitivity and definition, this length was a good compromise for this application. The coil had two layers of number 40 wire wound on a nylon coil form.
