ANL-5893
Metallurgy and Ceramics
(TID-4500, 14th Ed.)
AEC Research and
Development Report

NONDESTRUCTIVE TESTING OF EBR-I MARK III
FUEL ELEMENTS AND COMPONENTS

May, 1959

ABSTRACT

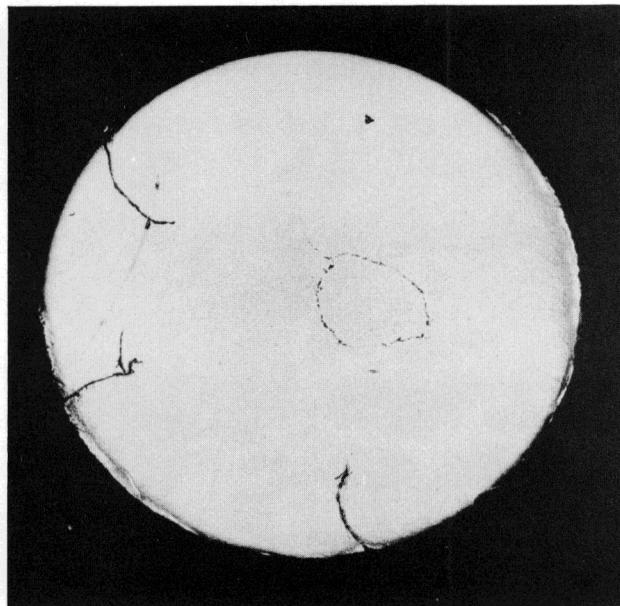
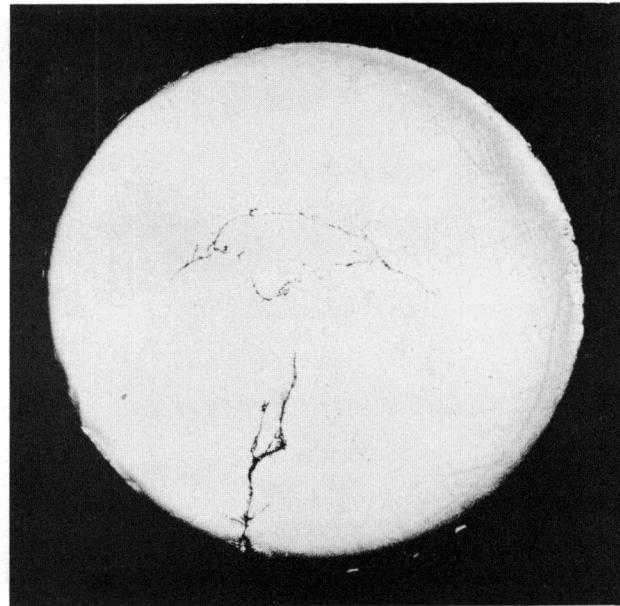
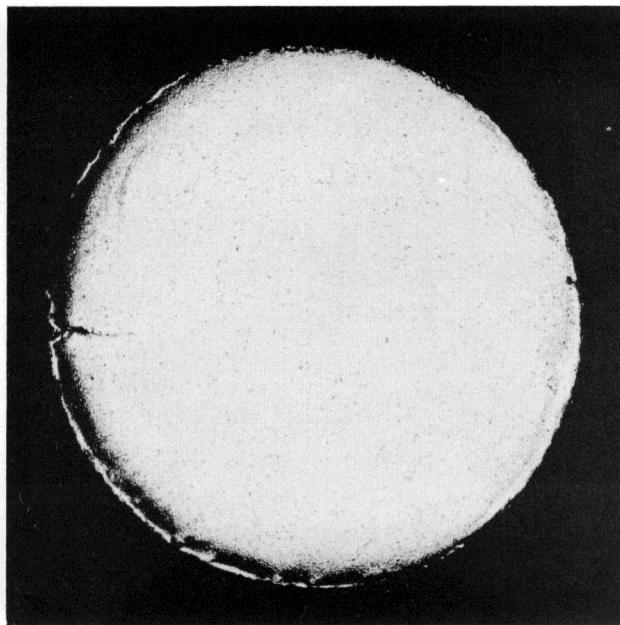
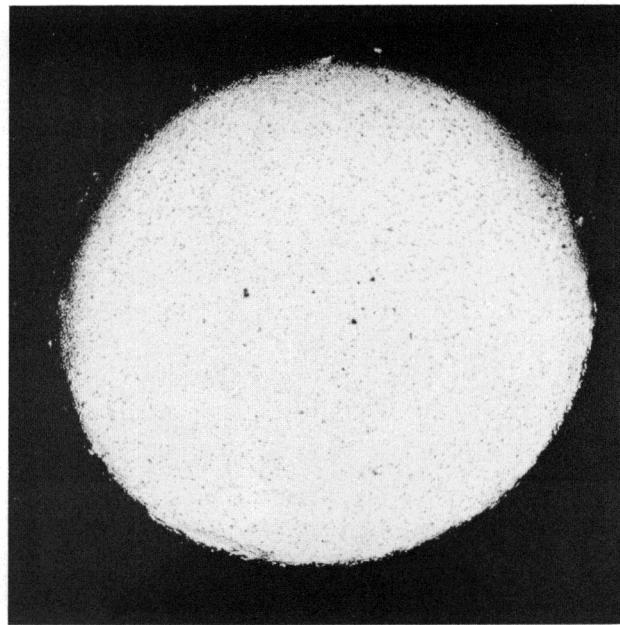
METER READING
STANDARD WIRE 5.0
TEST WIRE 0.0

METER READING
STANDARD WIRE 5.0
TEST WIRE 0.5

METER READING
STANDARD WIRE 5.0
TEST WIRE 2.0

METER READING
STANDARD WIRE 5.0
TEST WIRE 2.5

Figure 24
Wire Cross Sections and Corresponding Meter Readings

The defects in the wire appeared as cracks or voids along the length of the wire. The size of the crack or void determined the magnitude of the unbalanced voltage at the bridge terminals. The magnitude decreased as the size of the defect increased. Several typical cross sections of wire and corresponding meter readings are shown in Figure 24. A cross section of the standard wire is shown in Figure 25. The first two cross sections in Figure 24 were not etched, and this accounts for the smooth appearance of their surfaces.

To calibrate the meter test (T) scale, several wires were checked, and a complete range of voltage readings was obtained from the rectifier output. The wires were then sectioned at the points where the readings were taken, and the wire quality was determined. This gave two ranges of output voltage; 0.0 to 4.25 volts for the unacceptable wire, and 4.25 to 5.0 volts for the acceptable wire. To expand the range of acceptable wire, the test scale was calibrated for a full range of 2.5 volts. The value of the resistance (R_T) for this calibration was 0.2 megohm. The balancing adjustment in the meter circuit balanced out the undesirable 2.5 volts.

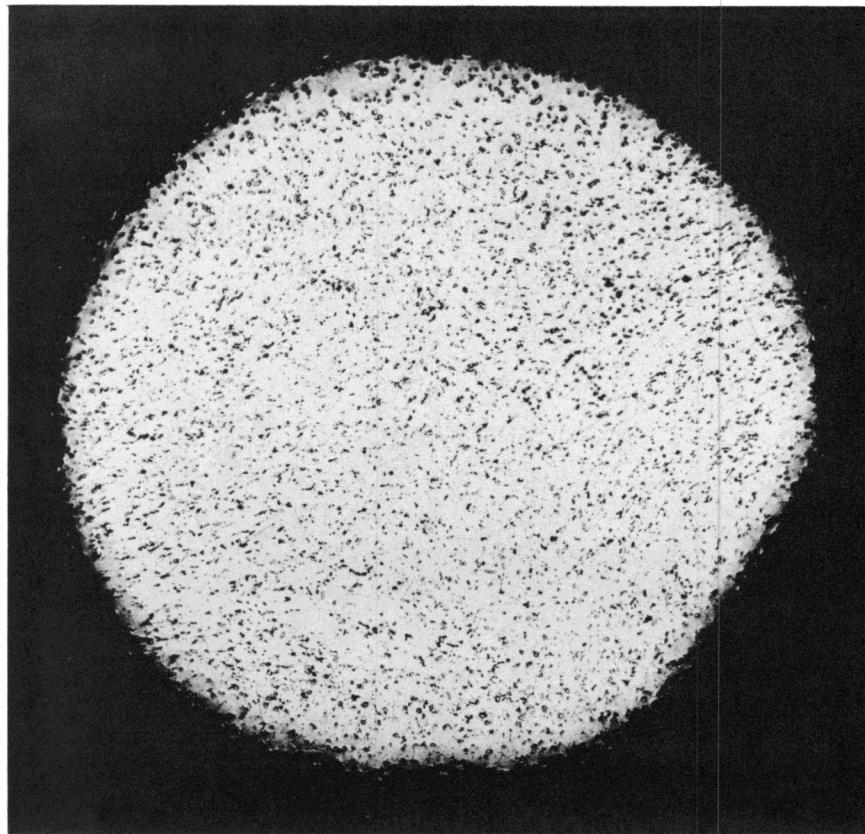
Figure 25

METER READING
STANDARD WIRE 5.0

Standard Wire Cross Section
