SNAP-21 PROGRAM, PHASE II

DEEP SEA RADIOISOTOPE-FUELED  
THERMOELECTRIC GENERATOR  
POWER SUPPLY SYSTEM

QUARTERLY REPORT NO. 4

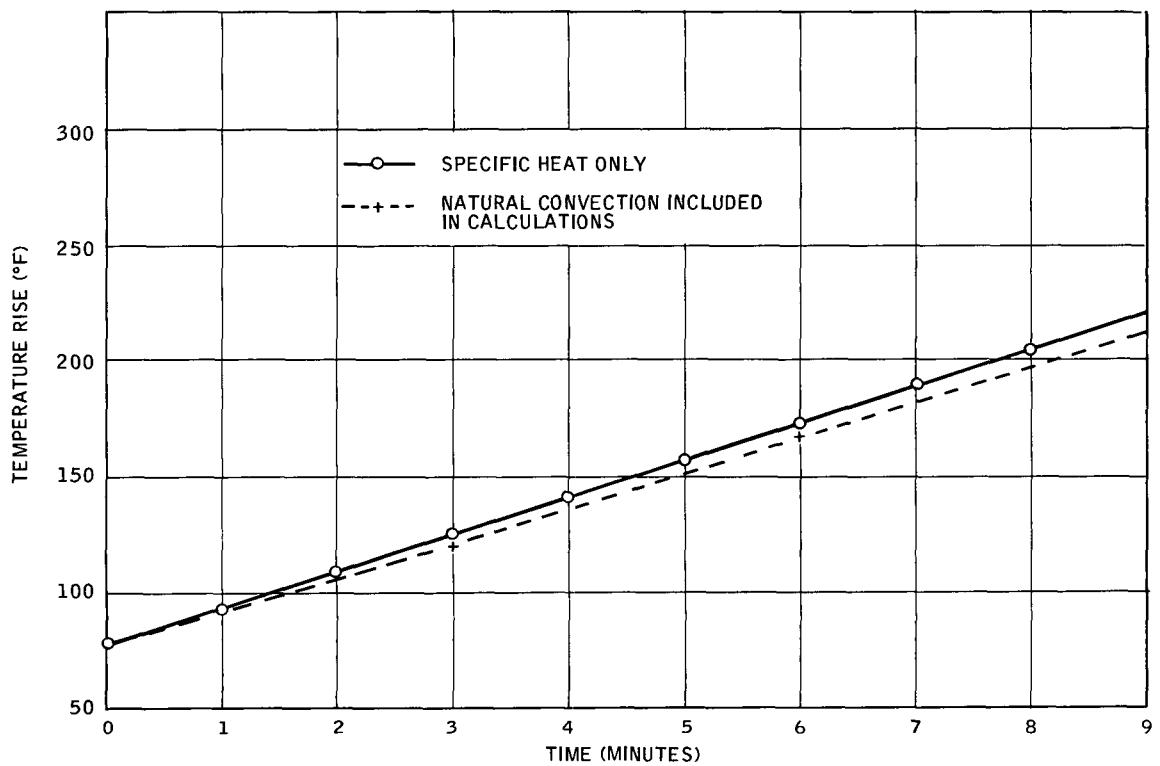
Figure 2-1. Temperature Rise of Fueled Capsule with Time

An analysis was performed to determine the minimum allowable time for transfer of the fuel capsule to the shield cavity before interference due to thermal expansion of the capsule occurs. Figure 2-1 shows the temperature rise of the capsule (203 watts) in air. Figure 2-2 indicates the rate of expansion of the capsule. The maximum dimensional tolerance on the capsule and the minimum tolerance on the mating surface of the inner liner (present designs) results in a clearance of 0.002 inch. Interference will occur in less than 6 minutes. Forced convective cooling, where the ambient air is moving at a velocity of about 5 ft/sec, can be used to dissipate 203 watts from the capsule so that no thermal growth occurs. However, a greater clearance (0.020 inch) for insertion is advisable for mechanical handling reasons and, with the greater latitude, capsule expansion should not pose a problem to insertion.

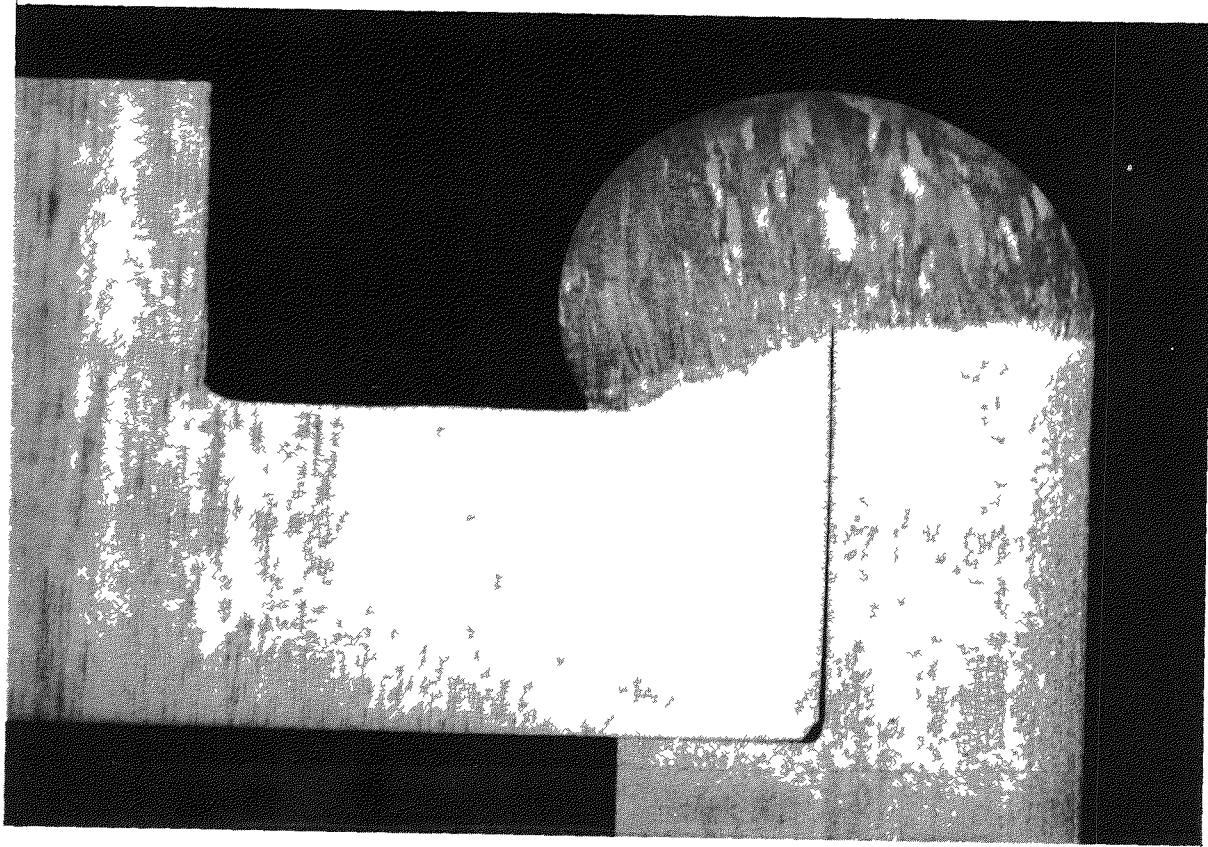
Figure 2-3 Typical Gas-Tungsten Arc Weld, 12X

A gas tungsten-arc weld typical of those previously sent to Pacific Northwest Laboratories (PNL) for evaluation is shown in Figure 2-3 for comparative purposes. First attempts at electron-beam welding resulted in welds similar to that shown in Figure 2-4. The conditions were 150 ma at 30 kv and 18 in. /min travel speed. Full penetration of the joint is evident; however, gross surface melting has resulted in undesirable weldmetal overhang. Increasing the welding speed to 30 in. /min and lowering the current to 125 ma results in somewhat less penetration (Figure 2-5) and no weldmetal overhang.

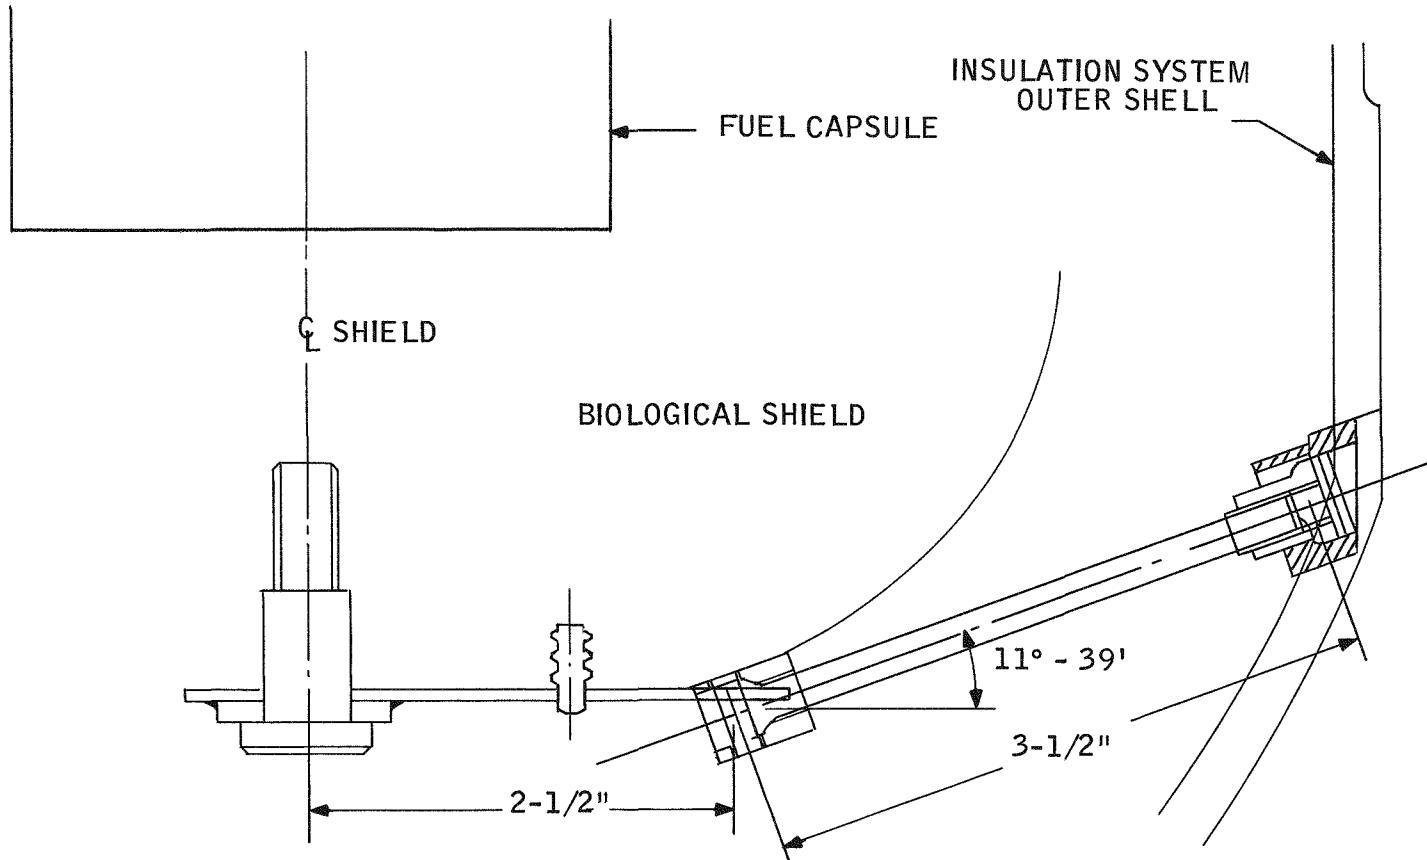
Figure 2-6. Tension Rod Support Concept

The shield support system must limit movement of the biological shield with respect to the outer case, to prevent the neck tube from buckling. The method selected to meet this requirement is a tension tie rod system in conjunction with a monocoque neck tube, as shown in Figure 2-6. Using the best available data, molybdenum was initially selected as the spider material because its low coefficient of expansion would allow a low tension tie rod angle. This would provide a high ratio of horizontal force to tie rod load, thus permitting a minimum tie rod diameter and, therefore, minimum heat leak. A detailed analysis of the molybdenum spider indicated, however, that because of the large variation in coefficients of thermal expansion between the shield material and the spider, it would be impossible to maintain the minimum relative movement within the system and stay within the elastic range of the spider materials. Because it was impossible to predict the failure point of a structural member being cyclically loaded beyond the yield point, this spider material was abandoned.

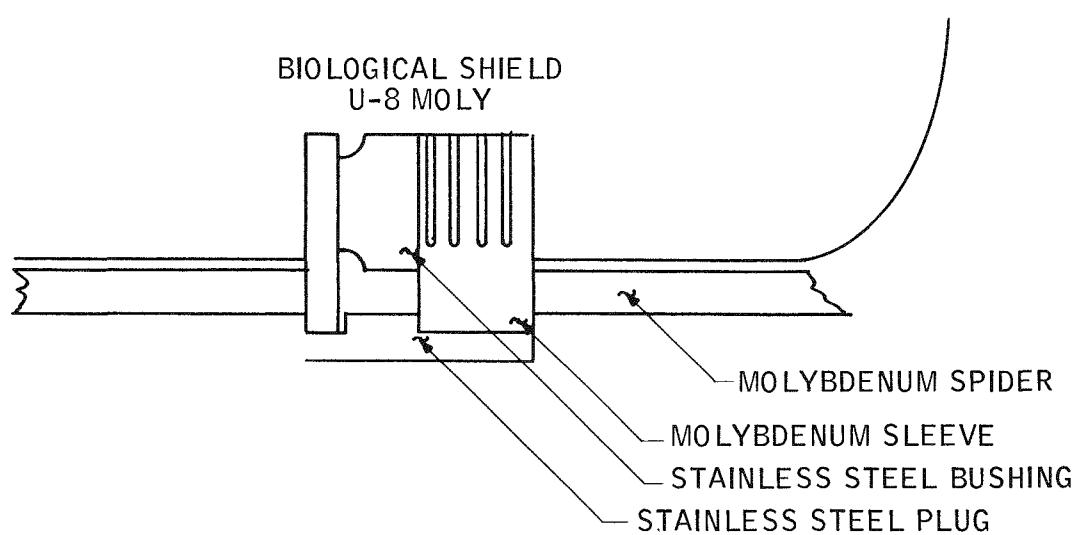
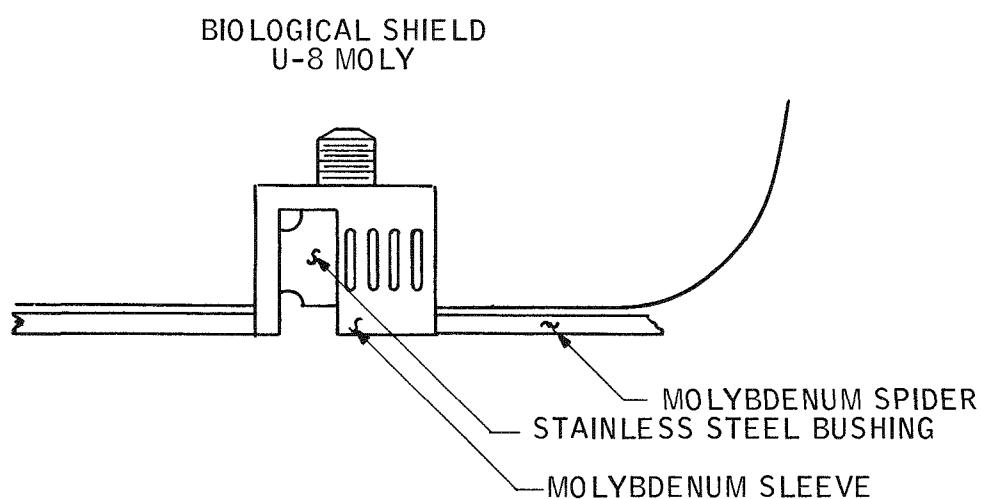
Figure 2-7. Two Shields to Spider Attachment Concepts

Two concepts which were considered for the shield to spider attachment are shown in Figure 2-7. These were unacceptable because it was impossible to design a rigid connector to prevent shield deflection and yet stay within the elastic range of the spider components under cyclic loads. The unknown strength characteristics of materials under cyclic loads at high temperatures makes this technically unacceptable.

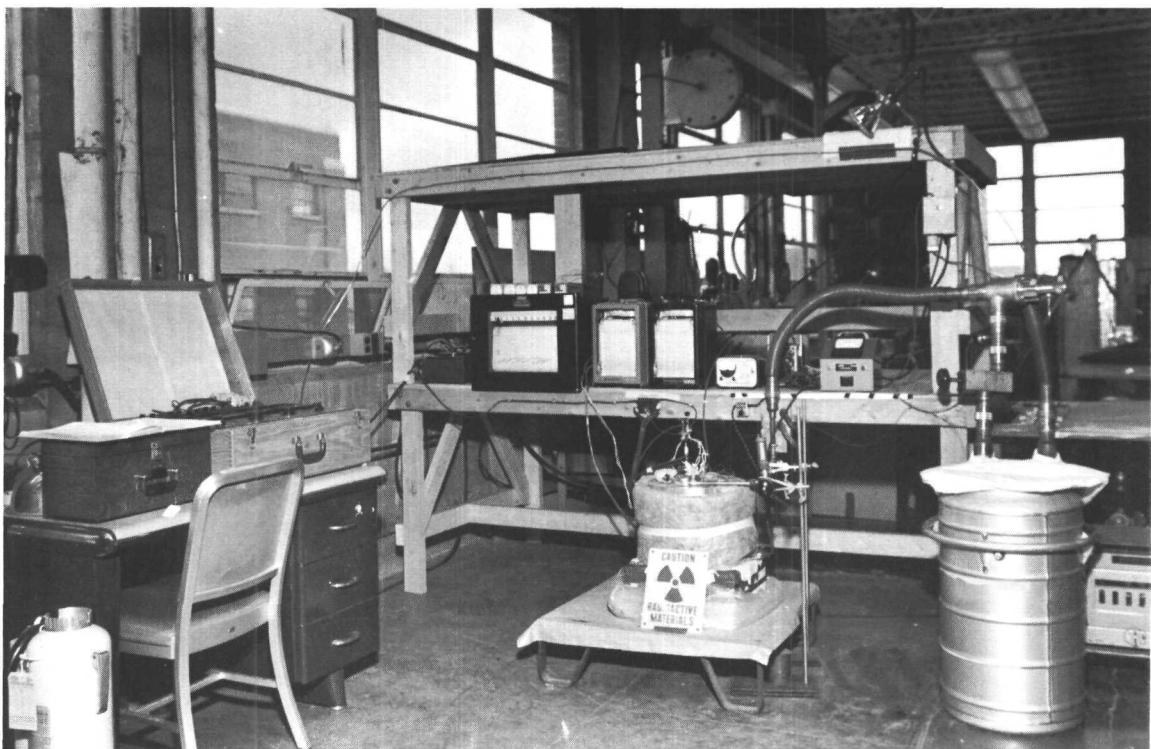
Figure 2-8. SNAP-21 Prototype Unit – Thermal Performance Test Setup

The SNAP-21 prototype insulation system which has been undergoing thermal conditioning is shown on test in Figures 2-8 and 2-9. At the end of the last reporting period, a heater failed while bringing the unit up in temperature. A plot of the temperature rise data is shown in Figure 2-10a. The heater block was removed from the unit and was machined so that larger diameter heaters could be used. For the next thermal performance test run, two Watlow LA411 heaters (5/8-inch O.D. x 4 inches long - 250 watts, 115 volts) were used. These heaters were connected in parallel to reduce the heater watt density. An isolation transformer was placed in the circuit. After running for 72 hours and attaining a maximum temperature of 1331°F, this test also had to be discontinued because of decreasing resistance in one of the heaters. The thermal test heater failure data is shown on Table 2-2. A plot of the temperature rise data for this test is shown in Figure 2-10b.

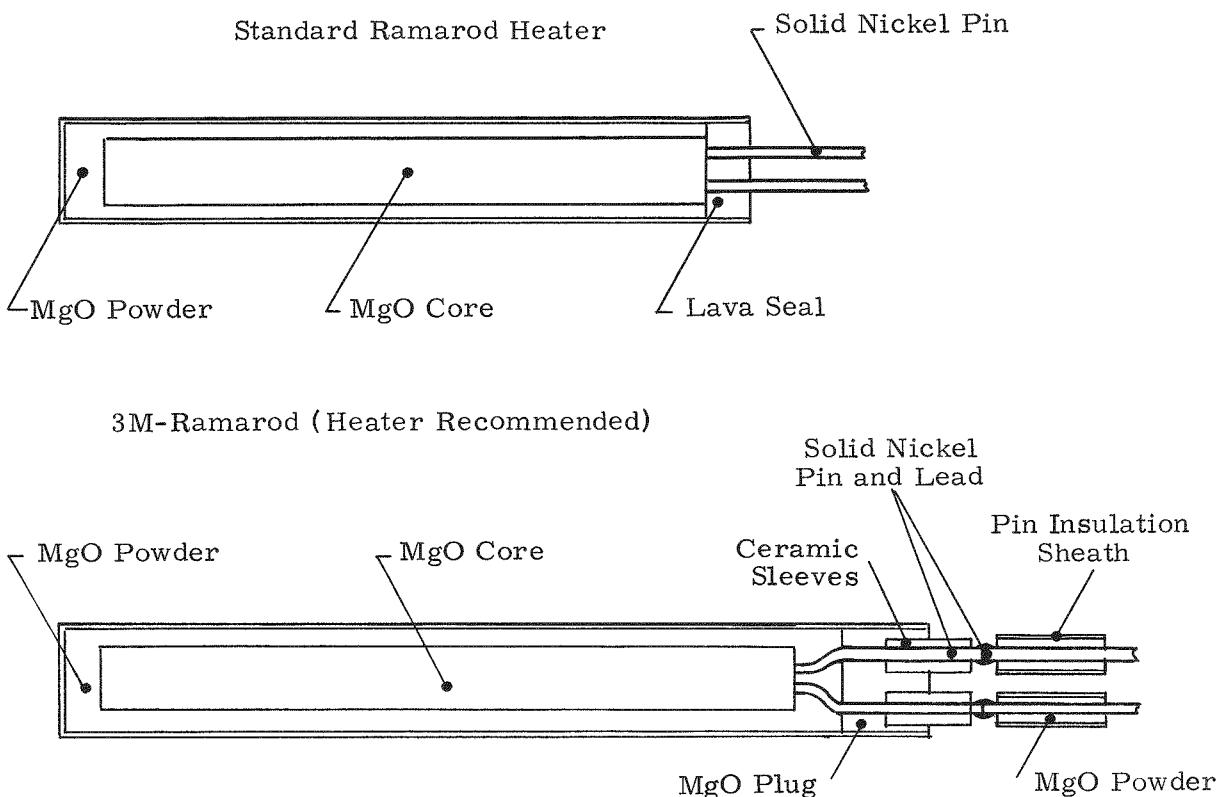
Figure 2-11. 1900°F Heaters

After the second heater failure, a meeting was held at Linde to discuss the heater problems. It was determined that additional contacts should be made with heater vendors to obtain a heater which would not fail at high temperatures. A trip was made to RAMA Industrial Heater Company, San Jacinto, California, to determine the causes of the heater failures and to get recommendations for heaters to be used in future tests. It was determined that the lava plug at the top of the heater had become carbonized from overheating so that the heater pins shorted out to each other through the lava. Sketches of the standard Ramarod heater and the heater recommended for the 3M application are shown in Figure 2-11.

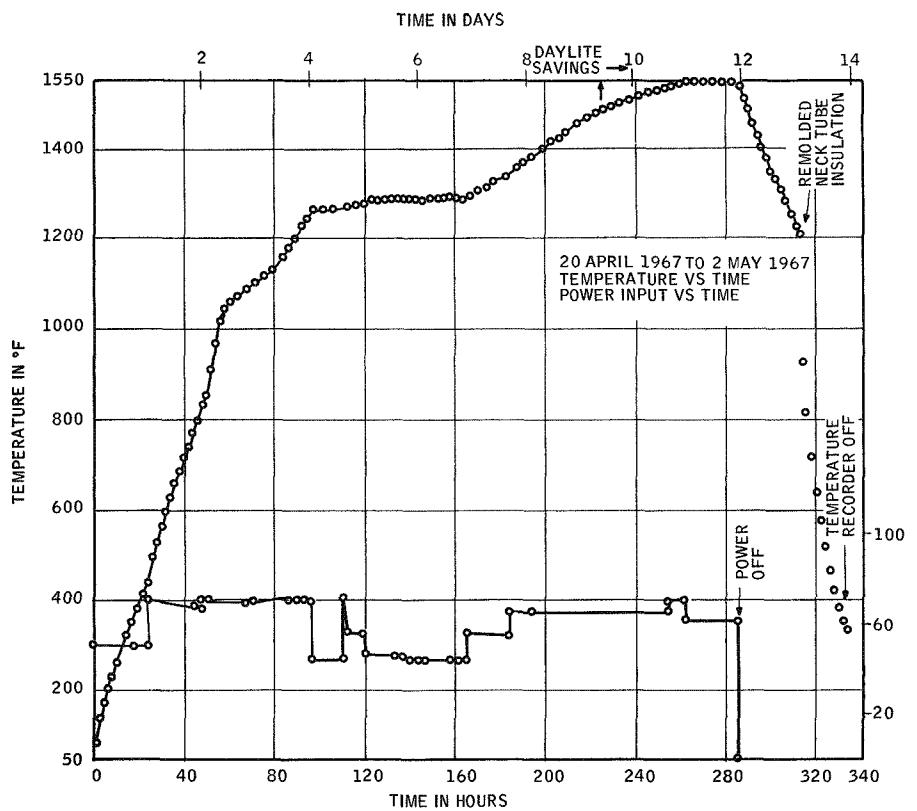
Figure 2-12. SNAP-21 Prototype Thermal Performance Test No. 3

A rate of heat up specification was prepared by 3M Company. This procedure was supplied with the heaters to Linde for use with the third thermal test. To preclude heater failure, the power input was limited to 70 watts maximum during the entire test. Power increases were made in small increments as shown on Figure 2-12. In the event of heater failure, it was decided to run the thermal performance test at 1285°F prior to conditioning at 1550°F as the unit has previously been at 1435°F during Run No. 1. The hot end neck tube temperature versus time for the entire run to include the thermal test and conditioning is shown on Figure 2-12.

Following the thermal performance test, the power was increased (see Figure 2-12) to bring the unit to 1550°F for conditioning of the insulation. The uncorrected power input at 1548°F was 60.5 watts, including all subtractable losses. The insulation pressure was maintained at 5.5 microns while vacuum pumping. In addition, the enclosure was heated with a blanket type heater to promote conditioning. At 1548°F hot end neck tube temperature, the following enclosure temperatures were measured: cold end neck tube, 230°F; enclosure at upper girth weld, 240°F; enclosure at lower girth weld, 200°F; center of bottom enclosure head 170°F.

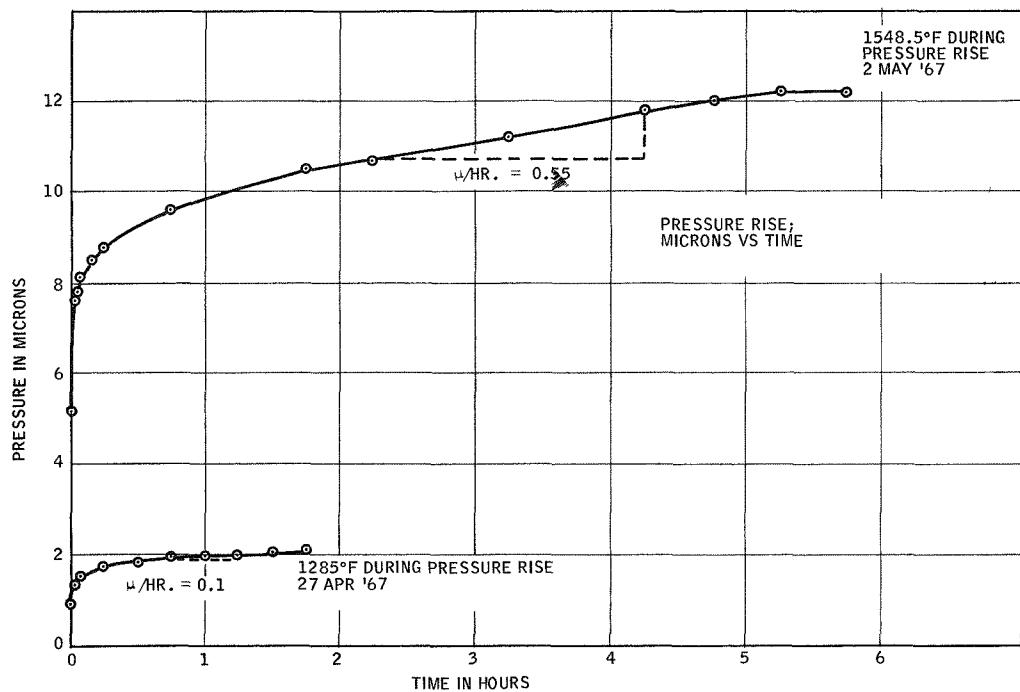
Figure 2-13. SNAP-21 Prototype Unit Pressure Rise

During Test Run No. 3, the unit was valved off at two constant temperatures to determine the unit pressure rise rate and thus the unit combined offgassing and leak rate. Figure 2-13 shows the two pressure rise curves. The initial portion of the curve from time zero to approximately 40 minutes is the time required for the unit to reach an equilibrium pressure after the vacuum pump is valved off. Note that the 1285°F pressure rise was performed before conditioning at 1548°F. The pressure rise rate after conditioning would be less. The offgassing plus leak rate can be calculated from the relationship - offgas rate = volume x pressure change/time period. With the prototype unit volume of approximately 0.55 ft<sup>3</sup>, the offgassing rate at 1285°F would be:

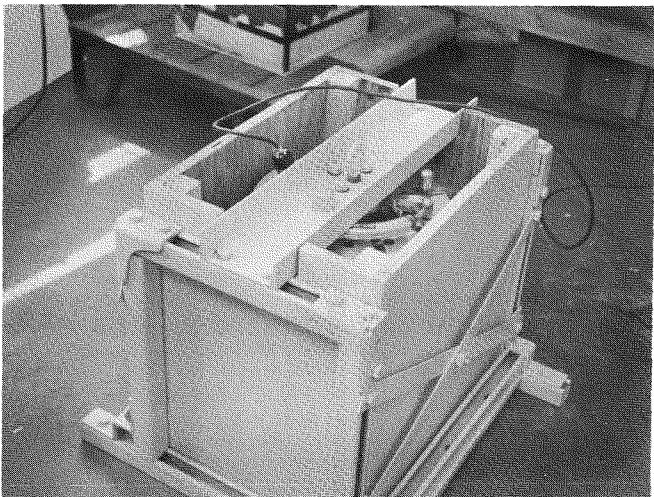
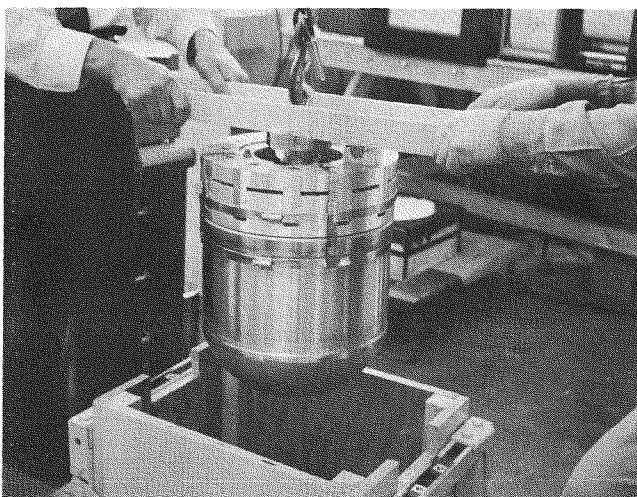
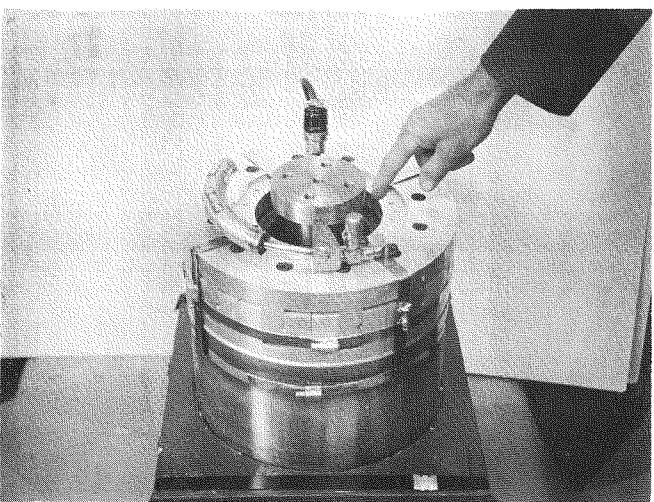
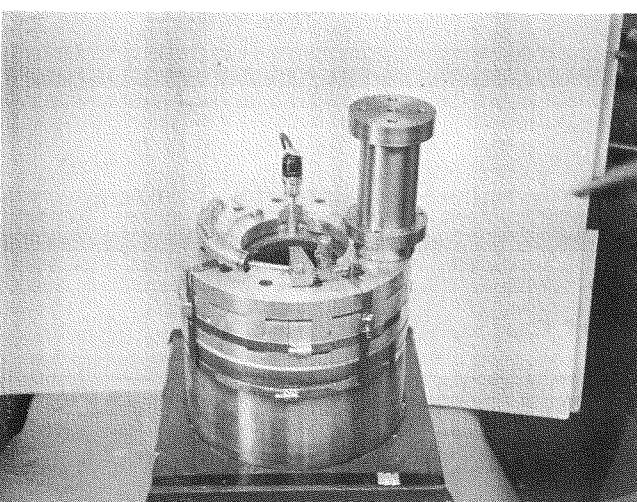
Figure 2-14. Insulation System Shipping Container Showing Method of Support

A shipping container for transporting the completed prototype unit was designed and drawings were prepared. One shipping container was fabricated during this reporting period. The container directly supports the biological shield through a solid neck tube plug which is bolted to the shield and the frame of the shipping container. The unit will be completely enclosed in the container with plywood sheet bolted to the container framework.

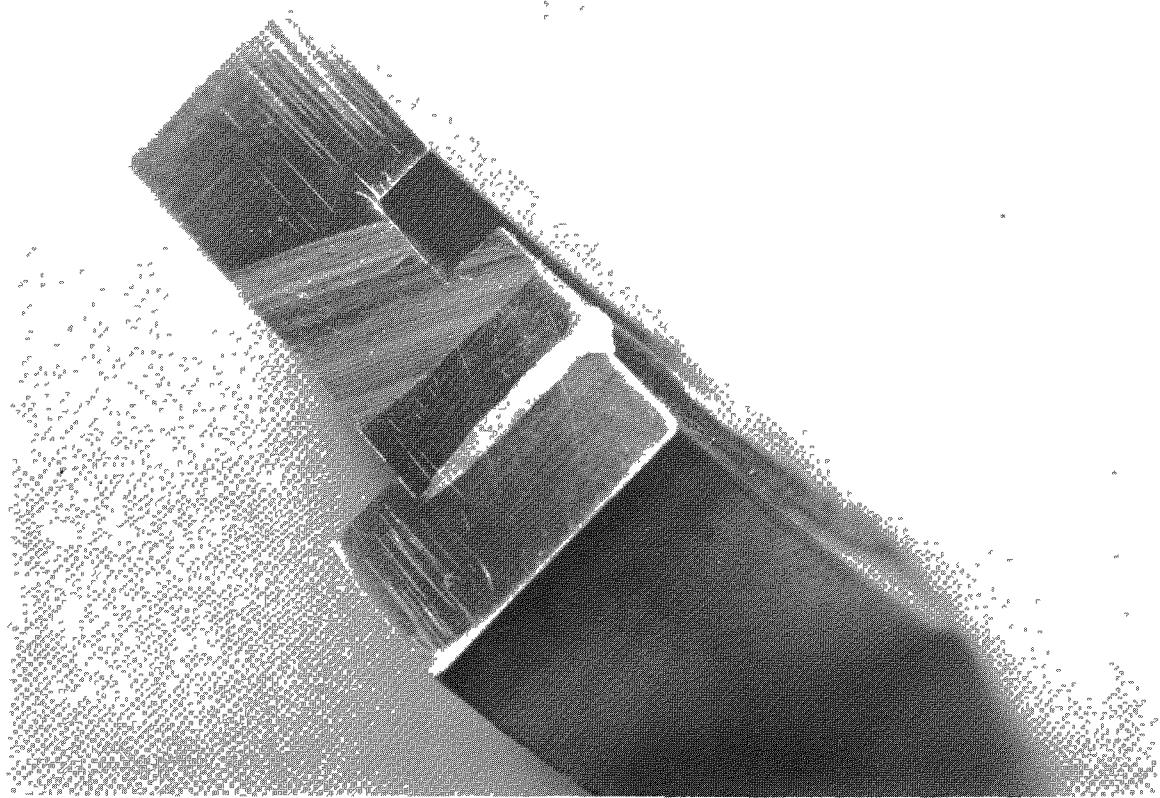
Figure 2-21. Cross Section of Electron Beam Weld

The weld conditions for the weld shown were:

\*Weld penetration obtained: 0.305 inch.

Beam current — 3.5 ma (tack welds)  
— 15.2 ma

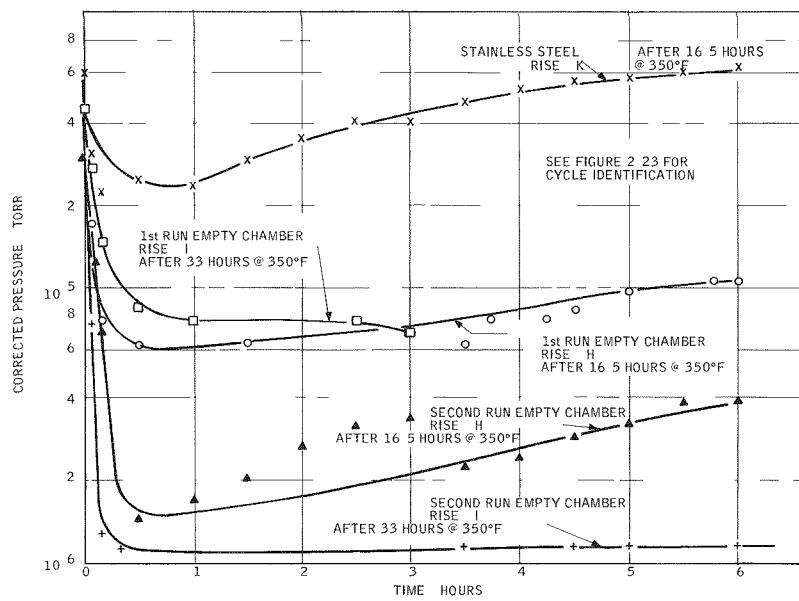
Figure 2-22. Corrected Pressure Rise Curves for Empty Chamber and Chamber with Stainless Steel

Following the chamber decontamination the empty chamber was maintained at 1550°F for 72 hours while vacuum pumping instead of the 1800°F for 48 hours as was originally planned. This change was made because it was felt that the 1550°F temperature would provide adequate conditioning for the stainless steel runs to be conducted at 100°F. At the conclusion of the conditioning, two empty chamber cycles were performed to determine the pressure rise characteristics of the empty chamber. Figure 2-22 presents the pressure versus time characteristics of the empty chamber. It can be seen that the second empty chamber run produced a lower pressure rise than the first run indicating that the chamber is more fully conditioned. Both empty chamber runs exhibited characteristics different from the empty chamber runs recorded during the prior offgassing work in that when the chamber was valved off at the start of the run the pressure was sharply reduced initially before it started a gradual rise. This phenomenon may be explained by the fact that the chamber had been conditioned at 1550°F and was therefore very clean for the runs at 100°F. For the low temperature offgassing cycle of stainless steel (condition at 350°F – run at 100°F), the chamber was most probably initially acting as an adsorber.

A comparison of this pressure-time history with rise K on Figure 2-22 shows that the additional 16.5 hours at 350°F initially reduced the offgassing rate of stainless steel by a considerable amount. If the rise could have been completed it is possible that the stainless steel would have been found to be an adsorber. At this point it was decided not to rerun rise L since the empty chamber cycles would have had to be rerun as well. Since the surface area of the stainless steel in the actual units is small, a conservative estimate of the getter requirement for stainless steel offgassing can be based on rise K which was taken after 16.5 hours of conditioning. Table 2-5 shows the results of the mass spectrometer gas analysis for both the empty chamber and the chamber with the stainless steel sample. Figure 2-23 shows the offgassing cycles schematically.

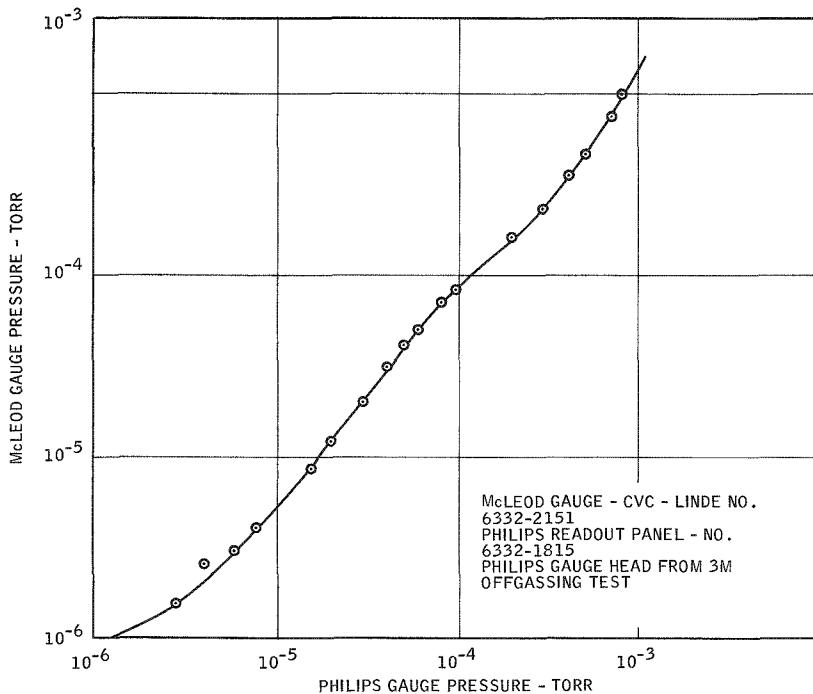
Figure 2-24. Calibration Curve for Philips Vacuum Gauge

At the completion of the stainless steel offgassing investigation as described above, the Philips type vacuum gauge used for all the offgassing runs except the quartz paper was removed from the offgassing test apparatus and calibrated against a McLeod type absolute vacuum gauge in air. Figure 2-24 shows the Philips gauge pressure versus the McLeod gauge pressure. The Philips gauge readings of the offgassing tests, corrected using Figure 2-24 are called  $P_{\text{true}}$  (pressure true). Because the major constituent gas of the offgassing tests is hydrogen,  $P_{\text{true}}$  was further corrected to account for the hydrogen in the gauge as follows:

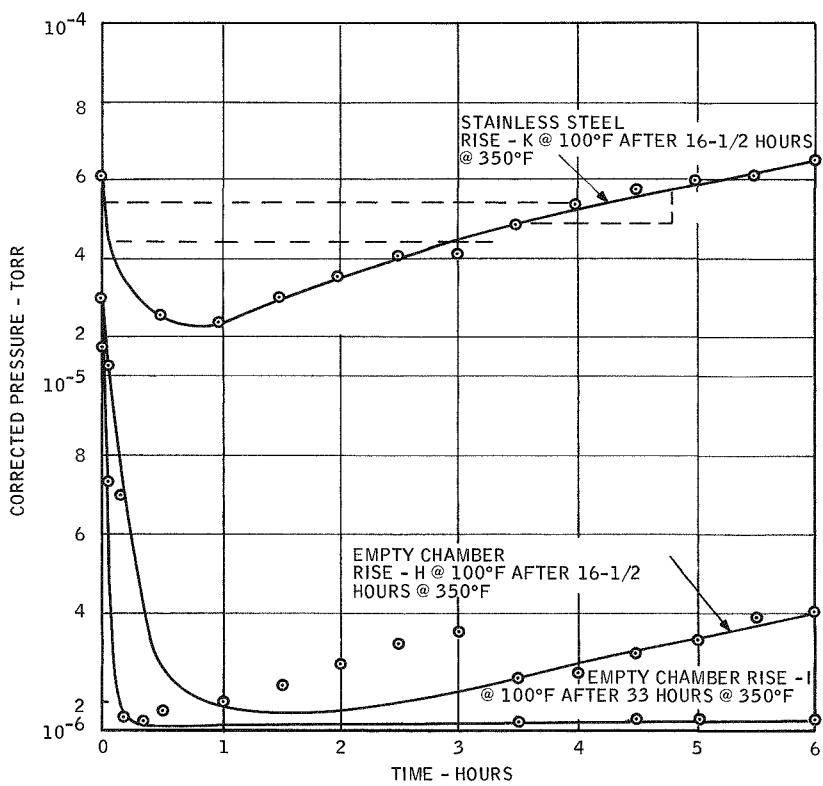
Figure 2-25. Pressure Rise Curves for Slope Determination

The offgassing rate for the stainless steel specimen was calculated at 100°F after 16.5 hours at 350°F. Figure 2-25 shows the corrected pressure rise versus time for Rise K plotted on rectangular coordinates to determine the slope of the curve. Because the empty chamber pressure rise was low compared to the chamber with stainless steel, it was not possible to subtract the empty chamber slope from the chamber with sample slope at an equal pressure. For calculating the stainless steel offgassing rates, as shown in Figure 2-26, plotted against pressure, and in Figure 2-27 plotted against time, the slope of the empty chamber was assumed to be zero.

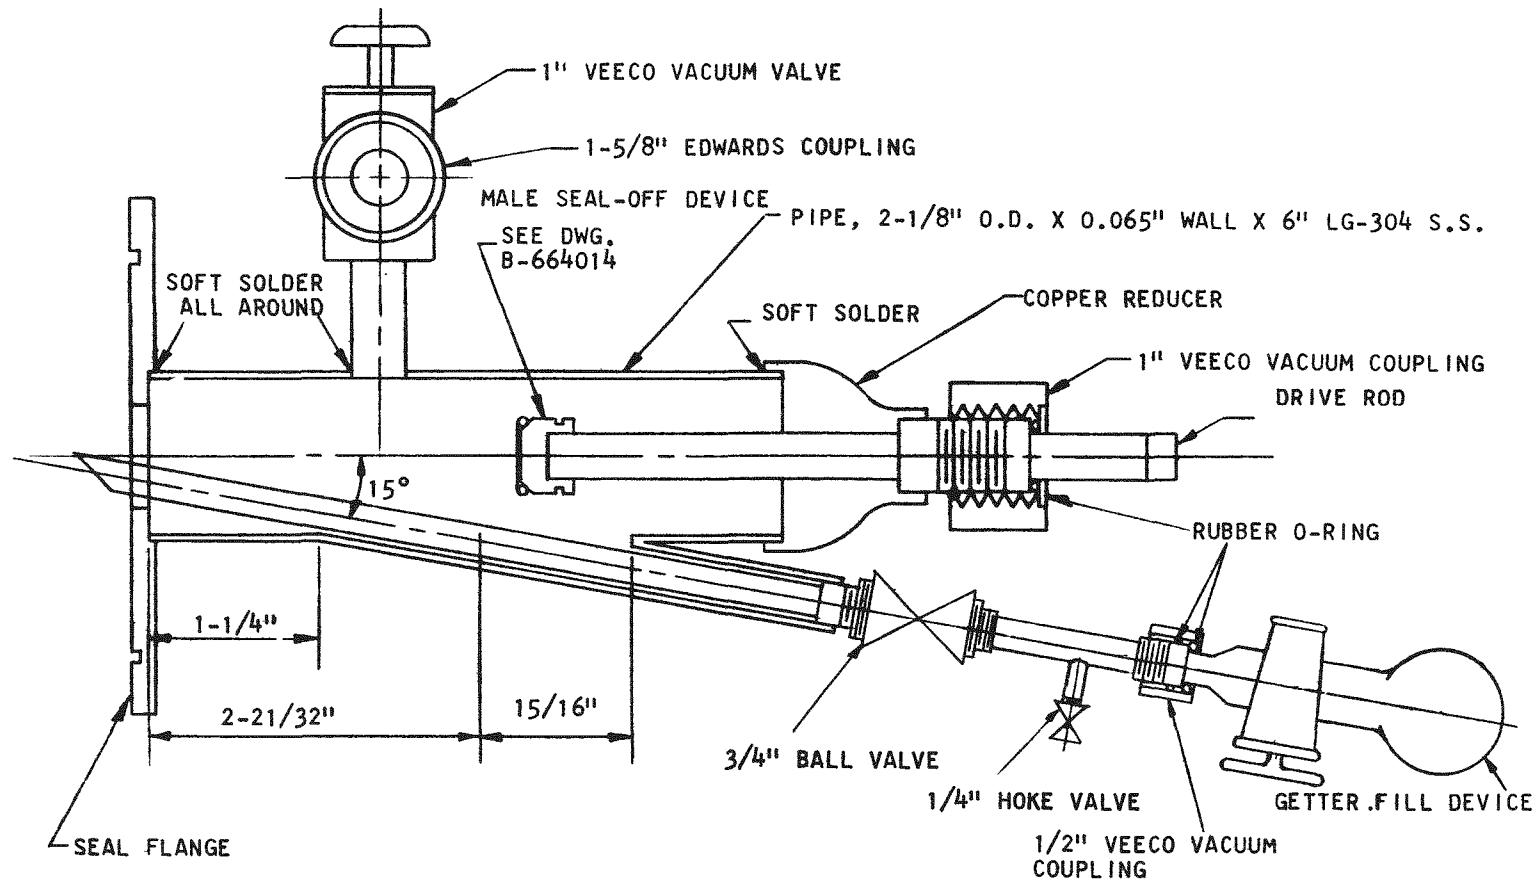
Figure 2-28. Schematic of Getter Installation and Seal-Off Apparatus

- a. Close ball valve and evacuate system to a pressure of 1 micron. .
- b. Insert glass getter fill tube into quick connect coupling and evacuate glass tube through Hoke vacuum valve.
- c. Open ball valve and close Hoke valve. Slide glass tube into female portion of seal of device.
- d. Open glass stop cock valve and allow simulated getter to flow into getter reservoir.
- e. Close glass valve and withdraw getter fill tube just past ball valve and close ball valve.

- f. Open Hoke valve and complete withdrawal of glass getter capsule.
- g. Traverse male plug push rod to engage seal-off device threads and apply required torque to seal.

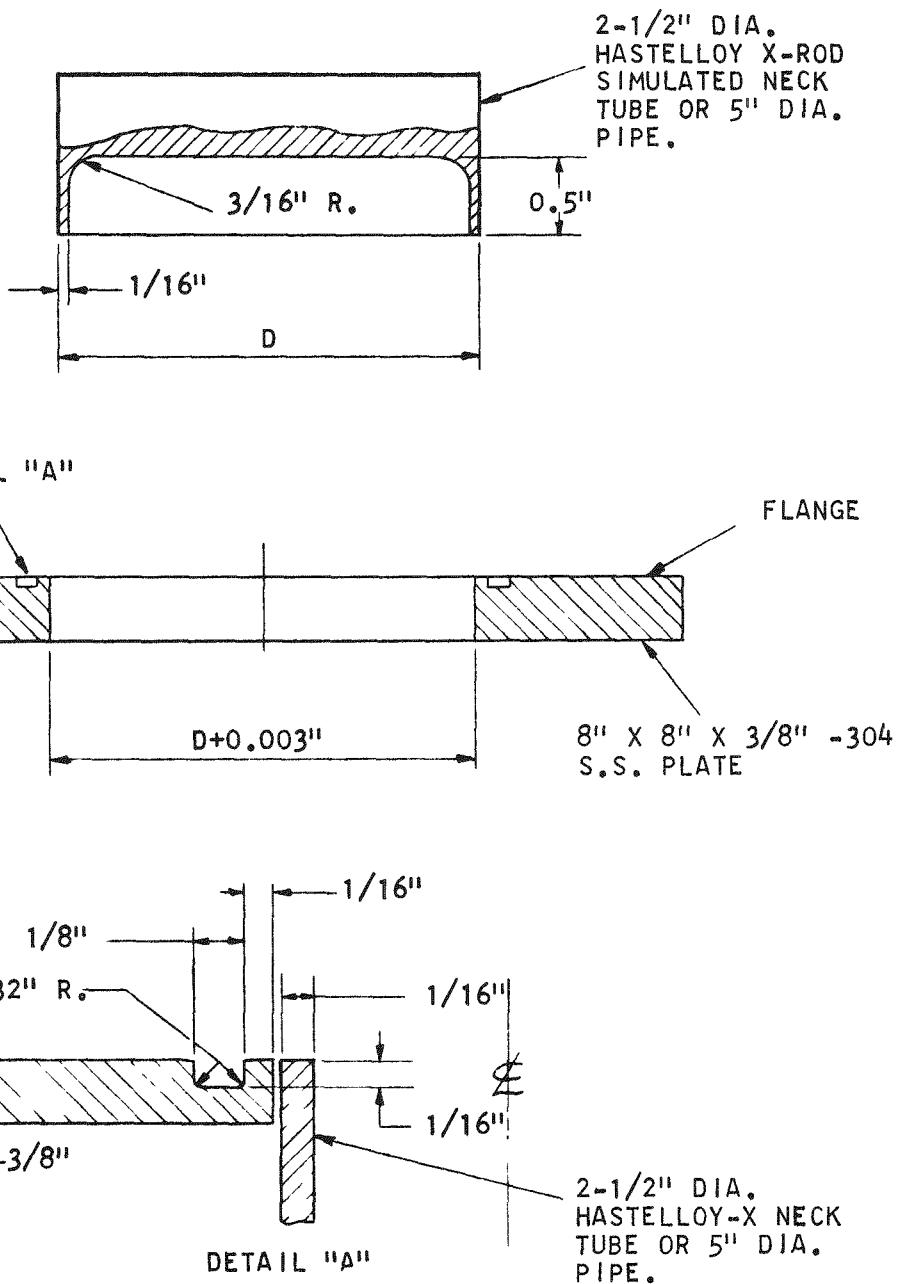
Figure 2-36. Neck Tube Weld Joint

Simulated neck tube joint welds between the Hastelloy-X neck tube material and the Type 304 stainless steel top flange material were made to determine the required weld parameters for an acceptable joint. Three joints each of 2-1/2 inch diameter and 5 inch diameter were semi-automatic heliarc welded. The weld geometry is shown in Figure 2-36.

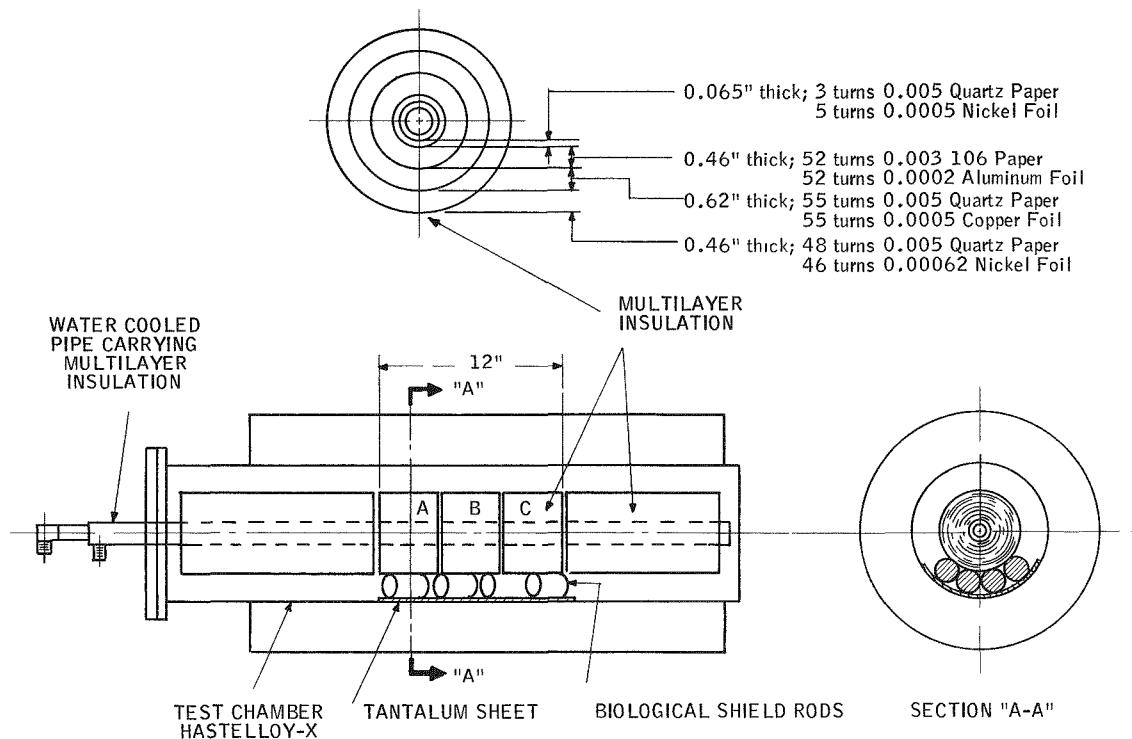
Figure 2-39. Schematic View Showing the Insulation and Biological Shield Material in Test Chamber

The average outside diameter of the test zone was 3-7/8 inches. Quartz string was used to secure the multi-layer insulation in place. The nickel and aluminum foils were unprocessed while the copper foil, quartz paper, and 106 paper were processed prior to application. The area on the ends of the three test zones was also insulated with multi-layer insulation, as shown in Figure 2-39.

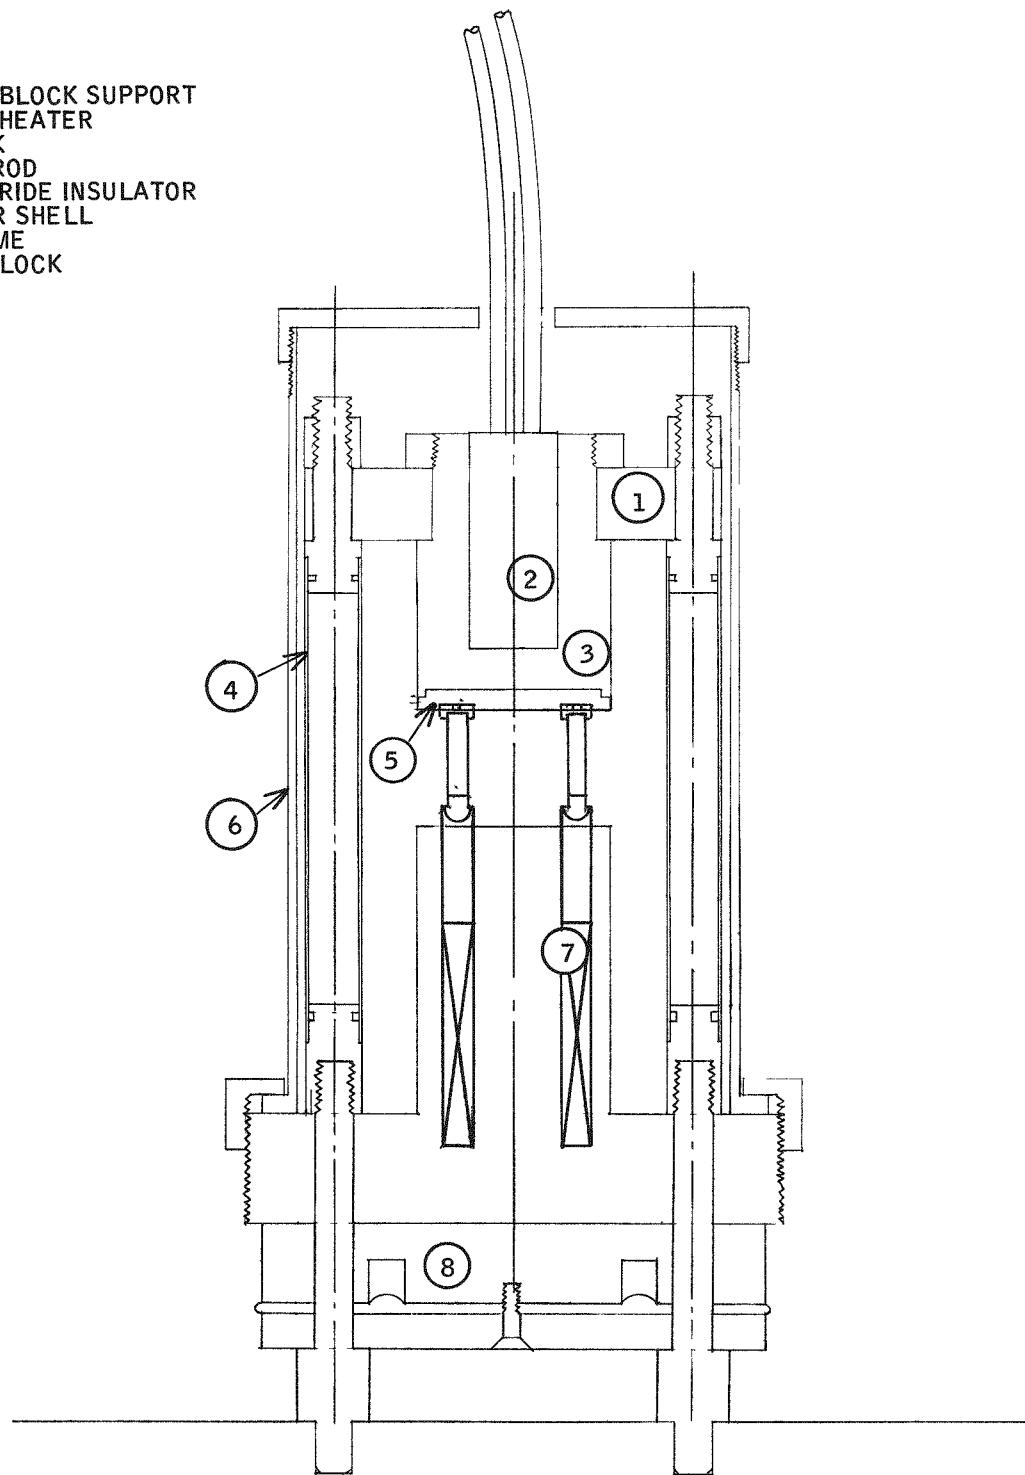
Figure 2-42. 6-Couple Heat Transfer Test Module

1. LAVA HOT BLOCK SUPPORT
2. ELECTRIC HEATER
3. HOT BLOCK
4. SUPPORT ROD
5. BORON NITRIDE INSULATOR
6. CONTAINER SHELL
7. COLD FRAME
8. COOLING BLOCK

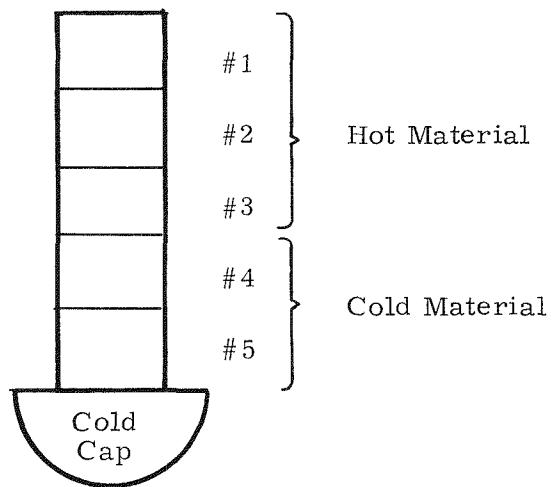
Ten P-and N-legs were devided into five segments each and the Seebeck coefficient-temperature profile for each segment determined. The segments are identified in the sketch below.

Segments 1, 2, and 3 comprise the hot end material, pbTe ( $p = 120 \mu\Omega\text{-in}$ ) or pb(Sn)Te for the N-and P-type materials, respectively. Segments 4 and 5 comprise the cold end material, pbTe ( $p = 400 \mu\Omega\text{-in}$ ) or Bi(Sb)Te for the N-and P-type materials, respectively.

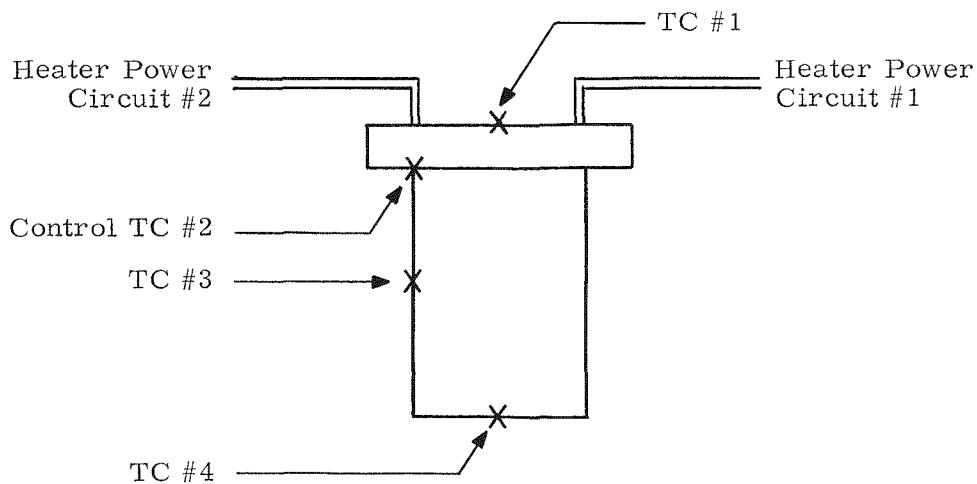
Figure 2-50. Schematic of Electrically Heated Hot Block and Location of Thermocouples

Thermocouple No. 2 is the control thermocouple for final system operating temperature. All remaining thermocouples are monitored but are classed as reference only.

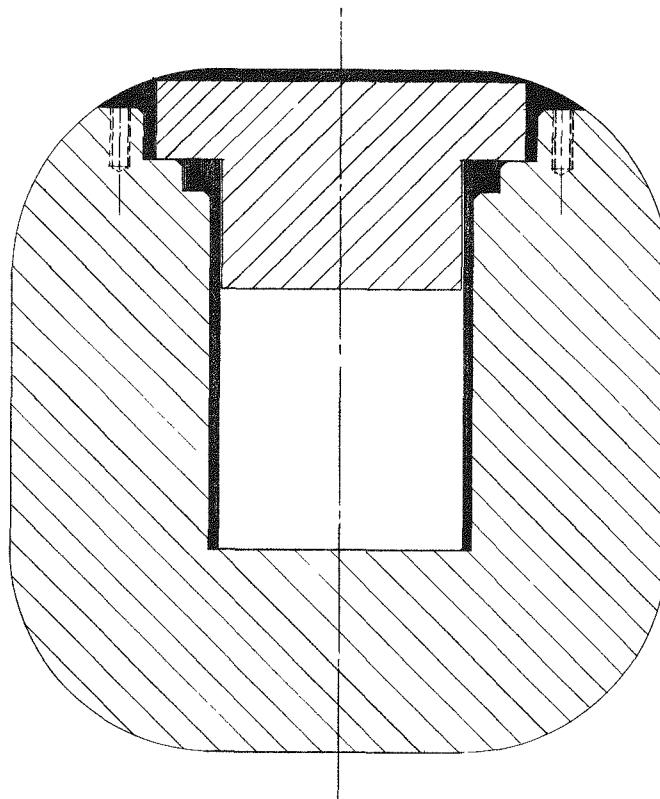
Figure 2-53. Reworked Biological Radiation Shield Showing Material Removed

Careful analysis of the actual configuration tested revealed a number of differences which account for the higher dose rates. For example, the original shield dimensions were based upon a 187-watt SrTiO<sub>3</sub> source. SrO fuel has a radiation intensity 13.6 percent higher than from SrTiO<sub>3</sub>; therefore, the radiation from the 200-watt source used for the test corresponded to about 227 watts of SrTiO<sub>3</sub>. Furthermore, the fuel capsule used had a wall thickness of 0.090 inch compared to 0.250 inch for the SNAP-21 design.
