**GENERAL-PURPOSE HEAT SOURCE:
RESEARCH AND DEVELOPMENT PROGRAM, RADIOISOTOPE
THERMOELECTRIC GENERATOR/THIN FRAGMENT IMPACT TEST**

M. A. H. Reimus and J. E. Hinckley

ABSTRACT

This report describes test RTG-3. This test, an edge-on fragment-impact test, was third in a series of RTG impact tests. The first two tests, RTG-1 and RTG-2, were designed to provide information on the response of a loaded RTG to end-on impact against a concrete target.¹⁵ The RTG impact tests were designed to evaluate the response of GPHSs, GPHS modules, and loaded RTGs to conditions that might be experienced as a result of potential on- and near-pad accidents involving failures of the Cassini spacecraft and/or launch vehicle. Specifically, the edge-on fragment-impact test was designed to provide information on the response of a loaded RTG to impact by the type of fragment that might be generated by breakup of the spacecraft propulsion module system (PMS). This test series utilized GPHS capsules fueled with $^{238}\text{UO}_2$.

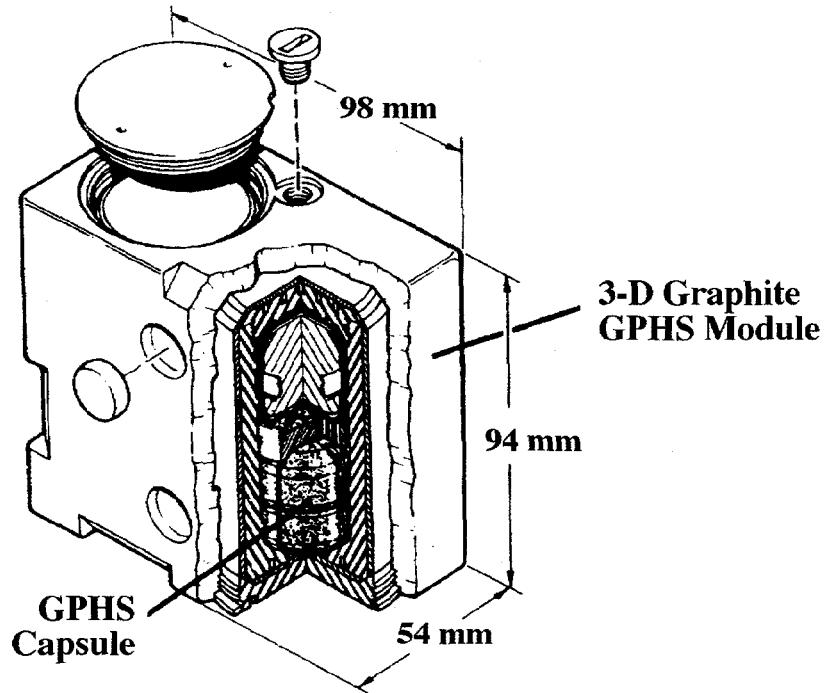
Figure 1. GPHS module.

The general-purpose heat source (GPHS) is a modular component of the radioisotope thermoelectric generators (RTGs) that will provide power for the National Aeronautics and Space Administration's Cassini mission to Saturn. An RTG generates electric power by using the heat of ^{238}Pu decay to create a temperature differential across a thermoelectric array. Each RTG is loaded with 18 GPHS modules, and each GPHS module (Figure 1) contains four $^{238}\text{PuO}_2$ fuel pellets that provide a total thermal output of about 250 W. Each fuel pellet is encapsulated in a vented DOP-26 iridium alloy shell. Two iridium capsules are held in a Fineweave-Pierced Fabric* (FWPF) graphite impact shell (GIS), and two GISs are contained within an FWPF aeroshell.

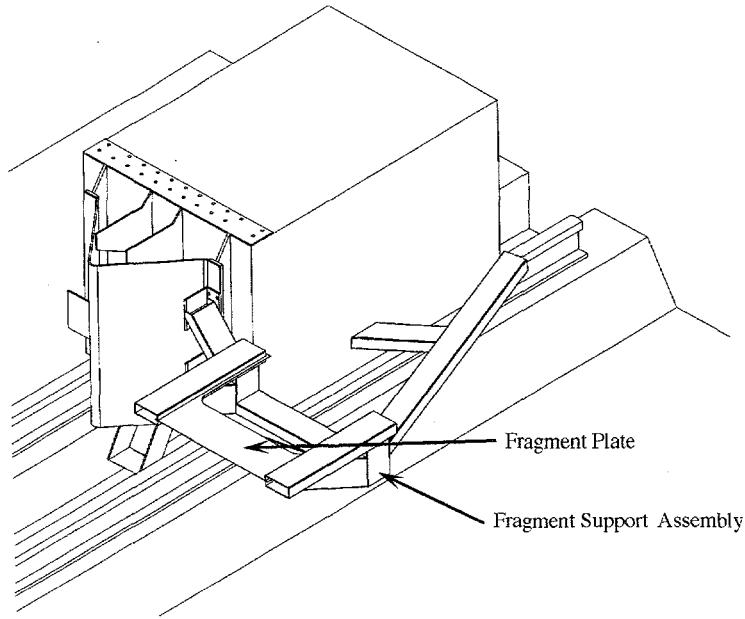
Figure 2. Aluminum fragment mounted on a support bracket on the side of the sled.

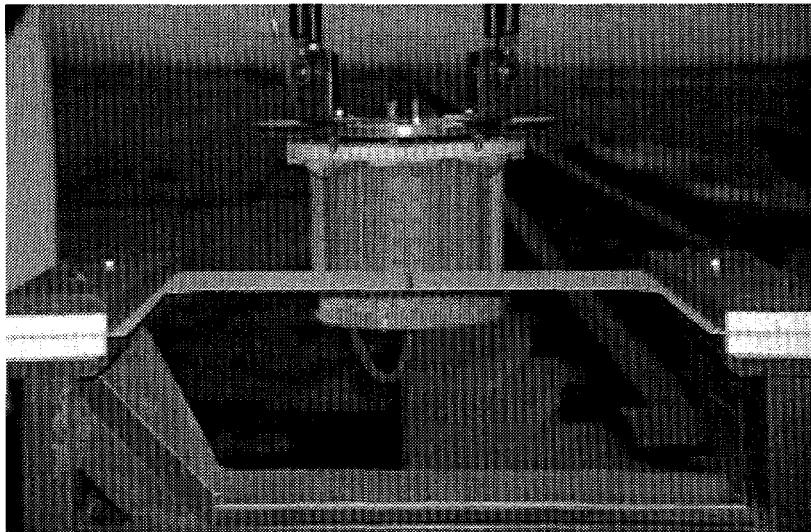
Figure 3. Test alignment of the plate with the converter housing. (Neg E-29)

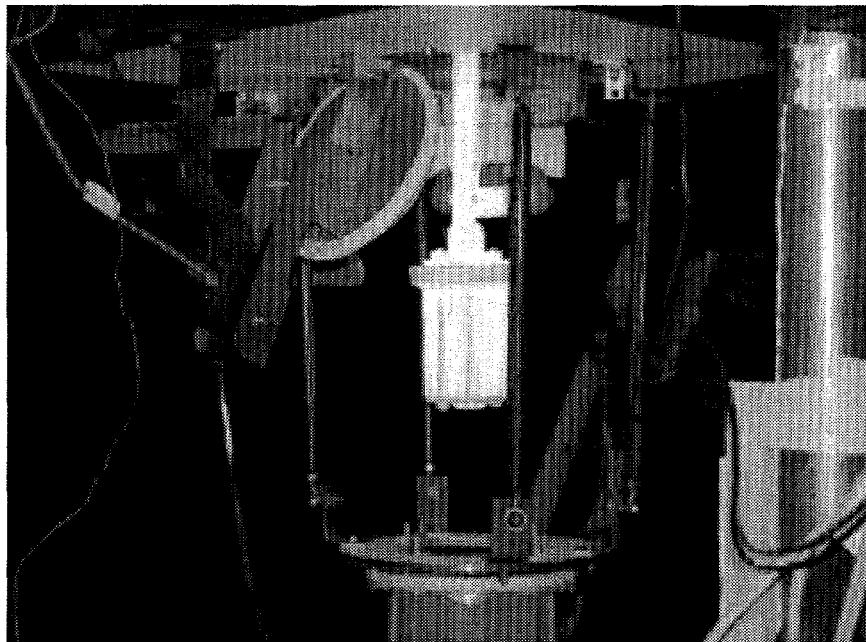
Figure 4. The heated stack being lowered into the converter housing. (Neg D-13)

The graphite module stacks were heated to approximately 1225°C. The rockets were readied, and the test sequence began with the remote opening of the furnace door. The stack was then remotely lowered from the furnace into the RTG housing (Figure 4). The fueled clads in the heated stack cooled to approximately 1090°C in the time required for the stack to be lowered into the converter housing and impacted by the fragment. This sequence was carefully timed, and the rocket sled was launched 140 seconds after stack placement initiation. The stack cooling characteristics were measured before testing at LANL and at the SNL test site.

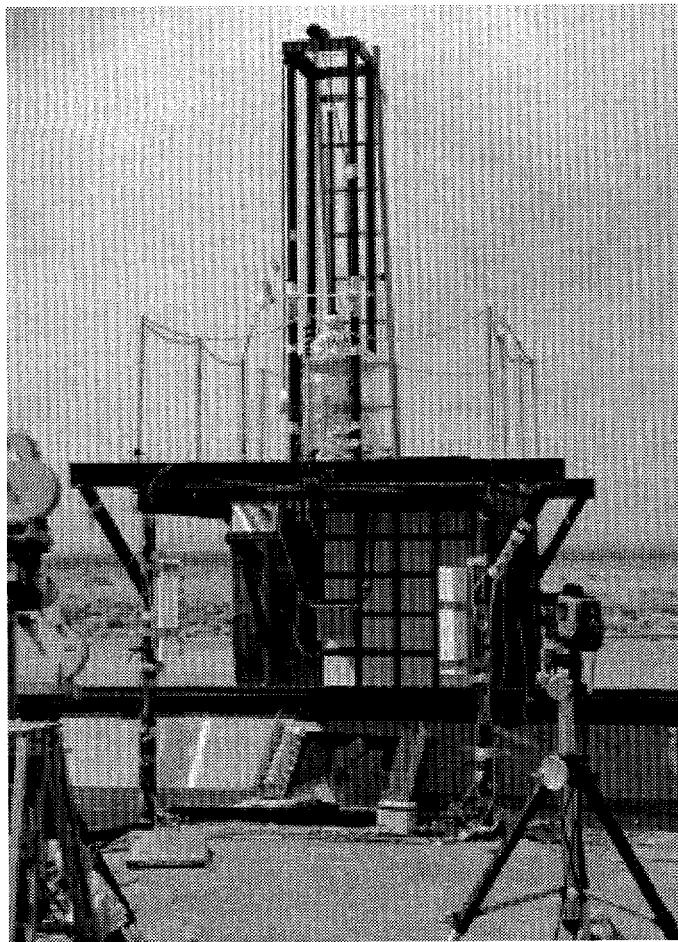
*Figure 5. Test stand for the RTG-3 test.
(Neg B2322, Roll 1, #15)*

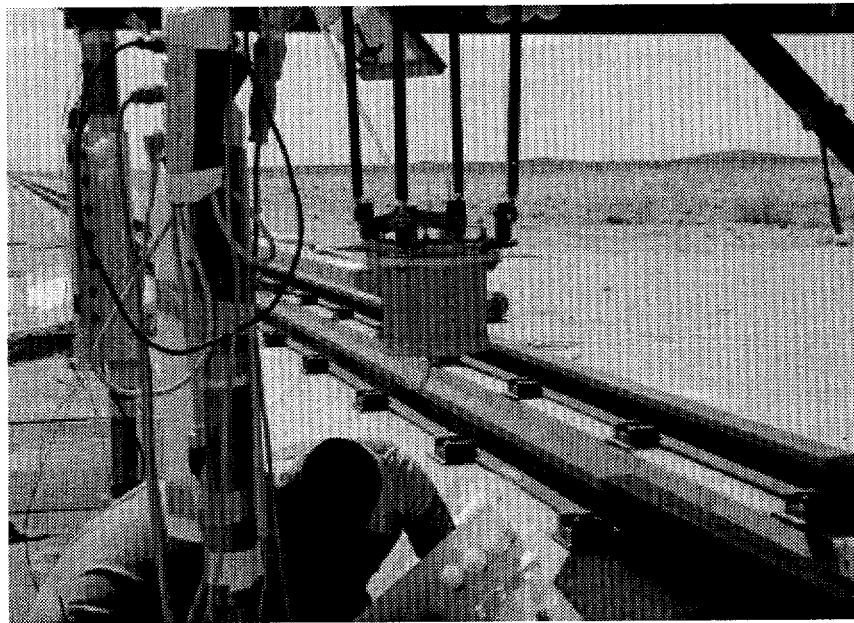
Figure 6. The converter housing suspended from the test stand platform for RTG-3. (Neg B2322, Roll 1, #11)

A representative section of a GPHS RTG with a simulant heat source stack made up of an FWPF module loaded with urania-fueled clads and POCO modules loaded with molybdenum slugs was impacted by an aluminum plate on March 26, 1996. The measured impact velocity was 306 ± 1.5 m/s, and the RTG graphite module stack temperature was $1090^\circ\text{C} \pm 10^\circ$. Figure 5 shows the entire furnace stand; Figure 6 shows the converter housing suspended from the furnace stand platform

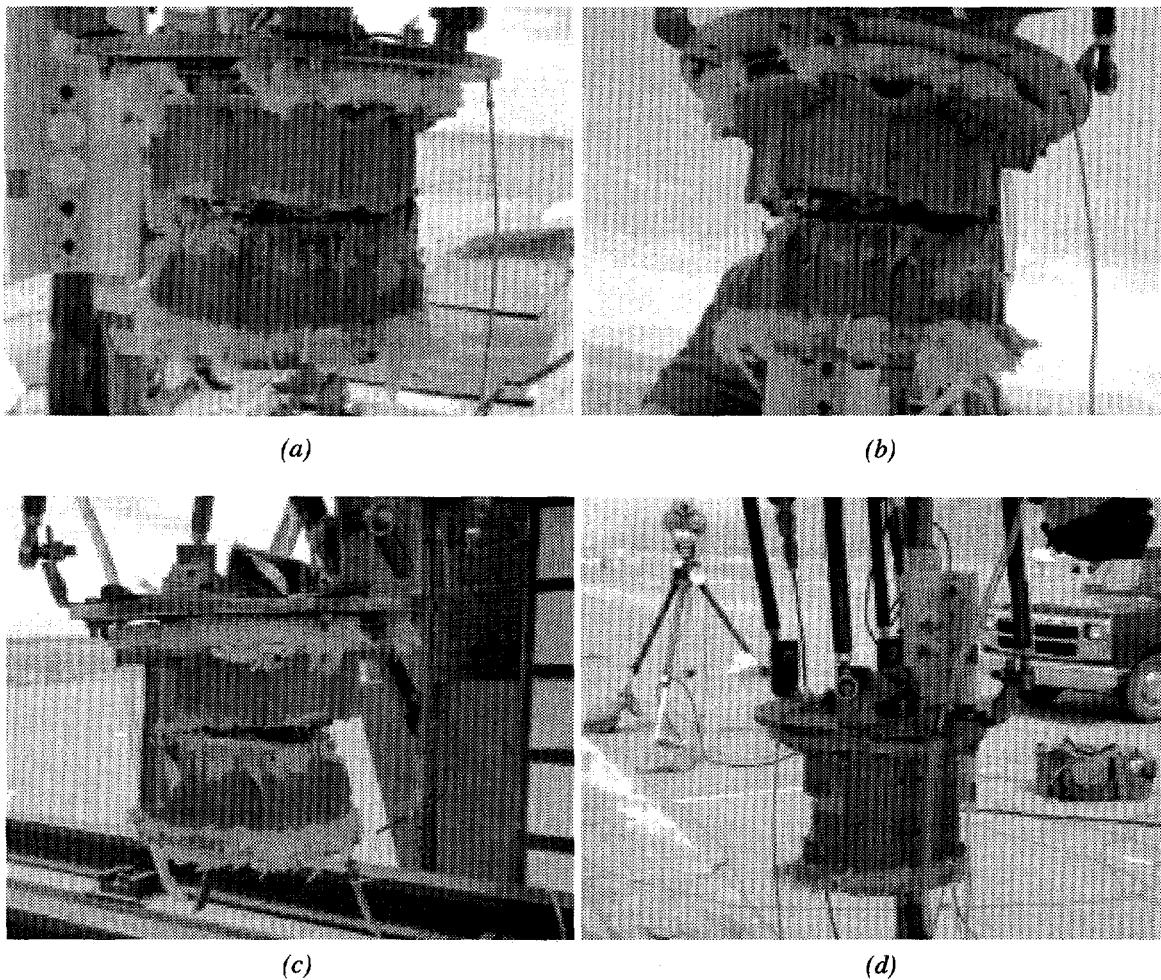
circumference (Figure 7). The width of the gap was approximately 2 cm. The cut was clean at its upper edge, but the lower edge was folded over, toward the inside of the shell. Radiological surveys of the converter's outer surface and the impact vicinity conducted immediately after the impact indicated that no urania was released from the converter.

Figure 7. The impacted converter housing: (a) impact face, (b) profile, (c) opposite profile, and (d) trailing face. (Neg B2322, Roll 2, #5; Roll 1, #26, 21, and 36)

High-speed photography of the impact indicated that the plate's leading edge impacted approximately 0.63 cm above the converter's midpoint. The fragment penetrated the converter shell, microfoil insulation, thermoelements, and GPHS graphitics and contacted a fueled clad. The converter was cut and torn over approximately 80% of its

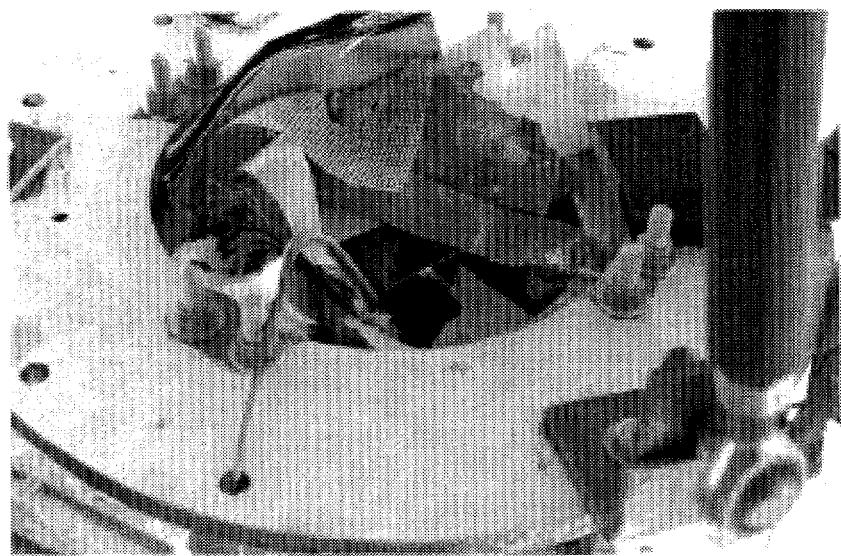
The top of the converter housing showed indications that materials within the housing were ejected through the top opening (Figure 8). One of the POCO graphite modules was ejected out of the top of the converter and was found lying a few feet away (Figure 9). Lying directly next to the ejected module was a molybdenum slug that was ejected from that module. The other slug that had been loaded into the module was also ejected and came to rest within a few feet (Figure 10). The module was intact but chipped. Preliminary field observations revealed no cracks. Other pieces of graphite were also observed in the impact area and appeared to have come from the top part of the graphite stack (Figure 11). A few pieces of FWPF graphite were also found.

Figure 8. Top of the converter housing, postimpact. (Neg B2322, Roll 1, #28)

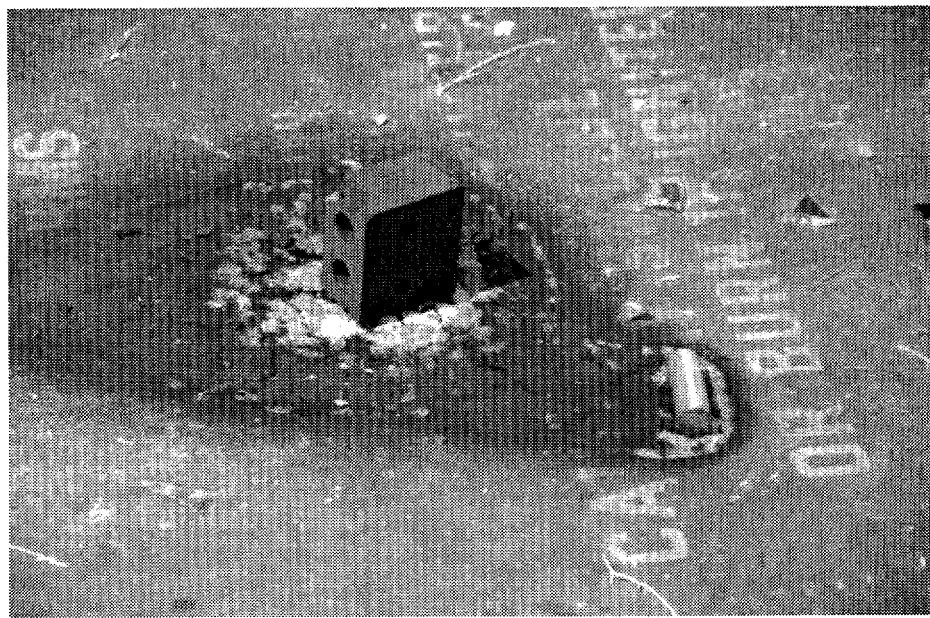
Figure 9. Ejected POCO graphite module with an ejected molybdenum slug. (Neg H-3)

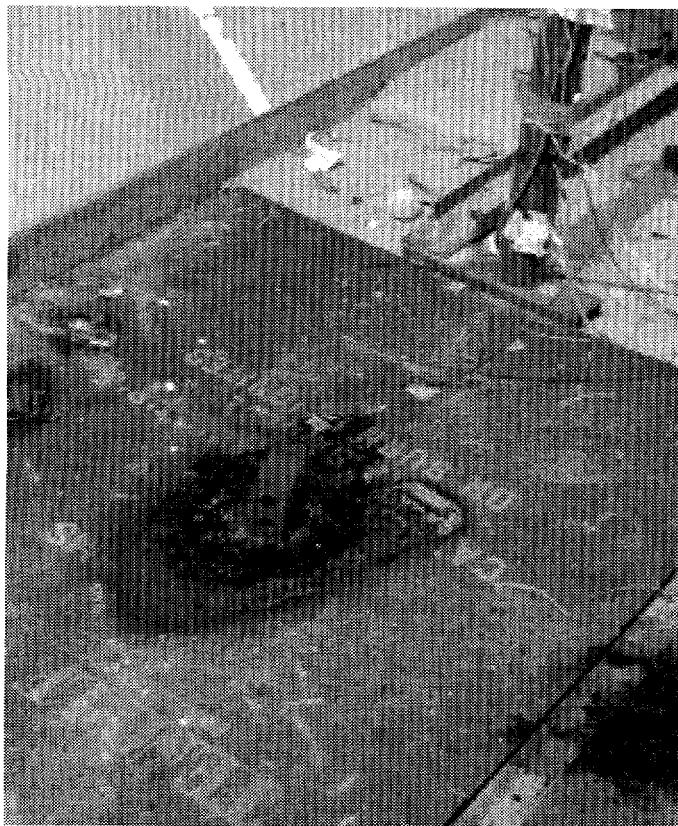
Figure 10. Ejected POCO graphite module with ejected molybdenum slugs. (Neg B2322, Roll 2, #15)

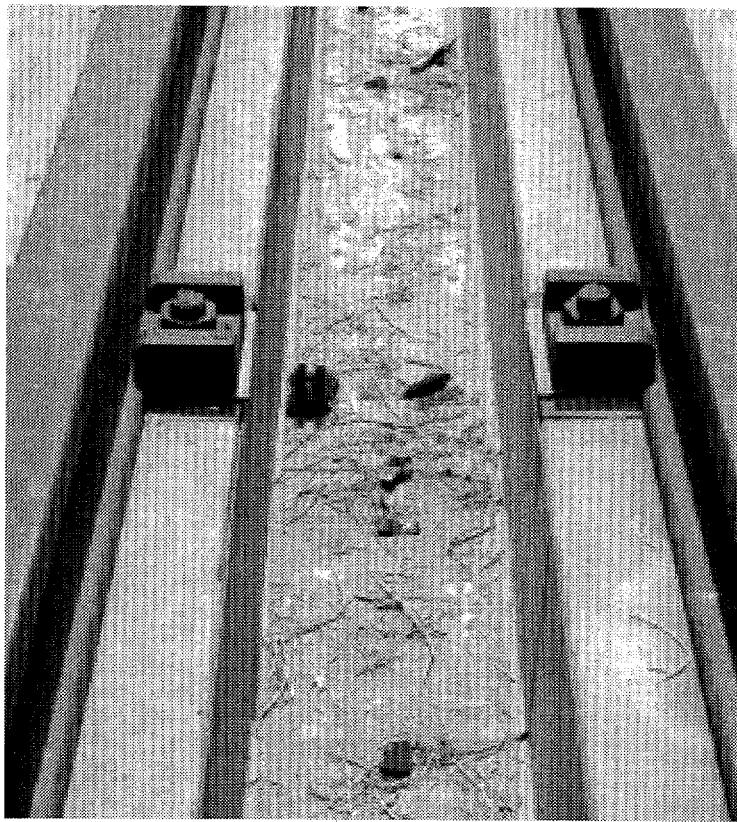
Figure 11. Ejected pieces of graphite (center of the photograph, between the sled rails) that appear to have come from the top of the test stack. (Neg B2322, Roll 2, #8).

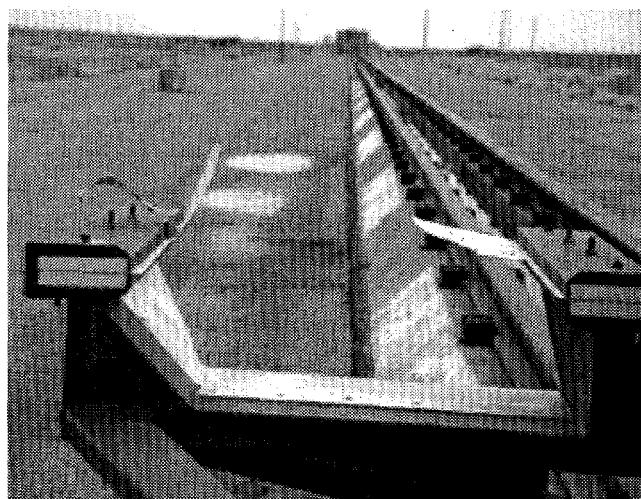
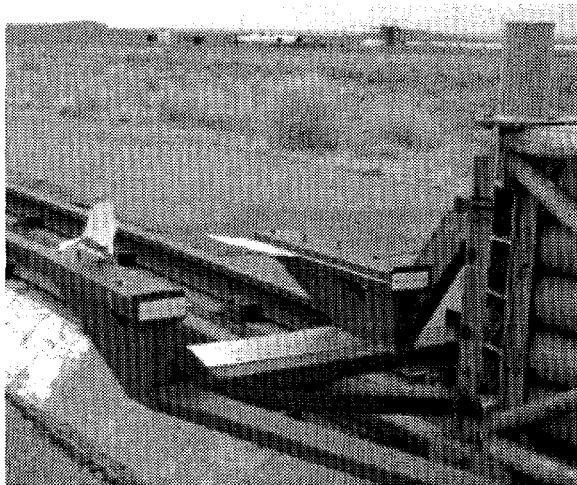
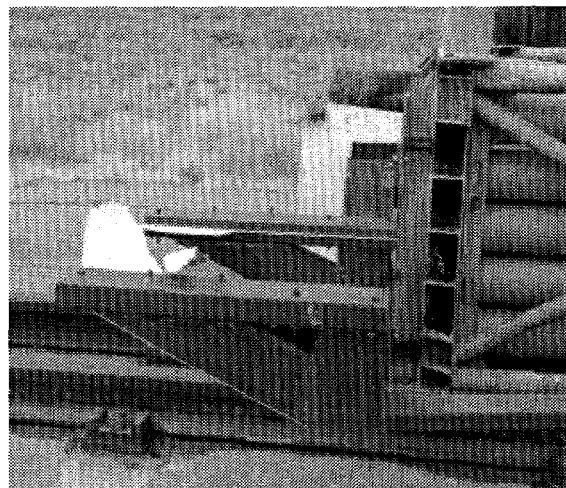
A relatively large piece of the fragment was torn from the sled (Figure 12). This piece, roughly trapezoidal, measured approximately 23 cm at the leading edge and 39 cm at the trailing edge. This piece was not recovered whole but represented the sum of several relatively small fragments. Most of these fragments were scattered outside the converter housing, but a few fragments were seen inside the converter during preliminary investigation.

Figure 12. A relatively large piece of the thin plate was torn from the sled: (a) view from the back of the sled, (b) view from an angle, and (c) profile. (Negs I-34; B2322, Roll 2, #35 and 34).

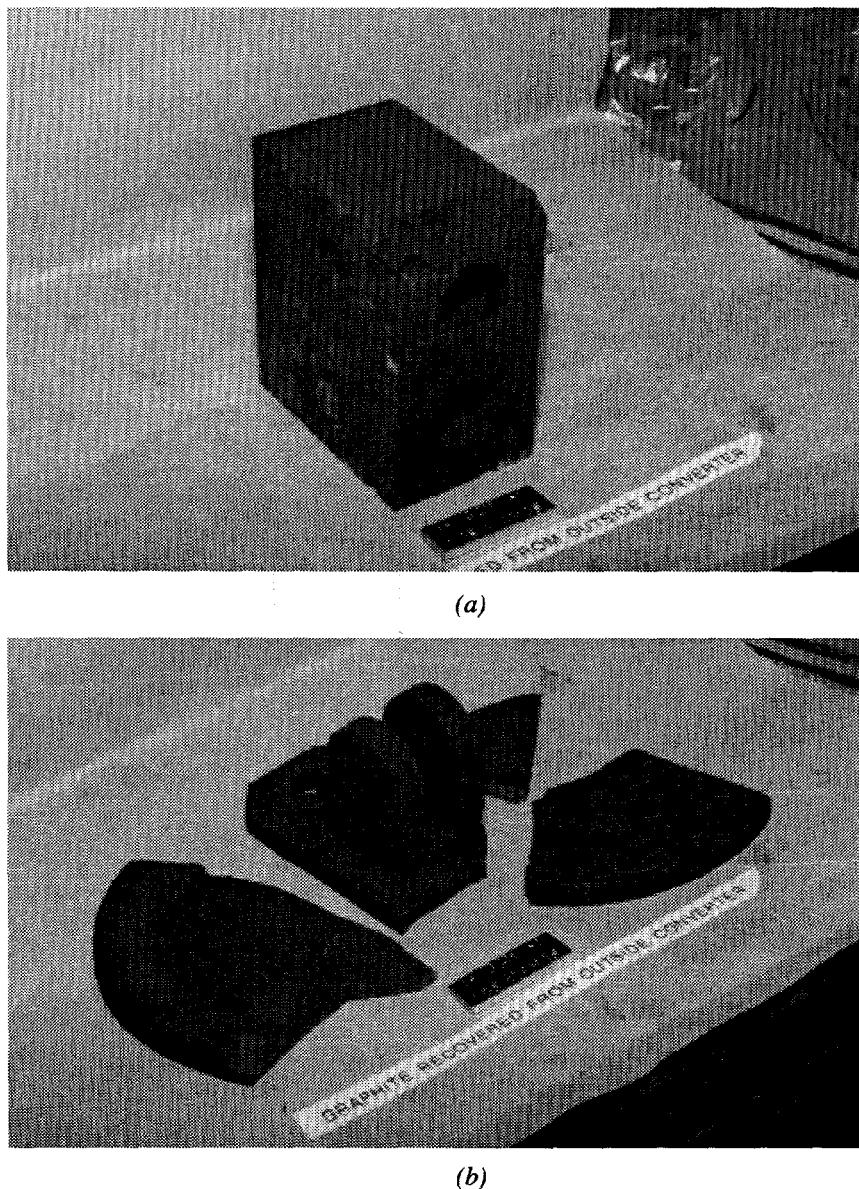
Postmortem examination of the test components began at Los Alamos on April 4, 1996. All graphite and aluminum fragment pieces that were recovered outside the converter were gathered together and photographed. Graphite recovered outside the converter consisted primarily of graphite components from the top of the graphite stack,

Figure 13. Graphite components recovered at the test site and found outside the converter housing: (a) the top of the POCO module and (b) the stack-lifting lug and other recovered pieces. (Neg B2323, Roll 5, #29 and 27)

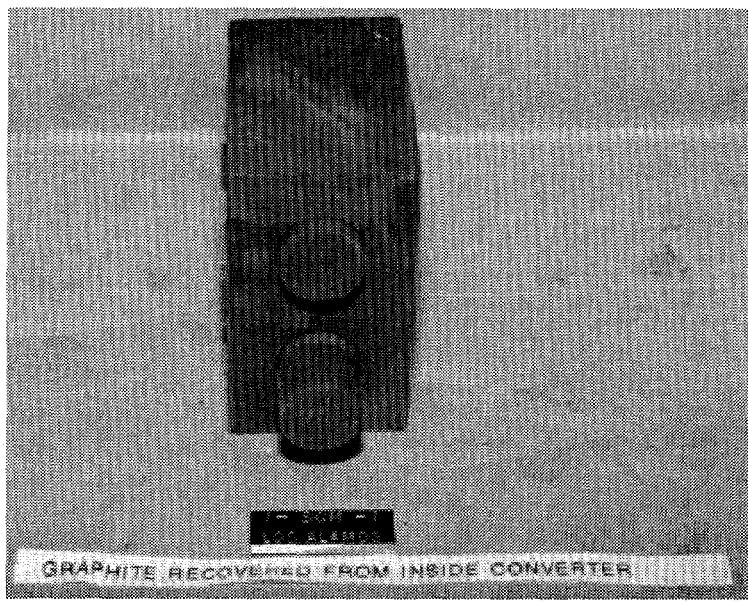
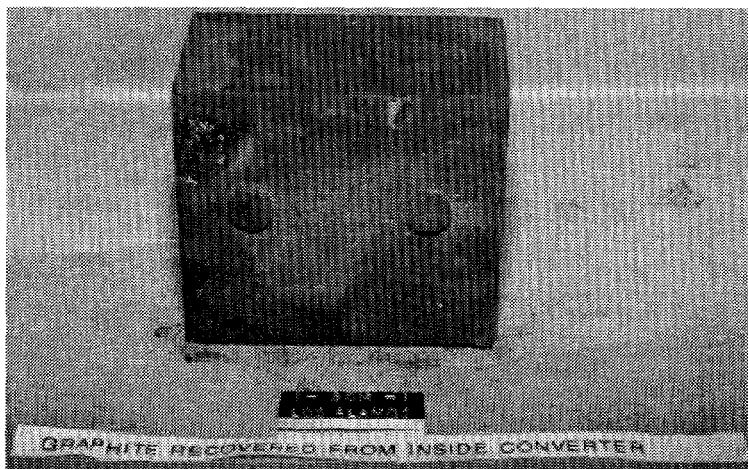
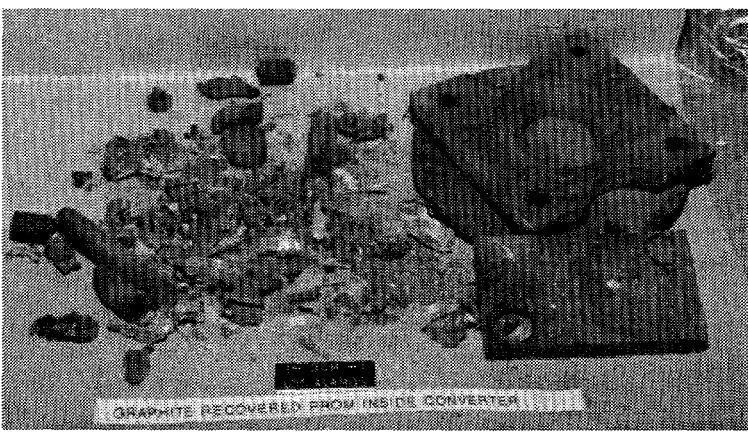
including the stack-lifting lug and the top POCO module (Figure 13). Graphite recovered from inside the converter consisted of the bottom POCO module and bottom support pieces (Figure 14) and the FWPF module (Figure 15). One molybdenum slug was totally dislodged from the bottom module; the other was partially dislodged. The aluminum plate fragments recovered outside the converter were severely deformed, as were the fragments recovered from the converter interior (Figure 16). Approximately three-fourths of the fragments recovered from the converter interior had melted and resolidified.

Figure 14. POCO graphite components recovered from the converter interior:
(a) end view of the bottom of the POCO module, (b) profile of the bottom of the POCO module, and (c) graphite bottom support pieces and miscellaneous shattered graphite pieces. (Neg B2323, Roll 5, #34 and 36A; Roll 6, #1).

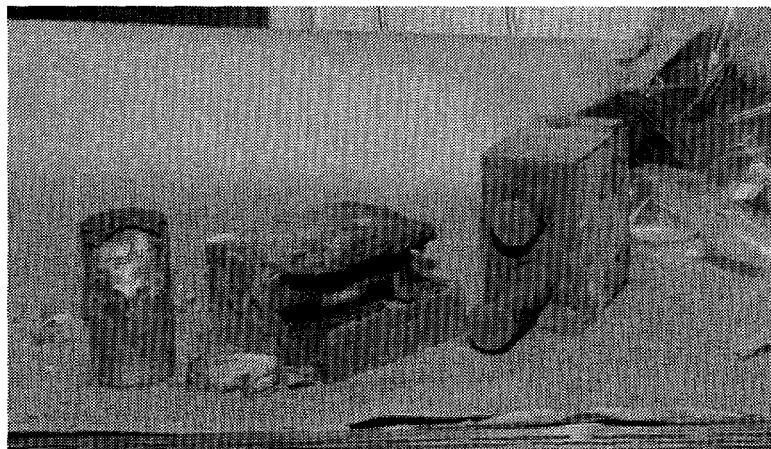
Figure 15. POCO module and FWPF module (the ejected GIS A to the left) recovered from the converter interior. (Neg B2323, Roll 1, #15)

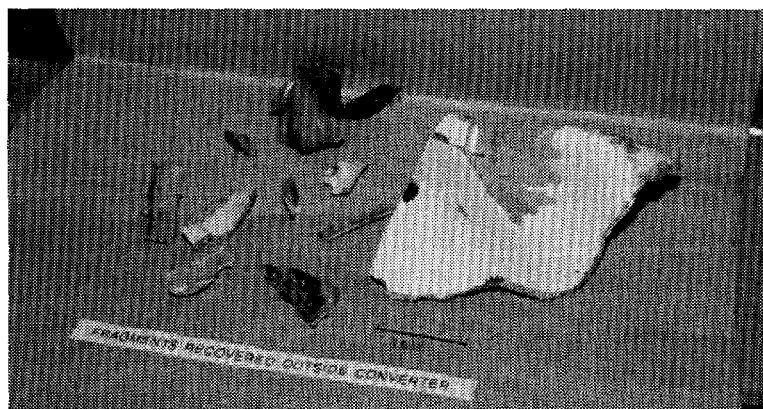
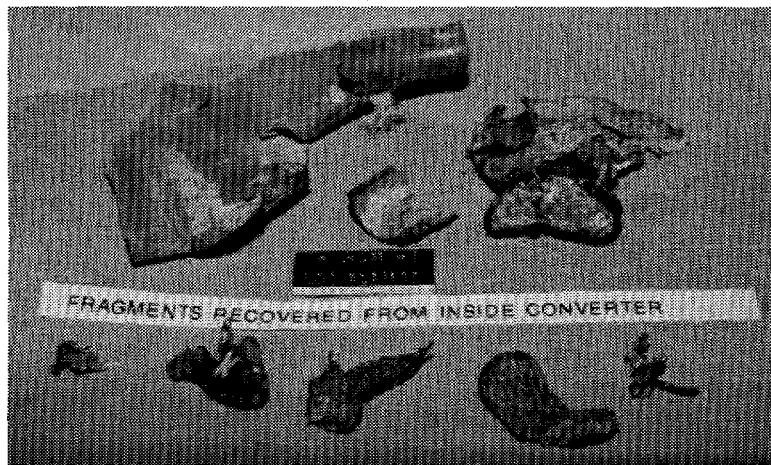
Figure 16. Aluminum fragments recovered from the impact test:
(a) fragments recovered outside the converter and (b) fragments
recovered from the converter interior. (Neg B2323, Roll 5, #3 and 10)

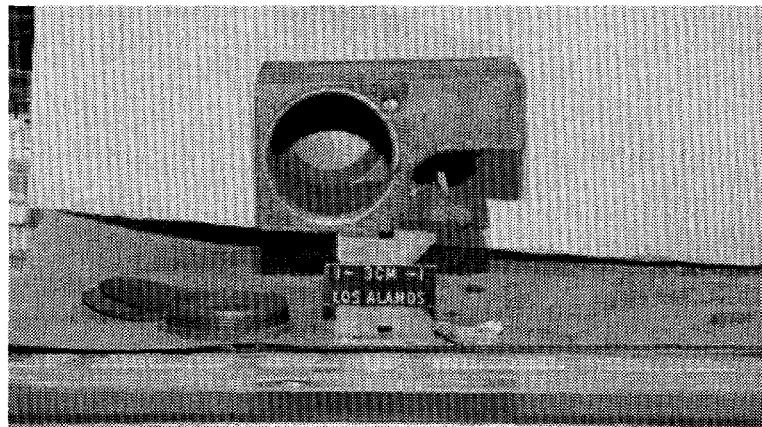
Posttest disassembly of the converter revealed that the leading edge of the fragment, which was roughly parallel to the long axis of the A GIS, penetrated into the A GIS cavity of the target GPHS module (Figure 17). One corner of the module, at the GIS cavity, was sheared off. The graphite module cap of this cavity was dislodged and had a gash that was apparently caused by penetration of the aluminum plate. The A GIS was ejected from the module. One-half of the GIS end cap had been severed from the GIS; the other half remained in place. A relatively large piece of the GIS at the impact area (approximately one-quarter of the top end) had been sheared off. Neither clad had been dislodged from the GIS. The open-end clad was breached on its shield cup (SC0126). Further disassembly revealed no other breaches in the remaining clads. The C GIS was unbreached and totally intact. Figure 18 shows an expanded layout of the FWPF module and its contents. Capsule deformations are listed in Table IV.

Figure 17. End view of the FWPF module showing a gash apparently caused by the impact of the plate with the A GIS cavity of the module. (Neg B2323, Roll 3, #11)

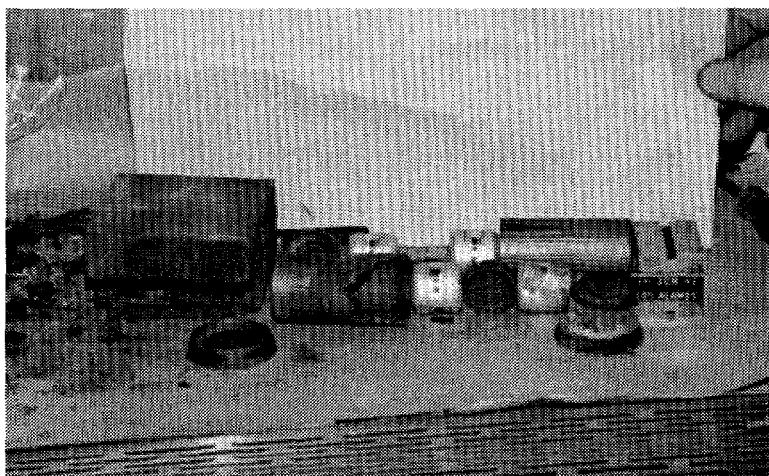
Figure 18. Expanded layout of the FWPF module and its contents. (Neg B2323, Roll 4, #36).

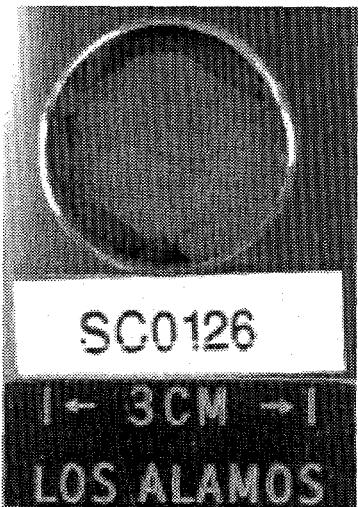
Capsule SC0126, which was located at the open end of the A GIS, had a small transverse breach (1.84 mm long, 0.40 mm wide) that was apparently caused by impact with the plate fragment (Figure 19). This breach was located between approximately 200 and 220 deg on the shield cup knuckle. Melted aluminum and material that appeared to be an Al/Ir reaction product surrounded the breach. This material was also observed on the capsule in several locations. Upon further investigation, this single breach was found actually to consist of two separate failures. During examination, fragments of the aluminum fragment that partially covered these clad failures began to flake off. Subsequent measurement revealed that this material had covered breaches that were larger than the initial measurement taken. One breach was circle shaped and measured approximately 2.1 mm in diameter (3.41-mm² breach area). The other breach measured approximately 3.68 mm long and 0.56 mm at its widest point (approximately 2.06 mm² breach area). Two other transverse hairline cracks were seen on the shield cup. One crack measured approximately 7.92 mm long and was located below the weld at approximately 115 deg from the weld start carets. The other crack was located at approximately 350 deg, on the cup knuckle, and measured approximately 3.58 mm. An atypical discoloration of the clad material was observed approximately 130 deg from the weld carats. The estimated amount of fuel released from the capsule was 0.0890 g (based on the weight of recovered fuel retained by the capsule).

Figure 19. Capsule SC0126 was the only capsule with breaches in test RTG-3: (a) impact face, (b) profile, (c) trailing face, (d) opposite profile, (e) vent end, (f) blind end, and (g) fuel fragmentation. (NMT-9 Negs SC126M12, SC126M13, SC126M10, SC126M11, SC126M8, SC126M9, and SC126M15)

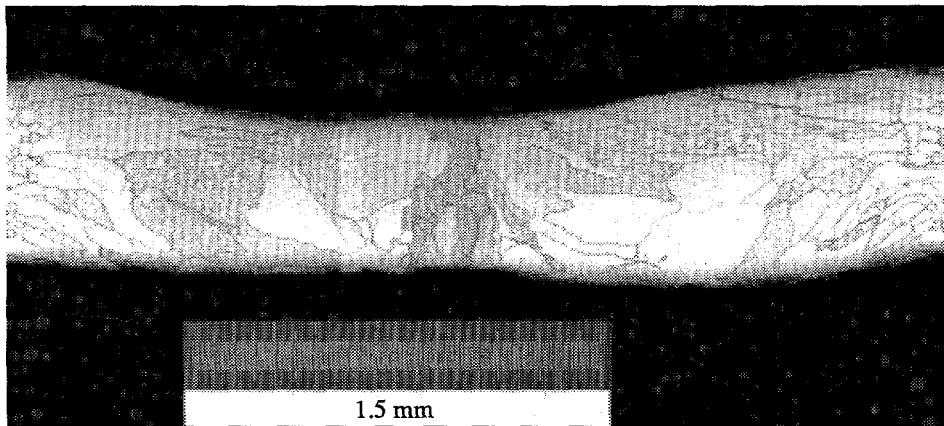
Figure 20. The microstructure of the weld overlap region was atypical. (Negs SC126-1-2 and -1-3, combined)

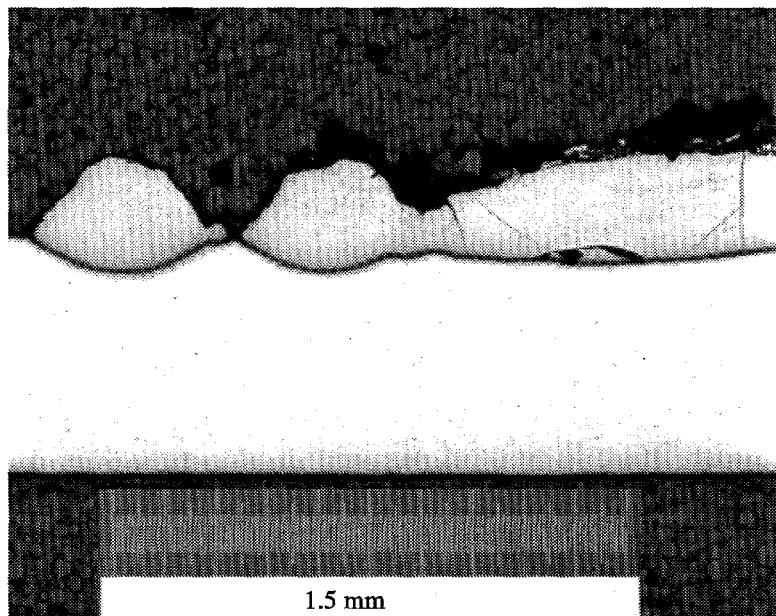
Metallographic examination of the Al/Ir reaction product revealed that it was clearly defined and homogeneous (Figure 21). The Al/Ir intermetallic compound contained several fractures. One of the intermetallic metallographic sections was submitted for scanning electron microscope (SEM) examination. The examination confirmed the presence of an Al/Ir reaction product having an Al:Ir atomic ratio of approximately 7:3.

Figure 21. Typical microstructure of the Al/Ir intermetallic deposits.
(Neg SC126-2-5)

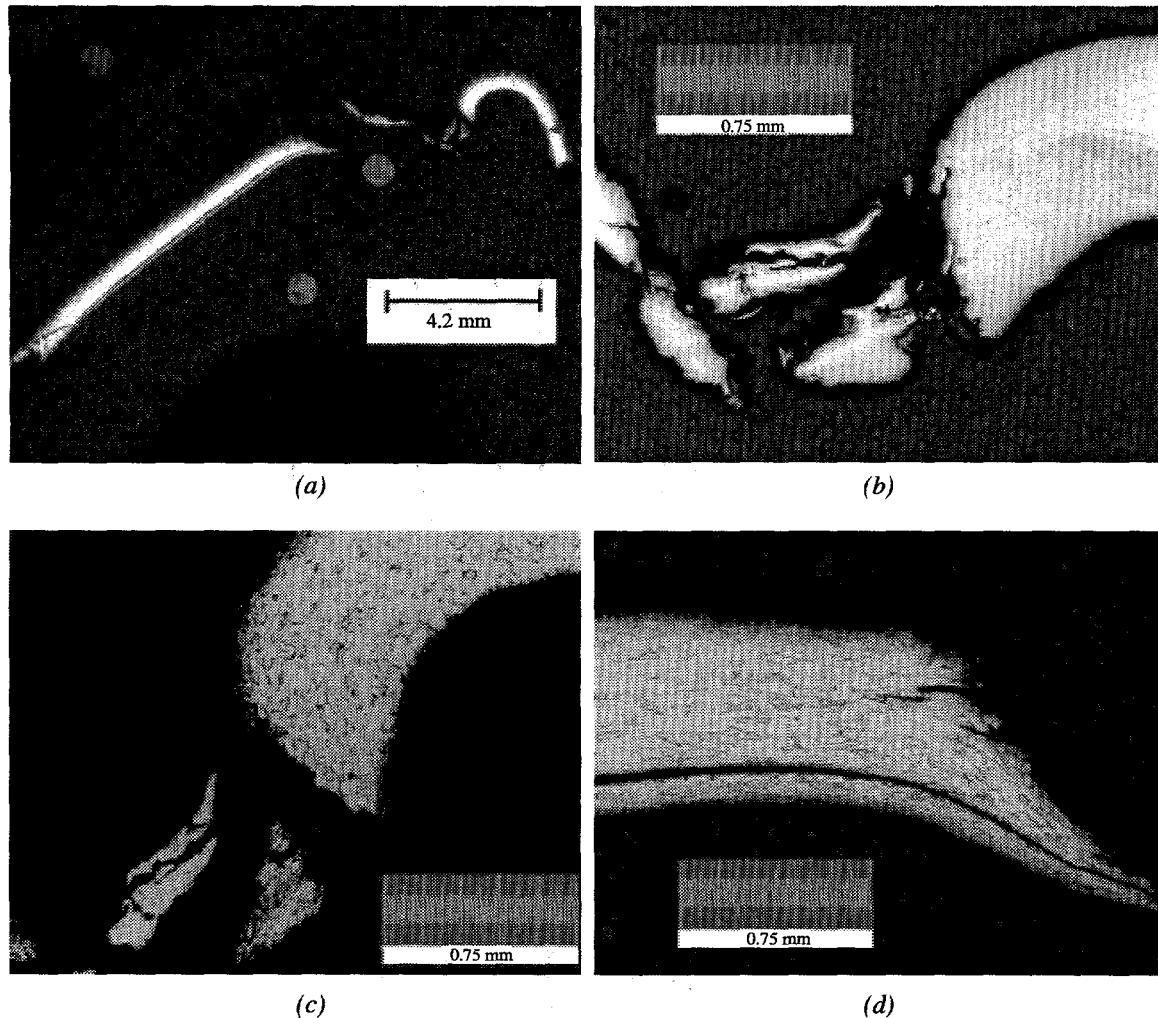
Examination of the two transverse shield cup breaches revealed intergranular failures with moderate grain elongation before failure (Figures 22 and 23). There was a minute deposit of the Al/Ir intermetallic product at both fracture sites, but there were no indications that the formation of the intermetallic had contributed to the failures. Metallographic examination of the clad's discolored area revealed no unusual microstructure.

Figure 22. Transverse breaching crack: (a) metallographic sample; (b) polished fracture end with an Al/Ir intermetallic deposit; (c) fracture end, etched; and (d) the other fracture end, etched. (Negs SCI26-8-1, SCI26-8-3, SCI26-8-4, and SCI26-8-8).

Although a brittle Al/Ir intermetallic deposit was formed by reaction of the aluminum plate with the hot iridium clad metal, it did not appear to have significantly affected the clad impact response. It may, however, have prevented a more significant release of fuel from the capsule. The reaction product surrounded the breaches and effectively reduced the size of the breaching cracks.

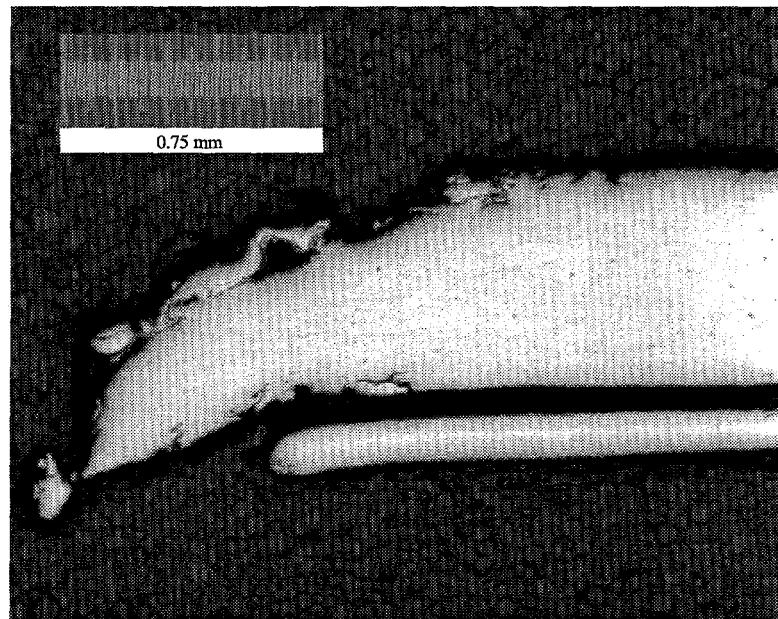
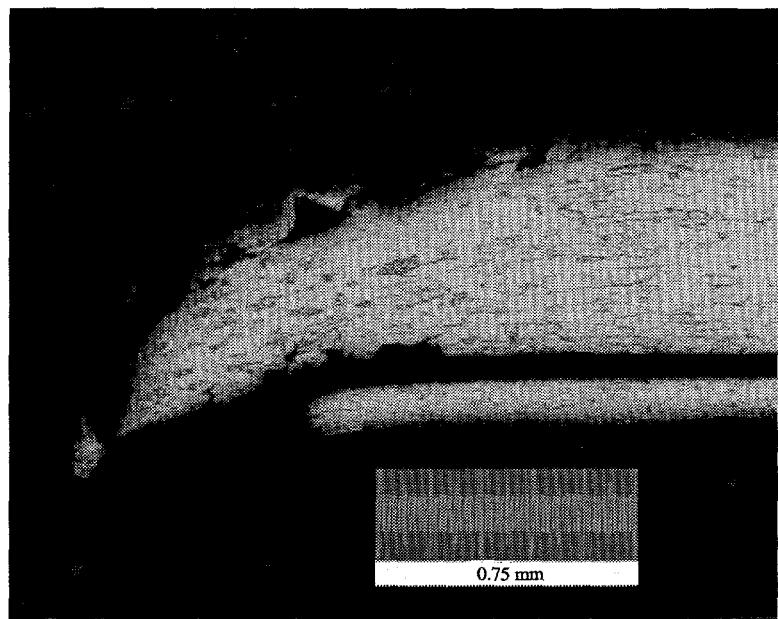
Figure 23. Transverse breaching crack, circle shaped: (a) polished fracture end with an Al/Ir intermetallic deposit and (b) fracture end, etched. (Negs SC126-7-2 and SC126-7-3).
