**TEST OF 6-INCH-THICK PRESSURE VESSELS.
SERIES 1: INTERMEDIATE TEST VESSELS
V-1 AND V-2**

REACTOR DIVISION

HEAVY-SECTION STEEL TECHNOLOGY PROGRAM

FEBRUARY 1974

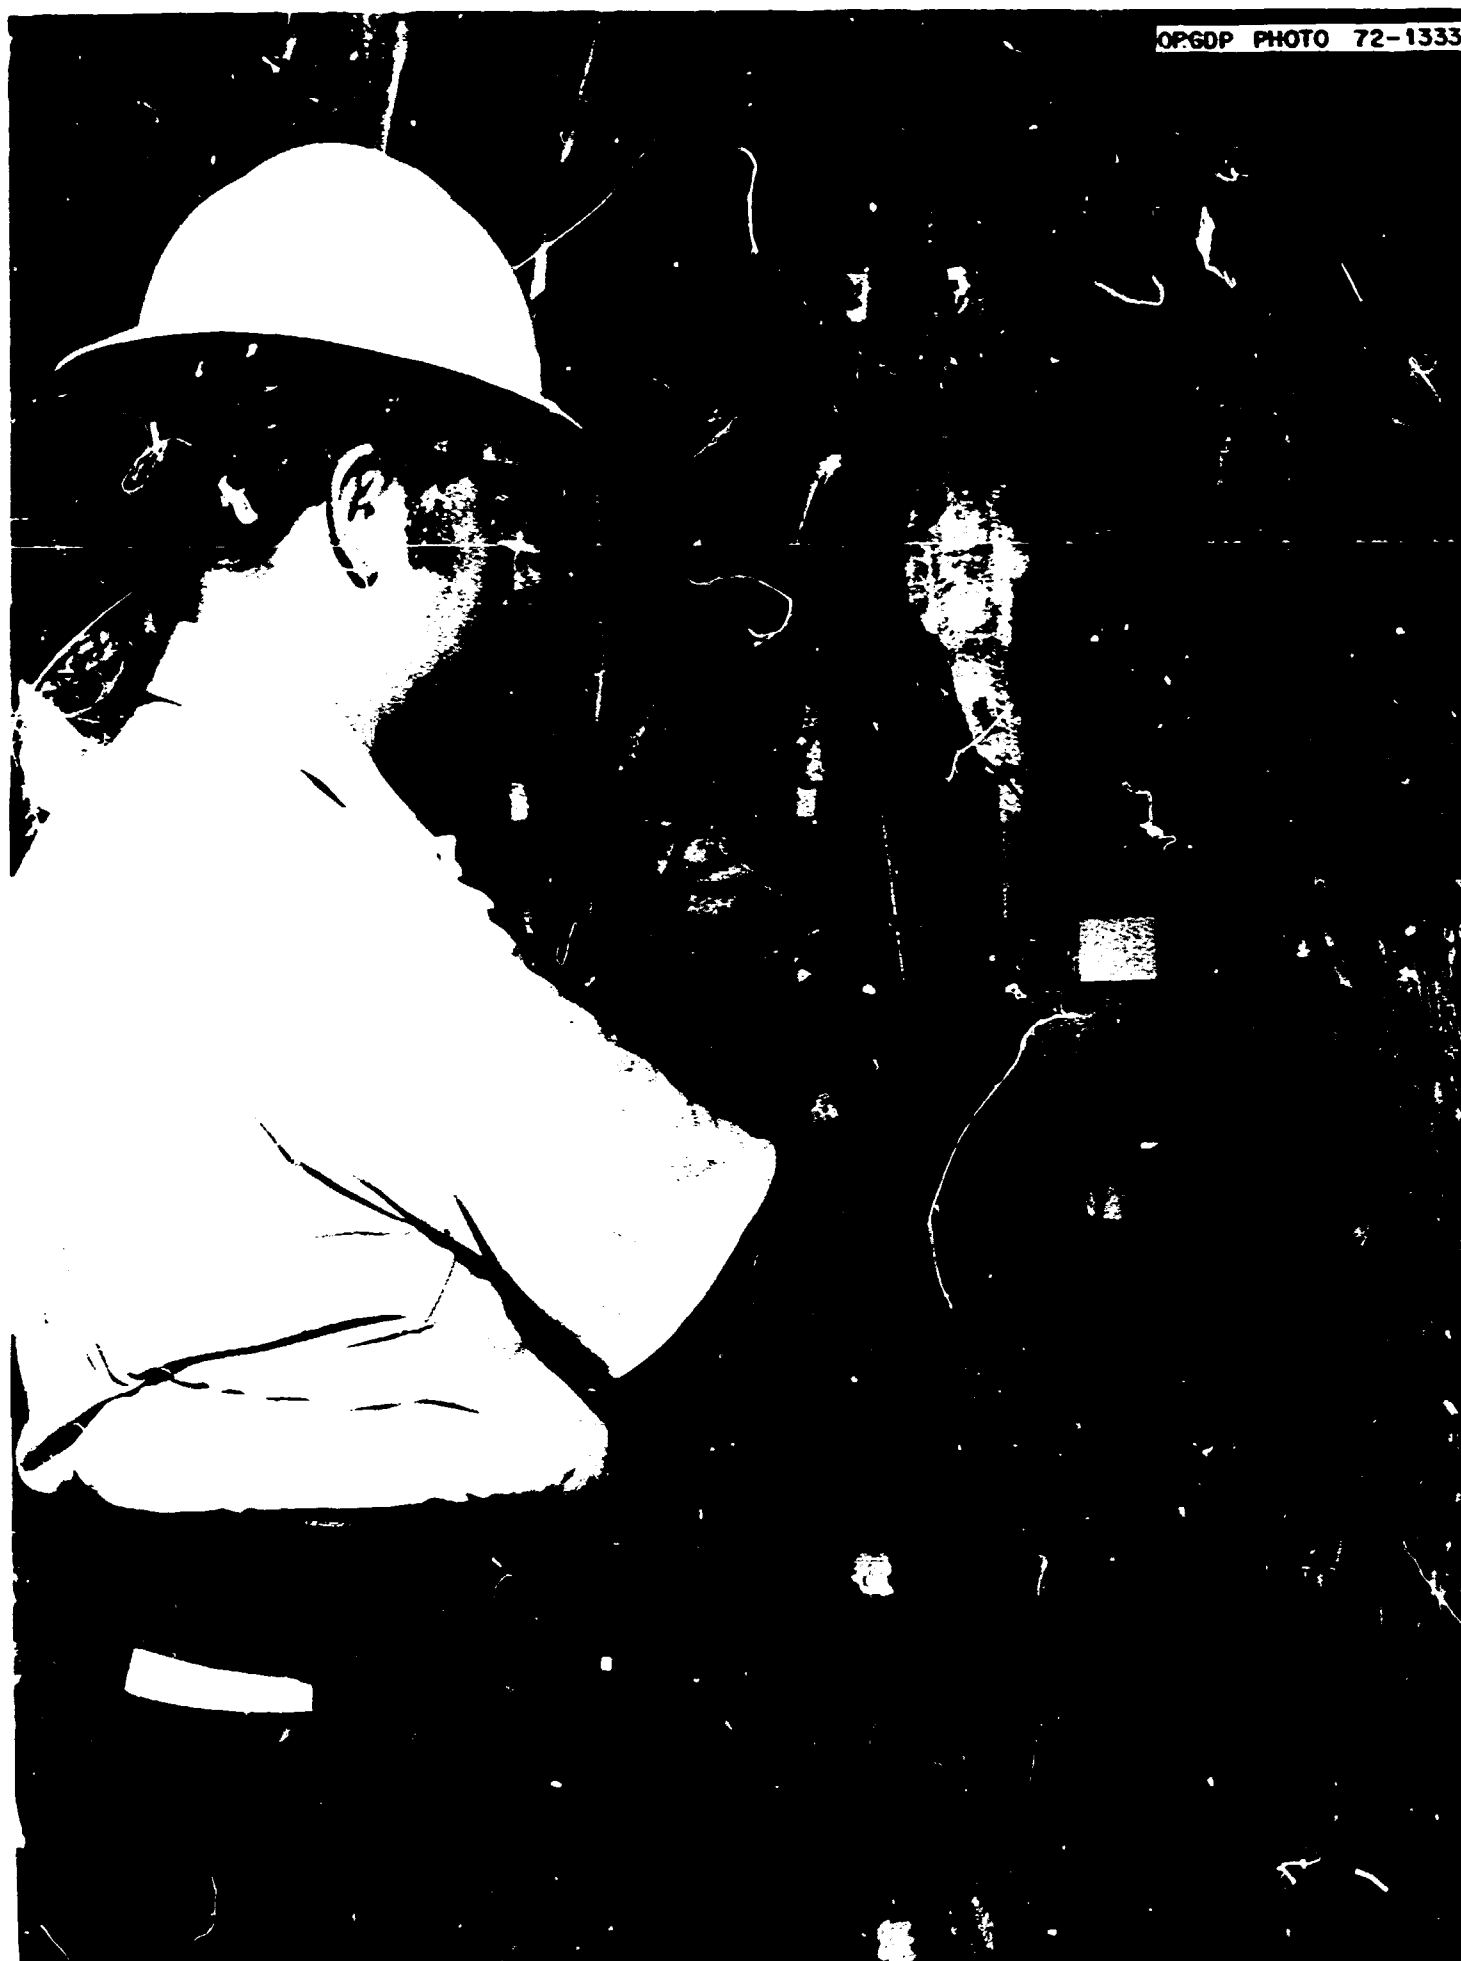
Fig. 8.13. Vessel V-1 in test pit showing size of opening in region of flaw.

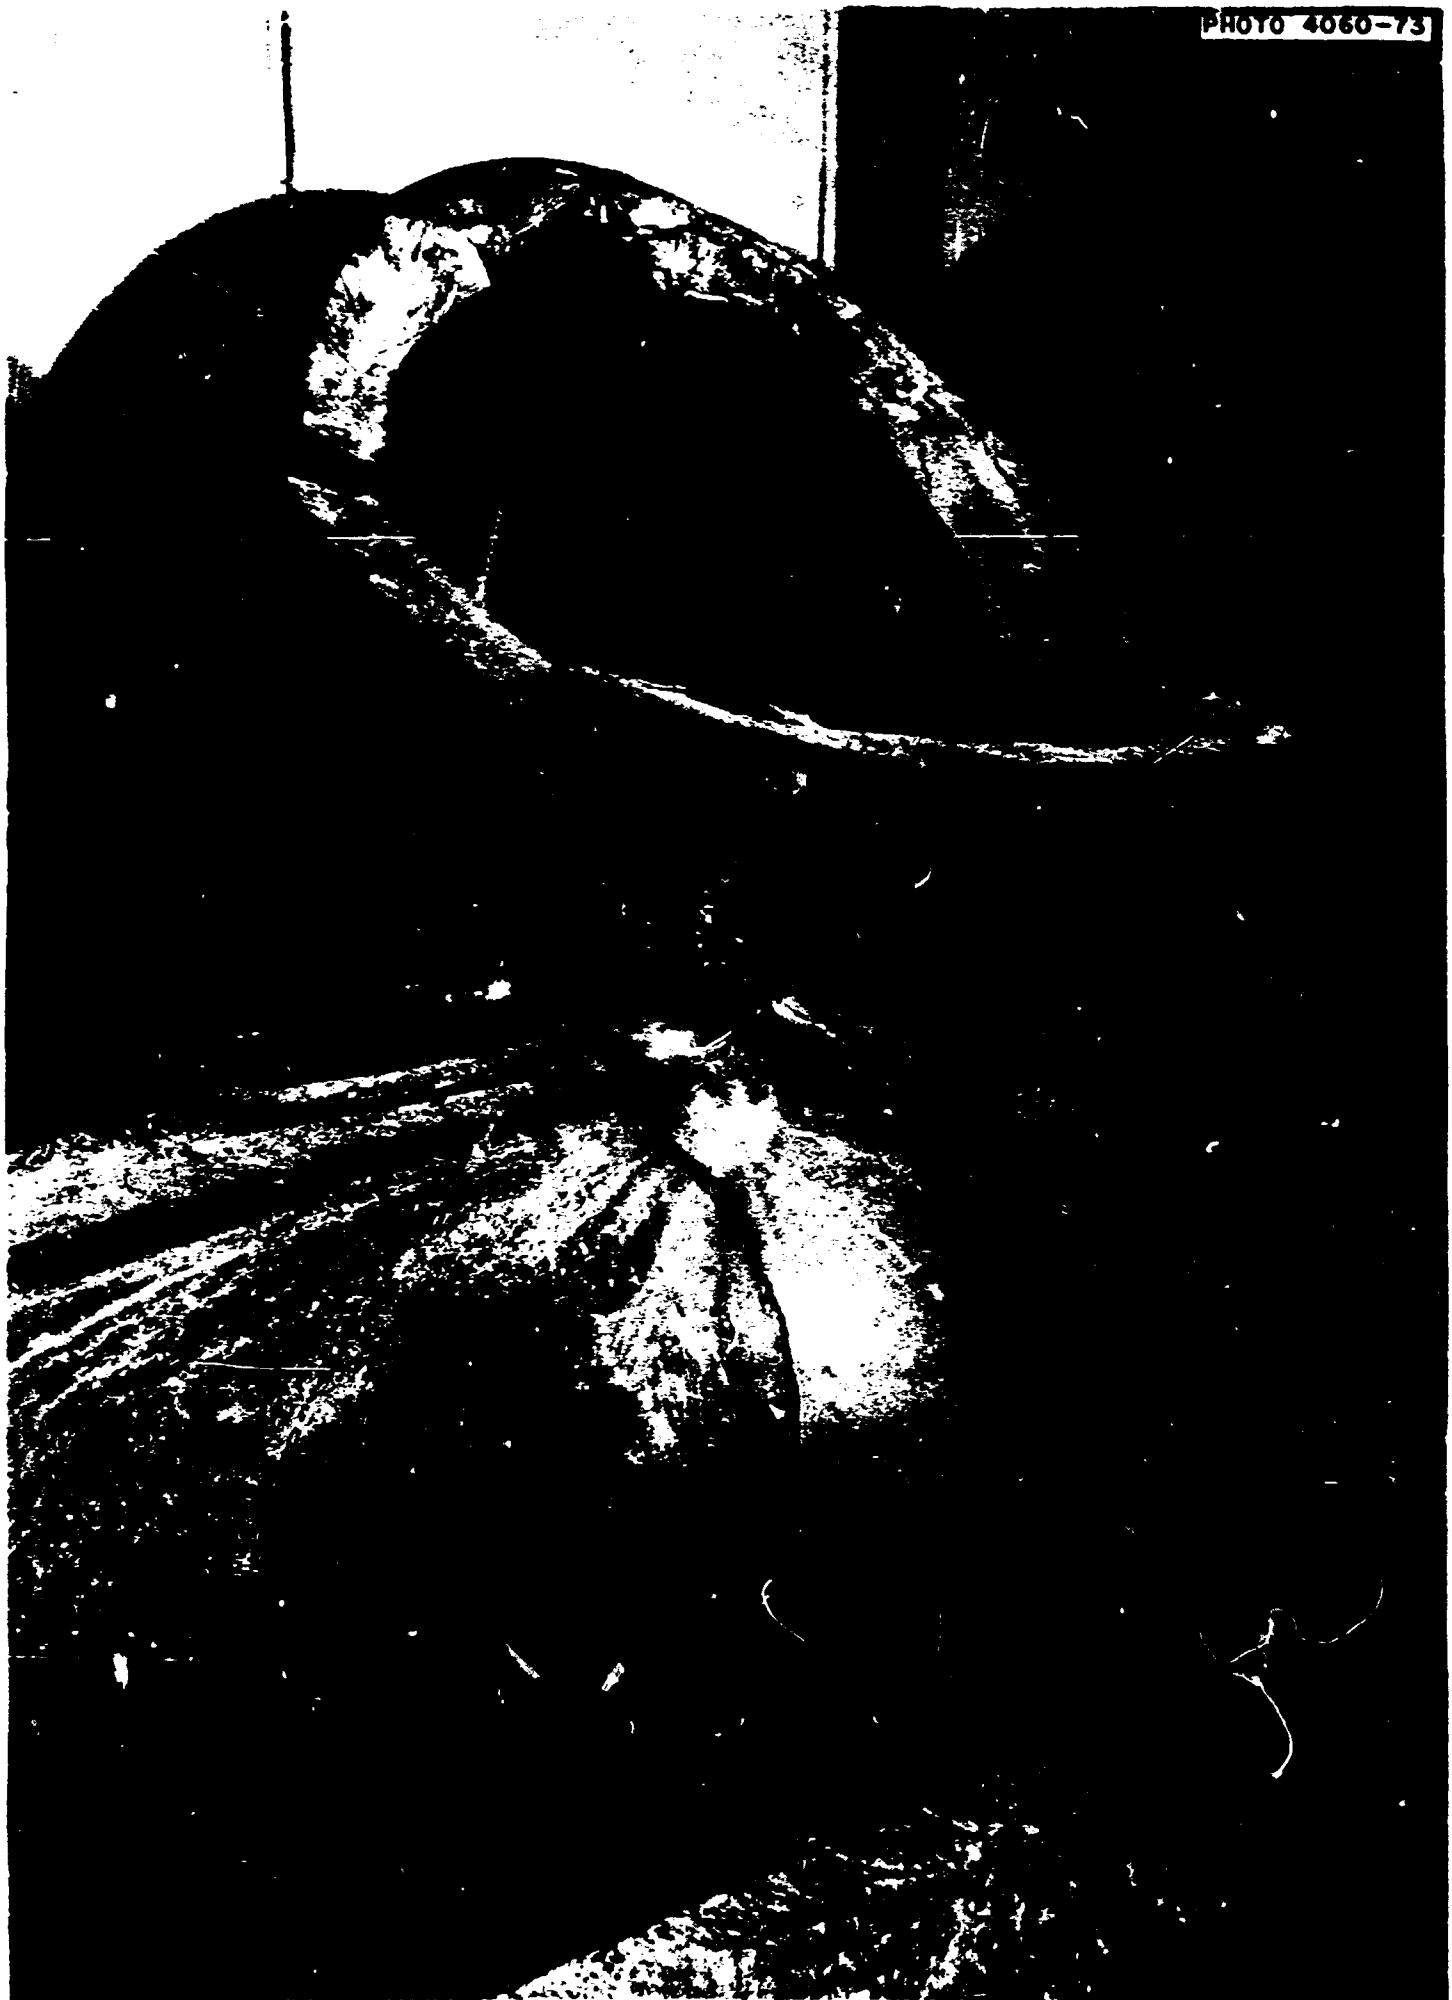
Fig. 8.27. Vessel V-2 removed from the pit, showing the extensive cracking. Pieces of model vessel tested at -55°F are shown on foreground fragment.

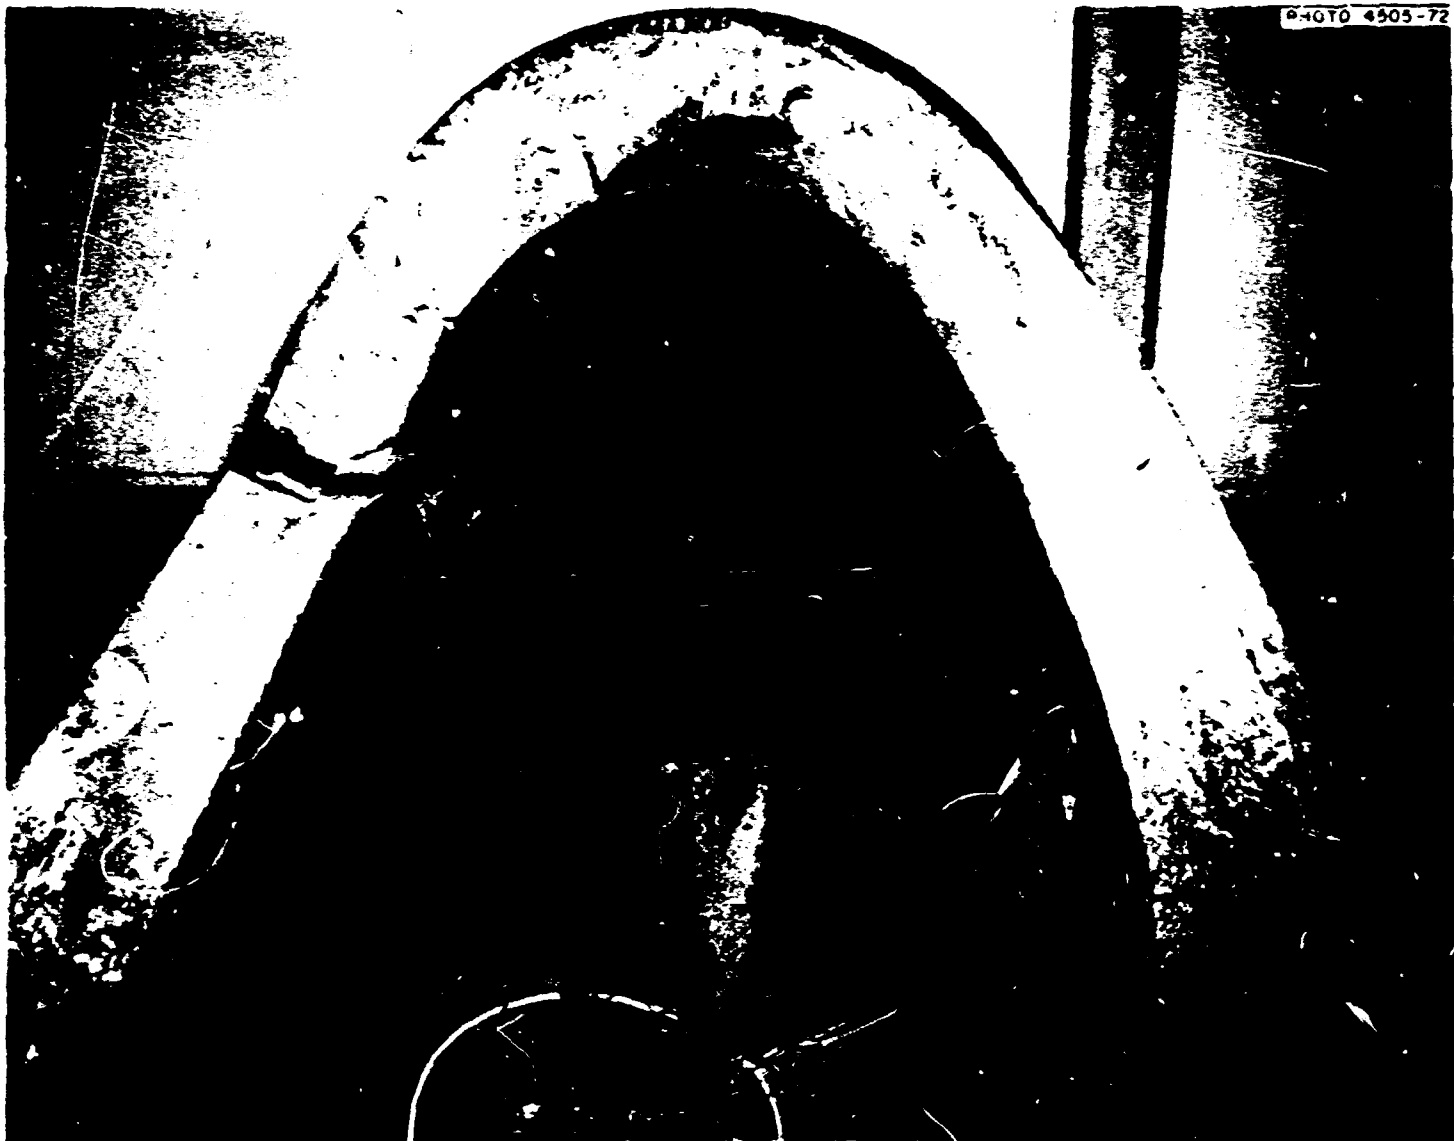
Fig. 8-28. Closure end region of vessel V-2 after fracture, showing the extensive cracking.
