Lance Water Injection Tests Adjacent to the 281-3H Retention Basin at the Savannah River Site, Aiken, South Carolina

B. Freifeld, L. Myer, G. Moridis, P. Cook,
A. James, L. Pellerin, and K. Pruess
Earth Sciences Division

September 1996

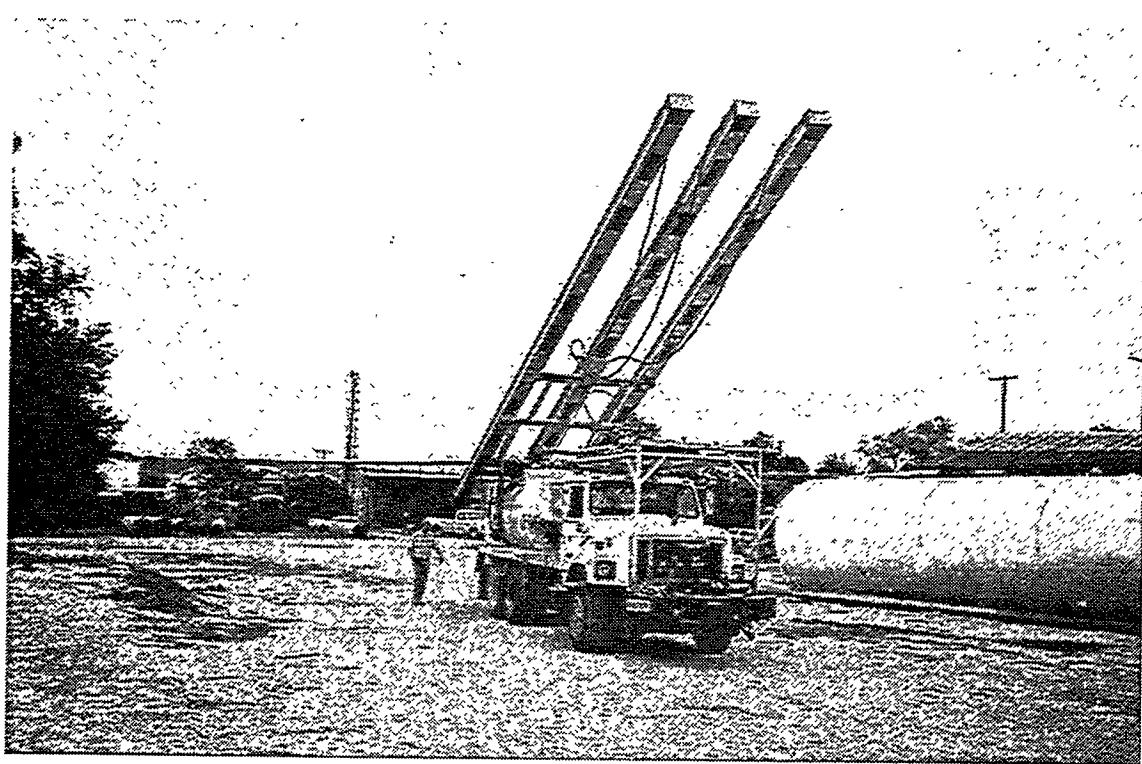
Figure 1. Lance Injection Truck with mast being raised. Total mast length is 45 feet.

The central piece of equipment used for the LWIT was a truck provided by Hayward Baker (equipment number 98312), through their Fort Worth office. The Lance Injection truck is displayed in Figures 1, 2, and 3. The truck which is commonly referred to as a 40 foot railroad injection unit was designed by Hayward Baker to inject lime-slurry grouts for stabilizing the bedding beneath railroad tracks. The total weight of the LWIT truck is 20,100 kg (44,220 lbs). The weight is distributed with 12,973 kg (28,540 lbs) on the rear axle and 7,082 kg (15,580 lbs) on the front. The truck mounted tank has a storage capacity of approximately 4920 liters (1300 gallons). The masthead which contains the three 12.2 m (40 foot) lances is 13.44m (44' 1") in length.

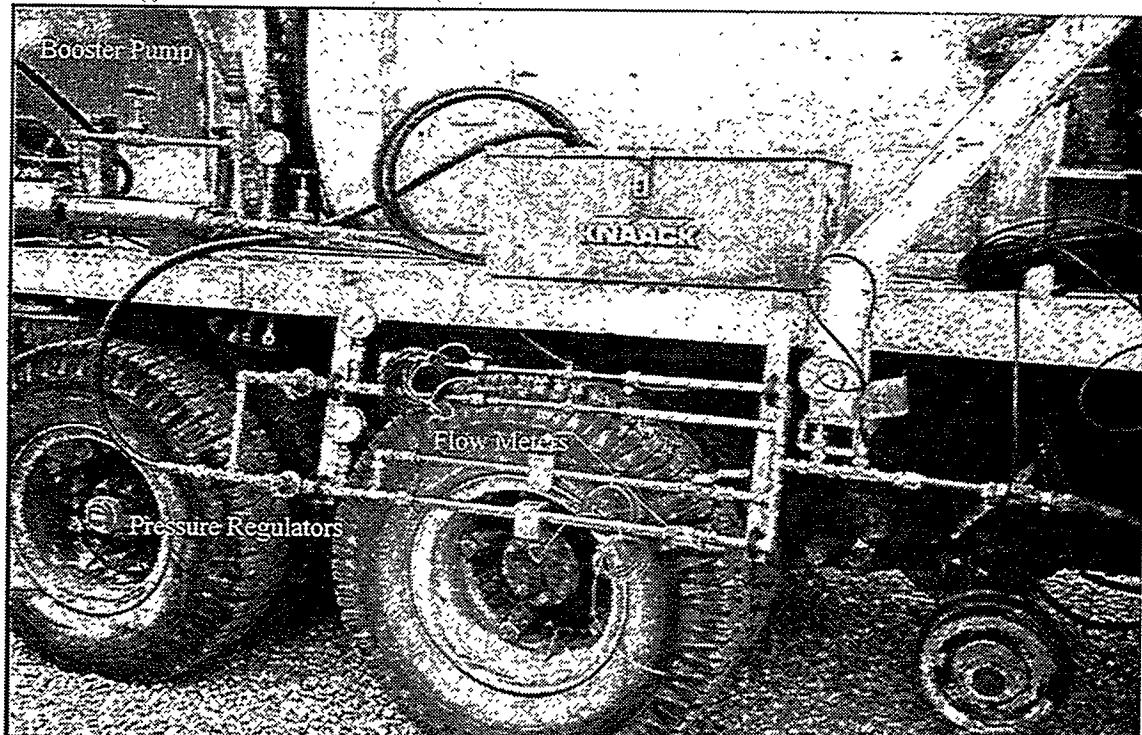
Figure 2. Flow control equipment mounted on the left rear portion of the Lance Injection truck.

The flow control equipment is pictured in Figure 2, as mounted on the Lance Injection truck. Water for injection was gravity fed into the Teel booster pump from a storage tank mounted on the rear of the truck. The Teel pump used to boost the water pressure has a maximum output of over 1.38×10^3 kPa (200 psi). At this pressure, the flow rate can still exceed 20 lpm. This would enable determination of the pressures required to fracture the formation, a situation to be avoided while permeation grouting. A recirculation line was fed back into the water storage tank from the outlet of the booster pump to enable the pump to operate at a wide range of flow rates and pressures. By

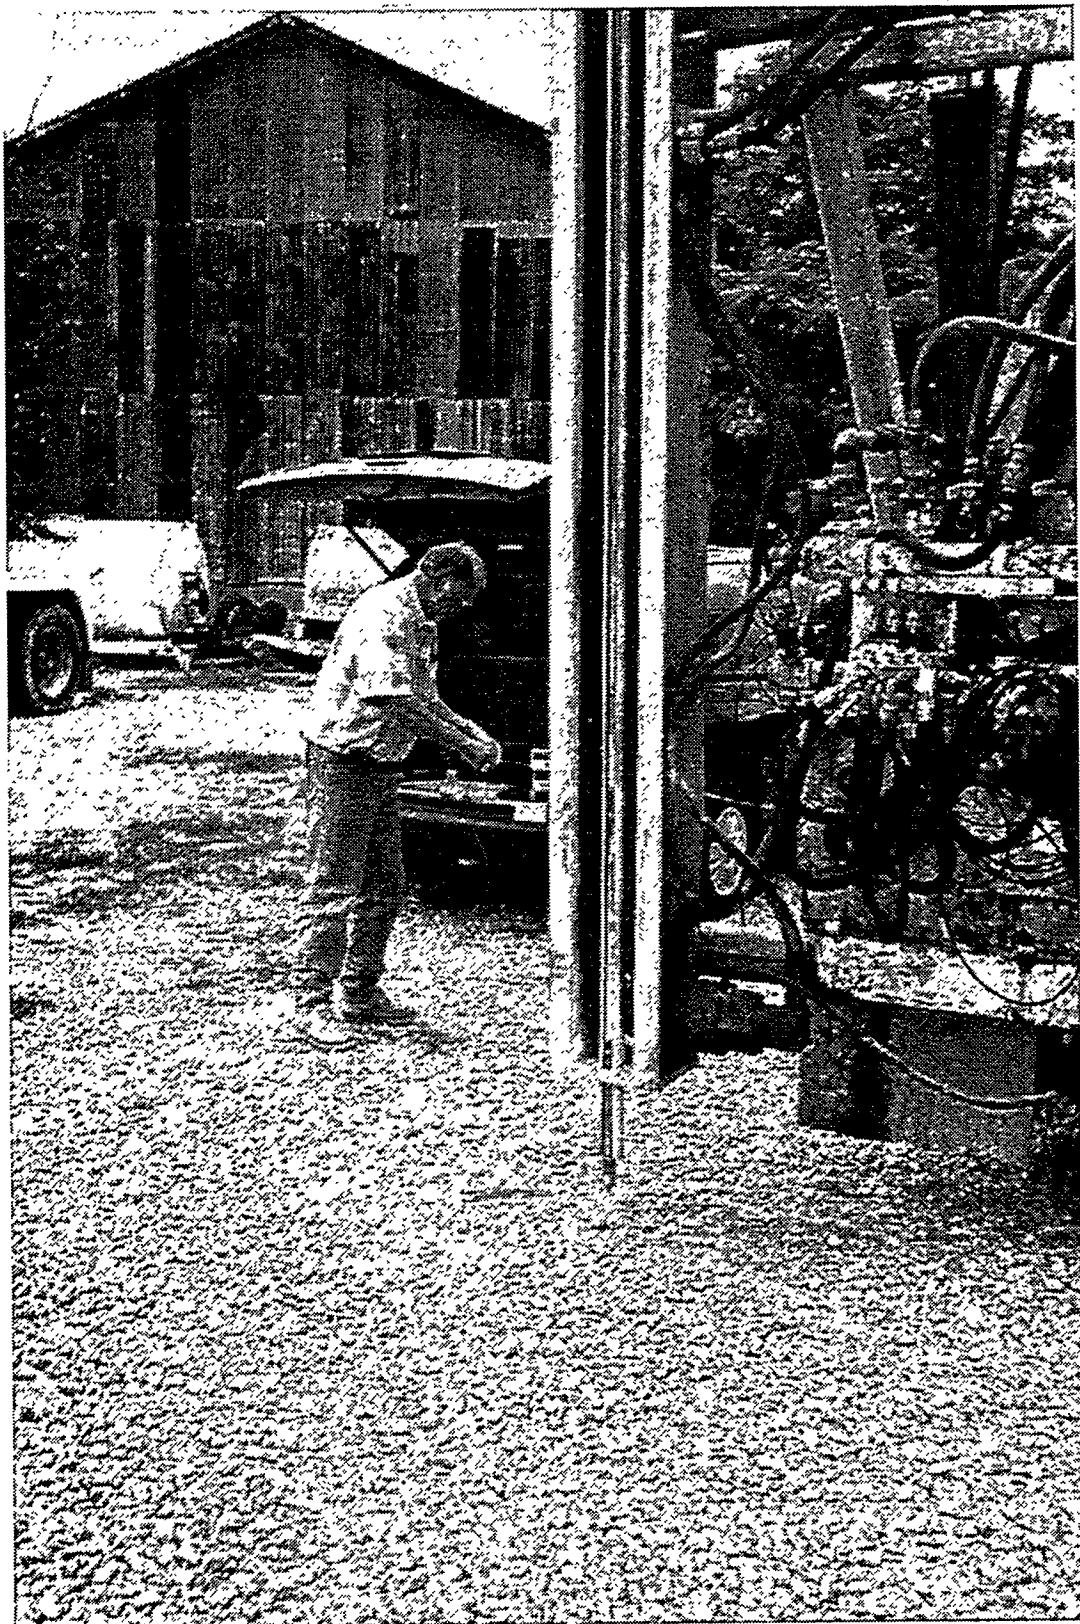
Figure 3. Lance injection truck with instrumented injection tip installed. Masthead is locked in the vertical position.

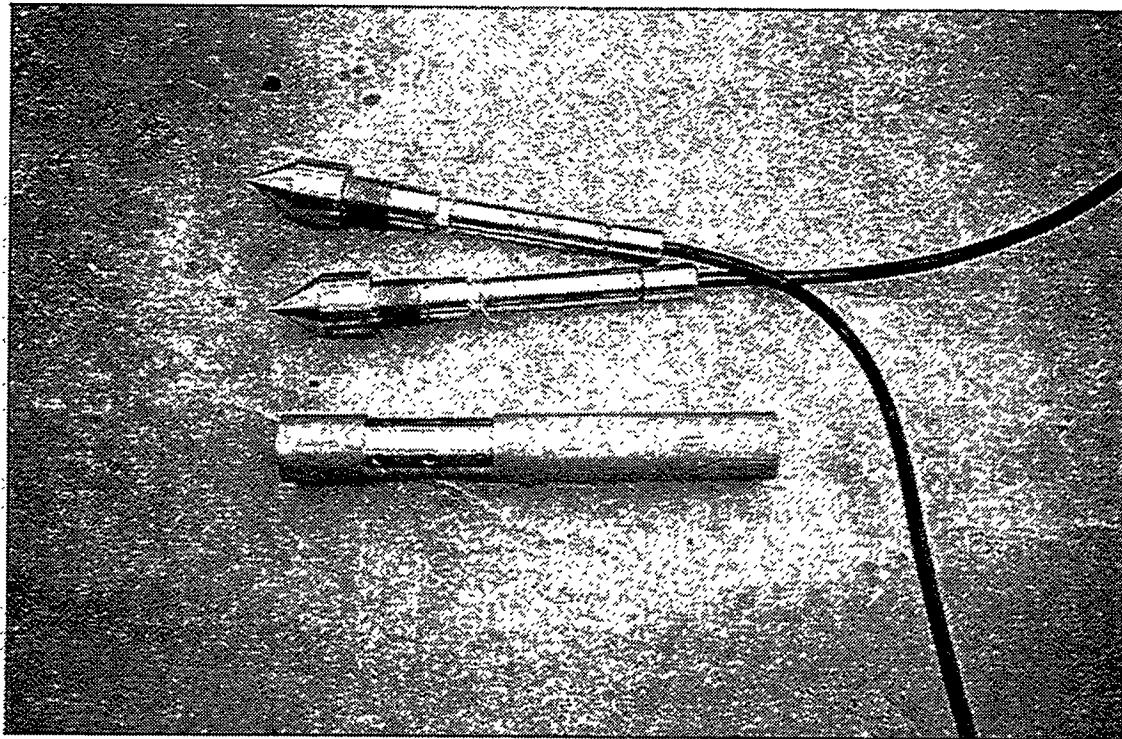
Figure 4. Lance tips with downhole pressure transducers installed.

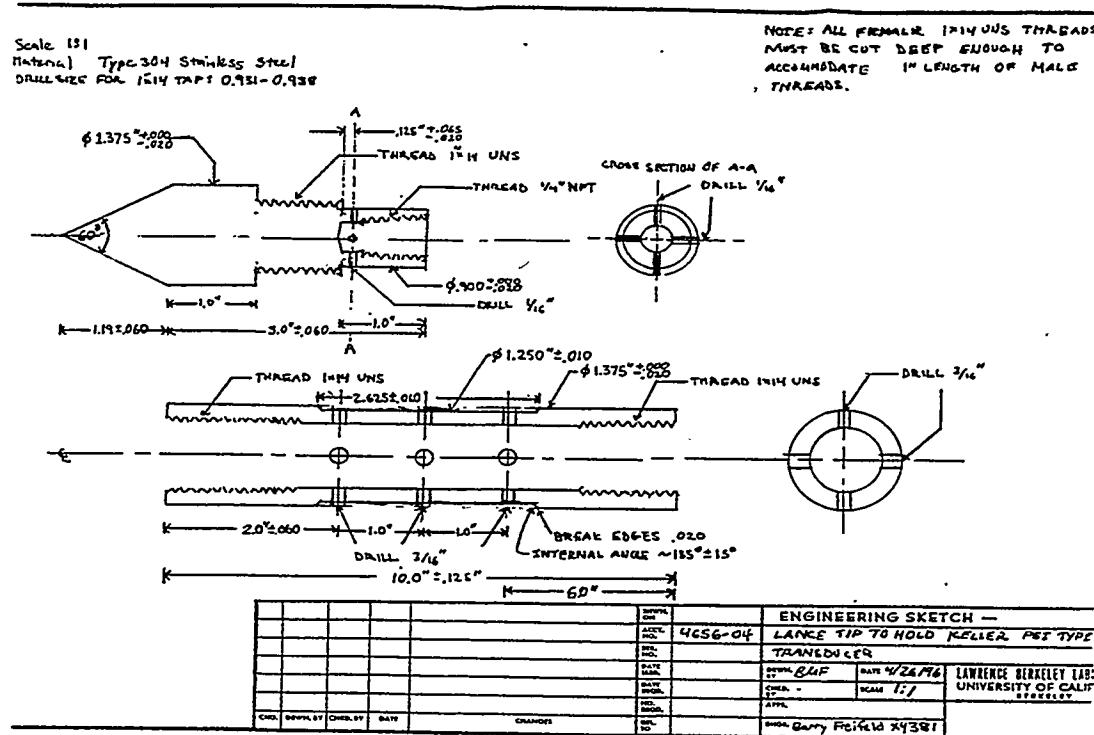
Figure 5. Engineered sketch of lance tip and lance body.

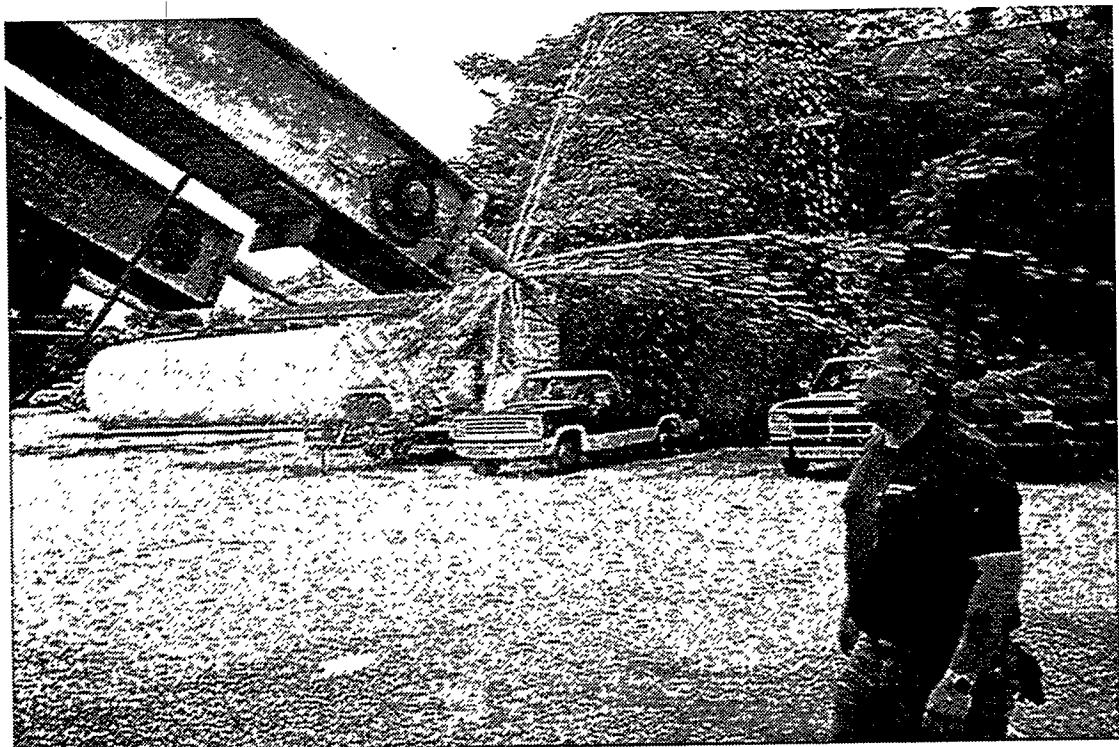
Figure 6. Testing the lance tips above the ground. Water is injected through four sets of three 3/16" holes.

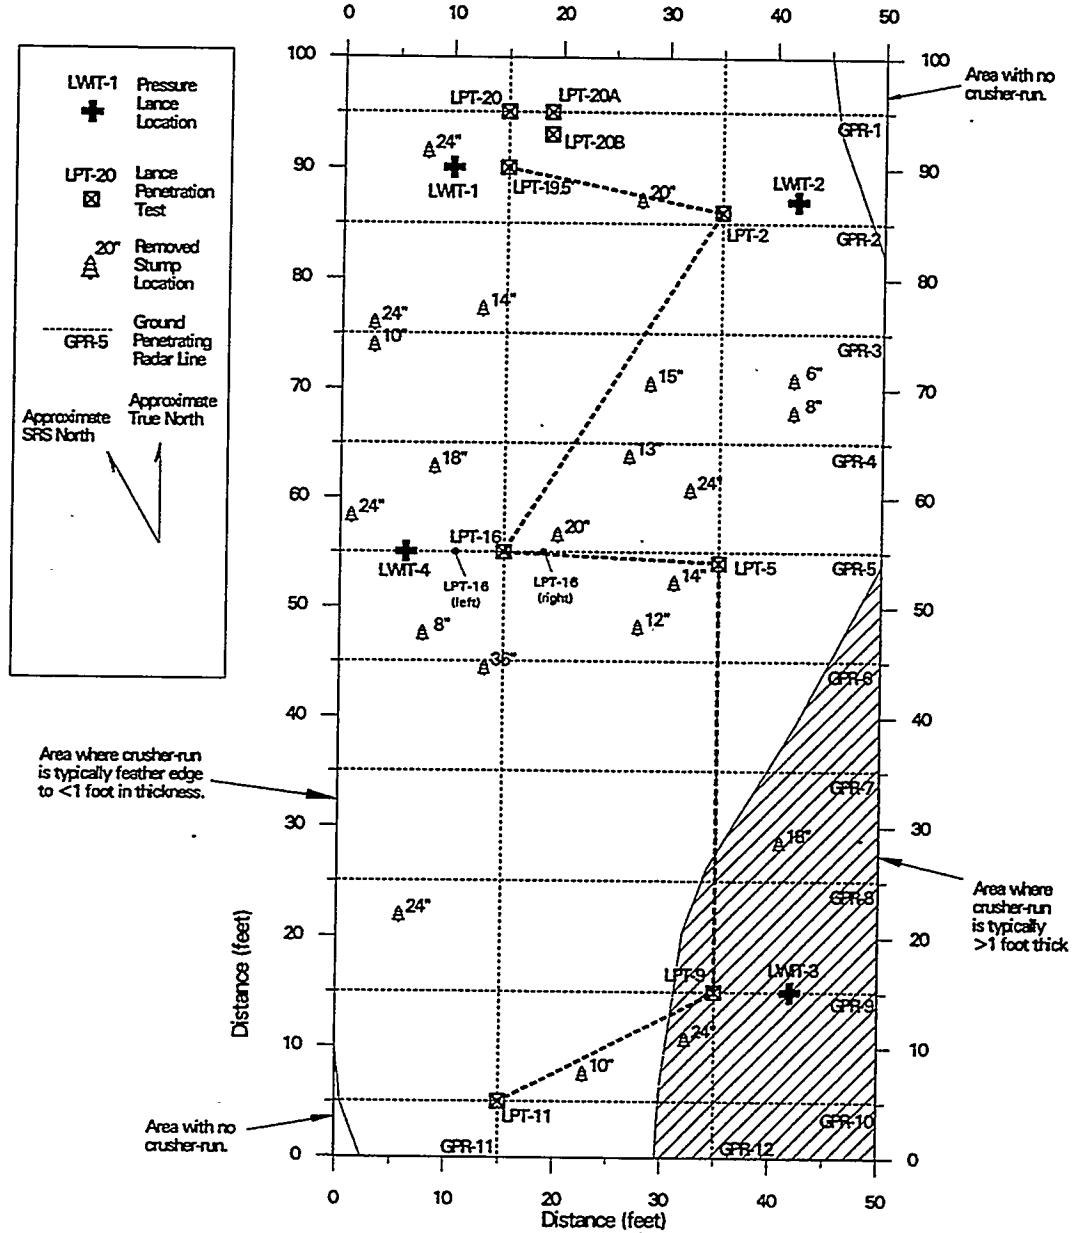
Figure 7. Location of test borings in the LWIT Footprint. Modified from WSRC 1996.

Accurate determinations of pore pressures and the water table location was not an object of the LWIT during active testing. Four piezometer tubes were installed within the LWIT grid as shown in **Figure 7**, for future monitoring. Detailed installation information can be found in WSRC, July, 1996. At the conclusion of the LWIT program, the piezometers were not yet at equilibrium and no evaluation of water table location could be made by direct measurements. Observations made while augering show the strong presence of water at about 19'. Even though lance injections were performed above and below this depth, no difference in the behavior was identified as a function of relative position to the presumed water table. It can be concluded that lance injections, as carried out during the LWIT program, are insensitive to the variations in liquid saturation that were encountered.

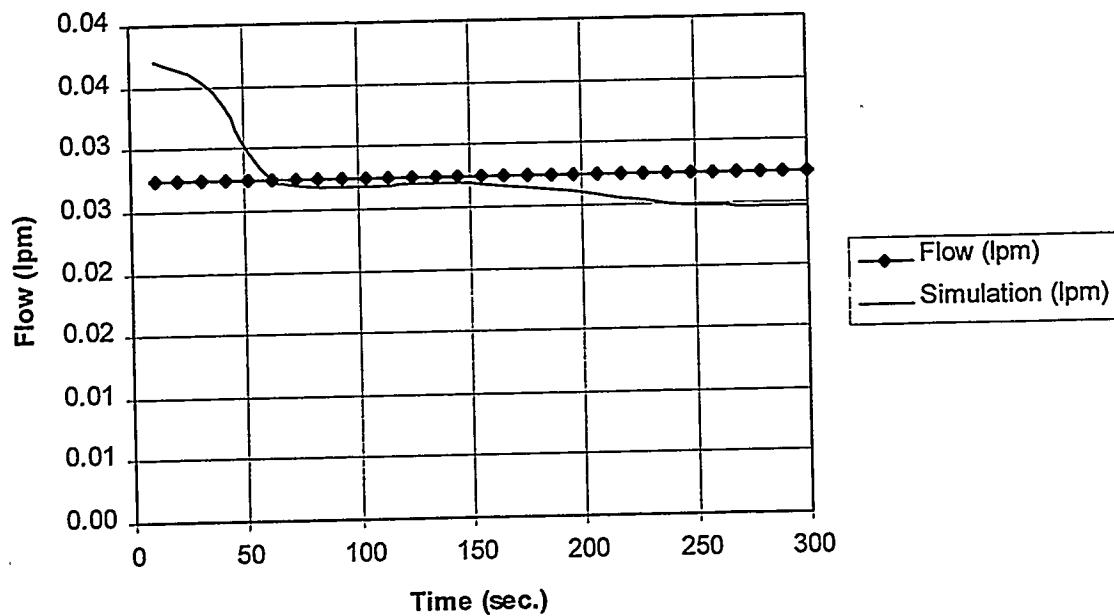
Figure 16. Comparison of LPT-5S injection at 16 ft. depth with TOUGH2 model.

Based on values of injection pressure and flow rate from some of the tests performed, an estimate of hydraulic conductivity was determined. Figures 15, 16 and 17 plot flow rate versus time, comparing the near constant flow rate measured in the field and the simulated time dependent flow rate for the three different tests. The numerical model does not produce a constant flow rate as observed in the field. There is an early time transient which is not seen in the field data, although it must be remembered that the very early time flow rate data was usually not measured. This was because the 1/2" flowmeter was used during lance movement. After the lance was stopped at the targeted depth, 5 to 30 seconds elapsed before the in line flowmeter was switched to a lower range unit, when the flow rate was below the 1/2" flowmeters detection limit.

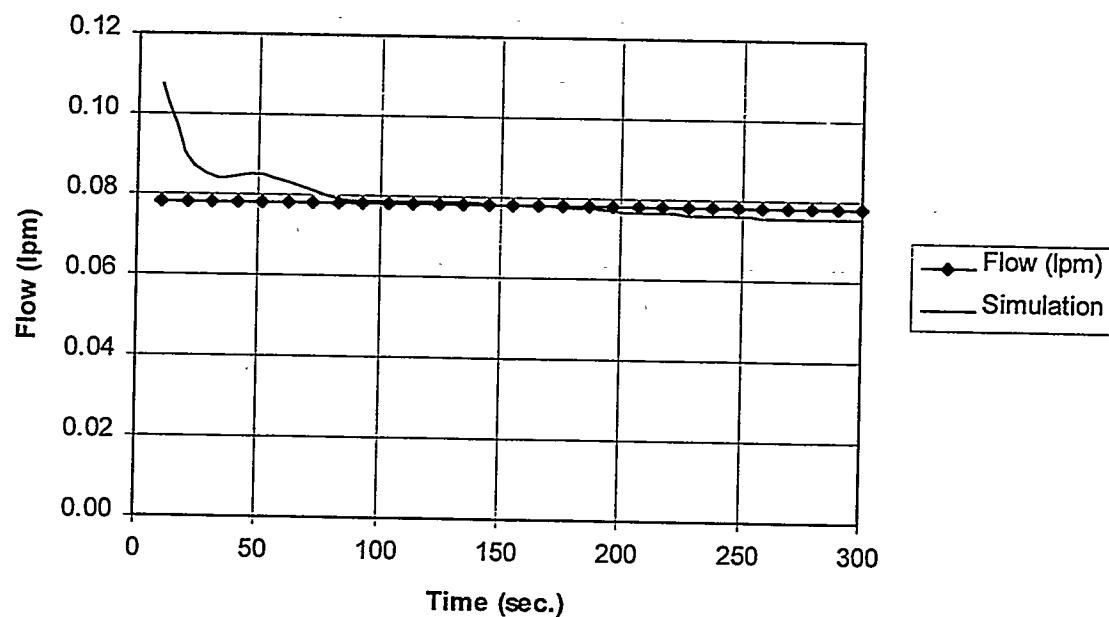
Figure 18. Comparison of LPT-19S injection at 17 ft. depth with TOUGH2 model.

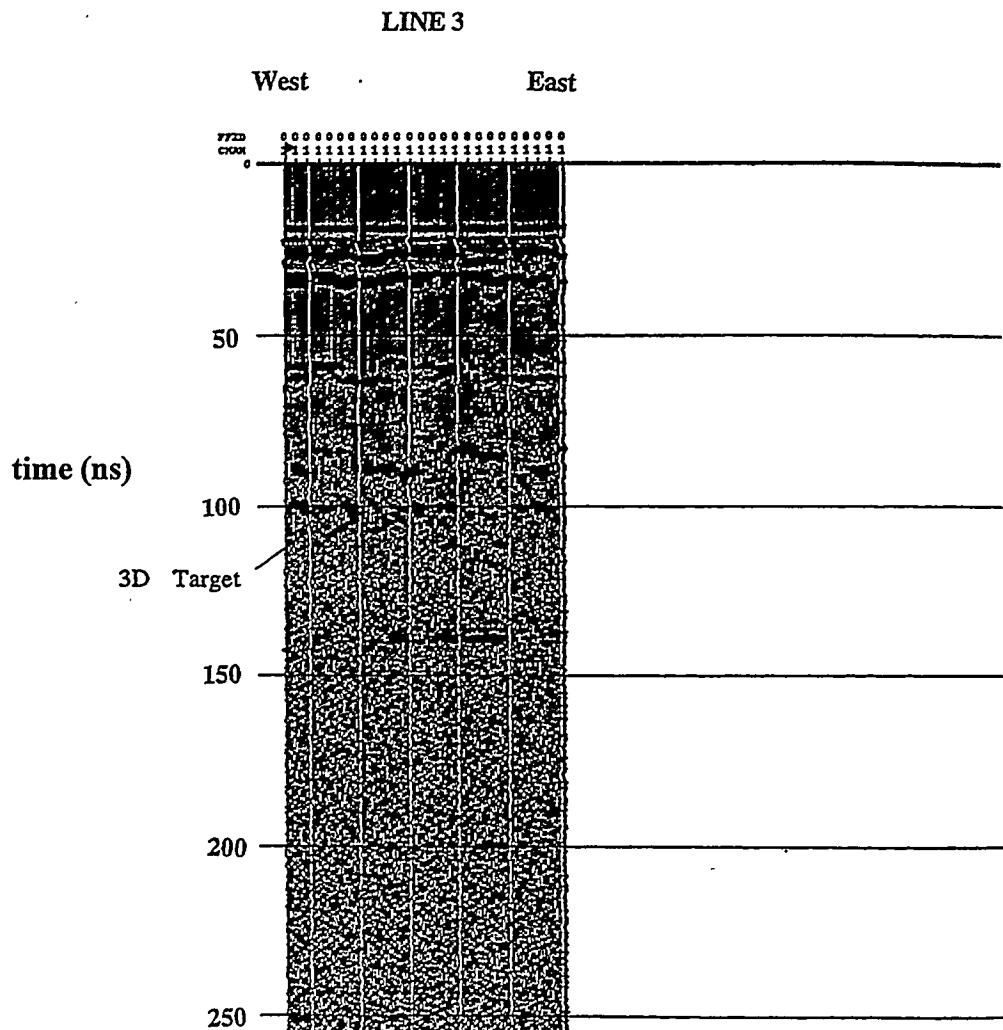
Figure 19. Ground penetrating radar taken along Line 3.

The GPR data illustrate that substructure can be imaged, but instrument artifacts obscure lithological reflectors. The data presented in **Figures 19 through 24** are the 300 MHz pre-injection data run on lines 3, 6, 8, 10, 11 and 12. Location along the GPR line is plotted on the abscissa and the time in nanoseconds (ns) is plotted along the ordinate. **Figure 7** shows the GPR line locations. Data on lines 3, 6, 8 and 10 are plotted from west to east and lines 11 and 12 from north to south. Line numbers and cardinal directions are noted on the top of each plot and the 50, 100, 150, 200 and 250 ns marks are noted along the vertical axis. Features of interest are outlined below and noted on the figures. The following observations can be made:

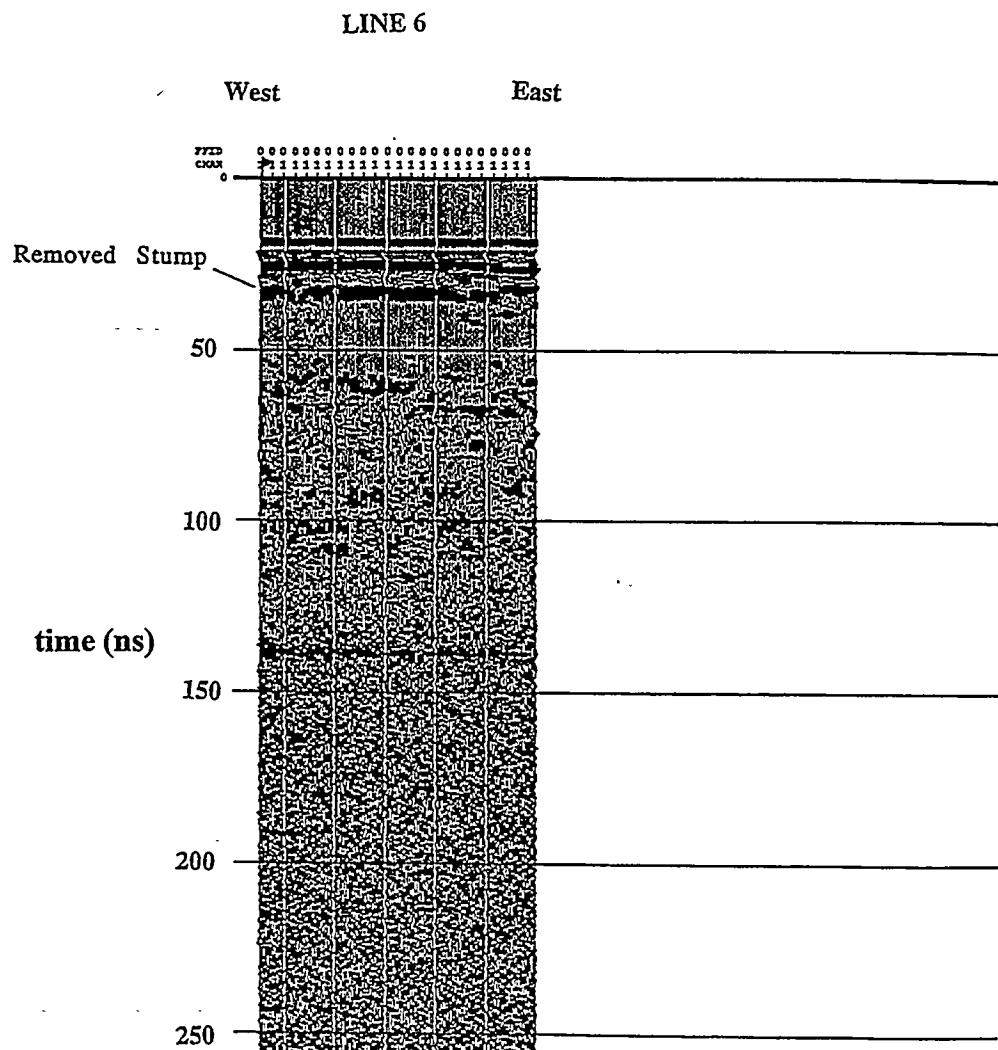
Figure 20. Ground penetrating radar taken along Line 6.

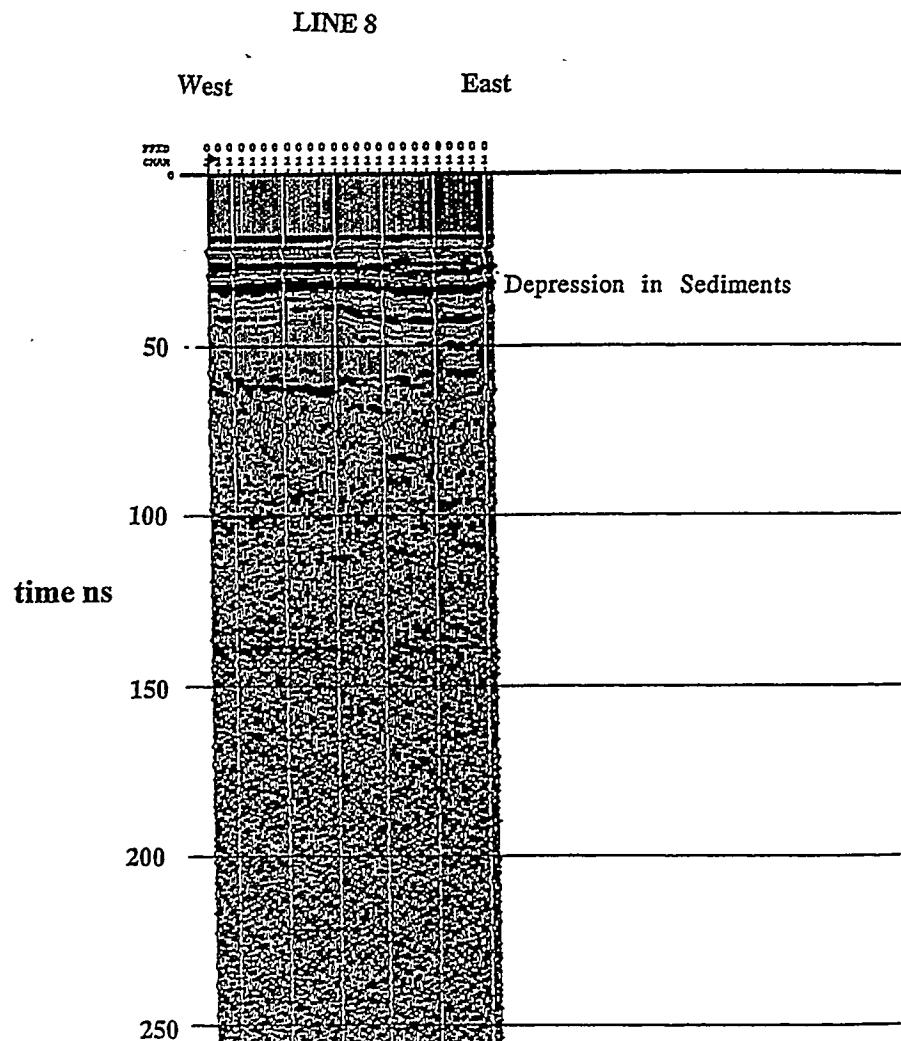
Figure 21. Ground penetrating radar taken along Line 8.

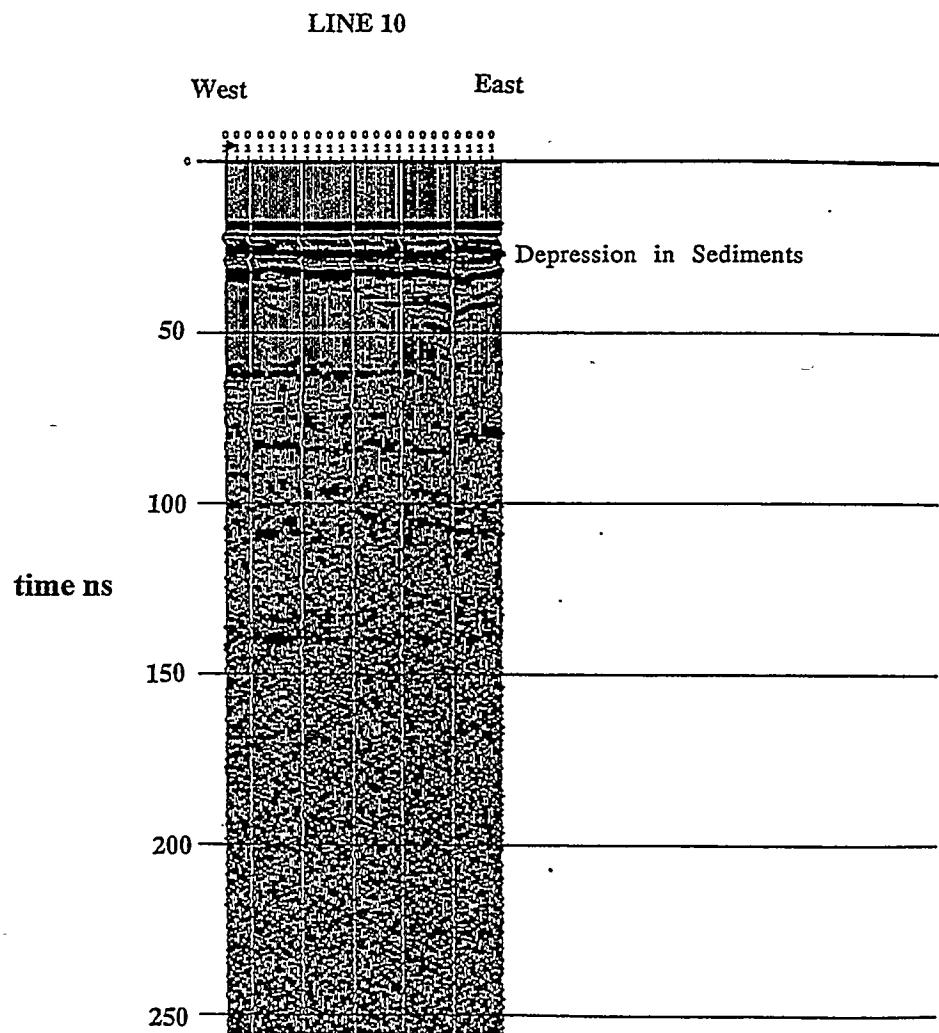
Figure 22. Ground penetrating radar taken along Line 10.

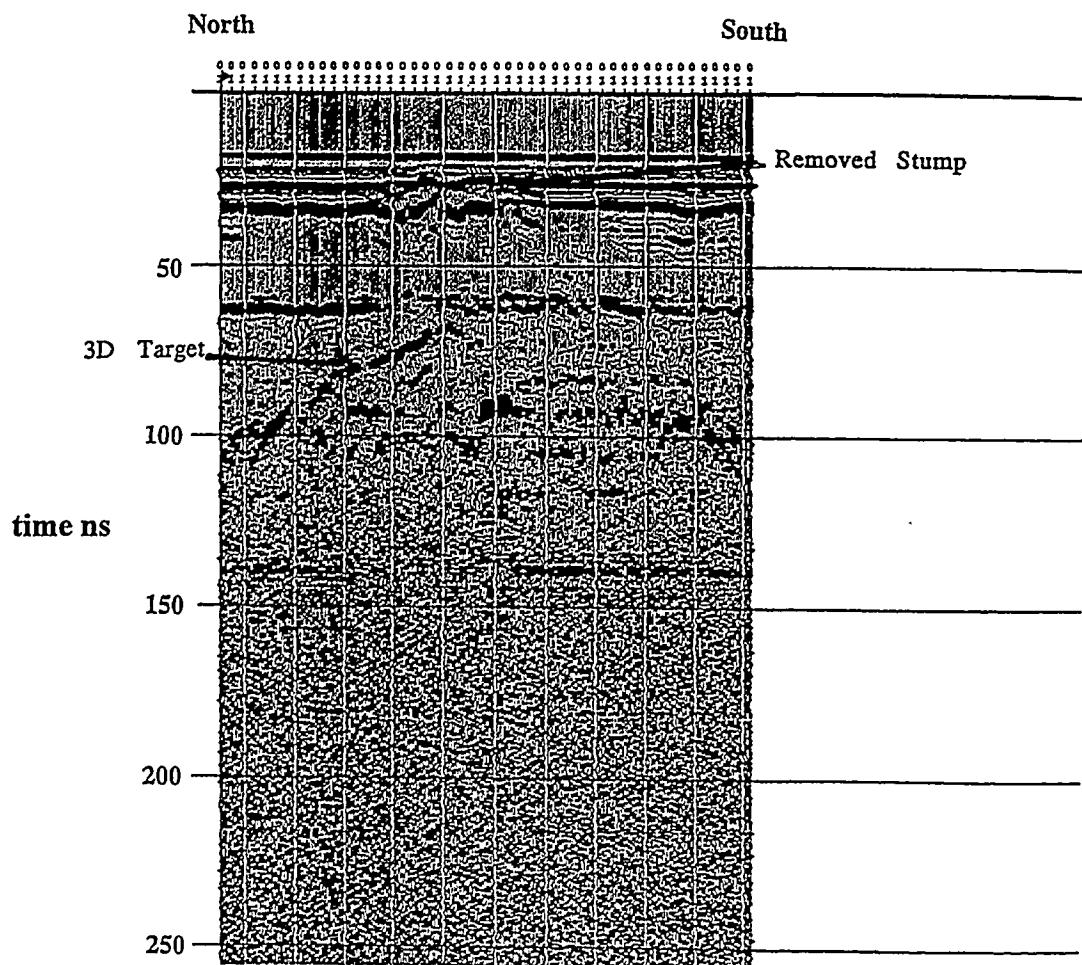
LINE 11

Figure 23. Ground penetrating radar taken along Line 11.

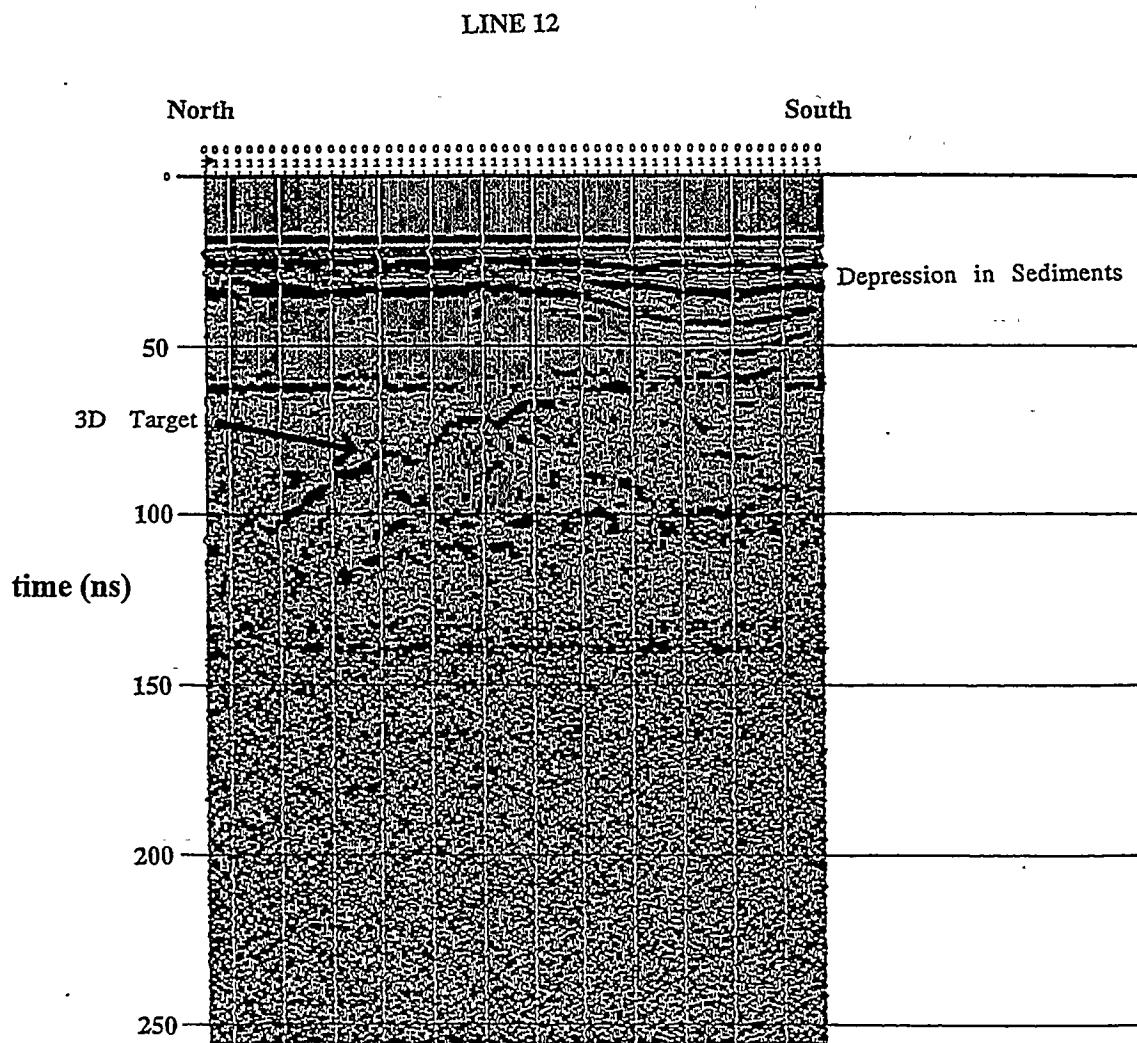
Figure 24. Ground penetrating radar taken along Line 12.
