## OAK RIDGE NATIONAL LABORATORY

58-1-72

SUBJECT: Quarterly Report of the Solution Corrosion Group for the Period Ending January 31, 1958.

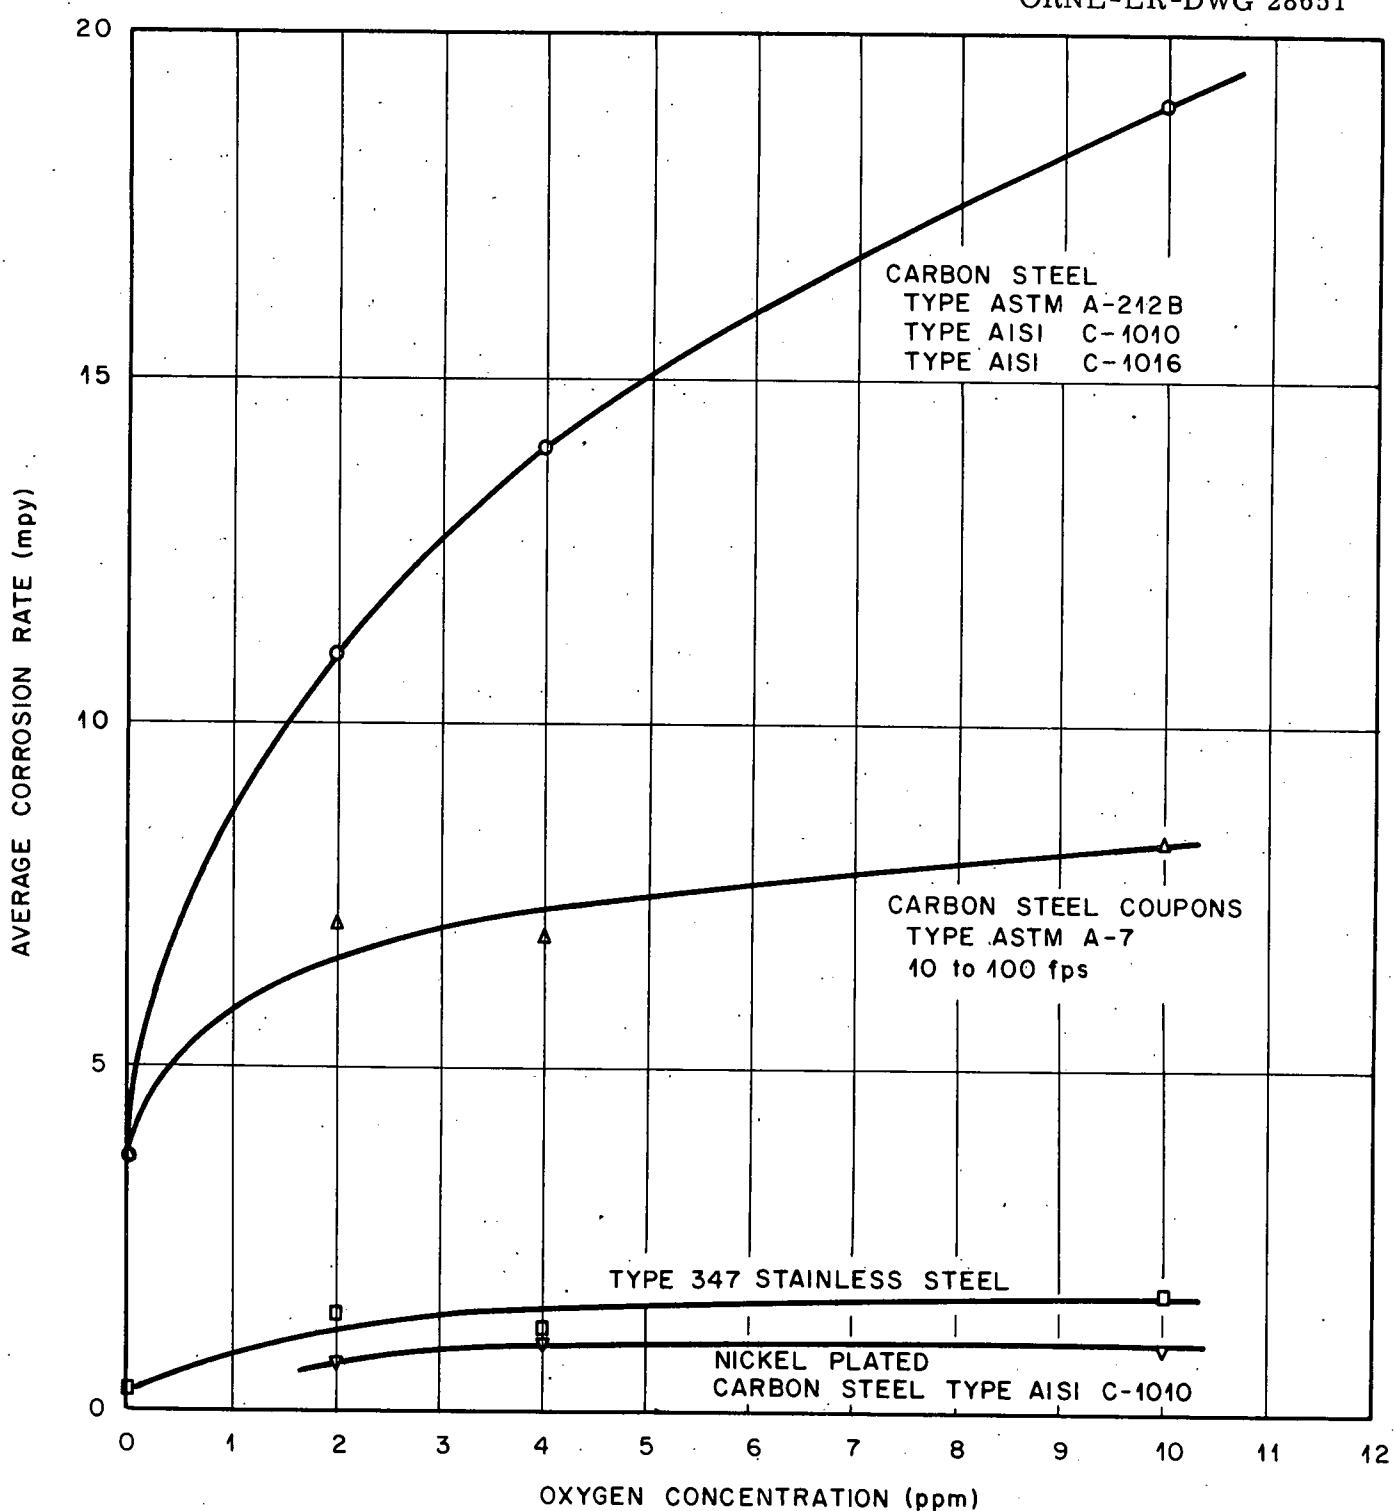
Fig. 1. Average Corrosion Rates of Carbon and Stainless Steels at 5 to 18 fpm in Boiler Water at 300°C as a Function of Oxygen Concentration (200 hr. runs)

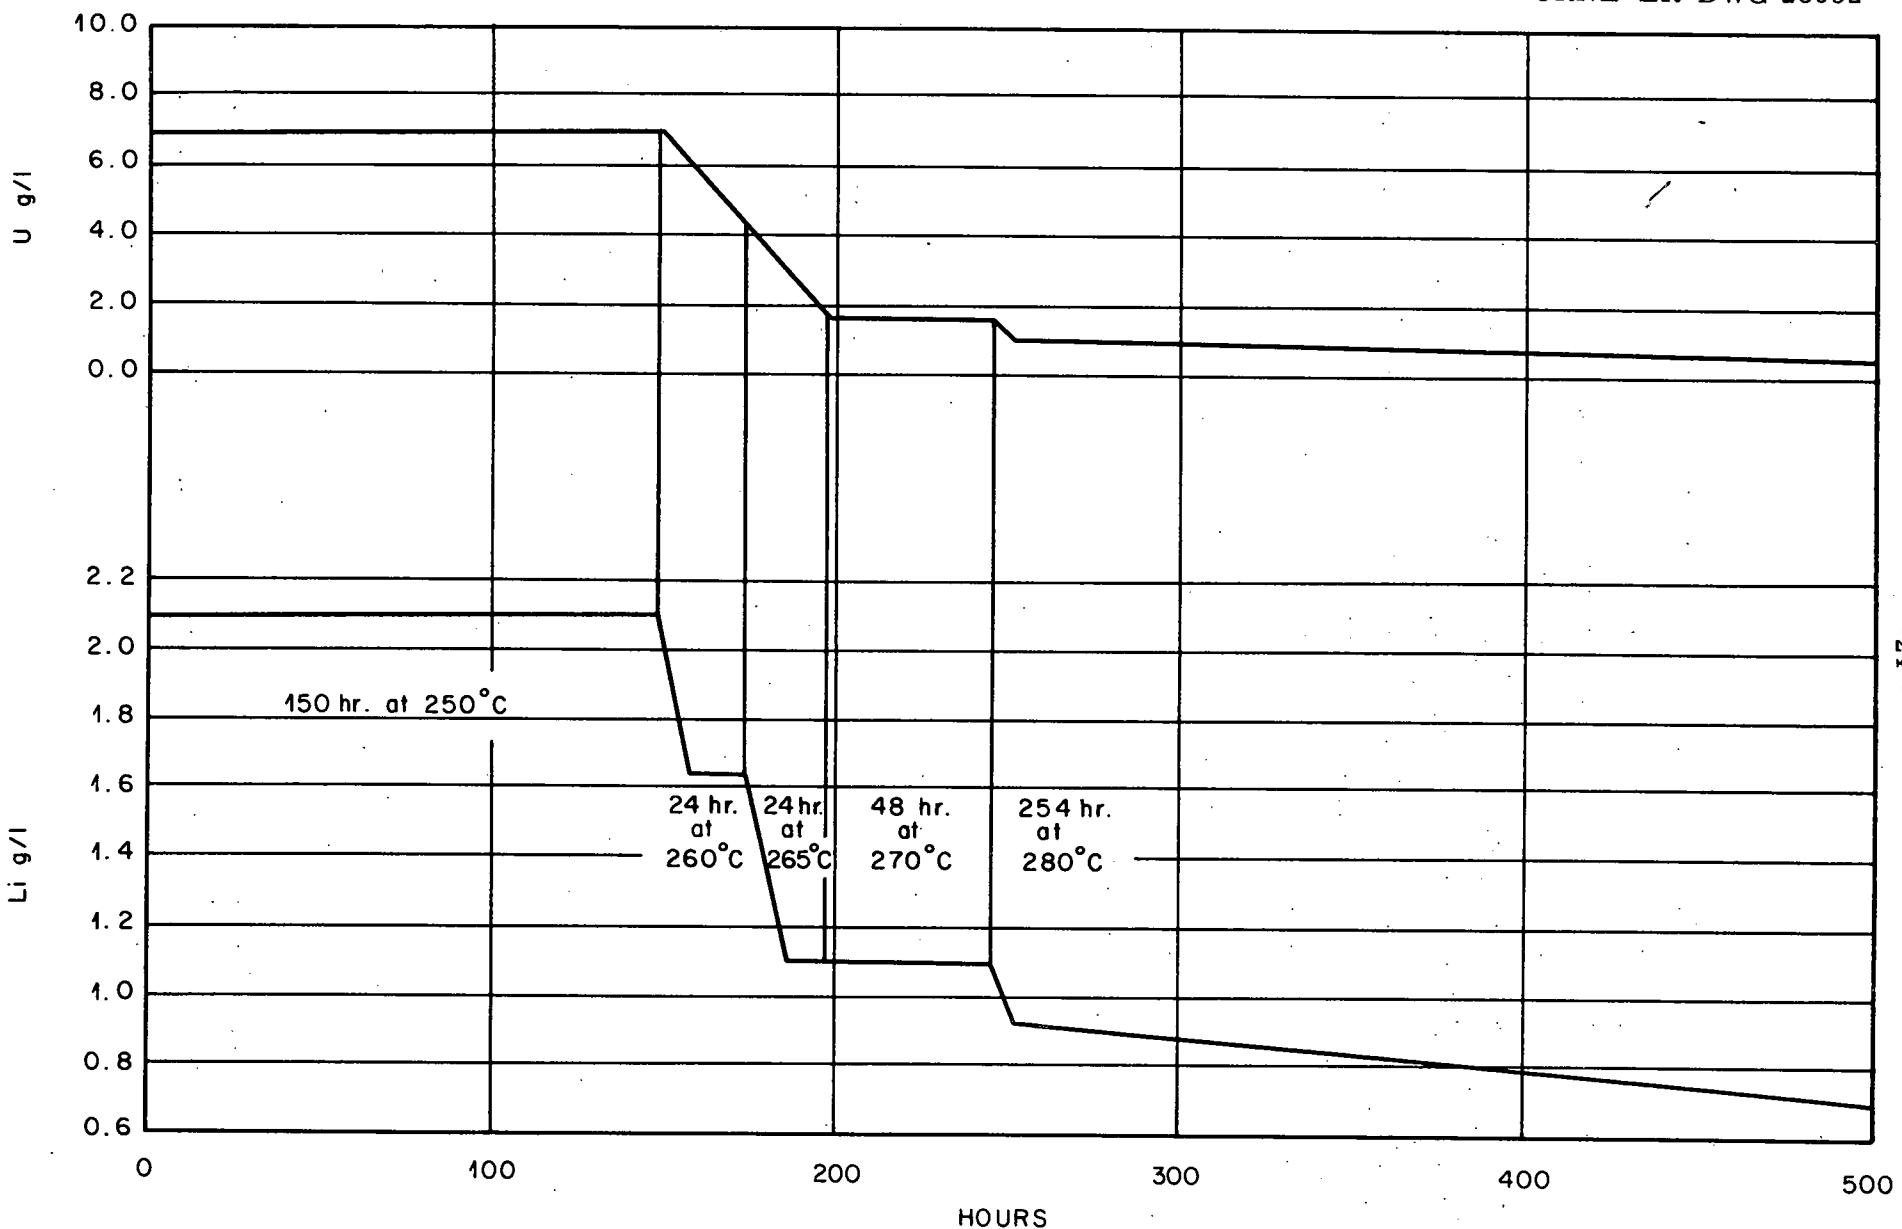
Fig. 2. Changes in Concentration of Uranium and Lithium at Various Temperatures in Run J-93 (Initially 0.03m  $\text{UO}_3$  Dissolved in 0.15m  $\text{Li}_2\text{CO}_3$  Under 600 psi  $\text{CO}_2$  Pressure at 250°C)

Unfortunately, the solutions were not stable. In the first run, J-91, uranium and lithium precipitated at 300°C from a solution initially containing 0.03 m  $UO_3$  (about 8 g of uranium per liter) dissolved in 0.19 m  $Li_2CO_3$  under 300 psi  $CO_2$ . Within 24 hr the solution contained only 0.002 m  $UO_3$  (about 0.5 g of uranium per liter) and 0.06 m  $Li_2CO_3$ . Increasing the carbon dioxide partial pressure to 600 psi failed to increase the solubility. Since Marshall and Secoy indicated that more uranium would be soluble in higher concentration  $Li_2CO_3$ ,<sup>(10)</sup> a second run was

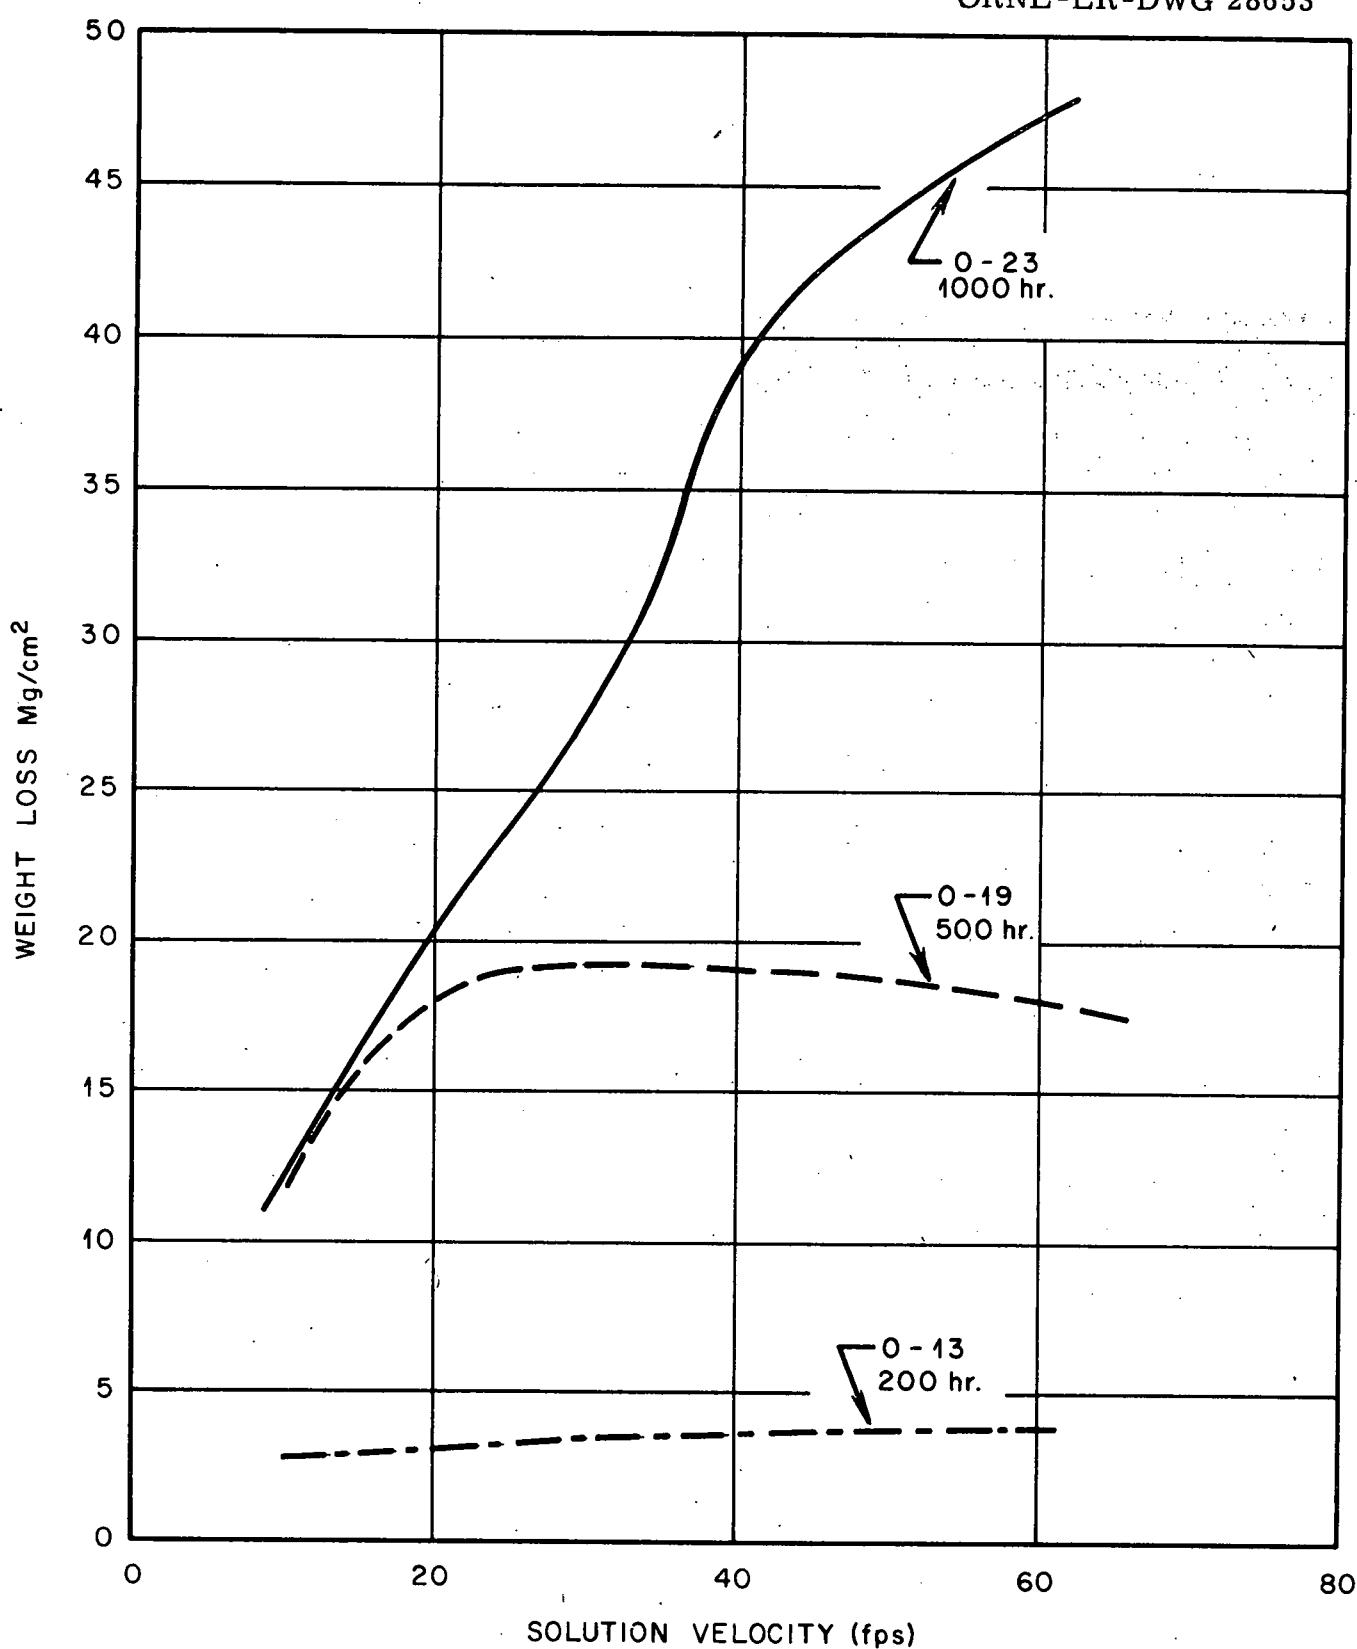
Fig. 3. Weight Losses of Type 347 Stainless Steel Coupons in  
 $0.04\text{m UO}_2\text{SO}_4 + 0.04\text{m BeSO}_4 + 0.005\text{m CuSO}_4$  at  $200^\circ\text{C}$

In Figure 3, it can be seen that at  $200^{\circ}\text{C}$  the specimens filmed over and showed no additional weight loss between 500 and 1000 hr at flow rates up to a velocity of 15 to 20 fps. Figure 4 presents similar data obtained at  $225^{\circ}\text{C}$  and shows that little additional corrosion occurred after the 200 hr exposure up to flow rates of 15 to 20 fps. In both cases corrosion rates above the critical velocity were lower by a factor of five than rates in the standard HRT fuel solution at

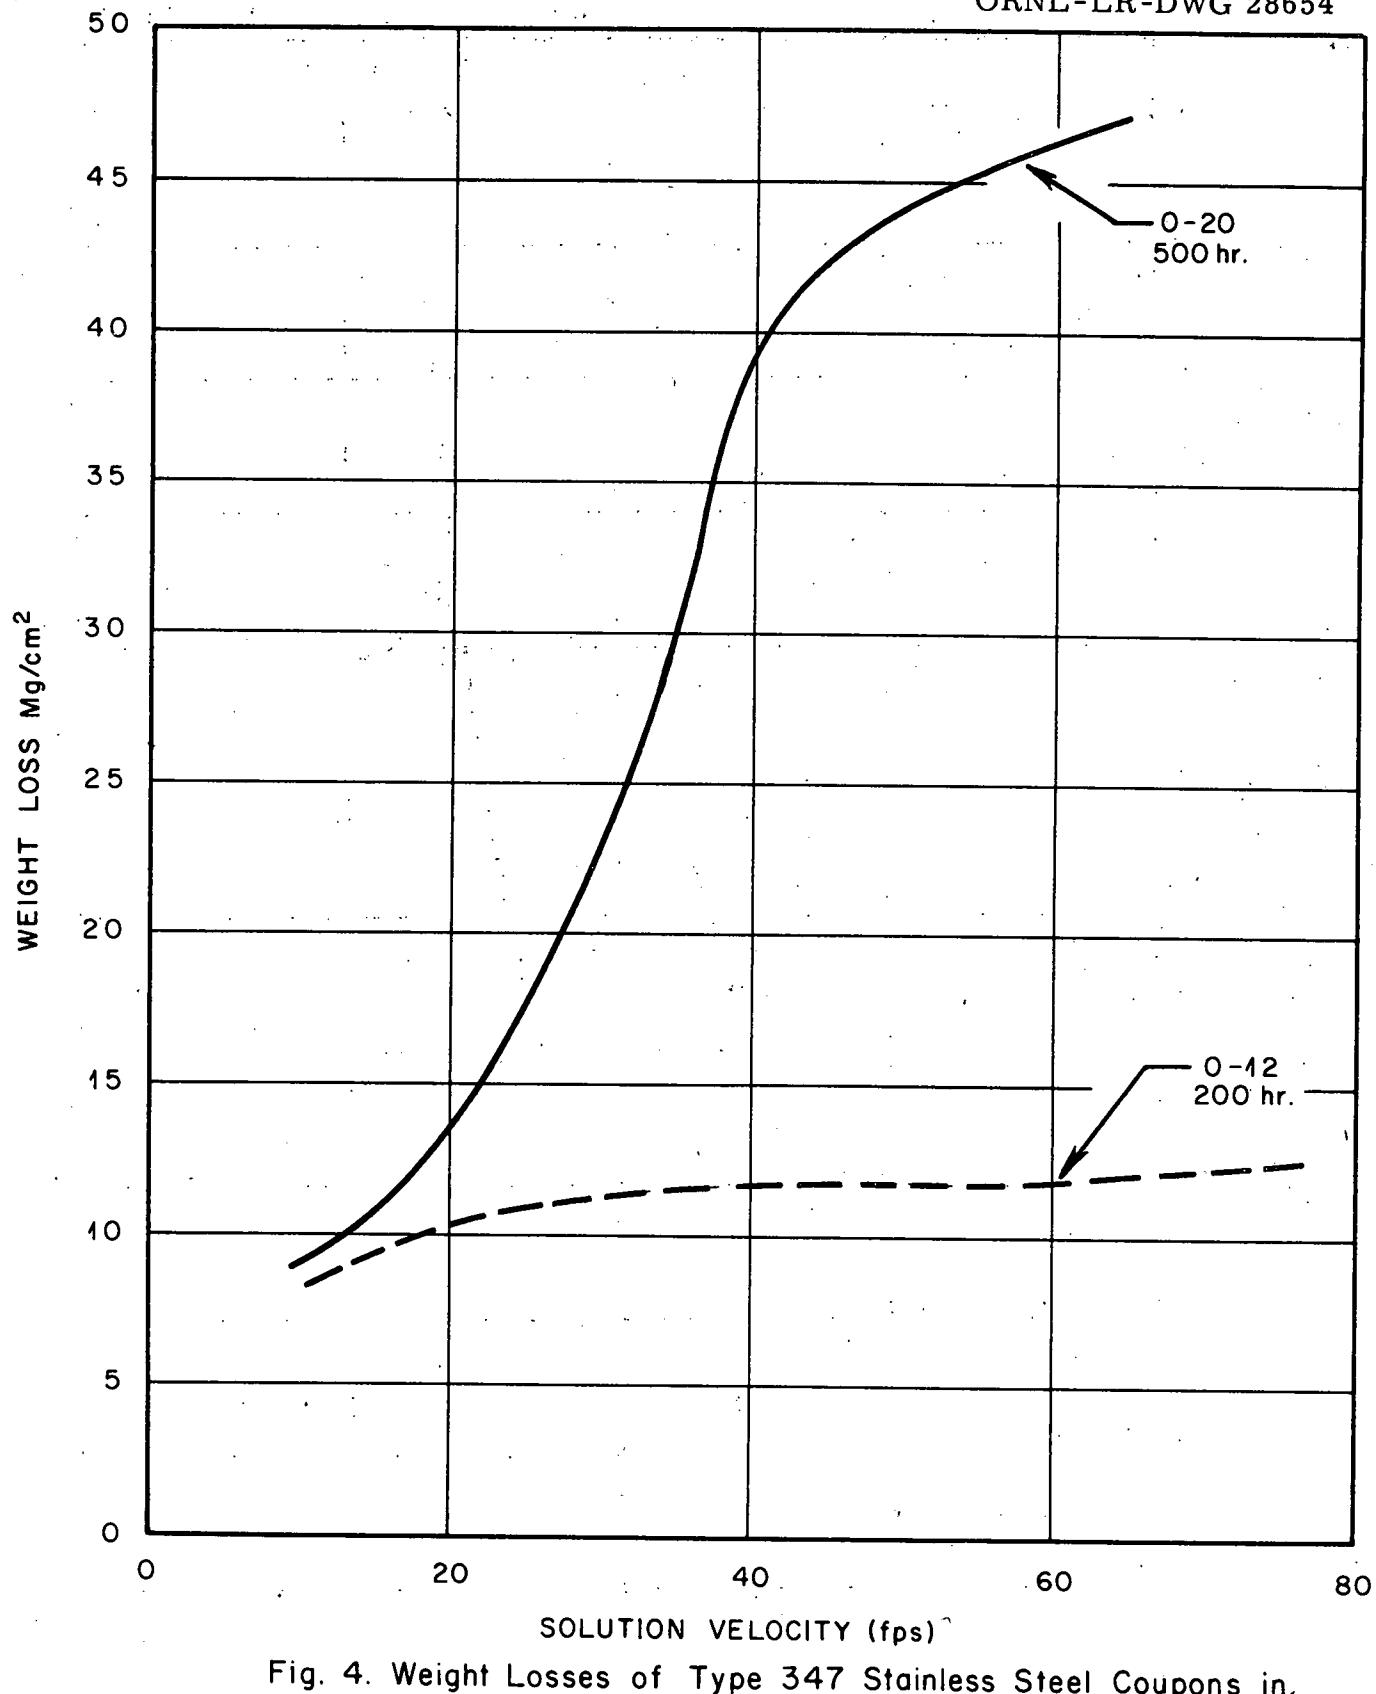
Fig. 4. Weight Losses of Type 347 Stainless Steel Coupons in.  
 $0.04m\ UO_2SO_4 + 0.04m\ BeSO_4 + 0.005m\ CuSO_4$  at  $225^\circ C$

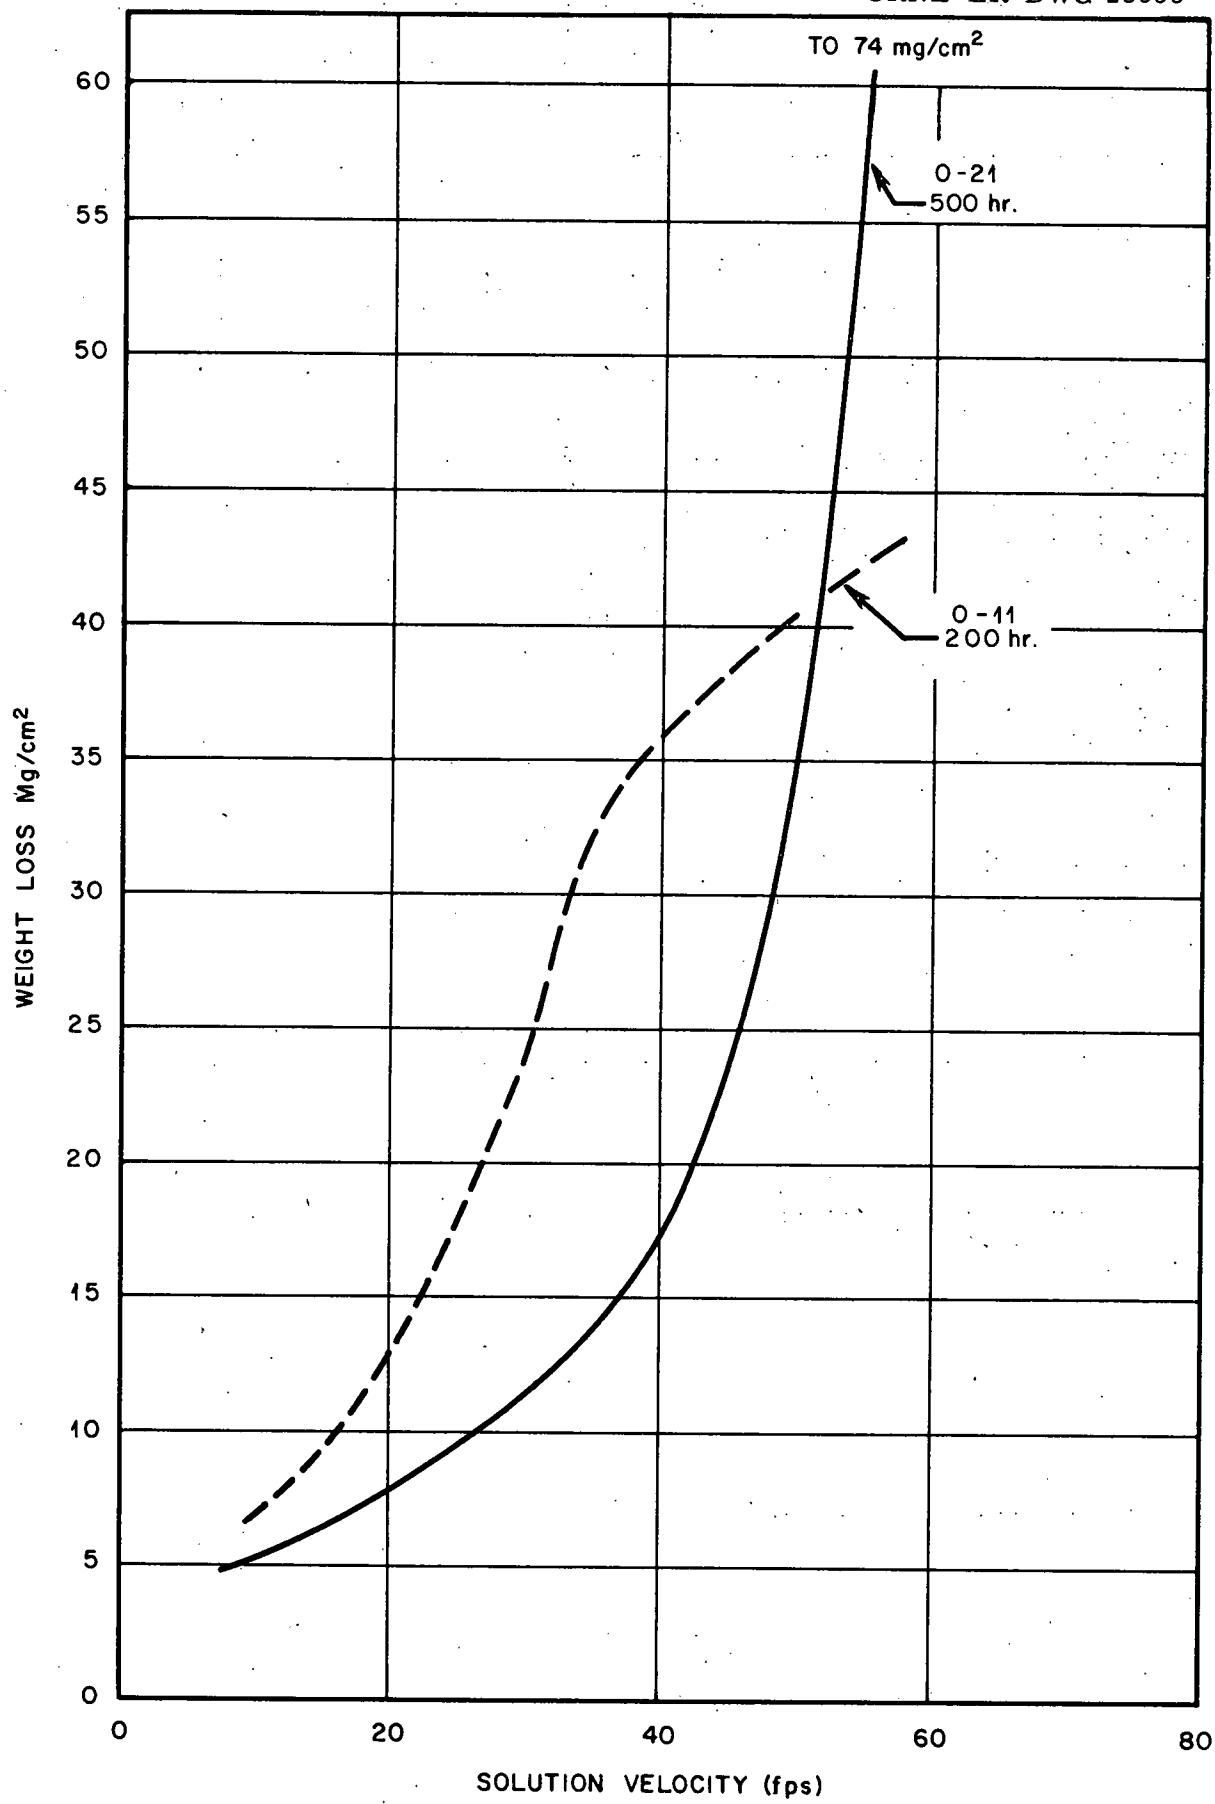
Fig. 5. Weight Losses of Type 347 Stainless Steel Coupons in 0.04m  $\text{UO}_2\text{SO}_4$  + 0.04m  $\text{BeSO}_4$  + 0.005m  $\text{CuSO}_4$  at 250°C

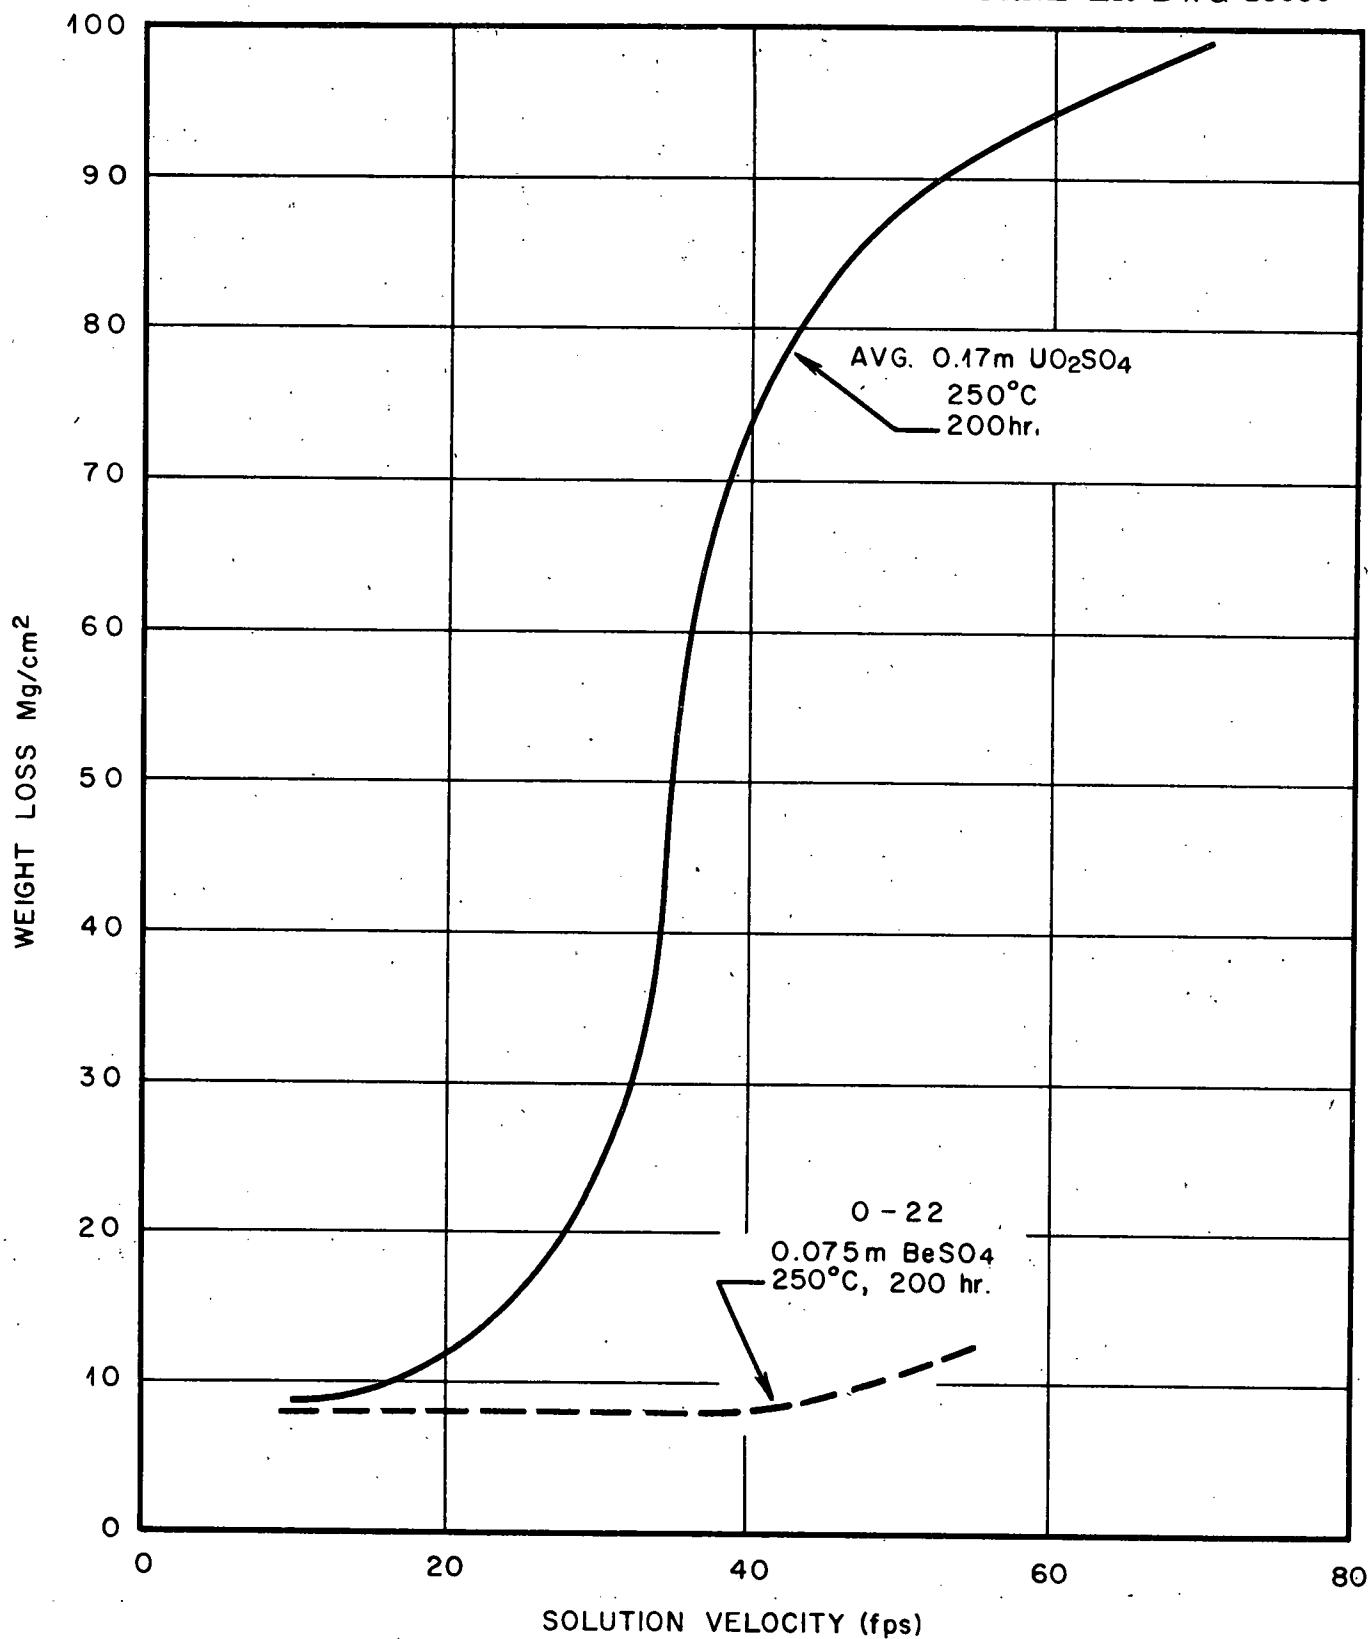
Fig. 6. Weight Losses of Type 347 Stainless Steel Coupons in 0.075M  $\text{BeSO}_4$  at 250°C.

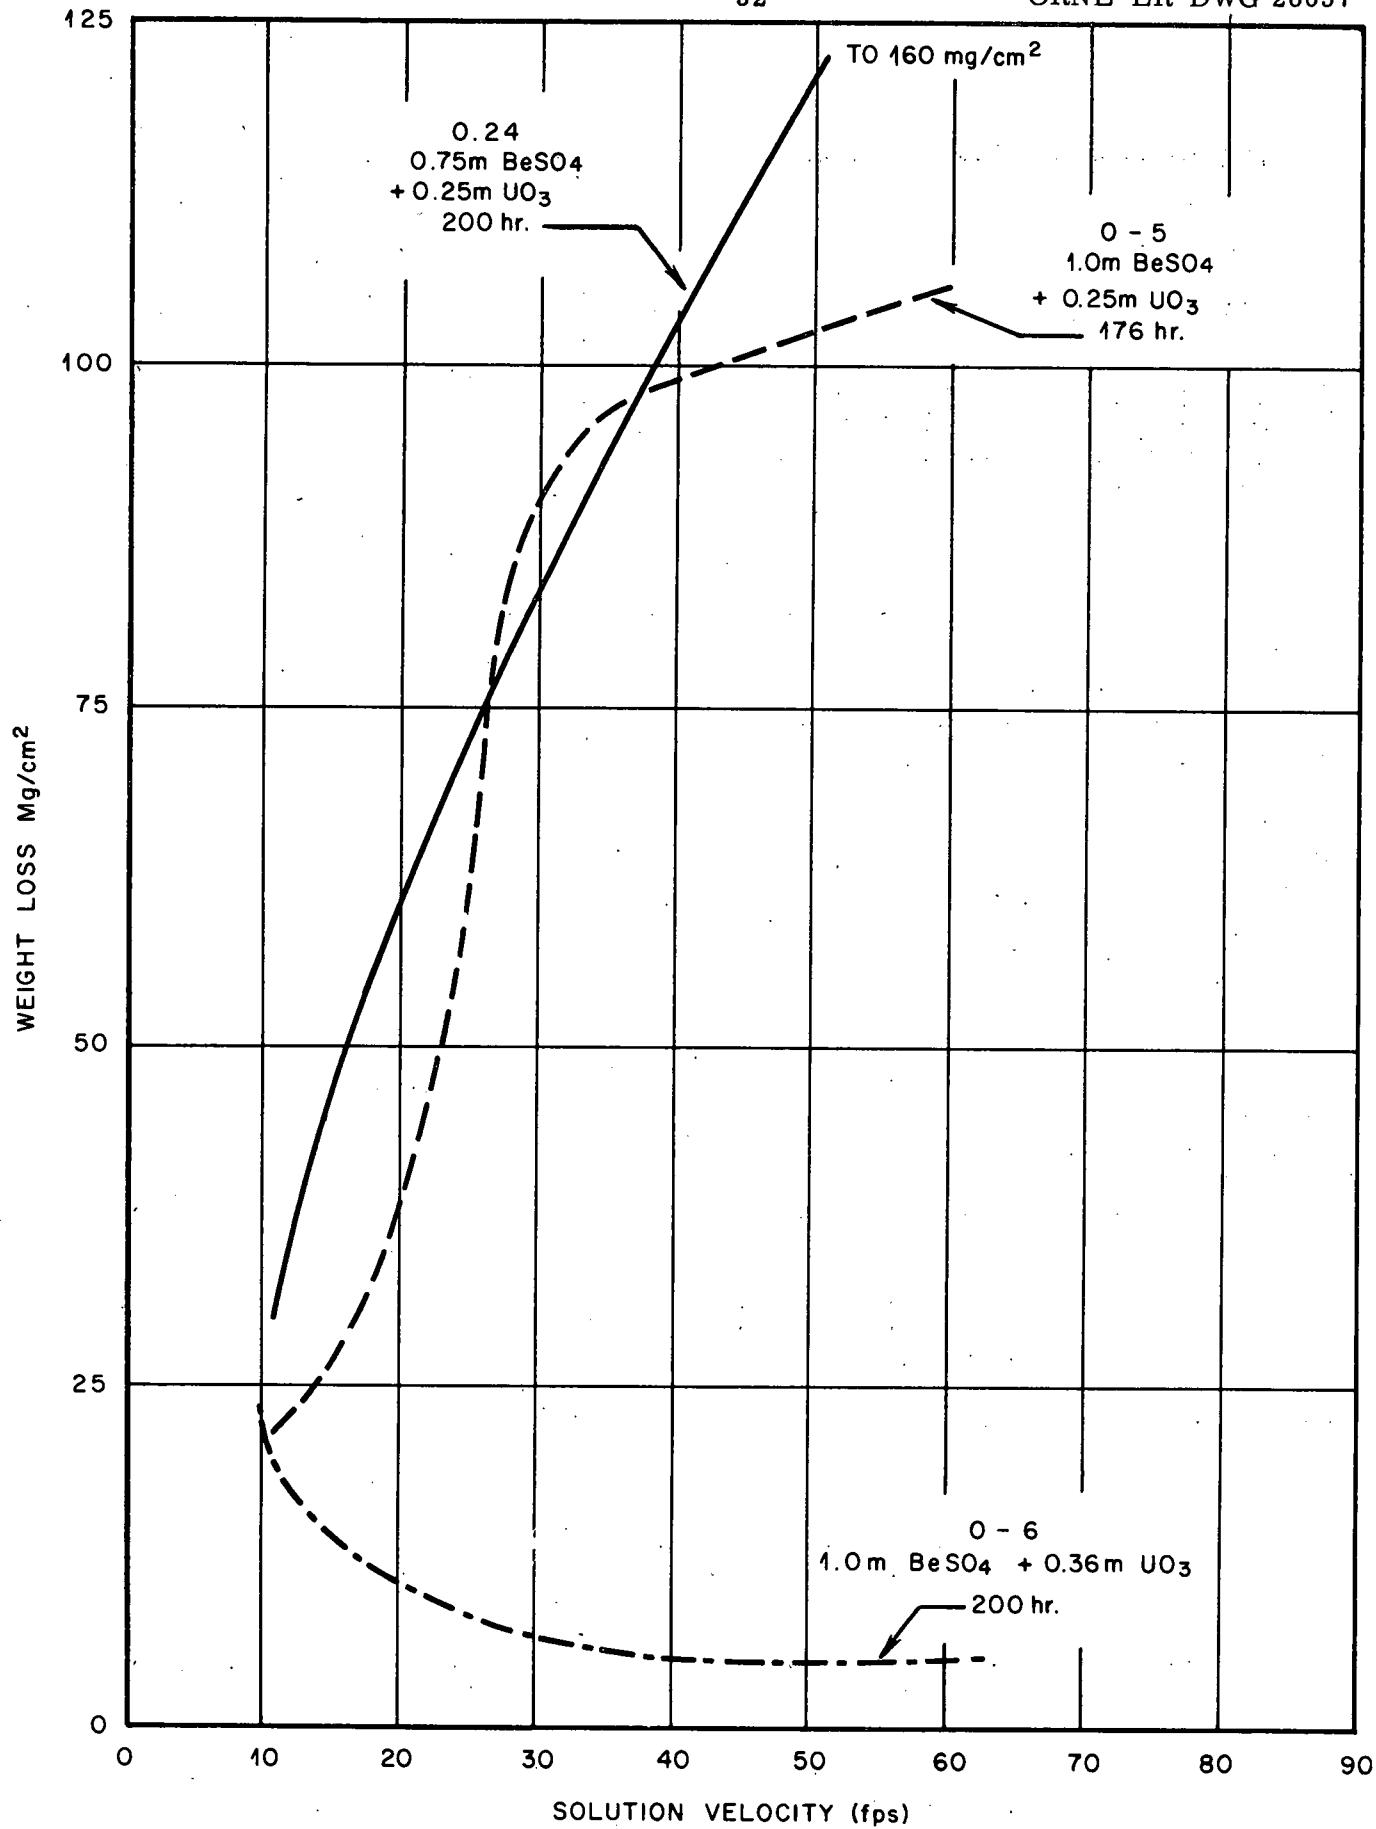
Fig. 7. Weight Losses of Type 347 Stainless Steel Coupons in  $0.75 \text{ m BeSO}_4$  Containing  $1.25 \text{ m UO}_3$  (Dissolved)

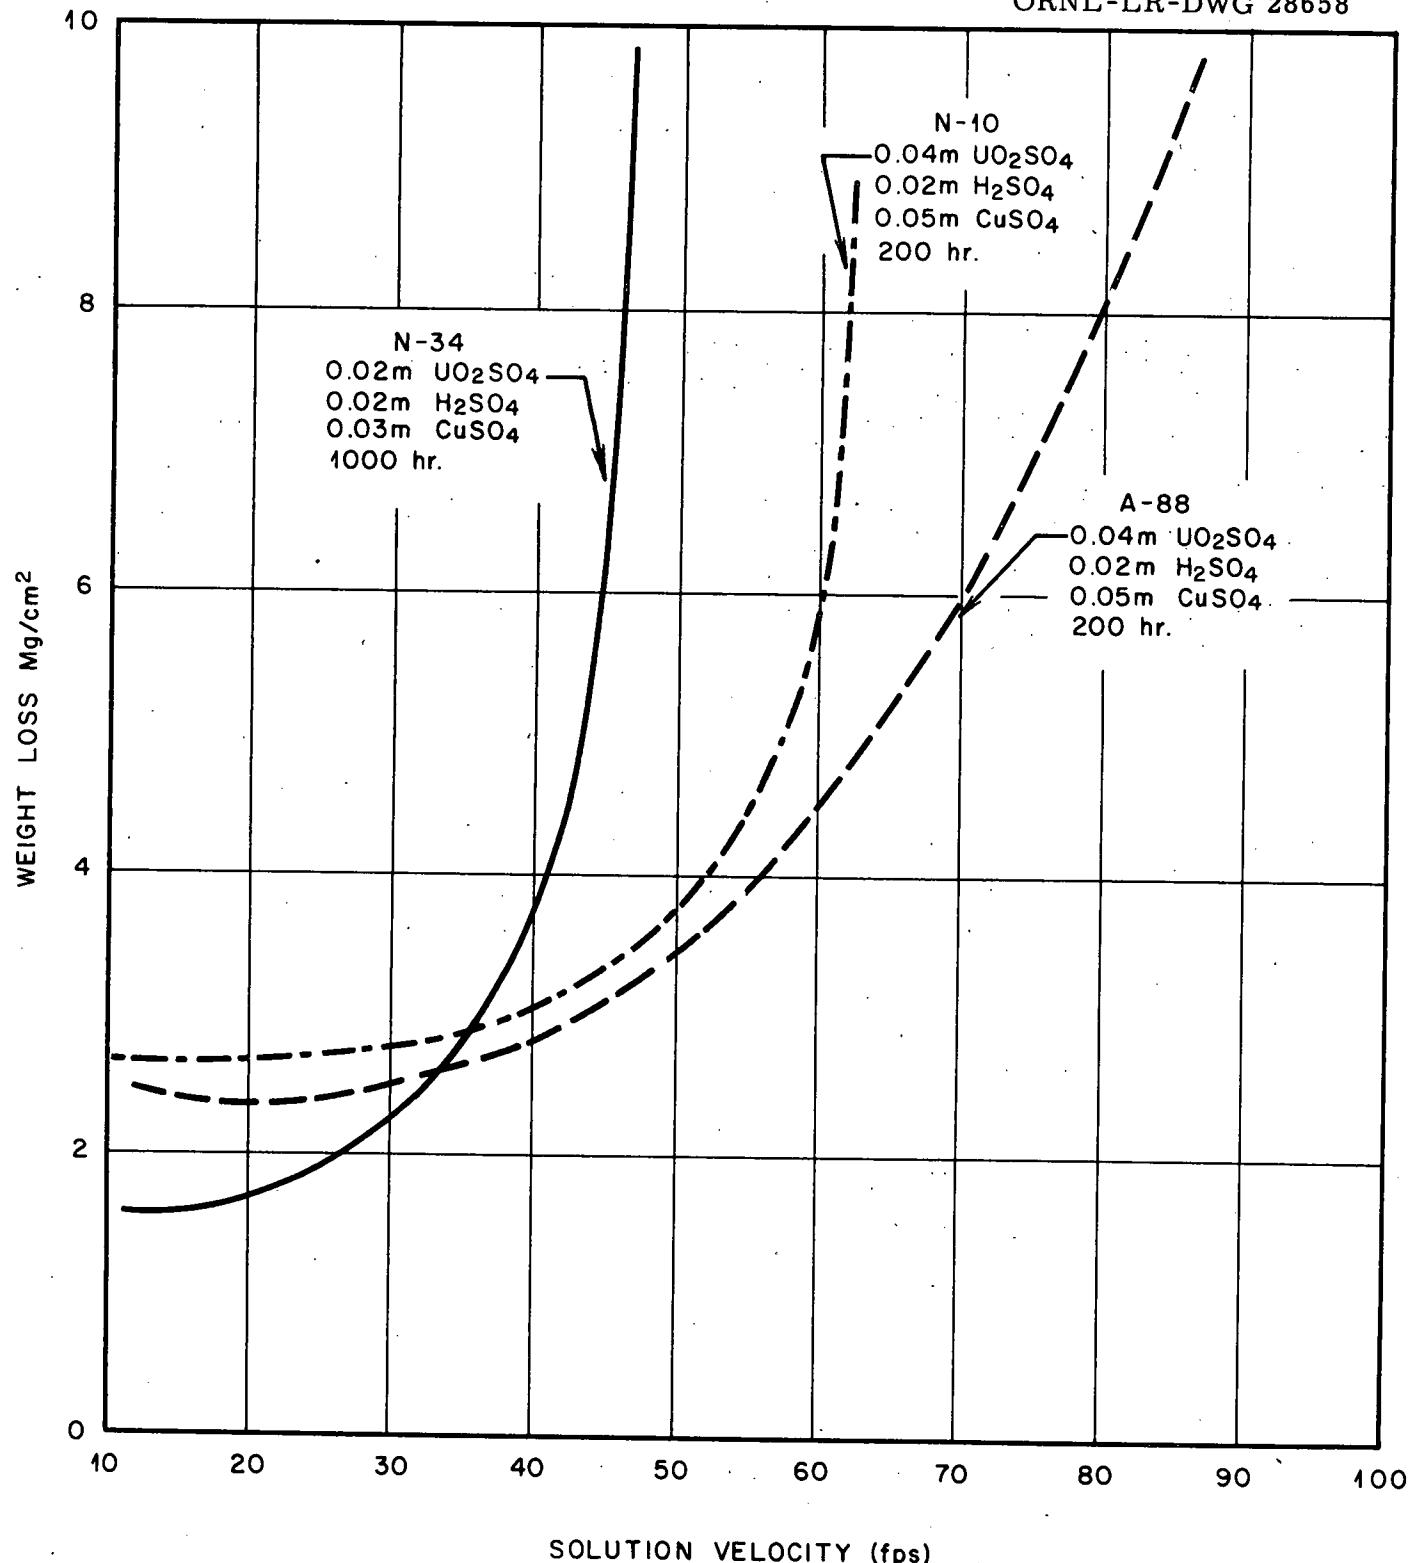
Fig. 8. Weight Losses of Type 347 Stainless Steel Coupons in Dilute Uranyl Sulfate Solutions Containing Sulfuric Acid and Copper Sulfate at 300°C

it is necessary for either 0.02 or 0.04  $m$   $\text{UO}_2\text{SO}_4$  solutions with copper sulfate to contain 0.02  $\text{H}_2\text{SO}_4$  for chemical stability; and with this amount of acid, both solutions are about equally corrosive.

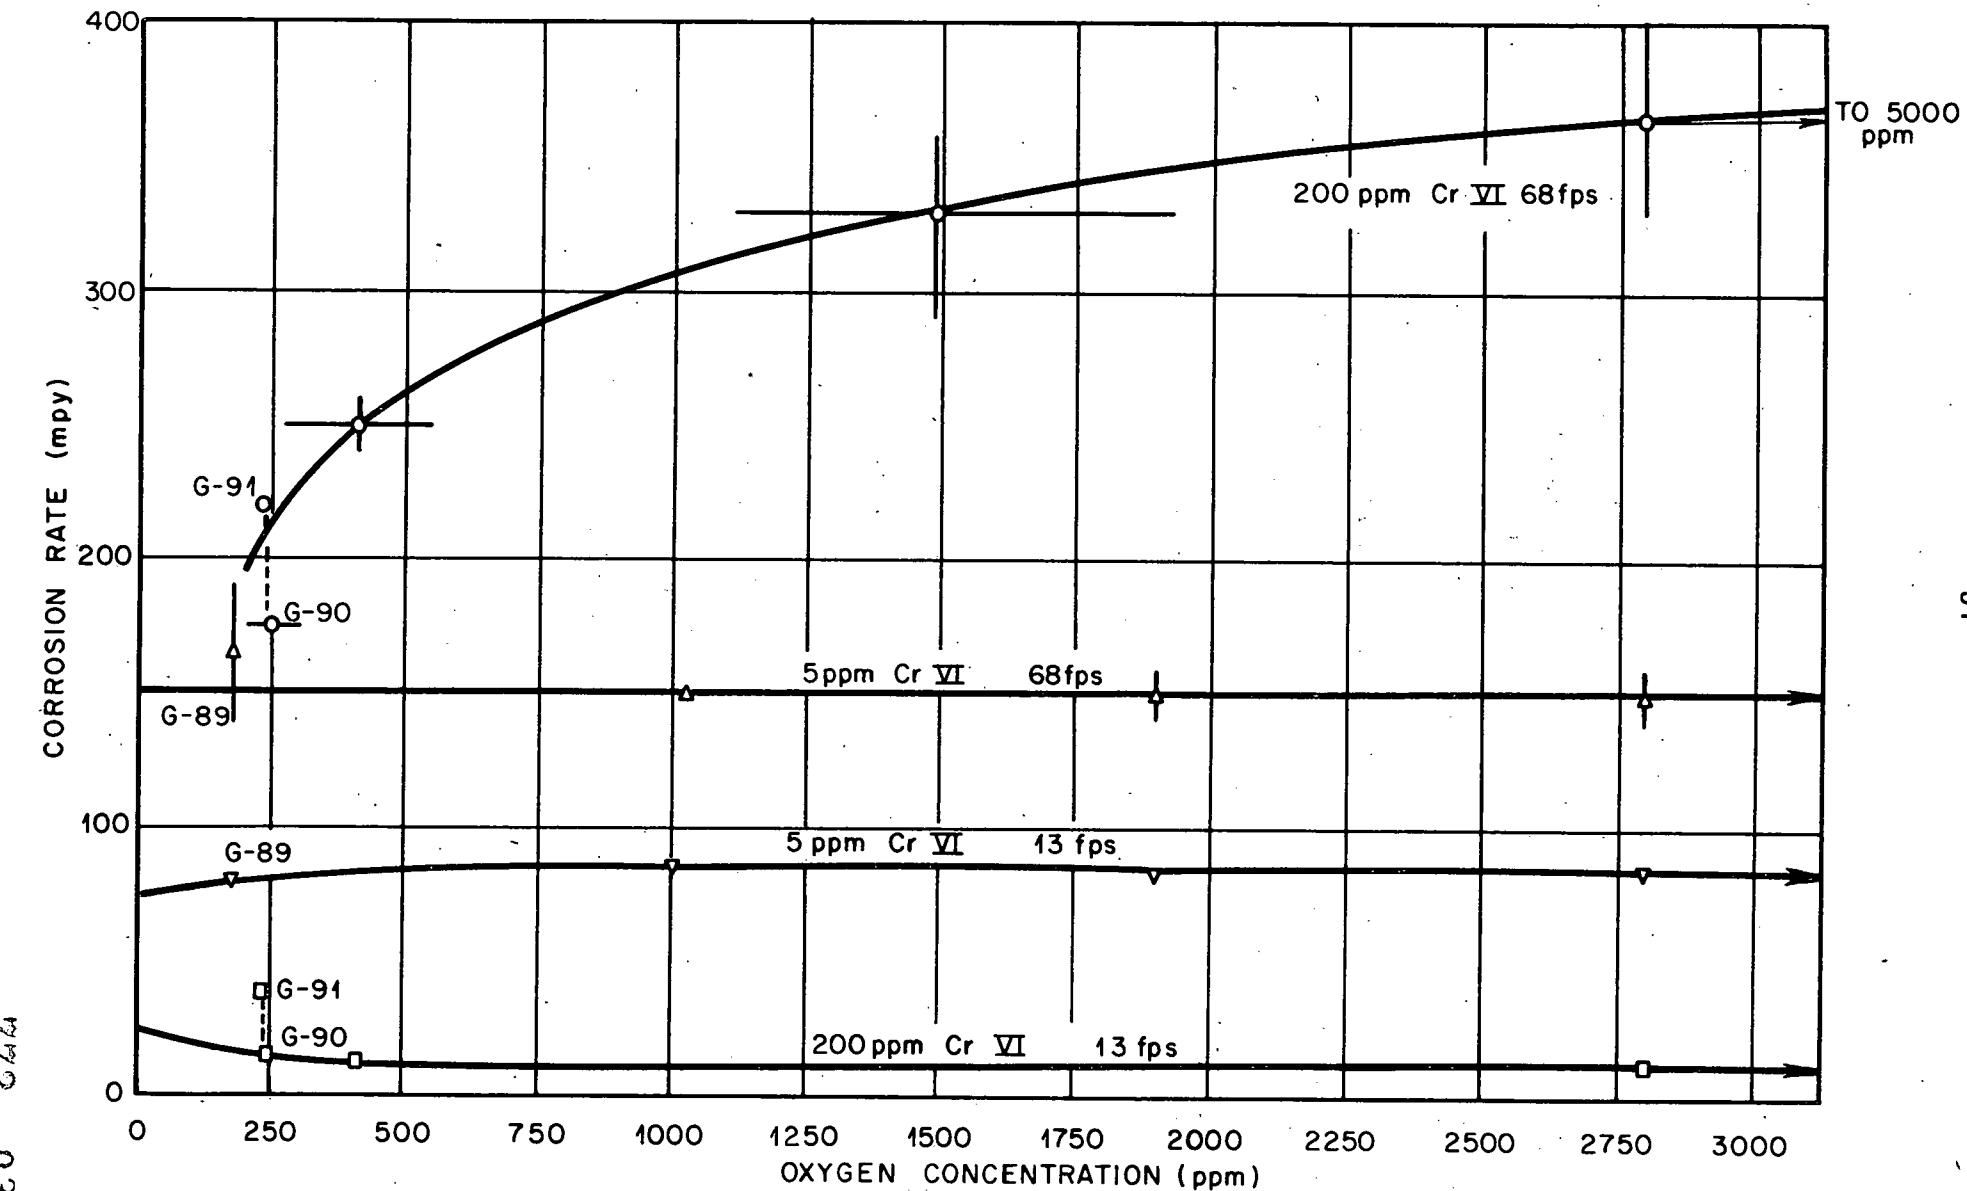
It can be seen that at 70 fps in the presence of 200 ppm chromium (VI) added as potassium dichromate corrosion rates decreased with decreasing oxygen concentration. When no chromium (VI) was added, corrosion rates did not vary with the oxygen concentration. The 5 ppm chromium (VI) came from oxidation of chromium in the stainless steel pins. At 13 fps there was little, if any, effect of oxygen concentration either in the presence or absence of added chromium (VI). The explanation of these results may be that in the absence of a protective film on the steel at high flow rates the 200 ppm chromium (VI) accelerates the corrosion rate to the point where the rate controlling step involves oxygen. This step could be either the diffusion of oxygen to the metal surface, the adsorption of oxygen on the surface, or the reaction of oxygen with the metal. In the absence of chromium (VI) some other process not involving oxygen would be the rate controlling step.

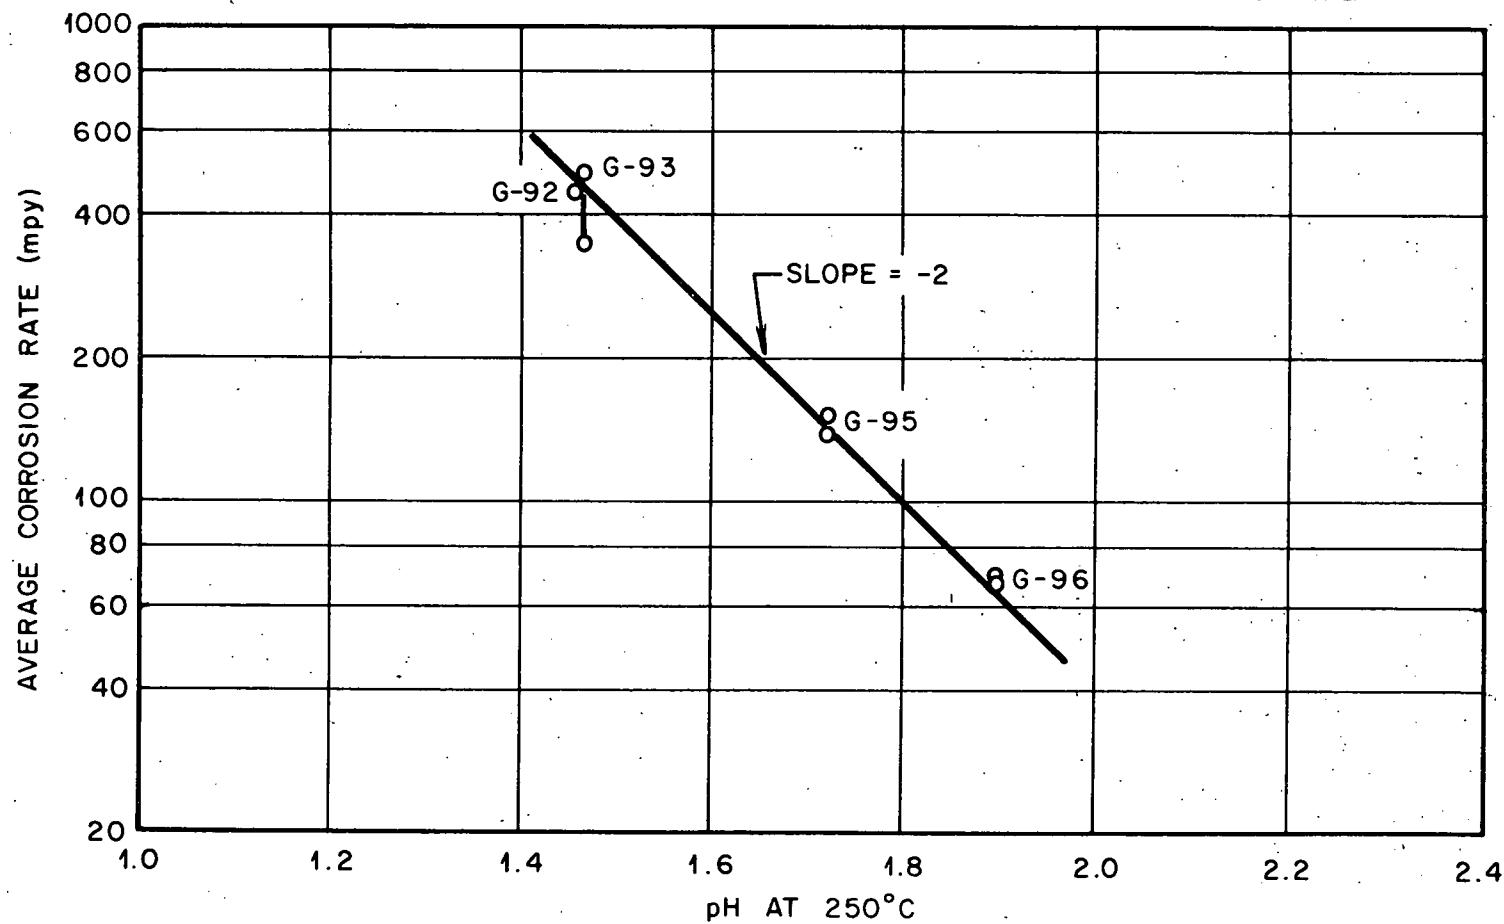
Fig. 10. Effect of Hydrogen Ion Activity (pH) on the Corrosion of Type 347 Stainless Steel Pins at 68fps in  $\text{H}_2\text{SO}_4$  at 250°C (Titanium Loop, 200 hr. Runs)

The corrosion rate of type 347 stainless steel in dilute sulfuric acid solutions was determined at 250°C. The data shows that the log of the corrosion rate at high flow rates is linearly related to the pH of the solution at 250°C.
