## OAK RIDGE NATIONAL LABORATORY

58-1-72

SUBJECT: Quarterly Report of the Solution Corrosion Group for the Period Ending January 31, 1958.

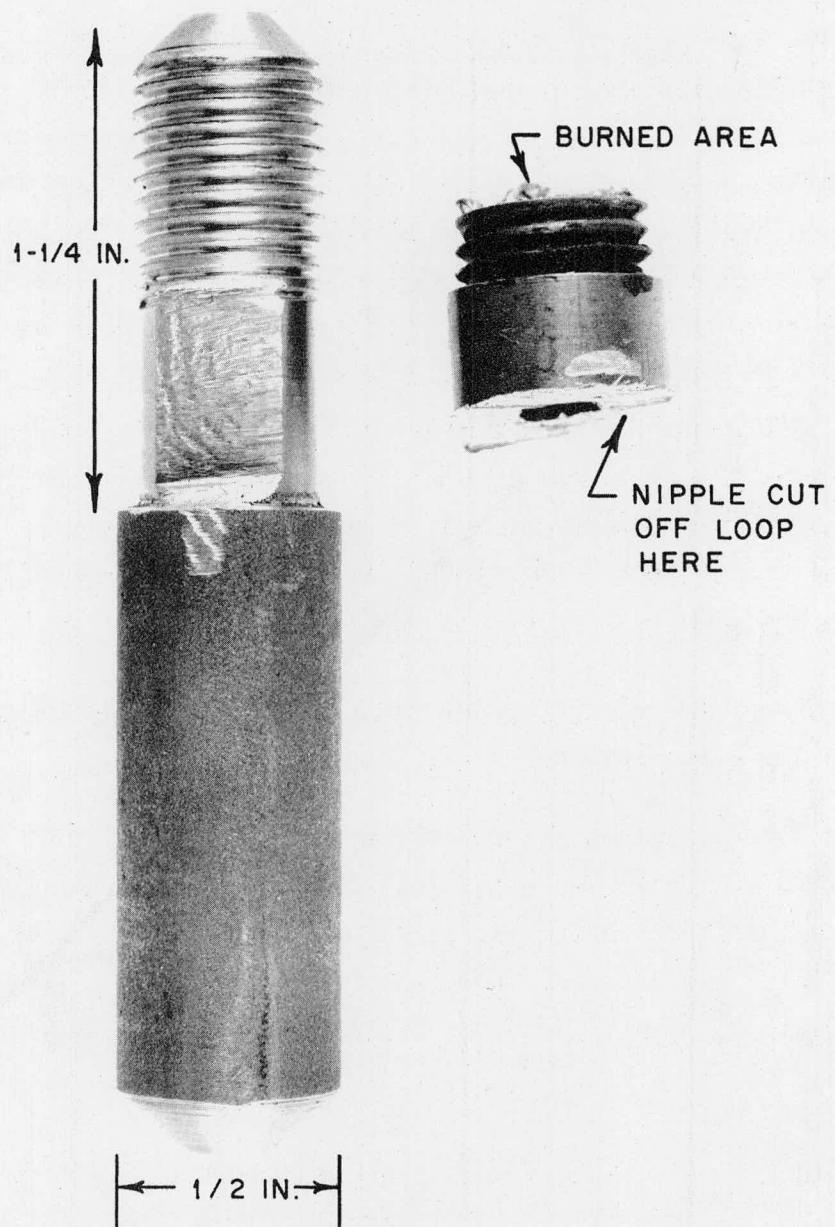
Fig. 11. The Burned Titanium Nipple (right) and a New Nipple (left) Identical to the Burned Nipple. (2054-1 Plate)

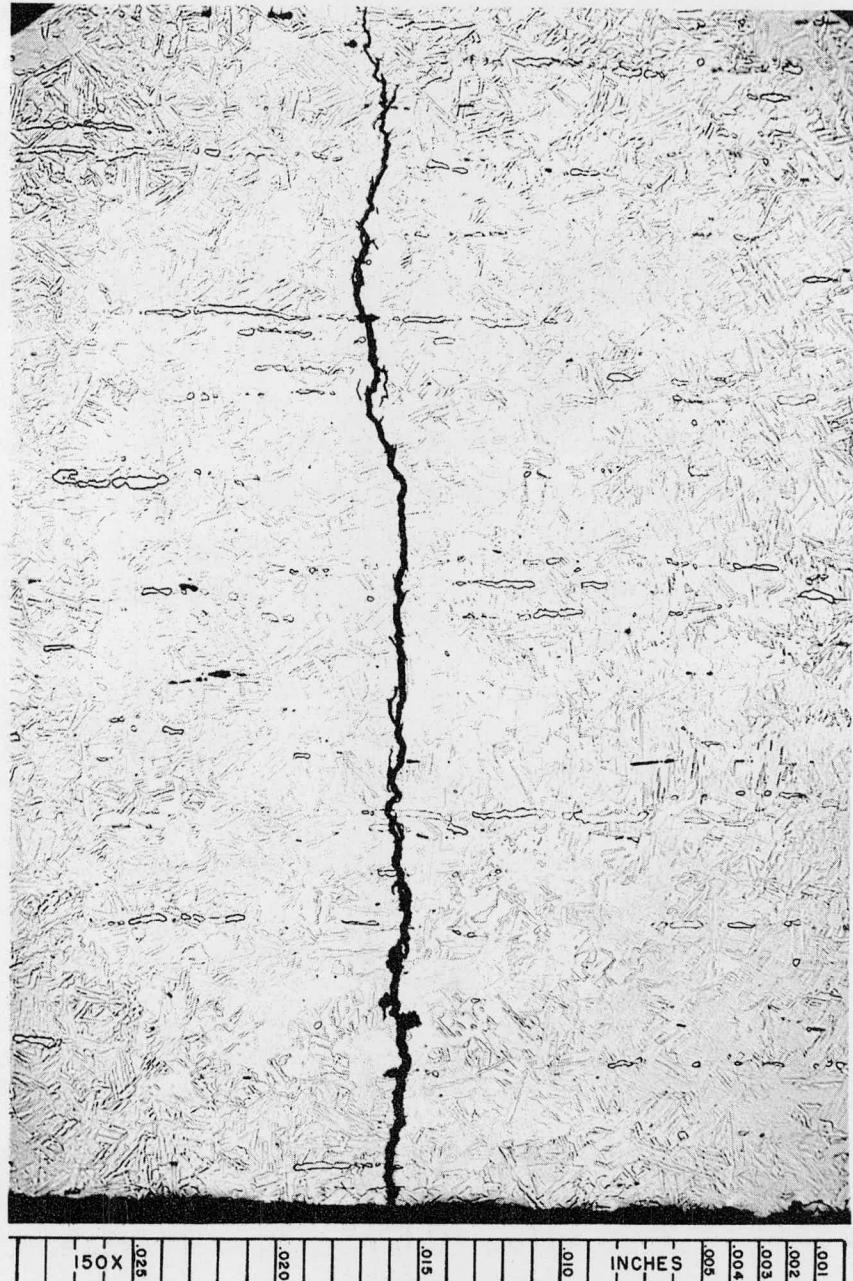
Metallographic examination of the 17-4 PH specimen stressed to 80,000 psi and exposed in the vapor above HRT solution at  $300^\circ\text{C}$  disclosed a stress-corrosion crack which penetrated about 80 percent of the 1/8 in.

thickness of the specimen. The crack is shown in Figure 12. No cracks were found in the area of maximum stress on the three other 17-4 PH specimens stressed similarly but exposed in the liquid. No cracks were found on the other types of stressed materials simultaneously exposed.

Fig. 12. Stress-Corrosion Crack in a 17-4 PH Stress Specimen Exposed 14,364 hr in the Vapor above HRT Solution at 300°C. (T13938)

A 17-4 PH stainless steel specimen stressed to 75 percent of its room temperature yield strength (80,000 psi) and exposed 19,364 hr to the vapor phase above HRT solution at 300°C was found to have a stress-corrosion crack penetrating 80 percent of its thickness.

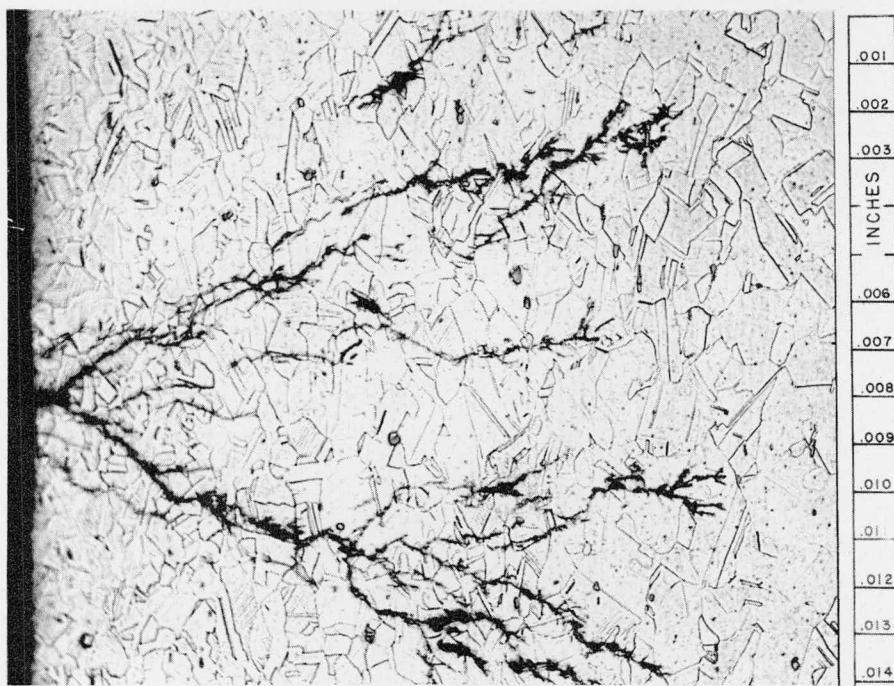
Fig. 13. Photomicrograph of Stress-Corrosion Cracking in Annealed Type 304 Stainless Steel After 100-hr Exposure to Distilled Water Containing 100 ppm Chloride at pH 2.8. Magnification 250X. (T13919)

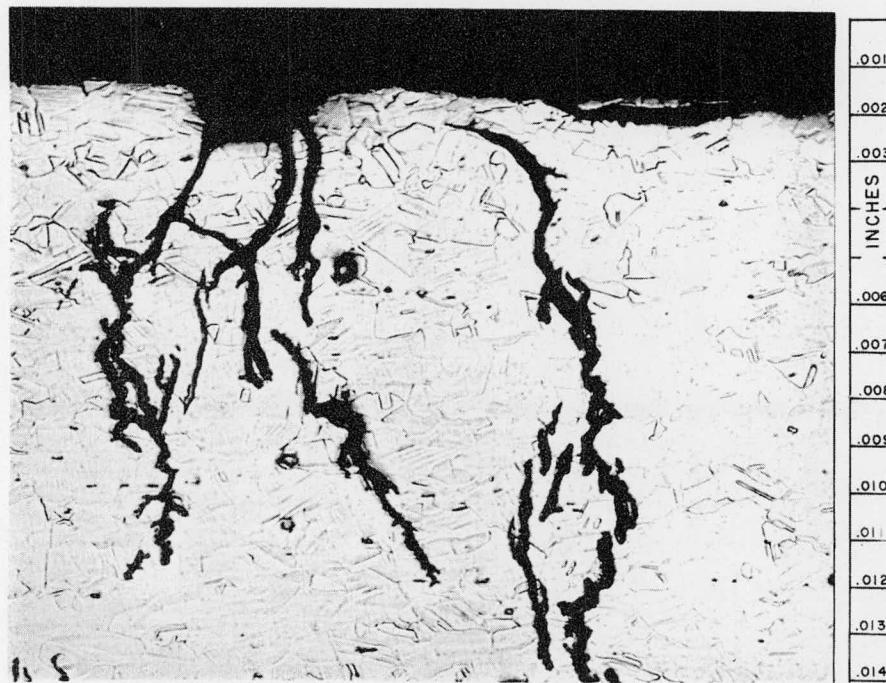
Fig. 14. Photomicrograph of Stress-Corrosion Cracking in Sensitized Type 304 Stainless Steel after 100-hr Exposure to Distilled Water Containing 100 ppm Chloride at pH 2.8. Magnification 250X. (T14242)

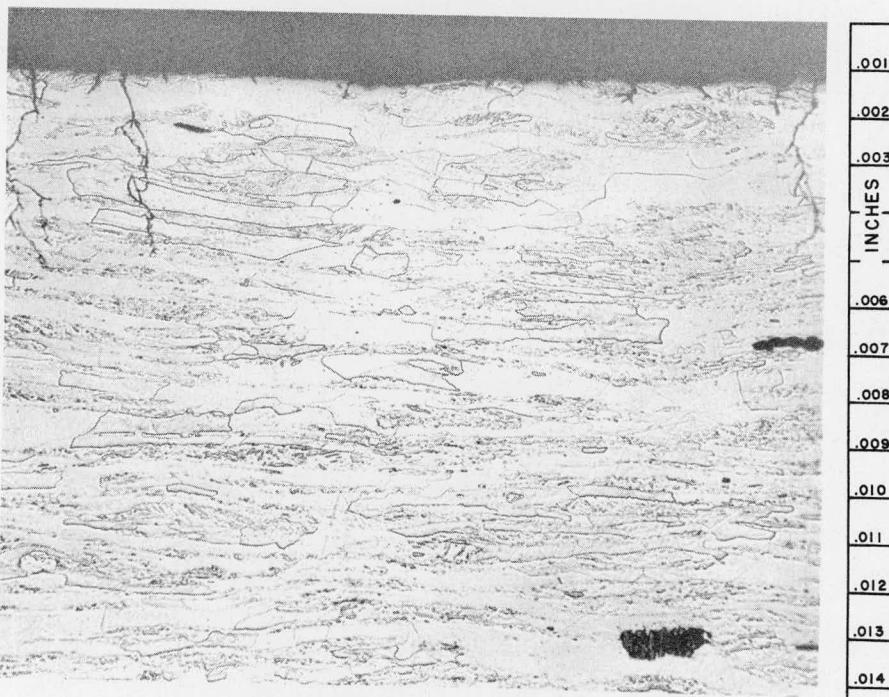
Fig. 15. Photomicrograph of Stress-Corrosion Cracks in Croloy 16-1 Stainless Steel after 100-hr Exposure to Boiling 42%  $MgCl_2$ . Magnification 250X. (T13645)

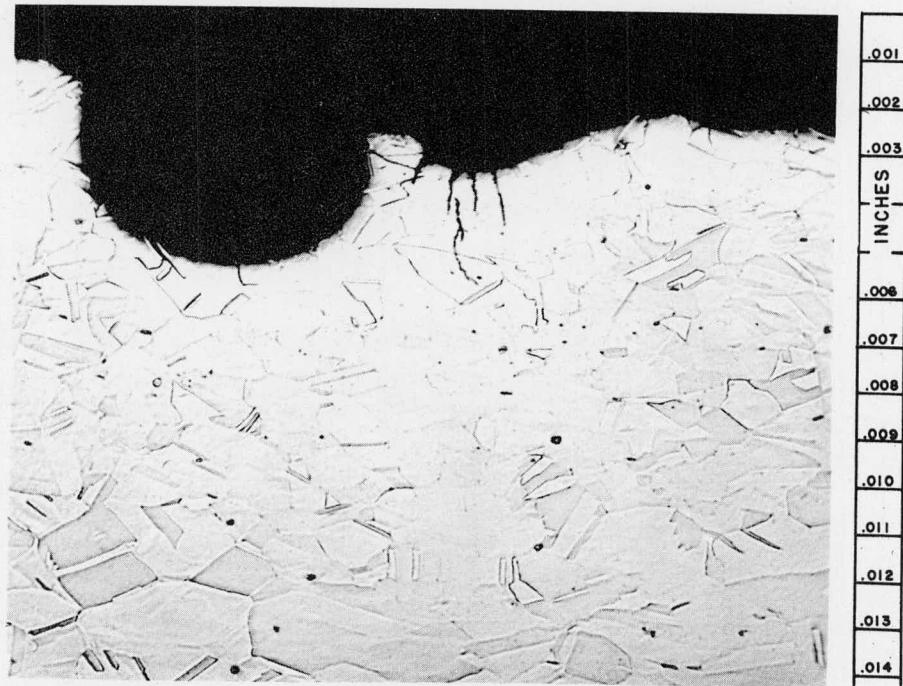
Fig. 16. Photomicrograph of Stress-Corrosion Cracking in Incoloy after 500-hr in Distilled Water at  $300^{\circ}C$  Containing 100 ppm Chloride at pH 2.8. Magnification 250X. (T-13569)

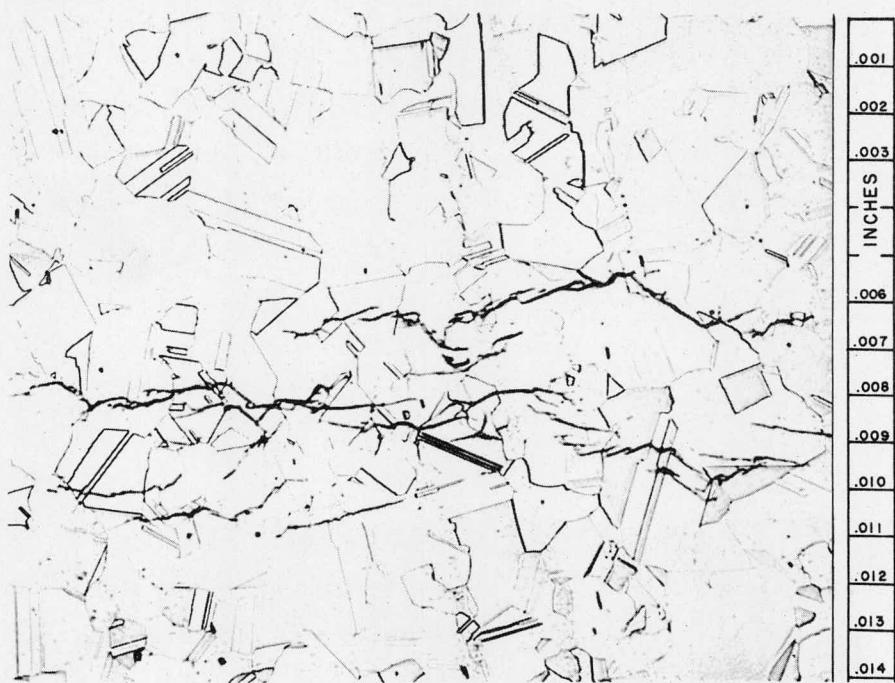
Fig. 17. Photomicrograph of Stress-Corrosion Cracking in Incoloy after 500-hr at 300°C in Distilled Water Containing 100 ppm Chloride at pH 2.8. Magnification 250X. (T13568)

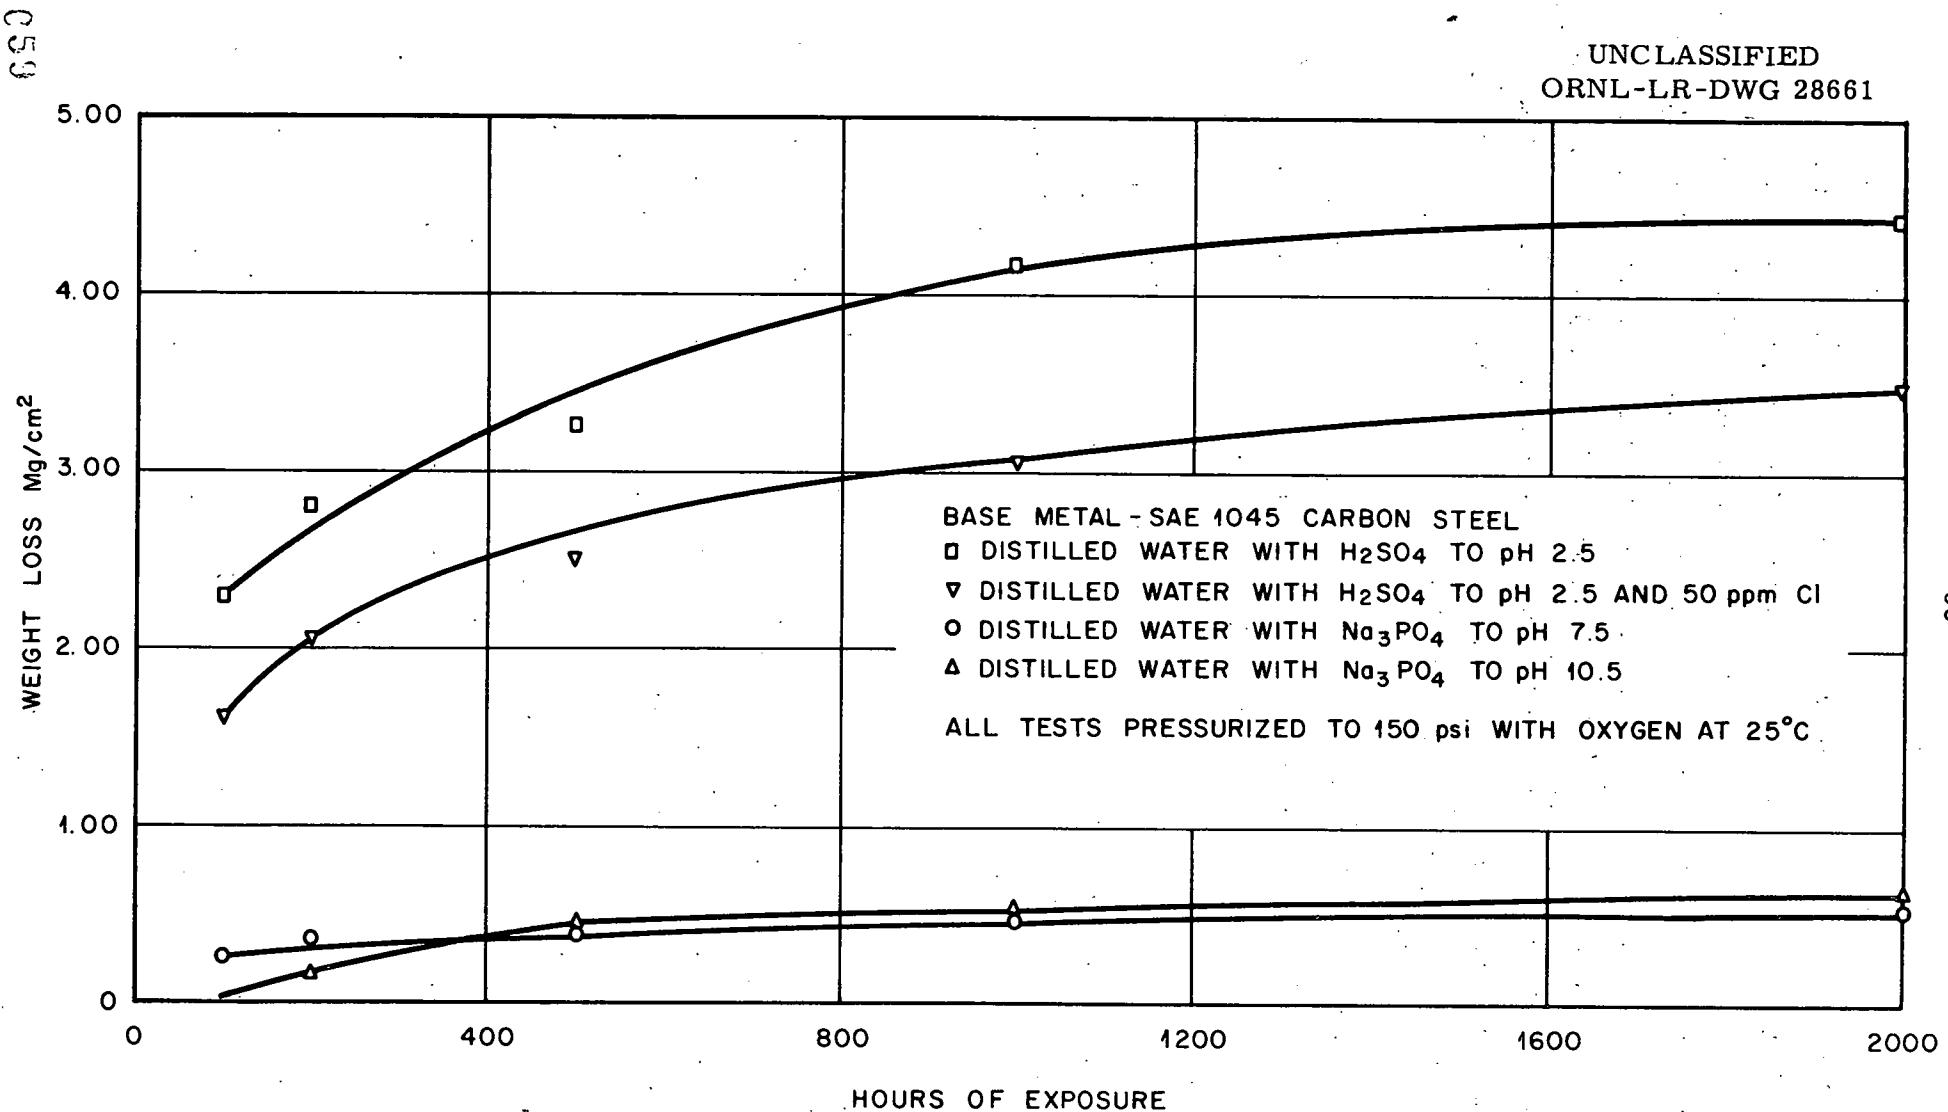
Fig. 18. Weight Losses of Electroless Nickel Plate at  $300^\circ\text{C}$

The corrosion behavior of electroless nickel plate on SAE 1045 carbon steel was excellent in distilled water at 300°C at adjusted pH levels of 2.5, 7.5, and 10.5. Corrosion rates were 1 mpy and less after 2000 hr. The presence of 50 ppm chloride did not affect the corrosion behavior.

The corrosion resistance of carbon steel in oxygenated steam or in water can be markedly improved by deposition of a thin layer of nickel on the surface of the steel. A technique of nickel deposition by a non-electrolytic process has been developed by the National Bureau of Standards. (27) Coupons of SAE 1045 carbon steel plated to a thickness of 2 mils by this method were tested at 300°C in distilled water under various pH conditions. A graph of weight losses as a function of exposure time for the different
