Title: END-ON RADIOISOTOPE THERMOELECTRIC GENERATOR IMPACT TESTS

14th Symposium on Space Nuclear Power and Propulsion, Space Technology & Applications International Forum (STAIF-97)
January 26-30, 1997
Albuquerque, NM

END-ON RADIOISOTOPE THERMOELECTRIC GENERATOR IMPACT TESTS

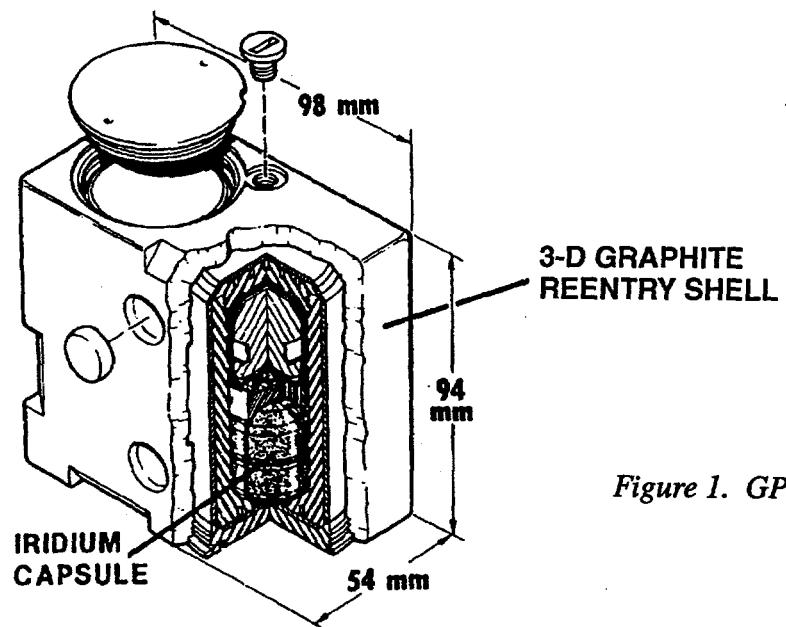
Figure 1. GPHS Module.

The modules consisted of FWPF aeroshells containing two GISs designated as A and C. The A GIS is inserted in the A GIS cavity. This cavity is identified by a small dimple on the face of the aeroshell that has flight control bevels machined on the edges. The dimple is located on the corner of the face closest to the A GIS cavity end cap.

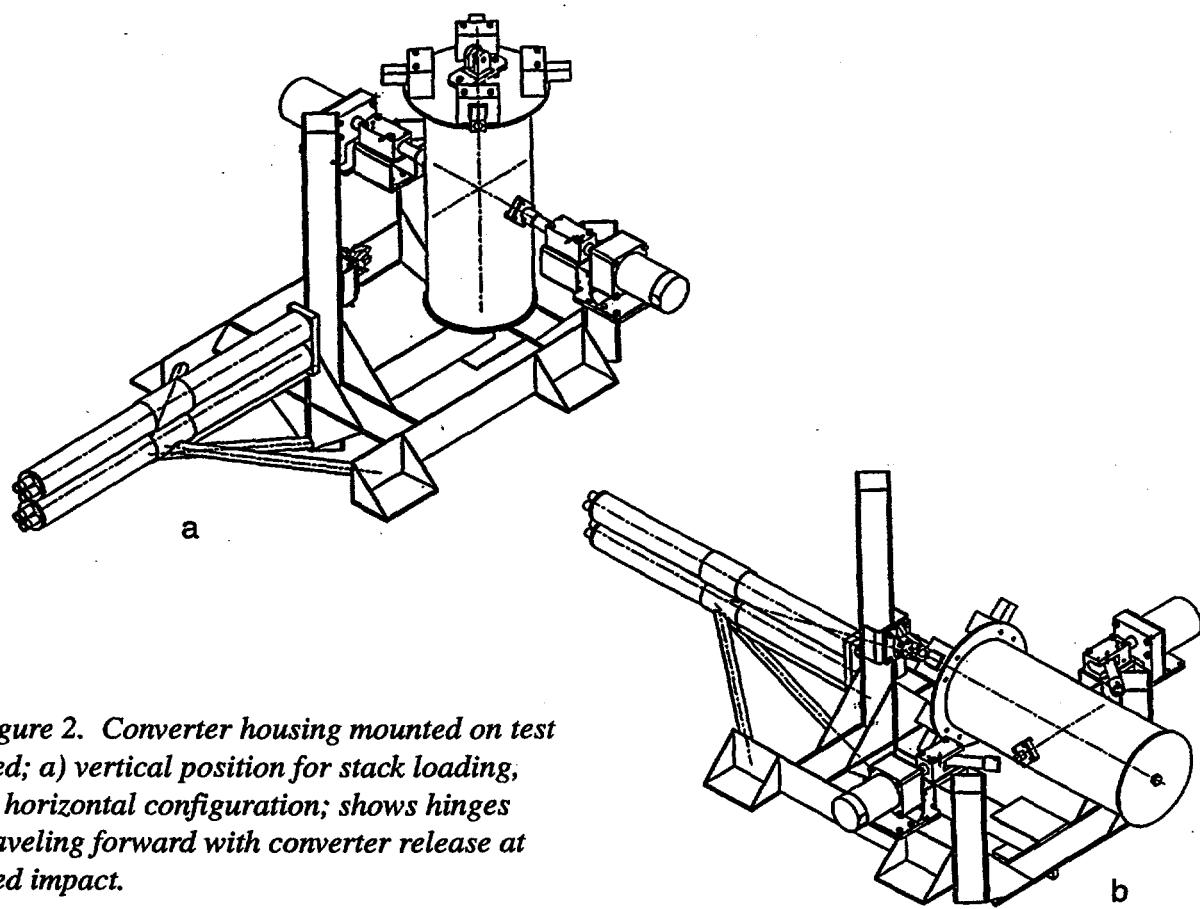
Figure 2. Converter housing mounted on test sled; a) vertical position for stack loading, b) horizontal configuration; shows hinges traveling forward with converter release at sled impact.

The tests were conducted at the Sandia National Laboratory (SNL) Rocket Sled Test Track area, within Area III. The test hardware consisted of the furnace and its support stand, the rocket sled, the aperture plate, and the concrete block. The furnace, designed to heat its contents in an argon atmosphere, had Canthol elements that were conditioned to reach 1200-1250°C. The furnace had a bottom "door" that could be remotely operated so that the graphite stack could be lowered from the furnace into the converter housing. The support stand was a steel structure that supported the furnace and the graphite stack lowering apparatus. The sled was designed to compress as it impacted the aperture plate. The aperture plate was designed to stop the sled while allowing the RTG housing to pass through an opening to the concrete target. The key features on the sled included the support/rotation shafts, the rear latch mechanism, the shaft rotation DC motor and its corresponding counter weight. The shafts supported the RTG housing and rotated the housing from vertical to horizontal orientation. Hinges in the shafts were designed to allow the shafts to travel forward through access slots in the mounting block as the sled impacted the aperture plate (Figures 2 and 3). The rear latch mechanism locked the RTG assembly in the horizontal orientation and held it in place while it was propelled down the sled track. The counter weight balanced the weight across the sled, thereby ensuring a uniform compression of the sled upon impact with the aperture plate.

The graphite module stacks were heated to approximately 1210°C. The rockets were readied and the test sequence began with the remote opening of the furnace door. The stack was then remotely lowered from the furnace into the RTG housing attached to the test sled. The lowering sequence was completed when the latches on top of the housing section engaged, securing the stack within. The RTG was then rotated 90 degrees into the end-on configuration and latched into place with the rear latch mechanism. After the appropriate amount of time had passed for the clads inside the stack to cool to nominally 1093°C (approximately one minute), the rockets on the sled were fired, propelling the sled and its components down the track and into the aperture plate (approximately 1.5 sec). Upon impact with the aperture plate, the sled was stopped and the RTG released through the aperture and impacted the concrete target. The stack cooling characteristics were measured prior to testing at LANL and at the test site at SNL.

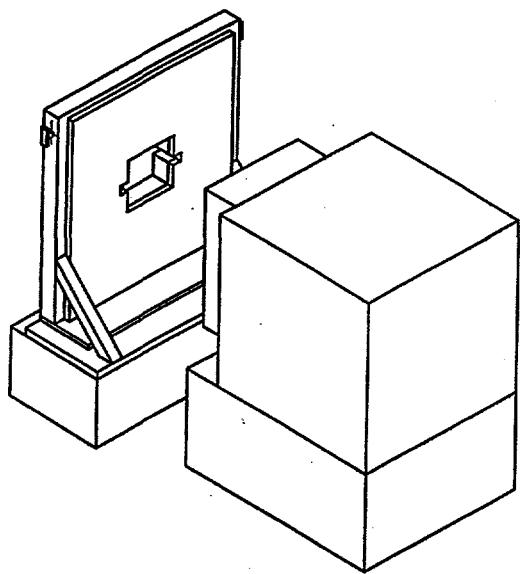
Figure 3. Aperture plate and concrete target.

The concrete target for each test was 36 in. \times 48 in. \times 18 in. thick. The concrete was provided by the US Air Force at Cape Canaveral. It is typical of the concrete used for launch pads and other installations in the area. Each concrete slab was oriented with the 36 in. edge horizontal and the 48 in. edge vertical. This face was centered across the sled track.

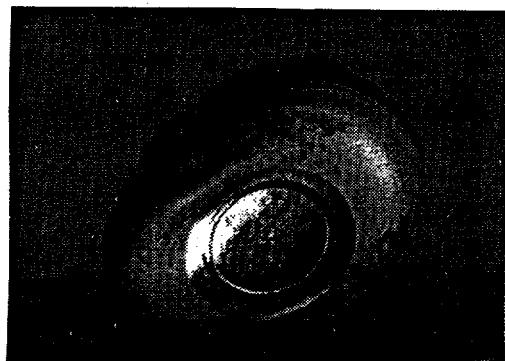
Figure 4. SC0076 experienced the greatest amount of strain in Test RTG-1; (a) impact face, (b) vent end.

Clad SC0076 was located in the blind end of the A GIS in Module 1 (Figure 4). This clad had the most deformation, as indicated by strain calculations, of the clads impacted in this test. In spite of its relatively large deformation, neither SC0076 nor any other clad breached. The impact face of this clad was centered at approximately 270 degrees from the weld start. Because this clad was the most highly deformed, it was selected for metallographic examination. It was defueled and the fuel submitted for particle size analysis.

There were no capsule failures in test RTG-1, although four capsules experienced dimensional strains greater than 10%. These capsules were located in Modules 1 and 2 on the impact end of the converter. One capsule in particular, SC0076, had a diametral strain above 20%. This strain would be expected to result in a failure. Previous testing with simulant-fueled capsules, in the cold-process verification (CPV) test series, resulted in failures at strains ranging from 12 to 16% (Reimus and George 1996). However, a full module impact in the CPV test series, at 54 m/s, did not result in clad failures.
