IN REACTOR PERFORMANCE OF DEFECTED ZIRCALOY-CLAD U₃Si
FUEL ELEMENTS IN PRESSURIZED AND BOILING WATER COOLANTS

AECL-3106

The results of two in-reactor defect tests of Zircaloy-clad U_3Si are reported.

Post-irradiation examination showed that both elements had suffered major sheath failures which were attributed to the volume increase accompanying the formation of large quantities of corrosion product formed by the reaction of water with the hot central part of the fuel.

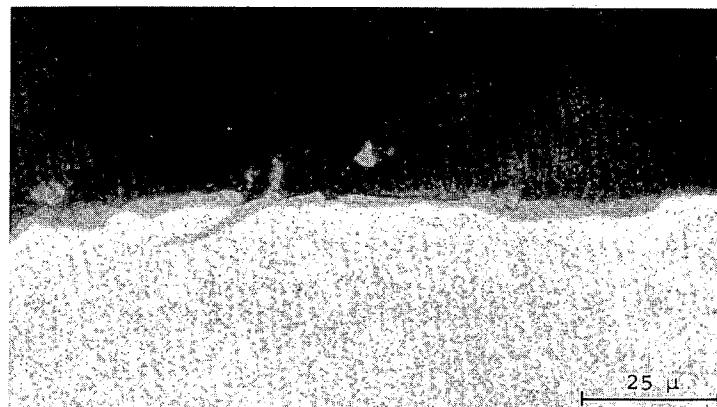
Figure 10 (R-28-C2) As Polished

Corrosion layer on the U₃Si periphery directly under the drilled defect.

Examination of section 1, through the original drilled defect, showed a star-shaped area of corrosion about the center of the fuel (Figure 9). There were cracks from the ends of the star arms to the fuel-sheath interface. The fuel element had split open longitudinally along the arm of the corrosion star immediately under the drilled defect. Corrosion on the fuel periphery was limited to a small area directly under the drilled defect and where the corrosion product was a maximum of 5 microns in thickness (Figure 10). Most of the fuel was in tight contact with the sheath and no corrosion product was seen at the interface (Figure 11).

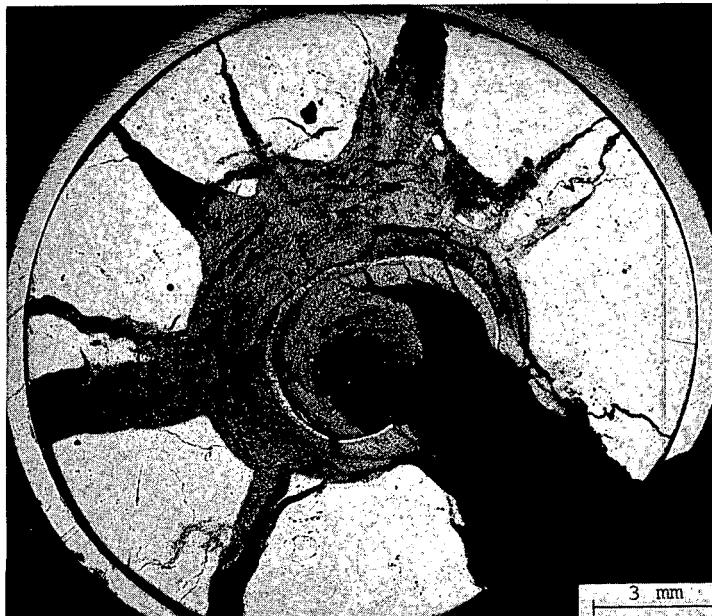
Figure 20 (R-27-A1) As Polished

Section near the drilled defect hole showing star shaped corrosion area and circular band of white phase.

Examination of section 4 (Figure 20) showed a star-shaped corrosion area similar to that in fuel element MJK, the corrosion product having completely filled in the central void. There was also a corrosion layer on the outer diameter (O.D.) of the U₃Si, the maximum thickness of which was 80 microns (Figure 21).

The same white phase seen in MJK was present as a broken ring within the final corrosion product at the center of the fuel (Figures 20 and 23). From its position, it seems probable that the ring had been formed on the surface of the central void originally present in the fuel, but it is uncertain how the corrosion product got inside the ring without breaking it up. The white phase was also present at the corrosion front (Figure 24). Also present at the corrosion front was a dark band similar in appearance to the "X" phase seen in fuel element MJK. Some of the U₃Si₂ particles ahead of the corrosion front had the dark phase associated with them in a similar manner to those seen near the corrosion front on the fuel O.D. On etching, the dark band was seen to consist of two phases (Figure 25). The darker of the two phases was called "X₁", and the other "X₂". The "X₁" phase was the one associated with the U₃Si₂ particles ahead of the main corrosion front. There were cracks in the "X₂" phase and in the U₂Si₂ in it. Within the final corrosion product there were particles consisting of the white phase and the "X₂" phase (Figure 25).

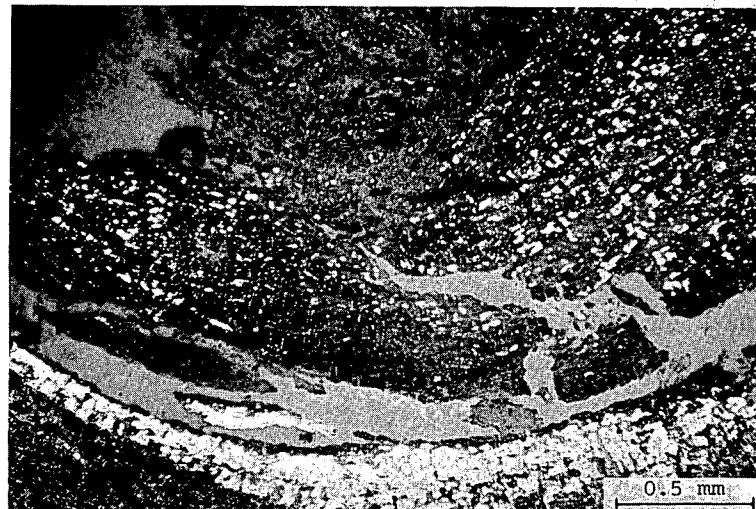
Figure 23 (R-27-A10) Etched

Broken ring of white phase in the center of the final corrosion product.

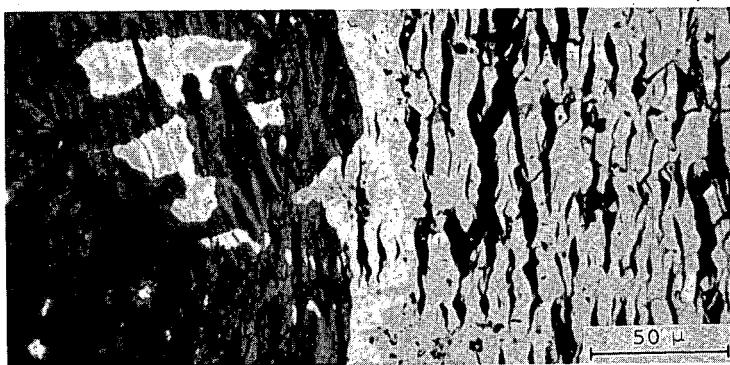
Figure 29 (R-27-B8) As Polished

X_2 phase and white phase layer at the center of the fuel. Dark final corrosion product containing particles of the white phase and X_2 phase.

white phase. Within the main corrosion product there were particles consisting of the white phase and the "X₂" phase (Figure 29).
