## **SNAP-21 PROGRAM, PHASE II**

**DEEP SEA RADIOISOTOPE-FUELED  
THERMOELECTRIC GENERATOR  
POWER SUPPLY SYSTEM**

**QUARTERLY REPORT NO. 7**

**SNAP-21 PROGRAM, PHASE II****DEEP SEA RADIOISOTOPE-FUELED  
THERMOELECTRIC GENERATOR  
POWER SUPPLY SYSTEM****QUARTERLY REPORT NO. 7****APRIL 1968****Period Covered**

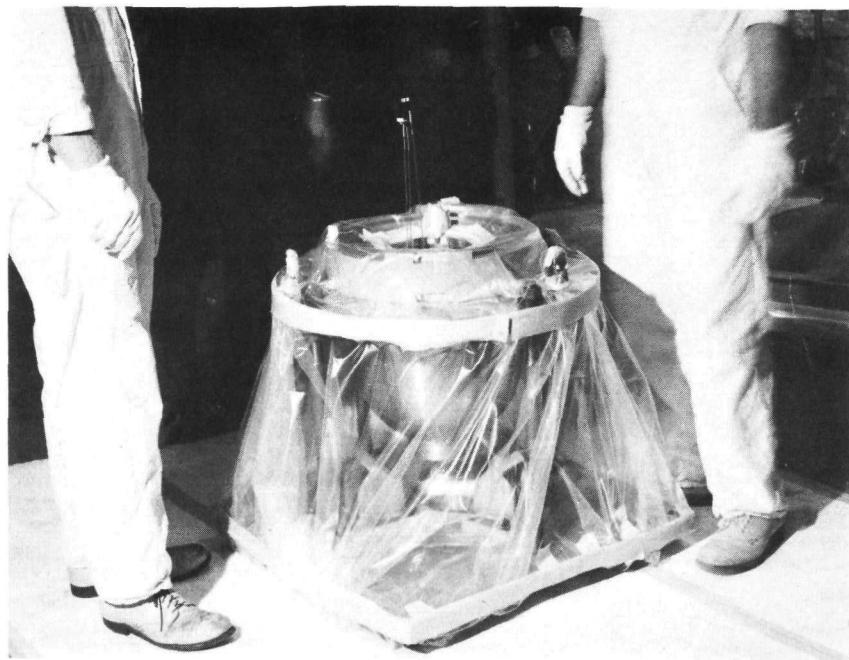
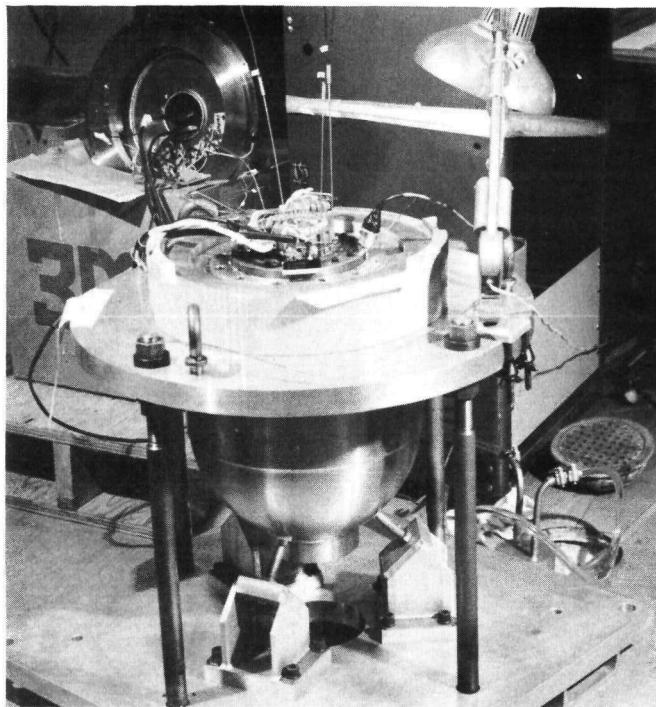
a) Lower Assembly Ready for Fueling

b) Fueled System Showing Thermoelectric Generator in Place

Figure D1. Steps in Fueling and Assembly, System S10D1A

c) System With Wiring Complete

d) Lowering Pressure Vessel Cover Completing System Integration

The assembled system was checked out both before and after the pressure vessel cover was bolted down; however, after about 16 hours of operation an internal short was discovered in the system. The cover was removed and the short located.
