ENRICO FERMI ATOMIC POWER PLANT

CURRENT EXPERIENCE SERIES

COMPILED OF CURRENT TECHNICAL EXPERIENCE AT ENRICO FERMI ATOMIC POWER PLANT NOVEMBER, 1967

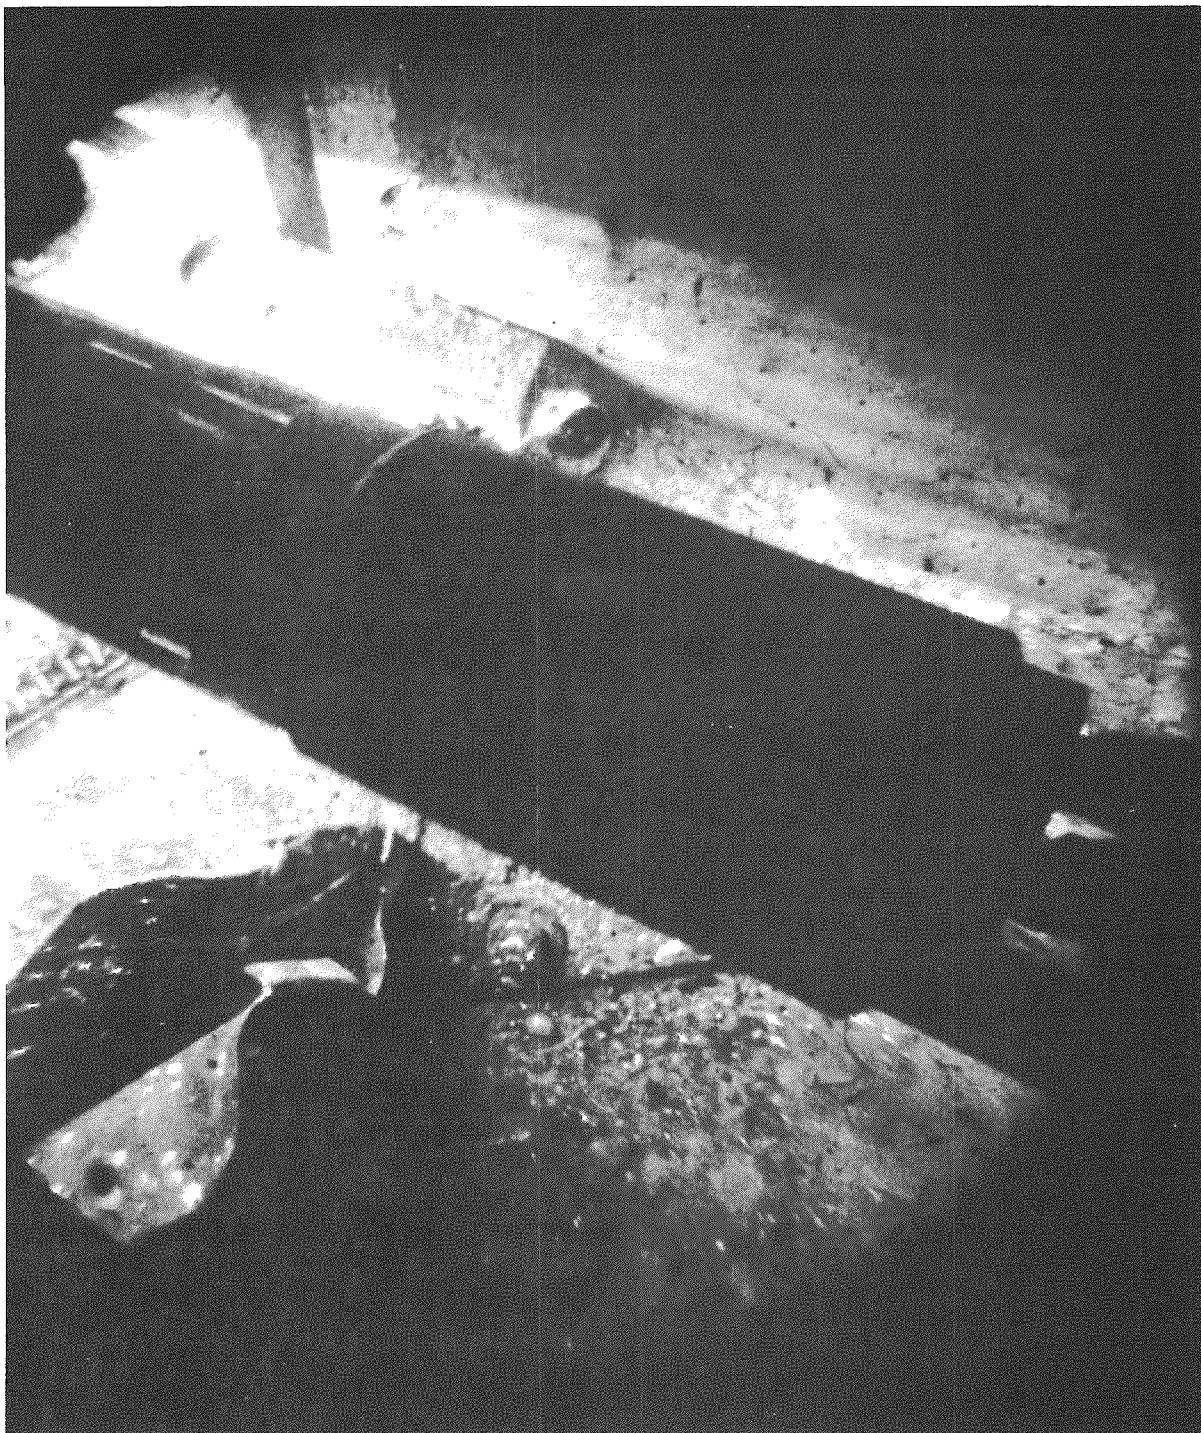
Figures 2, 3, 4, and 5 are representative of a great number of photographs taken when viewing the object straight downward. They reveal features of the object that were not observable when viewing horizontally. Most notable of the newly-observed features are a pie-shaped silhouette and what appears to be an expanse of flat surface that may have obstructed sodium coolant flow to the two subassemblies. See Section II. C for results of a study of these photographs.

FIG. 2 PLAN VIEW OF ONE SIDE OF UNIDENTIFIED FOREIGN OBJECT

FIG. 3 PLAN VIEW OF OPPOSITE SIDE OF UNIDENTIFIED FOREIGN OBJECT

FIG. 4 VIEW OF UNIDENTIFIED FOREIGN OBJECT WITH LIGHT SOURCE TUBE ABOVE

FIG. 5 CLOSE-UP OF UNIDENTIFIED FOREIGN OBJECT

Representatives of Battelle Memorial Institute examined photographs of the foreign object through a stereoscopic viewer for the purpose of determining contour and dimensions as accurately as possible. According to preliminary estimates, the object is now thought to be slightly larger than

the approximated dimensions of 9 inches by 4 inches by 4 inches reported in Section II, A of APDA-CFE-15.

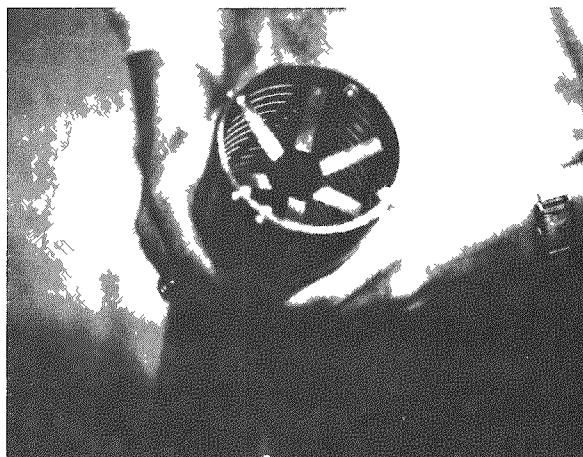
FIG. 15 END OF FIVE-INCH-DIAMETER FLEXIBLE DUCT SHOWING SPRING FINGERS DESIGNED TO ADMIT AND RETAIN UNIDENTIFIED FOREIGN OBJECT

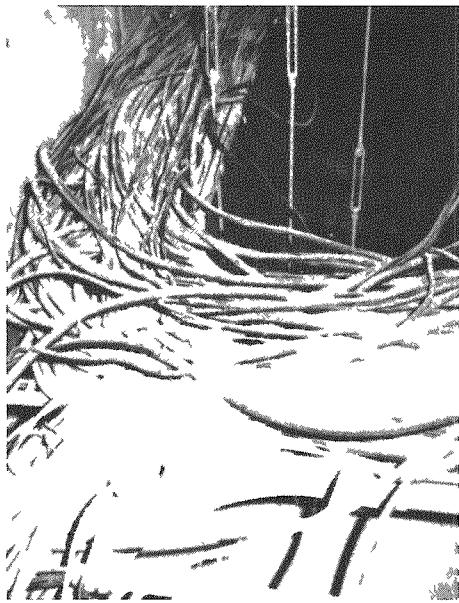
Much of the feeder wiring for the induction and resistance heating on the sodium and inert gas piping in the primary inert gas building was found to be deteriorated and was replaced. This condition was caused by overcrowded cable trays in areas of high ambient temperature (about 120 F). Inadequate heat dissipation from the cable bundles caused cable insulation to dry and crack. The condition was discovered during an investigation of the cause of a defective lighting circuit.

FIG. 24 CROWDED CABLE TRAY IN PRIMARY INERT GAS BUILDING BEFORE CABLE REPLACEMENT AND REROUTING

All damaged wire was replaced by asbestos-insulated wire. No. 8AA wire was substituted for all of the No. 12AA wire originally installed. To alleviate the crowded condition, many cables were rerouted and additional cable trays were installed adjacent to existing trays. Cable grouping was changed as necessary so that there were no more than seven cables tied together in a single group.

To maintain adequate heating service during repairs, defective wires were replaced individually whenever possible. This also helped to maintain circuit identification. About 1500 feet of defective cable was replaced. Affected by the repair were 56 induction heating circuits and 5 resistance heating circuits. Figures 24 and 25 are representative of the before and after cable conditions.
