GEAP-4310
JULY, 1963

GENERAL AND LOCALIZED CORROSION STUDIES OF TYPE 300 SERIES AUSTENITIC STAINLESS STEELS IN SIMULATED SUPERHEAT REACTOR ENVIRONMENT

ATOMIC POWER EQUIPMENT DEPARTMENT

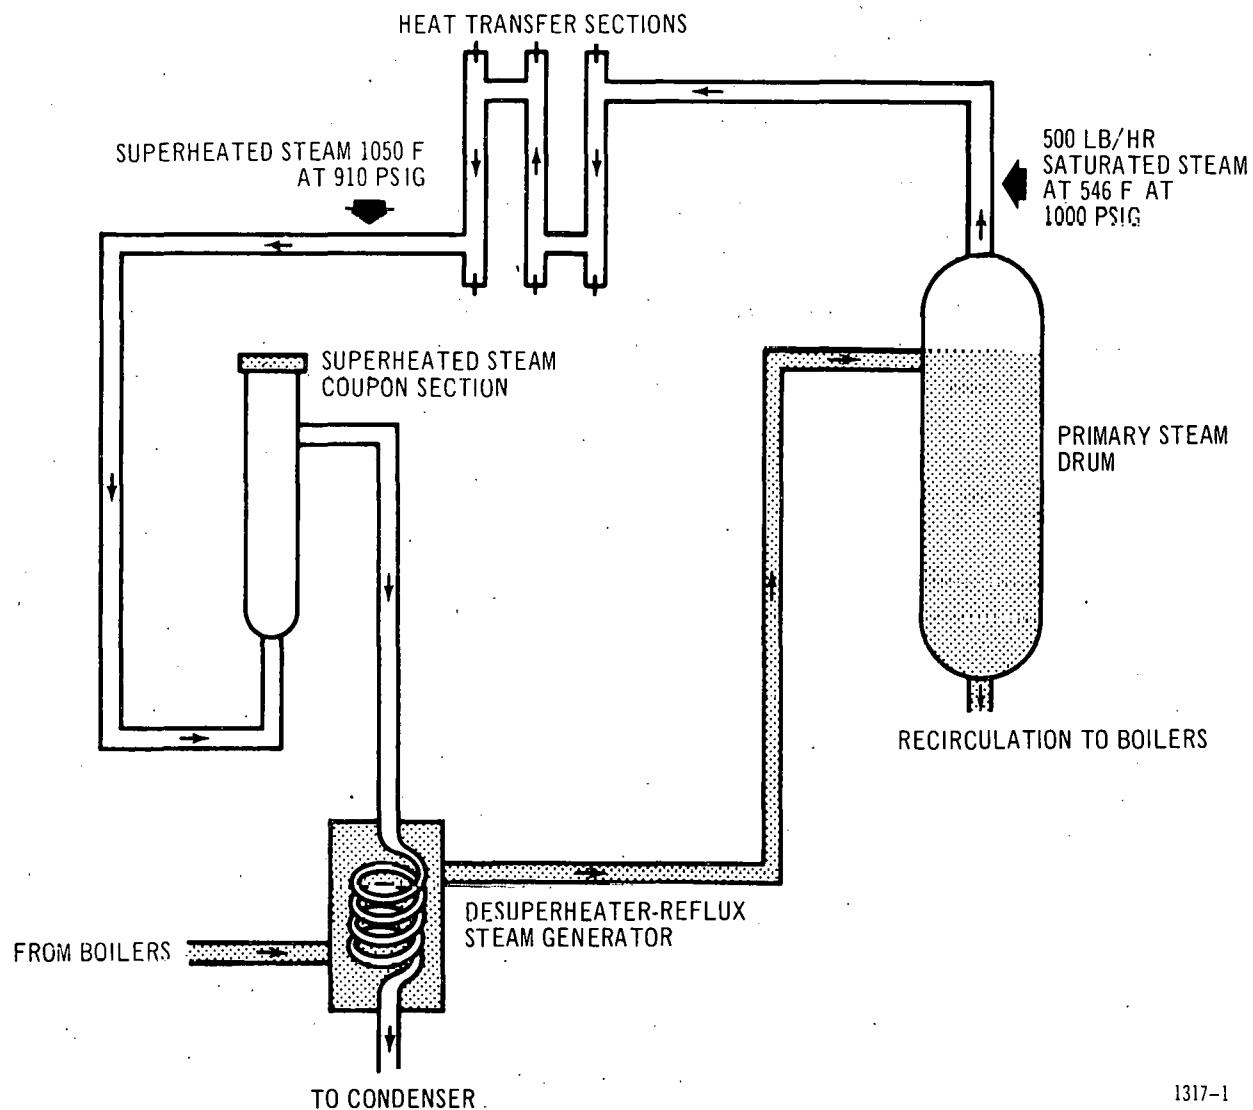
Figure 1. Superheat Corrosion Facility

The general corrosion tests were carried out in the CL-1 superheat corrosion facility, shown in schematic diagram in Figure 1 and previously described elsewhere. ^(9, 10) The tests with heat transfer were performed with longitudinal stresses applied when indicated, as described for stress testing of Type 304 stainless steel. ⁽³⁾ The runs for each material approximated 1000 hours. The facility water was maintained at neutral pH with no chemical additives. The water resistivity was maintained above 2 megohm-centimeters during the test runs with chloride maintained below 0.05 ppm. Oxygen and hydrogen were maintained in the water to result in a level in the steam typical of quantities generated radiolytically in a BWR system. The facility operating conditions during the general corrosion test runs are summarized in Table II. The test with Type 316 SS was carried out in the exit superheater position only.

The CL-1 and CL-4 superheat facilities, represented by the schematic diagram shown in Figure 1, were utilized for carrying out the localized corrosion evaluations.

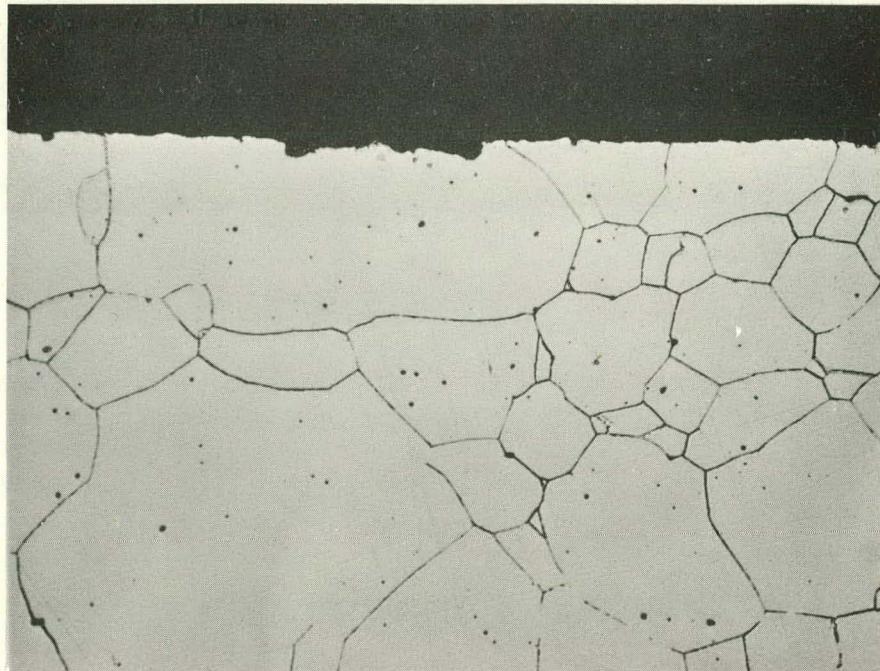
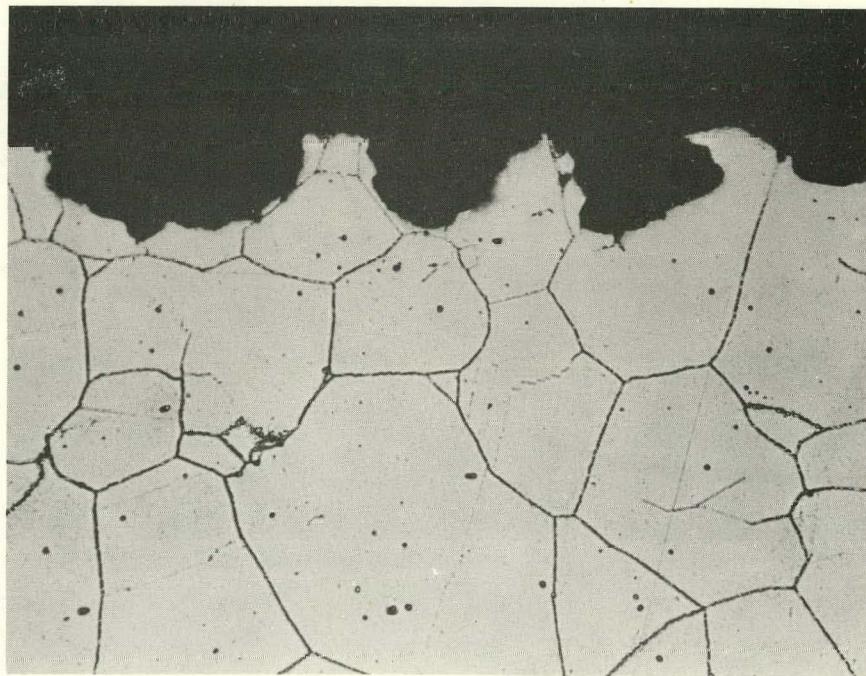
a. Calculated Metal Temperature - 1100 F

b. Calculated Metal Temperature - 1300 F

Figure 2. Type 316 SS, Heat Transfer Specimens, 895 Hours
Descaled Glyceregia Etch 500X

Almost complete spalling of the scale with a correspondingly high metal-to-system loss in the 1200-1300 F temperature range occurred on the Type 316 SS at the stresses that the Type 310 SS (LCVM) and Type 304 SS ⁽³⁾ had performed acceptably. Figure 2 shows sections of the Type 316 SS test sheath exposed at metal temperatures of 1100 F and 1300 F.

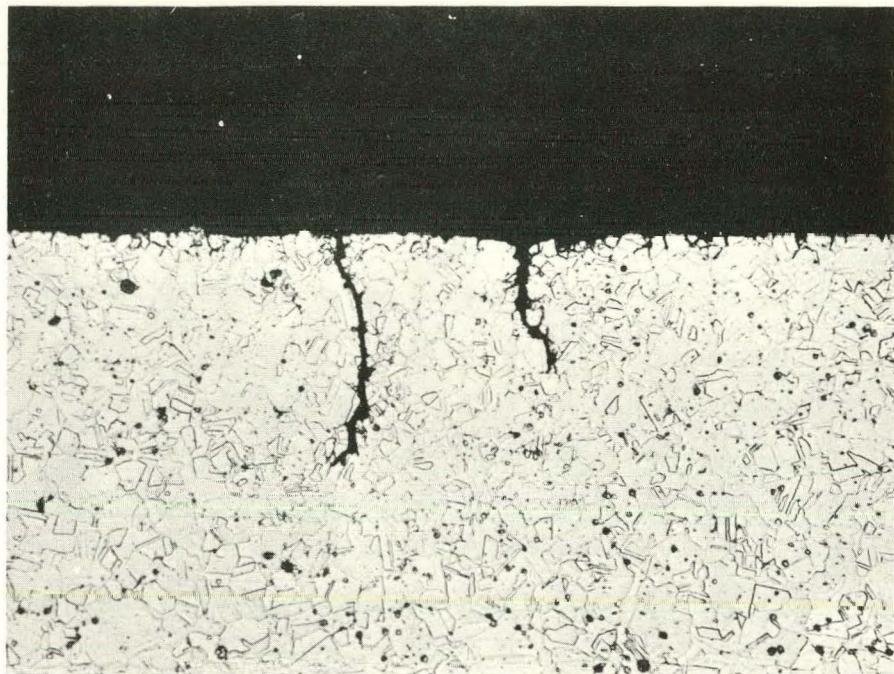
Figure 3. Type 347 SS Heat Transfer Specimen, 1016 Hours
Calculated Metal Temperature 1300 F
Descaled 60% Nitric Acid Etch 500X

The Type 347 SS, which had no applied stress, performed acceptably in general corrosion but had some intergranular attack indicated in the 1100-1300 F range as seen in Figure 3. The positive numbers indicated in Table III for metal to system loss in the 800-1100 F range probably result from some deposition on the sheaths from the flowing steam with little to no oxide lost to the system.

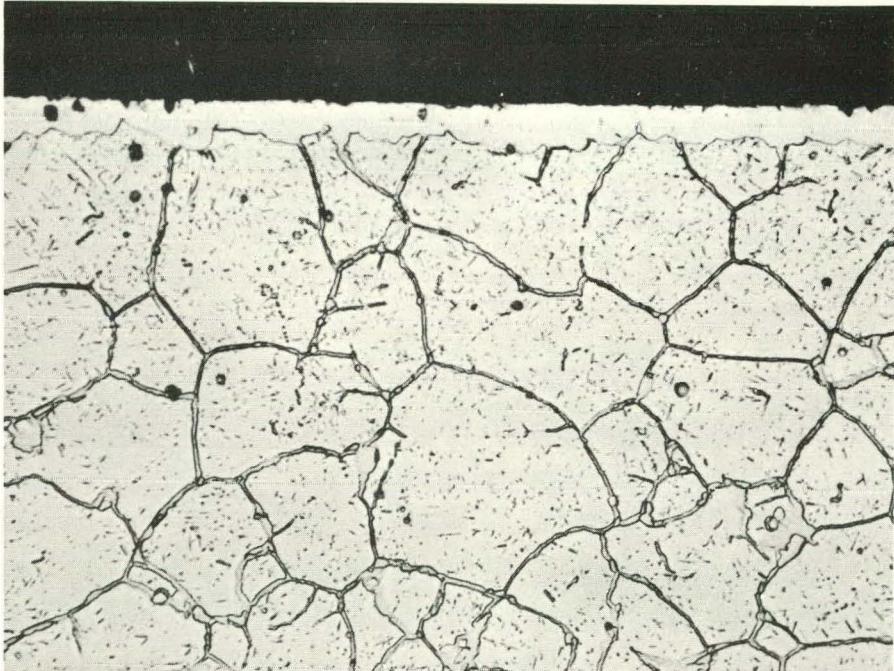
Figure 4. Type 310SS (LCVM) Heat Transfer Specimen, 997 Hours
Calculated Metal Temperature 1300 F Descaled
10% Oxalic Acid - Electrolytic Etch 500X

The Type 310 SS (LCVM) showed no evidence of localized attack. A compositionally disturbed layer as seen previously with Type 304 SS ⁽¹⁰⁾ and the high nickel alloys ⁽⁵⁾ was found on the 1300 F Type 310 SS specimen to an average depth of 0.5 mils, see Figure 4.

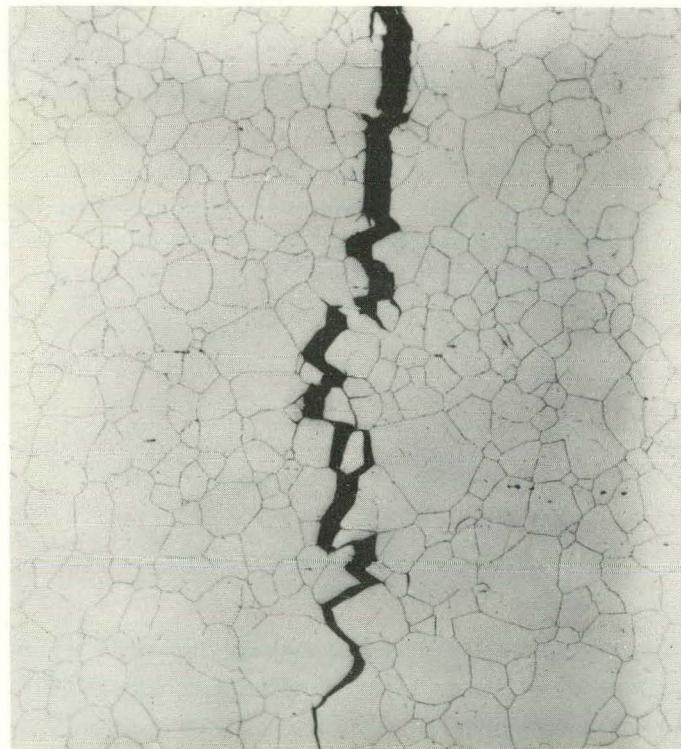
Figure 6. Type 304 SS, 324 Hours Exposure to NaCl Cycle Run
Transgranular and Intergranular Attack on Entrance
Superheater Sheath 10% Oxalic Acid - Electrolytic
Etch 150X

The cracks found on the entrance superheater sheath were primarily transgranular although at least one showed both intergranular and transgranular in the same crack as shown in Figure 6. It is probable that intergranular cracking was also present on the middle superheater although the sections taken did not show it. Visual and ultrasonic examination of the exit sheath indicated no cracking. With the exception of the through cracks, even though many cracks were visible, not one could be identified by the dye penetrant method.

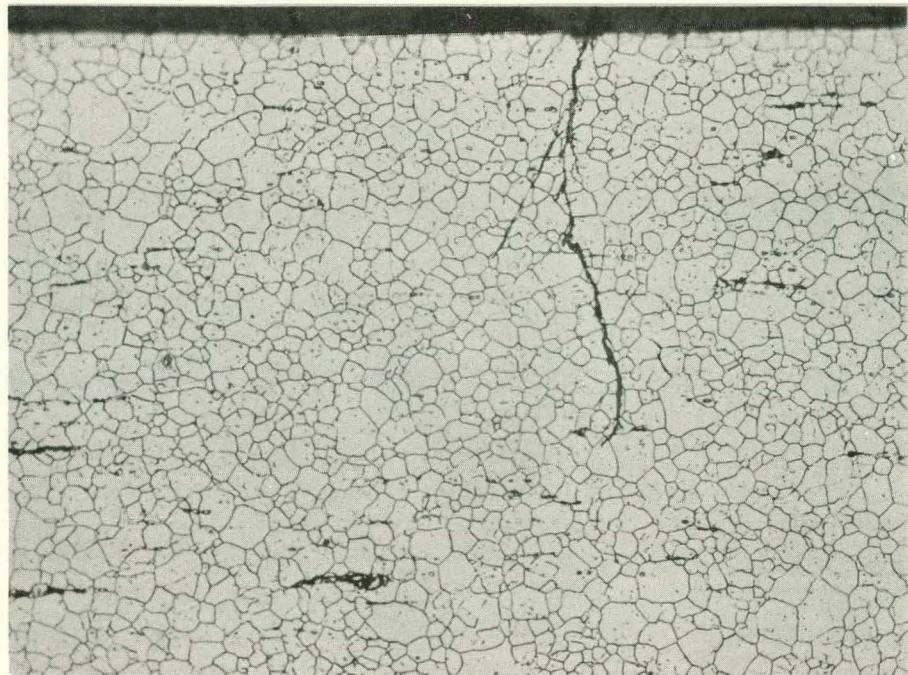
Figure 7. Type 347 SS, 327 Hours Exposure to NaCl Cycle Run
Transgranular Cracks on Middle Superheater.
60% Nitric Acid Electrolytic Etch 250X

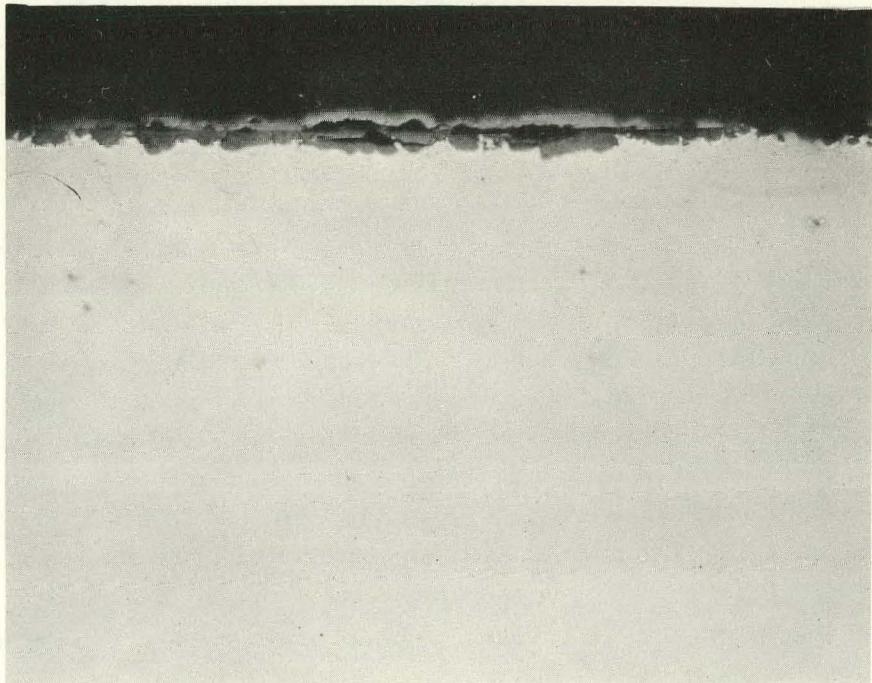
Figure 8. Type 347 SS, 327 Hours Exposure to NaCl Cycle Run
1200 F Highest Metal Temperature Unetched 500X

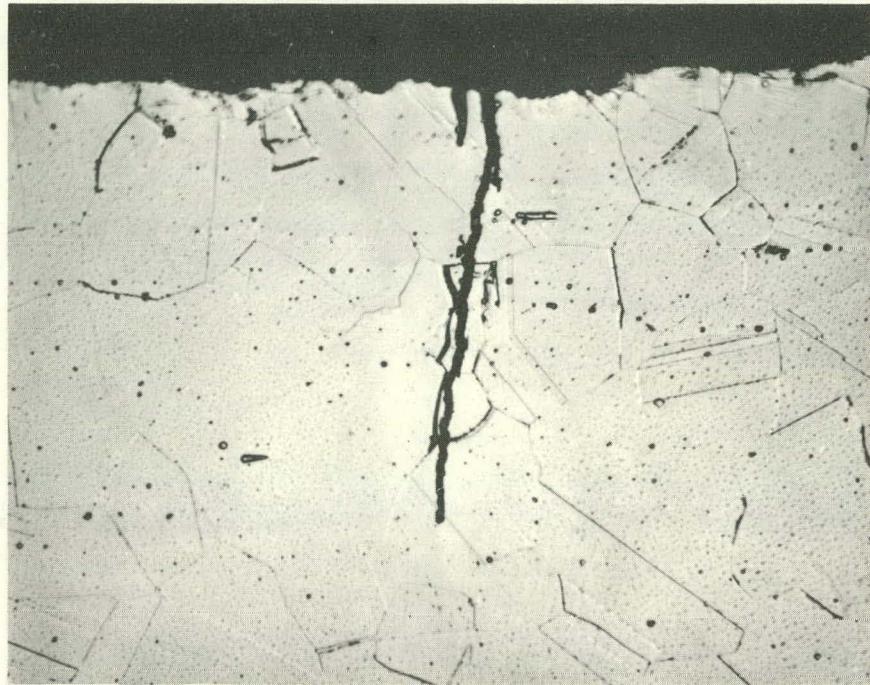
Figure 9. Type 304 SS (LCVM), 343 Hours Exposure
to NaCl Cycle Run Transgranular Cracks
on Middle Superheater Glyceregia Etch
500X

The microscopic examination of one cross section of the middle sheath that had been at a metal temperature of ~1000 F for 4 days indicated transgranular cracking as seen in Figure 9. Some sensitization is indicated.

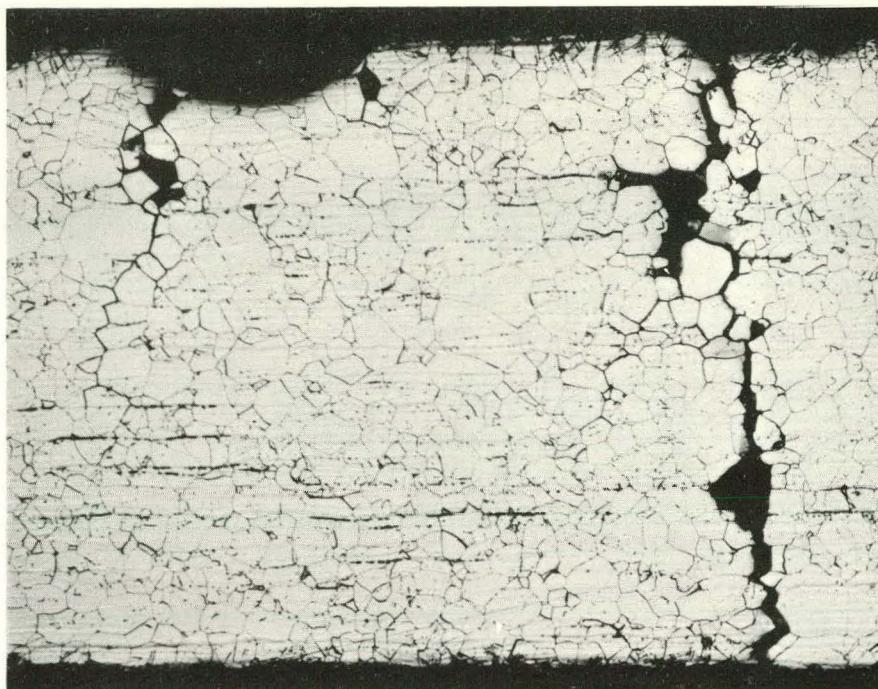
Figure 10. Type 304 SS (HCVM) 63 Hours Exposure to NaCl Cycle Run Failure Opposite Thermal Sleeve at End Fitting of Exit Superheater 10% Oxalic Acid - Electrolytic Etch 195X

The 0.07 percent carbon, low nitrogen Type 304 SS sheaths were sensitized for 112 hours at 1100 F prior to insertion in the test. The sheath in the exit heater position failed after 63 hours while the cycle was still in the first step of 350 F steam with 10 F superheat. A nonsensitized sheath was used for a replacement and the cycle continued. The sheath in the middle heater position failed after a total of 112 hours exposure. The cycle had reached the second step of 546 F steam with 10 F superheat. Examination of both failed sheaths revealed an intergranular attack opposite the thermal sleeves in the end fittings as shown in Figure 10. The intergranular attack appeared to originate from a pit. The middle sheath was covered with pits of a few mils in depth as indicated in Figure 11. There was no evidence of cracks originating in the pits examined.

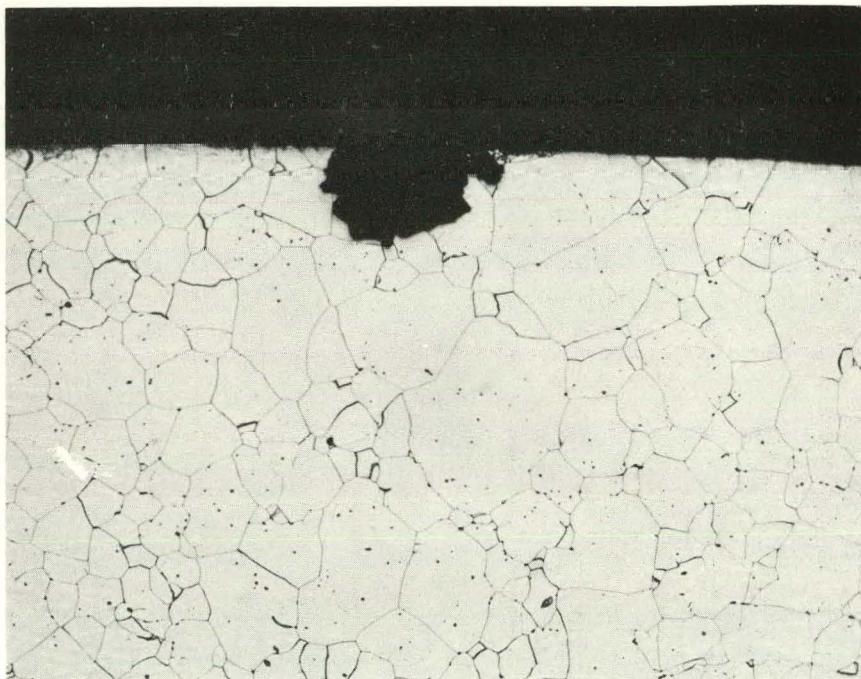
Figure 11. Type 304 SS (HCVM) 112 Hours Exposure to NaCl Cycle Run Pitting on Middle Superheater 10% Oxalic Acid - Electrolytic Etch 250X

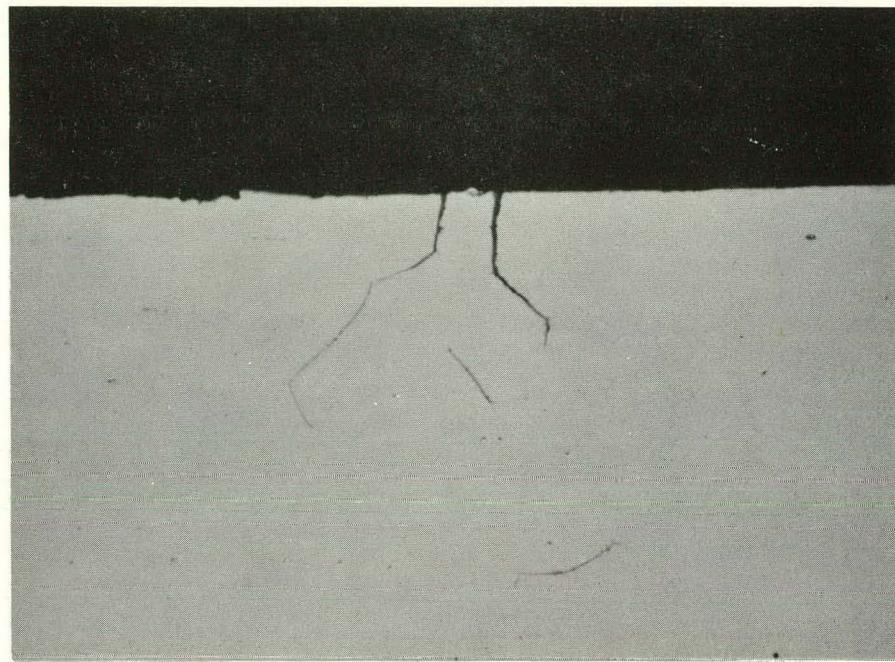
Figure 12. Type 316 SS FeCl_3 Development Cycle Run
Intergranular Attack Unetched 500X

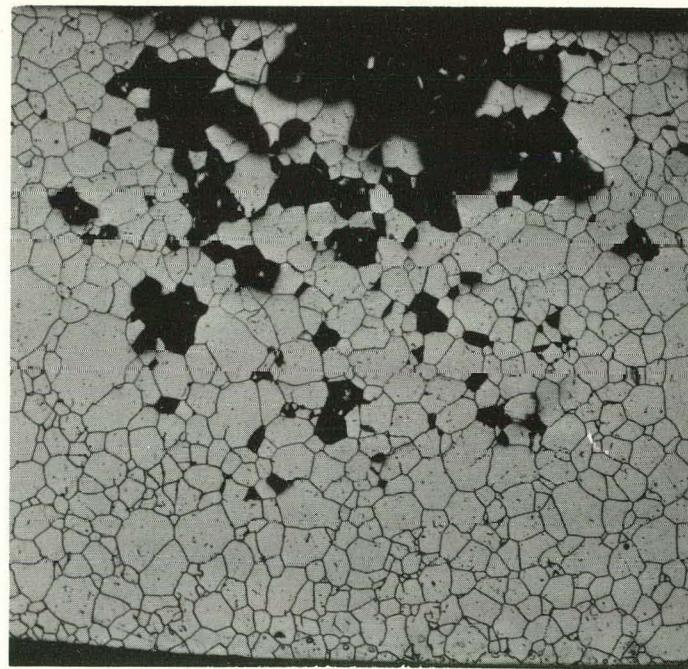
Figure 13. Type 304 SS FeCl_3 100X
Development Cycle Run ID Attack
10% Oxalic Acid - Electrolytic
Etch, Grains Removed During
Metallographic Preparation

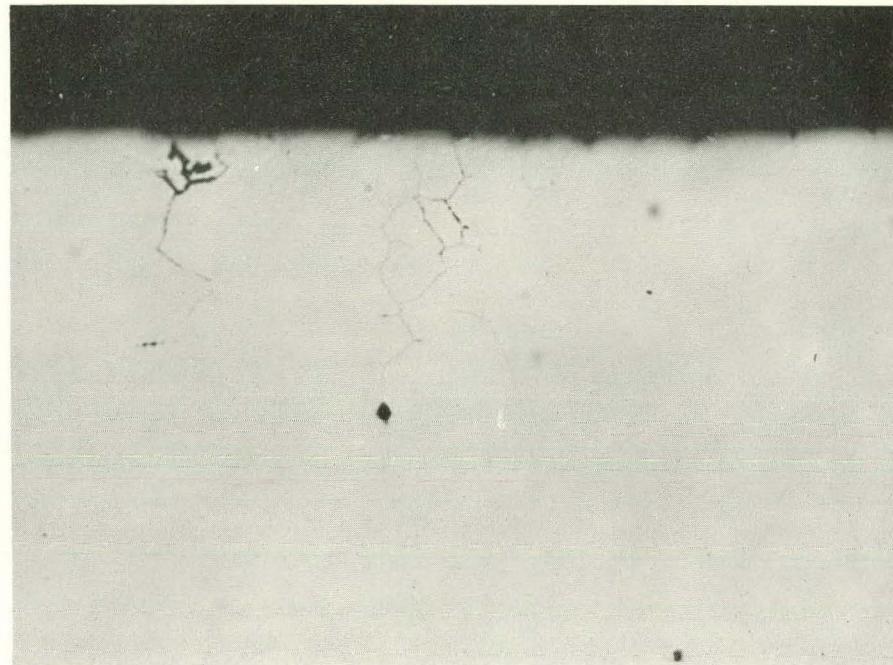
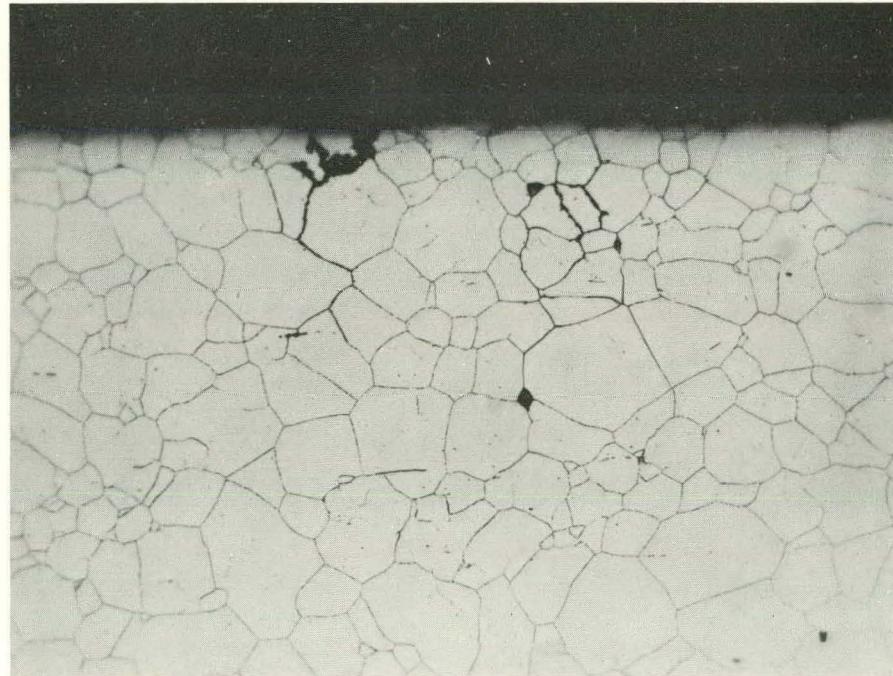
a. Unetched

b. 10% Oxalic Acid Electrolytic Etch

Figure 14. Type 304 SS 44 Hours Exposure to FeCl_3 Cycle Run
250X

The effectiveness of the FeCl_3 cycle was demonstrated by exposing three new Type 304 SS sheaths (Code Y), that had been heat treated for 100 hours at 1100 F. The run was terminated after 44 hours of step two because of failure of the non-heated specimen in the No. 3 position. Examination up to 40X showed attack on all three sheaths. Metallographic examination indicated the attack to be intergranular. Figure 14a shows an attacked area as-polished and Figure 14b the same area after etching.

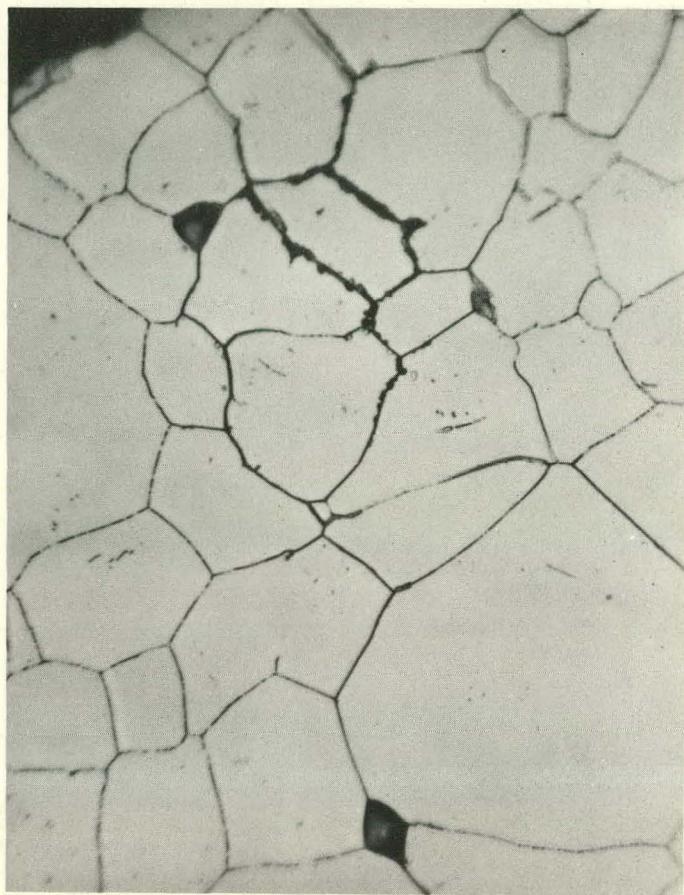
Figure 15. Type 304 SS 44 Hours Exposure to FeCl_3
Cycle Run
Enlargement of Figure 14b. 750X

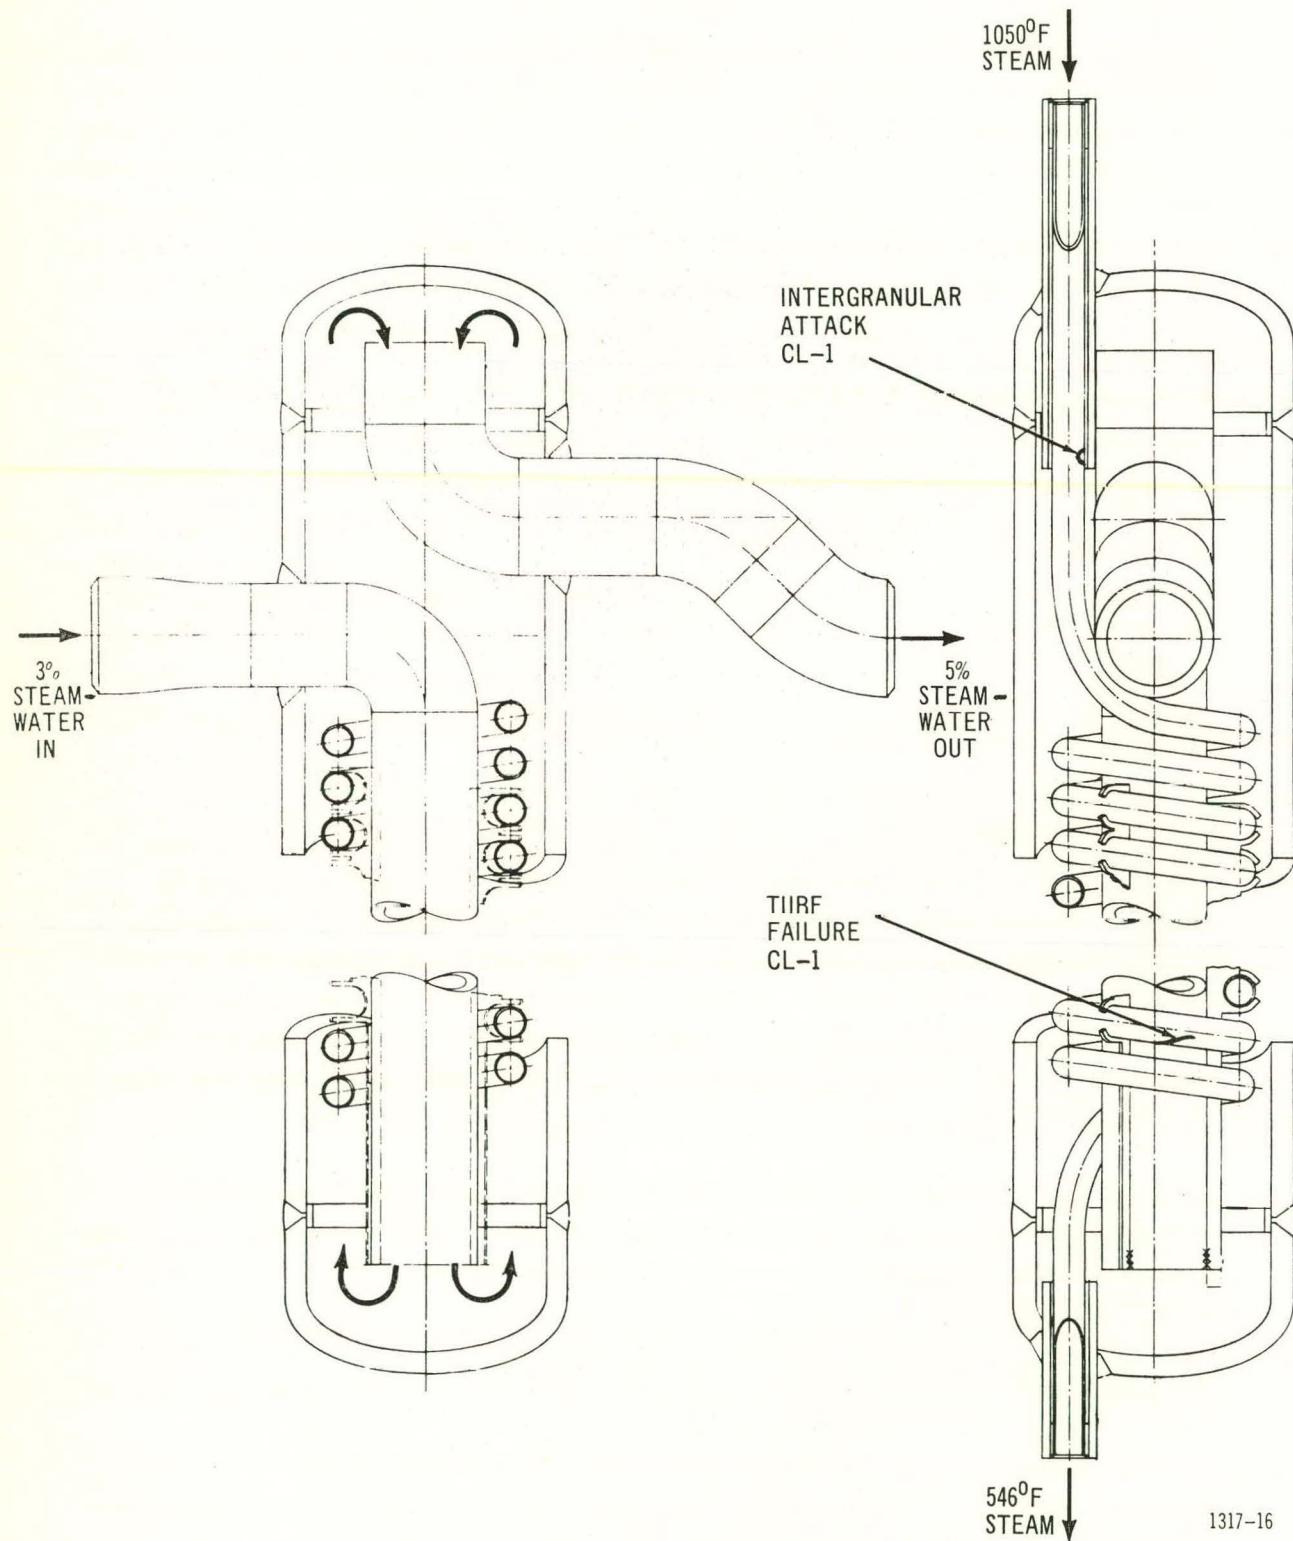
Figure 16. Desuperheater Section of the Superheat Facilities

The Type 316 SS desuperheater coil of the CL-1 facility failed after about 13,600 hours of operation. The facility had been operated for general corrosion testing about 10,000 hours with no added chlorides and for the NaCl cycle for the remaining 3600 hours utilizing 1.5 ppm chlorides in the recirculating water. The coil had failed near the outlet end where the superheated steam decreased to a temperature no higher than 650 F. Other cracks were noted only in the vicinity of the failure.

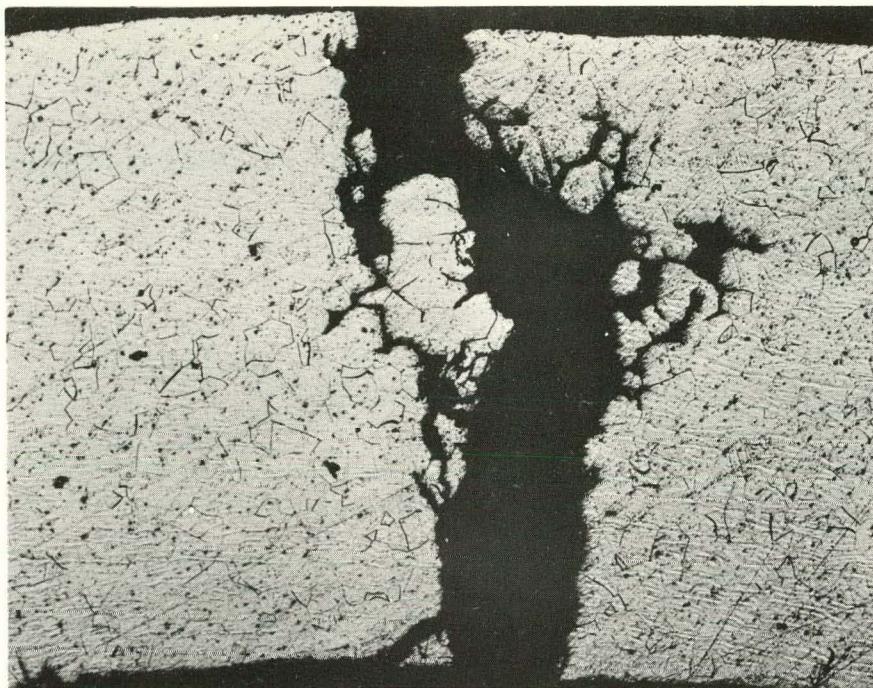
Figure 17. Large Transgranular Failure Showing Small Transgranular Cracks and Some Intergranular Attack Leading From It.

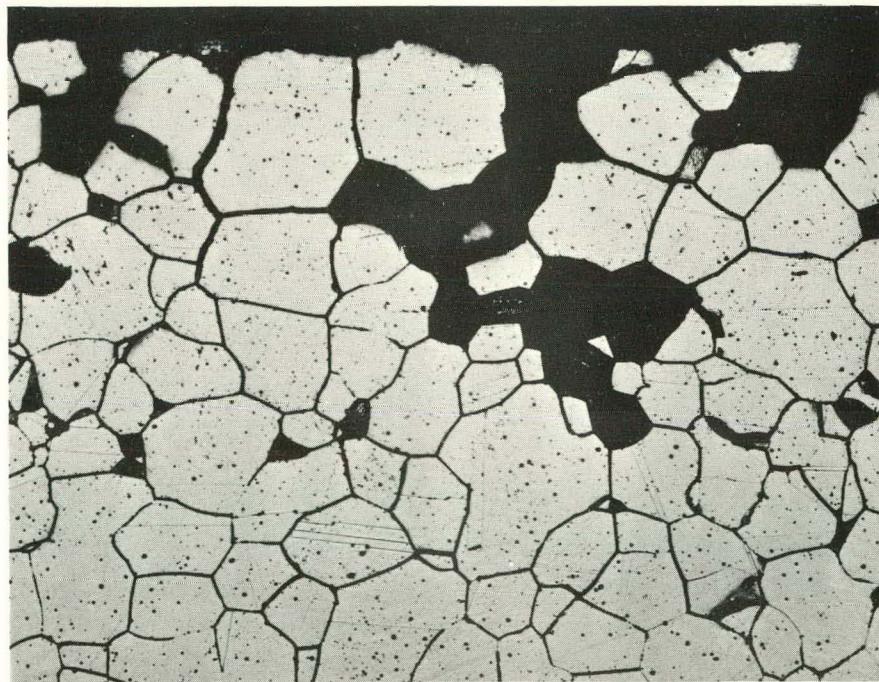
Figure 18. Section Taken Through the Inlet Tube Showing Sensitization, Intergranular Attack, and Missing Grains. Vilella's Etch

The inside surface of the sectioned coil was grey in color at the hot end with a light brown to orange color at the outlet end. Metallurgical evaluation indicated the failure to be transgranular attack with small transgranular and intergranular cracks leading from the main attack, see Figure 17. The inlet of the coil, which had been exposed to 1050 F steam for at least 12,000 hours, was found to be completely sensitized and subjected to intergranular attack as shown in Figure 18. The intergranular attack was found on the straight portion of the coil. The presence of significant stress in this area probably would have resulted in a more directionally oriented attack than seen in Figure 18.

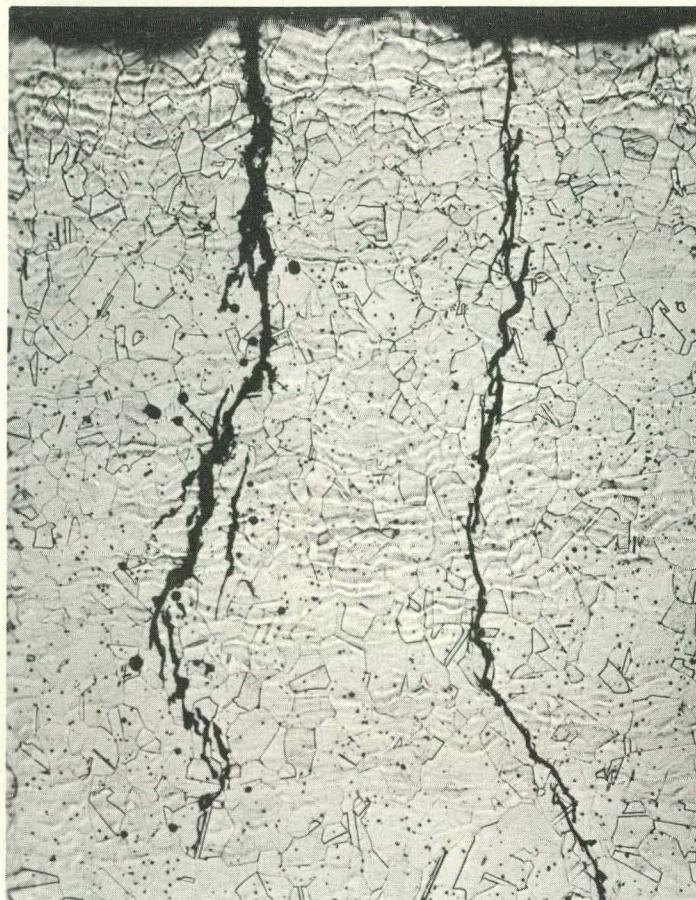
Figure 19. Section Through Hot-Leg of the CL-4 Desuperheater Coil Showing Transgranular Cracks, 60% Nitric Acid Electrolytic Etch 250X

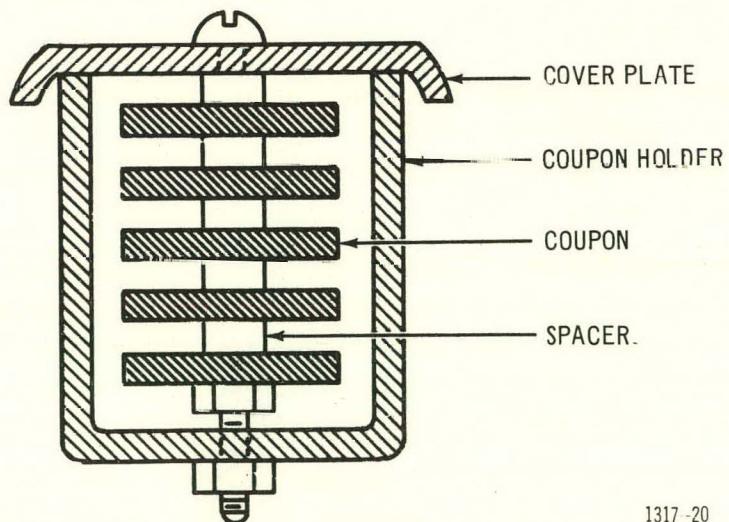
Figure 20. Schematic of Loaded Coupon Holder

A cover plate utilized with a superheat coupon holder in CL-4 was found to be cracked. The holder had been in the superheat coupon section during the NaCl-cycle runs for a total of 1728 hours of which 466 hours were at 1050 F. A cross section of a mounted cover plate is shown in Figure 20. When the coupon holder is in place in the superheat

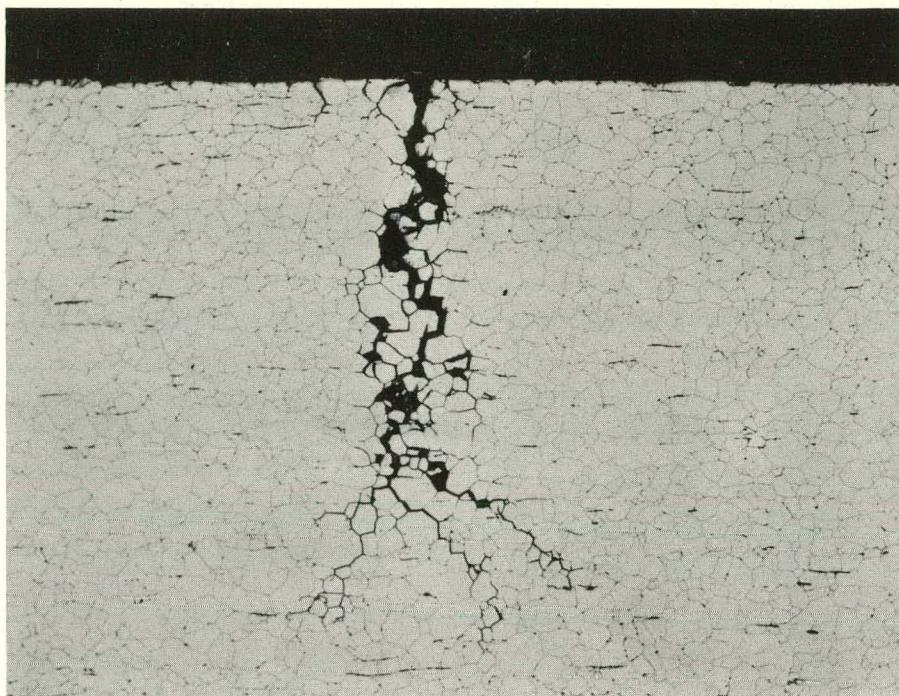
Figure 21. Section Through Cover Plate Exposed at 1050 F
Showing Sensitized Structure With Intergranular
Crack. 10% Oxalic Acid - Electrolytic Etch

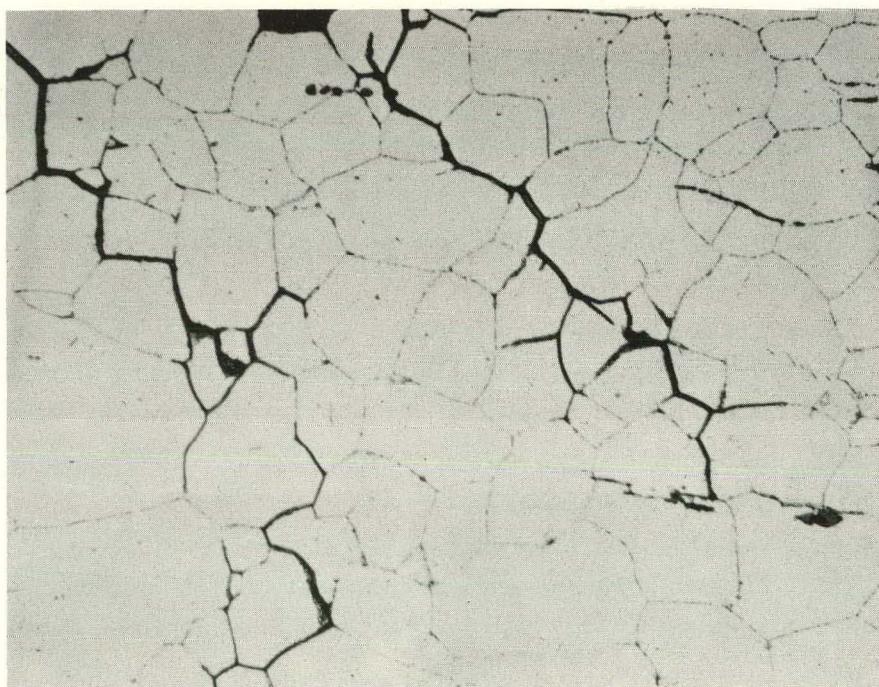
Figure 22. Enlarged Section of Cover Plate Shown in Figure 21.
10% Oxalic Acid - Electrolytic Etch

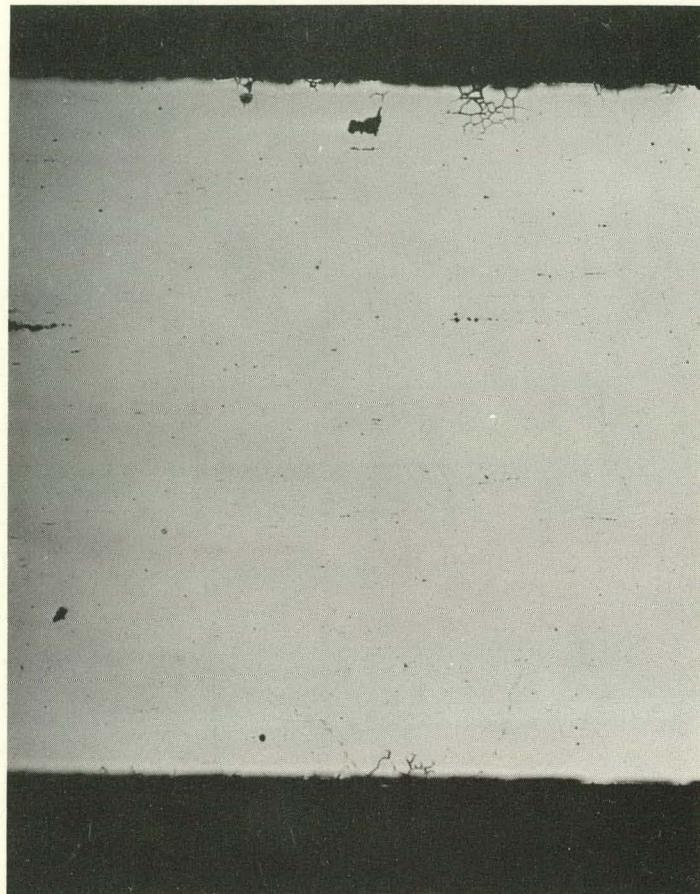
Figure 23. Intergranular Attack of Cover Plate Shown at Both the Tensile and Compressive Edges
Unetched '75X

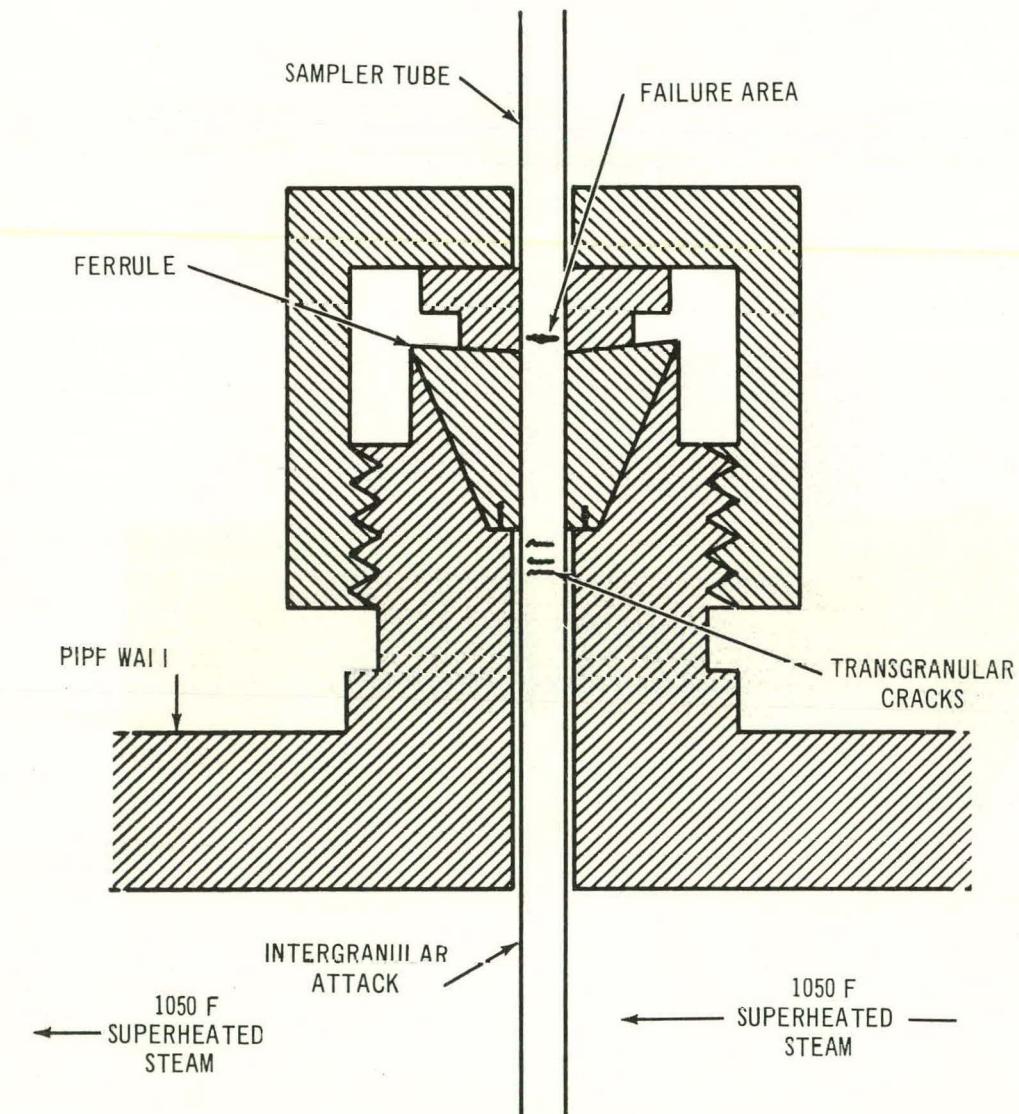
Figure 24. Sampler Location Schematic Illustrating the Failure Areas

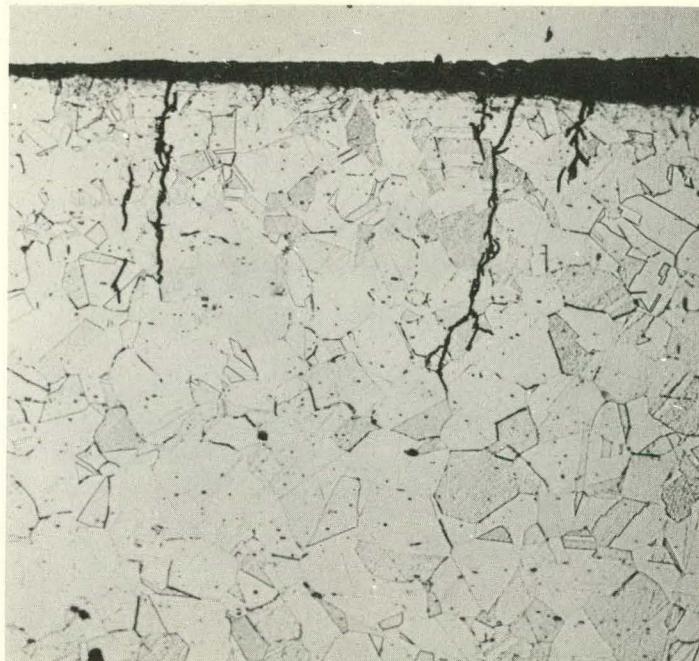
Figure 25. Section Through Superheat Sampler Adjacent to Ferrule Showing Transgranular Cracking 10% Oxalic Acid Electrolytic Etch 250X

Metallographic examination revealed the failure to be transgranular with other transgranular cracks in the region of the ferrule and in the ferrule itself. Figure 25 shows a region of transgranular cracks in the sampler section adjacent to the ferrule. Further examination revealed that the section of the sampler tube that was in the 1050 F steam path was completely sensitized and intergranularly attacked as shown in Figure 26.

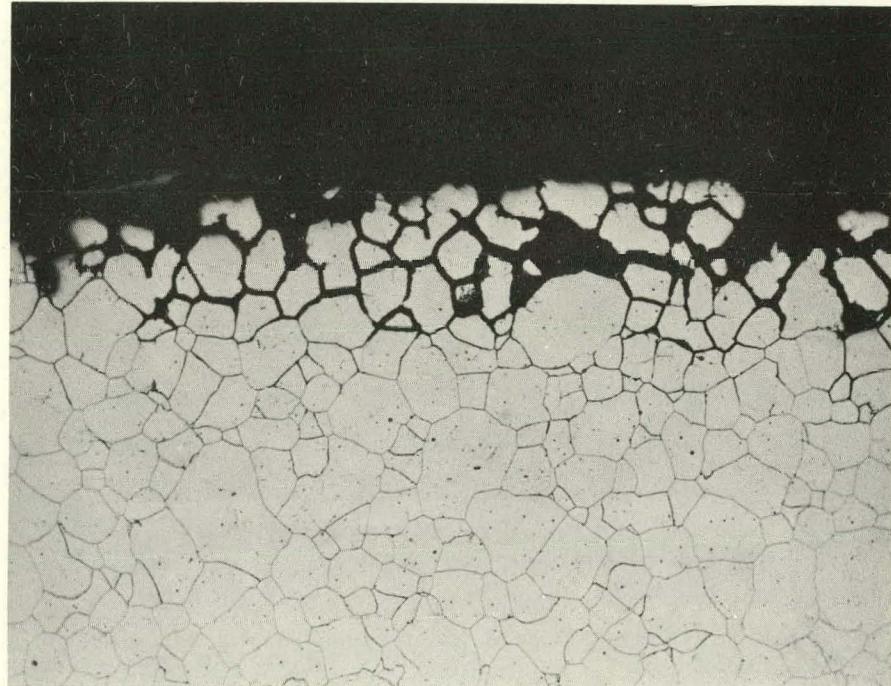
Figure 26. Section Through Superheat Sampler Tube Protruding in 1050 F Steam Path, Showing Intergranular Attack, 10% Oxalic Acid Electrolytic Etch 250X

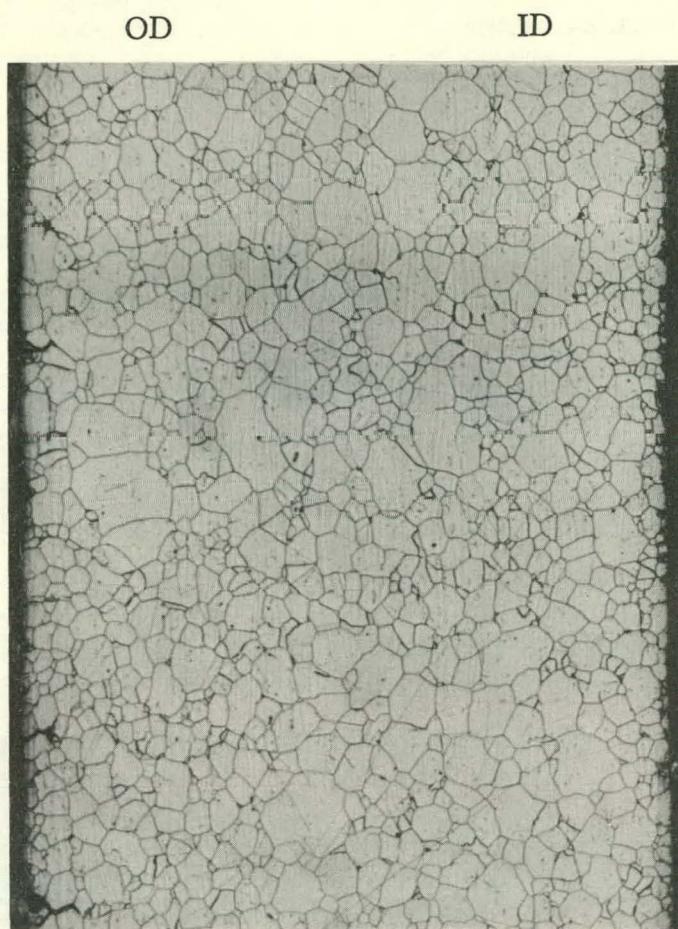
Figure A-1

Intercrysalline Cracks at OD of Tubing

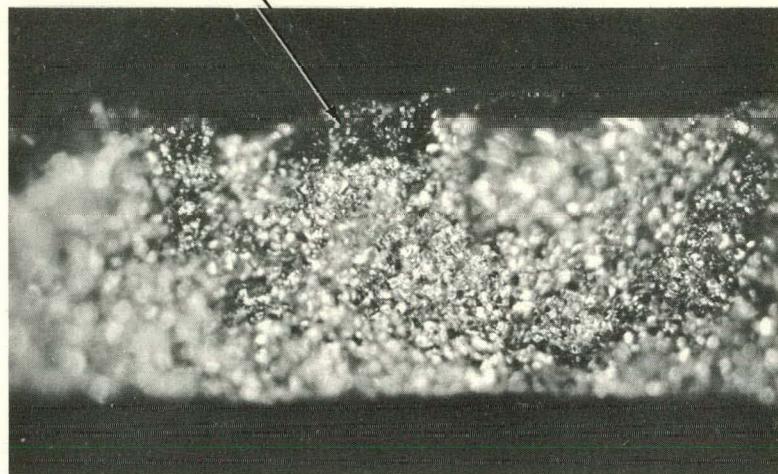
Figure A-4

Low Temperature Impact Fracture Surface

Since the tubing was intentionally sensitized, it was no surprise that the low temperature fracture was intergranular and brittle (Figure A-4). The electron micrographs, Figures A-5 and A-6, show clearly the intergranular nature of the low temperature impact fracture, especially in three dimensional viewing of stereo-pairs. The grain boundaries are covered with uniformly shaped chromium carbide precipitates which have either been extracted (black

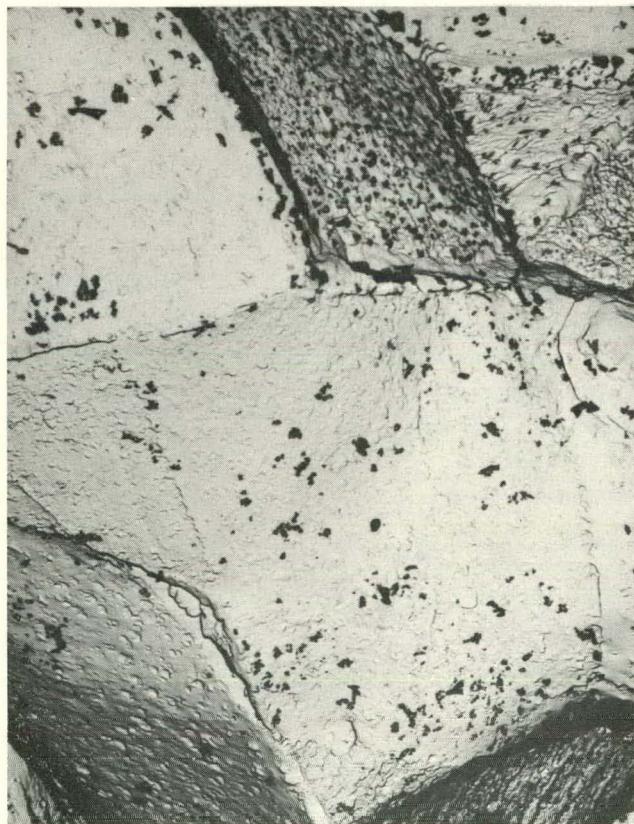
Figure A-5

Electron Micrographs of Extraction Replica
of Low Temperature Impact Fracture. Dark
Carbide Precipitates on Grain Boundaries.
