GEAP-4310
JULY, 1963

GENERAL AND LOCALIZED CORROSION STUDIES OF TYPE 300 SERIES AUSTENITIC STAINLESS STEELS IN SIMULATED SUPERHEAT REACTOR ENVIRONMENT

ATOMIC POWER EQUIPMENT DEPARTMENT

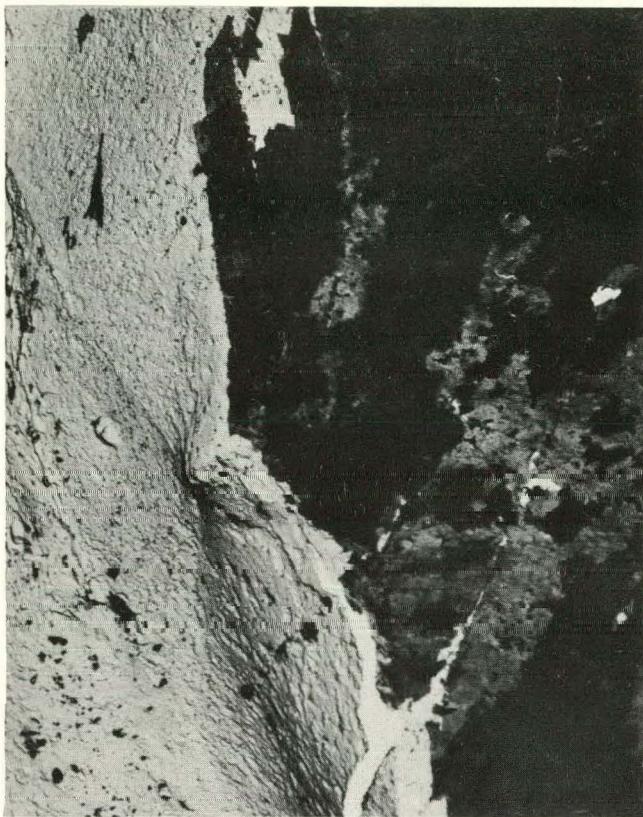
Figure A-7

Fracture Extraction Replica
With Corrosion Product On
Dark Spot Of Fracture Surface

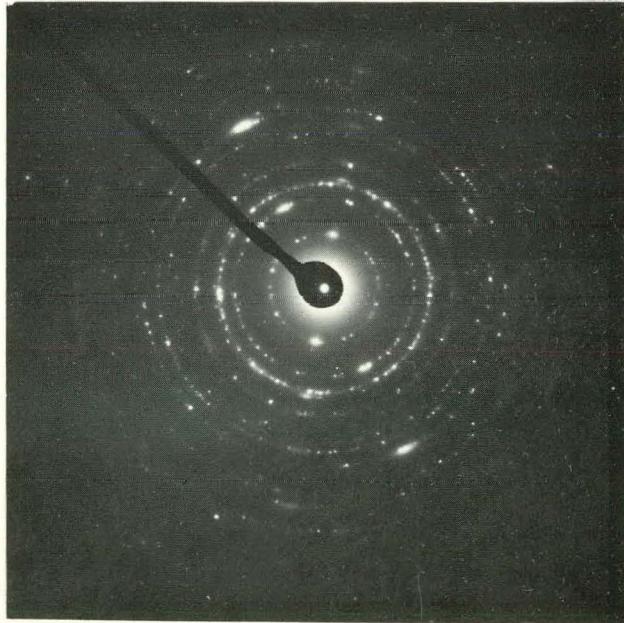
Figure A-9

Electron diffraction patterns of the corrosion product revealed a fcc structure with a lattice constant of approximately 8.4 Å. A number of Fe, Cr, Ni, Mn or similar spinels in varying proportions could account for this pattern.

Electron Diffraction Pattern
Of Area Shown In Figure A-8
