**FACTORS CONTROLLING CHLORIDE STRESS CORROSION
OF TYPE 304 STAINLESS STEEL***

S. P. Rideout - Savannah River Laboratory

E. I. du Pont de Nemours and Co.
Aiken, South Carolina

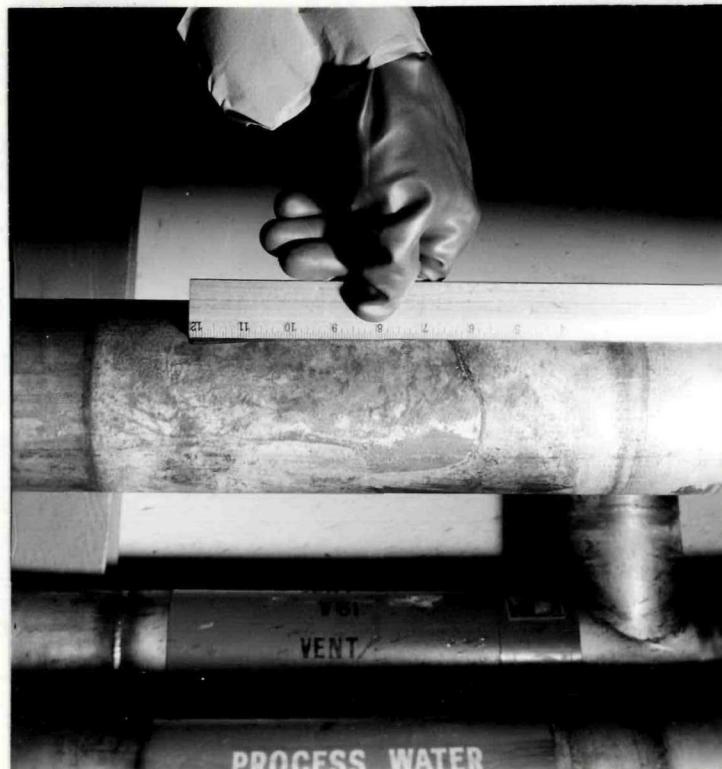
FIGURE 1. STRESS CORROSION UNDER LABELS.
Atmospheric moisture concentrates chlorides
under labels. Rusty corrosion products
indicate beginning of attack. Careful
inspection is required to detect cracks.

Cracking under polyvinyl chloride plastic identification bands and painted labels on process piping occurred where operating temperatures were above 70°C. At locations where pipes pass through concrete radiation shielding, (Figure 2) chlorides leached from neoprene coatings used to seal the opening caused cracking at temperatures as low as 50°C. The use of plastic bands and painted labels has been discontinued, and neoprene seals have been replaced with chloride-free polyurethane.

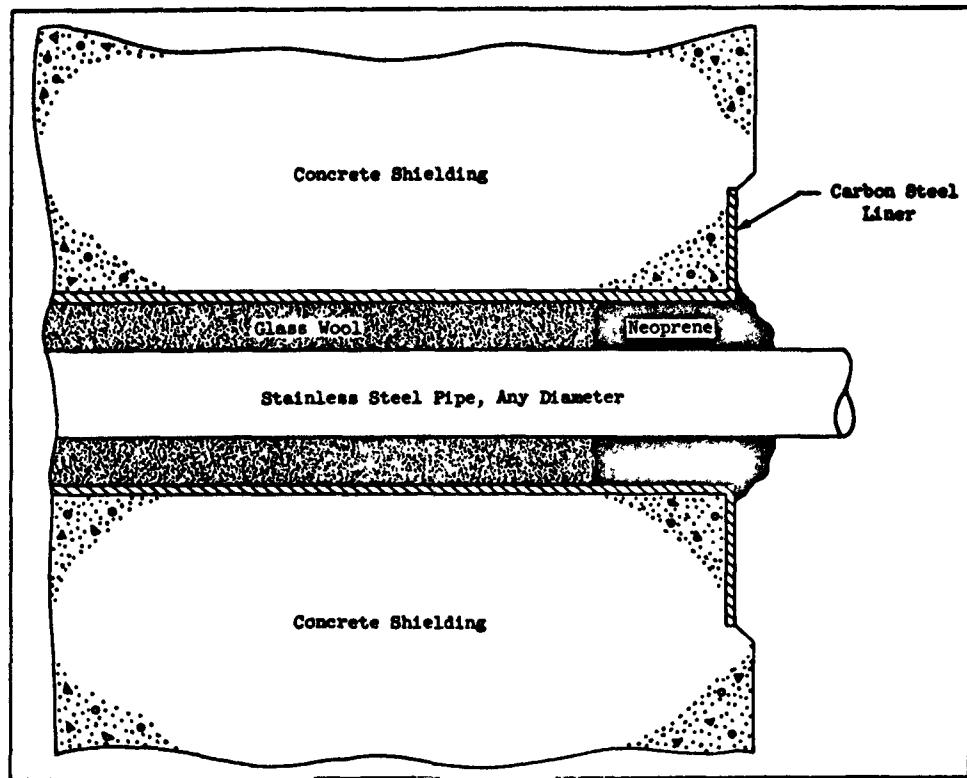
FIGURE 2. PIPE RUN THROUGH CONCRETE SHIELDING.
Chlorides leached from neoprene seal caused
severe stress corrosion cracking of pipe at 70°C.

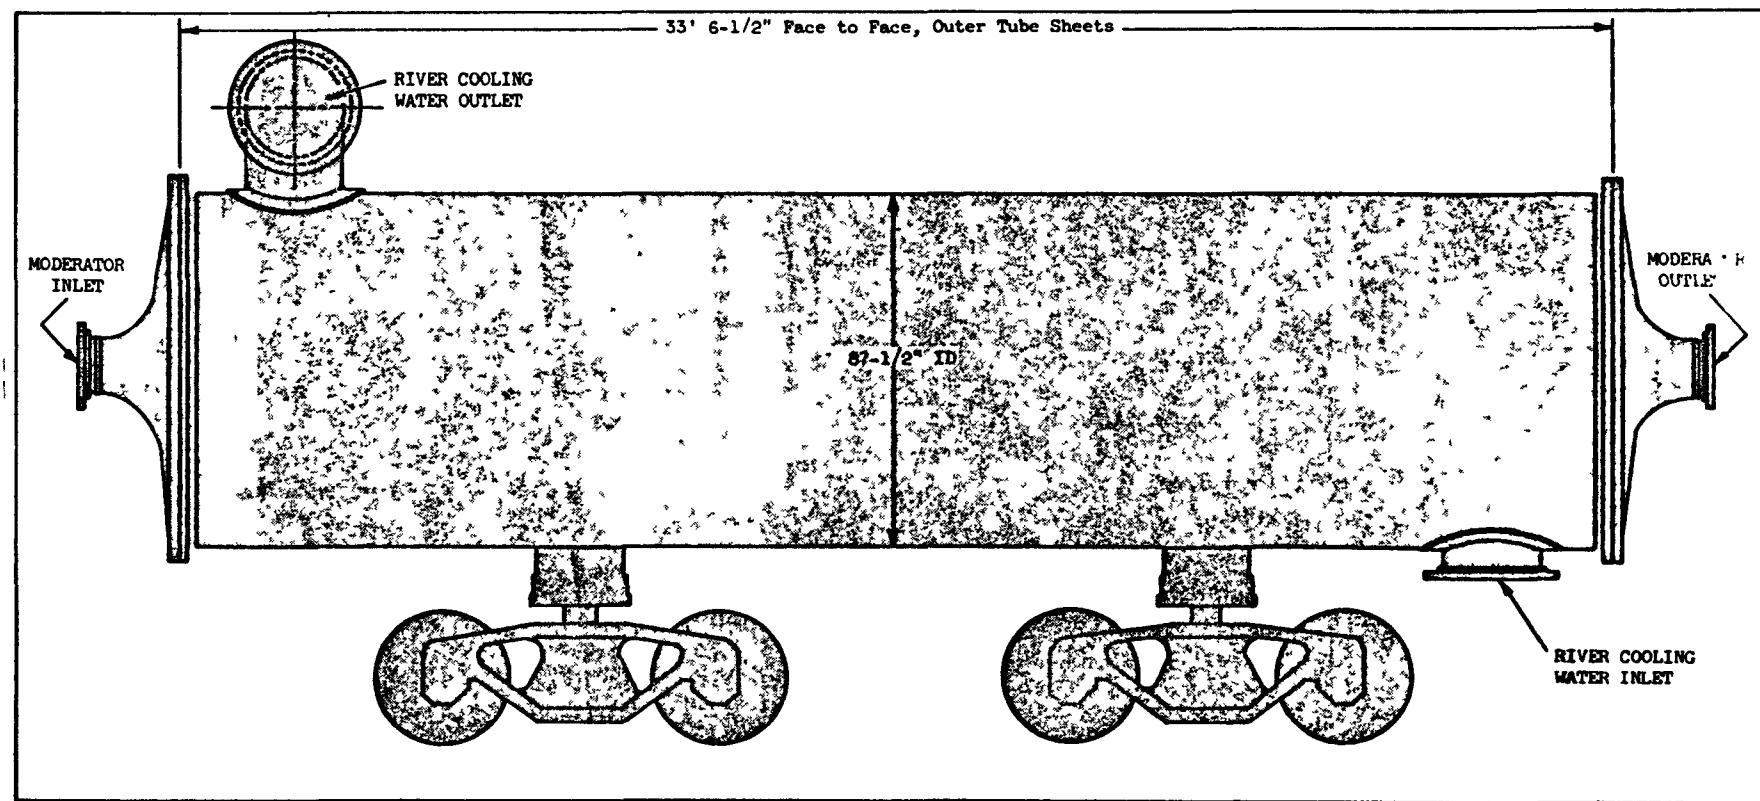
FIGURE 4. GENERAL ARRANGEMENT OF HEAT EXCHANGER

Savannah River Plant reactors are closed systems through which high-purity heavy water is circulated as moderator and coolant. Heat exchangers in the systems (illustrated in Figure 4) are of the shell-and-tube design, fabricated from types 304 and 304L stainless steel. They are 33' 6-1/2" long by 7' 4-1/2" in diameter. They operate with heavy water on the tube side and Savannah River cooling water on the shell side flowing countercurrent. Each heat exchanger contains 8957 1/2-inch OD x 18 BWG type 304 stainless steel tubes and is provided with a double tube sheet at both ends. The shell is fabricated from type 304L stainless steel and is welded to the 304L stainless steel inner tube sheets. Tubes are rolled into the four tube sheets, and the tube ends are welded to the outer tube sheets. The spaces between the inner and outer tube sheets are enclosed by carbon steel rings which slide into position against the outer tube sheet and are sealed by elastomer gaskets. The heat exchanger heads are held in position and reinforced by staybolts (type 303 stainless steel) screwed into the outer tube sheet. Details are shown in Figure 5. The double tube sheet design provides a "leak collection" space to prevent mixing of heavy and light water should a leak develop between the tubes and tube sheets. Leakage of heavy water into this space was detected in several heat exchangers after about 4-1/2 years operation.

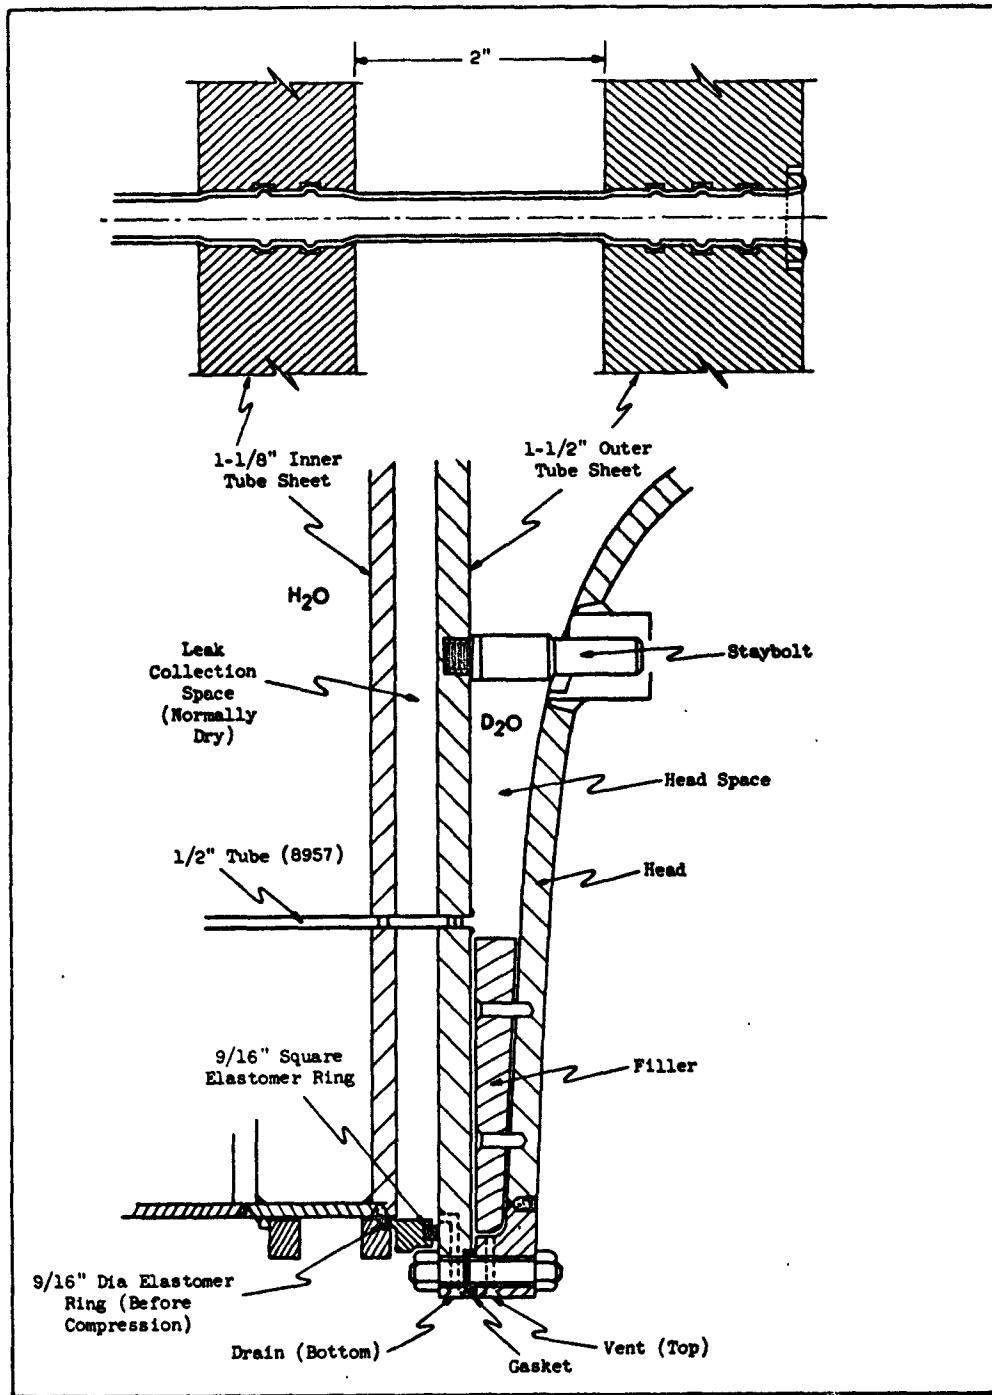
FIGURE 5. DETAILS OF LEAK COLLECTION SPACE AND DOUBLE TUBE SHEET

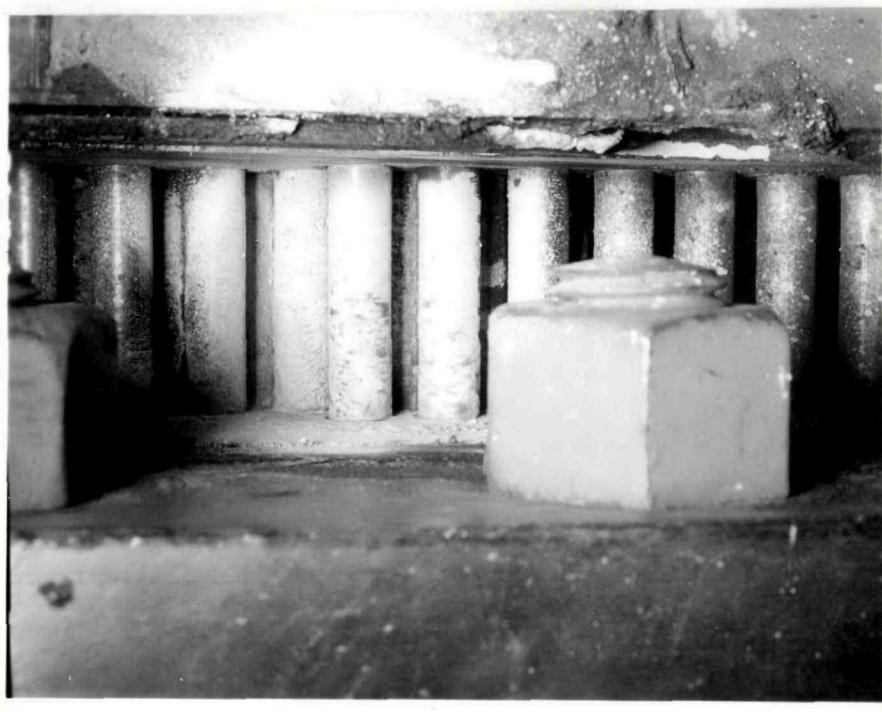
Inspections revealed that stress corrosion cracking had occurred in many tubes in the leak collection spaces at the inlet ends of the heat exchangers. The cracks originated on the air side

of the tubes. Some were visible to the eye while others were revealed by dye-penetrant inspection, as shown in Figure 6. The tube surfaces were covered by rusty corrosion products, some of which may have fallen off of the carbon steel rings. These corrosion products contained 300 ppm chloride ion by analysis. The chloride could have come either from the elastomer seal gasket (which contained 8% chloride) or from leakage of river water (2-9 ppm chloride) through the rolled joint between the tube and inner tube sheet. Severely cracked tubes were replaced, but less seriously damaged tubes were left in service to avoid costly shutdowns.

FIGURE 6. CRACKED TUBES IN LEAK COLLECTION SPACE
REVEALED BY DYE PENETRANT TEST

In order to minimize further stress corrosion damage of the tubes, the space between the double tube sheets was made part of a closed, recirculating liquid inhibitor system. The system was designed to protect tubes in leak collection spaces at both ends of all heat exchangers.

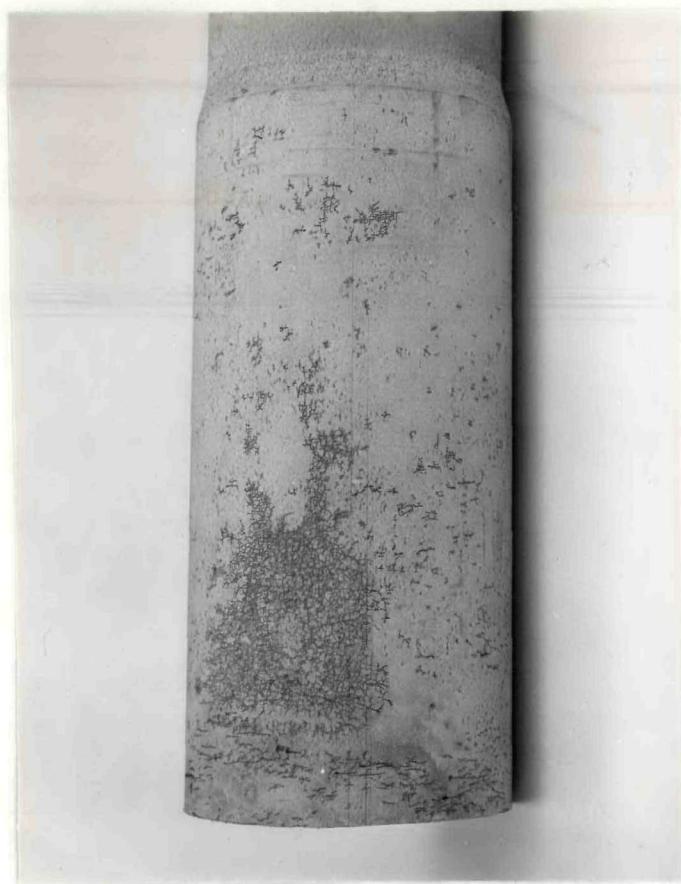
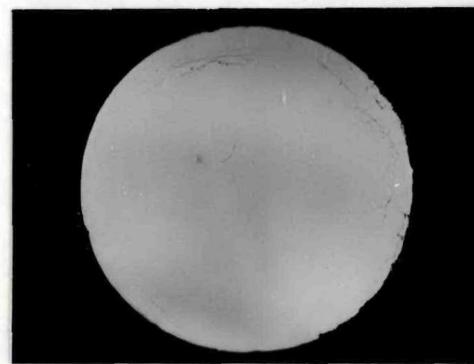
Cracking has occurred at other locations in these same heat exchangers. When the heads were removed to replace failed tubes, rust-type corrosion products and cracks were observed on many stay-bolts and O-ring seal surfaces in the head bosses. A cracked stay-bolt is shown in Figure 7. Chlorides were leached from the rubber O-rings either by condensate or water leakage. All cracked staybolts were replaced, and O-rings were eliminated by changing to a welded staybolt closure.

FIGURE 7. STRESS CORROSION CRACKING OF
HEAT EXCHANGER HEAD STAYBOLT. Cracking
was caused by chlorides leached from
O-rings.

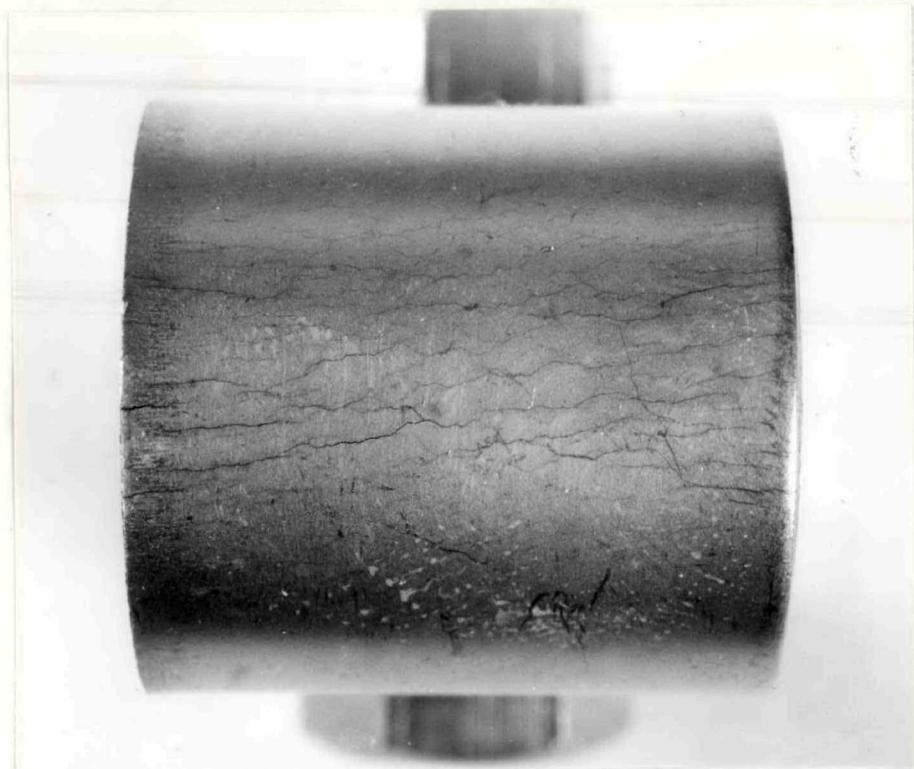
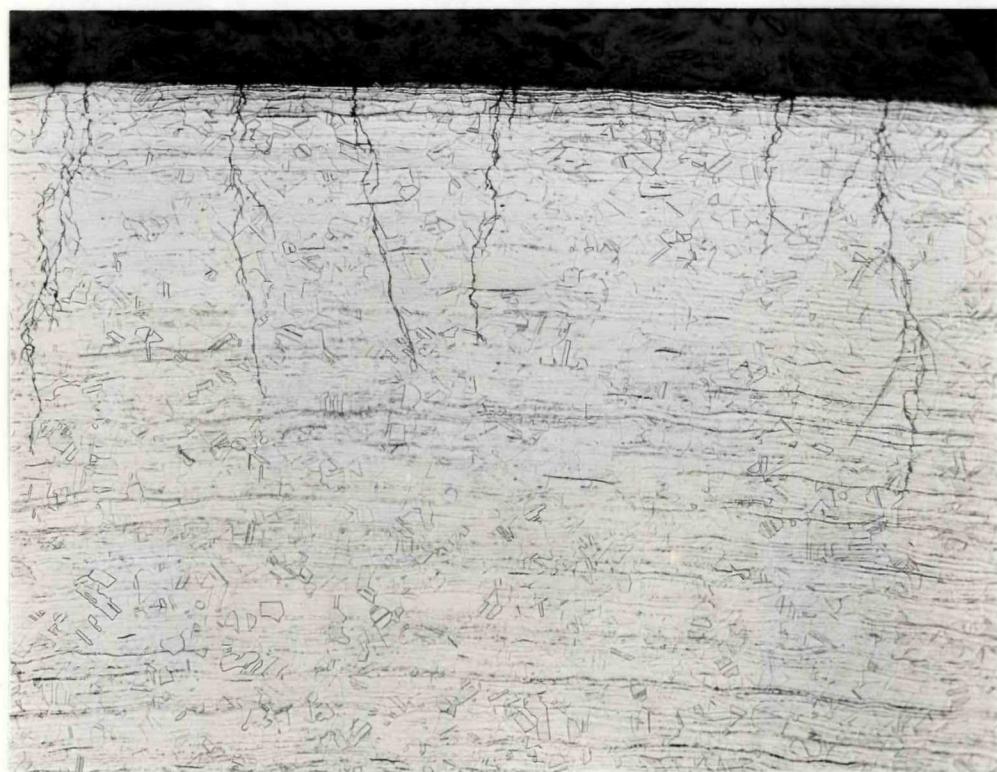
The samples were cold formed from 3-1/2- x 3/4-inch strips, which had been sheared from 16-gage mill-annealed sheet. They were not heat treated or surface ground. All samples were thoroughly washed and degreased prior to testing. Type 304 stainless steel was used in all cases except for one series of tests noted later in which type 304L stainless steel was used. The heat analyses of these steels are given in Table I. Type 304 stainless steel nuts and bolts (not insulated) were used to stress the samples. Samples used in tests to determine if existing cracks propagate were first exposed to boiling 42% MgCl₂ for 1 hour and then washed thoroughly in running water prior to exposure in the inhibitors. A sample typical of those used in crack-propagation tests is shown in Figure 8.

FIGURE 8. STRESS CORROSION CRACKING OF TYPE 304 STAINLESS STEEL SAMPLE AFTER 1 HOUR IN BOILING 42% $MgCl_2$. Typical of samples used to study propagation of existing cracks.

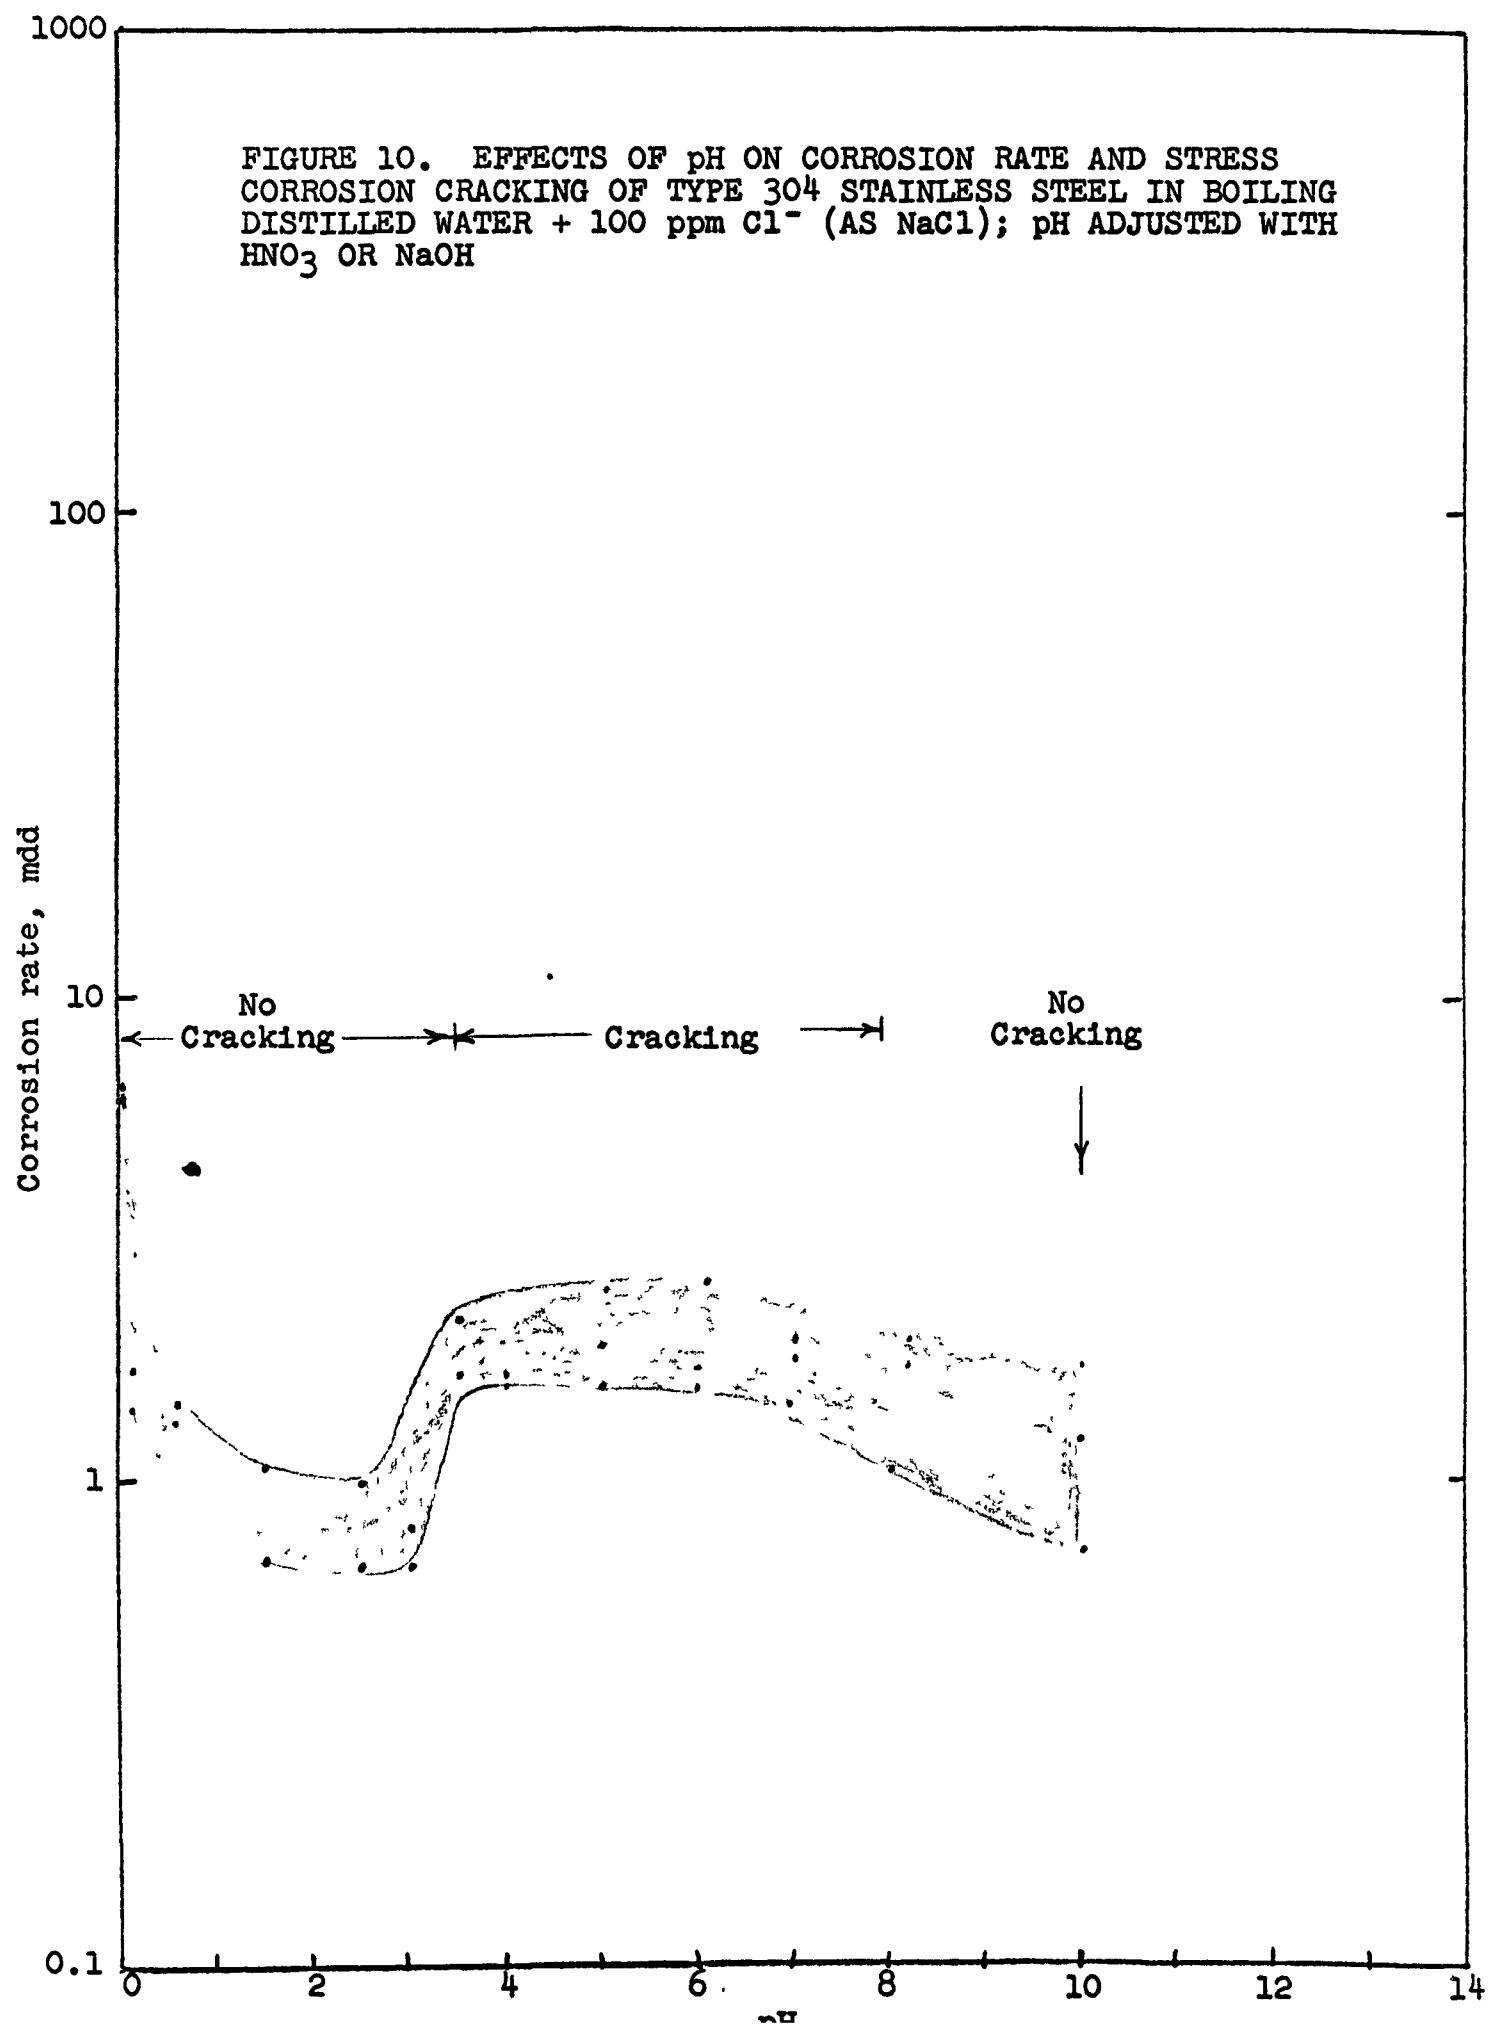
These tests demonstrated that pH exerts a very strong influence on stress corrosion cracking over a wide range of chloride ion concentrations. In solutions containing 100 ppm Cl⁻ (Figure 10), cracking occurred over the range of pH 3.5 - 8.0. Cracks were generally very small, originated at sheared edges, and propagated very little. No cracking occurred at pH 10, or in any solutions in the acid range below pH 3.0. Similar effects occurred in solutions containing 33,000 ppm Cl⁻ (Figure 11), except that cracking was more severe and occurred over the range 4 - 10. Increasing the chloride ion concentration to 100,000 ppm (10%) still did not cause cracking in solutions more acid than about 3.5 - 3.0 or less, as shown in Figure 13.

FIGURE 11. EFFECTS OF pH ON CORROSION RATE AND STRESS CORROSION CRACKING OF TYPE 304 STAINLESS STEEL IN BOILING DISTILLED WATER + 33,000 ppm Cl⁻ (AS NaCl); pH ADJUSTED WITH HCl OR NaOH
