FABRICATION AND QUALITY CONTROL TESTING OF SNAP-15C CAPSULES

MLM-1257
M-3679 (41st Ed.)
C-92a Isotopic
SNAP Program

Date: July 1, 1965

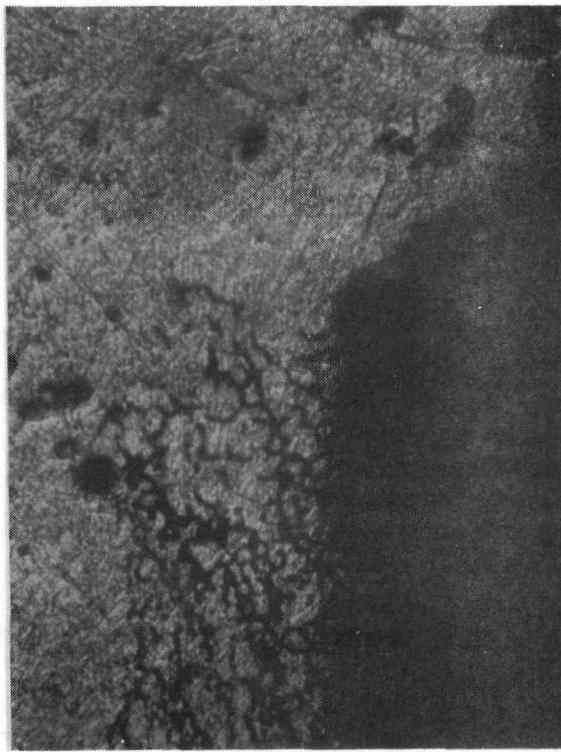
Figure 14. Inner Side Walls of Tantalum-10% Tungsten Capsule after Exposure to Molten Plutonium at 1800°F for 2 Hours

The right and left inner side walls of the capsule were also examined to determine if corrosion had occurred. These areas are shown in Figure 14. The right-hand view is for the wall about half-way up the side

of the capsule, whereas the left view is for the wall very close to the TIG-welded top. The plutonium, after being remelted in the capsule, occupies about one-half of the capsule volume. The surface of the plutonium would then be in the vicinity of the apparent corrosion indicated in the right-hand view. The area shown in the left-hand view is above the plutonium surface. The change in granular structure may be the result of plutonium which had been deposited in this area during the fabrication, or which had crept up the wall during the fire test. Figure 15 shows the condition of the underside of the cap and weld at the top of the capsule. This section was not in contact with the molten plutonium. It was exposed only to plutonium vapor at a very low pressure. No attack of the metal is evident.

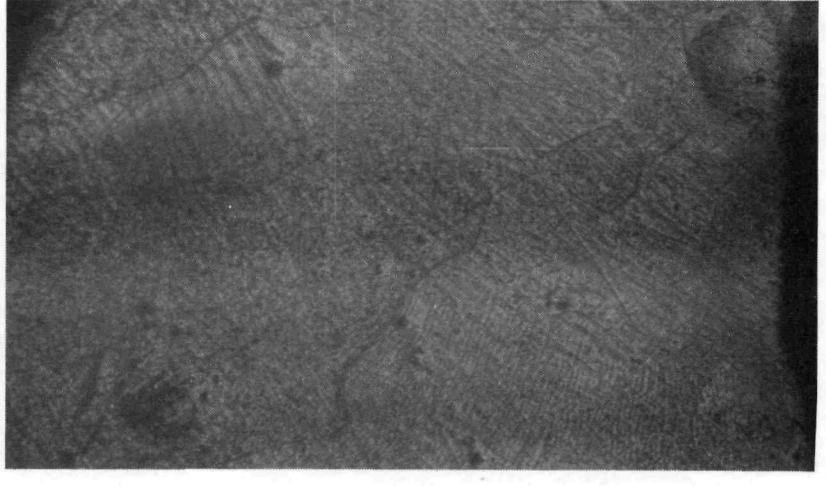
Figure 15. Underside of Cap and Weld of Tantalum-10% Tungsten Capsule after Exposure to Plutonium Vapor at 1800°F for 2 Hours (50X)
