NAA-SR-8304

PHASE I MECHANICAL AND
THERMOCHEMICAL TEST SERIES
SNAP AEROSPACE SAFETY PROGRAM

ATOMICS INTERNATIONAL
A DIVISION OF NORTH AMERICAN AVIATION, INC.

By
S. L. PFAHLER

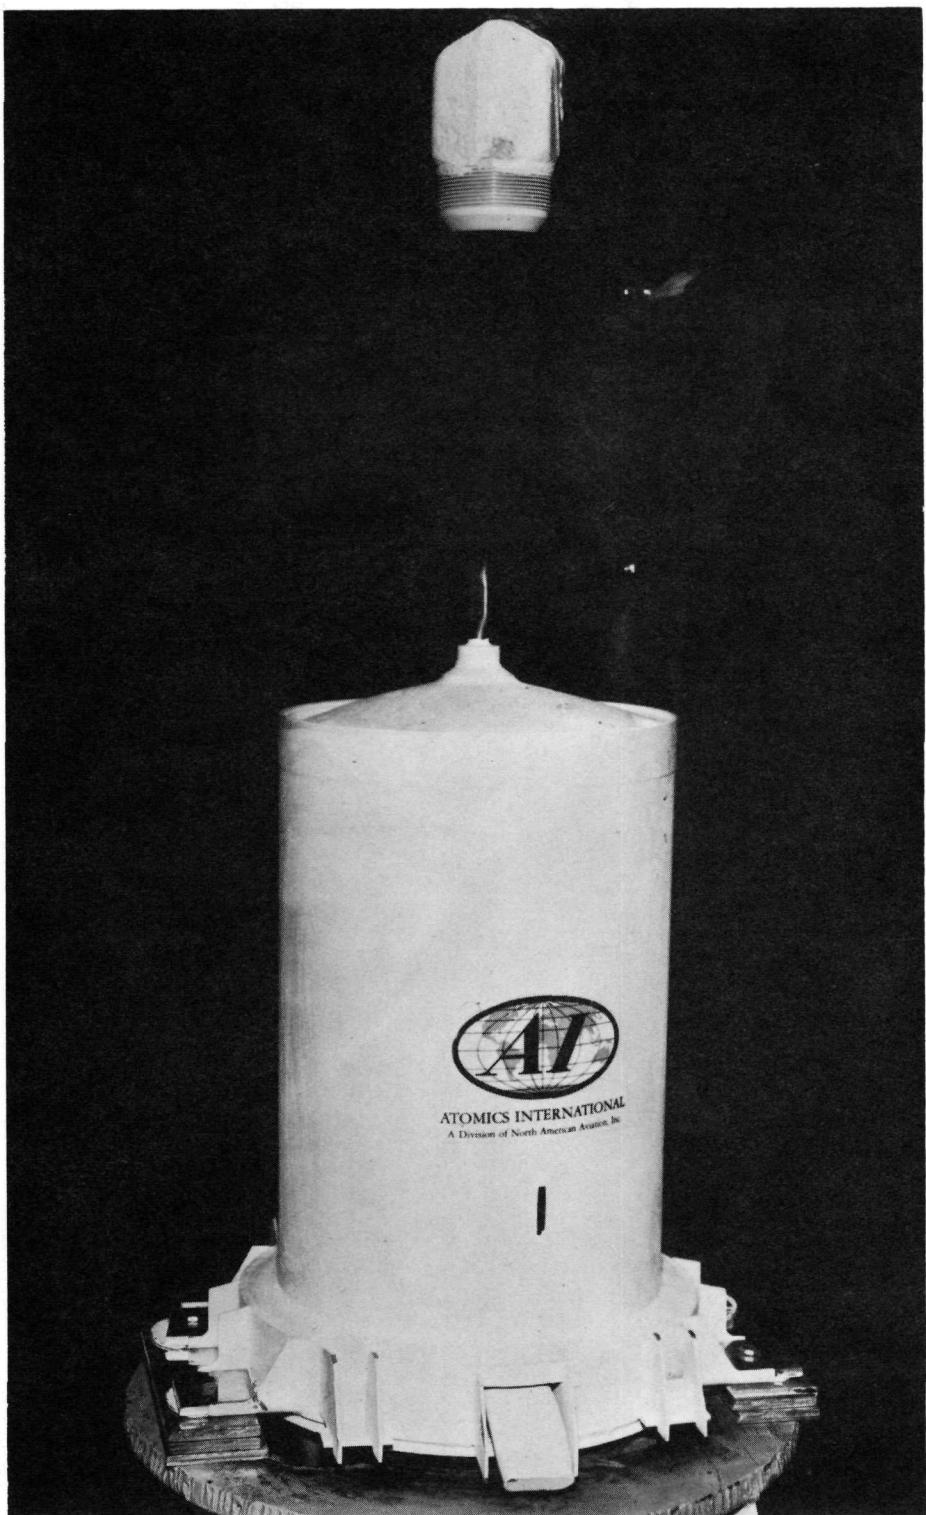
7611-5511

The test article consisted of the reactor vessel and its internals (see Figure 1). The nose cone and reflector assembly were not a part of the test article because it was reasoned that the nose cone would be damaged or destroyed during an abort condition, and the reflector assembly would have separated. Furthermore, thermal shock to the reactor vessel would be minimized with the nose cone in position.

Figure 1. Test Article Before LOX Spray Test

There was no external or internal physical damage to the reactor as a result of the test. A review of the oscillographic data showed that the head temperature, as indicated by a thermocouple attached to the head, varied irregularly during the first 18 sec of the test, and then leveled off at a temperature of 54.7°F. There was no response from the other instrumentation.

not damaging. It is concluded that the reactor and its internals can withstand thermal shocks resulting from a LOX spray such as might be released from an Atlas fuel tank and that no nuclear hazard exists unless the reactor is subsequently immersed in water.

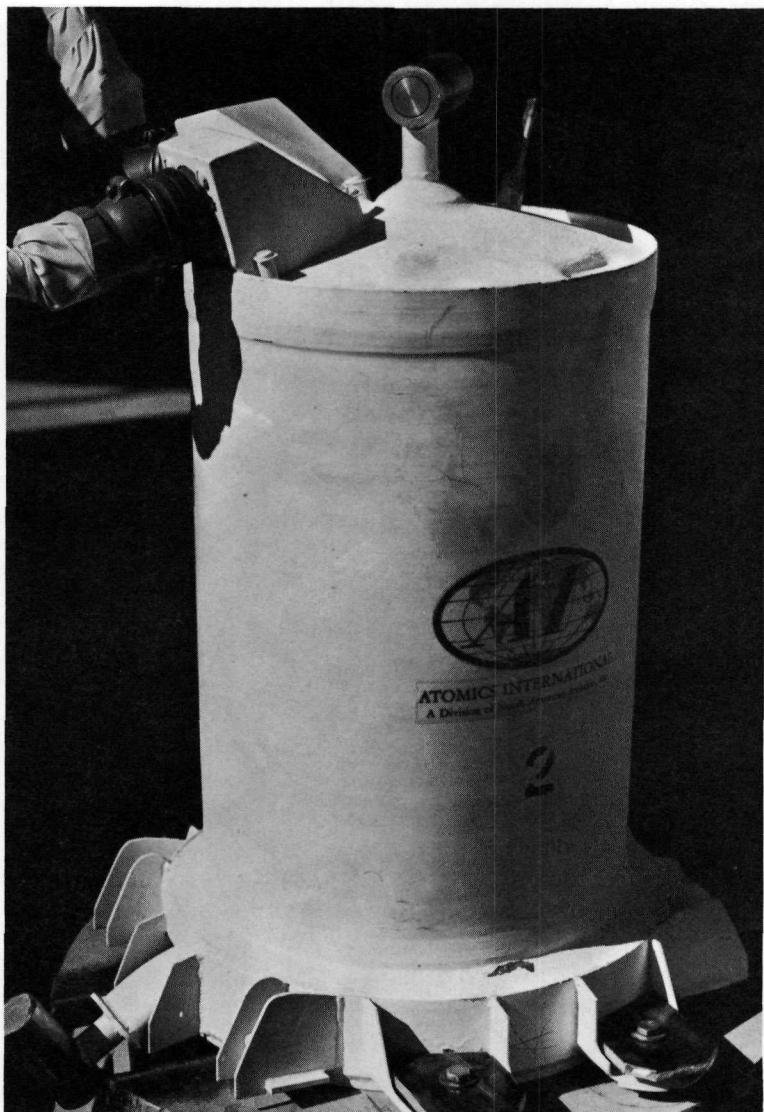
The test was performed on May 17, 1962. The test article, consisting of the reactor vessel and its internals (Figure 2), was mounted in an upright position. Two seconds before the LOX spray was initiated, small explosive devices were fired to rupture the two inlet nozzles and the outlet nozzle of the reactor. The LOX spray was continued for 40 sec.

7611-5512
Figure 2. Test Article Before LOX-NaK Interaction Test

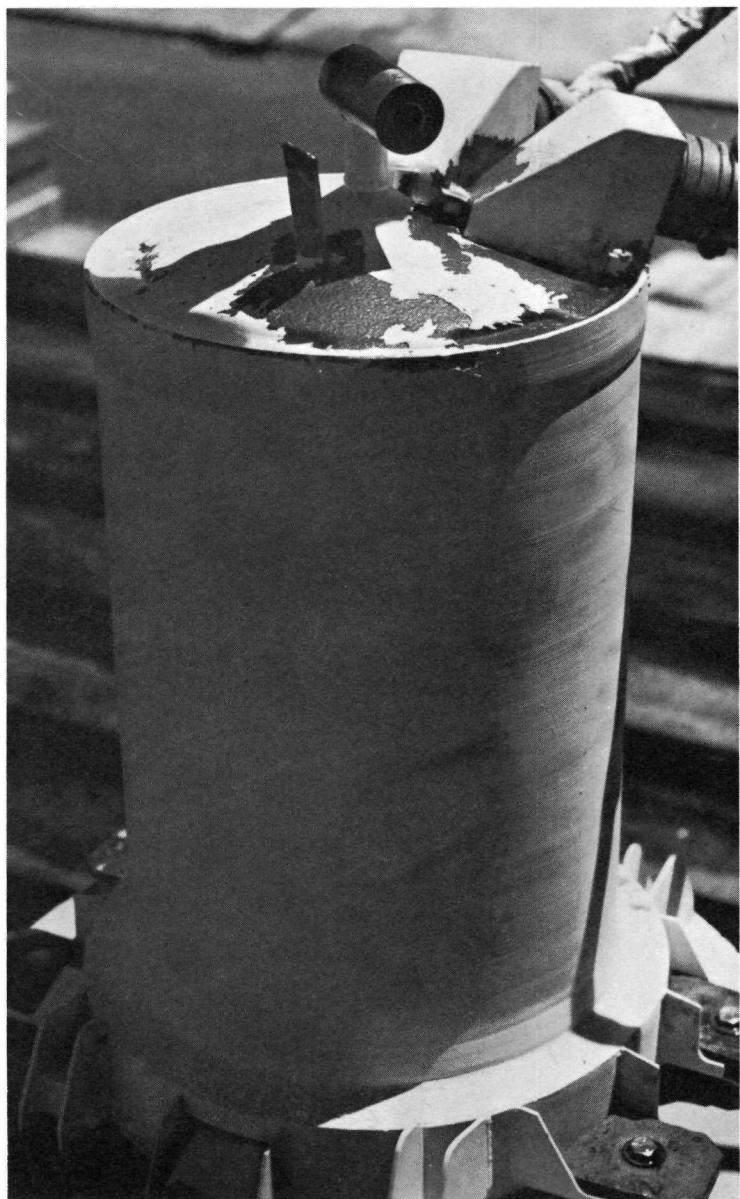
7611-5503

There was no explosion generated by the LOX-NaK interaction. The NaK was solidified at the nozzles and did not thaw until 8 min after the LOX spray was stopped. As shown in Figure 3, there was no external or internal damage to the reactor assembly. The internally mounted instrumentation indicated no large temperature changes.

Figure 3. Test Article After LOX-NaK
Interaction Test

It is concluded, from the test, that the reactor will not be damaged if the core vessel with ruptured NaK lines is subjected to LOX spray. No nuclear hazard exists unless the reactor is subsequently immersed in water.

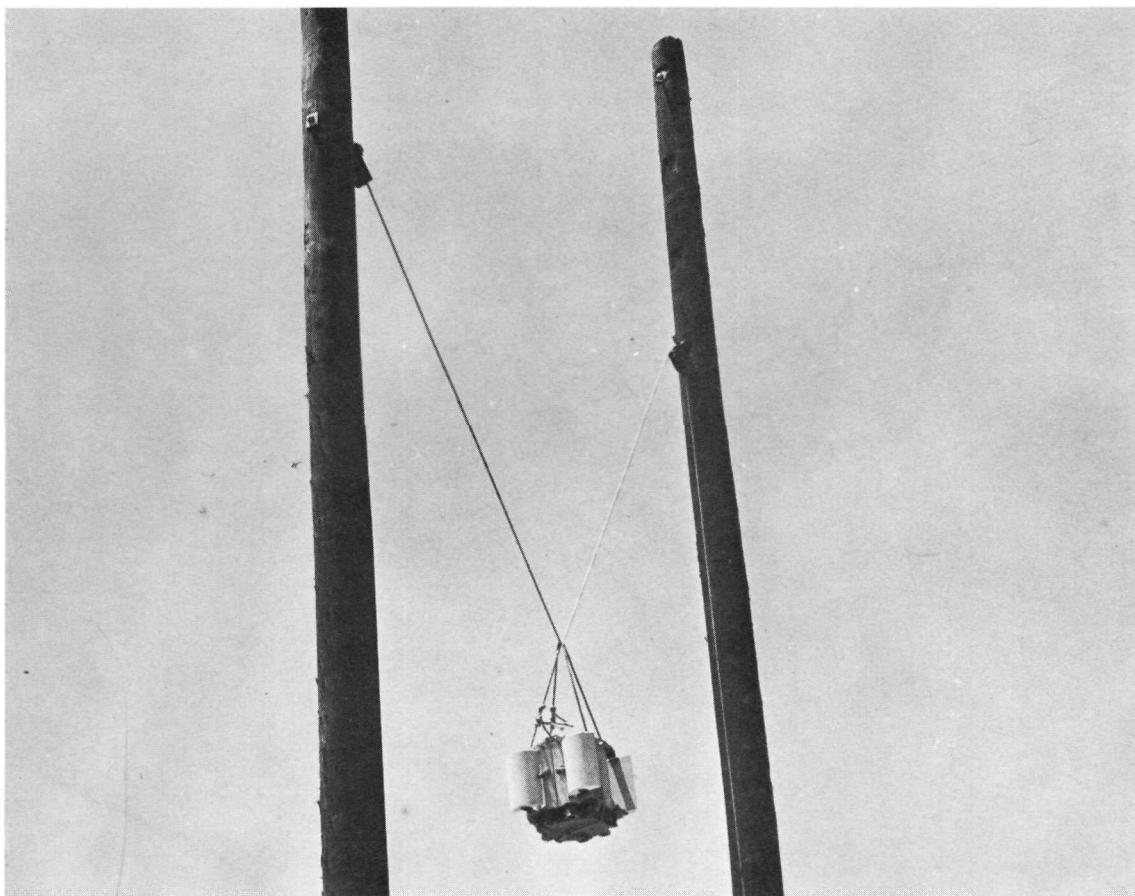
7611-5514

The test was performed on May 23, 1962. It consisted of exposing the test article to an overpressure in excess of 400 psi. The reactor assembly, including the reactor vessel with internals and fixed reflector blocks, was suspended on a line between two vertical poles. The explosive, 256 lb of TNT, was positioned 13 ft below the test article on a 3-ft-high table resting on the ground. Instrumentation coverage included a ground-mounted pressure transducer, high-speed color film documentary of prerun through postrun activities, and black and white still photos taken before and after the test (see Figures 4 and 5).

Figure 4. Test Article Before Explosion Test

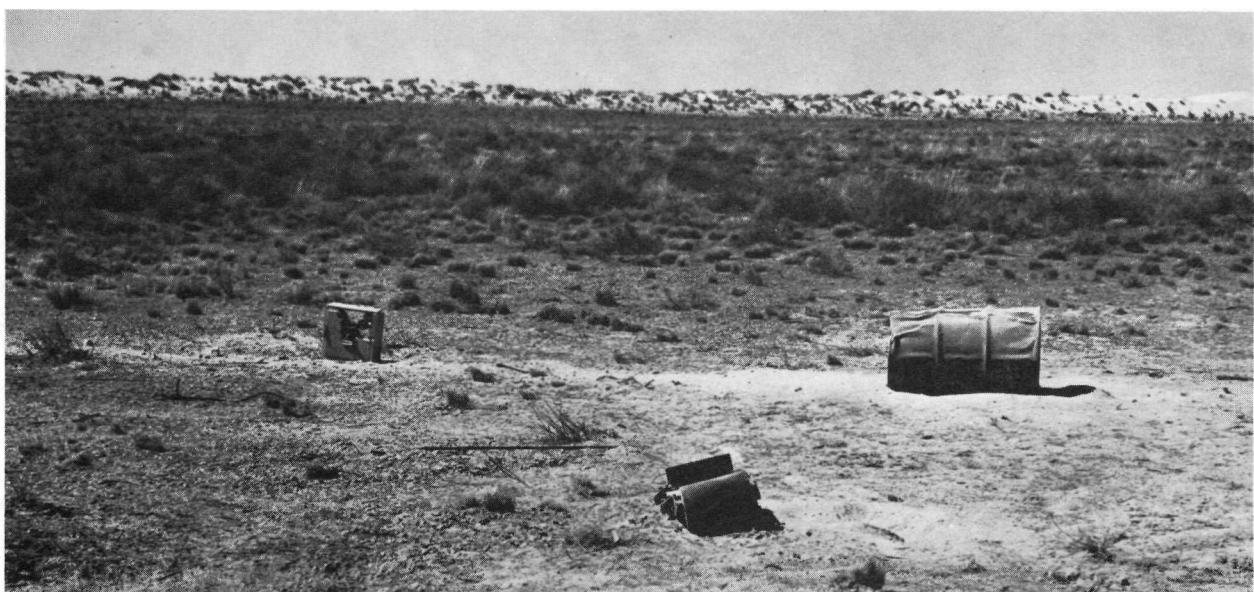
7611-5517

Simultaneously with the detonation of the TNT, the test item suspension system was severed. The force of the explosion ruptured the reflector block retaining tension band. Each of the reflector block halves came to rest 35 ft from their original position; the two halves were 70 ft apart. The reactor vessel was blackened, and its bottom was deformed inwardly by the explosion. Of the four high-speed cameras provided for film coverage, two jammed, and two recorded only the light flash from the explosion and dust. The pressure transducer did not give useful results. A positive-phase pulse duration of 2.8 msec was estimated. The calculated overpressure, at the test article, was 415 psi.

Figure 5. Pieces of Test Article After Explosion Test

Some question remains as to how the conditions during this test would compare to an actual missile abort explosion. Some literature refers to much higher overpressures during rocket explosions. It is reasonable to assume that the damage to the reactor with a higher overpressure would be more severe; consequently, chances of a nuclear excursion would be lessened. The condition of the reactor after the above described test explosion was such that the core would not have become supercritical unless it was immersed in water.

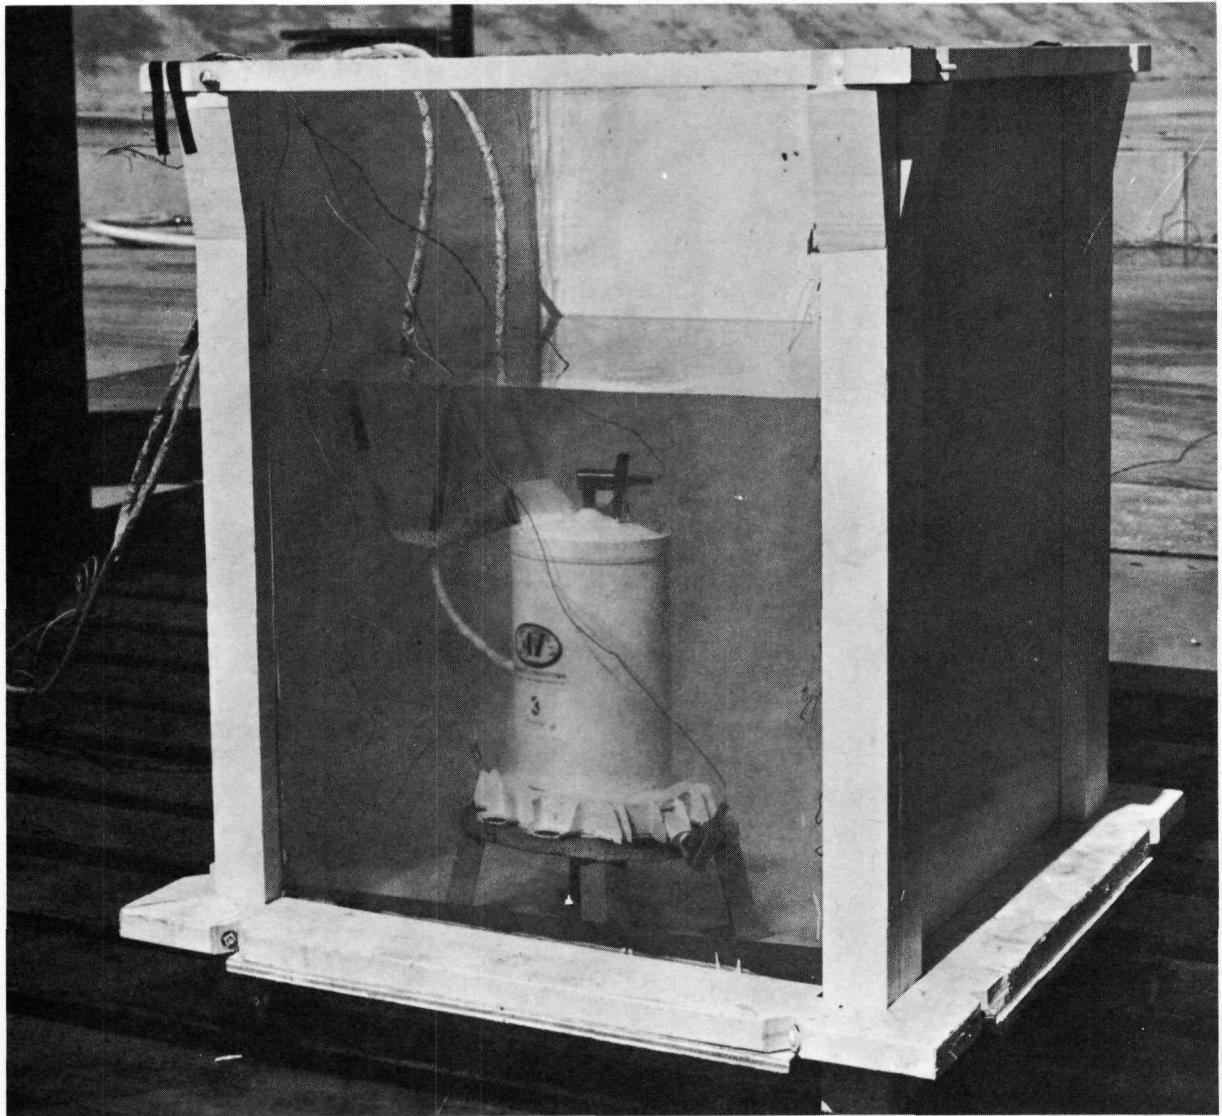
7568-0281

Figure 6. Test Article in Water Tank Before $\text{NaK}-\text{H}_2\text{O}$
Interaction Test

placed in a 36-ft³ tank which had one plexiglas side (see Figure 6). Instrumentation similar to that for the LOX spray and LOX-NaK tests was provided. This test was performed on June 6, 1962.

After the tank was filled with clear water, squib-actuated NaK valves were opened, thereby bringing the NaK into contact with the water. The initial explosion, at one of the valves, burst one side of the water tank. This allowed the water to drain from the tank.

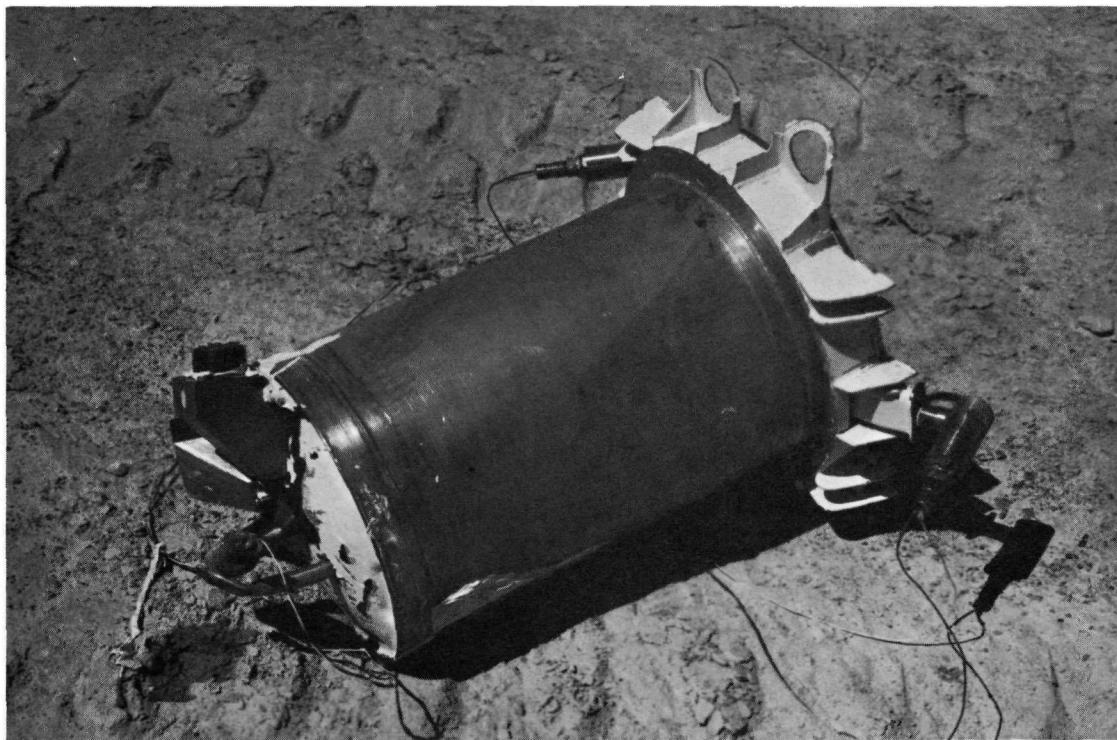
7611-5502

The core vessel was found to be slightly ballooned, with outward convexity of the bottom head. This was caused by pressure buildup in the vessel from the NaK- H_2O reaction. However, because of the water tank failure, the test is considered to have been an undertest. There was no response from the internally mounted instrumentation. Figure 7 shows the test article after the test.

Figure 7. Test Article After NaK- H_2O Interaction Test

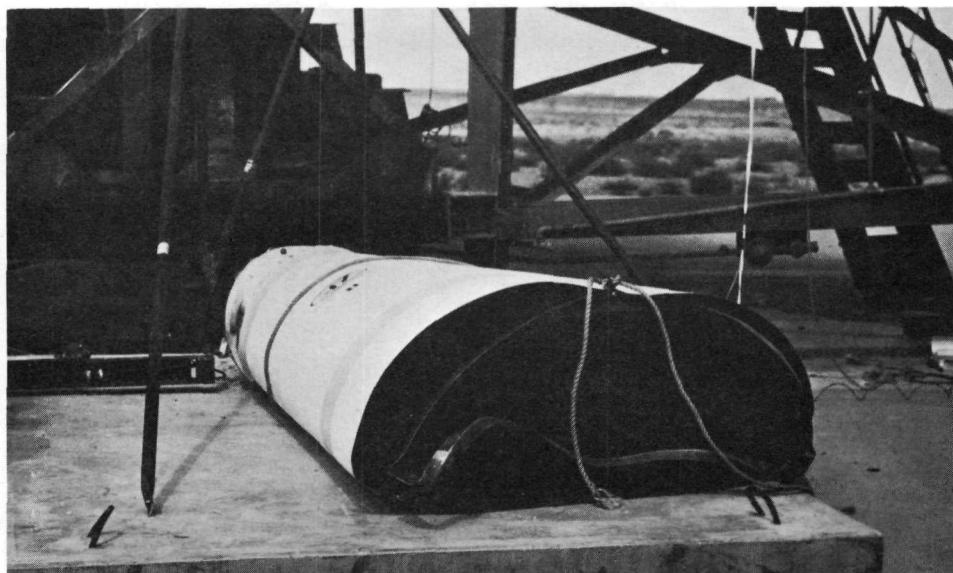
7611-5510

For the side-on drop test, 1-in. pipe guides were placed at the center of gravity and at the end of the APU to ensure proper impact attitude. The model struck the concrete pad at 68.8 ft/sec (see Figure 8). All four reflector drums

Figure 8. Converter After 100-ft, Side-On Drop Test

appeared to be thrown into the air. The core vessel skidded 10 ft from its point of impact. After closer examination, it was found that the main reflector block was in four pieces, and that three of the four reflector drums were severed from their supports. The four ejection springs were on the ground; the core vessel was intact with only a small puncture in its side (see Figure 9). All the support legs failed, and the converter structure was completely flattened up to the shield.

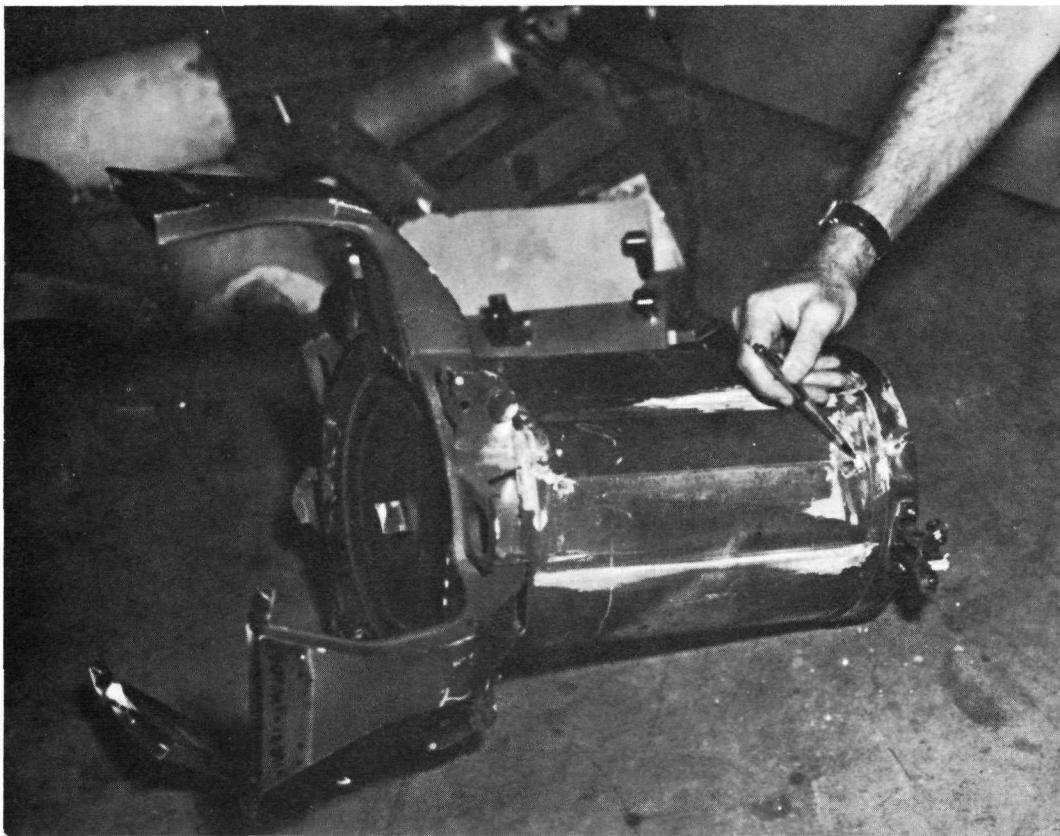
7611-5501

Figure 9. Reactor Vessel After 100-ft, Side-On Drop Test

Analysis of the documentary films taken during this test revealed that one drum rotated in, two drums did not rotate in, and the position of the fourth drum could not be established. It was determined that one drum started to rotate 7 msec after impact. The retaining band failed 22.5 msec after impact, and at 30 msec, the reflector blocks were well separated from the reactor. The angular velocity of the rotating drum was calculated to have been $5.5^\circ/\text{msec}$; a simplified analysis of the possible drum rotation predicted a velocity of $8.1^\circ/\text{msec}$.

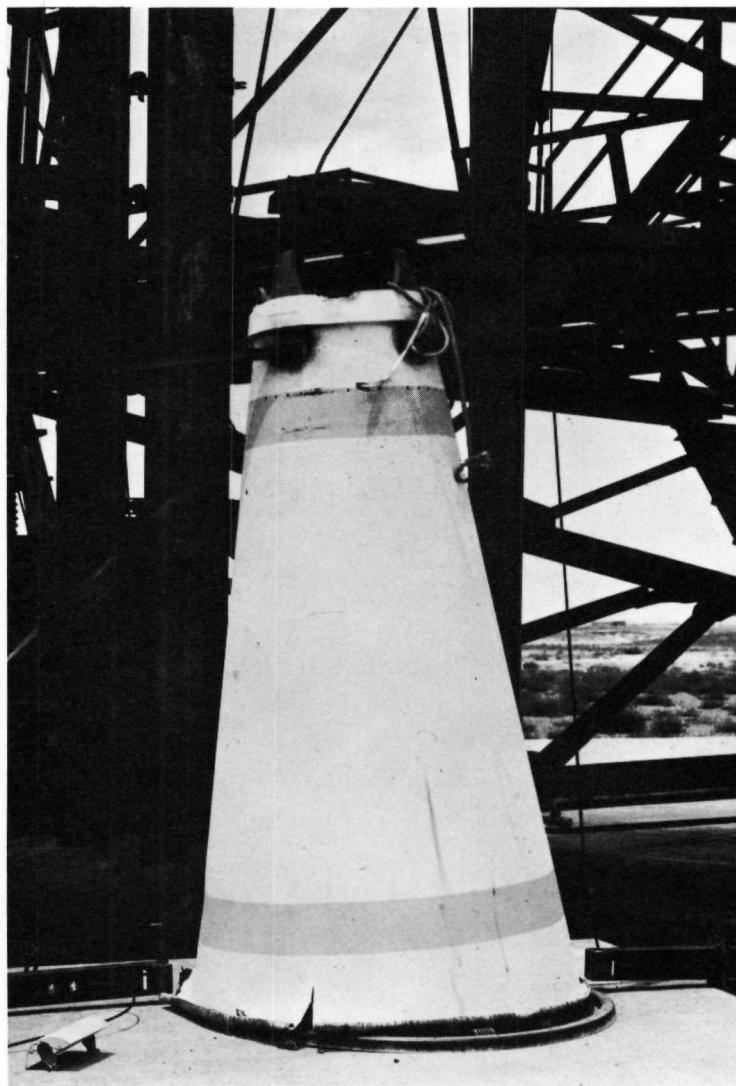
7611-5509

Upon tail-on impact, 9 in. of the converter end rolled up as shown in Figure 10. For an instant after the impact, it appeared as if the reactor would remain in its original position, then it fell into the converter cone. All parts of the reflector assembly and reactor structure, except one reflector drum, were contained within the converter cone. All bottom drum brackets were severed, and all top pins were bent out. A circumferential buckle developed at the

Figure 10. Test Article After 100-ft,
Tail-On Drop Test

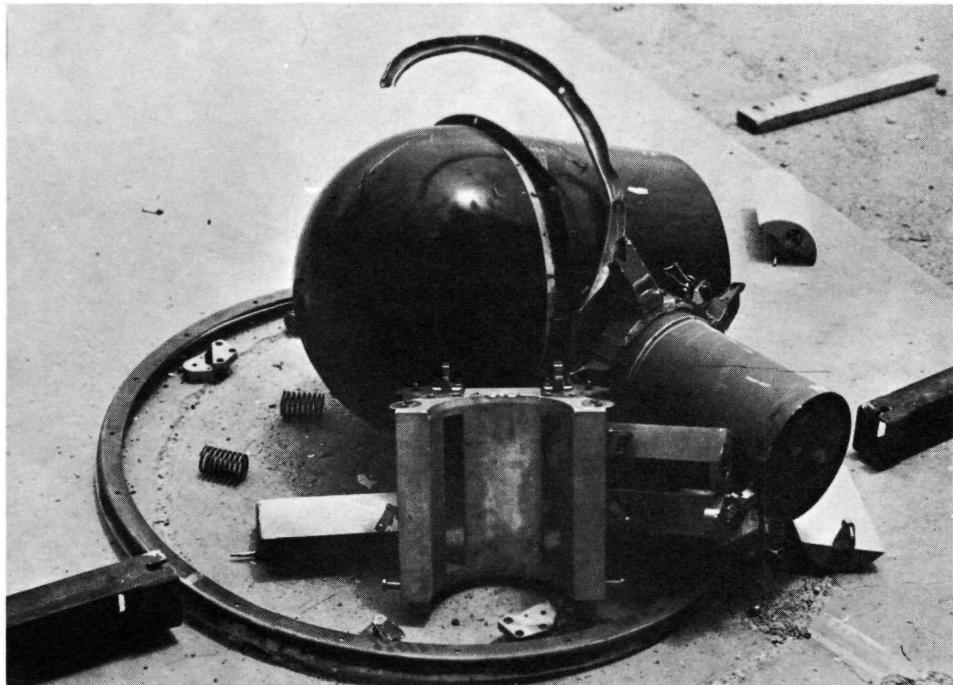
7568-0283

transition region of the core vessel. In the buckle region, the vessel wall was parted almost completely around the circumference. The steel tension band was severed, but one of the two fixed reflector blocks remained with the vessel (see Figure 11).

Figure 11. Reactor After 100-ft, Tail-On Drop Test

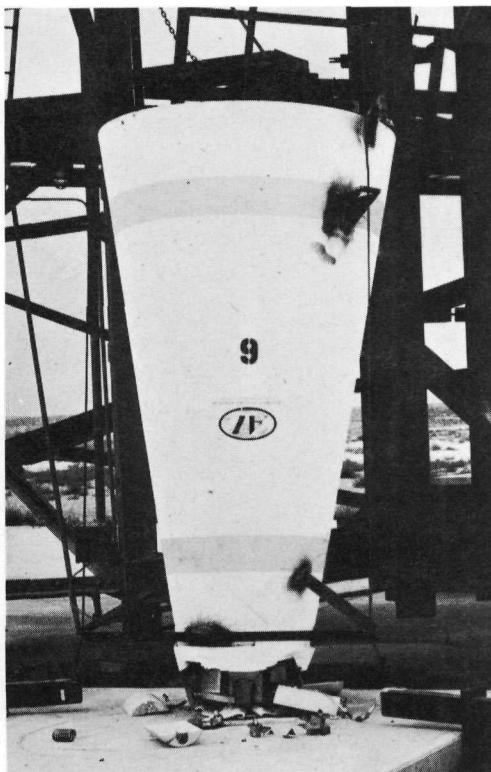
The velocity of the test article in the nose-on impact was 64.4 ft/sec. The impact caused complete failure of the pump radiators and severed all of the reflector drums. After the vessel support legs failed, the reflector blocks were pushed into the converter structure and were held around the reactor vessel by the structure (see Figure 12). The bottom grid plate was severed, and seven fuel elements punctured the bottom head of the core vessel. The elements protruded 3 in. through the head, as shown in Figure 13. This failure is thought to have occurred because of a cutout from the shield which was made to provide room for the accelerometer. Had this cutout not been made, the vessel would not have failed in this manner because of the support provided to the head by the shield. All vessel support legs were severed.

Figure 12. Test Article After 100-ft, Nose-On
Drop Test
(7611-5508)

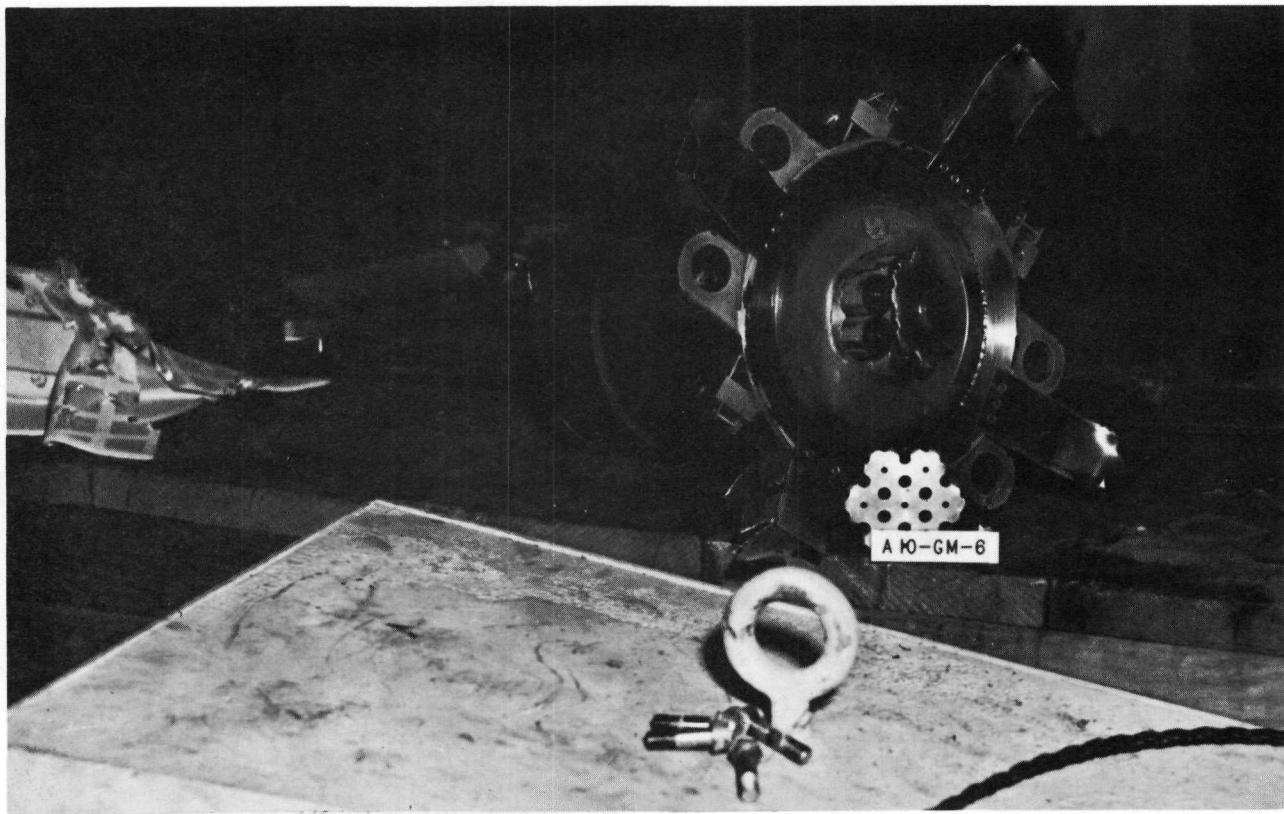
7611-5505

Figure 13. Reactor Vessel After 100-ft, Nose-On Drop Test

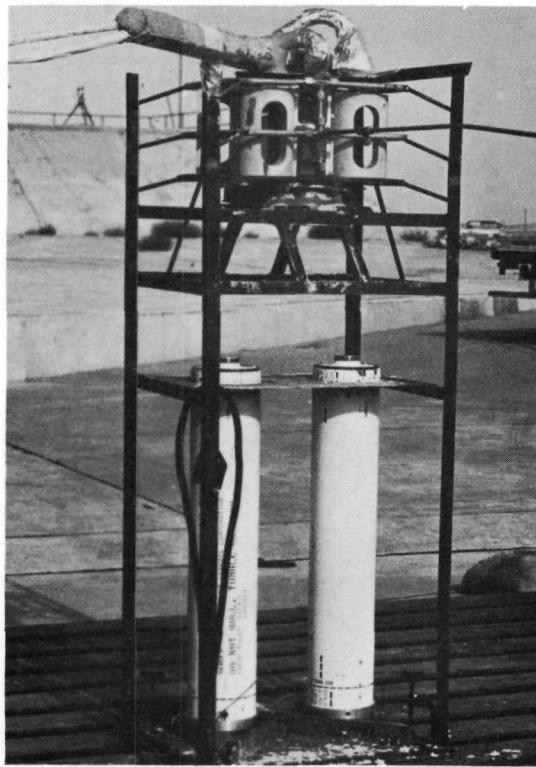
7611-5516

This test was performed on July 19, 1962. The test article, including the reactor vessel and reflector assembly, was mounted on a horizontal test stand (see Figure 14). A burning cycle of 4000°F flames for 2.2 sec, and 1500°F flames for 15 min completely surrounded the reactor. Two Sparrow rocket motors, with expansion nozzles removed, provided the high temperature for the 2.2 sec. A triple-ring butane burner, using an oxygen-rich mixture, was used for the 15-min soak. This burning cycle was chosen based upon data obtained from the Martin Company report number MND-P-2352. The nose cone was not installed on the test article. In the event of fire with the nose cone attached, a destruct charge (HMX explosive, self-igniting at 720°F) would ignite and separate the reflector assembly from the reactor.

Figure 14. Test Article Before Fire Test

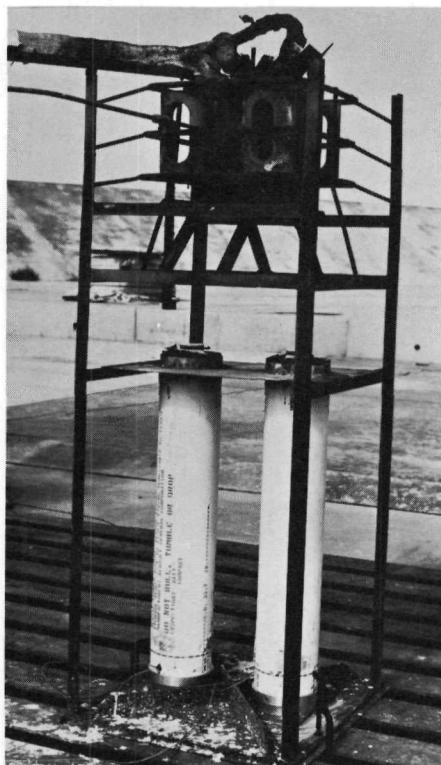
7611-5515

Figure 15 shows the test article after the test. The steel tension band was severed during the initial high-temperature run. This allowed the reflectors to separate from the vessel. The reflectors, as shown in Figure 15, were prevented from falling away from the vessel by the triple-ring butane burner. A local deflection inversion, 6 in. in diameter, was also observed on the lower head. These were the only visible effects of the test. No nuclear hazard would have existed unless the reactor was subsequently immersed in water.

Figure 15. Test Article
After Fire Test

Some question exists as to the conditions during this test and how they would compare to an actual missile abort fire. Indications are that the energy generated during the test was less than that which would be released during a launch pad abort; therefore, the test results are a conservative indication of the consequences.

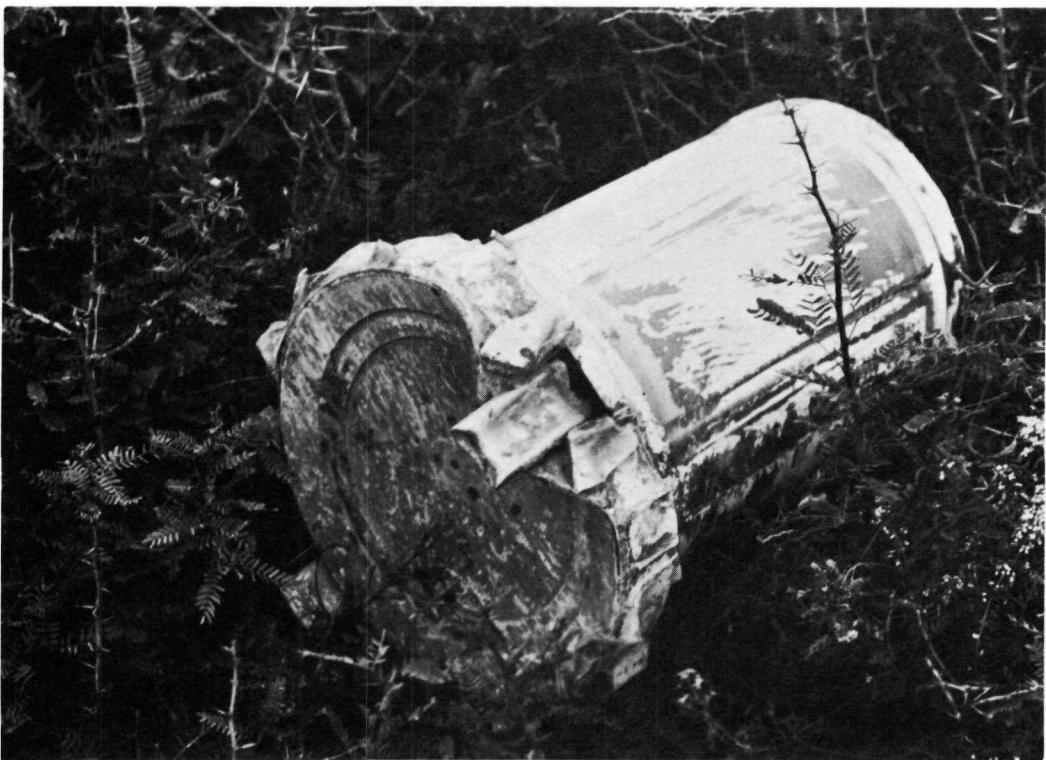
7611-5507

The side-on water impact test was performed on August 1, 1962. Impact velocity in this test was 550 ft/sec; the reactor passed through the water tank and came to rest on a mound of loose dirt behind the tank. The fixed reflector blocks and the reflector drums were completely separated from the reactor vessel in the water. The vessel was found intact (see Figure 16). No useful data were obtained from the onboard instrumentation because the recording equipment failed to operate.

Figure 16. Reactor Vessel After Side-On Water Impact Test

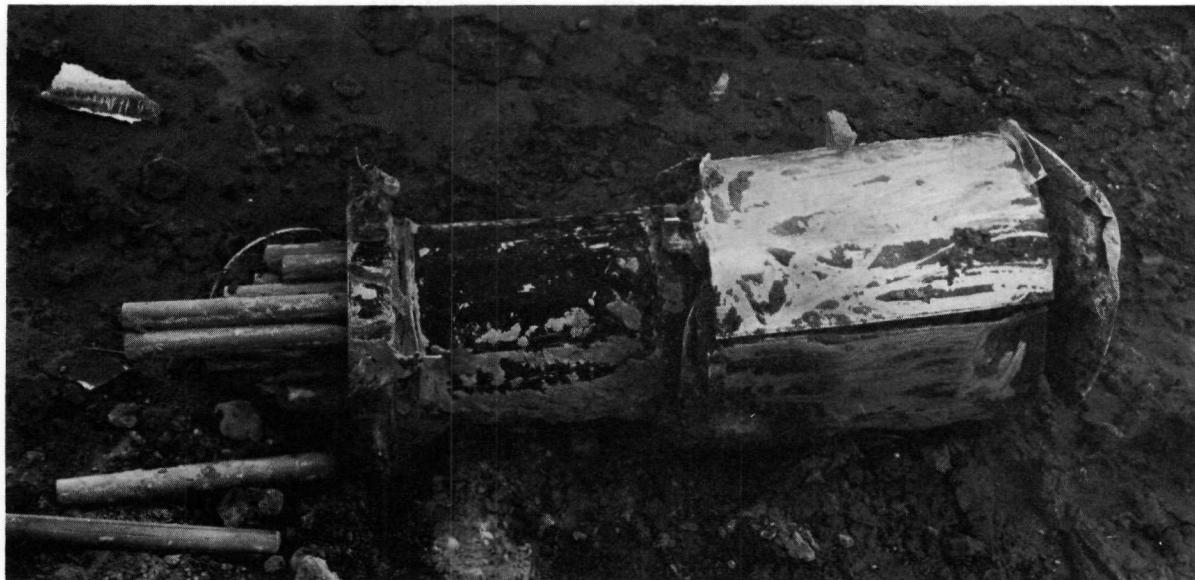
7568-0282

The tail-on water impact test was performed on October 4, 1962. Impact velocity in this test was 596 ft/sec. The reflector assembly was separated, and the core vessel split open axially. Fuel elements were displaced longitudinally through the bottom of the vessel. Two elements were completely ejected from the array (see Figure 17). The core would have gone critical in the water.

Figure 17. Reactor Vessel After Tail-On Water Impact Test

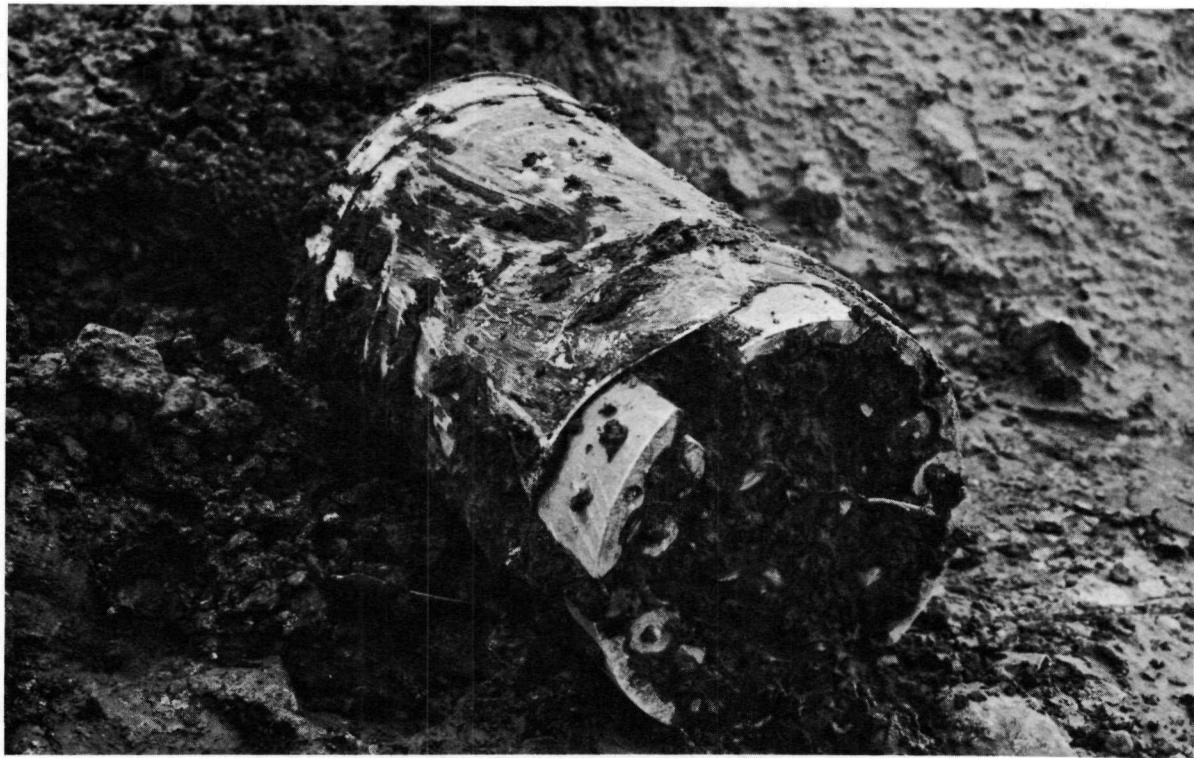
7611-5506

The nose-on water impact test was performed September 12, 1962. Impact velocity in this test was 573 ft/sec; the reactor passed through the water tank and came to rest on a mound of dirt 20 ft behind the tank. The reflector assembly separated completely from the reactor vessel in the water. Also, the NaK pump, the upper head, and the upper grid plate were severed from the test article. Fuel elements were displaced longitudinally in such a manner as to form a spherical pattern at the ends. Sufficient disassembly of the core did not occur to prevent its criticality in the water.

Figure 18. Reactor Vessel After Nose-On Water Impact Test

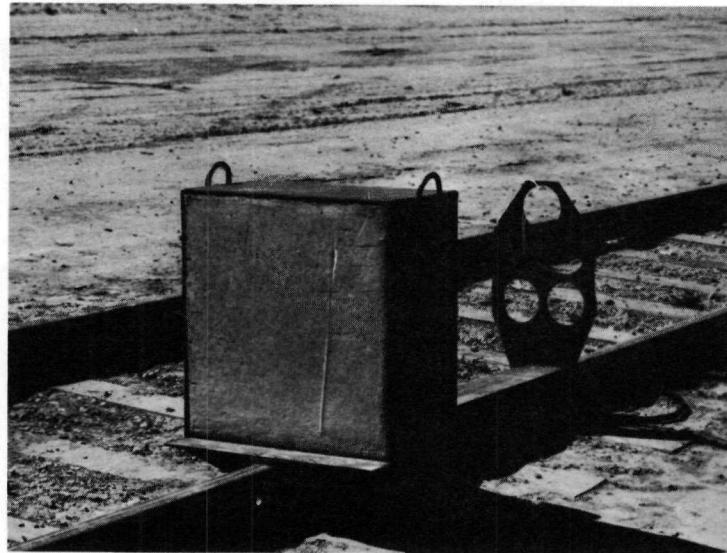
7611-5504

The test was performed on August 15, 1962. A concrete-faced monorail sled was impacted at 560 ft/sec onto the pump end of the test article (see Figures 19 and 20). The impact completely destroyed the reactor. The vessel was in three parts: the upper head, lower head, and the shell. The lower head was not found, but some shrapnel-shaped pieces of the upper head were collected. The shell was completely flattened and had many local failures. Figure 21 shows the pieces of the test article which were gathered after the test.

Figure 19. Concrete-Faced Monorail Sled Used in Concrete Impact Test

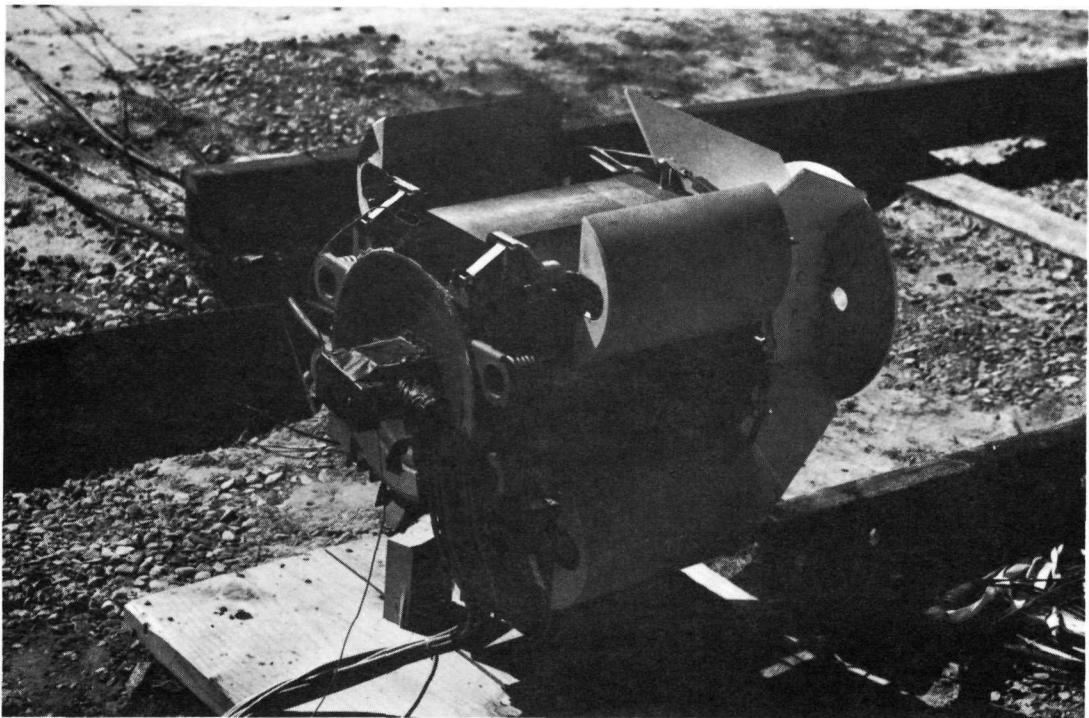
7611-5513

The test article included the NaK pump, core vessel, internals, and reflector assembly. Five strain gages and an accelerometer were on board. High-speed film coverage and still photography were provided.

Figure 20. Test Article Before Concrete Impact Test

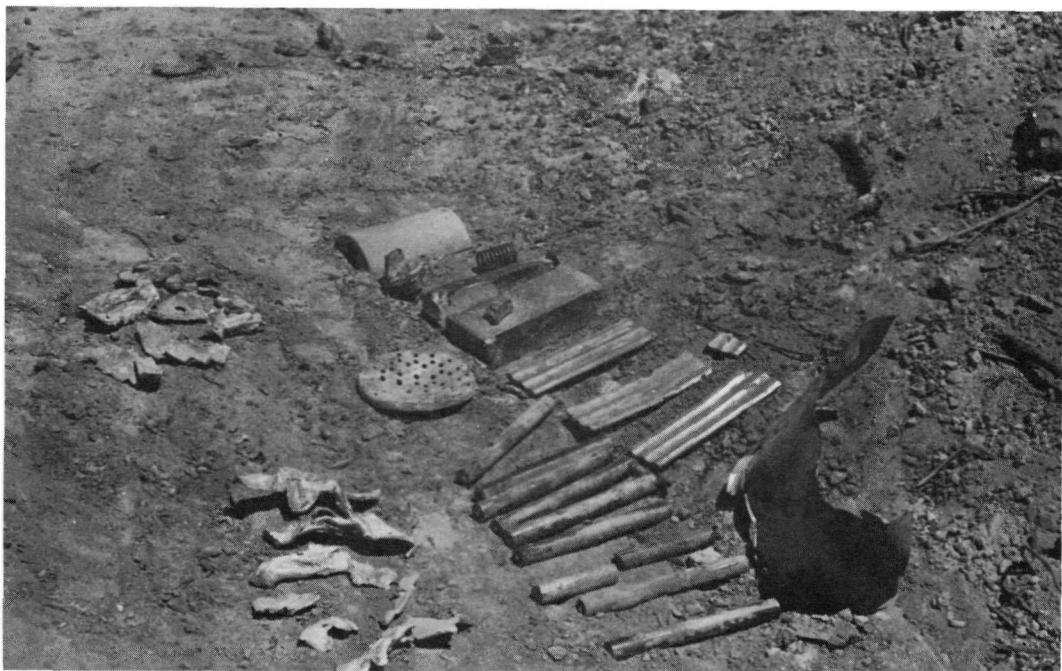
7568-0284

Figure 21. Pieces of Test Article Recovered After Concrete Impact Test

In Test No. 9, a concrete-faced monorail sled was impacted upon a stationary test article. The velocity of the sled at impact was 560 ft/sec. The test article was completely destroyed; debris from the test article was scattered over the test area.
