LONG TERM IRRADIATION OF  
SAP-CLAD,  $UO_2$  FUELLED, TREFOIL BUNDLES  
IN THE X-7 ORGANIC COOLED LOOP

Exp-NRX-70911

R.F.S. ROBERTSON, H.E. THEXTON, D.E. LEW,  
R.D. MacDONALD and K.G. HEAL

AECL-1782

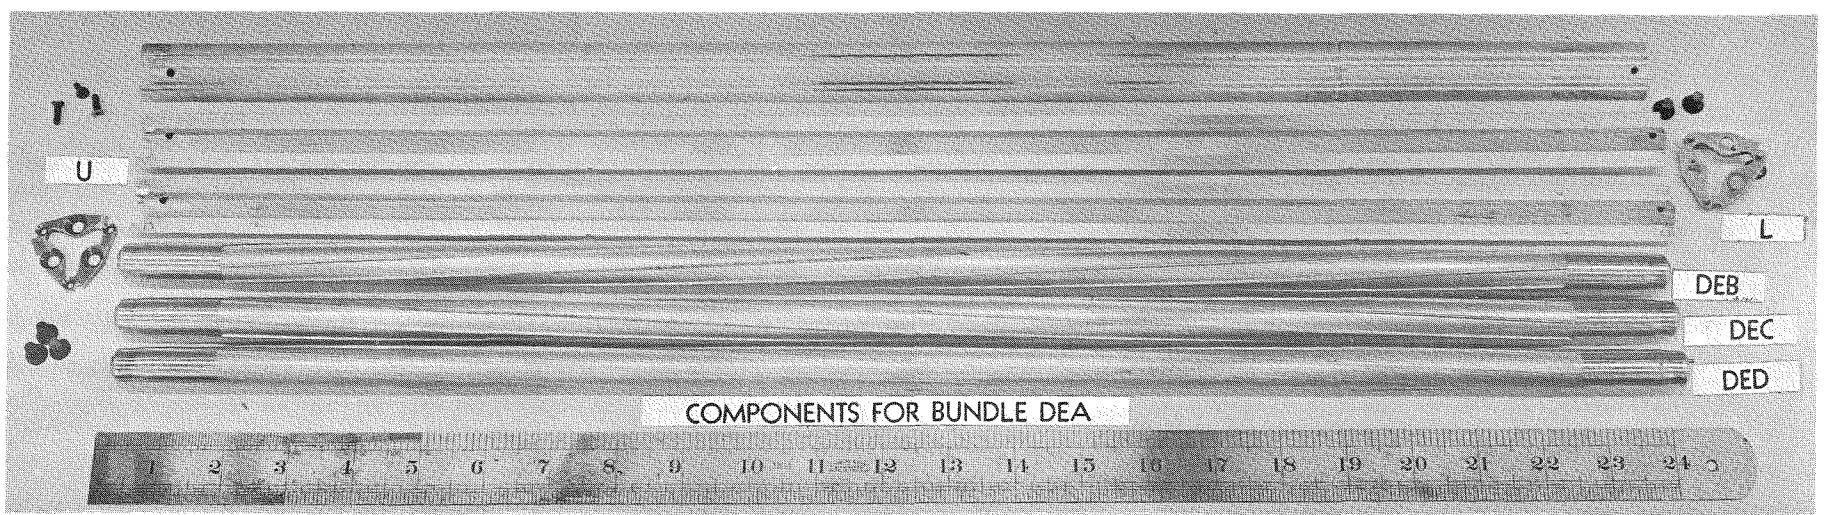
FIGURE 1

Bundle DEA disassembled, showing filler pieces at top and fuel elements below. End plates are at either side.

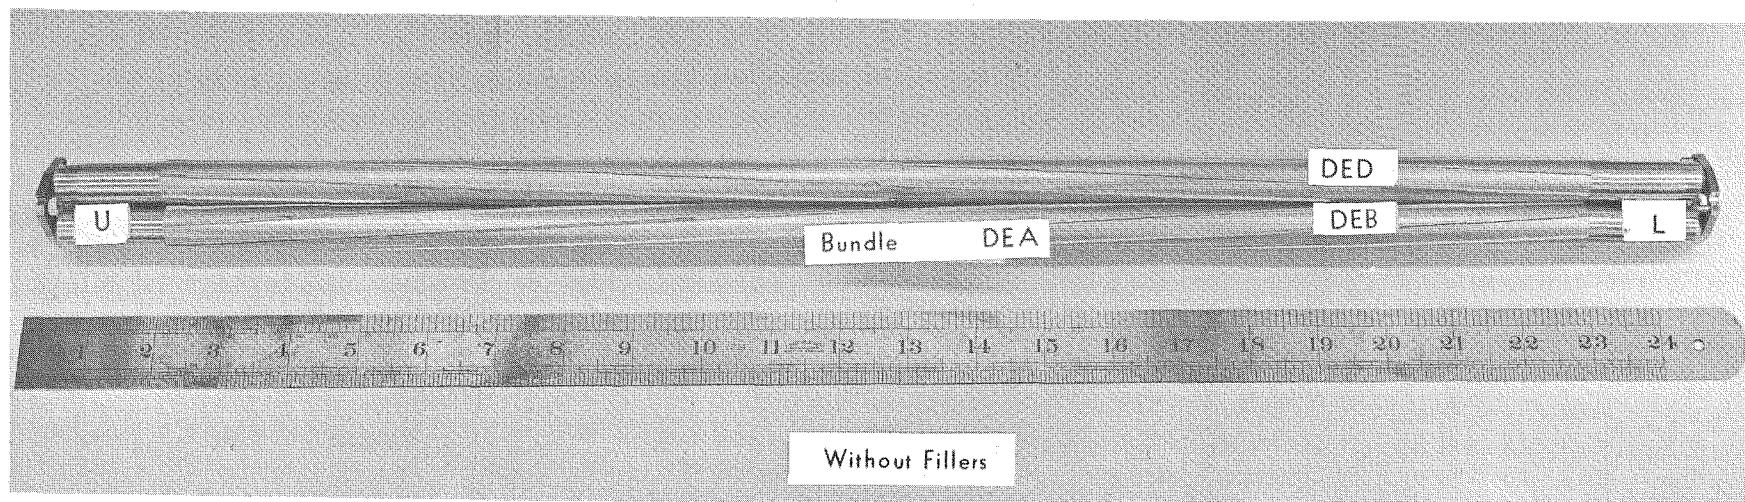
FIGURE 2

BUNDLE DEA WITHOUT FILLER PIECES

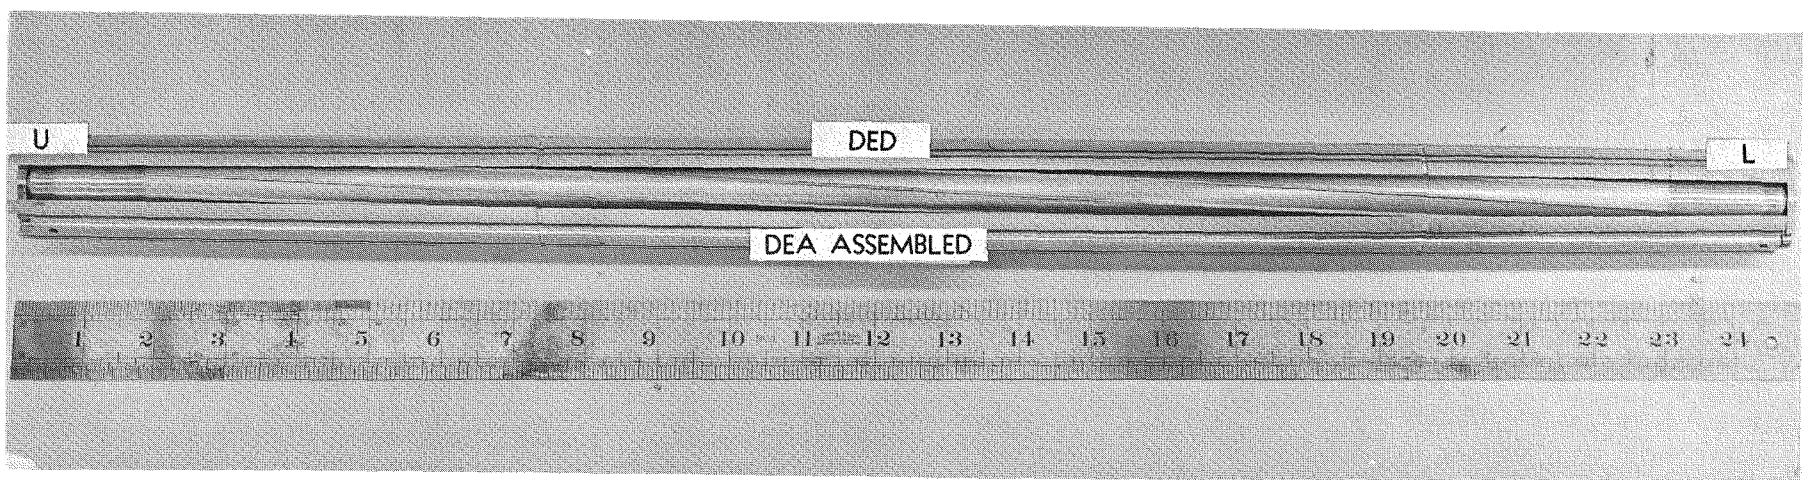
FIGURE 3

BUNDLE DEA ASSEMBLED

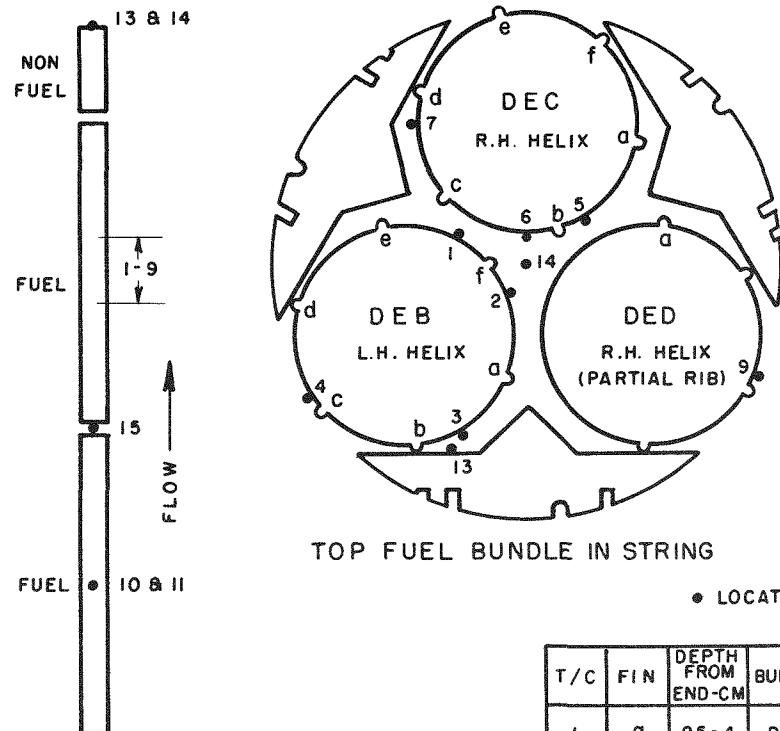
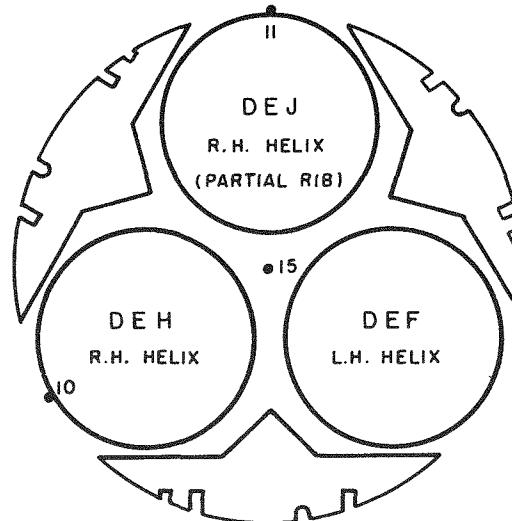
BUNDLE DEA

BUNDLE DEE

TOP FUEL BUNDLE IN STRING

#### • LOCATION OF MEASURING JUNCTION

Twelve thermocouples were located in the fins of the six elements. These thermocouples were of the sheathed variety with the chromel-alumel conductors embedded in MgO insulant and sheathed in stainless steel sheaths 0.51 mm in diameter. The measuring junction was embedded in the fin and the wire ran the length of the fin embedded in the groove. About 1 metre from the hot junction a transition was made from 0.51 mm to sturdier 1.0 mm diameter thermocouple wire. Details of how the thermocouple were attached and of the transition junctions are given in reference 3.

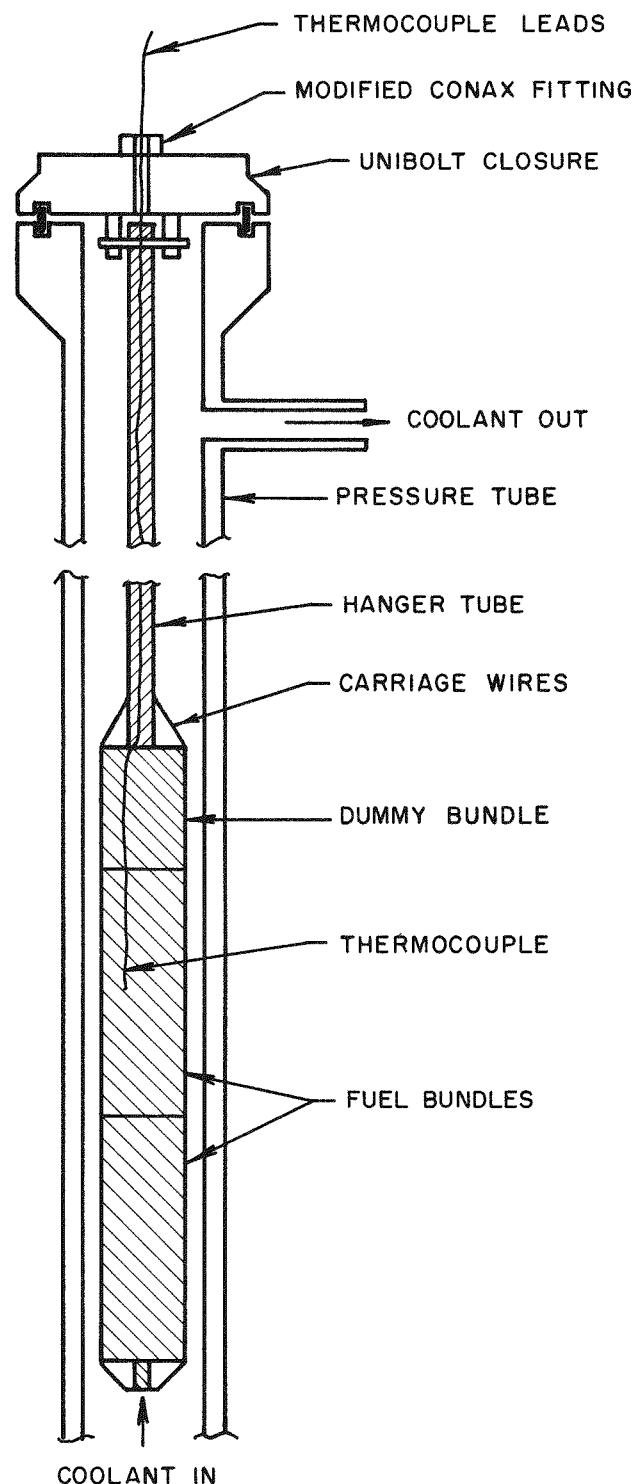
FIG. 5

SCHEMATIC REPRESENTATION OF X - 7 LOOP TEST  
SECTION & X-709 EXPERIMENTAL ASSEMBLY.

The test section of the loop consists of a stainless steel pressure tube of 3.57 cm ID and 0.125 cm thick. This tube, which is inserted in a fuel rod position of the NRX reactor, contains the fuel bundles under irradiation. The coolant is circulated upwards through the stainless steel tube from the bottom; Figure 5 shows a schematic representation. The coolant entrance and exit are connected to the organic circulating system by welded carbon steel piping. The top closure of the tube is made by a "Unibolt" closure adapted so that thermocouple leads can be taken out through a modified Conax seal.

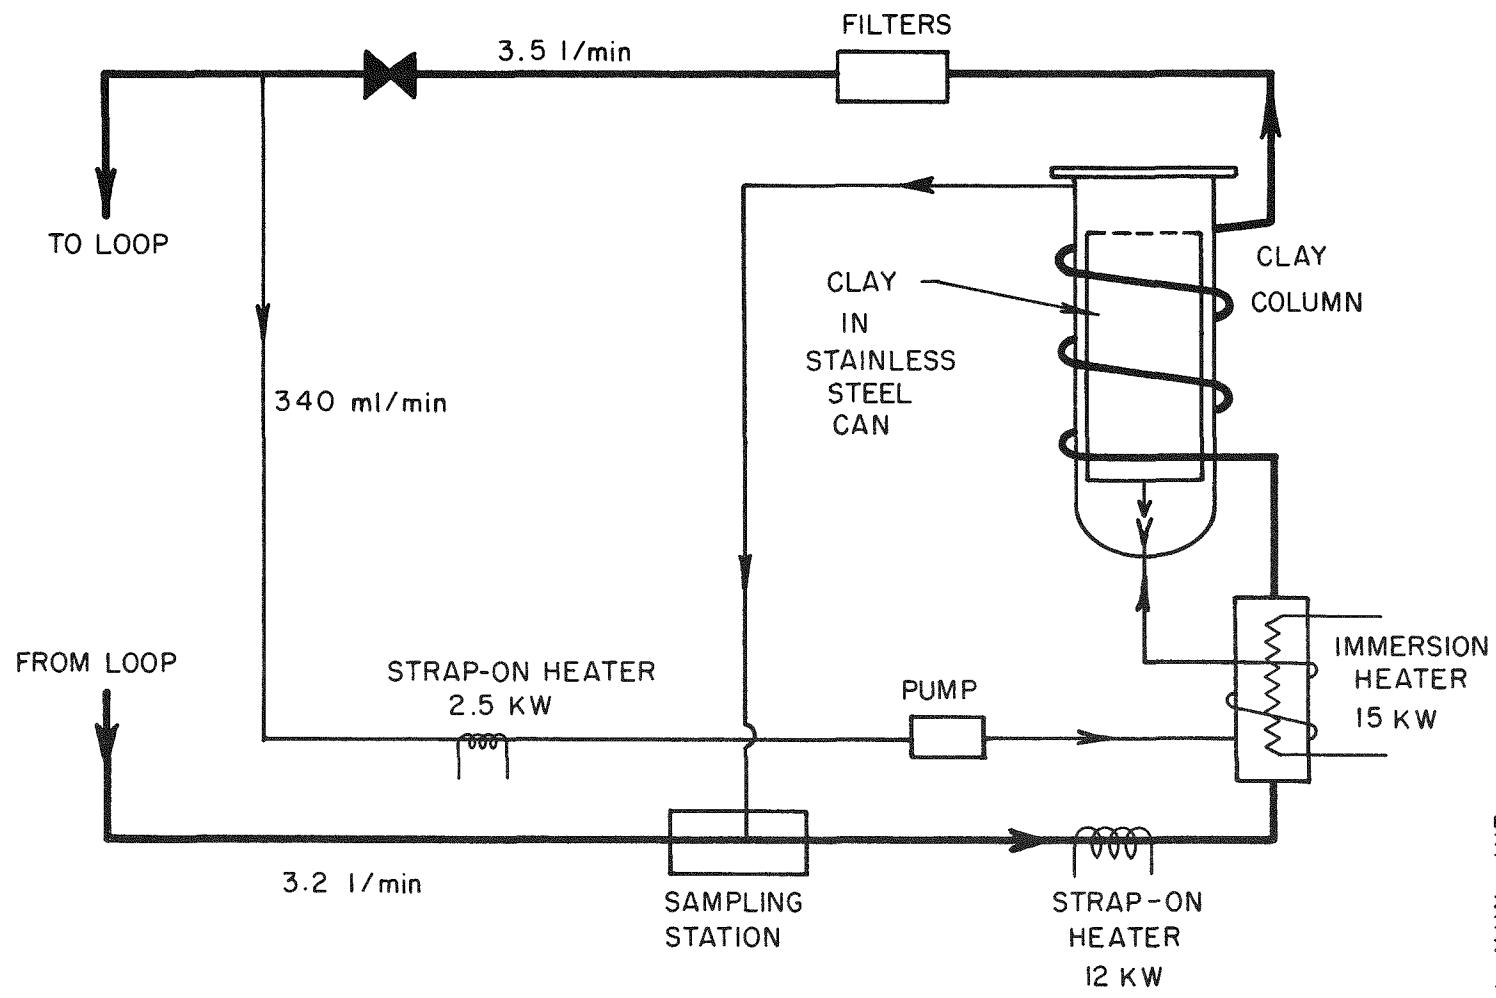
FIG. 6

ADSORPTION COLUMN AND FILTER CIRCUIT

The clay, Attapulgus clay of 30-60 mesh, was held in a stainless steel can 53 cm in diameter and 61 cm high, which was open at the top and closed at the bottom except for a centrally located inlet tube. This can held about 80 kg of clay. The bottom of the can was first lined with a pad of Pyrex glass wool, the clay was then poured in until the can was almost full and then another pad of Pyrex glass wool covered the top above which was placed a screen of woven stainless steel wire. This assembly was held inside a large vessel roughly 75 cm in diameter and 1 metre high. The entrance tube for the organic coolant was welded through the dome shaped bottom of the vessel and ended in a cone shaped receptacle. A spigot, with the lower end rounded, was welded on the tube leading into the bottom of the can holding the clay. The spigot fitted into the cone shaped receptacle and was held as a press fit by the weight of the can plus clay. This is sketched diagrammatically in Figure 6.

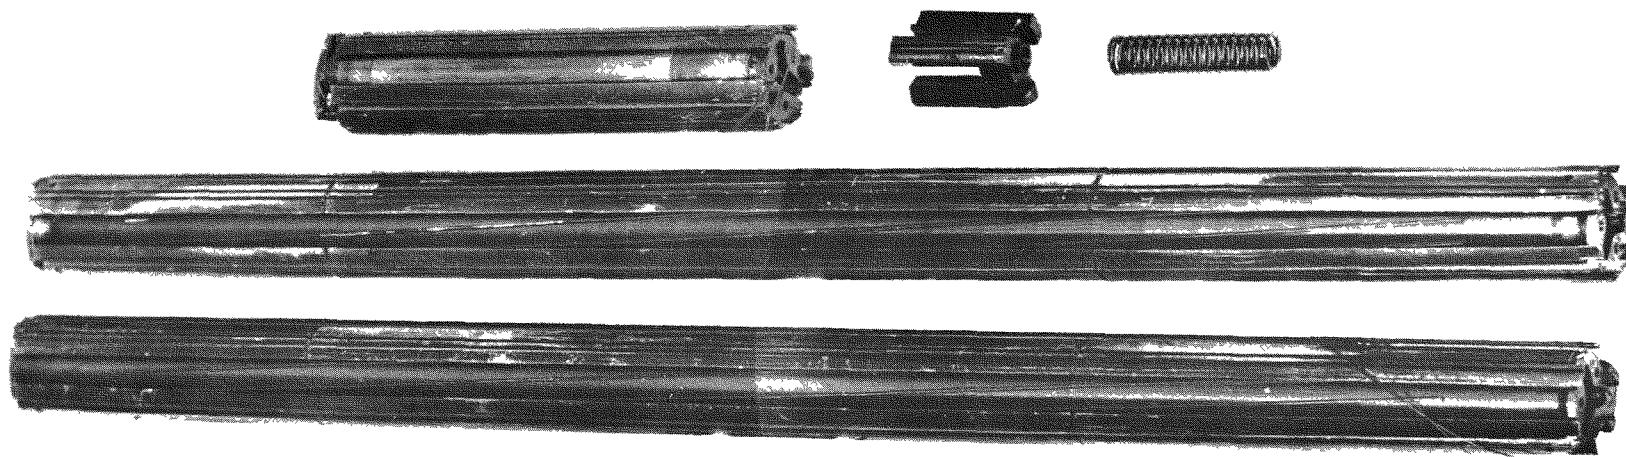
FIGURE 9

Composite photograph of partially disassembled fuel string after irradiation

Top Non-fueled bundle, Upper carriage spider and carriage spring

Flow was from left to right over all components

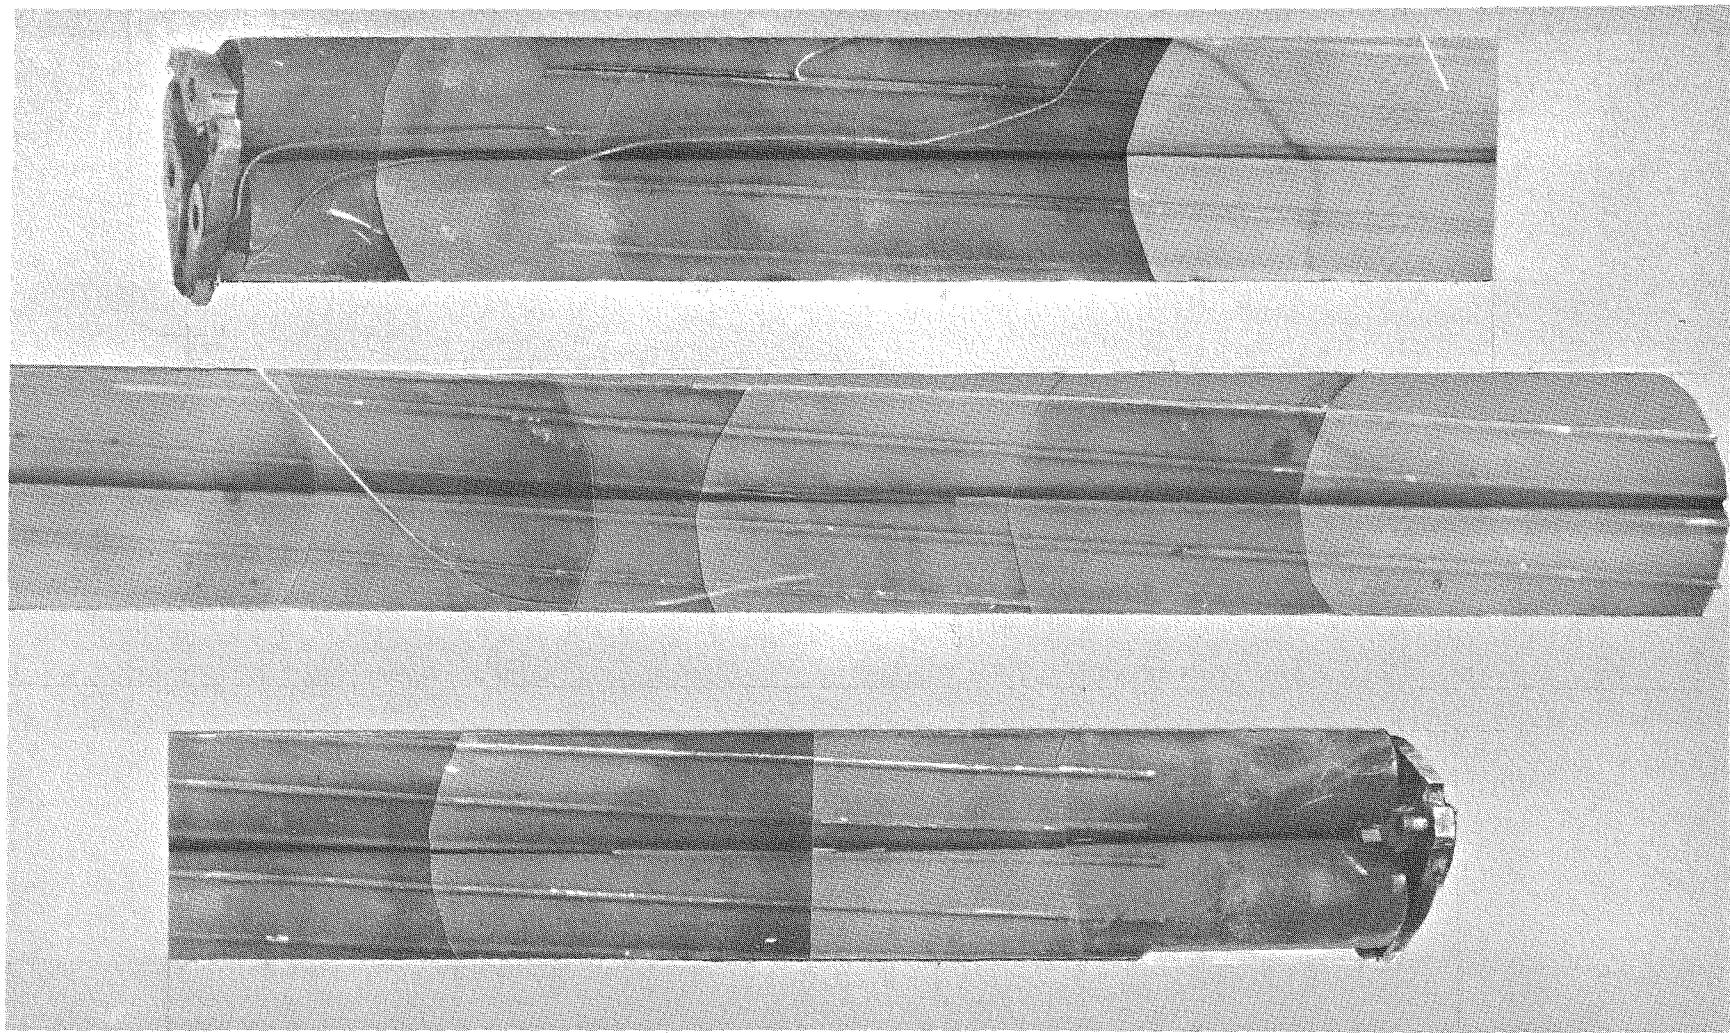
Figure 10

Composite photograph of bundle DEA with filler pieces removed  
Flow from left to right

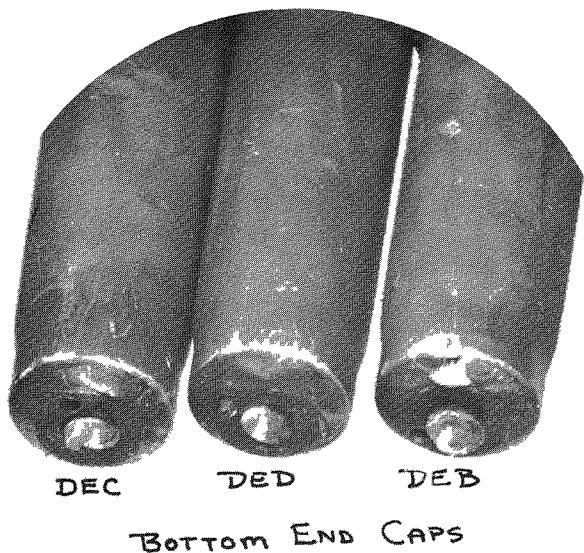
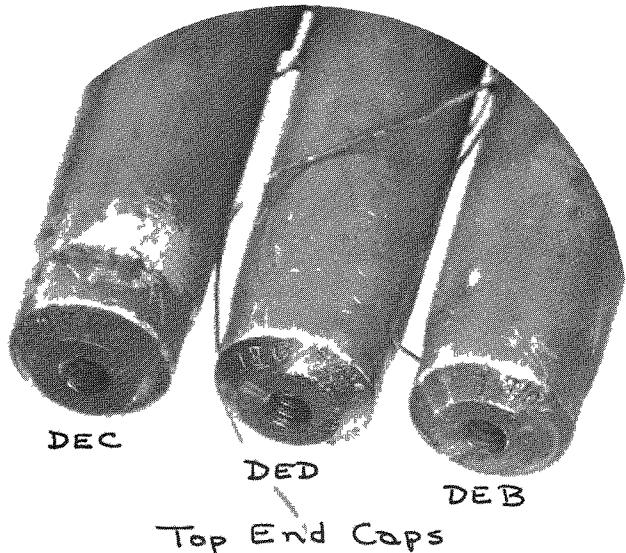
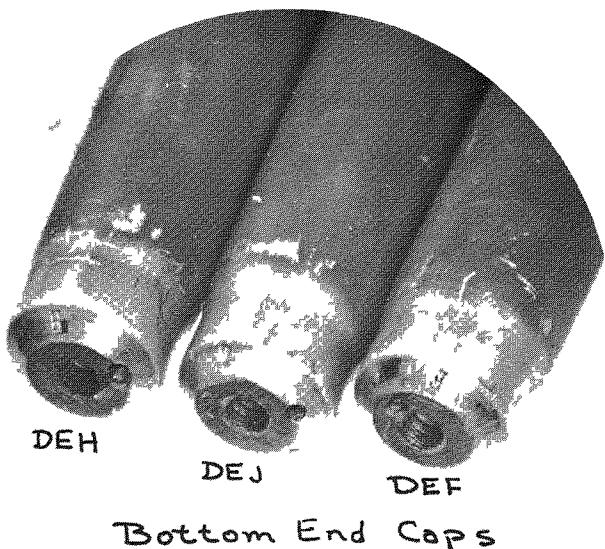
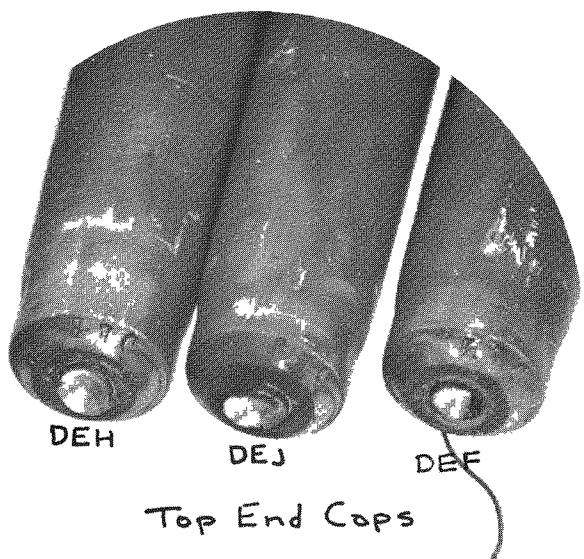
FIG. 11

BUNDLE DEA

BUNDLE DEE

END CAP FOULING

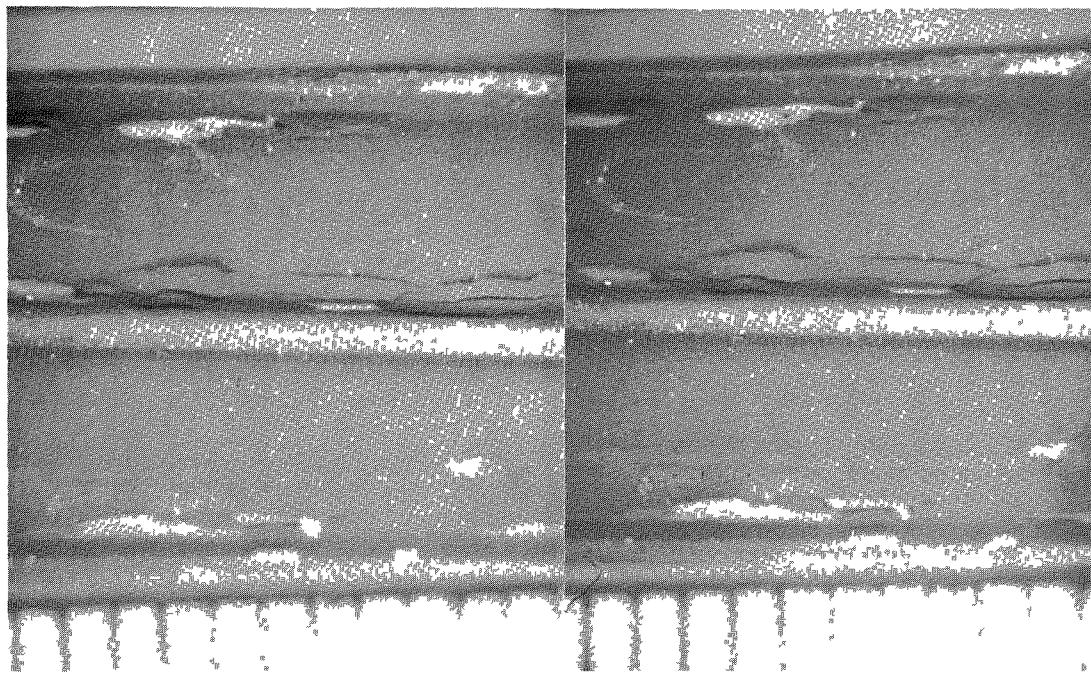
FIGURE 12

Cracked layer of fouling film next to fins on  
Element DEH. (stereopair)

- (5) On the elements, the film appeared thinner on the fins than on the rest of the element. There was a tendency for the film to be cracked at the edge or base of a fin (See Figure 12). Also when the elements were separated, discontinuities could be seen where the fin of one element had been in contact with the body of another (See Figure 13).

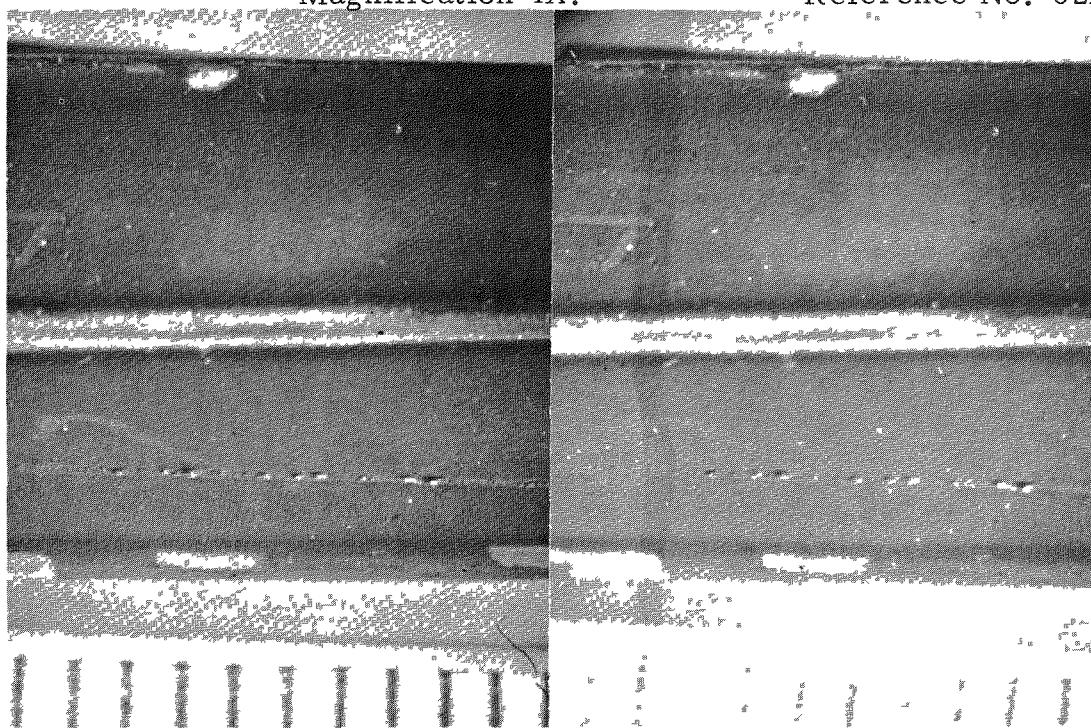
FIGURE 13

Stereopair showing line where fin of another  
element came in contact with the sheath of element  
DEH.

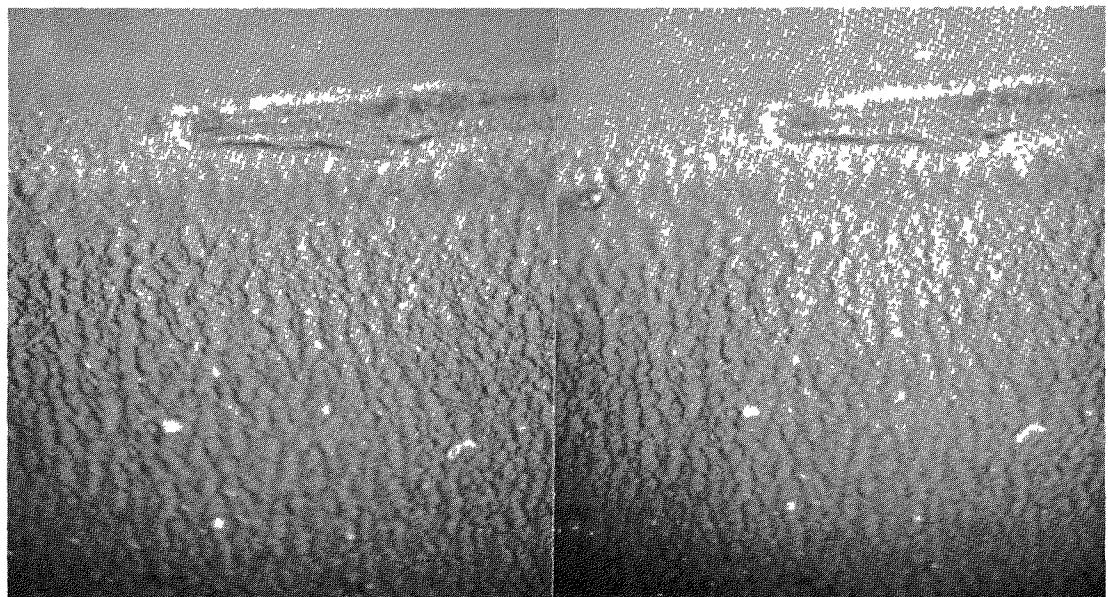
FIGURE 14

Wrinkled surface of the fouling film, Element DEB.  
Magnification 12X. Reference No. 6228

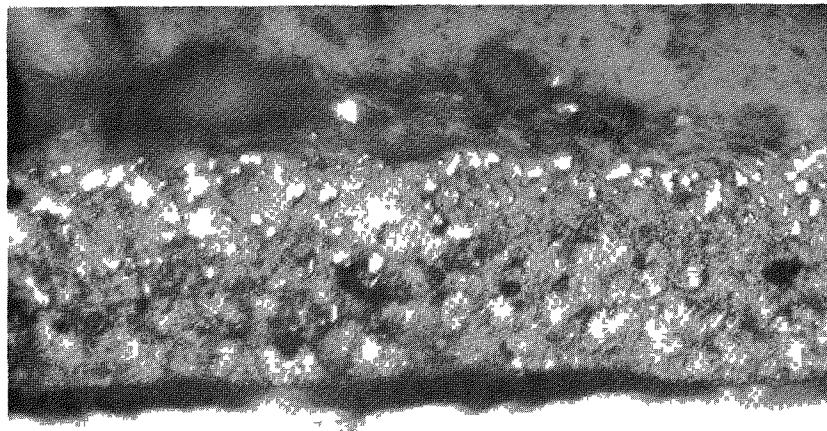
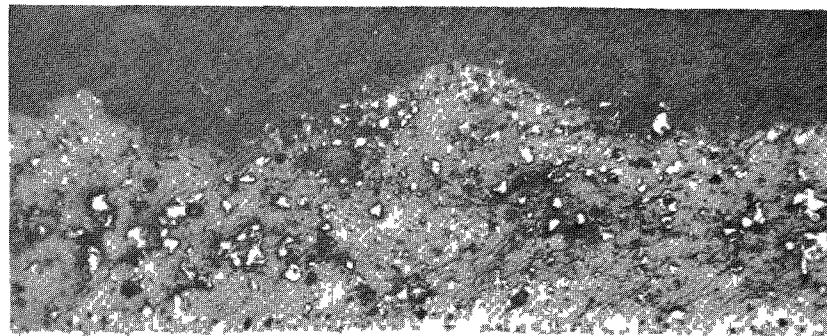
FIGURE 15

← Mount  
← White Granular  
Particles  
← Fouling film  
← Sheath

Bundle DEE, Element DEJ

← Mount  
← Fouling film  
← Sheath

Considering the approximate nature of this calculation the agreement of the calculated roughness with the observed value (Section 6.4.1.1) of  $20 \mu\text{m}$  is reasonable. For instance in Figure 15, one photograph shows a variation of  $\sim \pm 10 \mu\text{m}$  in the surface while the other shows an essentially smooth surface.

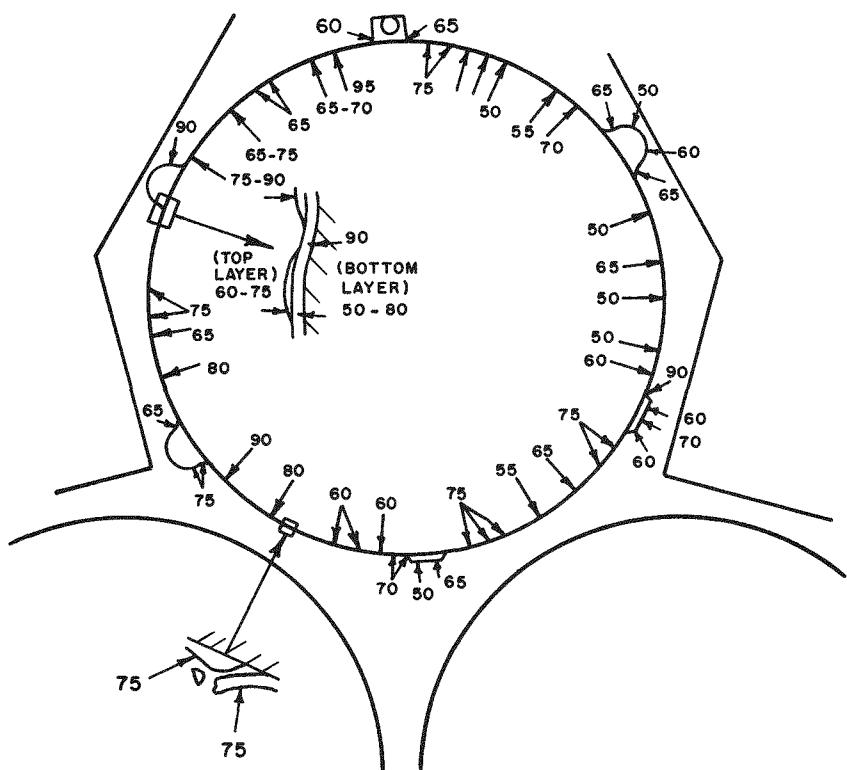
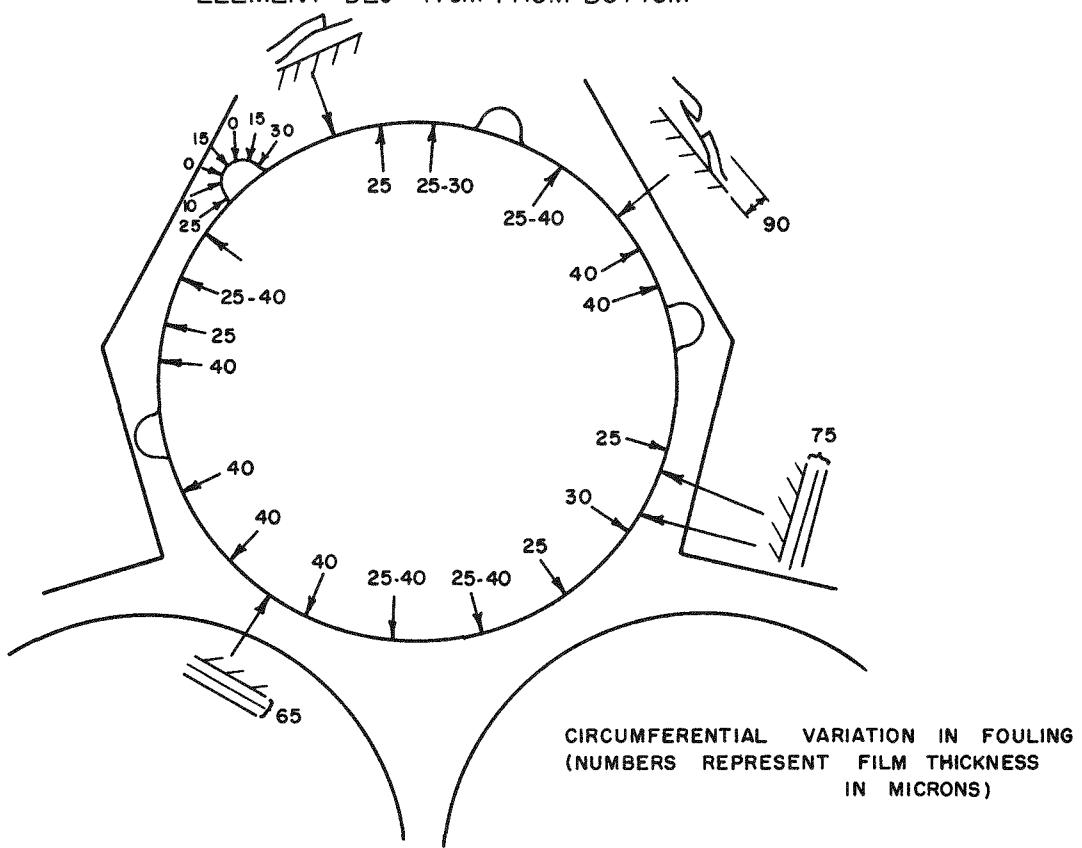
FIG. 16  
ELEMENT DED - 29 cm FROM TOP

ELEMENT DEJ - 11 cm FROM BOTTOM

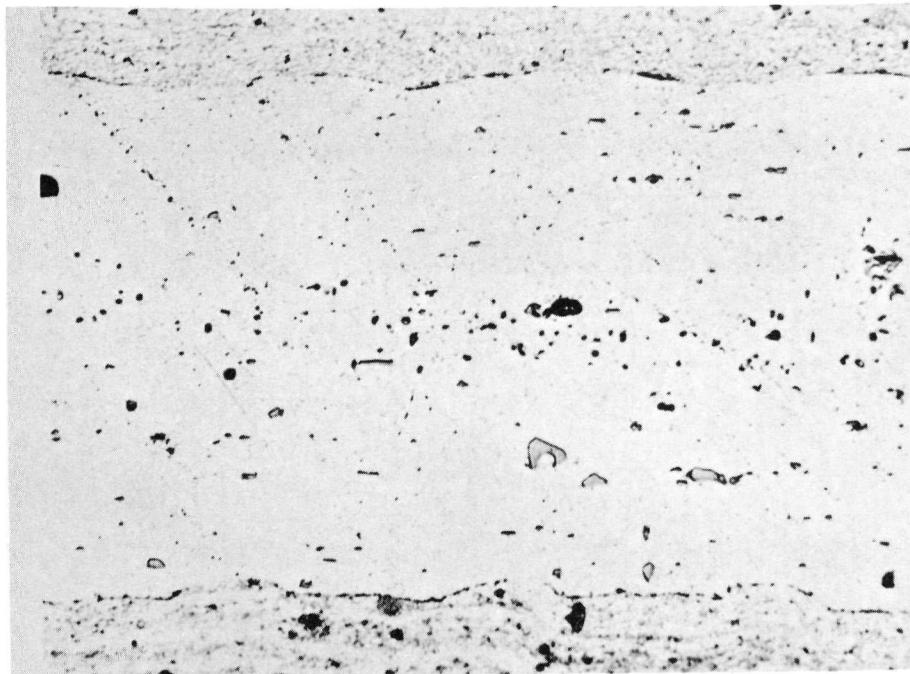
FIGURE 17

← SAP M-583

Alcan 65 S  
Interface material

PHOTO MICROGRAPH SHOWING SMALL  
AMOUNT OF POROSITY AND DISCONTINUITIES  
AT SAP - 65 S interface

Small discontinuities (< 0.02 mm long) were observed along the pressure bond but otherwise Figure 17 shows the bond to be in good condition.

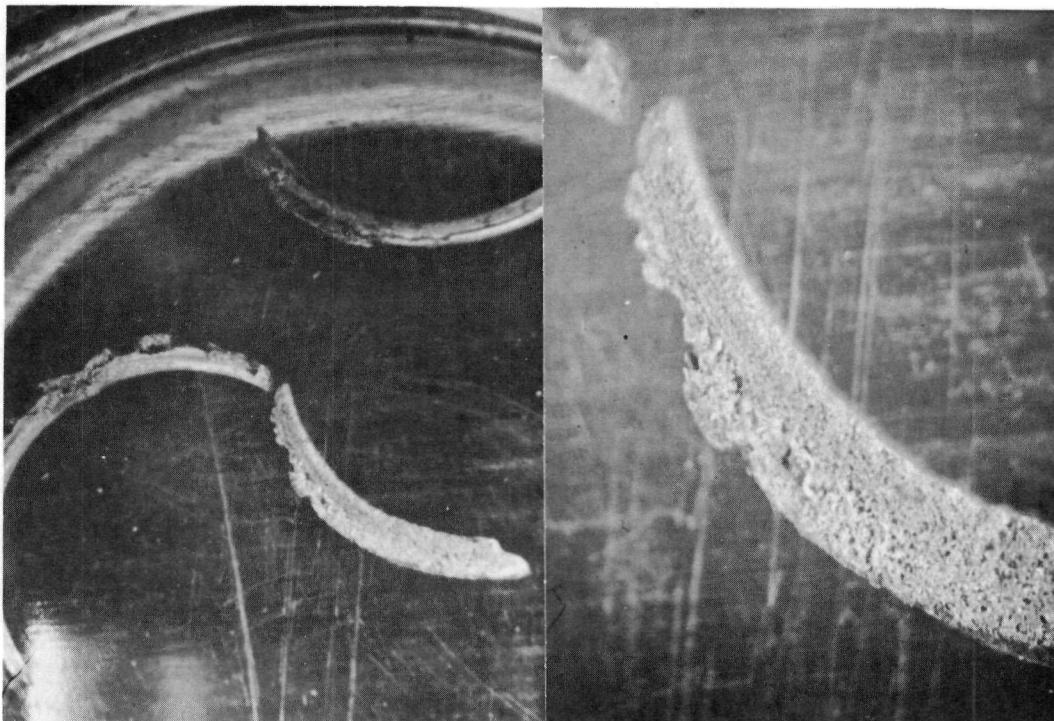
FIGURE 18

Cobalt-copper monitor from Element DEJ showing the extent of damage.

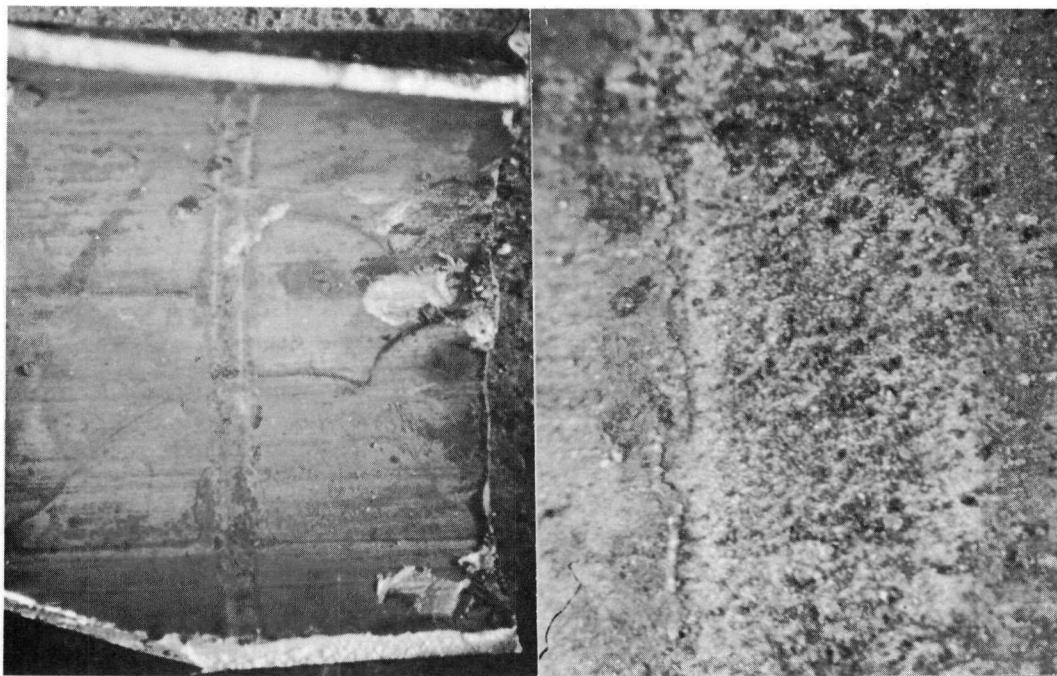
FIGURE 19

Inside surface of sheath, Element DEJ, showing the vertical line which is the location of the monitor in Figure 18.

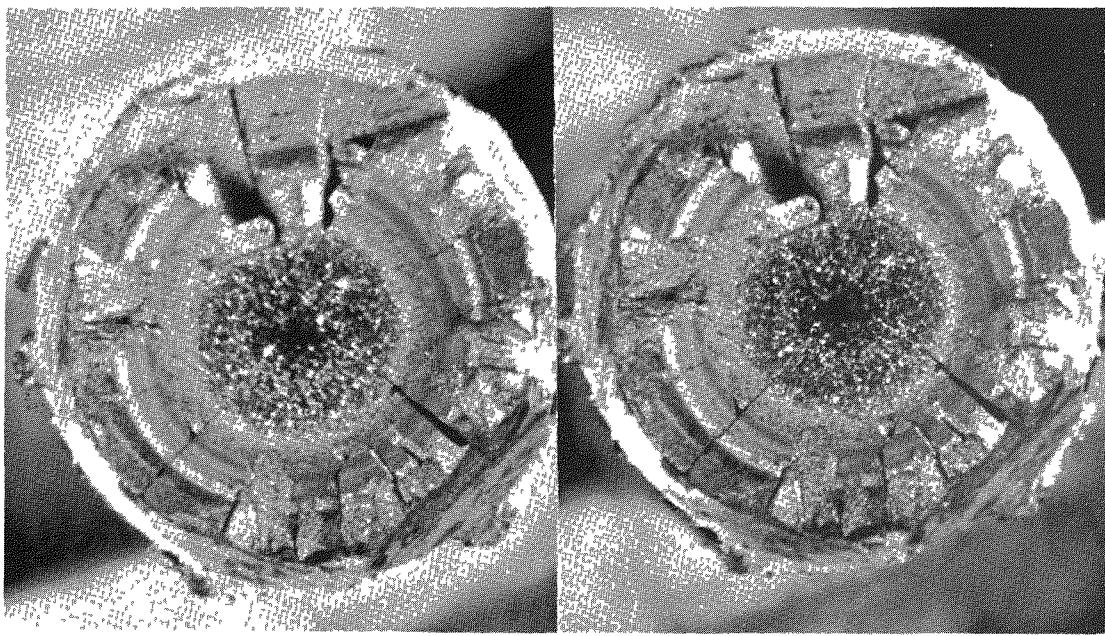
FIGURE 20

A pellet face, Element DEJ, showing equiaxed grain growth and dark concentric rings in the  $\text{UO}_2$ . (stereopair).

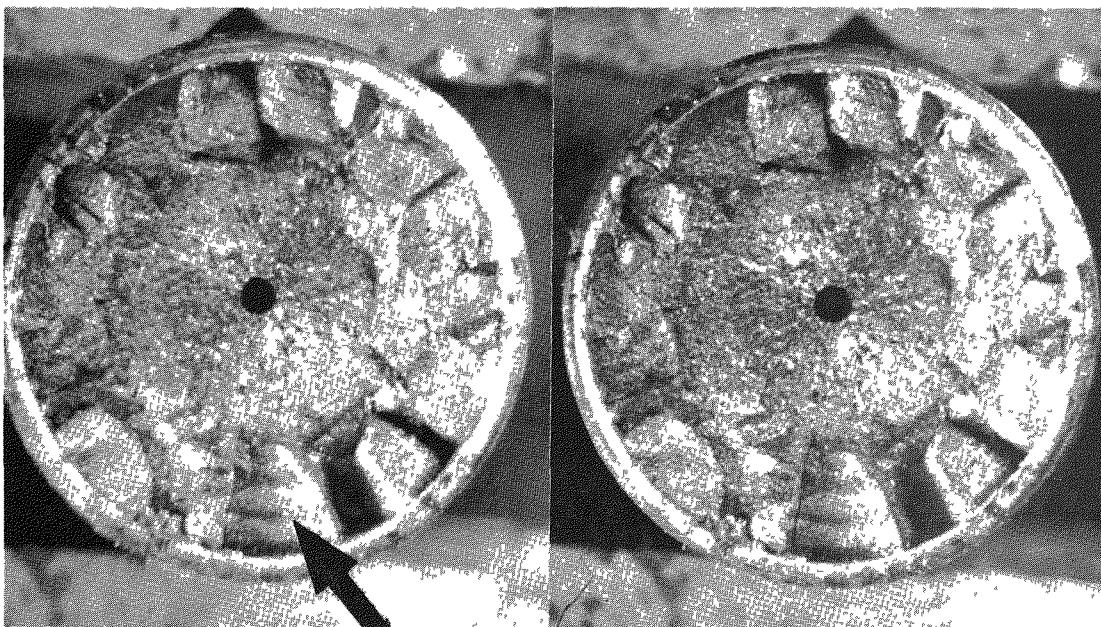
FIGURE 21

Central void surrounded by small columnar grains and dark rings in outer oxide (arrow) of Element DEH. (stereopair).

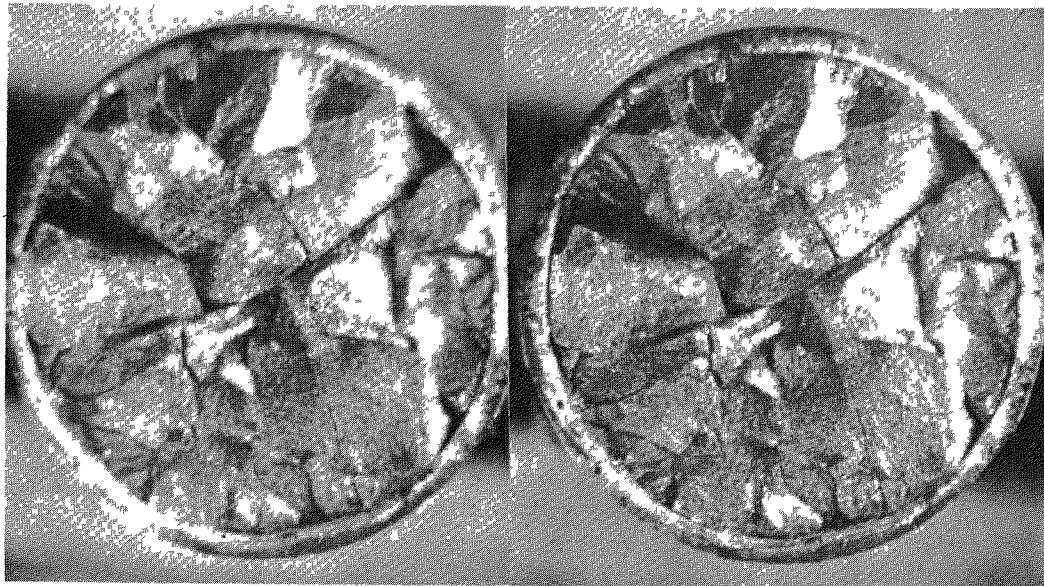
FIGURE 22

Typical UO<sub>2</sub> section which had not undergone grain growth. Note random cracking. Element DEF.  
(stereopair).

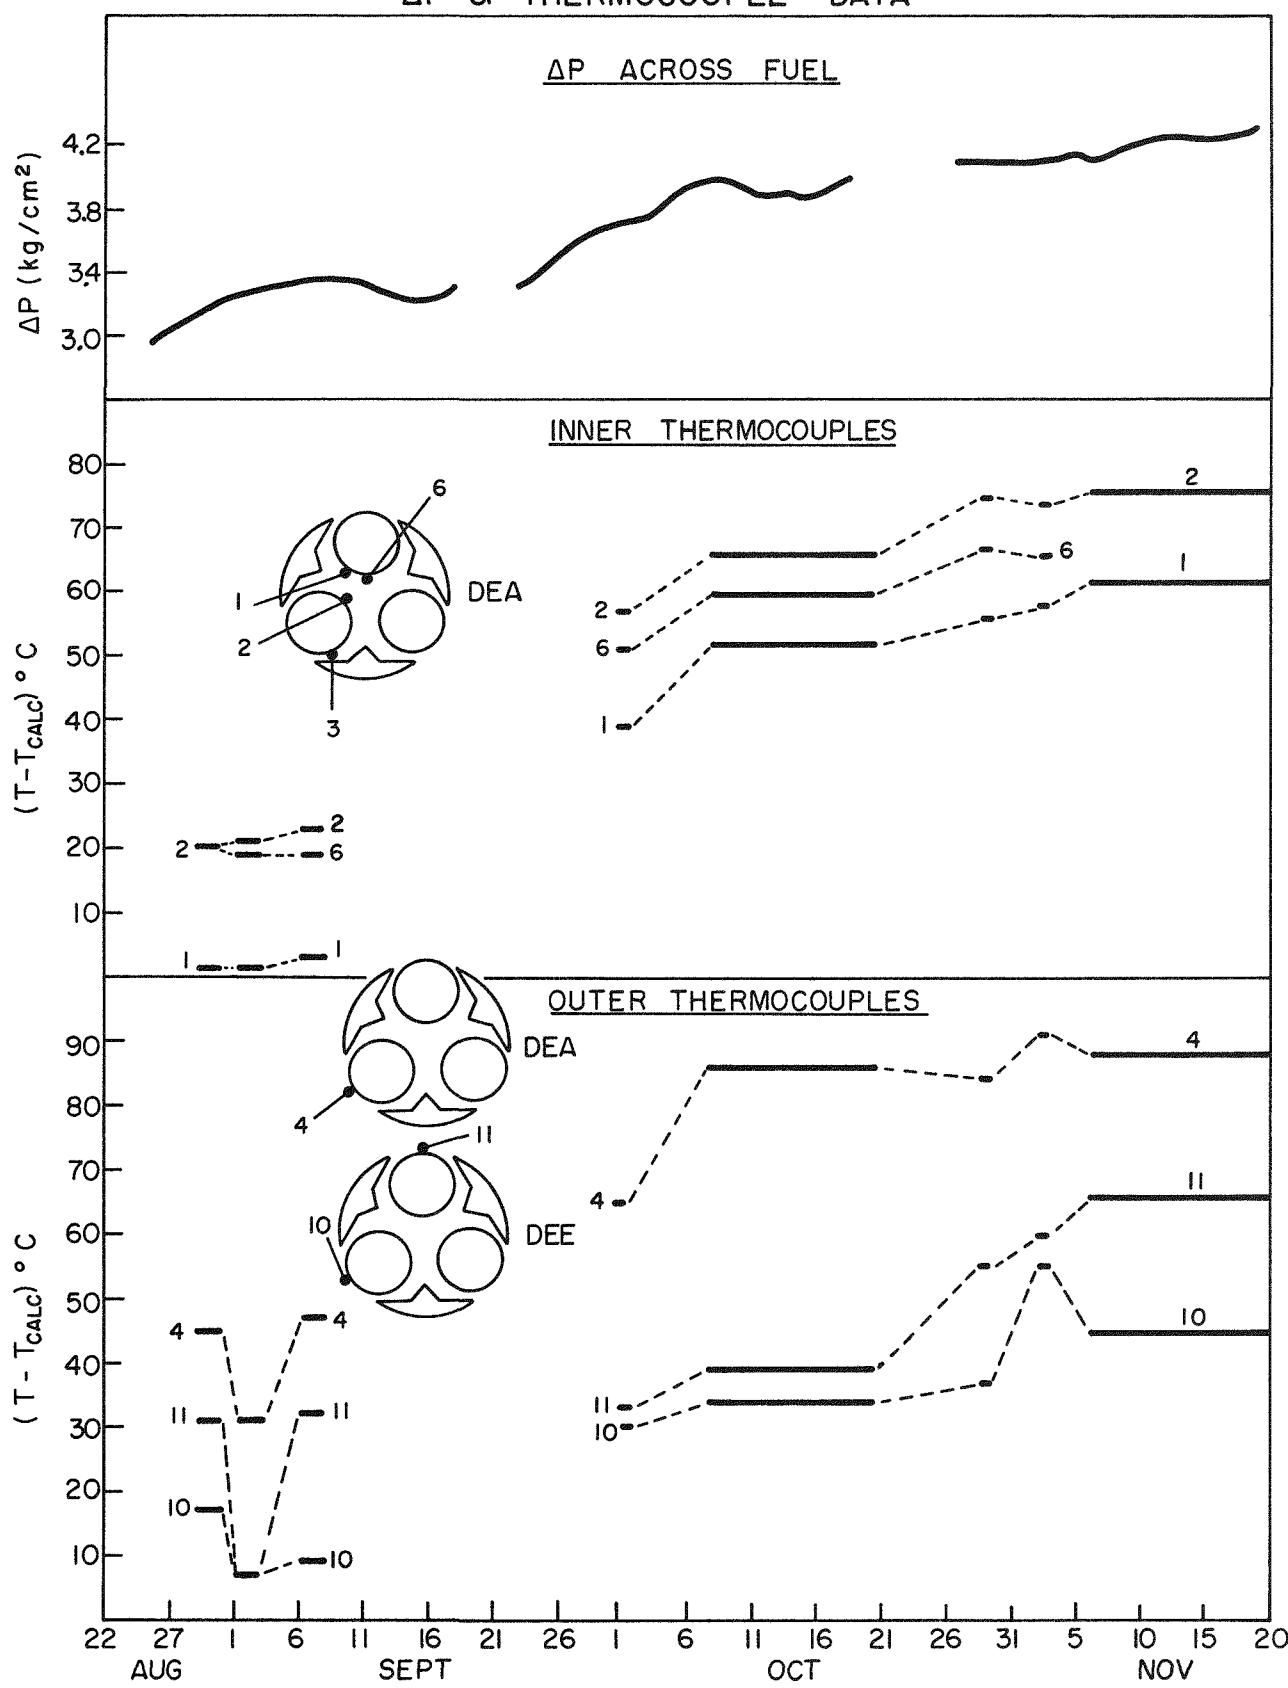
FIG. 23  
 ΔP & THERMOCOUPLE DATA

Figure 23 shows that for thermocouples 4, 10 and 11 there were often sharp changes in sheath temperature. These changes occurred quite suddenly for no apparent reason. It will be noted that these thermocouples are all located in "outer" channels between the fuel elements and the pressure tube.

(c) The difference between this calculated temperature and the temperature as actually read by the thermocouples was noted. Details of calculations are not shown here but values of  $T_{\text{meas}} - T_{\text{calc}}$  for various sheath thermocouples are listed in Table 13 and plotted as a function of time in Figure 23.
