Metallographic Analysis of Dart II Heat Source Capsule

R. E. Fitzharris, M. D. Kelly and J. E. Selle

September 17, 1971

MOUND LABORATORY

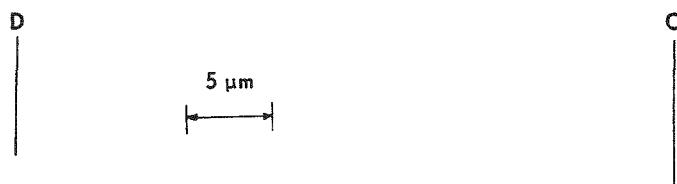
Figure 12 - Continued (read from right to left).

FIGURE 12 - Electron microprobe strip chart of large impurity reaction product from Sample III.

Photomicrographs were taken at different magnifications along the fuel-liner side wall interface, (Sample III in Figure 5b) and are shown in Figure 11. A trace of the microprobe strip chart and photomicrograph of the large white reaction product are shown in Figure 12. A plutonium-tantalum reaction product of 22 μm wide is seen near the surface. The trace also shows that the fuel impurities penetrated the liner 120 μm . Figure 12, Area A on the photomicrograph, is the outer dark band and is a reaction between plutonium and tantalum as well as other mixed reaction products. The major white phase in Figure 12, Area B is a mixture of cobalt, chromium, and iron intermetallics. The gray phase at the inner edge of Area B is richer in nickel and tungsten. The cobalt peaks in the strip chart trace show that Area C contains iron, cobalt, nickel and tungsten. The iron, chromium, cobalt and nickel are present as impurities in the fuel as shown in Table 1. No reason can be given for the spasmodic concentration of these impurities along the interface, unless the impurities are not homogenously distributed throughout the fuel. The increase in the oxygen trace in Area D shows the dark fine stringers to be rich in oxygen.

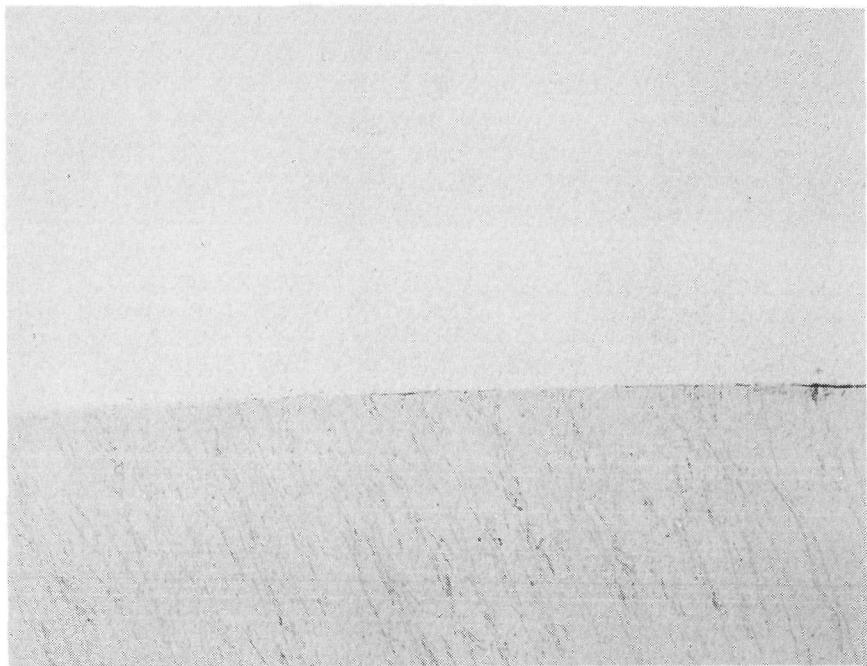
FIGURE 18 - Photomicrograph of liner-strength member interface.
Unetched, 130X

Liner Strength Member Interface - A photomicrograph of the tantalum-10% tungsten liner-TZM strength member interface can be seen in Figure 18. The tantalum oxide stringers can be seen extending completely through the liner to the strength member. The strip chart trace in Figure 19 shows a 10 μm diffusion zone between the molybdenum in the strength member and the tantalum in the liner. Where the tantalum diffused into the TZM at the interface, a tungsten buildup is shown in the strip chart trace because the tantalum was depleted from the liner. The presence of oxygen in the liner is seen as a slight increase of O_2 on the strip chart trace on the liner side. Also, the slight increase in the background along with the hardness data in Figure 20 of the oxygen trace suggests solution of oxygen in the tantalum alloy.

The morphology of the tantalum oxide stringers suggests the oxygen diffused down short circuiting paths. These short circuiting paths could either be grain boundaries or dislocations. Distortion of the metal near the surface, probably by the machining step, is indicated by the change in orientation of the stringers at the interface.
