GEAP-4165A
AEC-RESEARCH AND
DEVELOPMENT PROGRAM
MARCH 1963
(Supersedes GEAP-4165)

GENERAL AND STRESS CORROSION OF HIGH NICKEL ALLOYS IN SIMULATED SUPERHEAT REACTOR ENVIRONMENT

VALLECITOS ATOMIC LABORATORY

Prepared for the
NUCLEAR SUPERHEAT PROJECT
Sponsored by the
UNITED STATES ATOMIC ENERGY COMMISSION
under
Contract AT(04-3)-189
Project Agreement No. 13

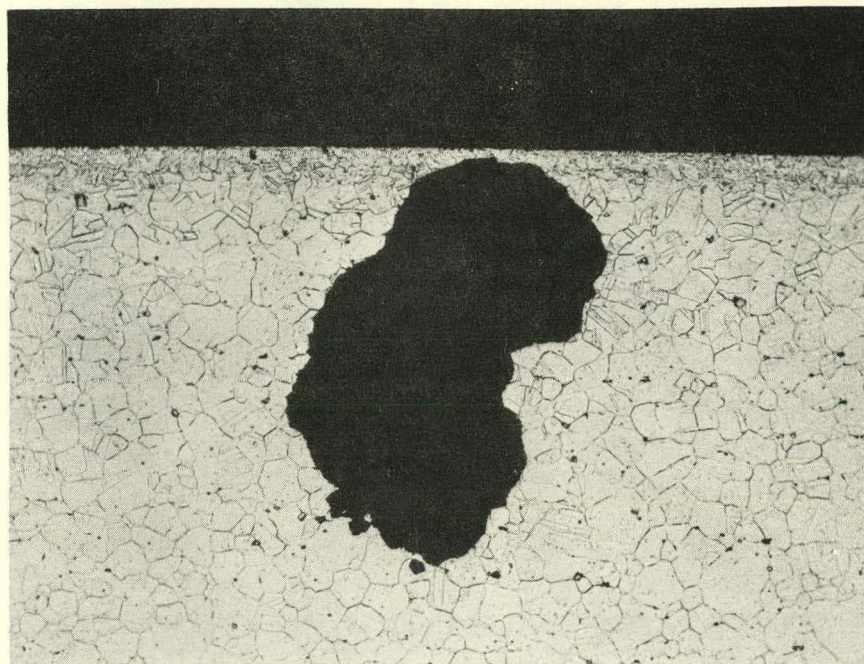
1037-4

a. TYPE 304 SS

b. INCONEL

FIGURE A-2 AS RECEIVED MATERIAL EXPOSED TO CUPRIC CHLORIDE
SOLUTION, 210-220 F, 400 PPM CHLORIDE, 24 HOURS
10% OXALIC - ELECTROLYTIC ETCH (250 X)

c. INCOLOY

d. HASTELLOY X

In the as-received condition, the materials were tested in atmospheric boiling CuCl_2 at concentrations of 400 and 20,000 ppm Cl^- for 24 hours and 1 hour respectively. In the 400 ppm Cl^- test, the Type 304 stainless steel, Inconel, and Incoloy specimens were pitted while the Hastelloy-X was not attacked as shown in Figures A-2a to A-2d. The results were the same in the 20,000 ppm Cl^- solution. It was found that the Inconel had some degree of sensitization in the as-received condition.

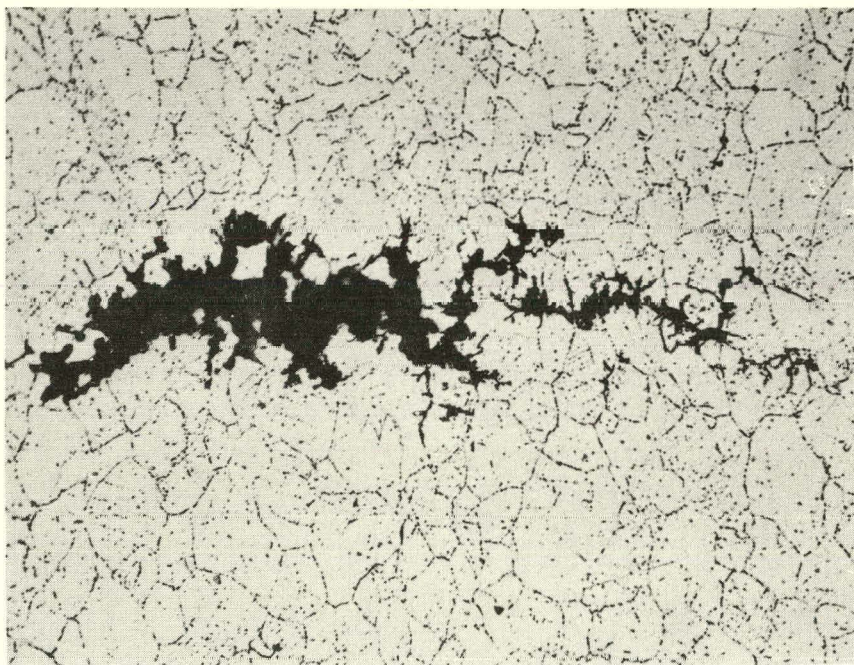
1037-9

a. 1/4 HARD
250 X

b. 3/4 HARD
500 X

FIGURE A-5 TYPE 304 SS COLD WORKED EXPOSED TO CUPRIC CHLORIDE SOLUTION, 210-220 F, 20,000 PPM CHLORIDE, 1 HOUR
OXALIC - ELECTROLYTIC ETCH

Type 304 stainless steel in the 1/4 hard and 3/4 hard condition was tested in atmospheric boiling CuCl_2 with 20,000 ppm Cl^- for 1 hour. The 1/4 hard material had transgranular cracks as shown in Figure A-5a and the 3/4 hard material, found to have been received in the sensitized condition, was intergranularly attacked as seen in Figure A-5b. U-bends of annealed, 1/4 hard and 3/4 hard Type 304 stainless steel were tested in atmospheric boiling CuCl_2 containing 20,000 ppm Cl^- for 1 hour. All the materials had transgranular cracks associated with pits and the severity of cracking increased with the amount of total stress (residual plus applied).
