SNAP-19B(IRHS) RECOVERED HEAT SOURCES
FINAL REPORT

D. E. Loyer and C. H. Davenport

Issued: September 15, 1969

Two SNAP-19B (IRHS) heat sources which had fallen into the Pacific Ocean on May 18, 1968, as a result of the abort of a NIMBUS-B satellite were recovered on October 9, 1968, and returned to Mound Laboratory for examination and fuel recovery.

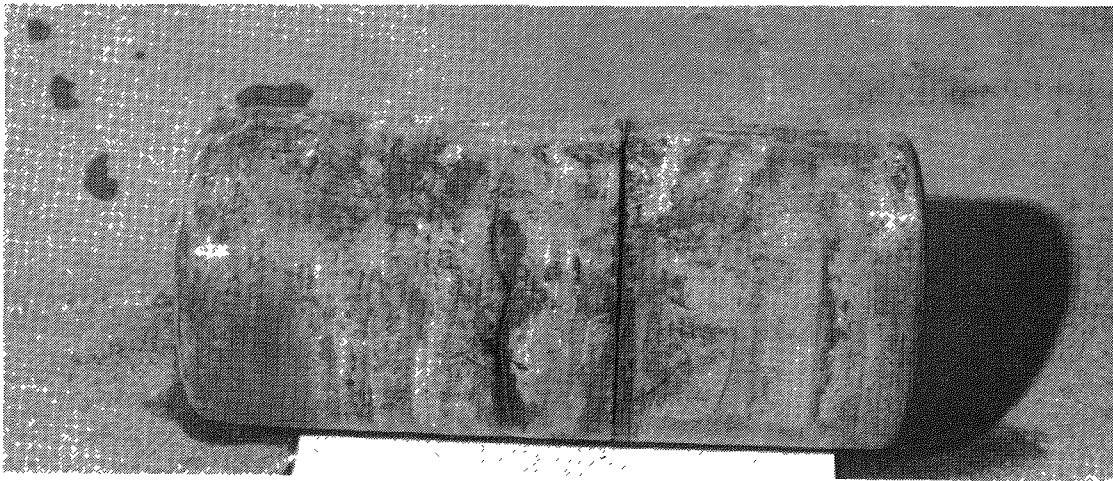
PHOTOGRAPH 1 - Heat source 375/369 without heat accumulator block.

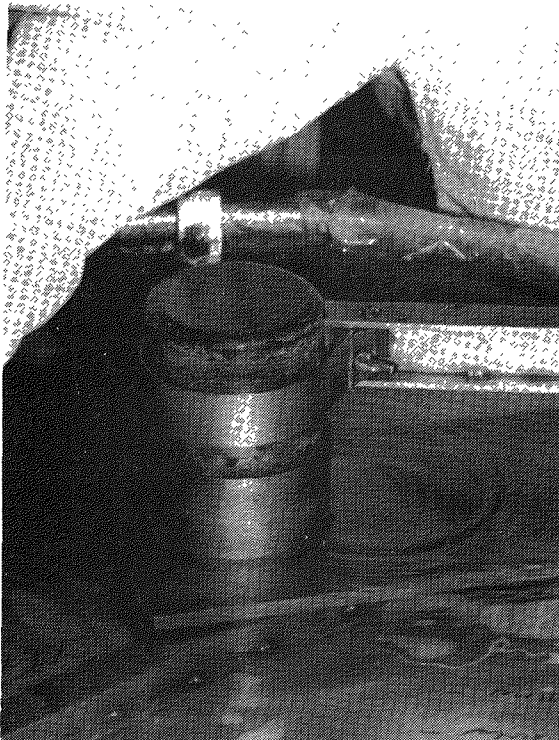
PHOTOGRAPH 2 - Unscrewing the graphite block.

Upon completion of a health physics survey which indicated no release of alpha contamination, the heat source was placed into a holder and a strap wrench was attached to each half of the graphite heat shield (Photographs 2, 3, 4). Initially, a small torque was needed to unscrew the graphite halves but after several turns, the unscrewing became easy. The same strap wrenches, holder, and personnel that were used in the original assembly in December, 1967, were employed for this disassembly operation. As the last few threads were approached,

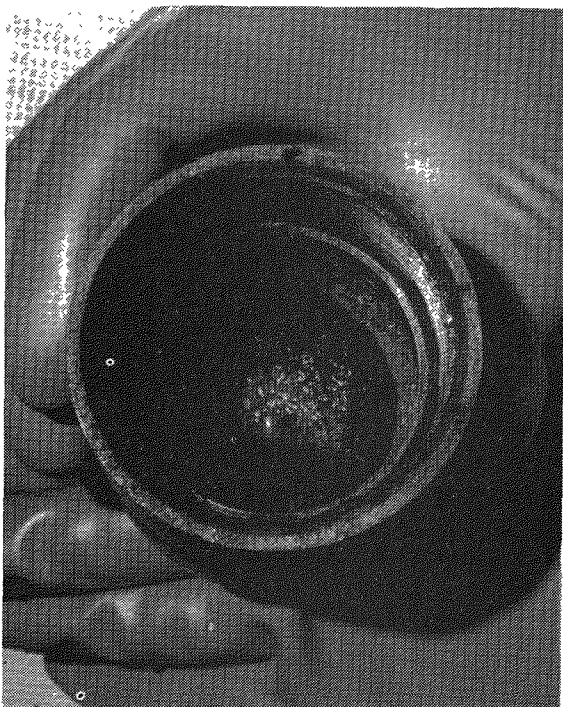
PHOTOGRAPH 5 - Female half of heat shield with water inside.

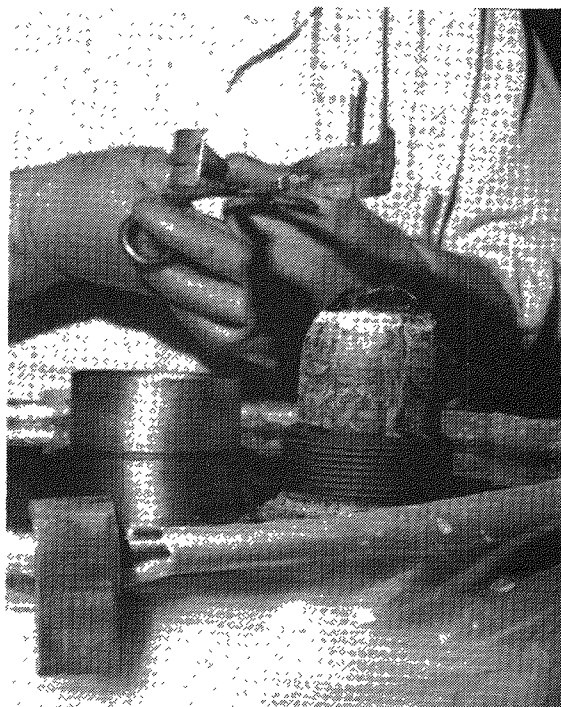
PHOTOGRAPH 6 - Canistered capsule showing deposits on canistered surface.

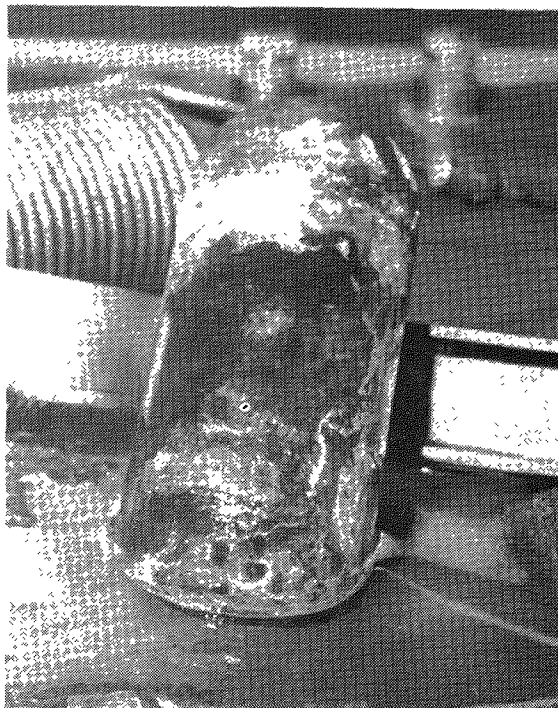
The canistered capsule had salt deposits on its surface (Photograph 8). A portion of the canistered sleeve had disintegrated (Photograph 9). The canister cap was removed intact (Photograph 10); it had a small crack starting from the edge and ending just below the center of the cap. The canister was embrittled and parts broke while being disassembled (Photograph 10). The coatings on the inside of the canister had come off in several areas. The canister was submitted to metallography for inspection.

PHOTOGRAPH 9 - Canistered capsule showing disintegrated portion of canister sleeve.

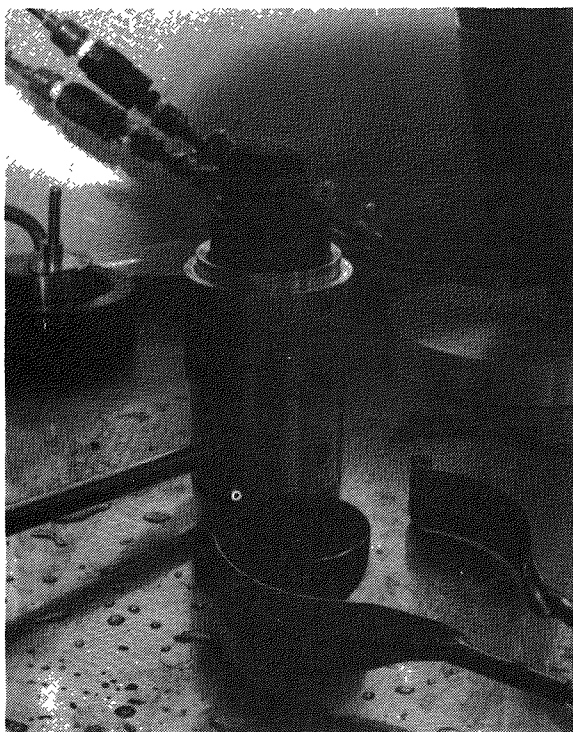
On January 16, 1969, the vent end of capsule SN 375/369 was cut off with a tubing cutter. The fuel was found to be sintered, as indicated previously by the radiographs, and took the shape of the inside of the capsule (Photograph 15). The glowing red, sintered clump appeared to be thicker in the mid-section than at the domed end (Photograph 16). There was no visible indication of salt inside the capsule. A sample of the sintered clump was taken for analytical

PHOTOGRAPH 15 - Upper portion of capsule exposing fuel.

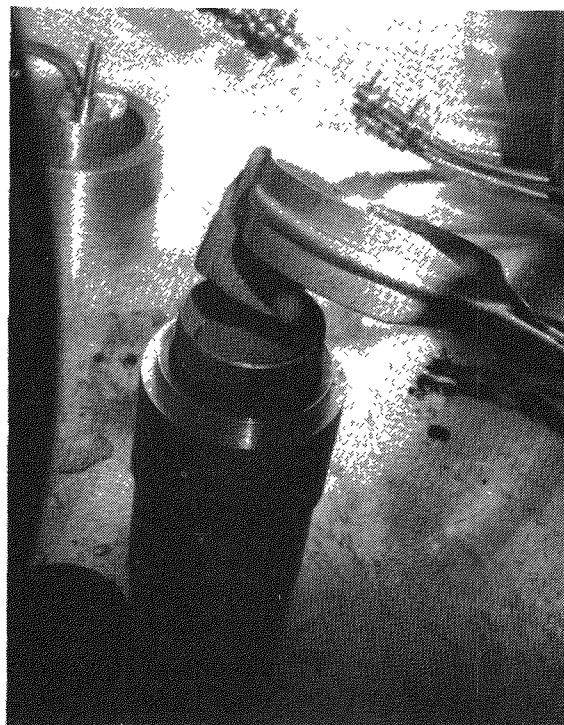
PHOTOGRAPH 16 - Removal of agglomerated fuel.

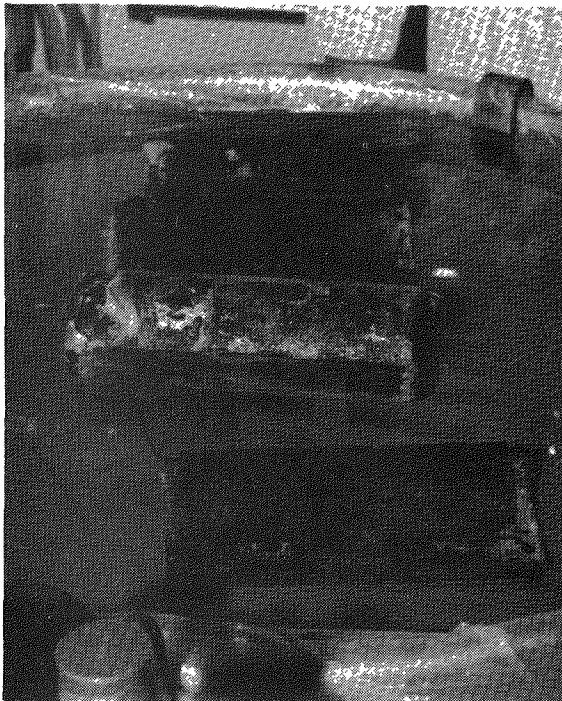
The graphite heat shield was removed from the second SNAP-19B (IRHS) unit on January 20, 1969. The operation was begun by removing the graphite heat accumulator block from around the graphite heat shield (Photographs 17-19). Salt deposits were present on the outside of the heat shield (Photograph 20). The graphite heat shield was visually inspected and no cracks could be seen. Dimensions were determined using a vernier caliper; but due to the various surface deposits as stated previously (Section III-A) it was difficult to obtain a comparison with the original dimensions. No alpha contamination was detected. The source was then placed into a holder. Several attempts were made to unscrew the heat shield, but each ended in failure (Photographs 21 and 22). The heat source was then put into a fume-hood, and the graphite heat shield was carefully broken from around

PHOTOGRAPH 17 - Removal of heat accumulator block from heat source SN 361/368.

PHOTOGRAPH 18 - Heat source SN 361/368 with heat accumulator block off.

PHOTOGRAPH 19 - Heat source SN 361/368 with heat accumulator block off (90° from Photograph 18).

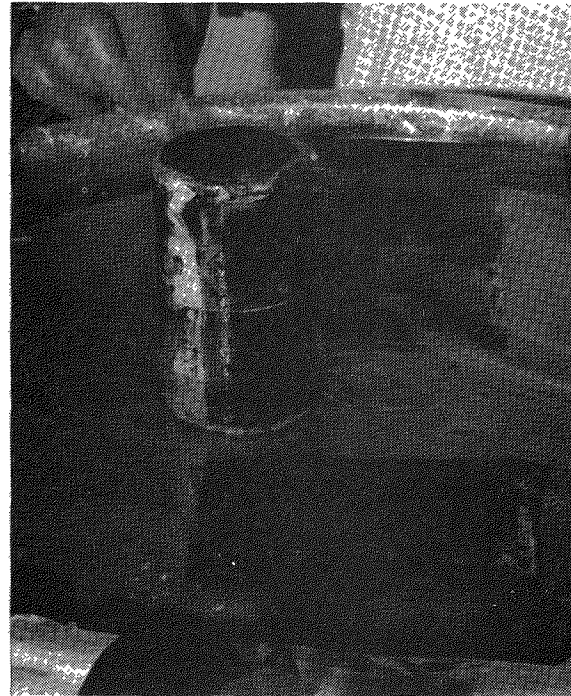
PHOTOGRAPH 20 - Heat source SN 361/368 with heat accumulator block off (180° from Photograph 18).

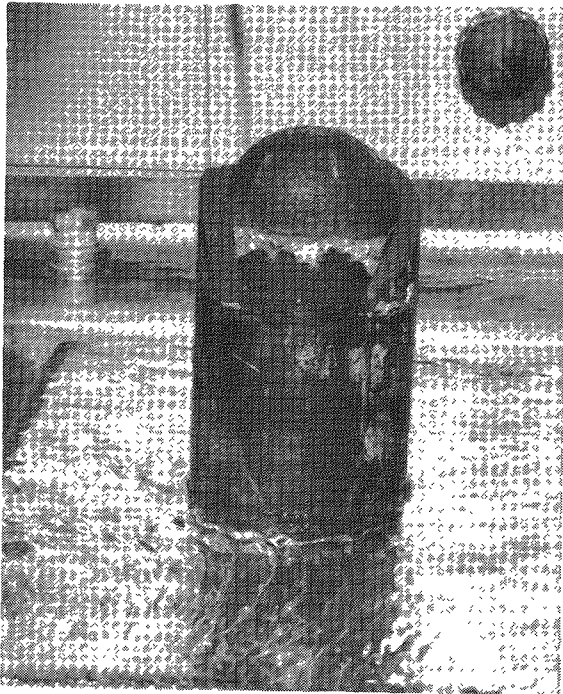
PHOTOGRAPH 23 - Exposed canistered capsule with tantalum pad stuck to domed end.

Upon removal of the canistered capsule from the broken heat shield, parts of the compliance pads were found to be stuck to each domed end of the canister (Photograph 23). Salt deposits were on the canister. The cap and sleeve portions were removed intact except for a small area around the top of the sleeve portion (Photograph 29) which had to be broken to initiate canister sleeve removal (Photograph 30). The coating on the inside surface appeared to be intact and the canister was embrittled. Photographs 31 and 32 show the various components removed from around the capsule. All the components that were removed were found to be free from contamination.

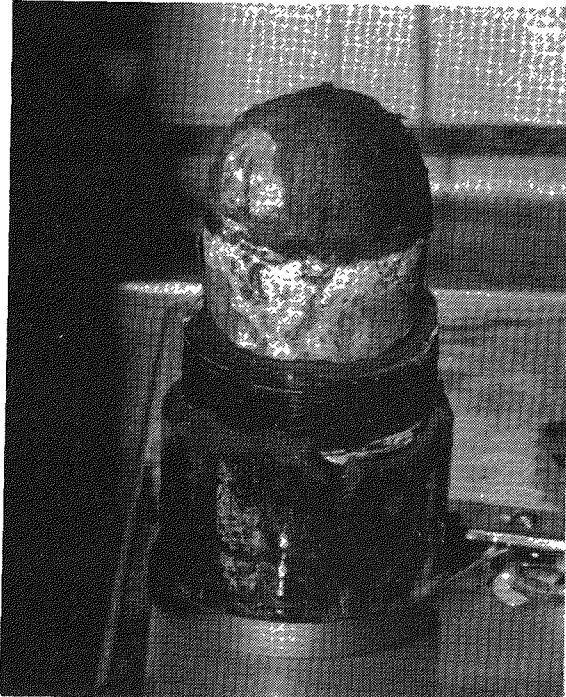
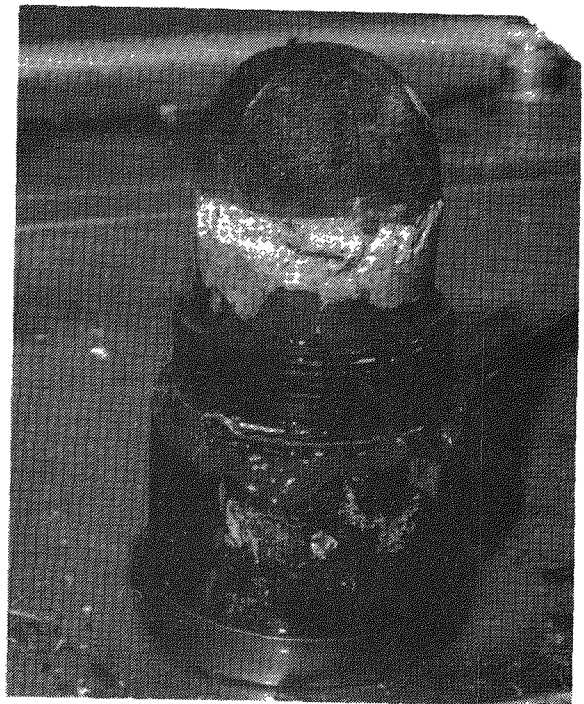
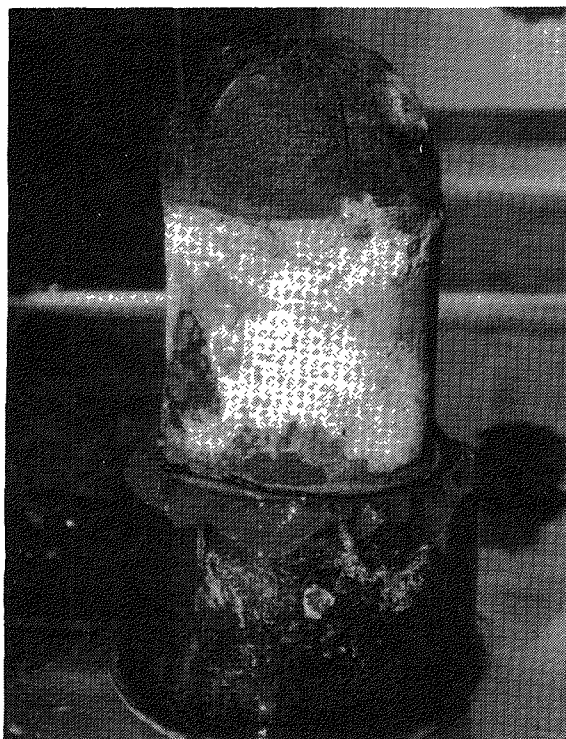
the canistered capsule using a hammer and screwdriver. Photographs 23-28 illustrate the sequence of this breaking-off operation. The coating on the inside of the graphite heat shield was not attached to the mid-section of the graphite. Water was found on the inside of the heat shield.

PHOTOGRAPH 24 - Exposed canistered capsule with male section of graphite heat shield broken off.

PHOTOGRAPH 25 - Exposed canistered capsule.

PHOTOGRAPH 26 - Exposed canistered capsule.

PHOTOGRAPH 27 - Exposed canistered capsule.

PHOTOGRAPH 28 - Exposed canistered capsule.

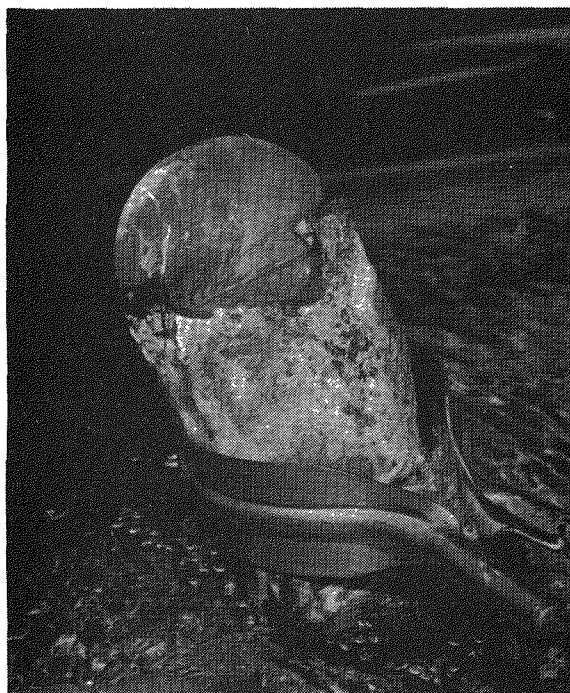
PHOTOGRAPH 29 - Exposed canistered capsule showing area that was broken to initiate canister sleeve removal.

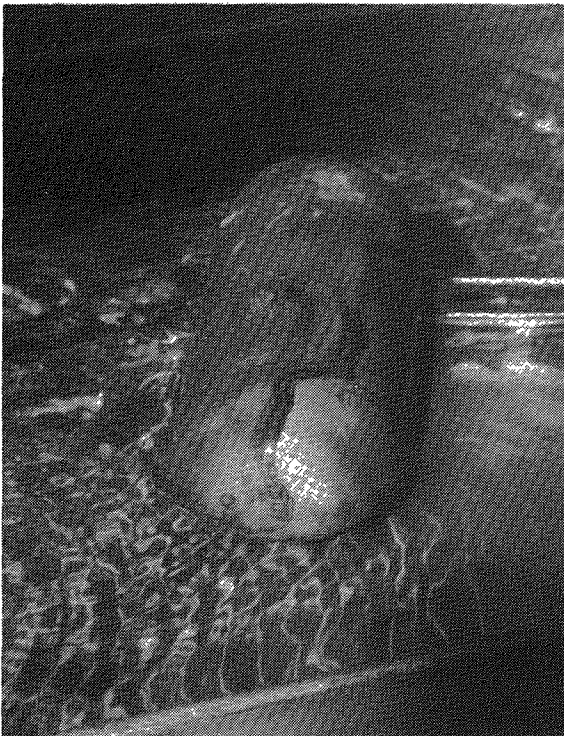
There was no noticeable surface corrosion on the capsule as was the case with capsule 375/369. There were some greenish streaks running the length of the capsule and white deposits on various areas of the capsule surface (Photographs 33 and 34). The filter diaphragm area was not caked with white deposits (Photograph 30) as previously noted on capsule SN 375/369.

PHOTOGRAPH 33 - Capsule showing green streaks.

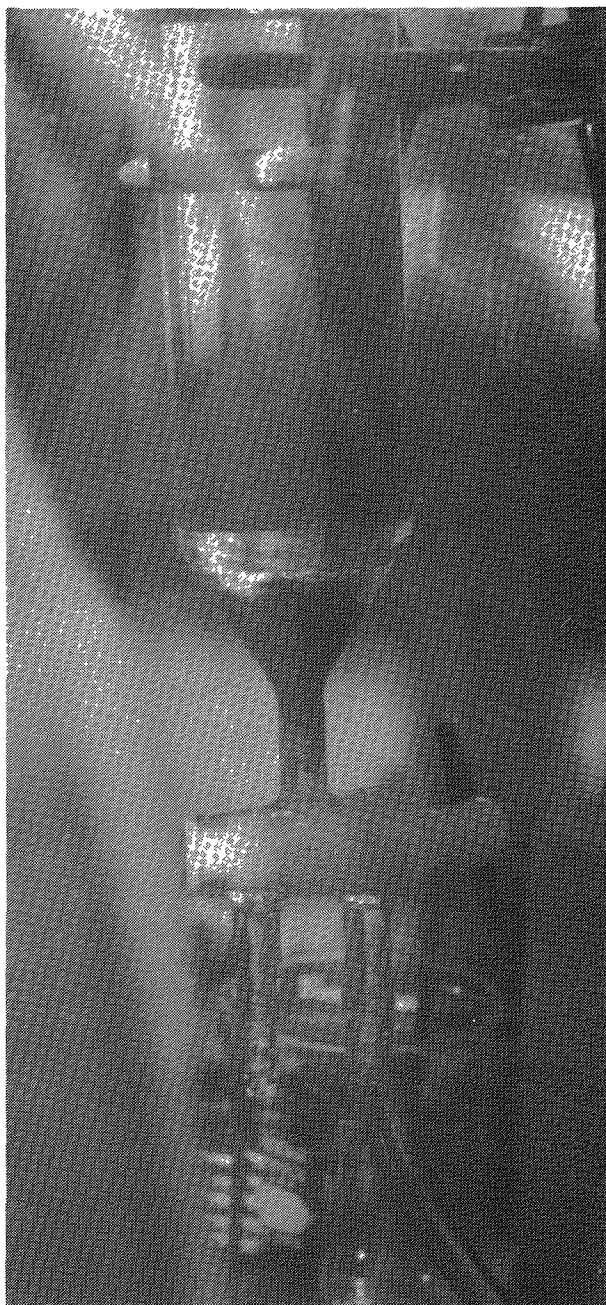
Figure 2 shows a schematic illustration of the operation which followed. The capsule was inverted, and ~10 g of fuel came out into the elutriation column (Photograph 35). This operation was repeated

PHOTOGRAPH 35 - Elutriation column containing $^{238}\text{PuO}_2$ microspheres.

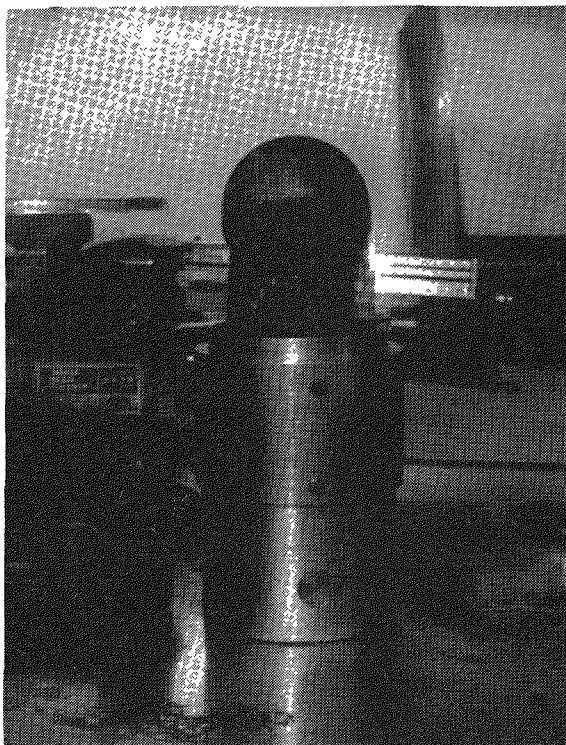
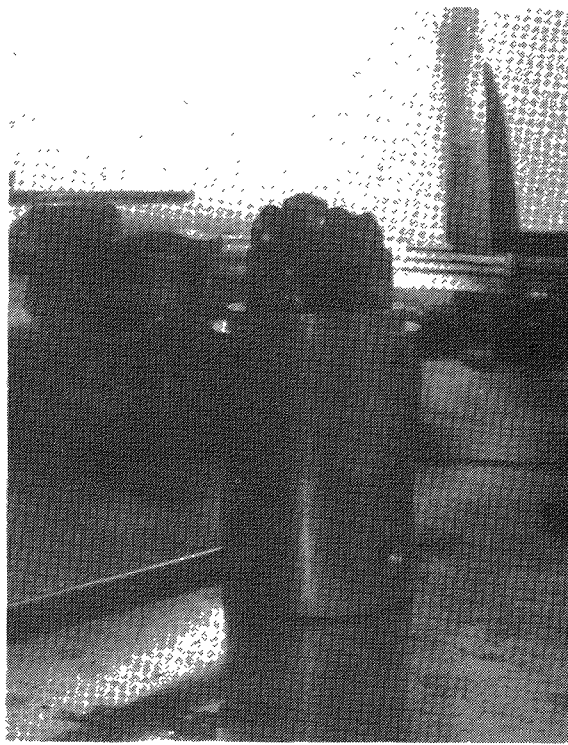
On January 24, 1969, the vent end of capsule SN 361/368 was cut off with a tube cutter. The fuel was sintered, but the large clump had broken into several pieces (Photographs 36 and 37). This probably occurred during removal of the graphite heat shield from around the capsule because preliminary radiographs had shown the fuel bed to be intact.

PHOTOGRAPH 36 - Capsule vent end lifted up to show exposed fuel.

PHOTOGRAPH 37 - Capsule vent end removed to show exposed fuel.
