SNAP-21 PROGRAM, PHASE II

**DEEP SEA RADIOISOTOPE-FUELED
THERMOELECTRIC GENERATOR
POWER SUPPLY SYSTEM**

QUARTERLY REPORT NO. 11

Space and Defense Products
ELECTRICAL PRODUCTS GROUP
3-M CENTER, ST. PAUL, MINN. 55101, PH 633-9400

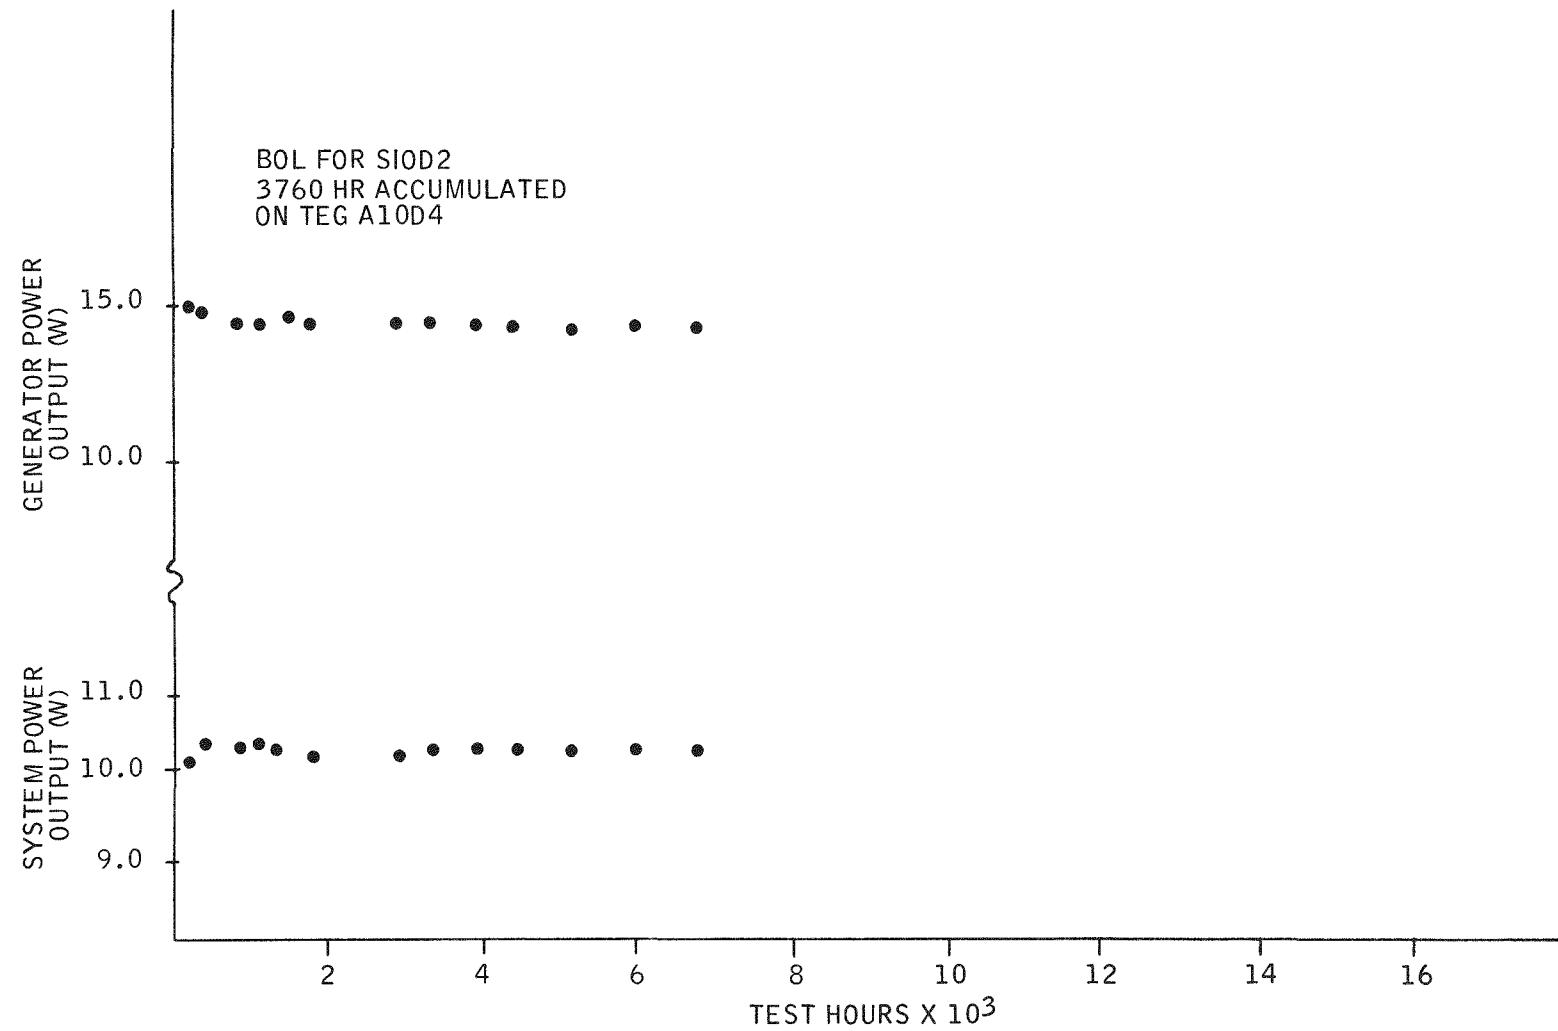
Figure 2-1. System S10D2 Performance

System S10D2 continued on long-term performance test. There have been some changes in the system temperature. This is due to the one watt decrease in power input. One watt is equivalent to approximately 8°F on the hot side. Figure 2-1 shows thermoelectric generator and system power output. For this report period the performance for the system has been stable. Table 2-1 shows the thermoelectric generator and system electrical performance. Table 2-2 shows the thermal performance data for the system. Figure 2-2 shows system instrumentation. The normalized thermoelectric generator performance data is presented in Figure 2-3. It can be seen that the thermoelectric generator and system performance have been stable.

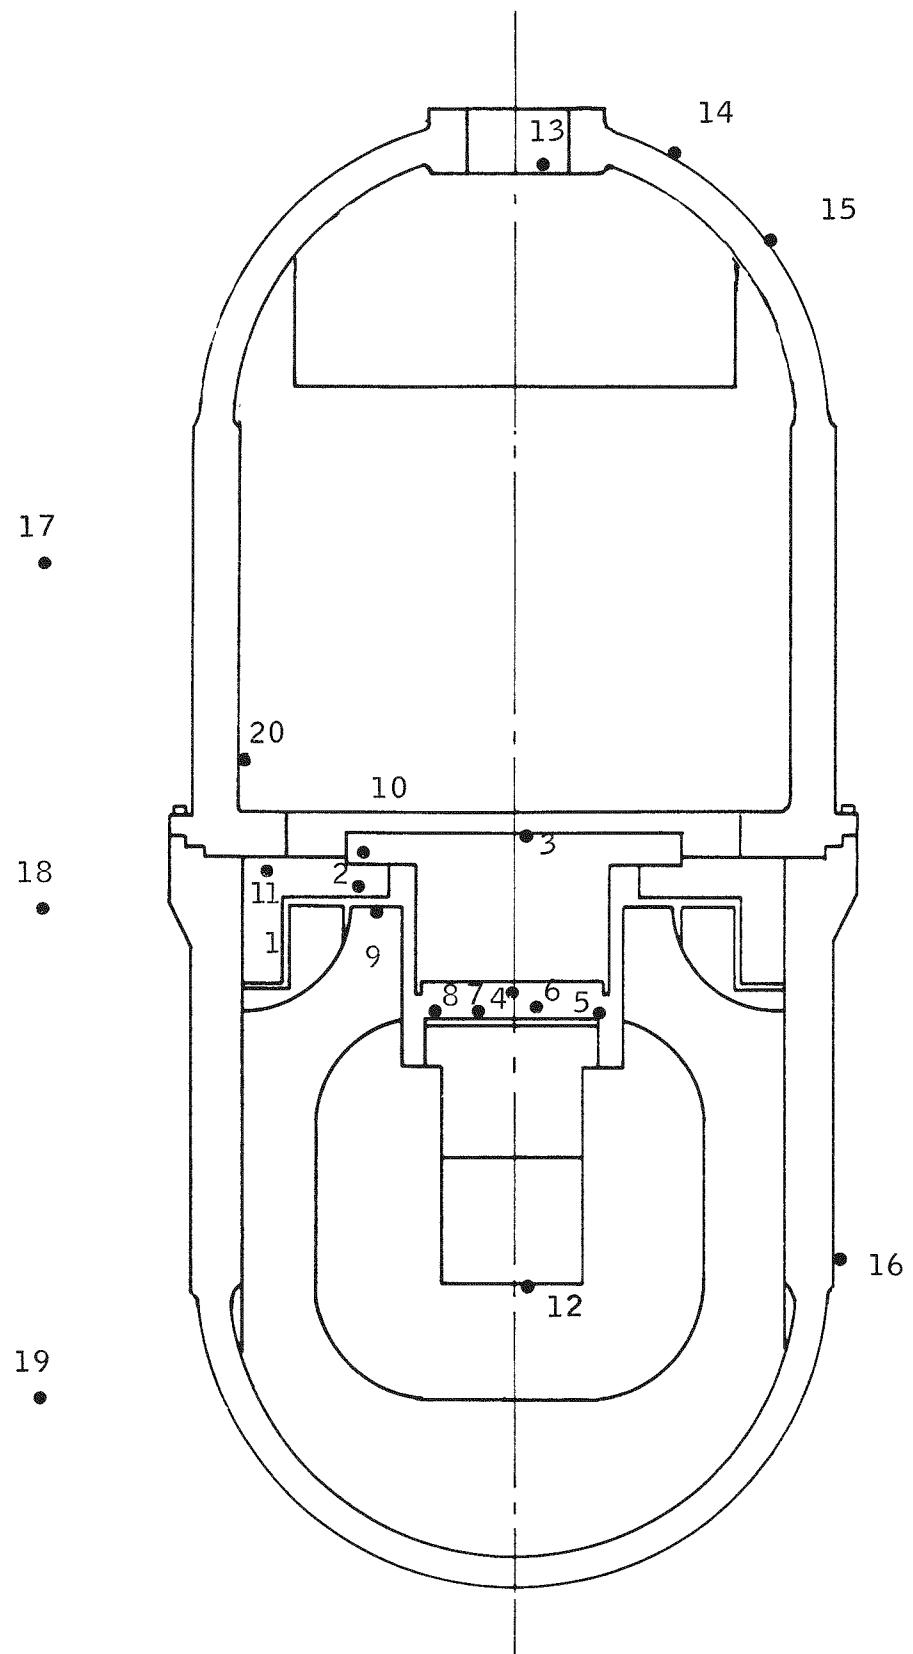
Figure 2-2. System S10D2 Instrumentation

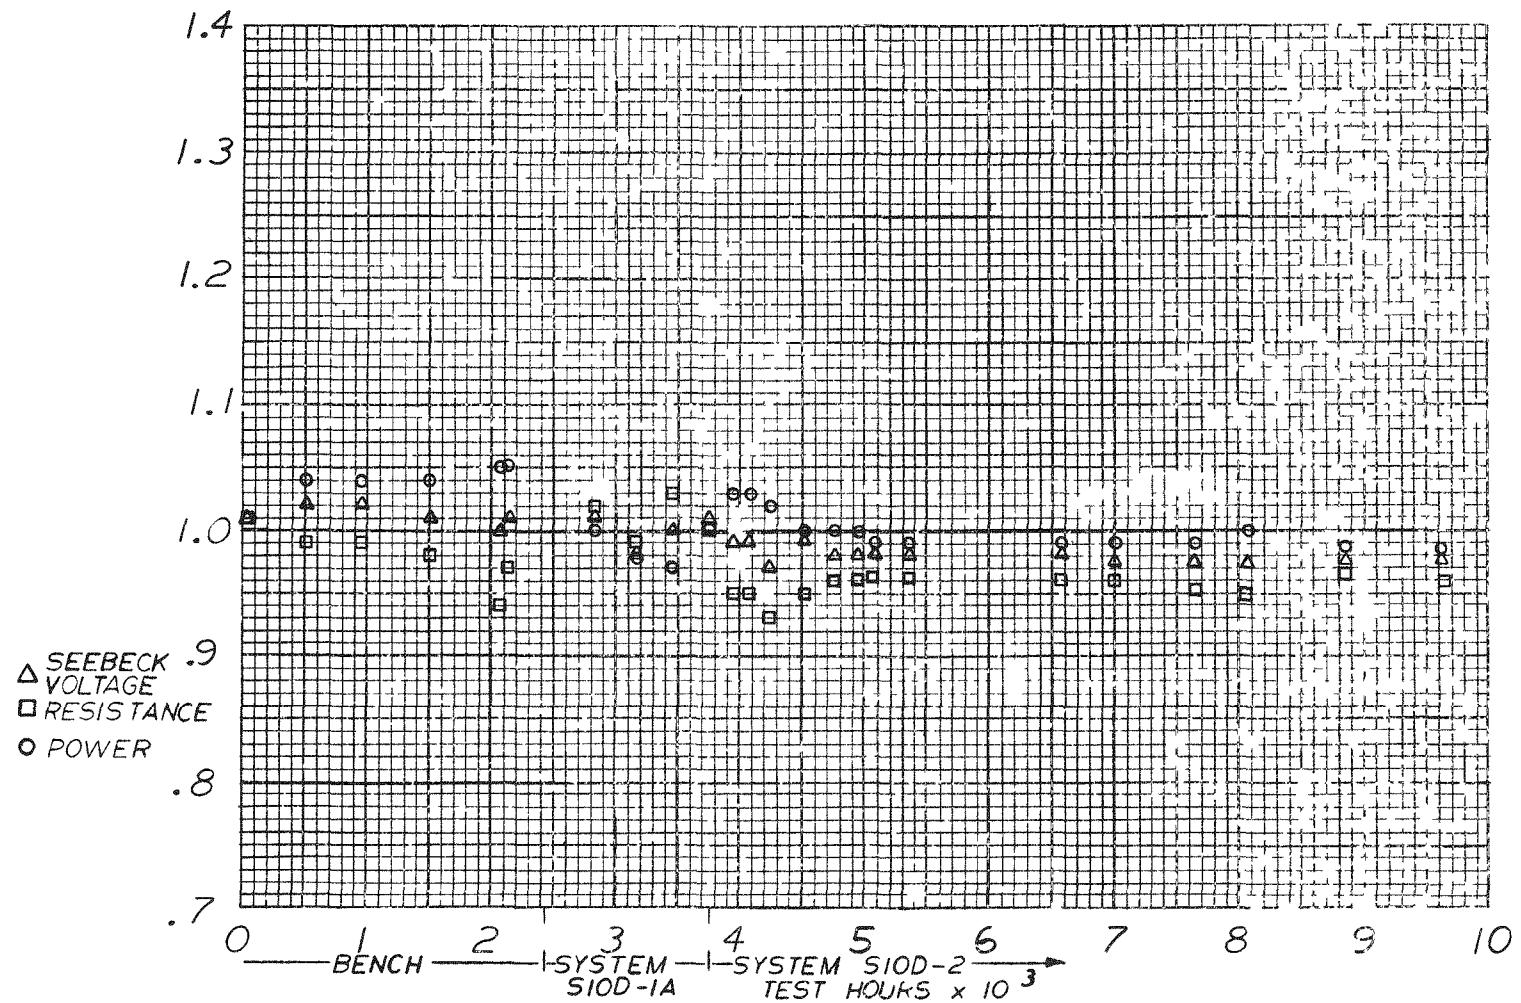
Figure 2-3. SNAP-21 Thermoelectric Generator A10D4 Normalized Data

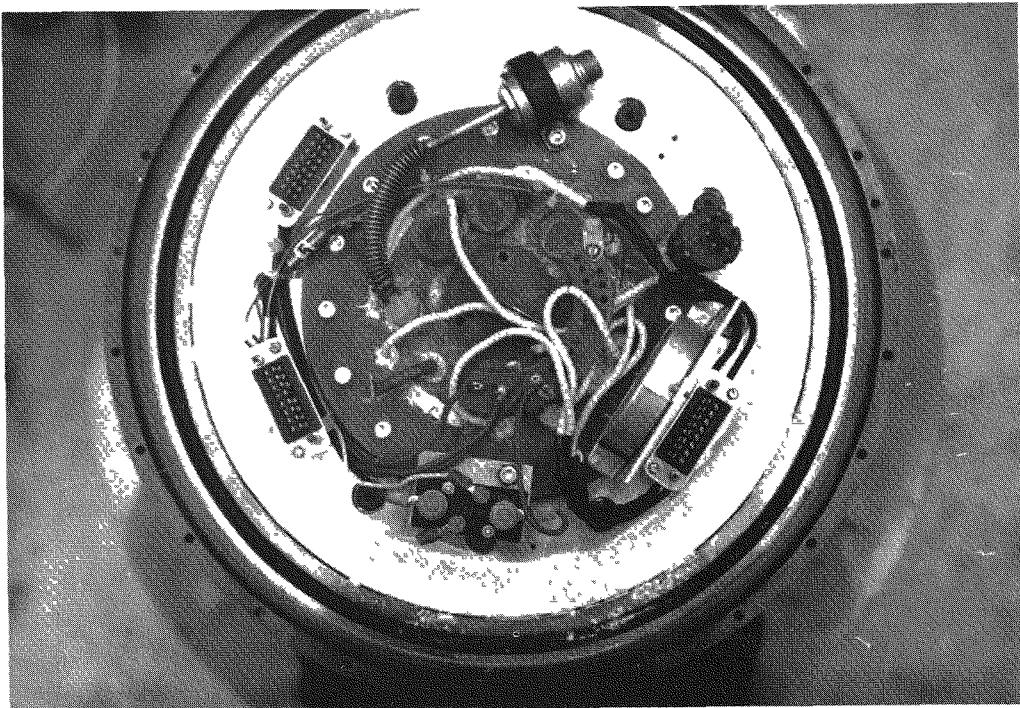
Figure 2-5. System S10D3 Showing Min-K on the Pressure Vessel Flange and the "O" Ring

One other procedure was changed during the assembly operation. The nitrogen purging operation (performed while the pressure vessel cover was mated with the body) had apparently disturbed the Min-K and had blown it into undesirable locations within the system. (Figure 2-5 shows Min-K on the pressure vessel "O" ring.)

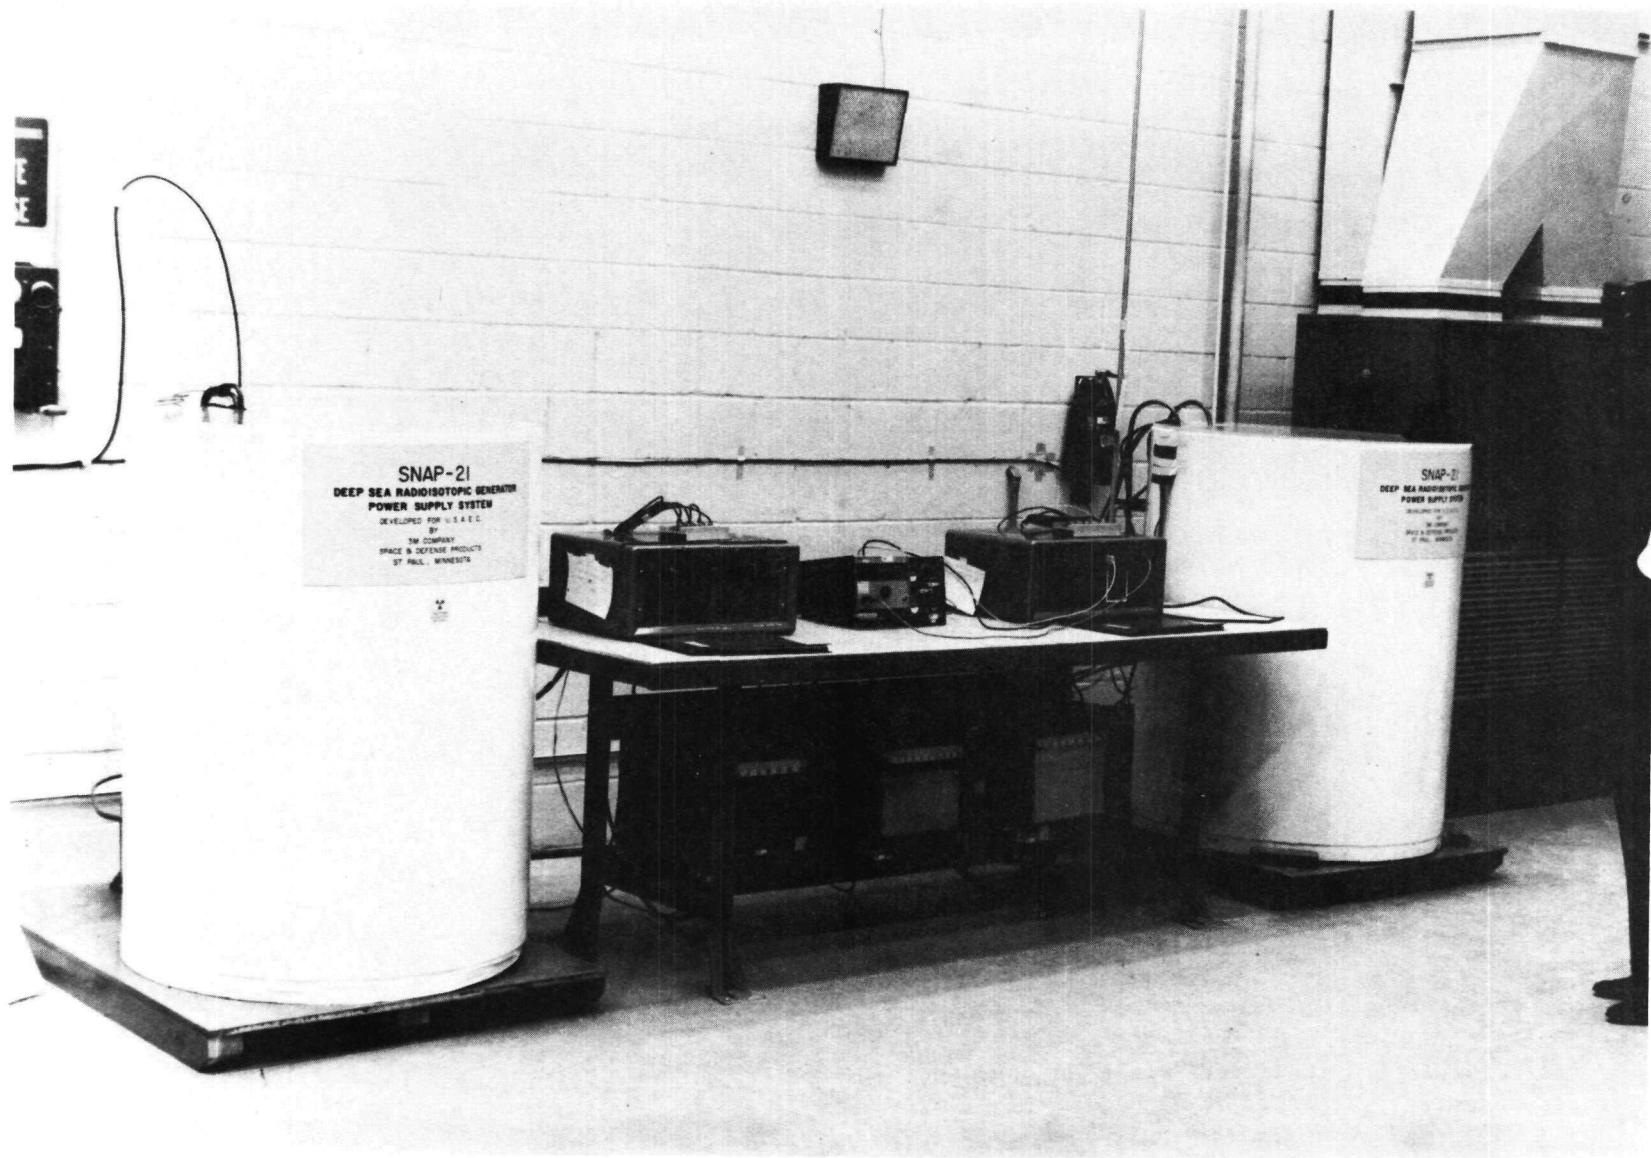
Figure 2-6. System Load and Environmental Characteristic Test Set-Up

The first three SNAP-21 fueled systems (S10P1, S10P2, and S10P3) were tested this past quarter. All environmental testing has been completed except System Load and Environmental Characteristics testing on S10P3. Shown in Figures 2-6 and 2-7 are a picture and drawing of the System Load and Environmental Characteristics test set-up for systems S10P1 and S10P2. At the present time,

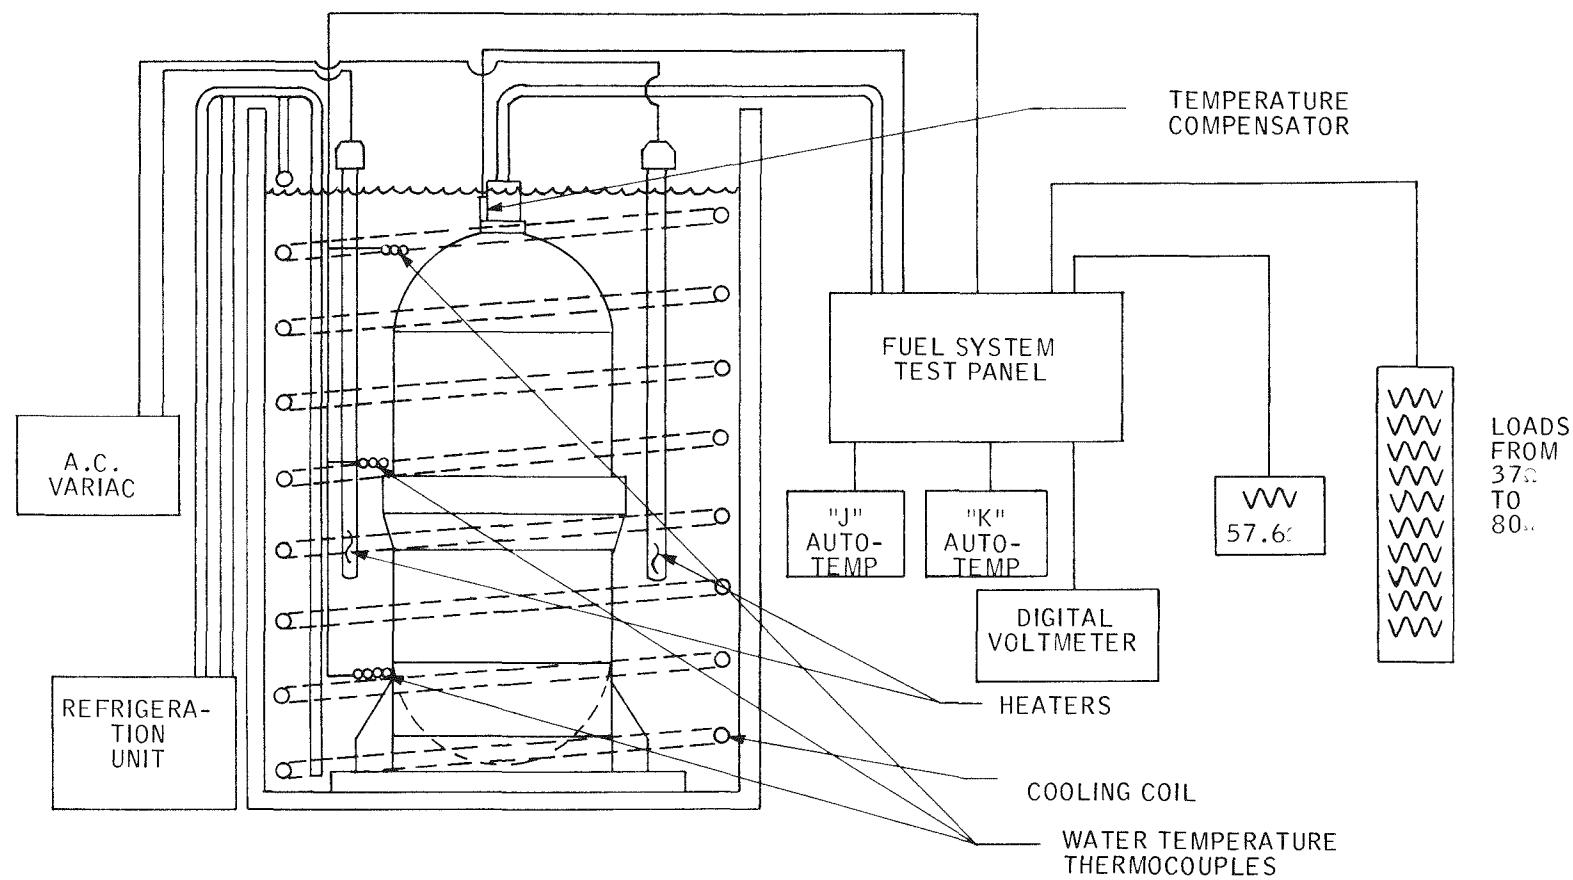
Figure 2-7. Schematic of the Set-Up for Fueled System Load and Environmental Characteristic Test

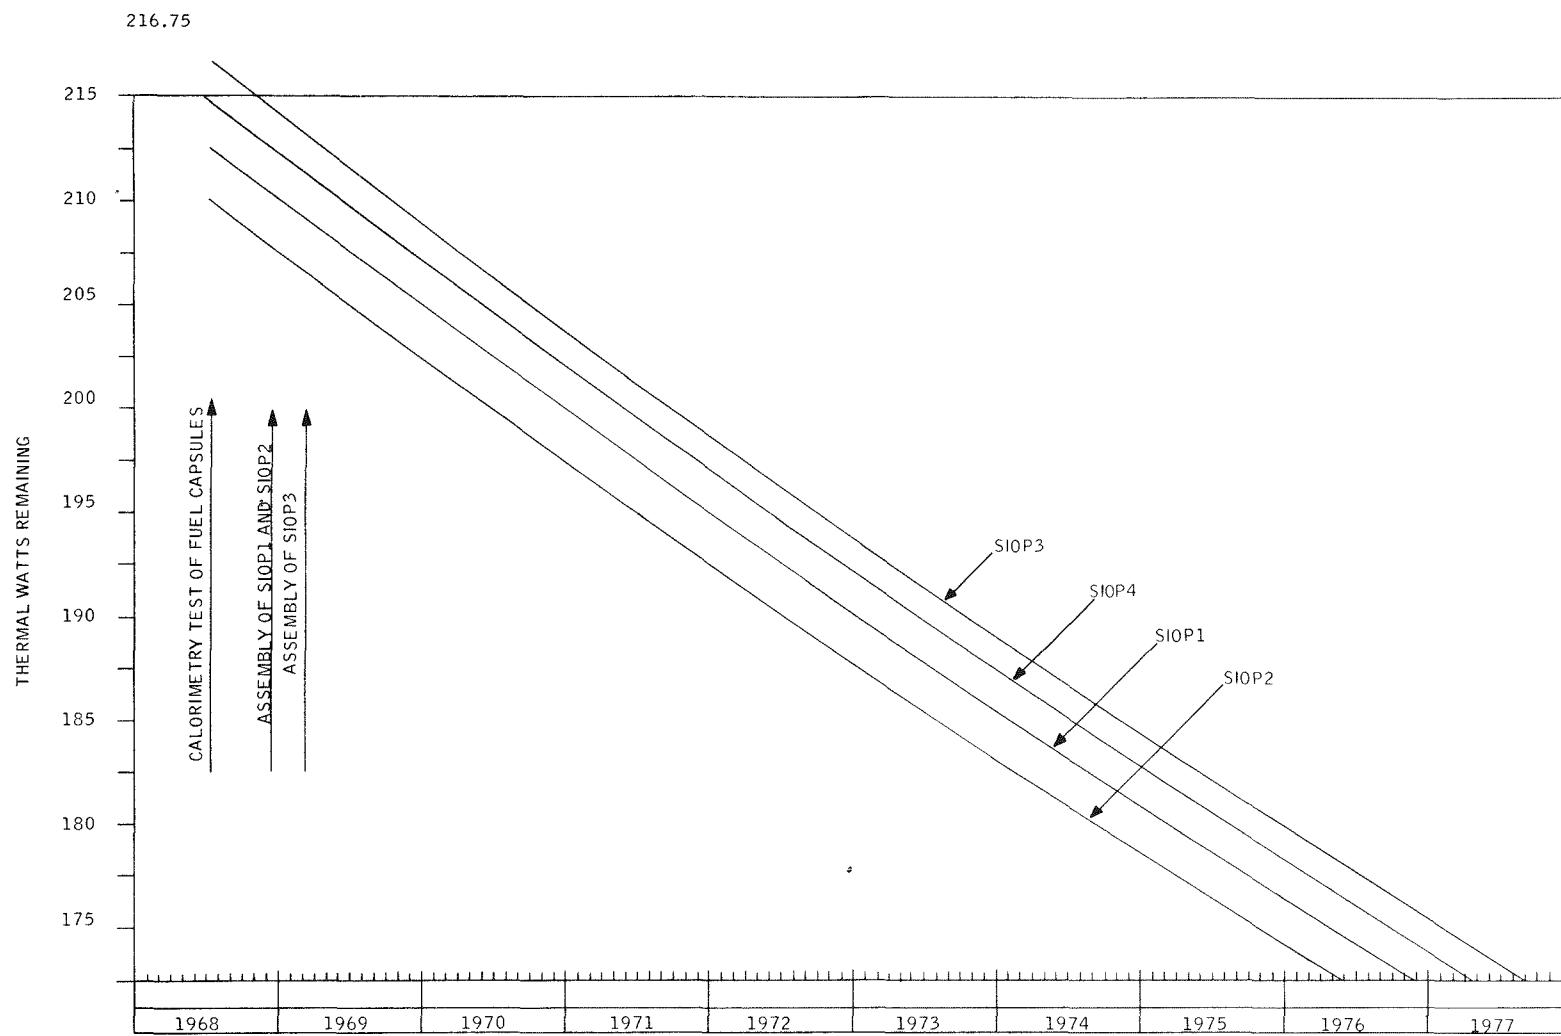
Figure 2-8. SNAP-21 Fuel Decay

Figure 2-8 shows the decay rate for strontium 90 in the fuel capsules for each system. This graph will be used for future analysis of the systems.

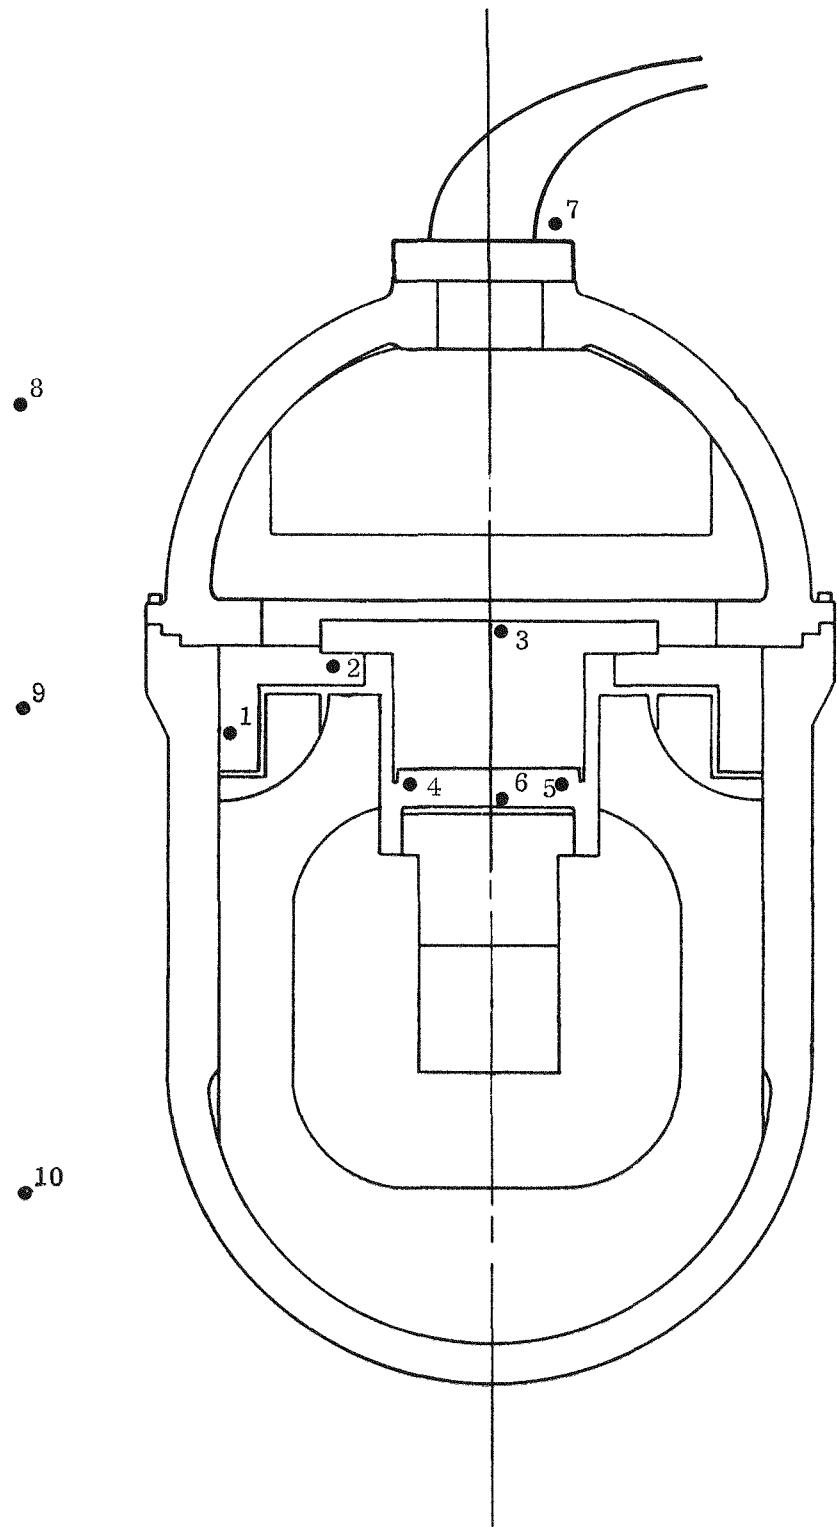
Figure 2-9. General System Instrumentation

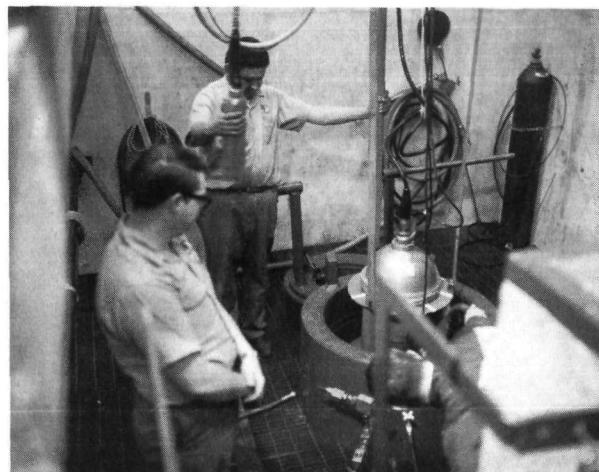
Figure 2-10. SNAP-21 System Being Removed from Test Chamber after Hydrostatic Test

Because of the trouble with system S10P2 (see section 2.1.2.2b), system S10P1 experienced more than the required 5 hours at 10,000 psi. This was necessary in order to ascertain the difficulties with S10P2. The system was at 10,000 psi for a total of 6.5 hours and was subjected to a total of 5 cycles from ambient to 10,000 psi. Figure 2-10 shows removal of the system from the hydrostatic test chamber.

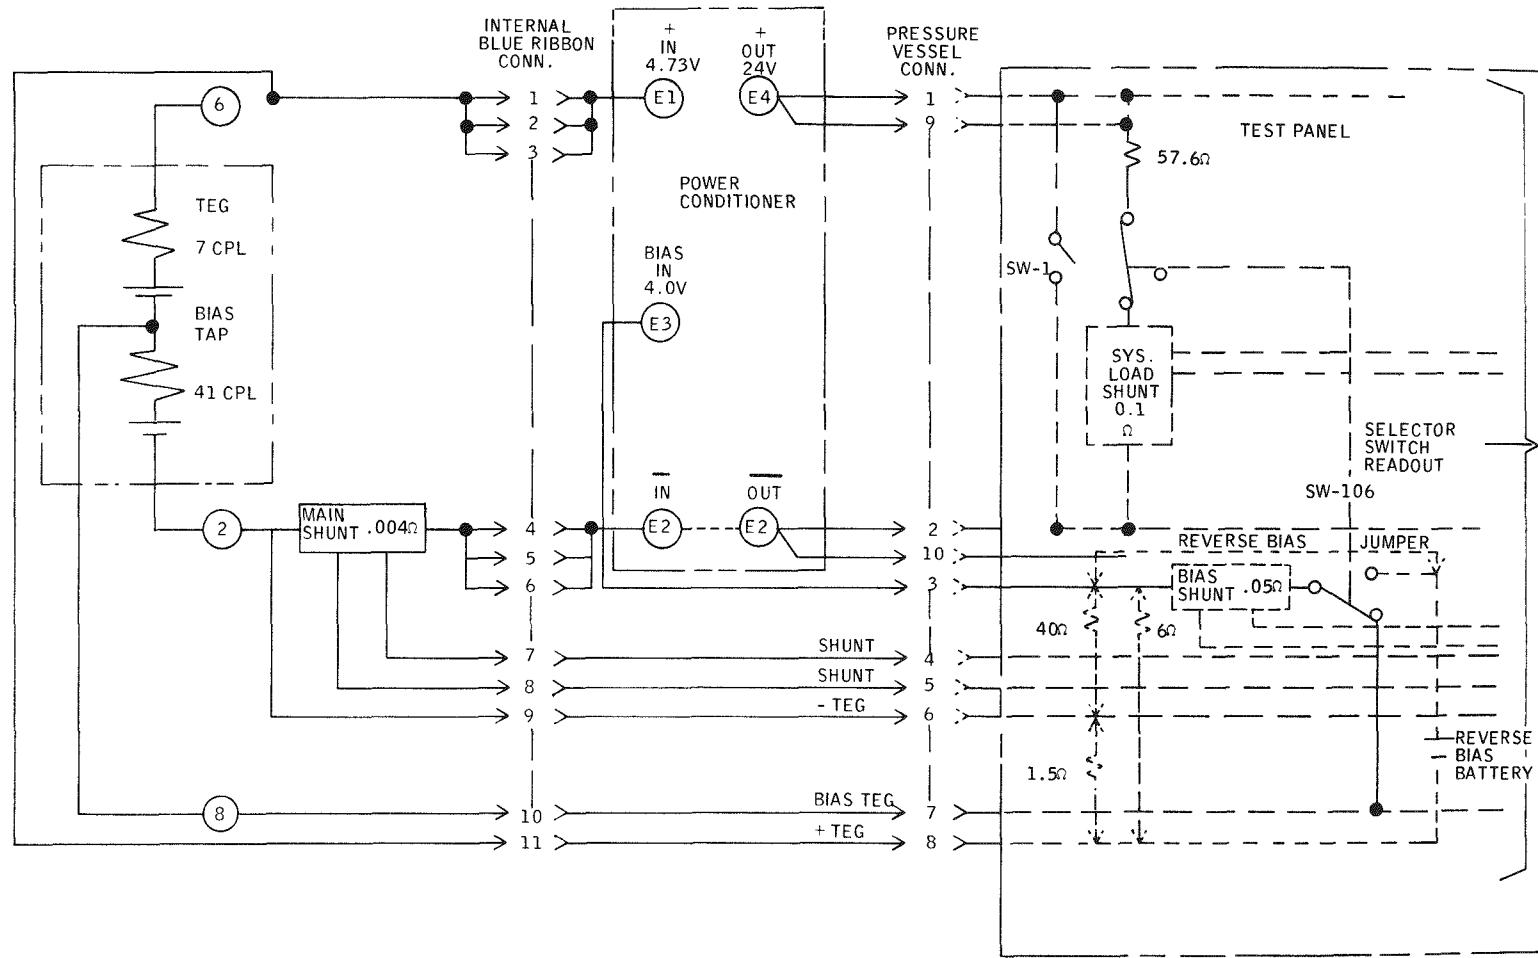
Figure 2-11. SNAP-21 10-Watt Electrical Schematic

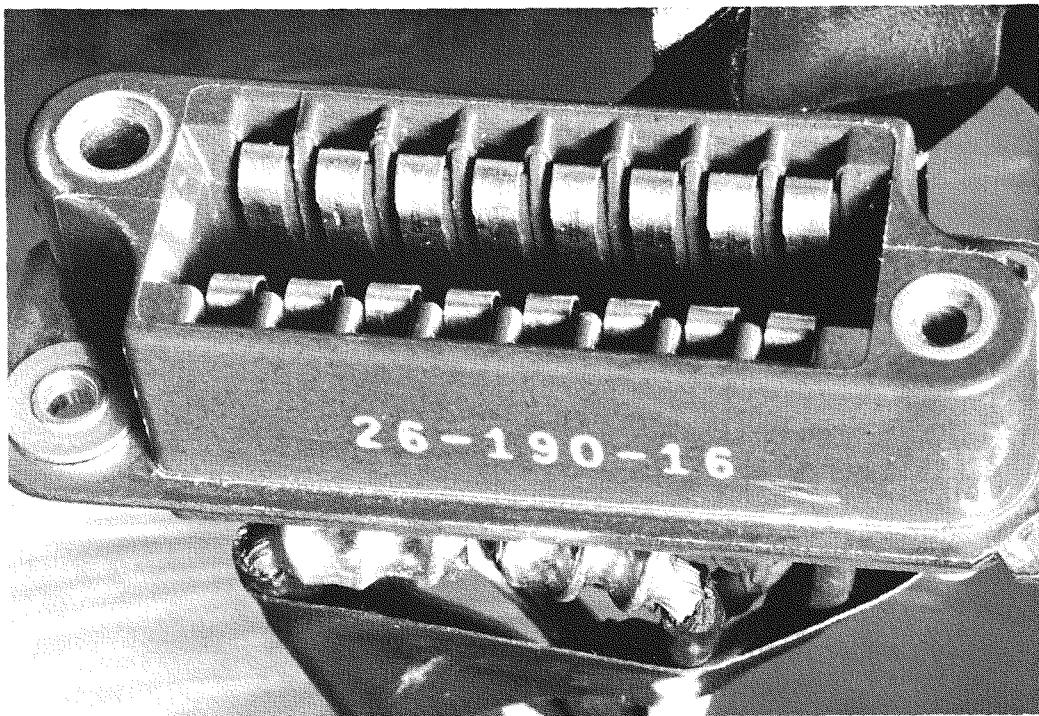
Figure 2-12. Female Half of Blue Ribbon Connector Showing Scratch on Second Pin from Left

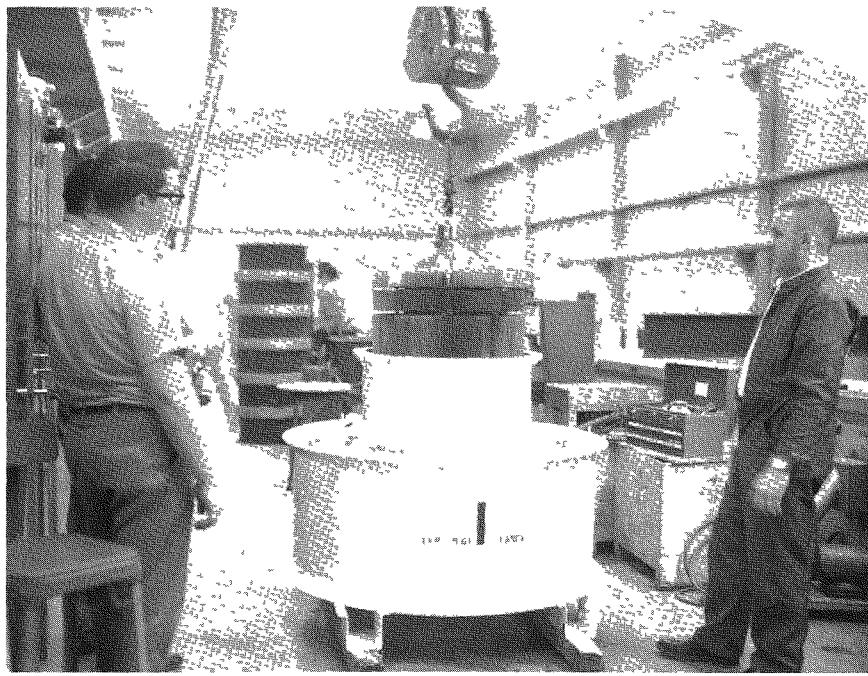
Figure 2-13. Fueled System Installation into Shipping Container

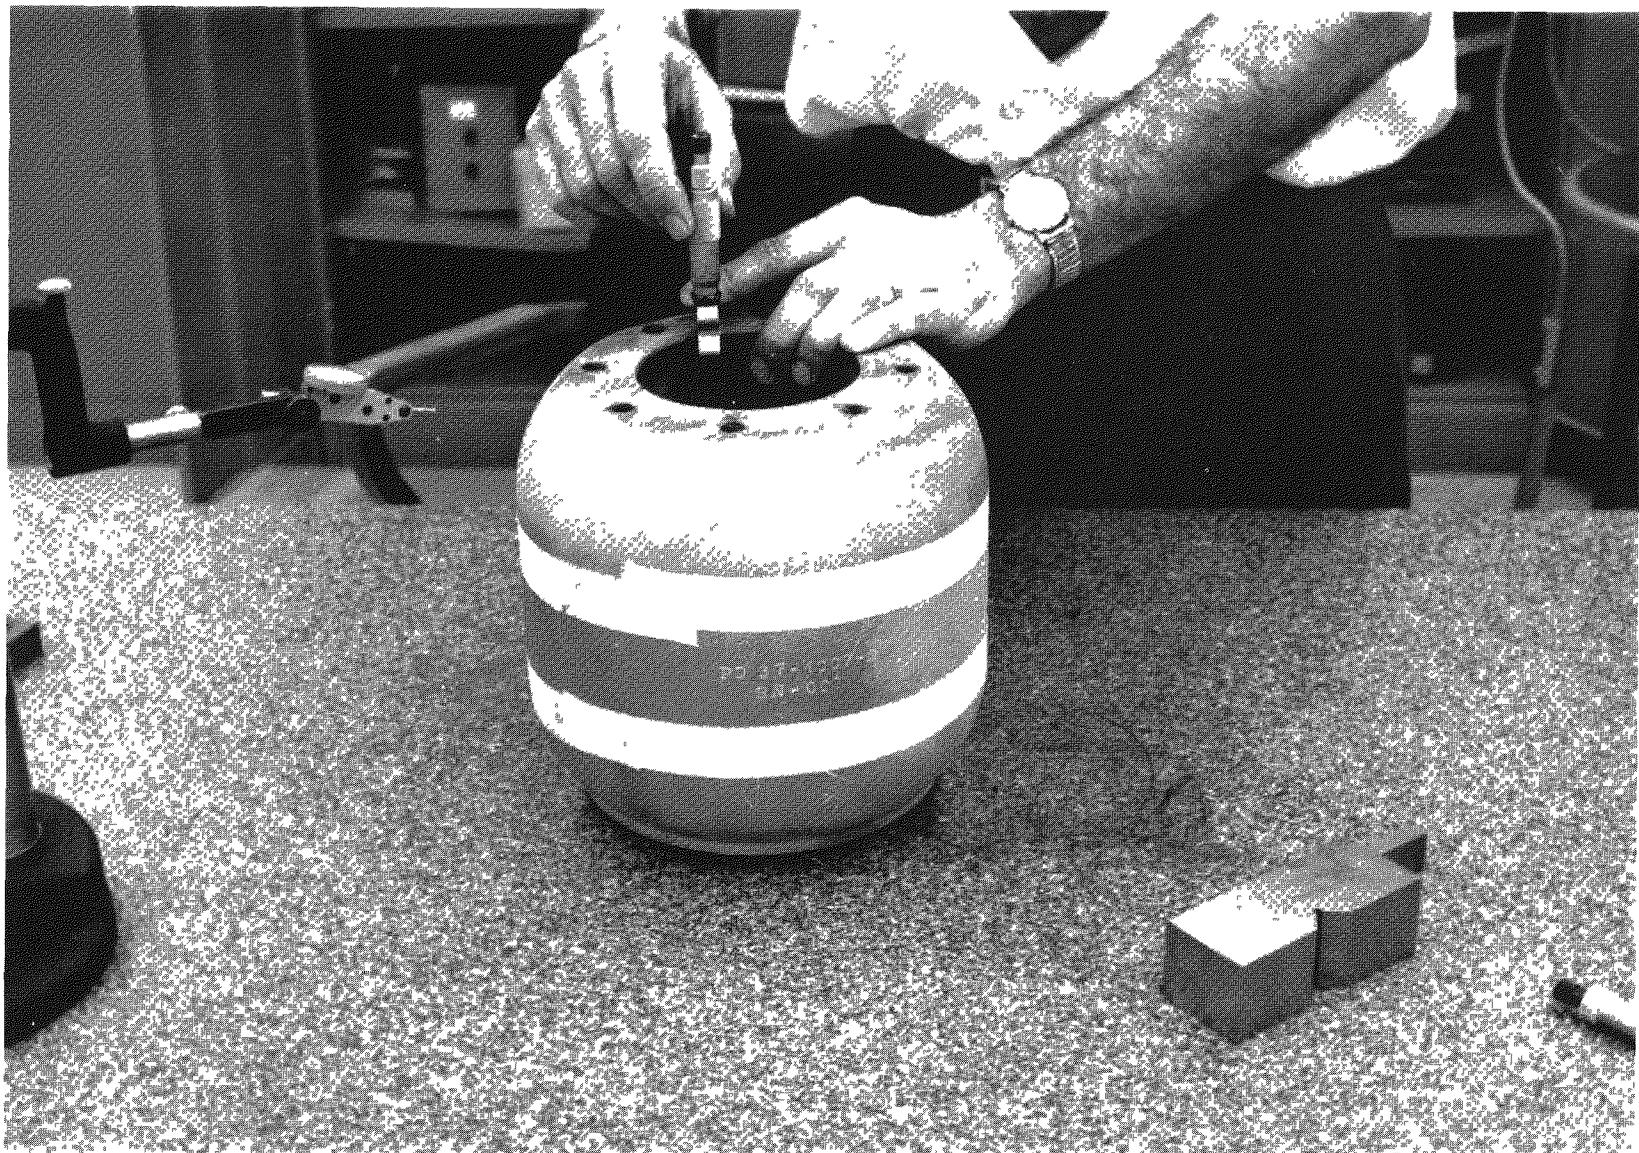
Figure 2-14. Dimensional Inspection, Biological Shield after Light Treat and Copper Flashing

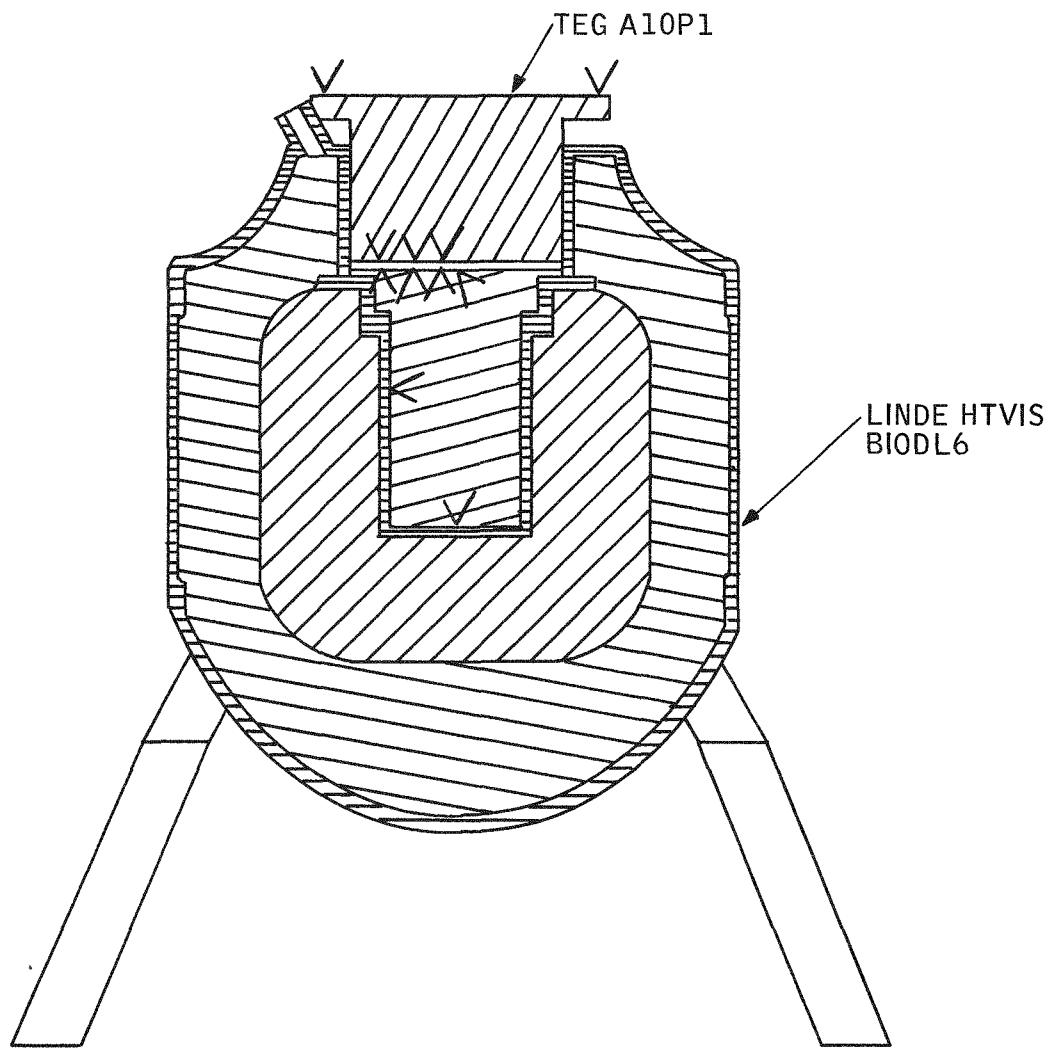
✓ CHROMEL-ALUMEL THERMOCOUPLES

Figure 2-15. Instrumentation for HTVIS B10DL6 and TEG A10P1

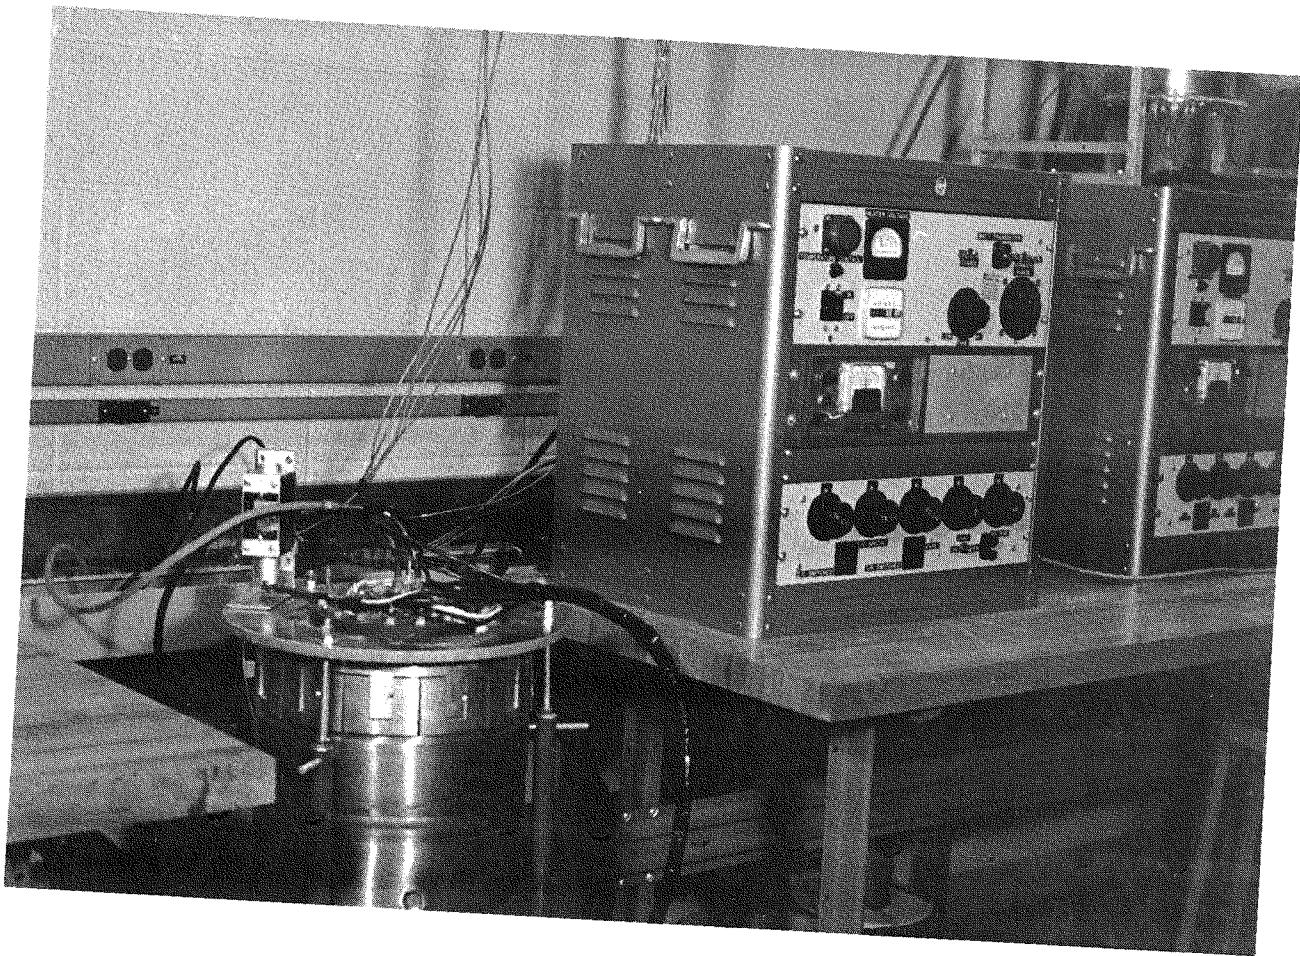
Figure 2-16. HTVIS B10DL6 and TEG A10P1 Test Set-Up

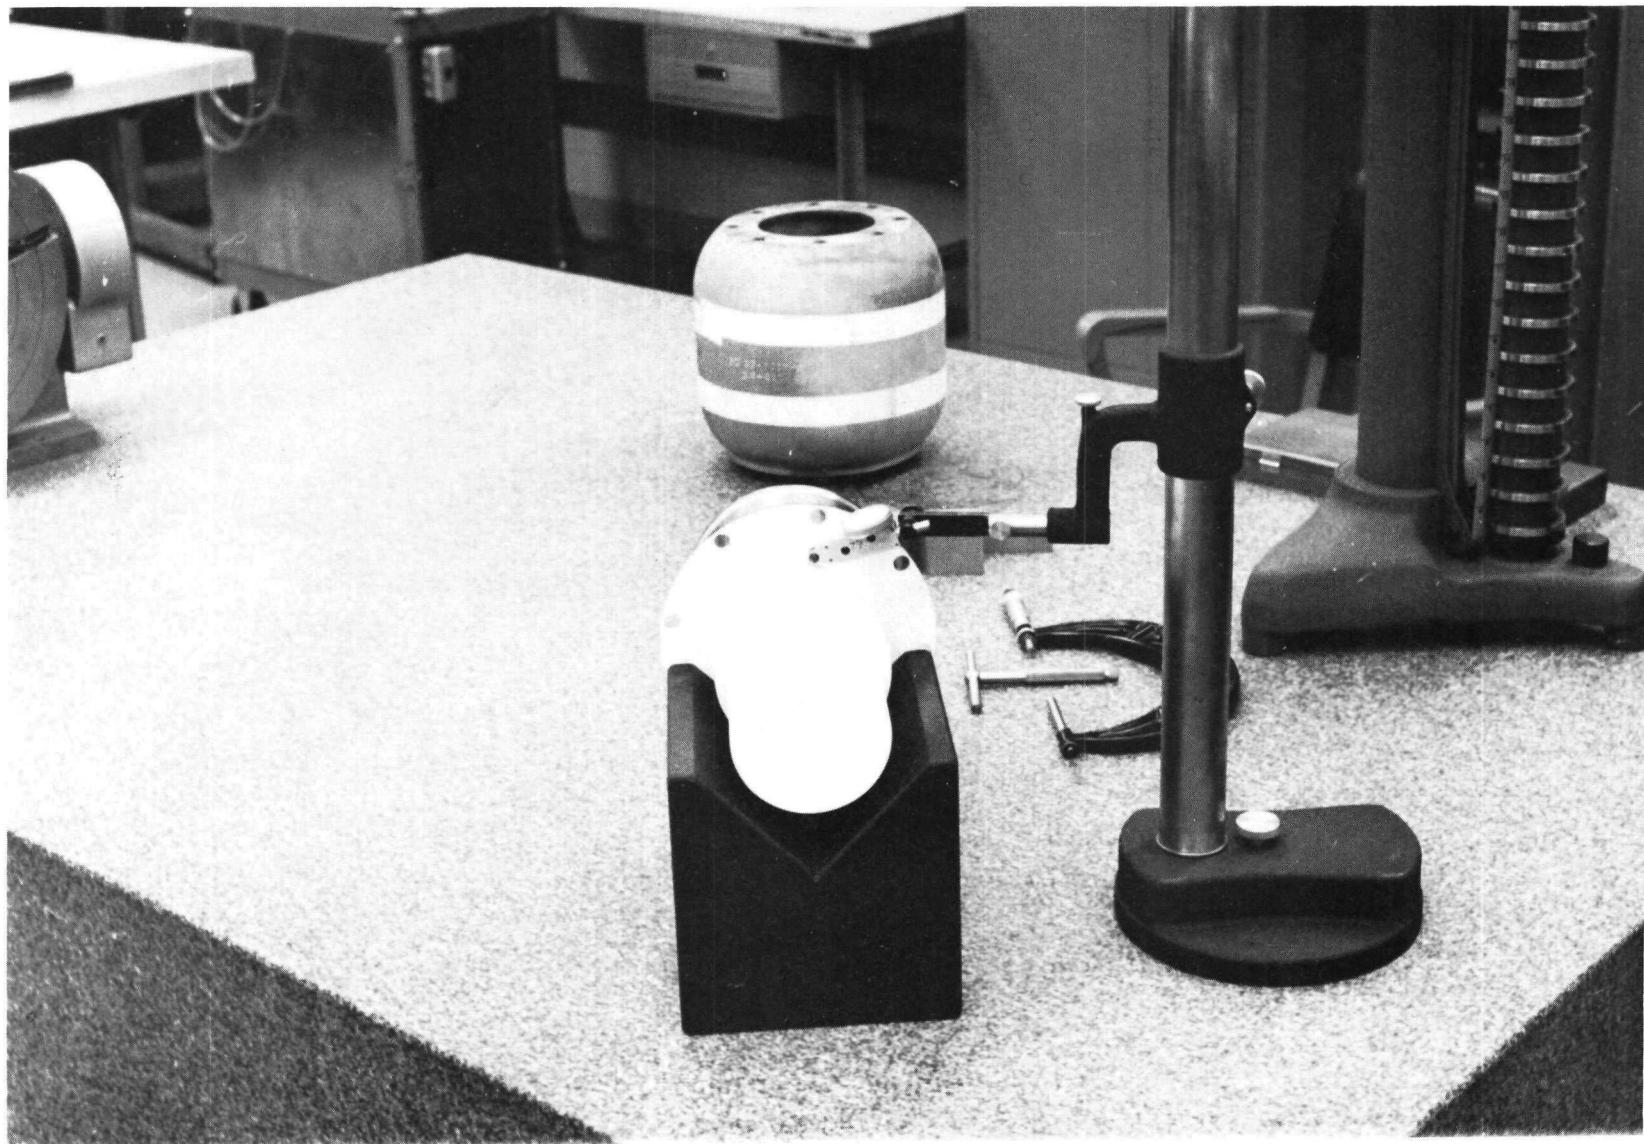
Figure 2-17. Inspection of Inner Liner
