SNAP-21 PROGRAM, PHASE II

**DEEP SEA RADIOISOTOPE-FUELED
THERMOELECTRIC GENERATOR
POWER SUPPLY SYSTEM**

QUARTERLY REPORT NO. 11

Space and Defense Products
ELECTRICAL PRODUCTS GROUP
3-M CENTER, ST. PAUL, MINN. 55101, PH 633-9400

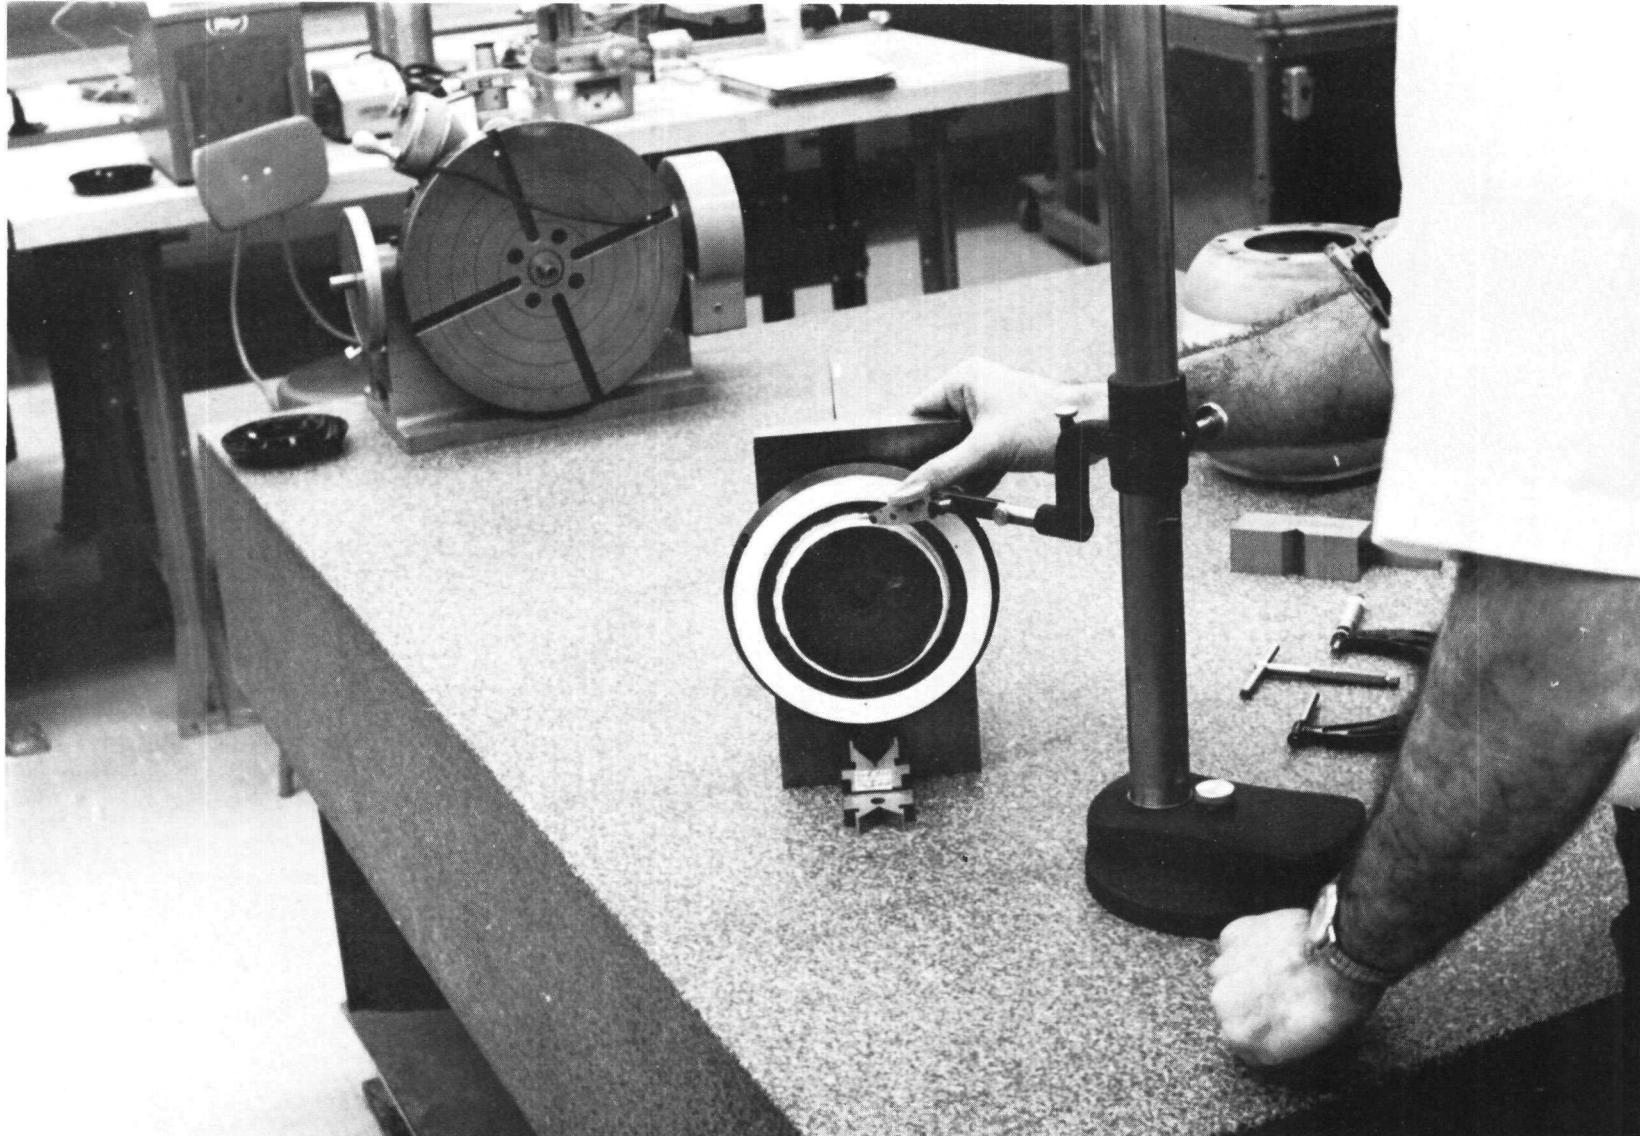
Figure 2-18. Inspection of the Spider, as Plasma Spray with Aluminum Oxide, Prior to Grinding for Interface with the Biological Shield

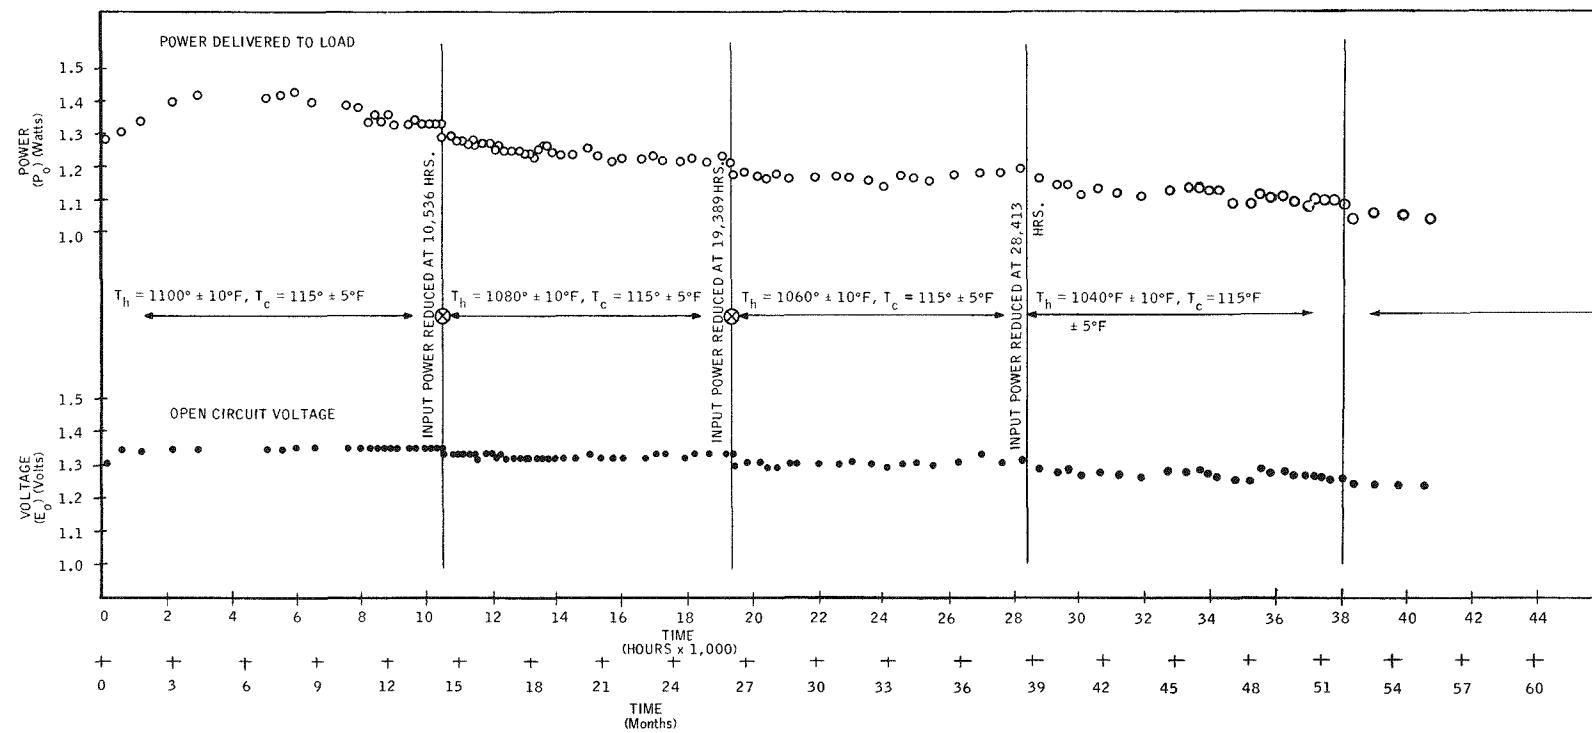
Figure 2-19. SNAP-21B 6-Couple Module A1

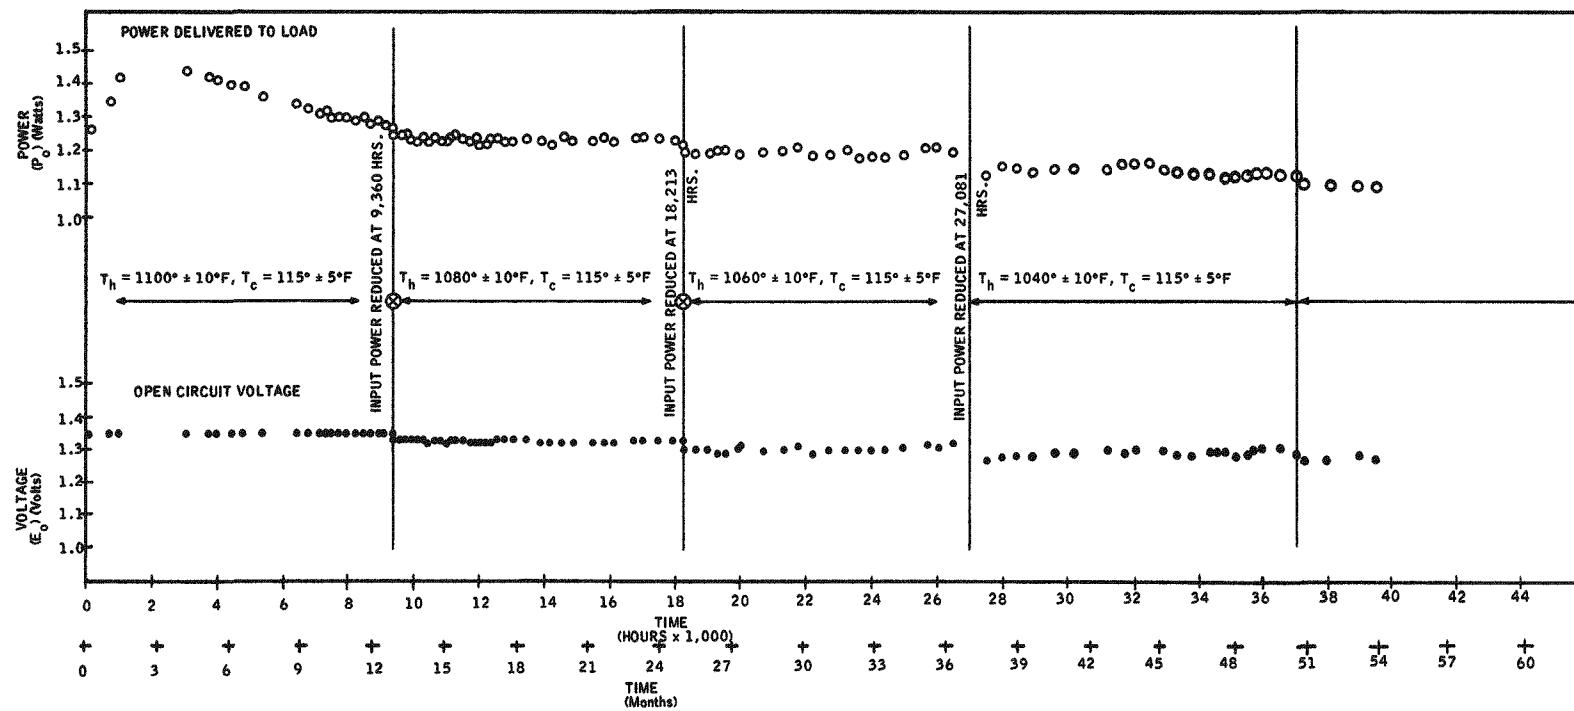
Figure 2-20. SNAP-21B 6-Couple Module A3

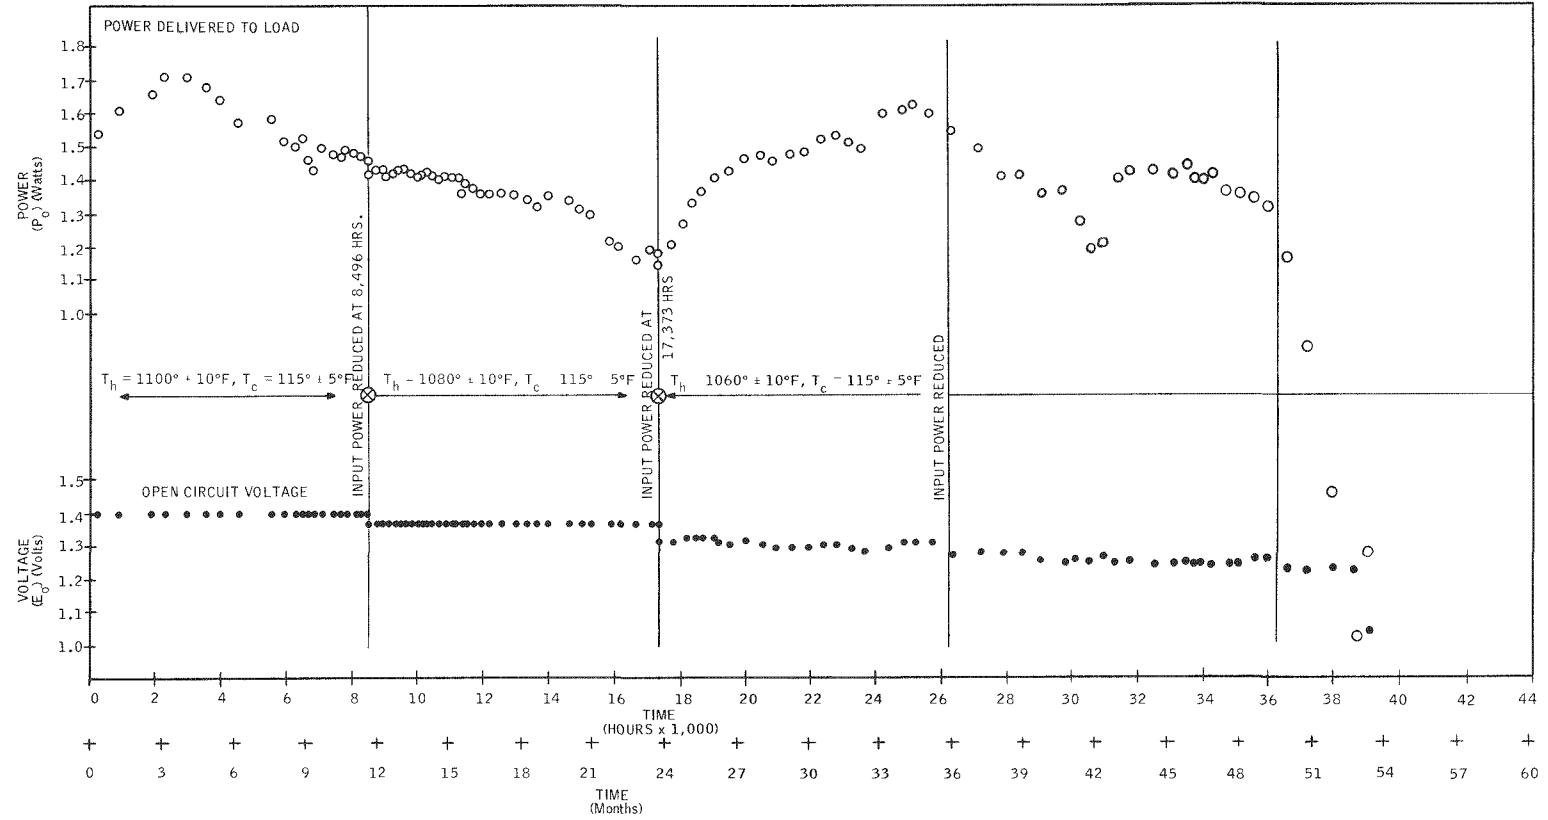
Figure 2-21. SNAP-21B 6-Couple Module A4

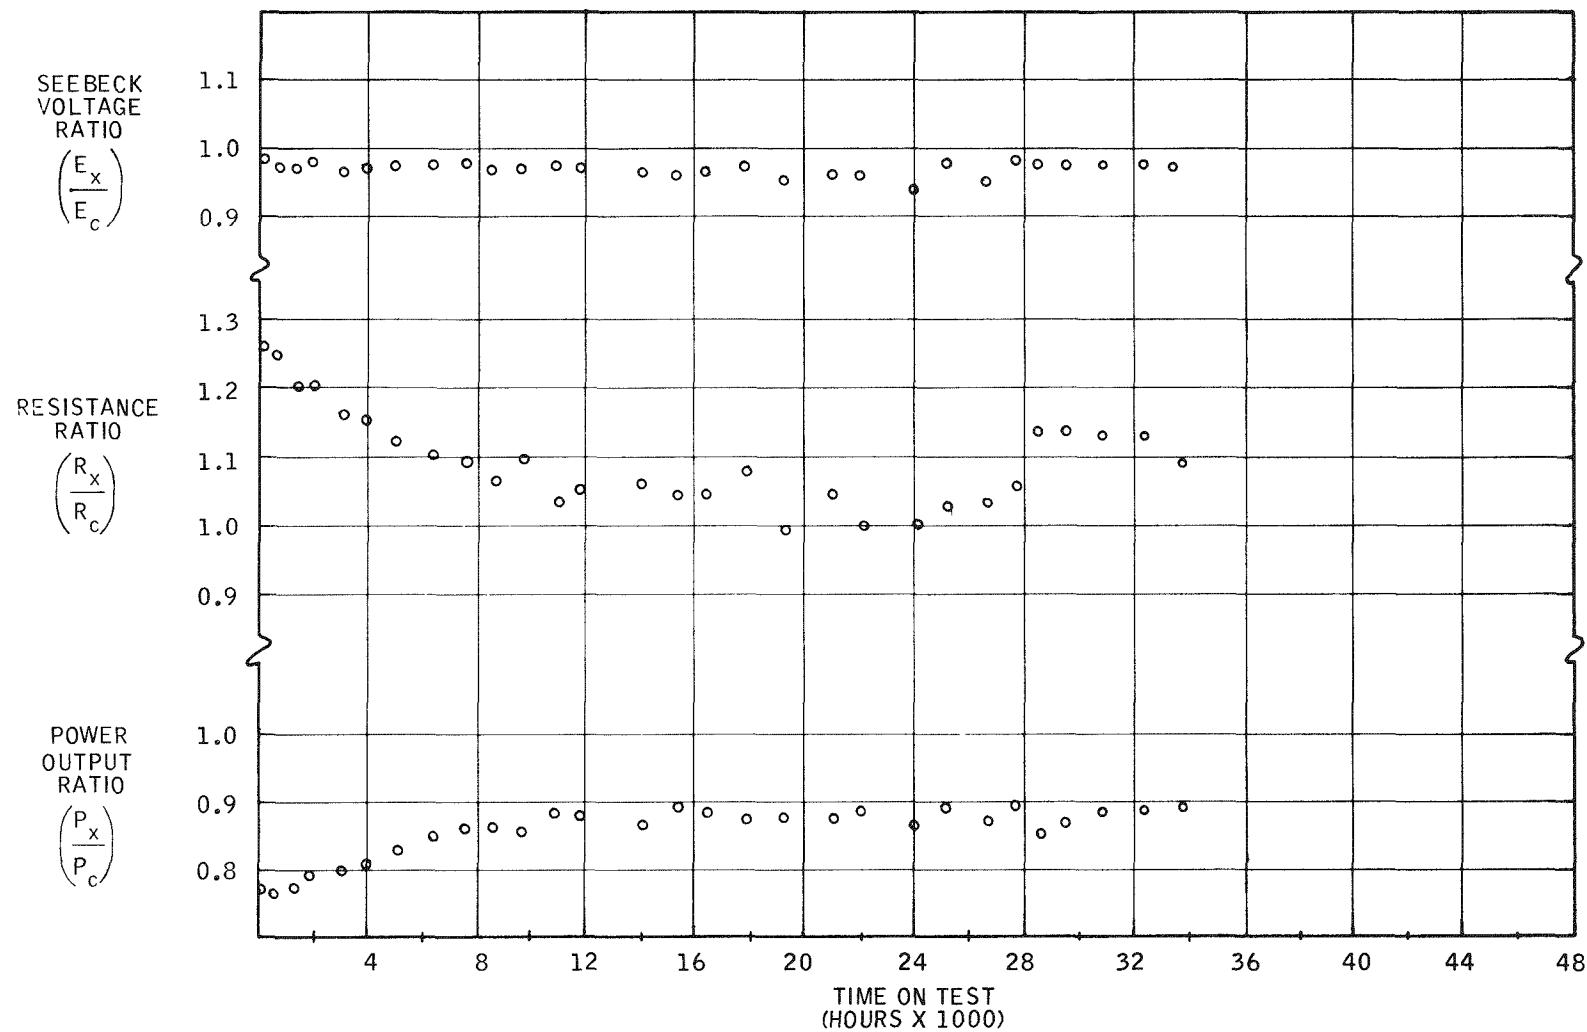
Figure 2-22. SNAP-21B 48-Couple Prototype Generator P5 Performance Ratios (Experimental/Calculated)

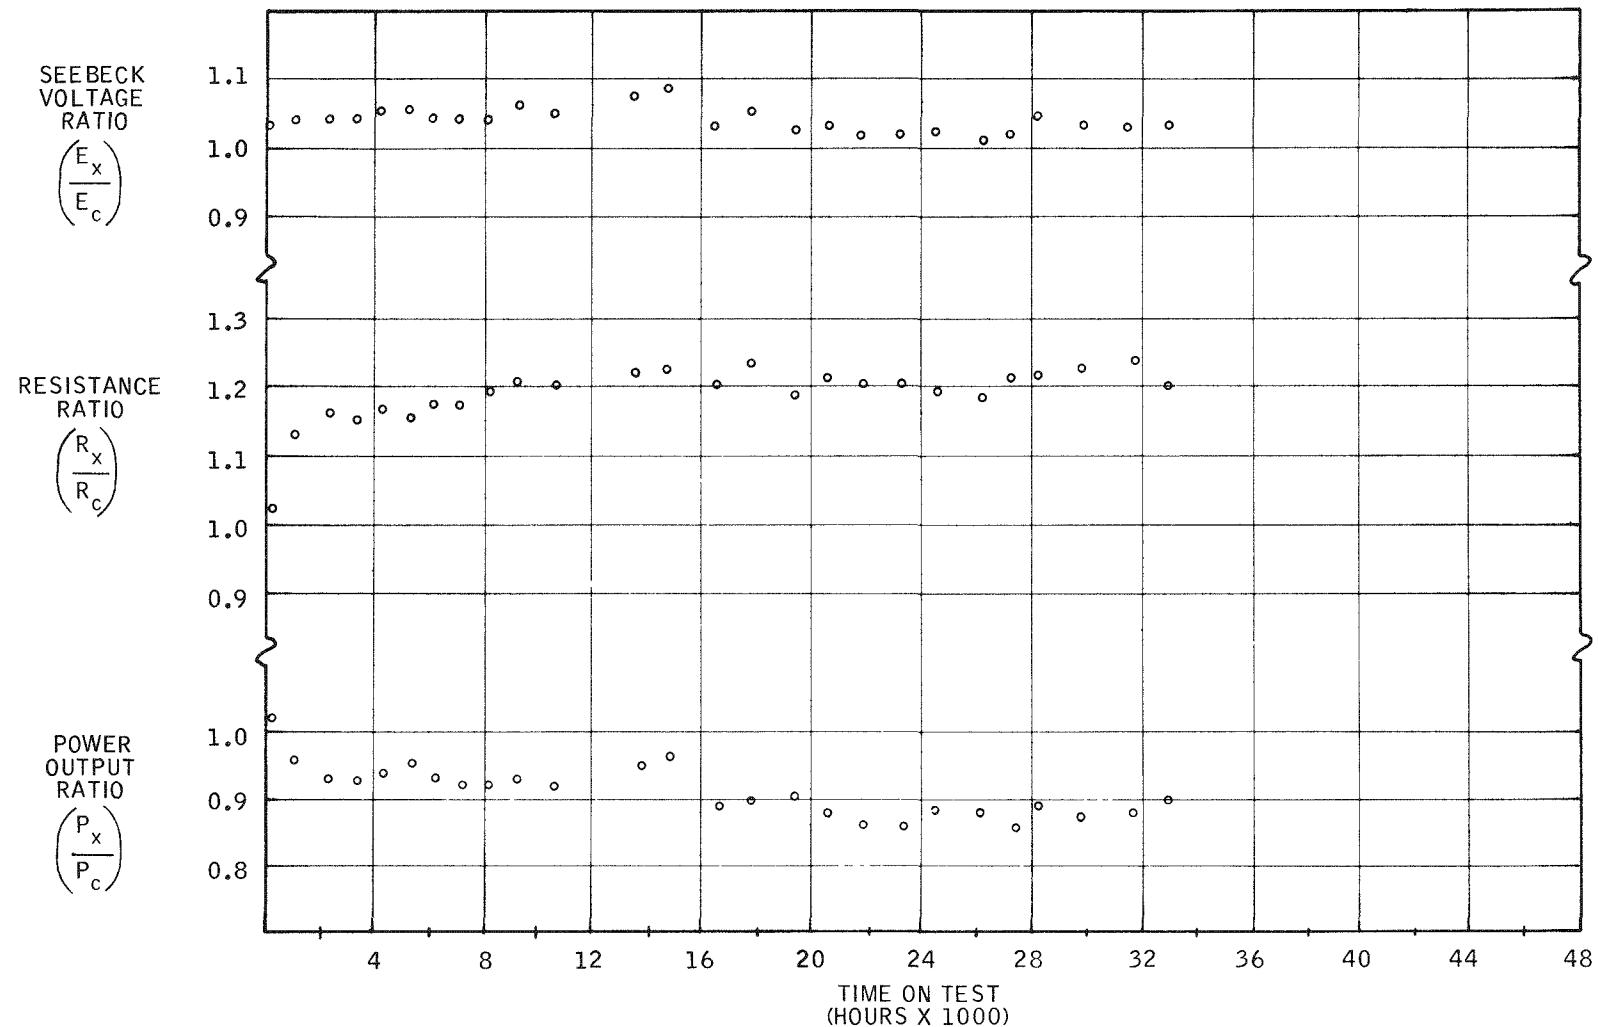
Figure 2-23. SNAP-21B 48-Couple Prototype Generator P6 Performance Ratios (Experimental/Calculated)

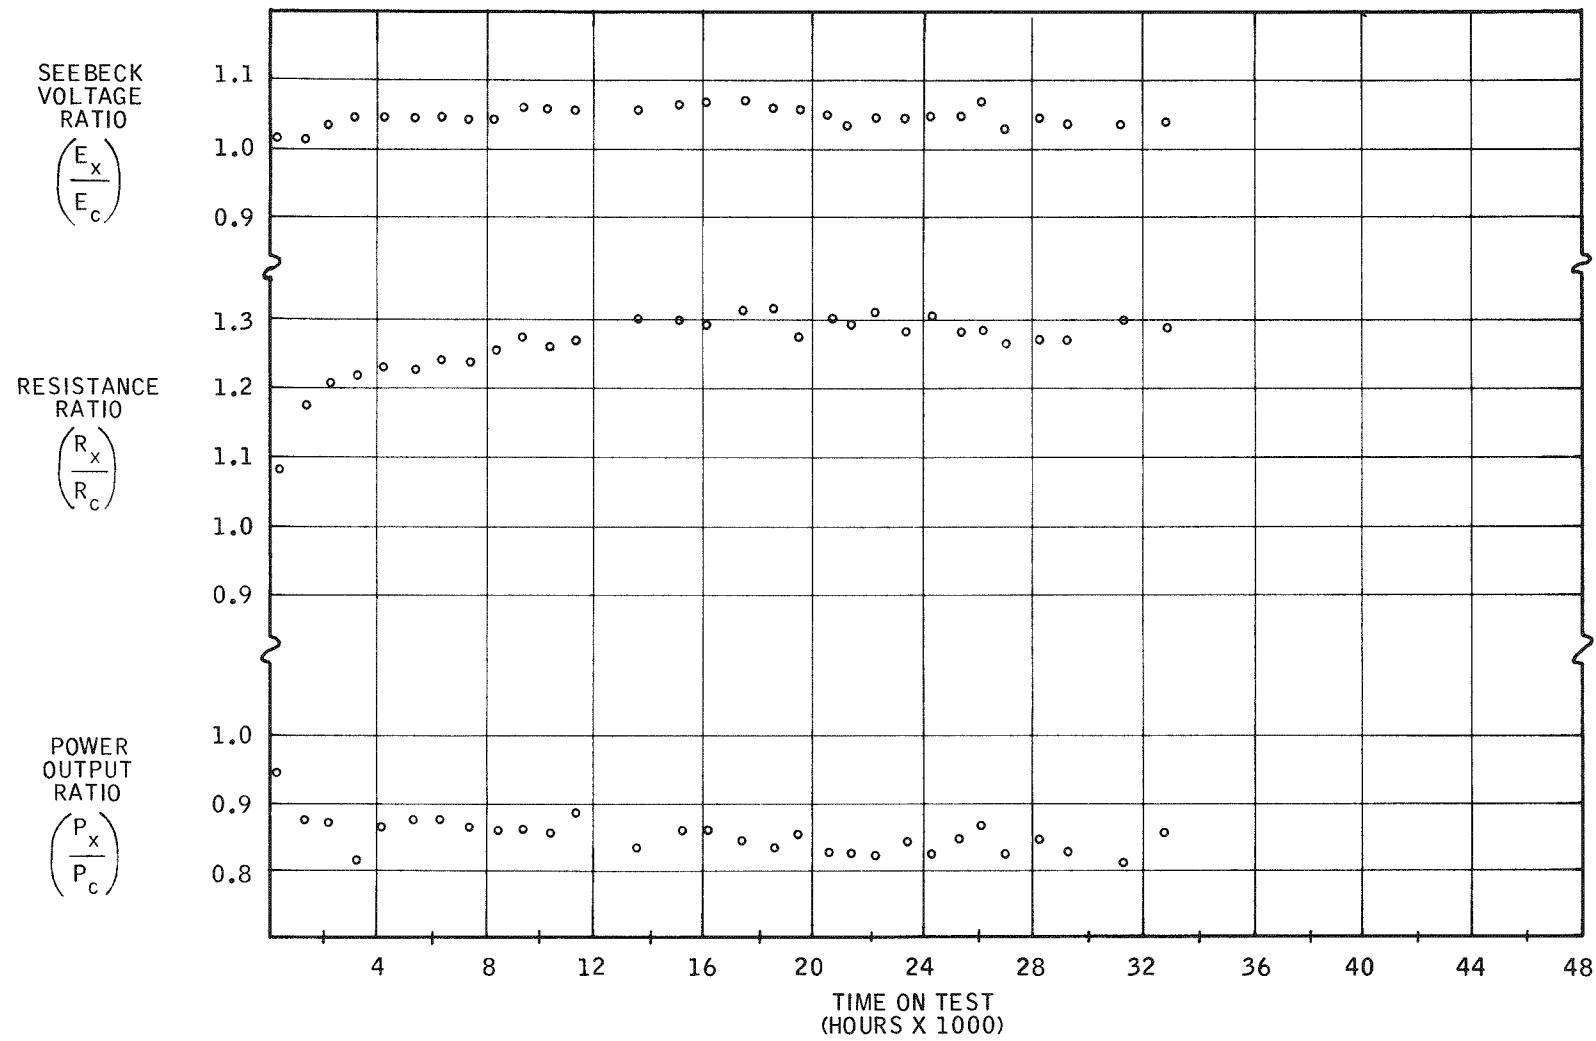
Figure 2-24. SNAP-21B 48-Couple Prototype Generator P7 Performance Ratios (Experimental/Calculated)

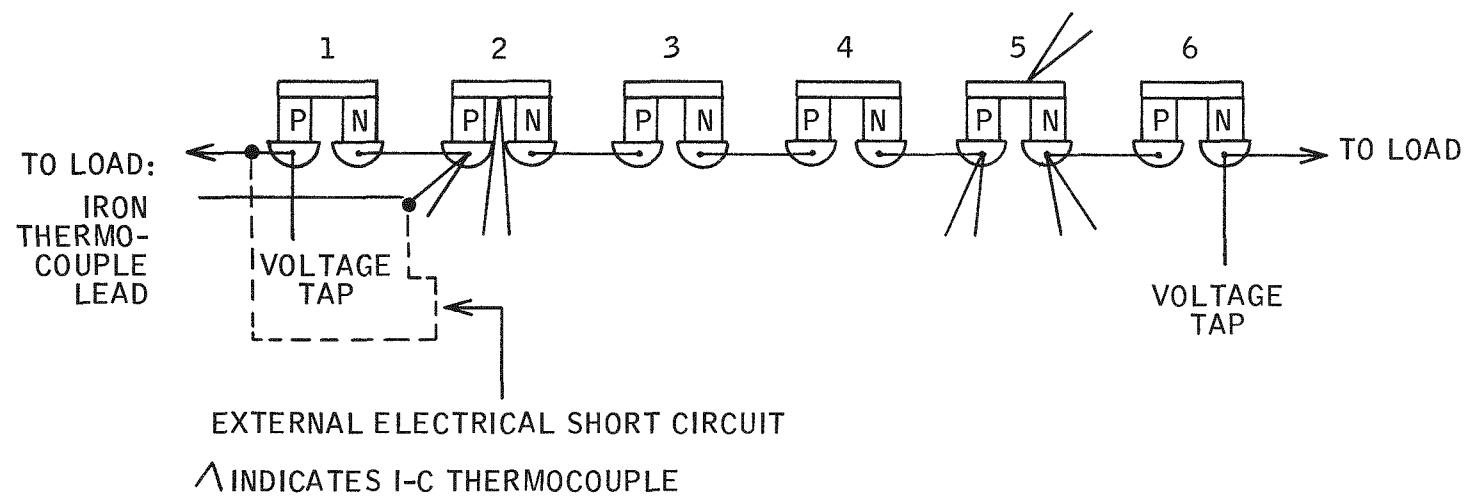
Figure 2-25. 6-Couple Module A4 Circuit Diagram

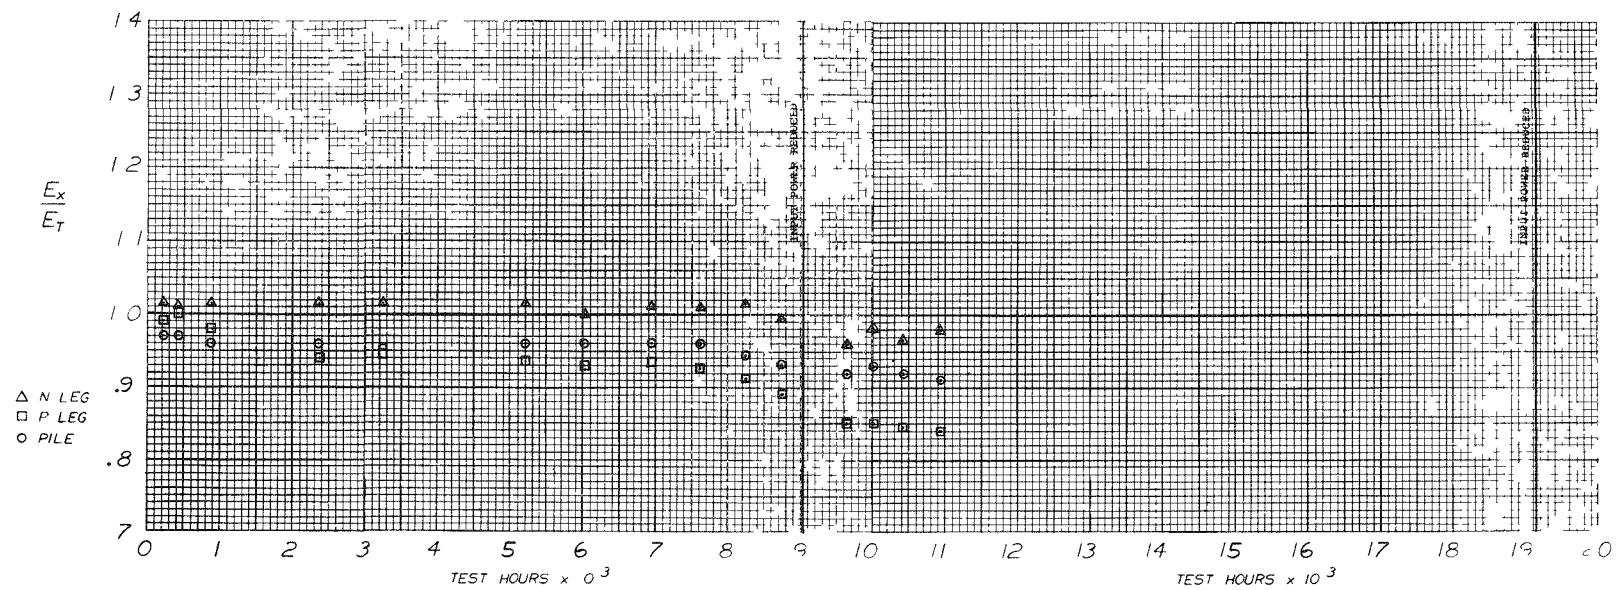
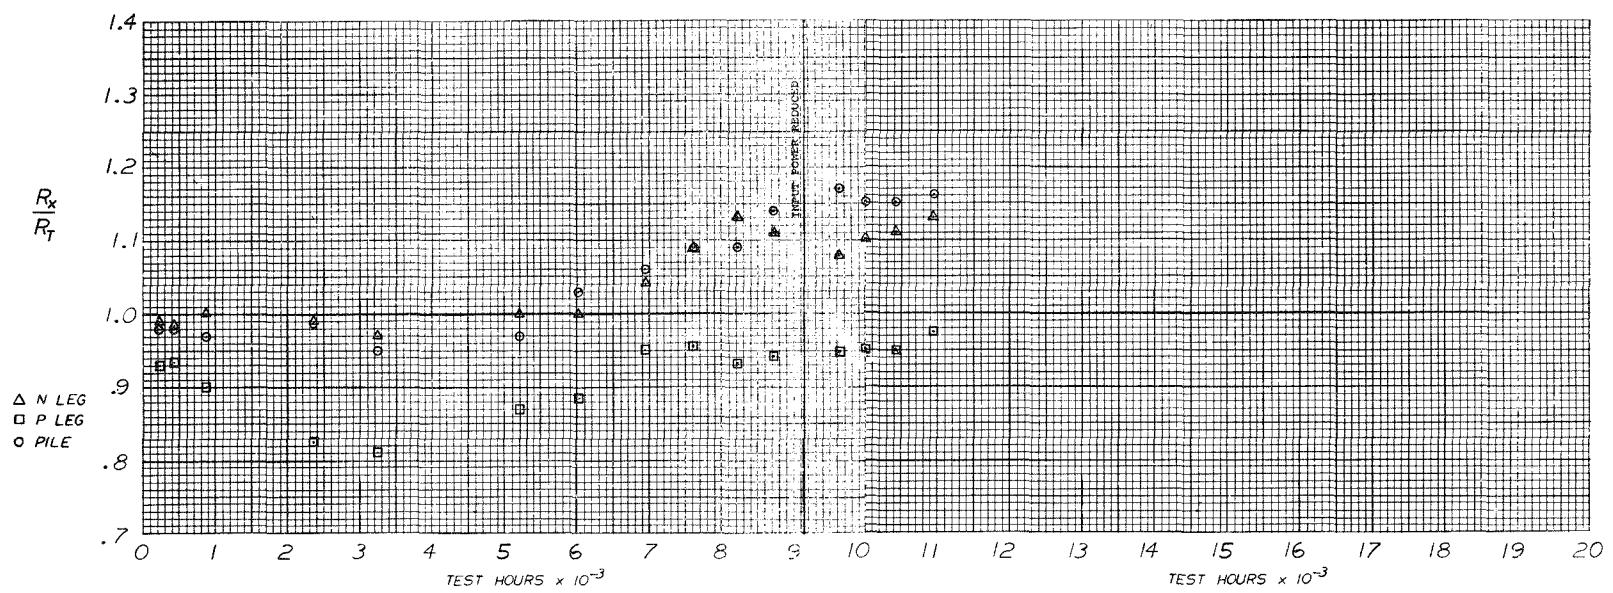
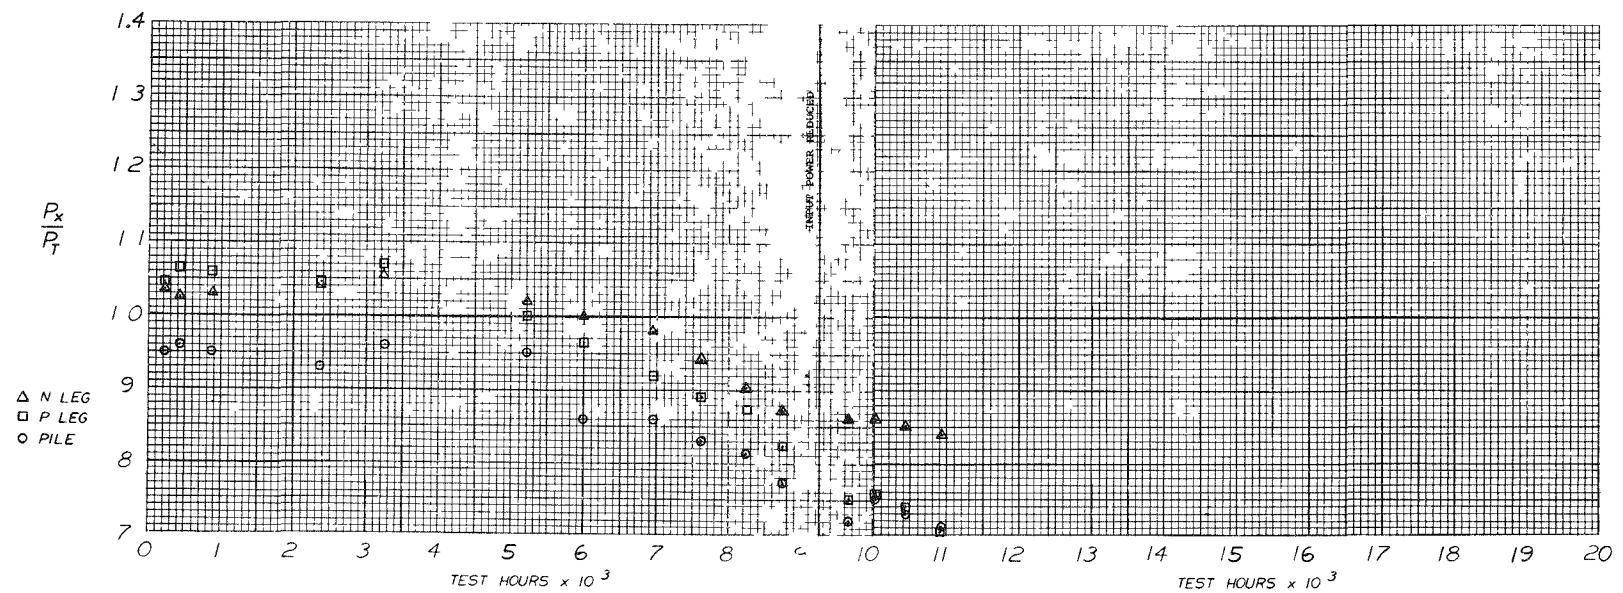
Figure 2-26a. SNAP-21 Thermoelectric Generator A10D1 Normalized Seebeck Voltage Ratio

Figure 2-26b. SNAP-21 Thermoelectric Generator A10D1 Normalized Resistance Ratio

Figure 2-26c. SNAP-21 Thermoelectric Generator A10D1 Normalized Power Ratio

Figures 2-26a through 2-26c show the performance curves for this generator. There was an approximate 7% drop in power-out this past quarter. The major cause for this is due to the increase in resistance. Also, there has been a decrease in Seebeck voltage. There have been no apparent short term effects from the malfunction of the voltage regulator.

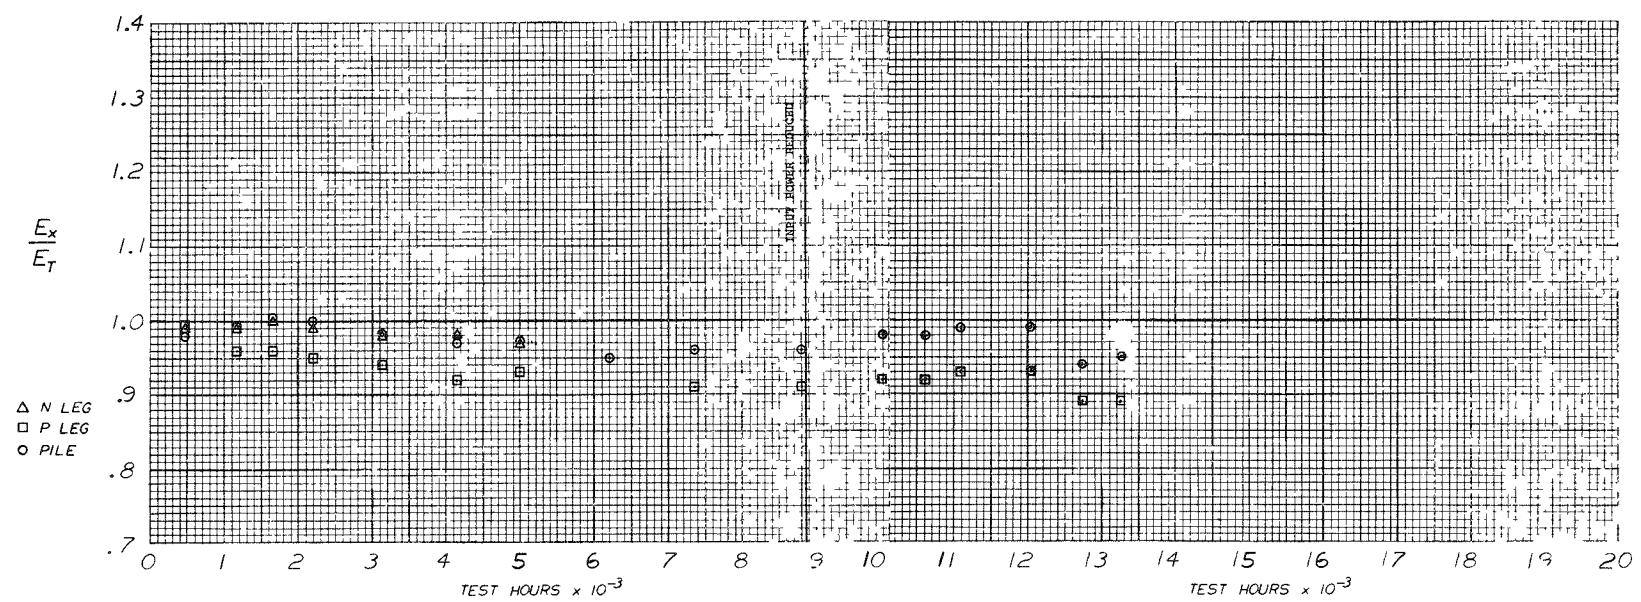
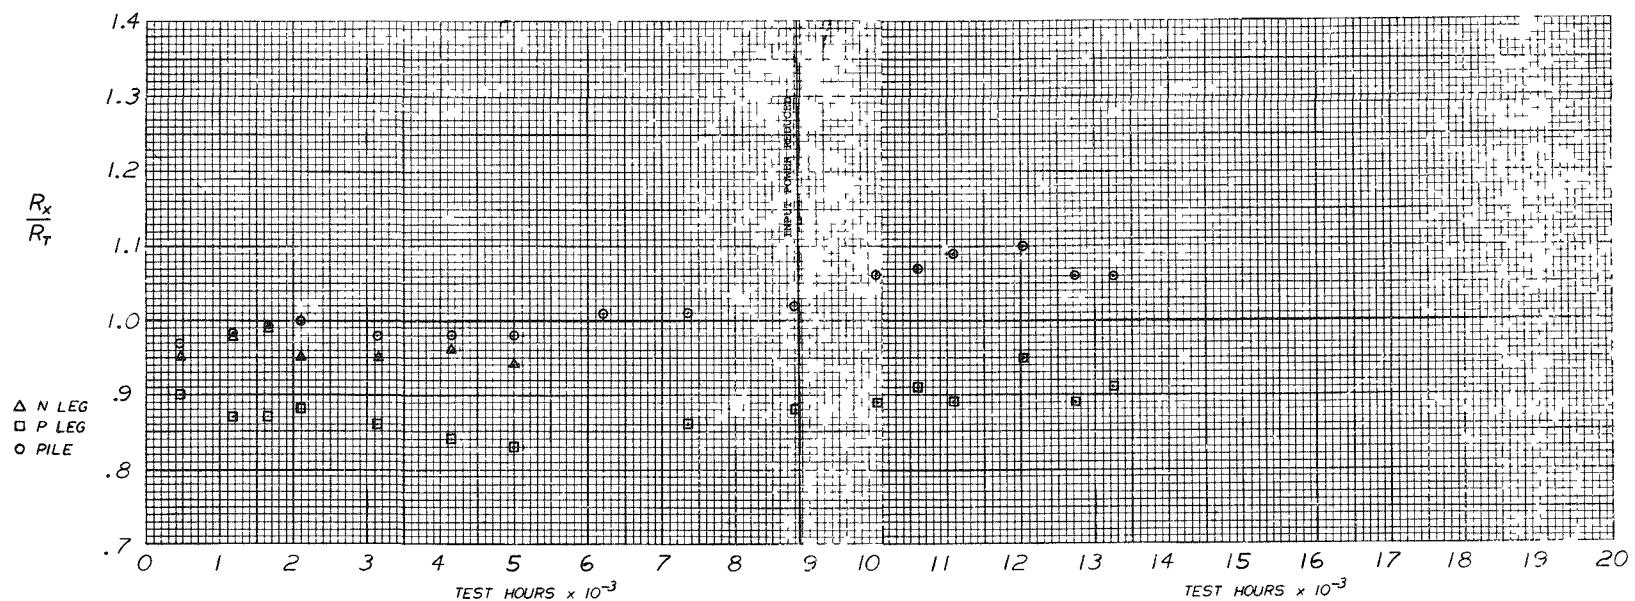
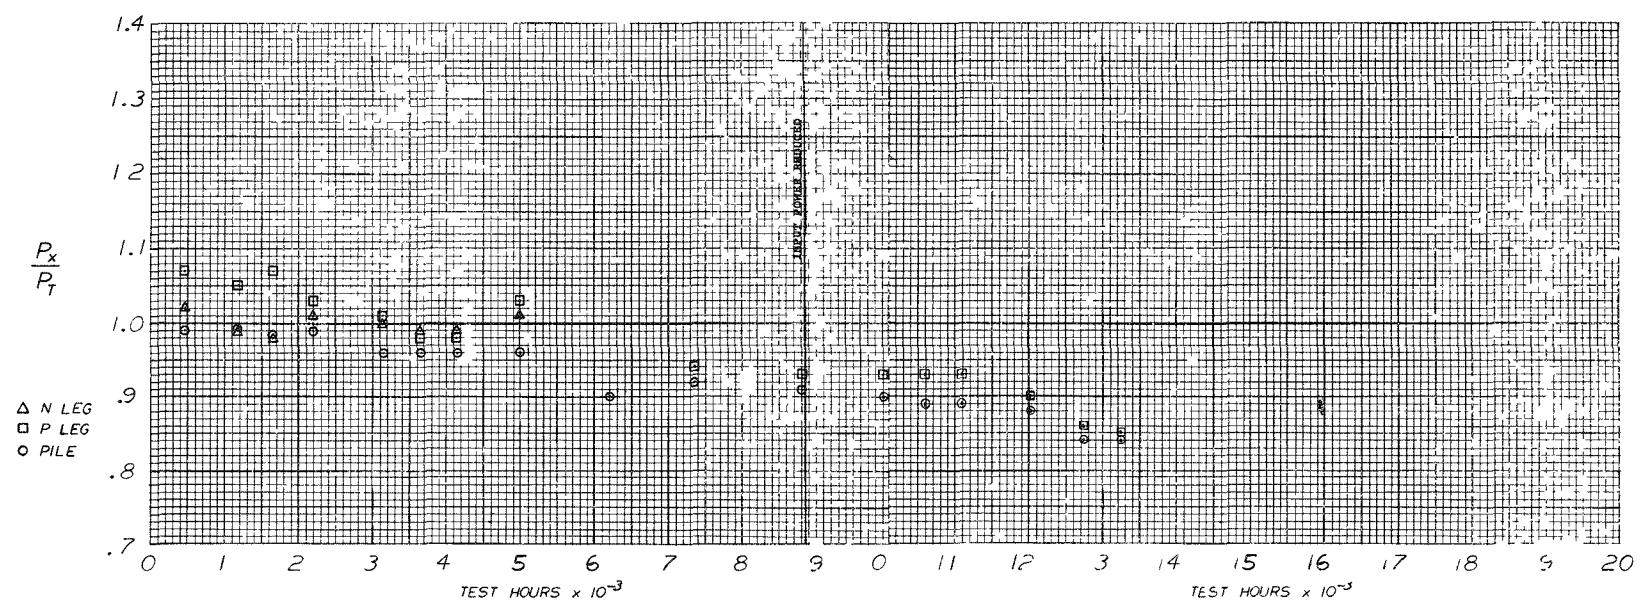
Figure 2-27a. SNAP-21 Thermoelectric Generator A10D2 Normalized Seebeck Voltage Ratio

Figure 2-27b. SNAP-21 Thermoelectric Generator A10D2 Normalized Resistance Ratio

Figure 2-27c. SNAP-21 Thermoelectric Generator A10D2 Normalized Power Ratio

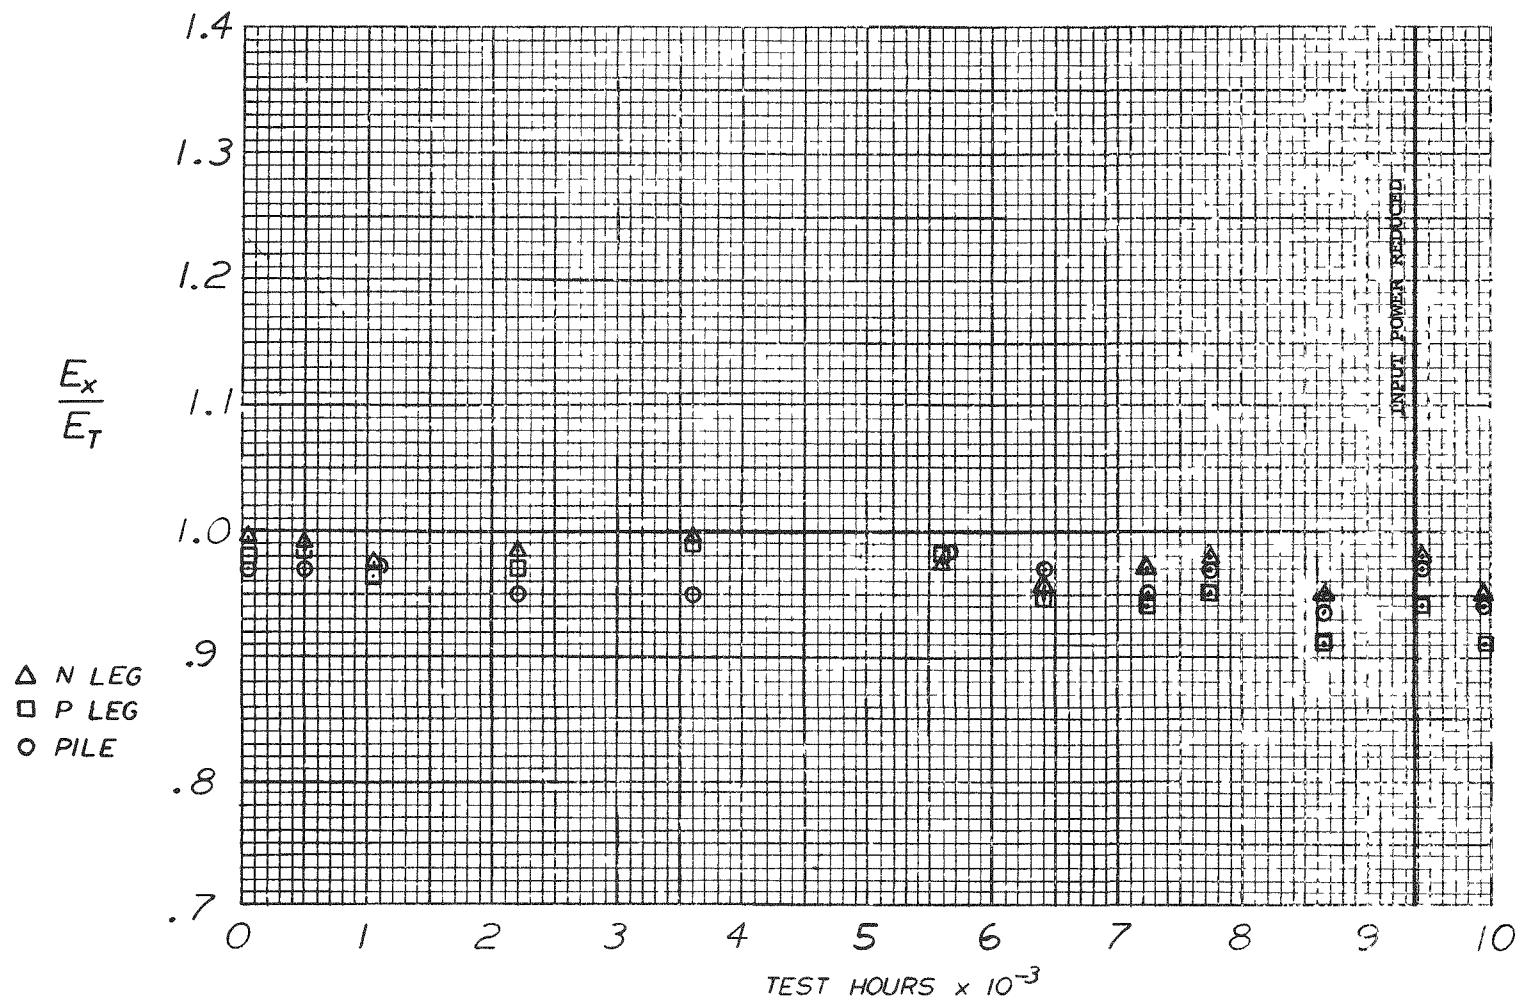
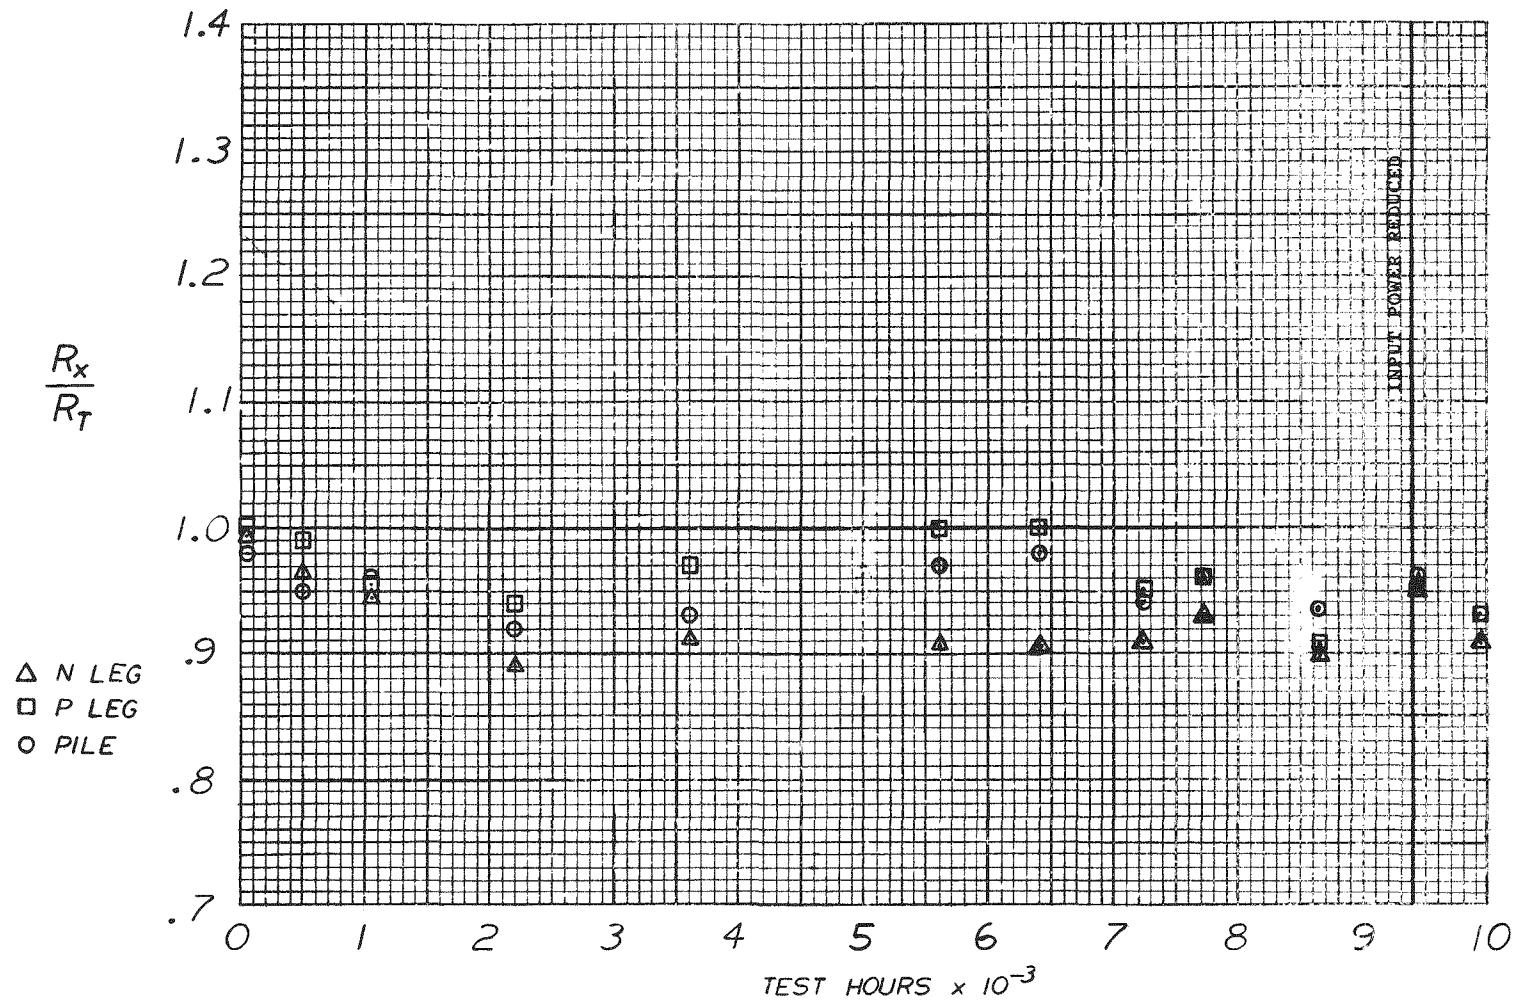
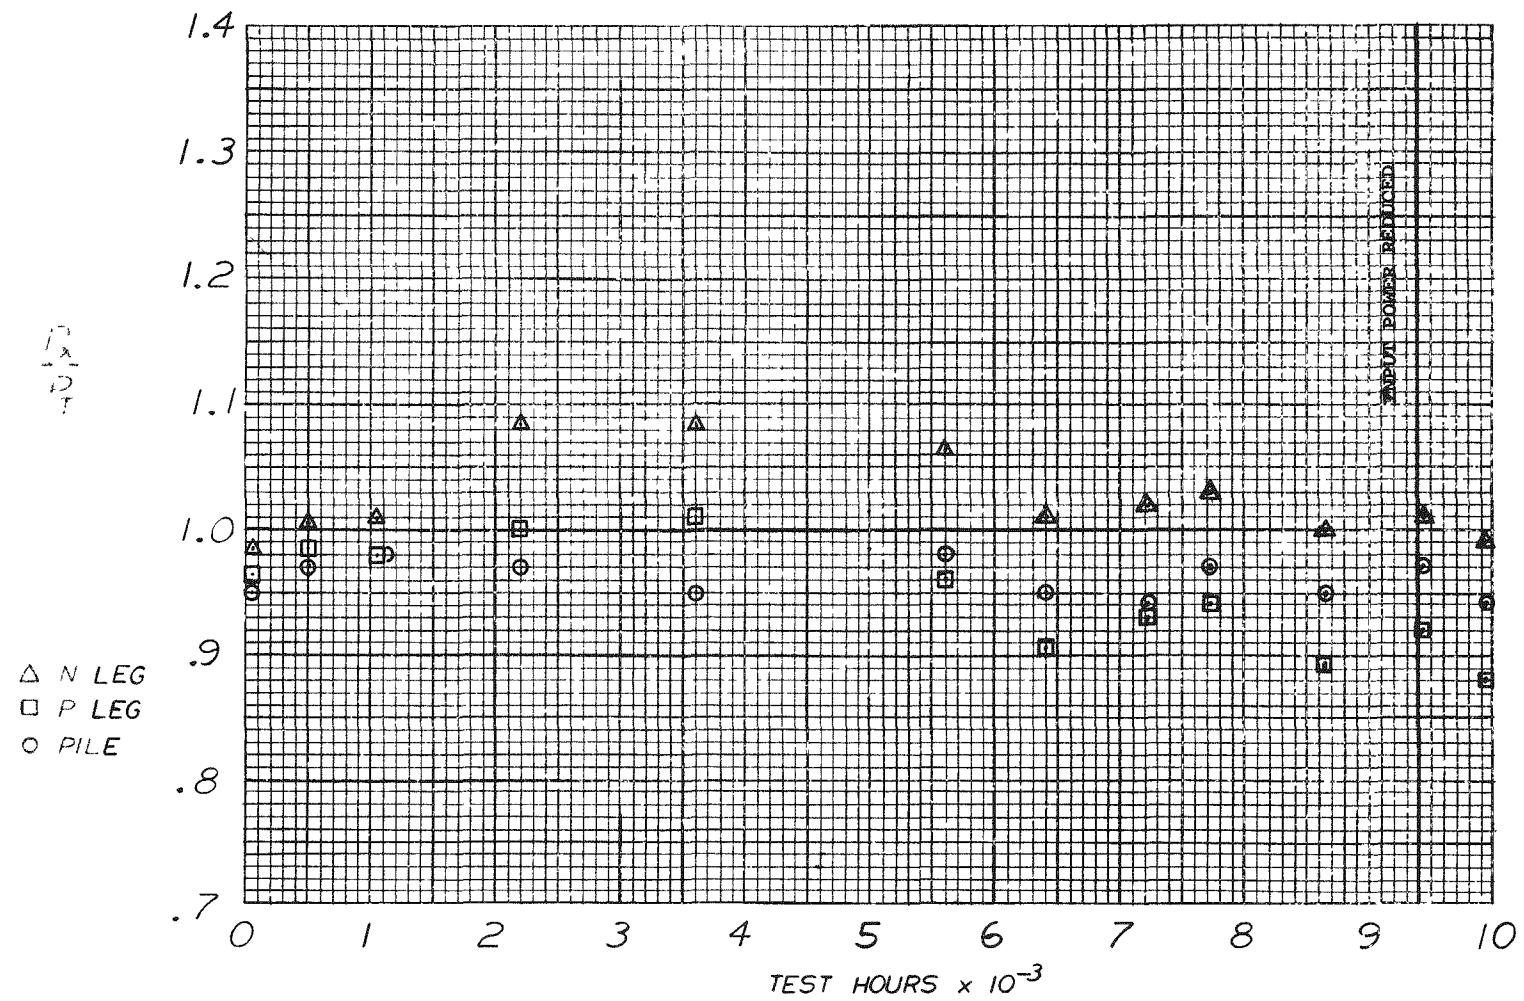
Figure 2-28a. SNAP-21 Thermoelectric Generator A10D6 Normalized Seebeck Voltage Ratio

Figure 2-28b. SNAP-21 Thermoelectric Generator A10D6 Normalized Resistance Ratio

Figure 2-28c. SNAP-21 Thermoelectric Generator A10D6 Normalized Power Ratio
