SNAP-21 PROGRAM, PHASE II

**DEEP SEA RADIOISOTOPE-FUELED
THERMOELECTRIC GENERATOR
POWER SUPPLY SYSTEM**

QUARTERLY REPORT NO. 11

Space and Defense Products
ELECTRICAL PRODUCTS GROUP
3-M CENTER, ST. PAUL, MINN. 55101, PH 633-9400

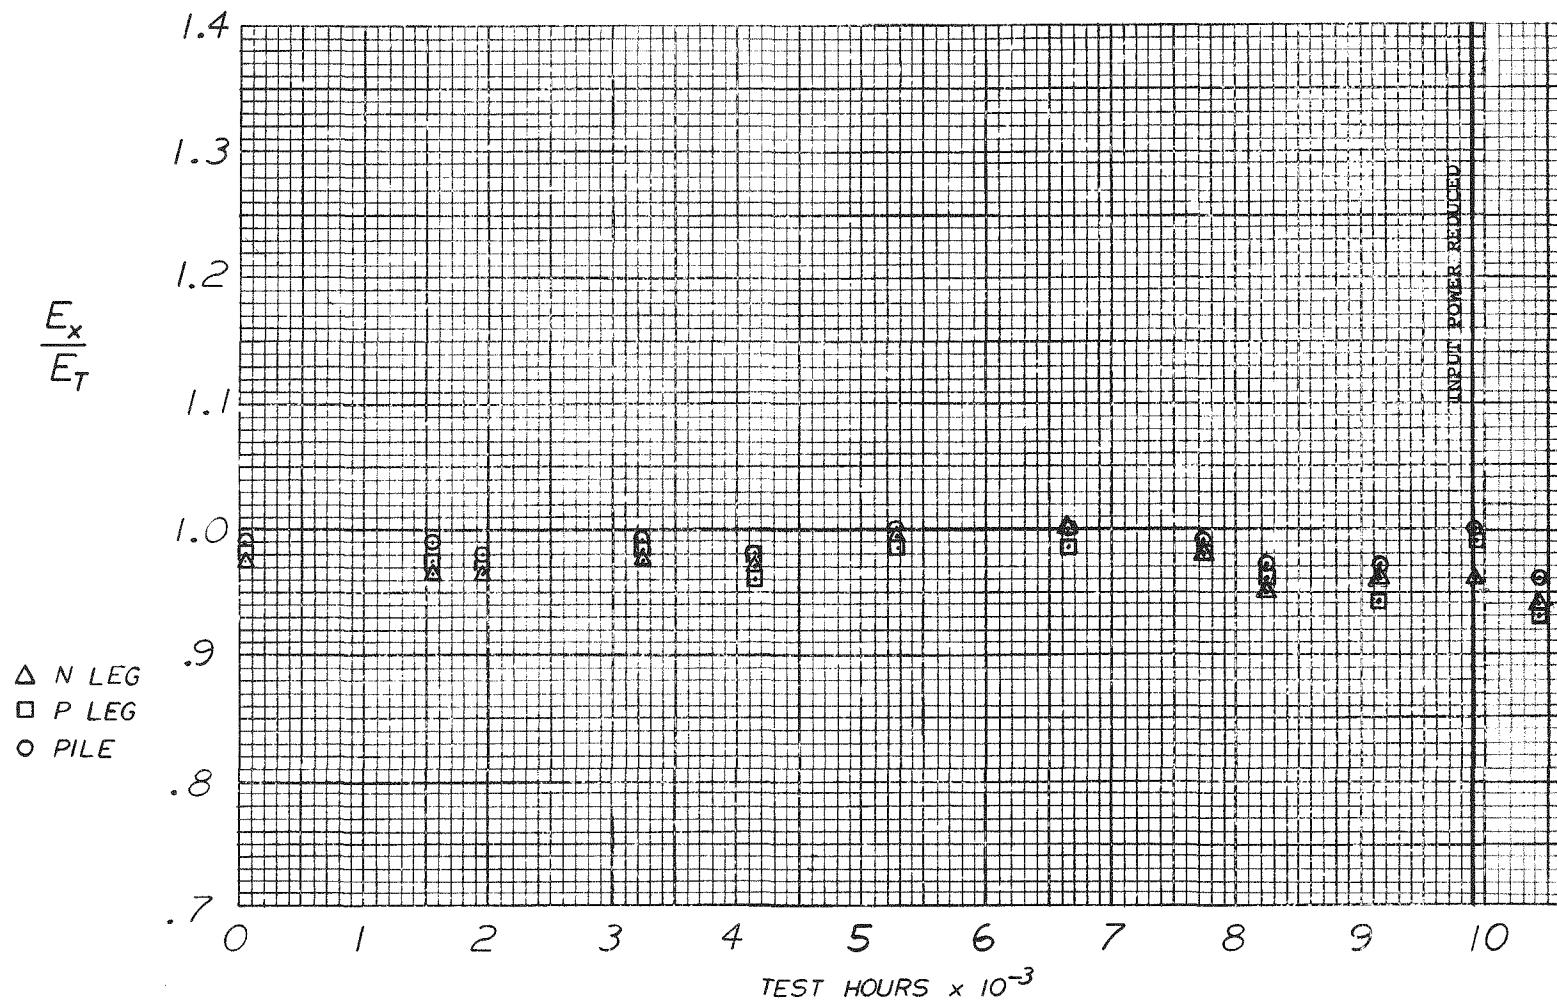
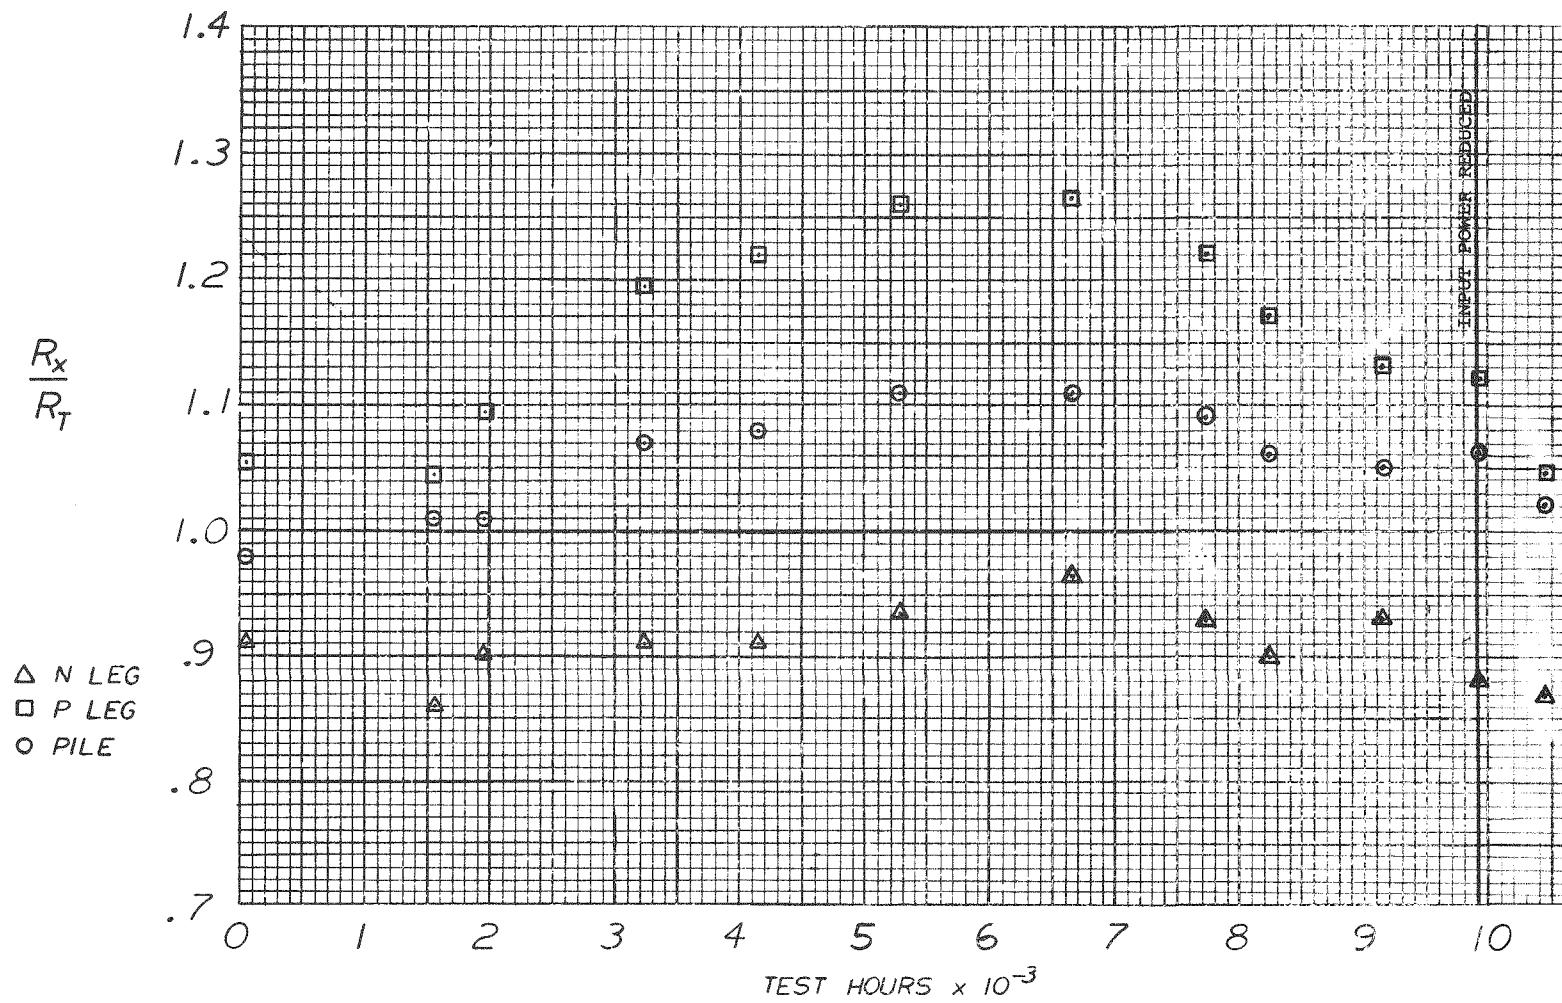
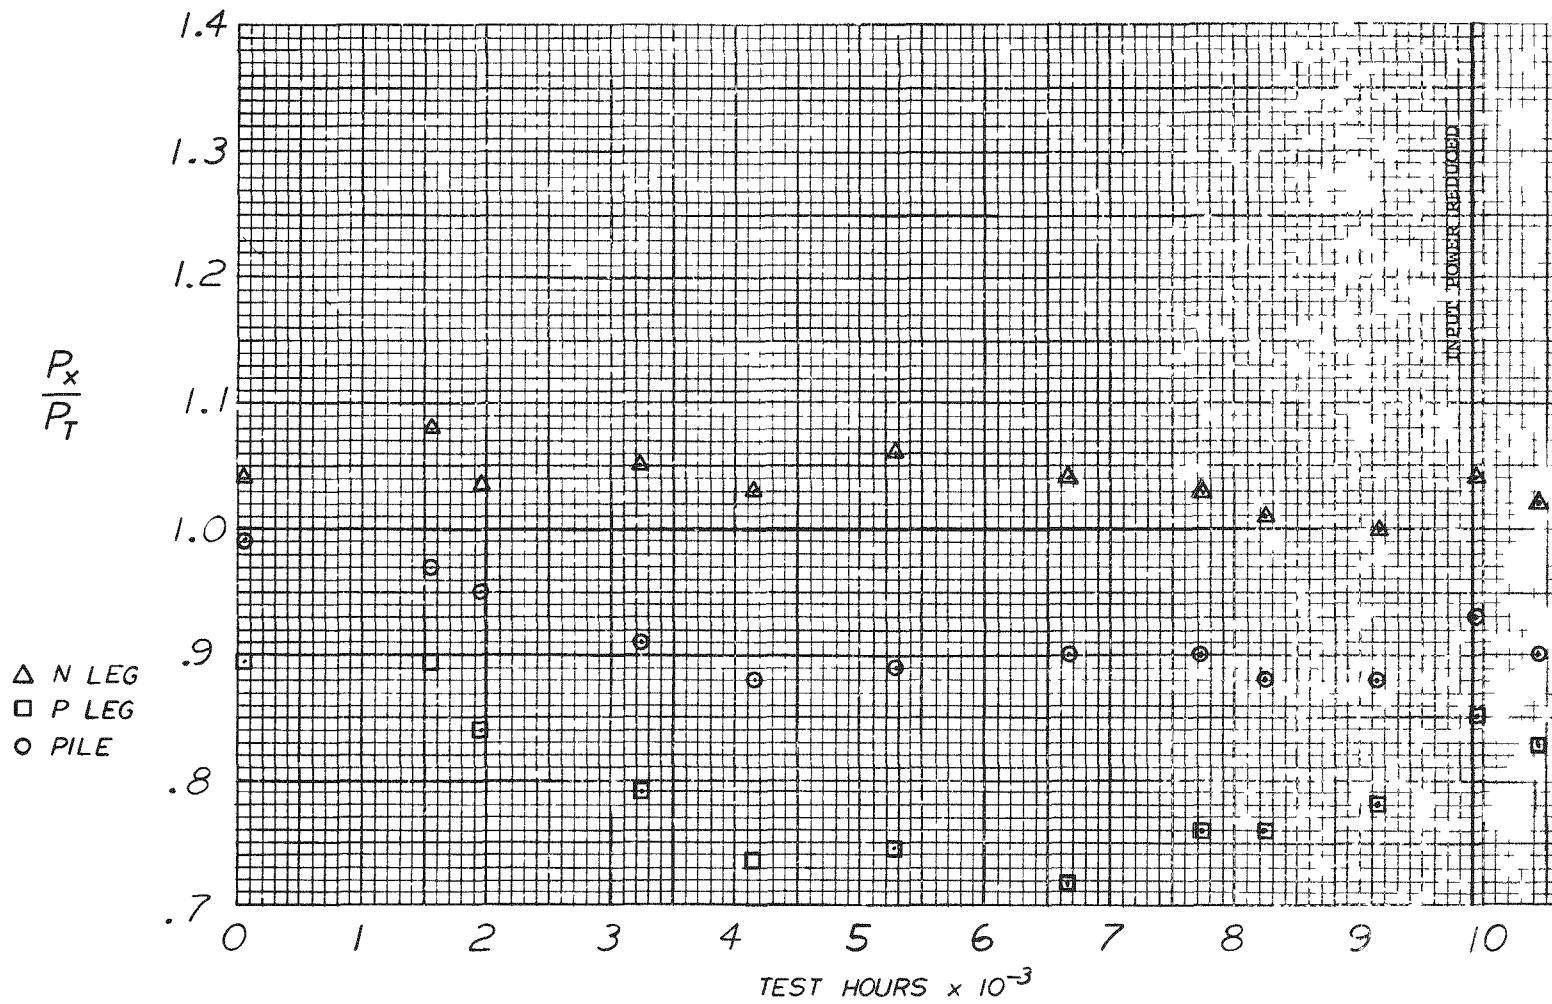
Figure 2-29a. SNAP-21 Thermoelectric Generator A10D7 Normalized Seebeck Voltage Ratio

Figure 2-29b. SNAP-21 Thermoelectric Generator A10D7 Normalized Resistance Ratio

Figure 2-29c. SNAP-21 Thermoelectric Generator A10D7 Normalized Power Ratio

Figures 2-29a through 2-29c show performance curves for this unit. The P-leg continued to decrease in resistance. At the end of this report period, the resistance of the P-leg was at approximately the same value as at the start of test. Also, the N-leg and thermopile decreased slightly. The changes in Seebeck voltage and resistance caused the thermopile and N-legs power-out to stay approximately the same, while the P-leg power-out increased about 7%. There have been no apparent effects from the malfunction of the voltage regulator.

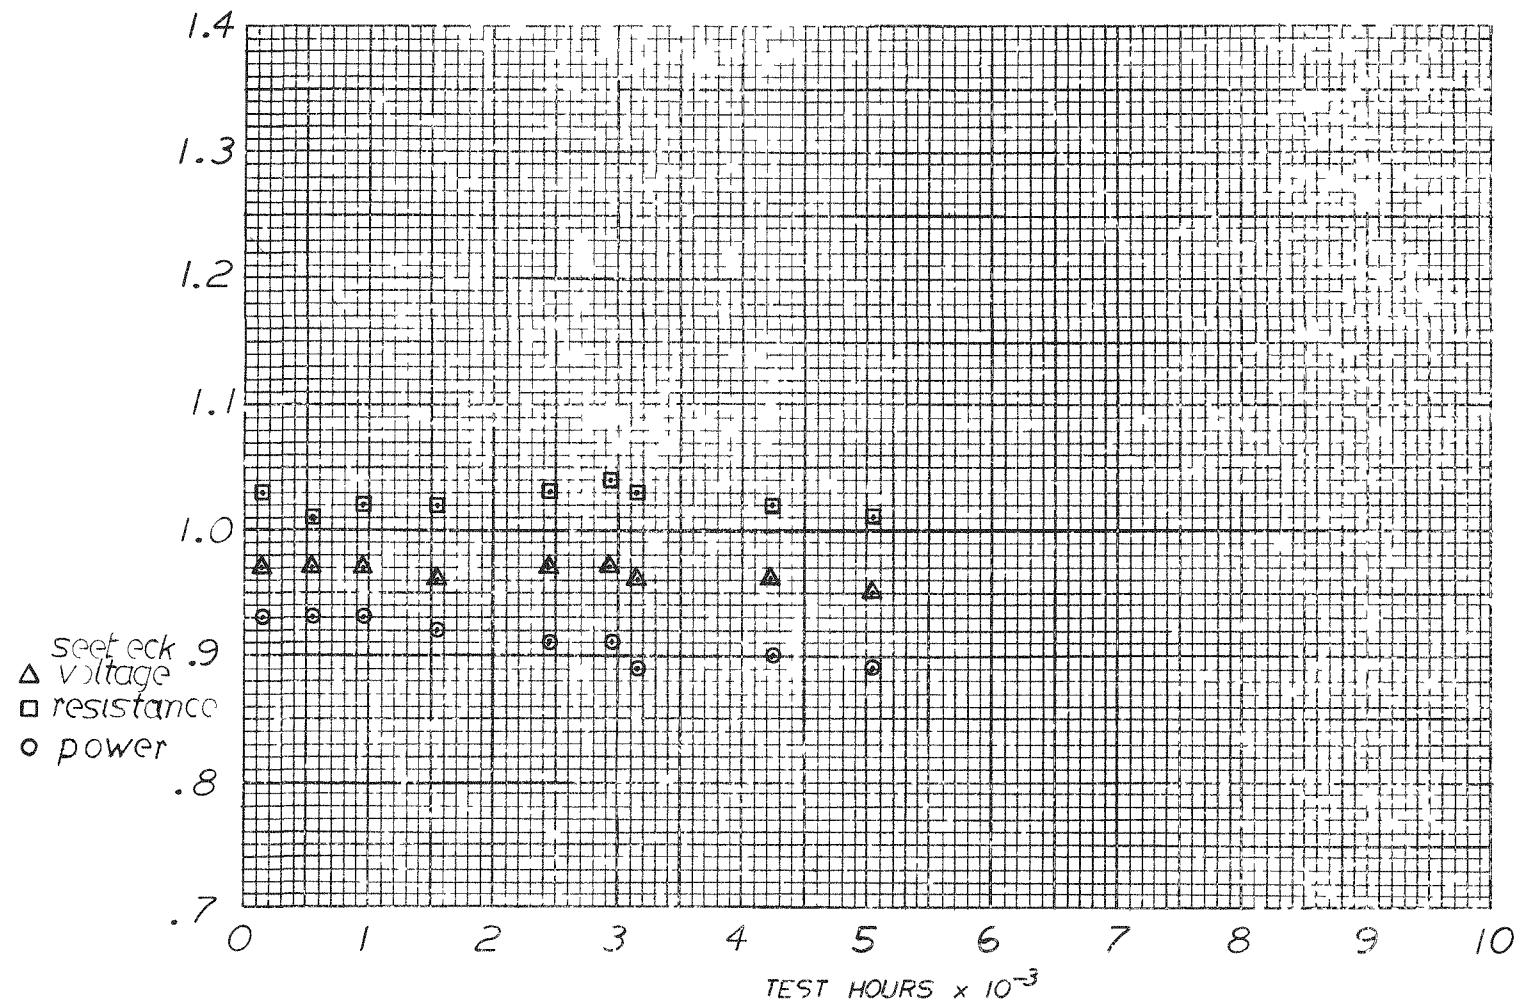
Figure 2-30. SNAP-21 Thermoelectric Generator A10P1 Normalized Data

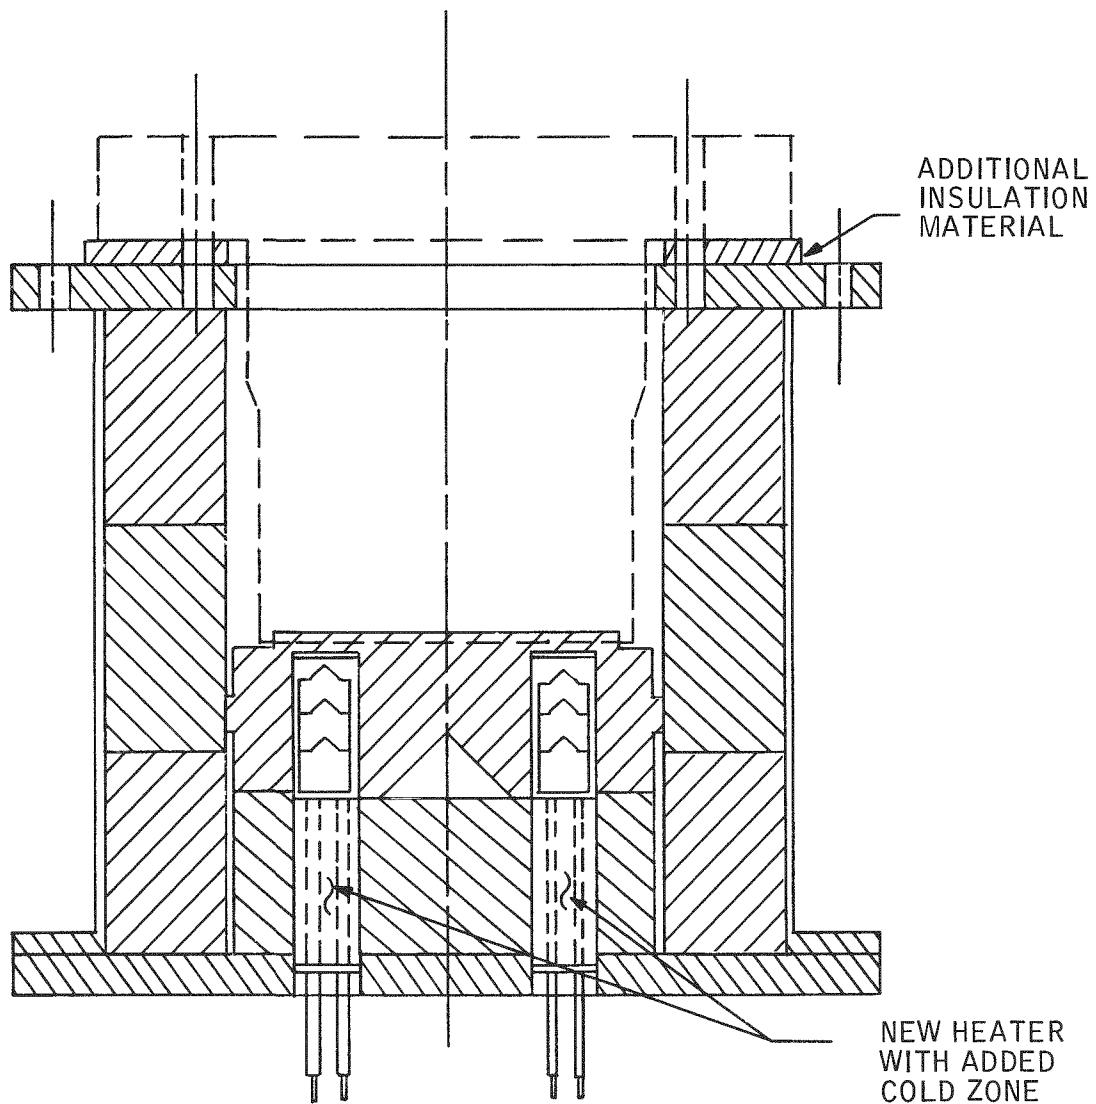
Figure 2-31. Revised Configuration of Test Fixture Showing the New, Dead-Space Heaters

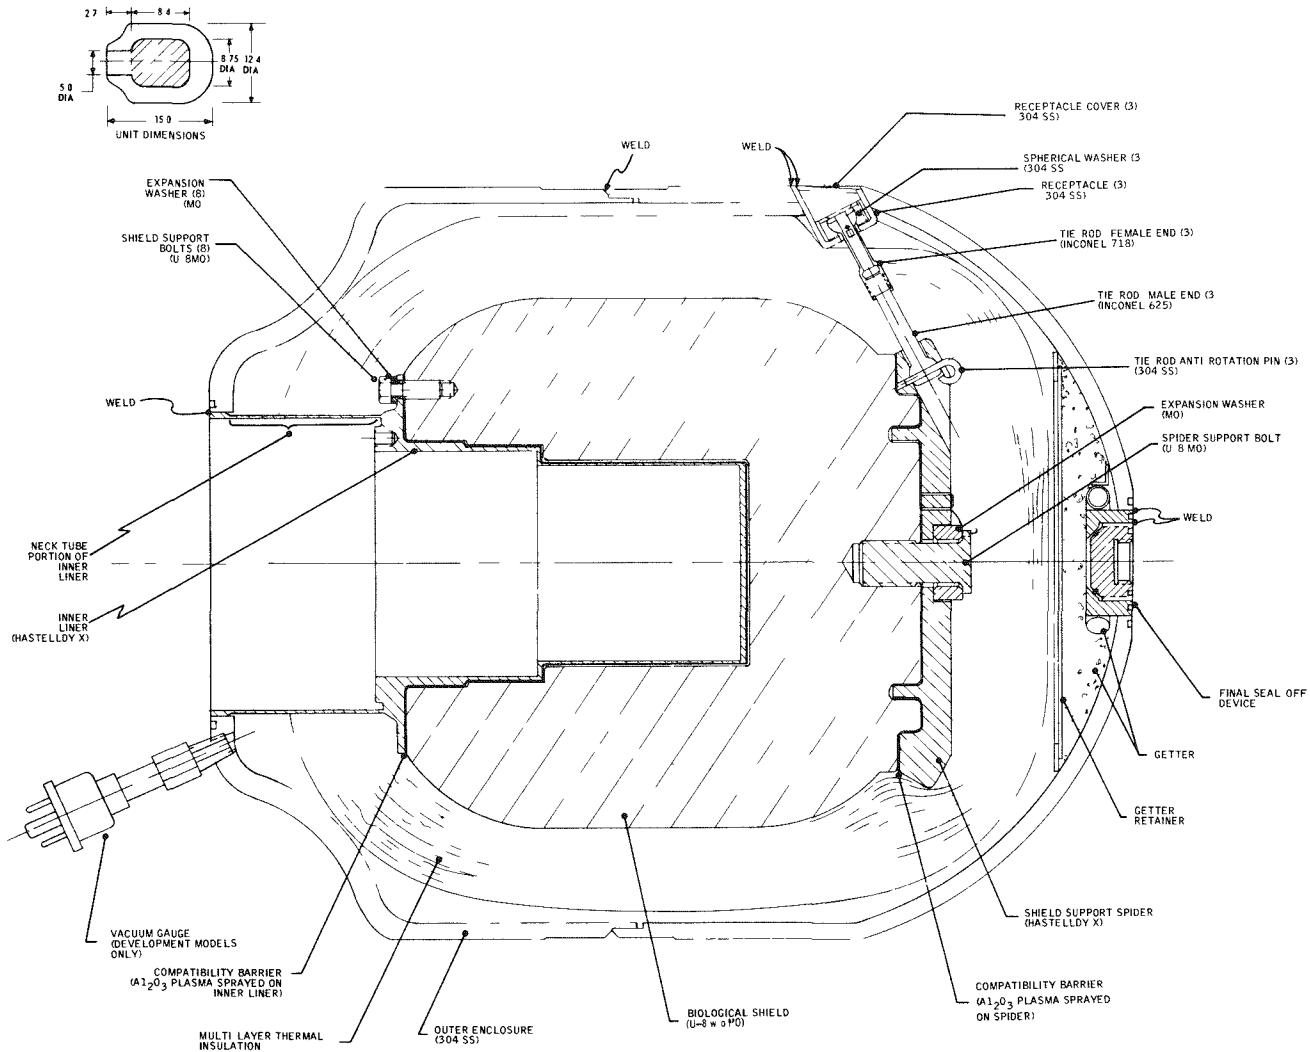
Figure A-1. SNAP-21 High Temperature Vacuum Insulation System

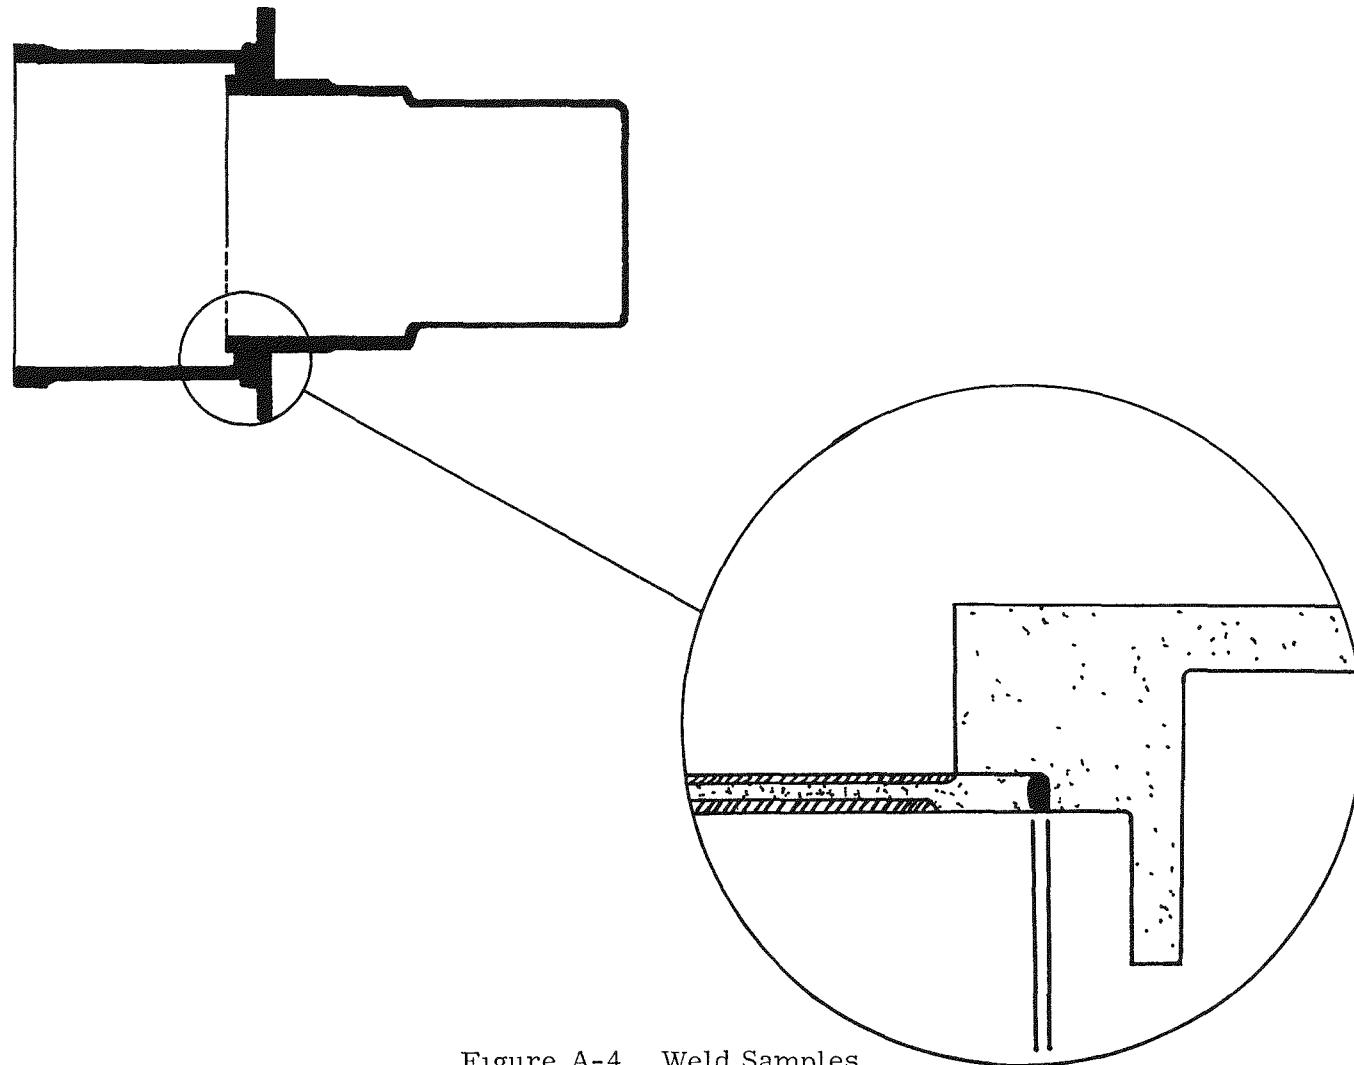
Figure A-4. Weld Samples

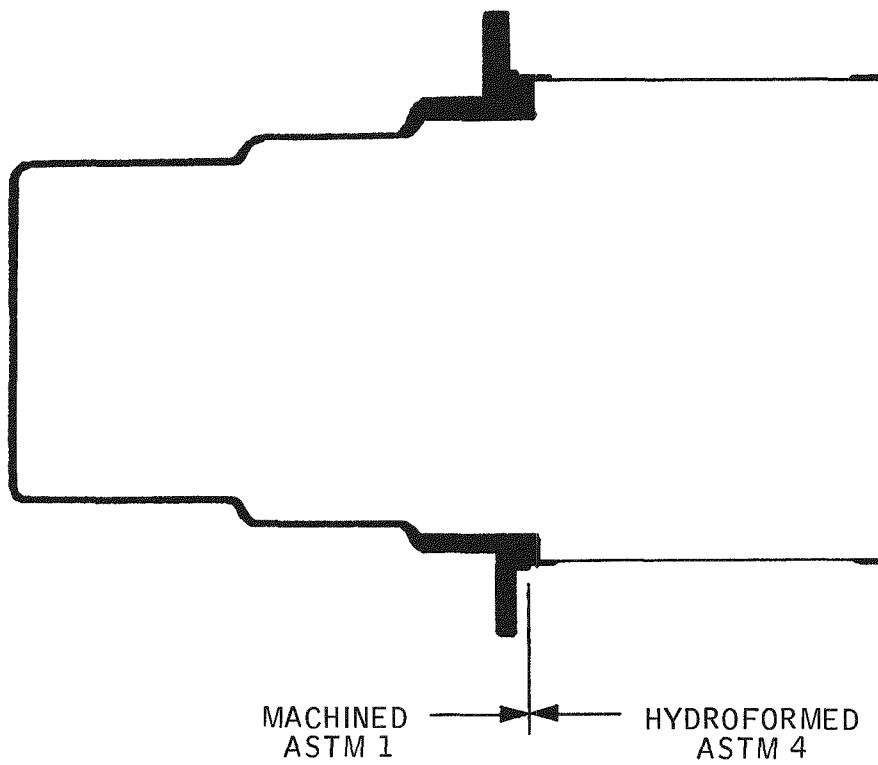
Figure A-5. Minimum Grain Size

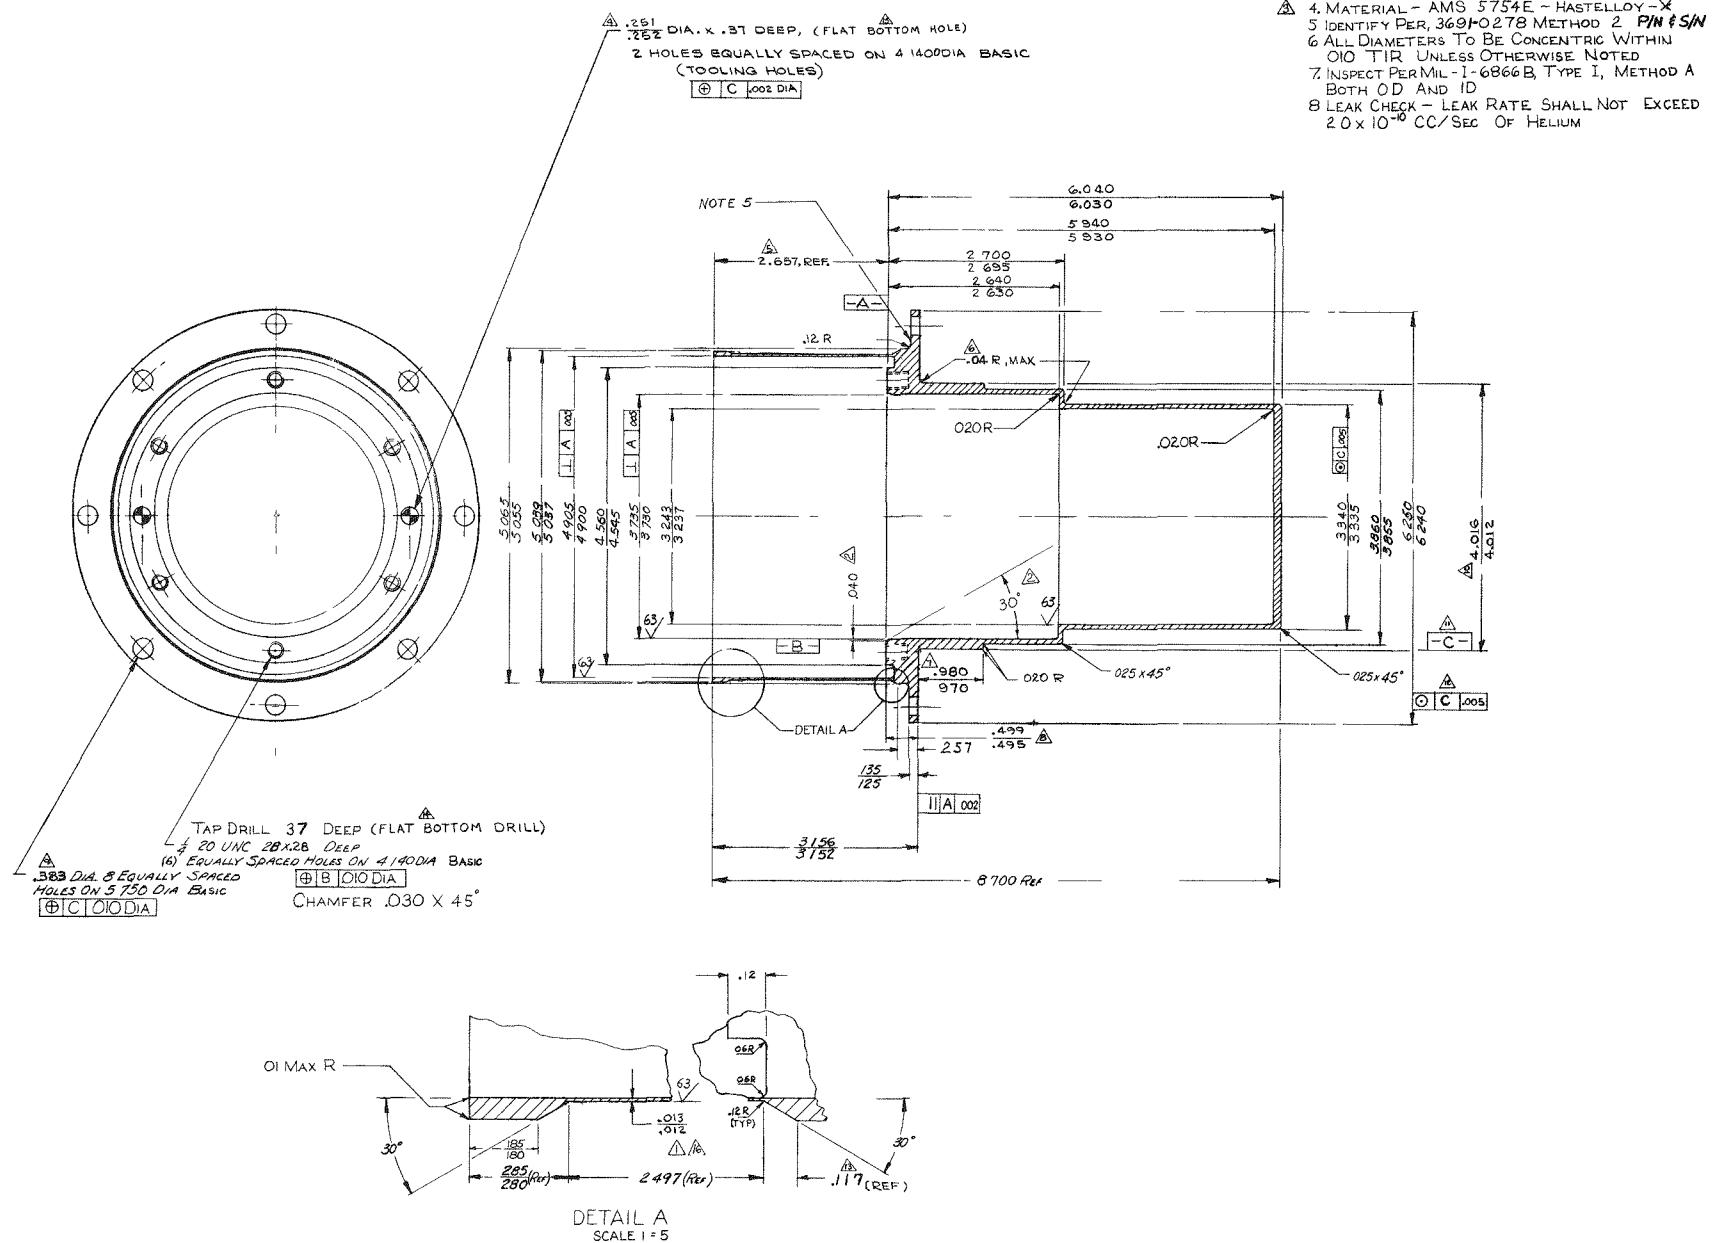
Figure A-6. Inner Liner, Insulation System

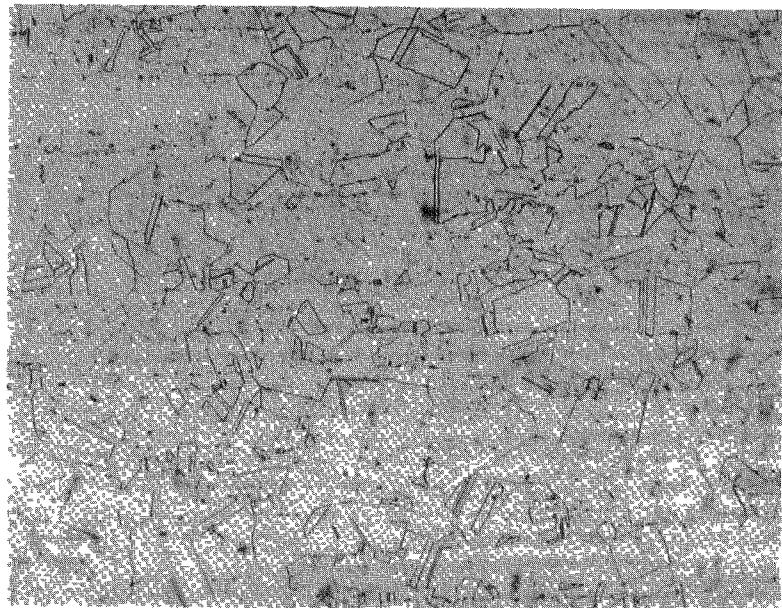
100X

Figure S-47. 0.125 Thick - As Received Sheet
ASTM Grain Size 4-5

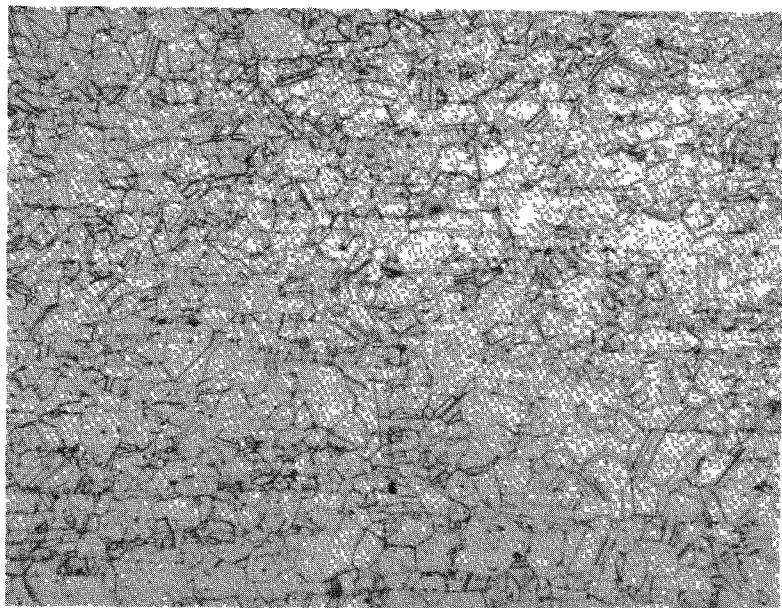
100X

Figure S-50. 0.090 Thick - As Received Sheet
ASTM Grain Size 5-1/2-6-1/2

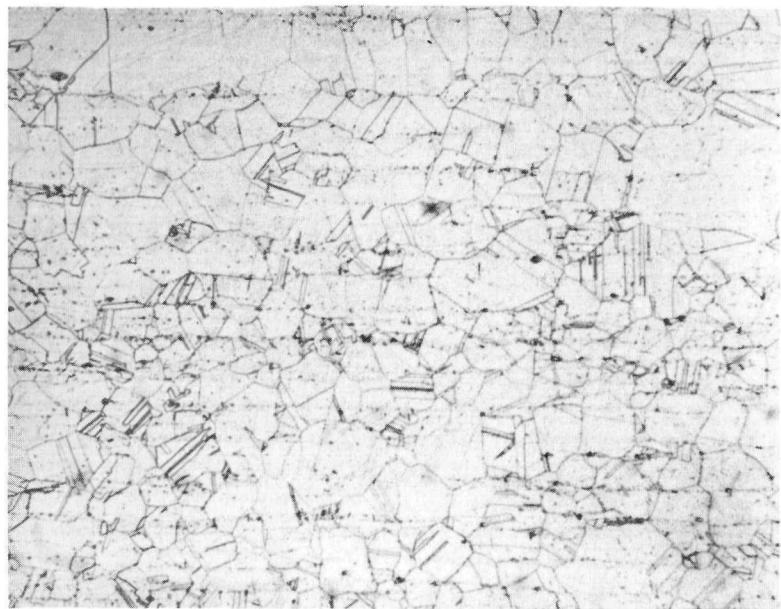
100X

Figure S-60. 0.125 Thick - As Received Sheet
Solv'n Annealed at 2150°F for 10 Min
ASTM Grain Size 4-1/2-5-1/2

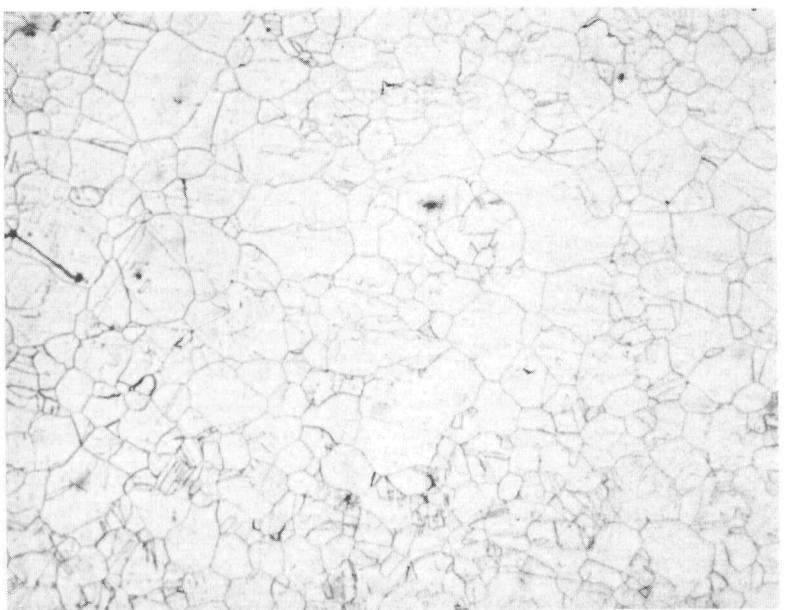
100X

Figure S-91. 0.125 Thick - As Received Sheet
Solv'n Annealed at 2050°F for 10 Min
ASTM Grain Size 4-5-1/2

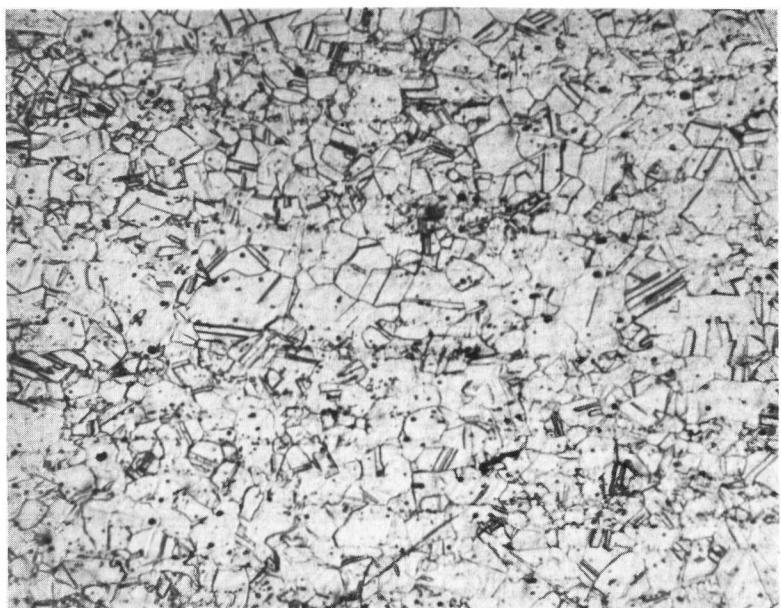
100X

Figure S-56. 0.090 Thick - Hydroformed
#7 - Top
ASTM Grain Size 5-1/2-6-1/2

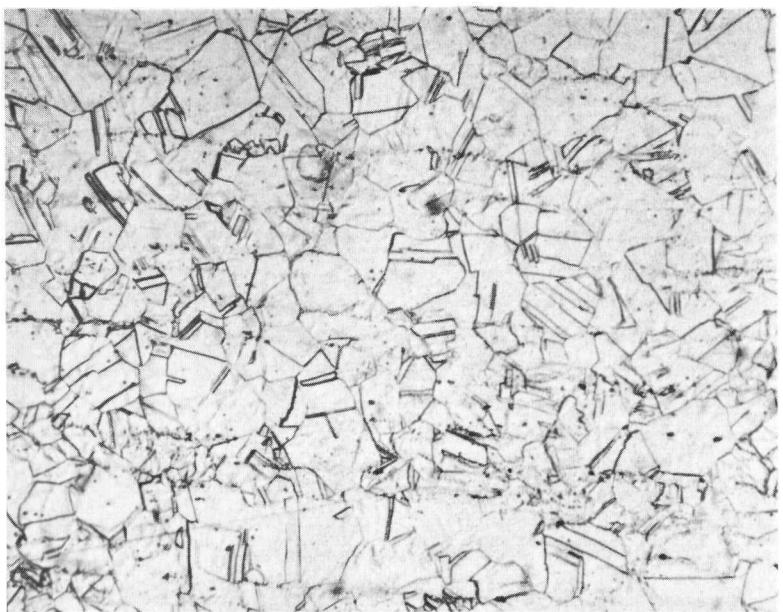
100X

Figure S-58. 0.125 Thick - Hydroformed
#8 - Top
ASTM Grain Size 4-5-1/2

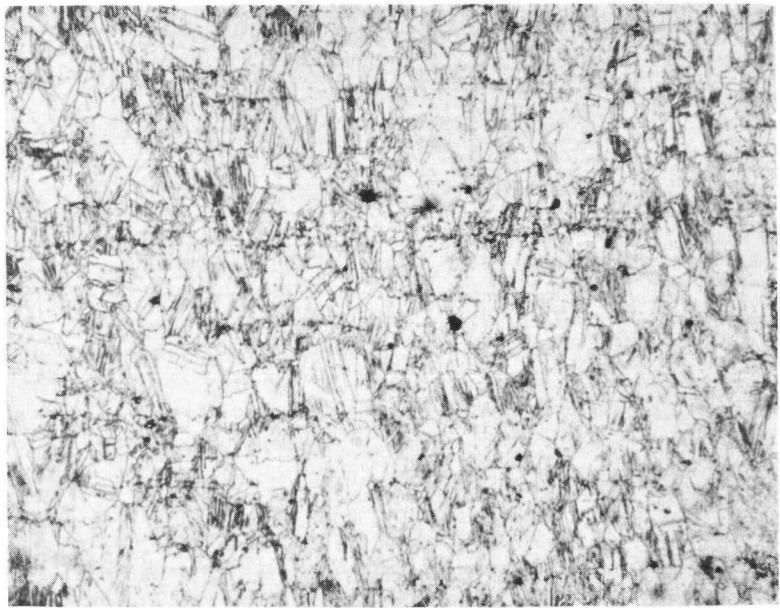
100X

Figure S-59. 0.125 Thick - Hydroformed
#8 - Bottom
ASTM Grain Size 4-1/2-6

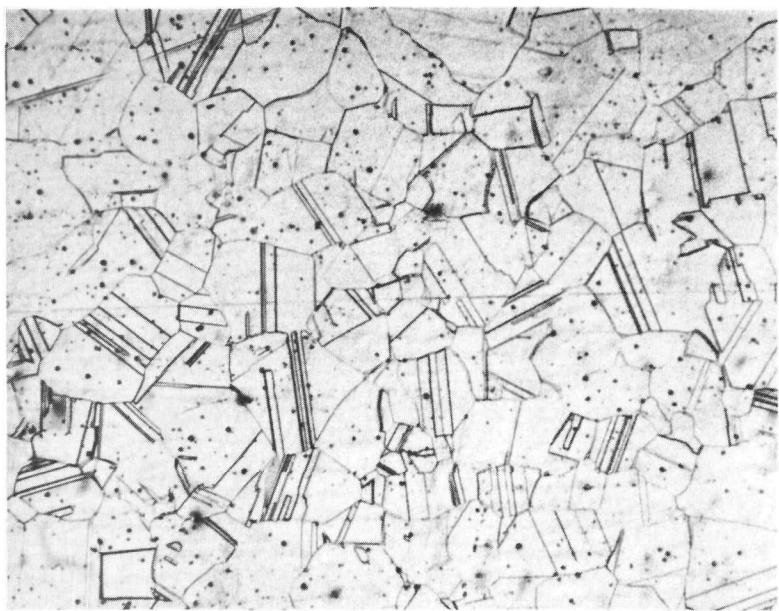
100X

Figure S-99. 0.090 Thick - Hydroformed
#7 - Top
Sol'n Annealed at 2150°F for 10 Min
ASTM Grain Size 4-5

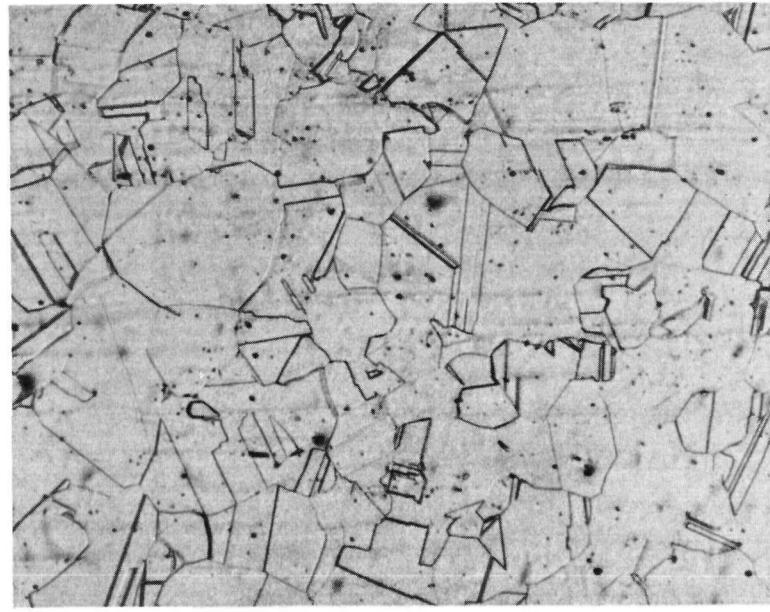
100X

Figure S-101. 0.125 Thick - Hydroformed
#8 - Bottom
Sol'n Annealed at 2150°F for 10 Min
ASTM Grain Size 3-1/2-5

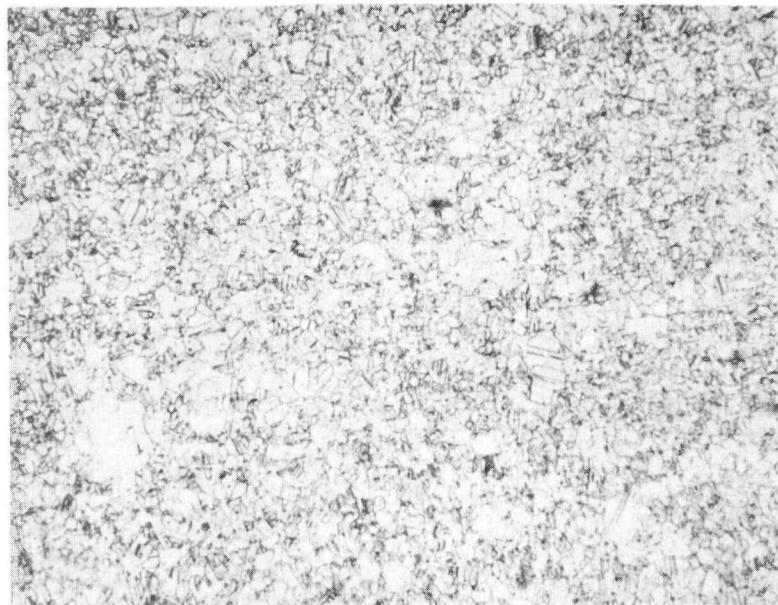
100X

Figure S-88. 0.090 Thick - Hydroformed
#7 - Top
Solv'n Annealed at 2050°F for 10 Min
ASTM Grain Size 6-7-1/2

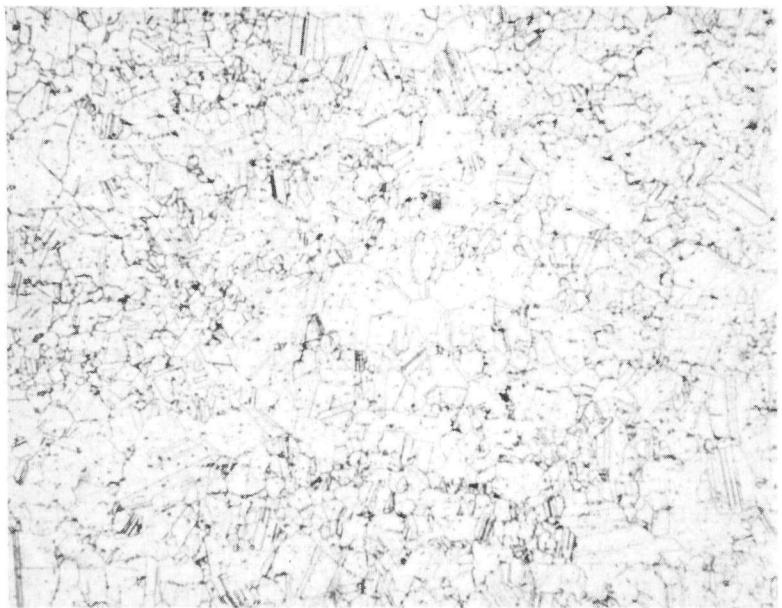
100X

Figure S-80. 0.090 Thick - Hydroformed
#7 - Top
Sol'n Annealed at 1950°F for 10 Min
ASTM Grain Size 5-7

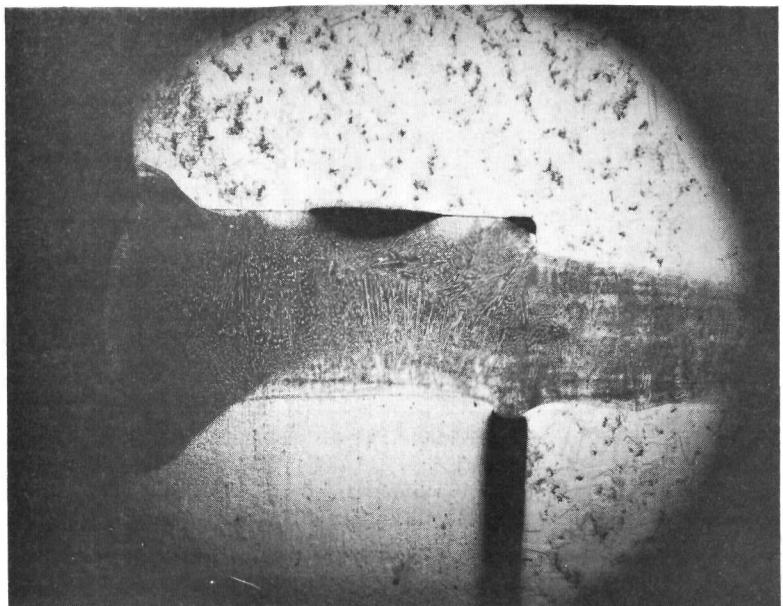
16X

Figure S-65. Inner Liner #2
Electron Beam Welded Joint Showing
the Results of an Improperly Located
Beam on the Weld Joint

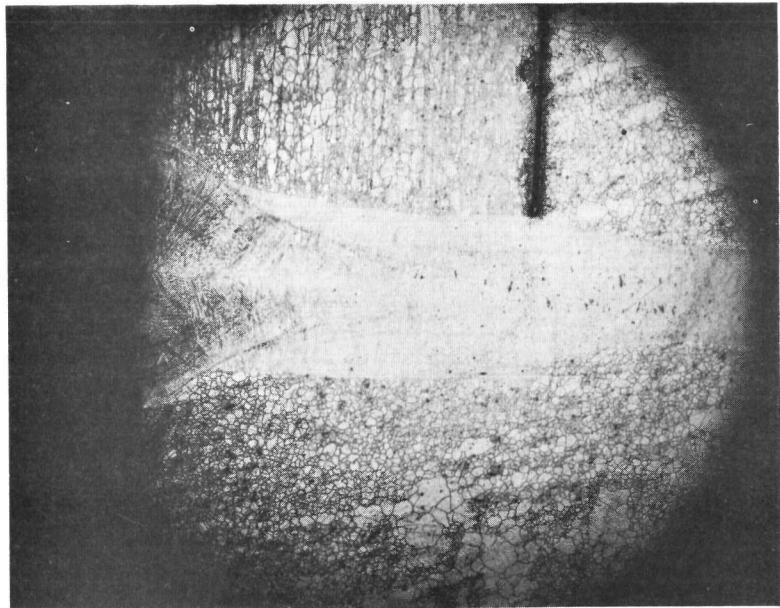
16X

Figure S-95. Inner Liner #1
Example of Satisfactory Weld Joint

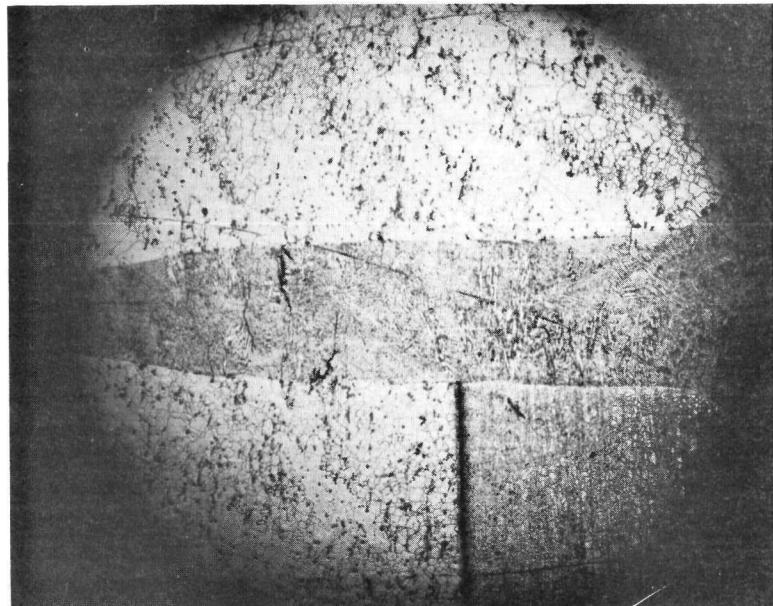
16X

Figure S-93. Inner Liner #3
Electron Beam Welded Joint Showing
Stress Cracking in the Weld Zone that
Penetrated Too Deeply into the
Base Material

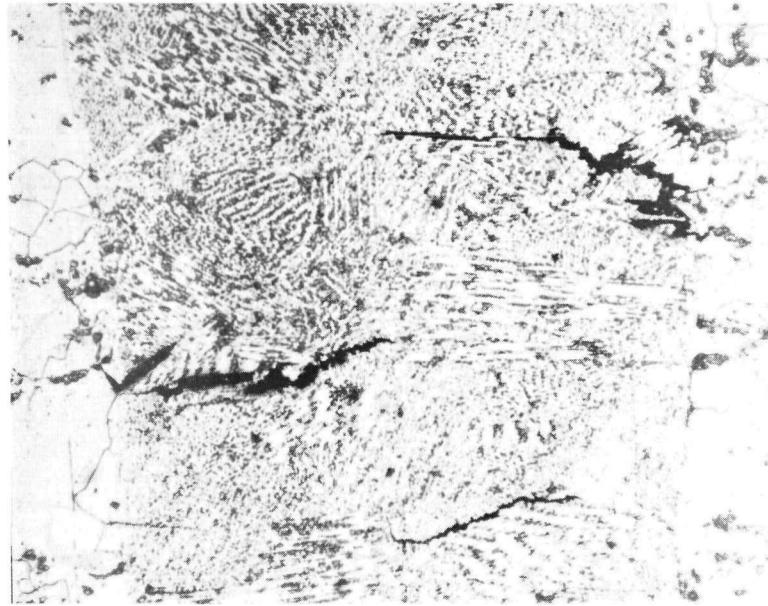
100X

Figure S-93A. Magnified View of the Cracked Area Shown in
Figure S-93. Note that the Cracks Appear to
Extend into the Grain Boundaries of the
Base Material
