GA-9356

TESTS RELATING TO CORROSION PROTECTION FOR TENDONS OF THE PUBLIC SERVICE COMPANY OF COLORADO PRESTRESSED CONCRETE REACTOR VESSEL

Gulf General Atomic Project 901

August 6, 1969

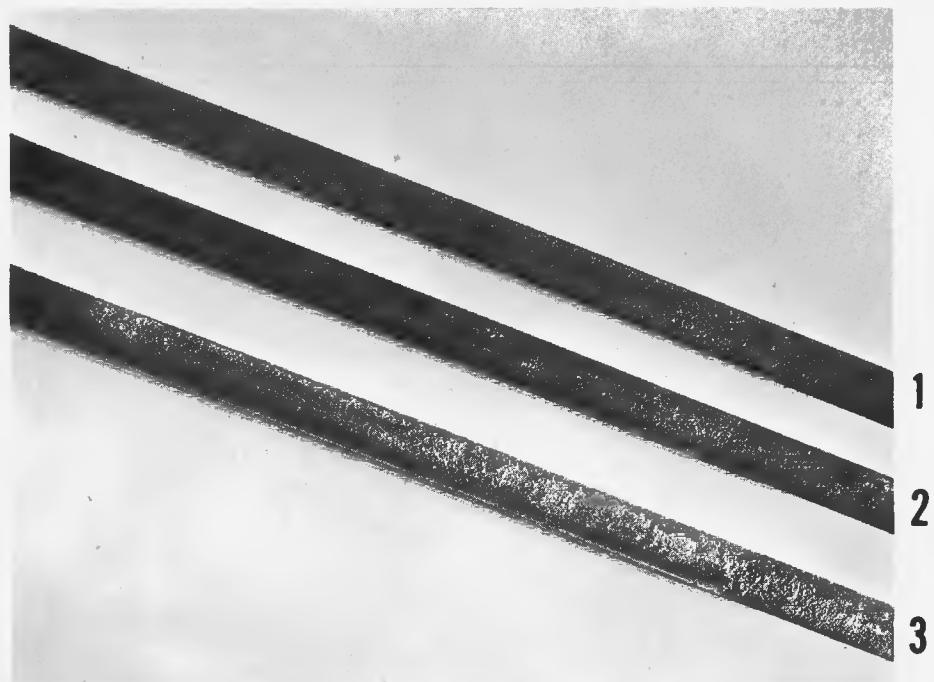
HT72666

Fig. 4.6. Samples of production Meta Bond coated wire after 6-month exposure to coastal environment: (1) and (2) fully exposed; (3) partially exposed

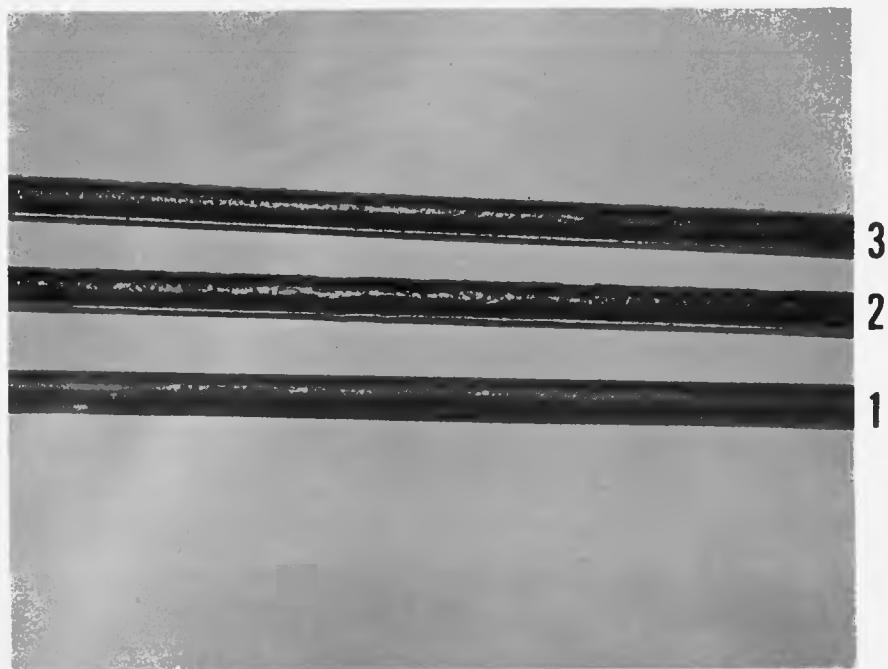
Z0232

Fig. 4.10. Coated tendon wires after 18-month coastal exposure. Wire coated with No-Ox-Id 500 (1) exhibited some rust; wires coated with No-Ox-Id 500 plus CM (2) and with CM alone (3) were not visibly rusted.
